# NAVAL POSTGRADUATE SCHOOL

A-10/GAU-8 LOW ANGLE FIRINGS VERSUS  
SIMULATED SOVIET TANK BATTALION  
(HONEYWELL LOT NUMBER 0L78D043-016)  
(ARRAY 3)

2 FEBRUARY 1979

R.H.S. STOLFI  
R.R. MCEACHIN

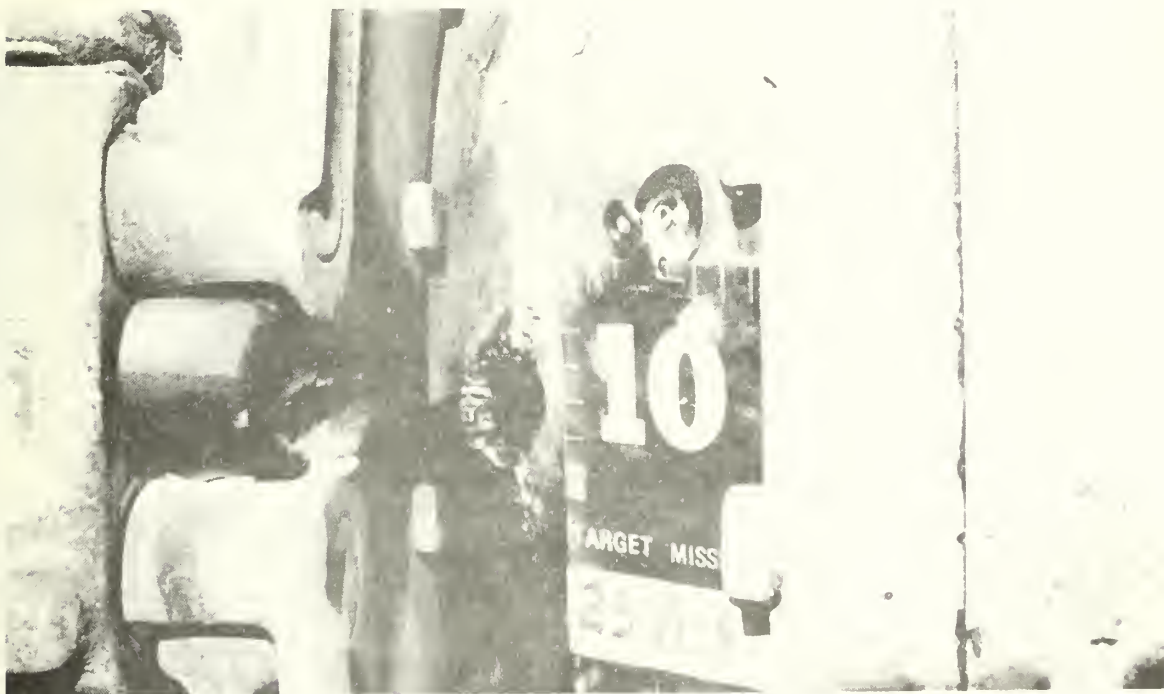
Both final drives were damaged sufficiently to cause an M-Kill. Impacts 10 and 11, shown in Figures 38 and 39, respectively, penetrated the left final drive. Impact 25 (Figure 40) penetrated the right final drive.

FIGURE 38. Impact Ten, Target 23, Penetration into the Left Final Drive.

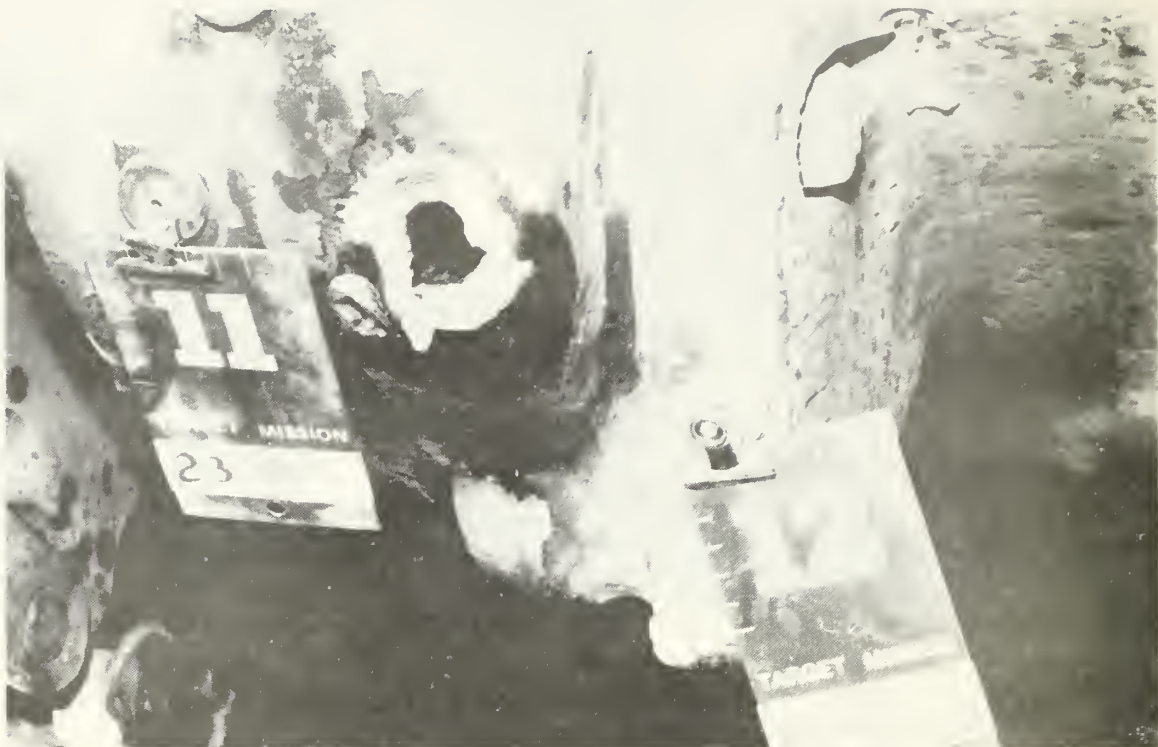
FIGURE 39. Impact Eleven, Target 23, Penetration into the Left Final Drive.

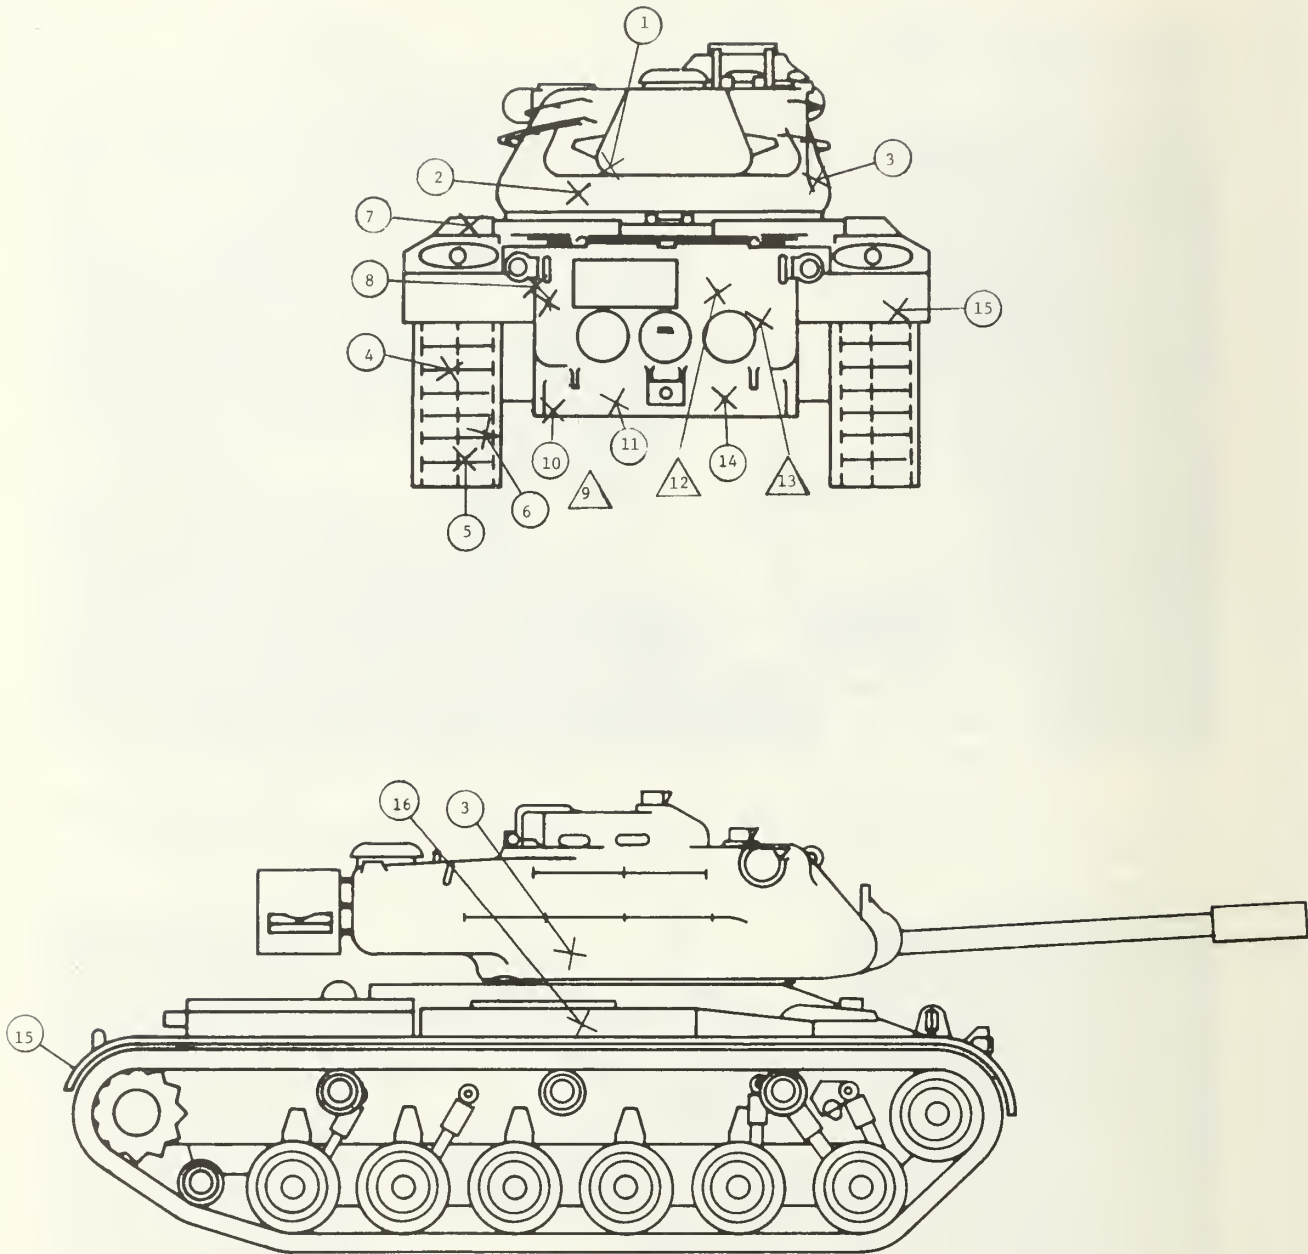
FIGURE 41. Impact Diagram, Target 26.

100% M-Kill, resulting from the following projectile impacts, shown in Figure 41:

A 100% M-Kill was assessed because of Impacts 12 and 13, shown in Figures 42 and 43, respectively, which perforated the rear hull armor and penetrated the transmission case. Two other impacts (4 and 6), which caused slight damage to the track, made a minor contribution to the kill. One other hit (Impact 9) perforated the rear hull into the transmission compartment, but the extent of the damage could not be determined.

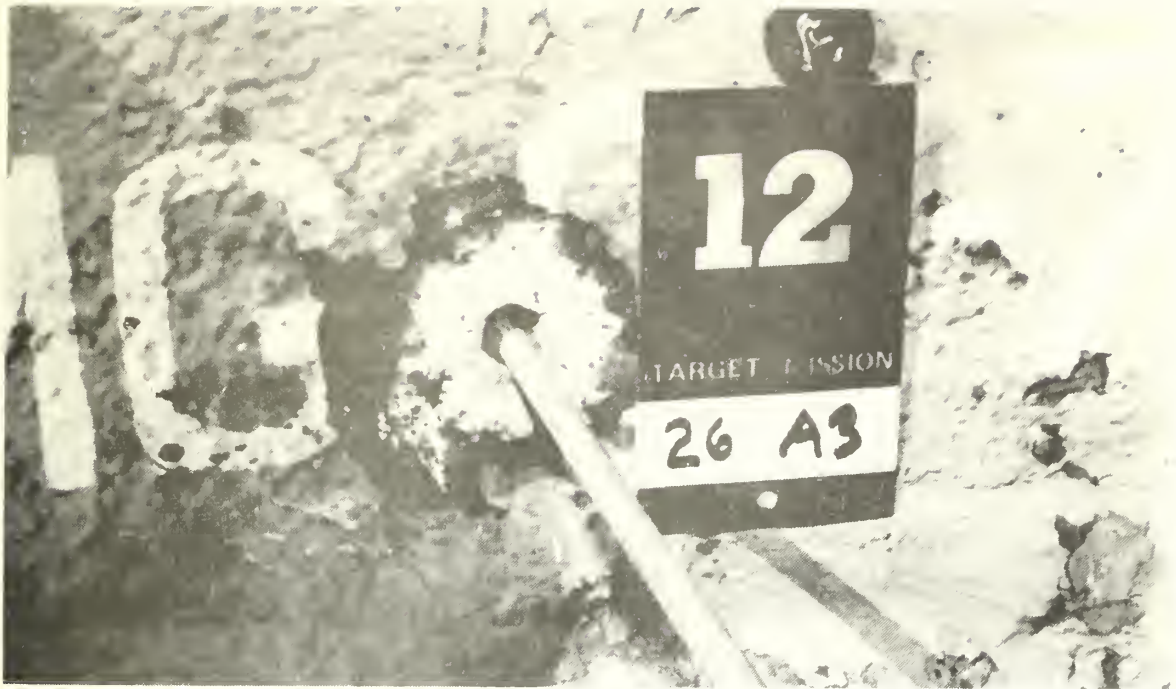
FIGURE 42. Impact Twelve, Target 26, Perforation of Rear Hull Armor and Penetration into the Transmission Case.

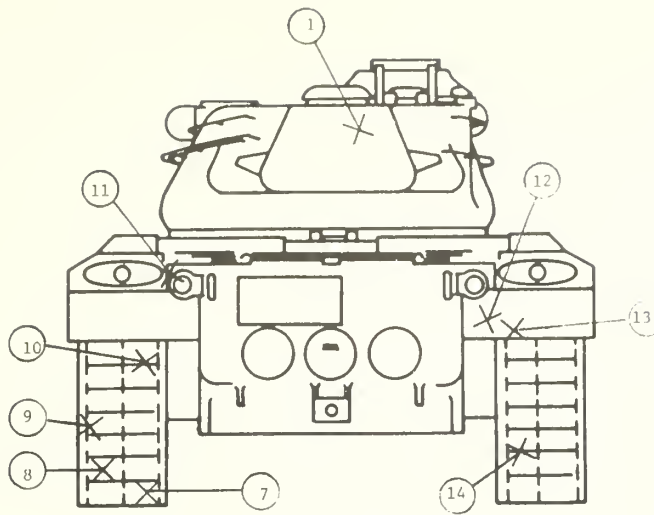
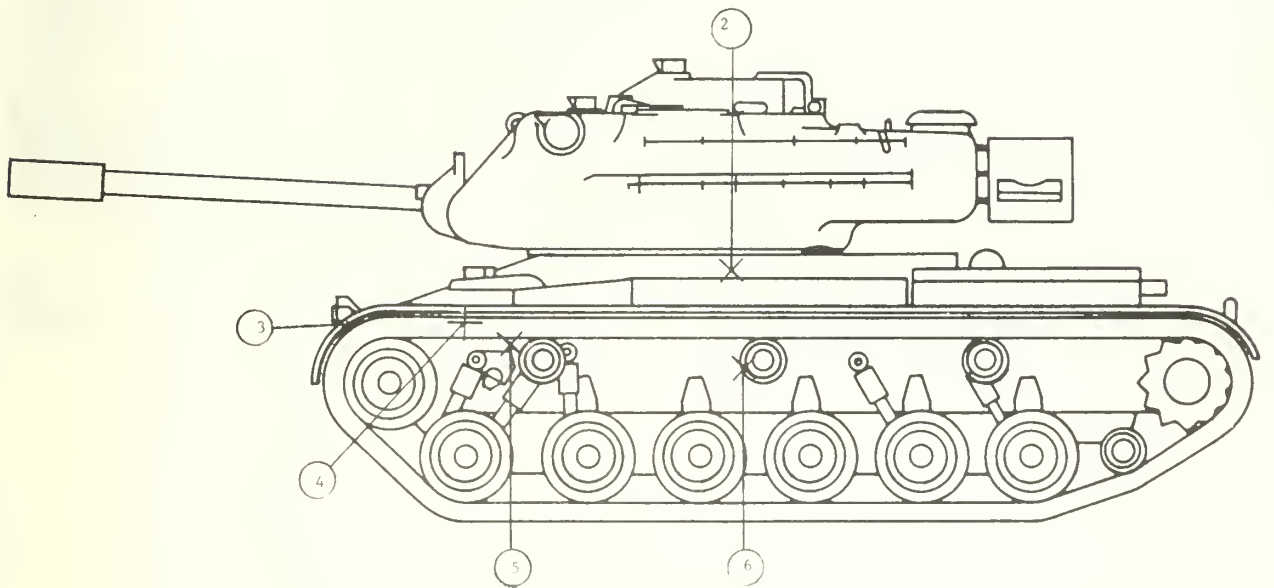
FIGURE 44. Impact Diagram, Target 27.

10% M-Kill, resulting from the following projectile impacts, shown in Figure 44:

A 10% M-Kill was assessed due to the impacts on the track and suspension system. Impact 6, shown in Figure 45, is representative of the most severe damage inflicted during this attack.

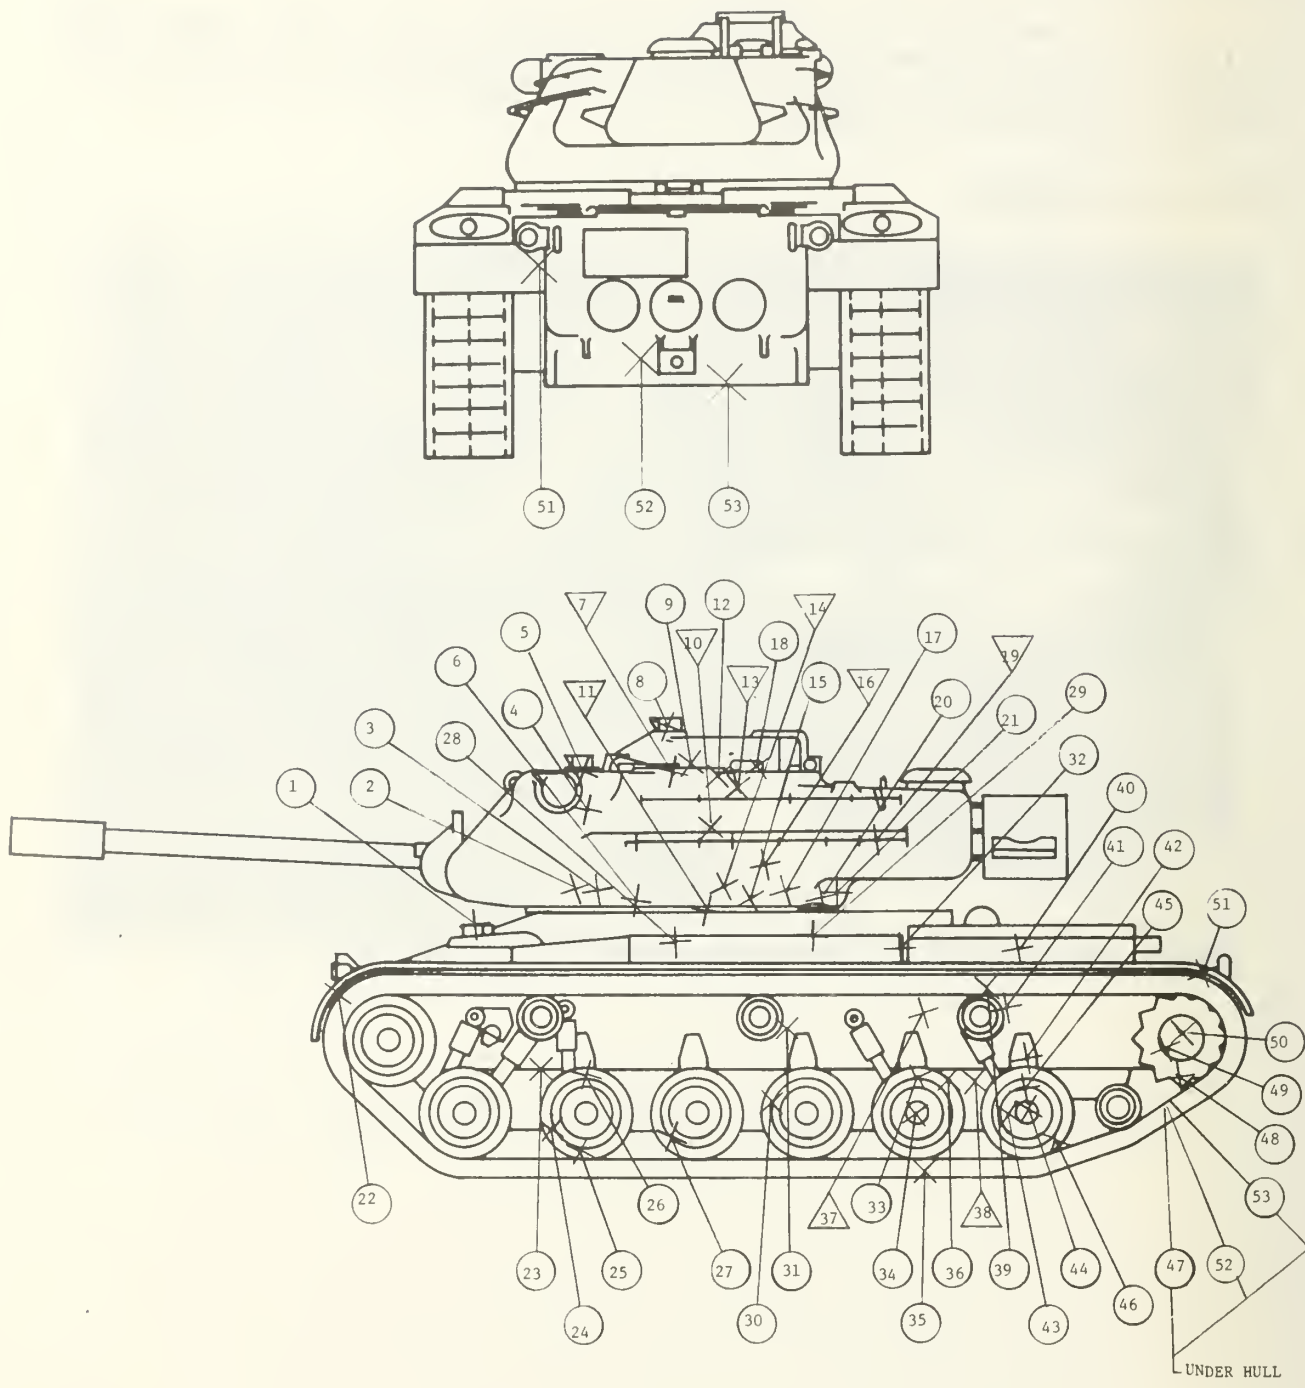
FIGURE 46. Impact Diagram, Target 28.

100% M-Kill and 95% F-Kill, resulting from the following projectile impacts, shown in Figure 46:

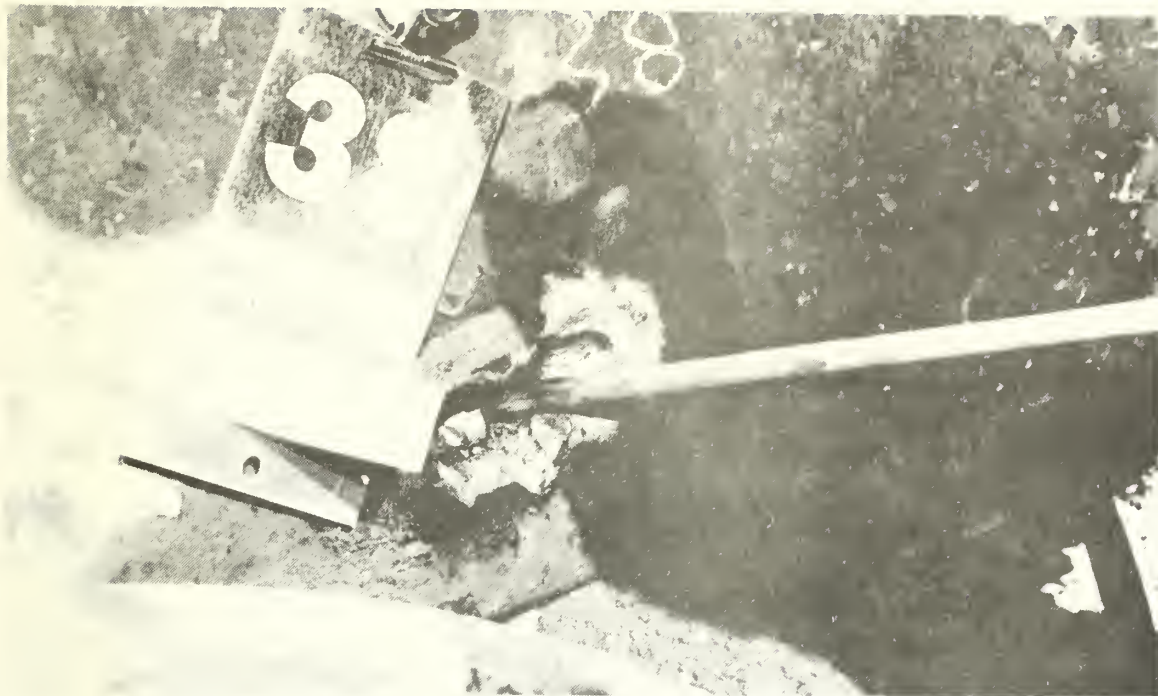
- a. M-Kill: A 100% M-Kill was assessed because of Impact 38 (Figure 47) which perforated the left hull and penetrated the left fuel tank, and to Impacts 34 and 44, shown in Figures 48 and 49, respectively, which destroyed the left #5 and #6 roadwheel hubs. Cumulative damage to the track and suspension system from 10 other impacts contributed to the M-Kill.
- b. F-Kill: A 95% F-Kill was assessed because of casualties caused to all crewmen in the fighting compartment by eight perforations of the hull and turret armor. One additional perforation had no behind-the-plate effects.

FIGURE 47. Impact Thirty-Eight, Target 28, Perforation of Hull Armor and Penetration into Left Fuel Tank.

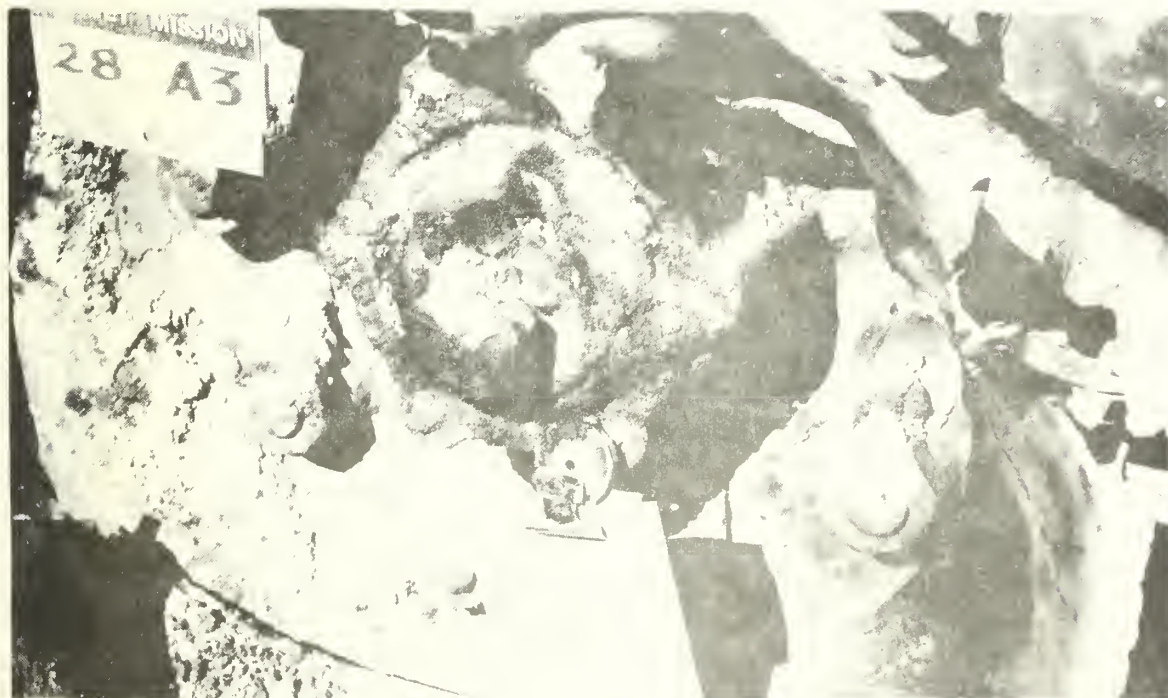
FIGURE 48. Impact Thirty-Four, Target 28, Which Destroyed the Left Number 5 Roadwheel Hub.

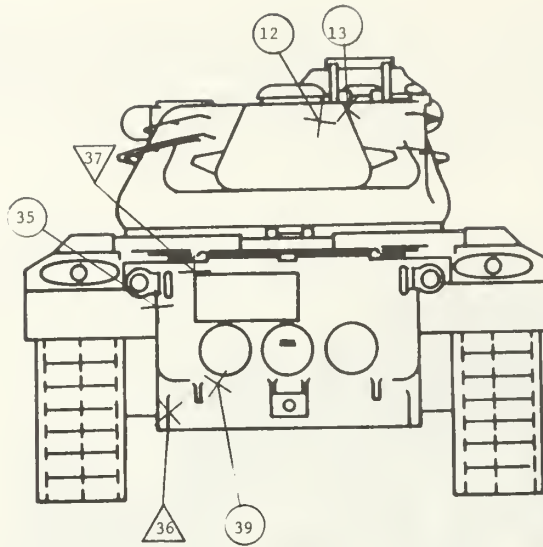
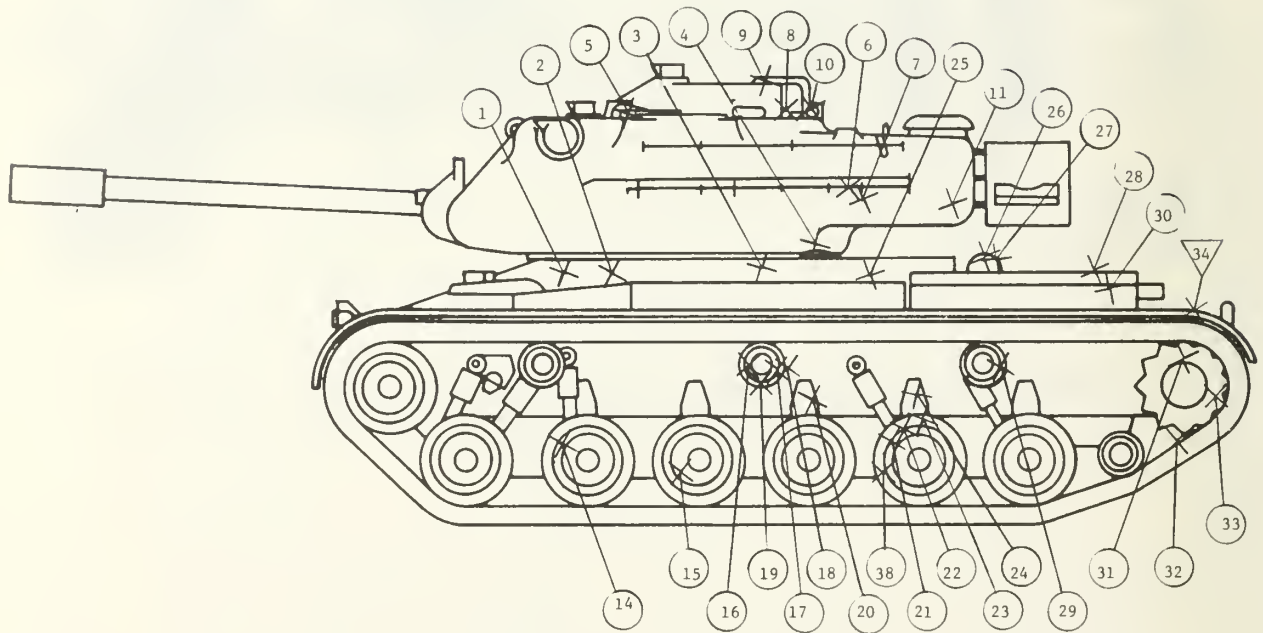
FIGURE 50. Impact Diagram, Target 29.

100% M-Kill, resulting from the following projectile impacts, shown in Figure 50:

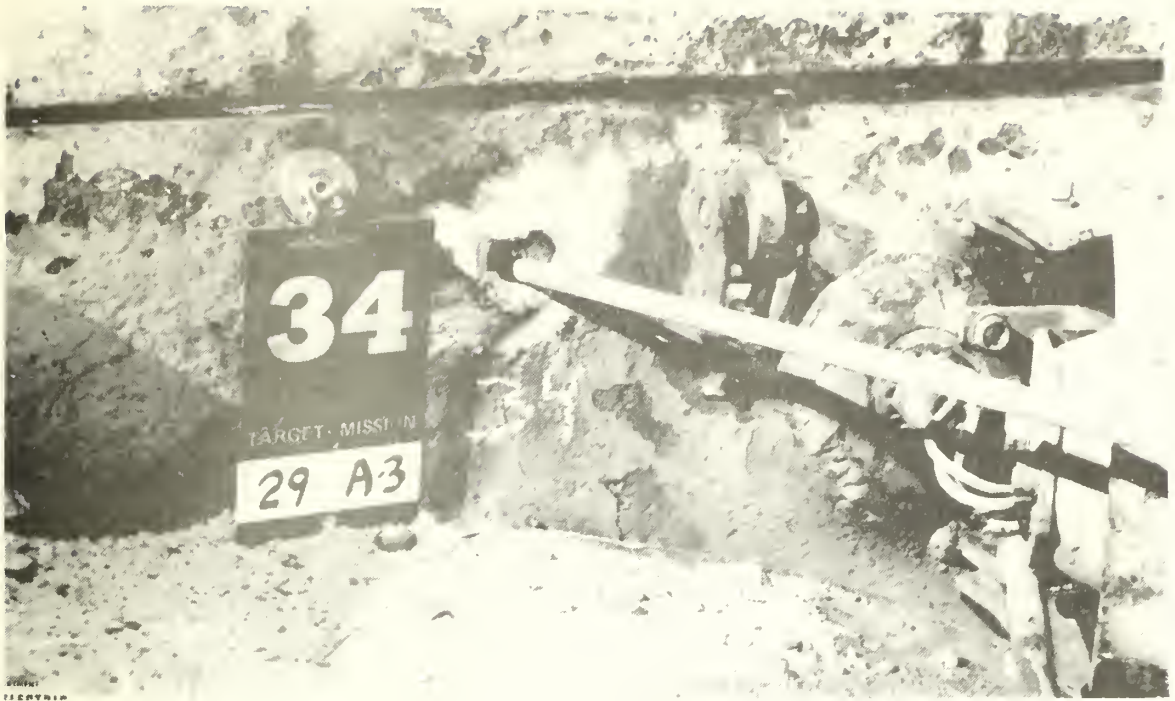
There were three perforations into the transmission compartment, one of which (Impact 37) had no behind-the-plate effects. Either of the other two perforations was capable of causing an M-Kill. Impact 34 (Figure 51) perforated the left hull armor and severed the steering control rod. Impact 36 (Figure 52) perforated the rear hull armor and penetrated the transmission case. Cumulative damage to the track and suspension system from 14 other impacts contributed to the kill.

FIGURE 51. Impact Thirty-Four, Target 29, Perforation of Left Hull Armor Which Severed the Steering Control Rod.

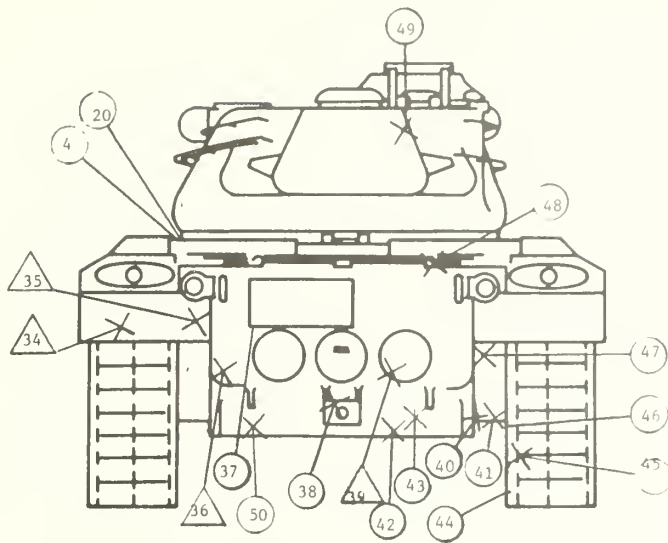
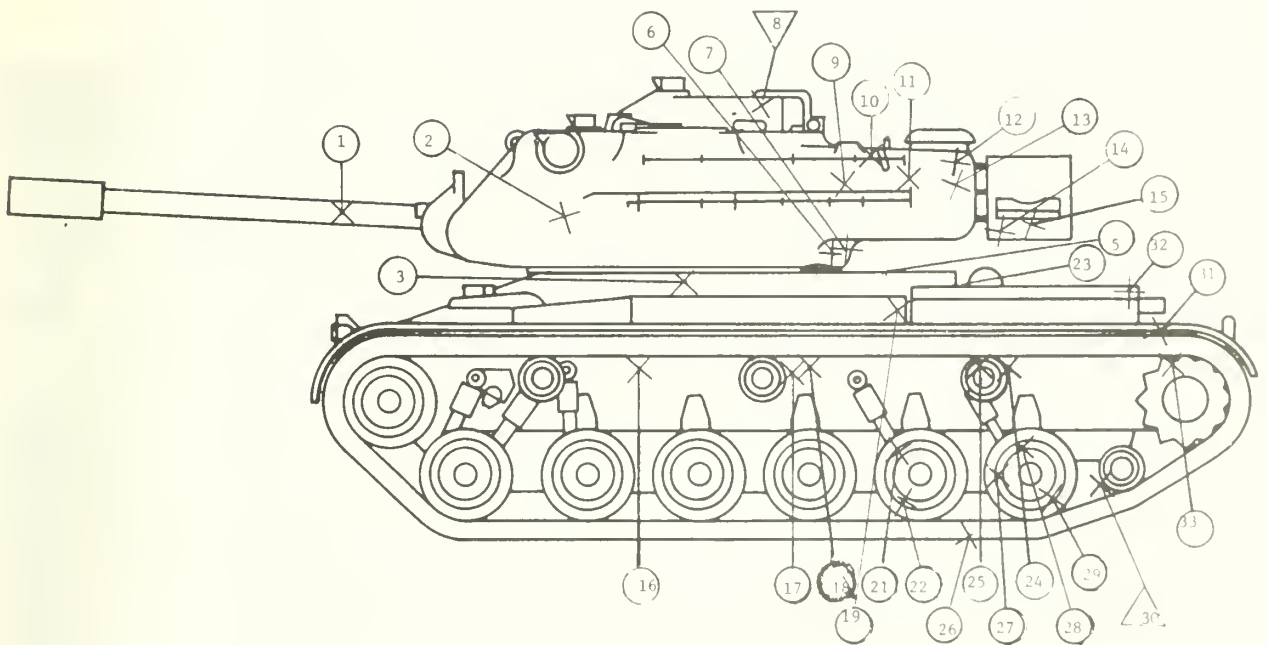
FIGURE 53. Impact Diagram, Target 30.

100% M-Kill and 100% F-Kill, resulting from the following projectile impacts, shown in Figure 53:

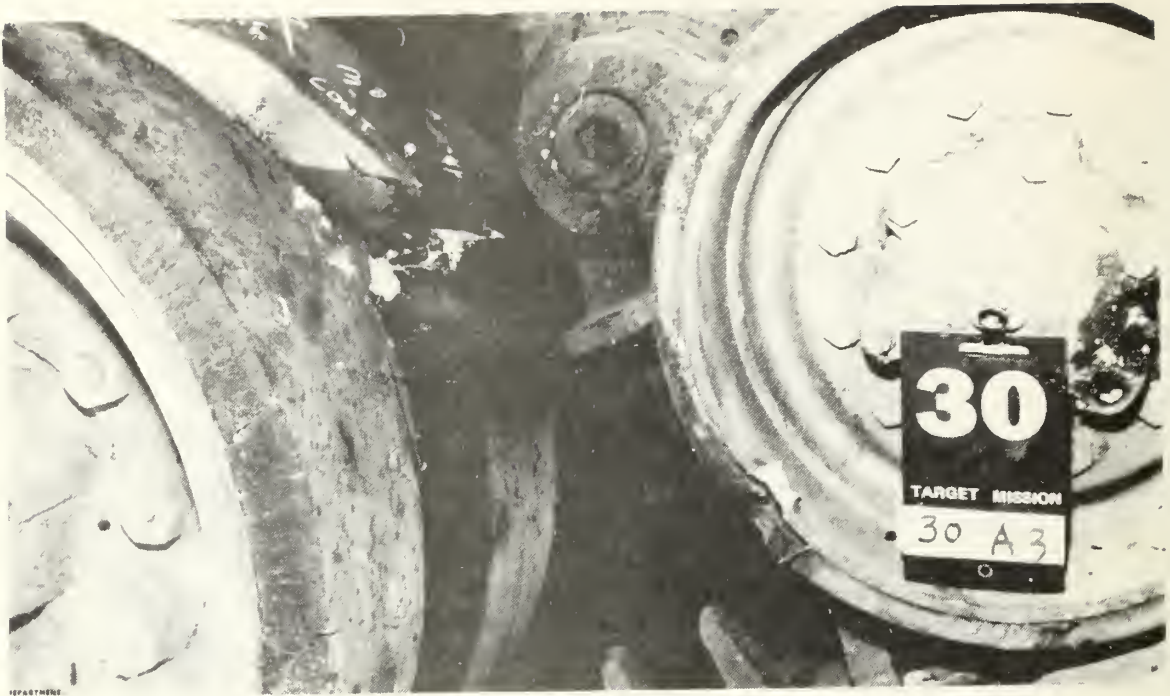
- a. M-Kill: This target suffered three perforations of the hull and one other impact which were capable of causing an M-Kill. Impact 30 (Figure 54) perforated the left hull armor and penetrated the left fuel tank. Impact 34, shown in Figures 55 and 56, respectively, perforated the left hull armor and penetrated an oil cooler line. Impact 36 (Figure 58) perforated the rear hull armor and penetrated the transmission case. Impact 47 (Figure 58) penetrated the right final drive. Two other perforations (Impacts 35 and 39) into the engine compartment had no behind-the-plate effects. Cumulative damage to the track and suspension system from seven other impacts contributed to the kill (these included a possible perforation of the left hull armor and penetration into the left fuel tank).

FIGURE 54. Impact Thirty, Target 30, Perforation of Bottom Hull Armor and Penetration into Left Fuel Tank. (Initial Impact was on Left Track Tension Idler Wheel and Left Number 6 Roadwheel)

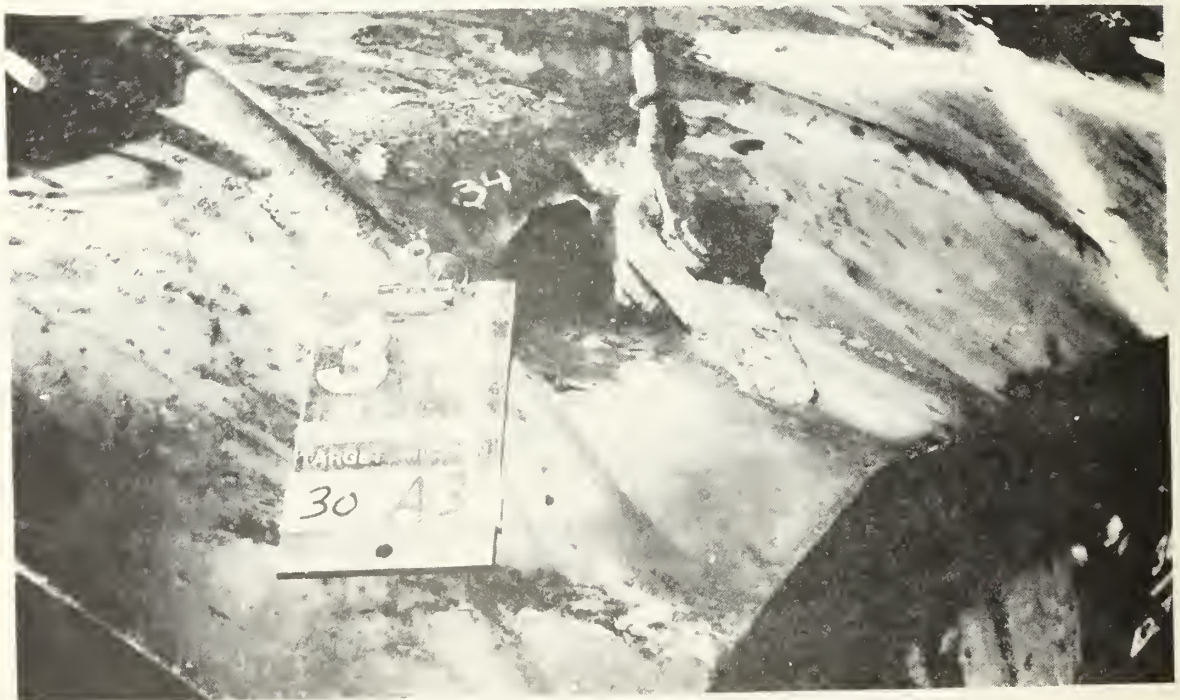
FIGURE 55. Impact Thirty-Four, Target 30, Perforation of Left Hull into Transmission Compartment.

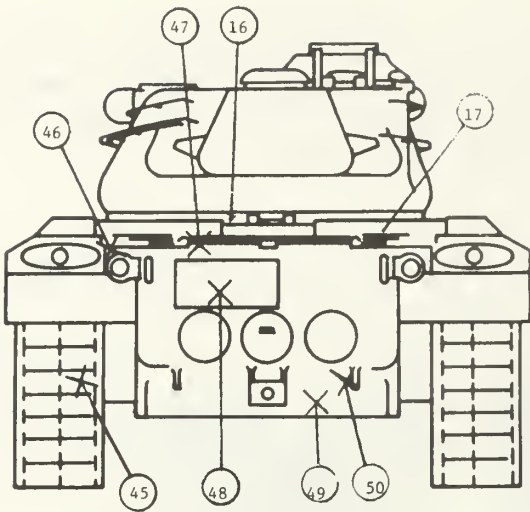
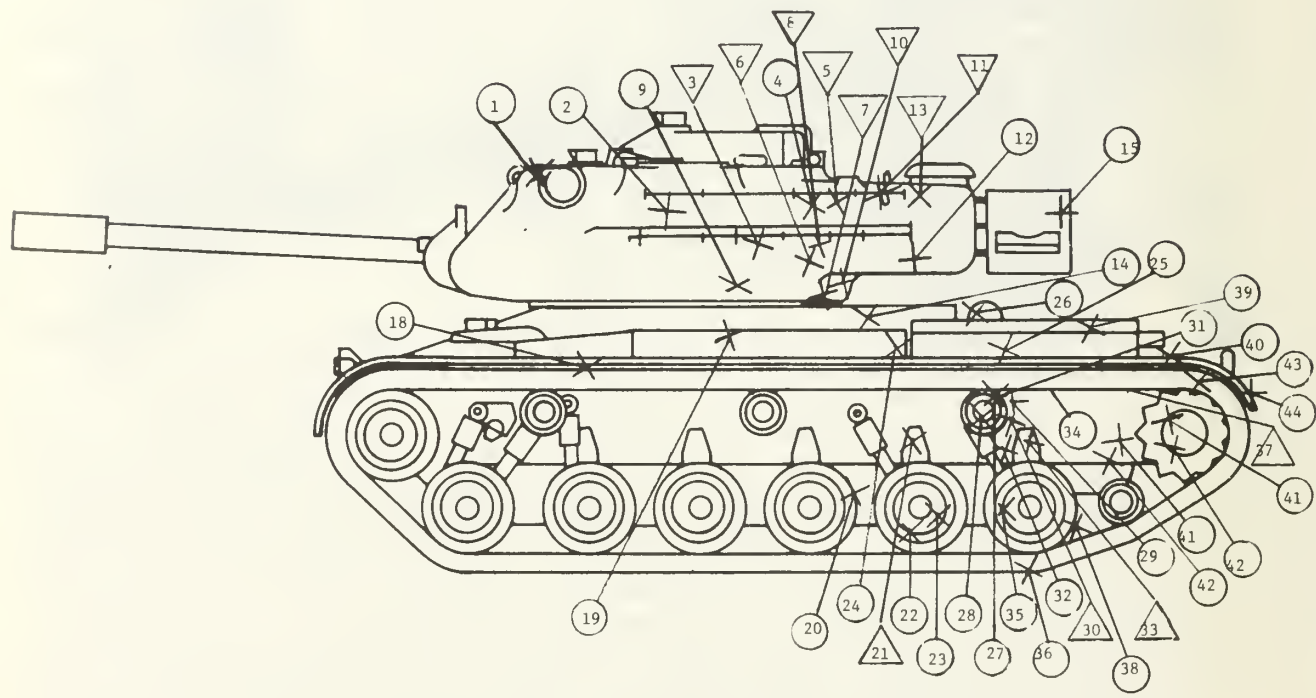
FIGURE 59. Impact Diagram, Target 31.

100% M-Kill and 100% F-Kill resulting from the following projectile impacts, shown in Figure 59:

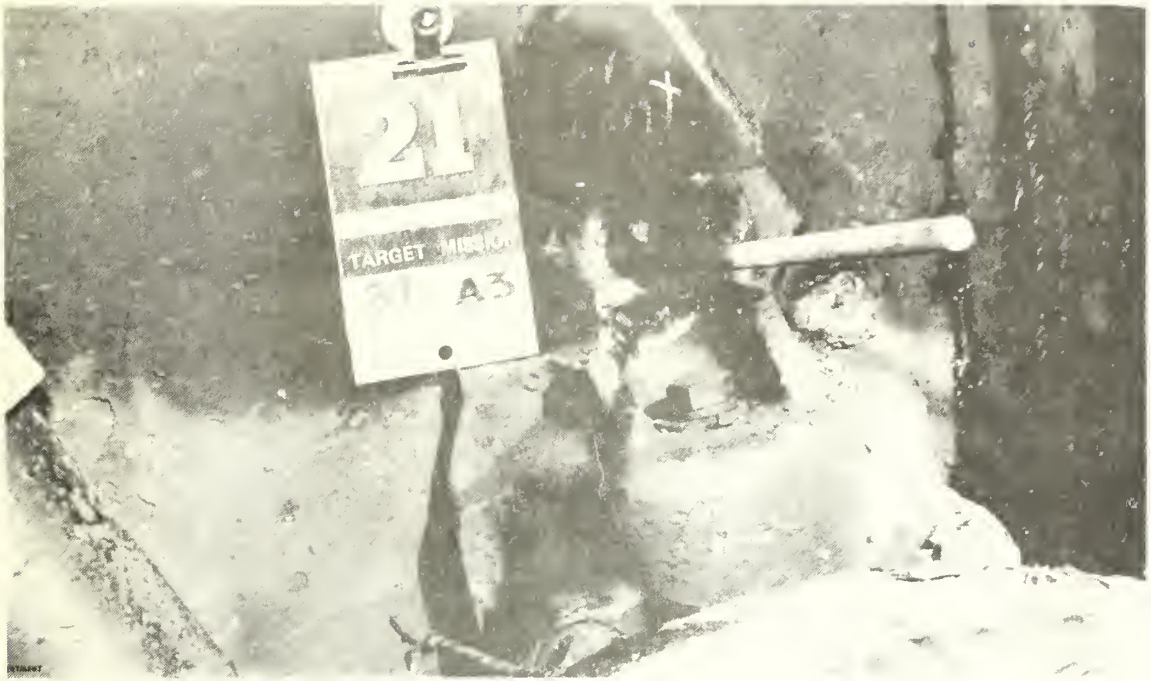
- a. M-Kill: This target suffered three perforations which alone or together were capable of causing an M-Kill. Impacts 21 and 30, shown in Figures 60 and 61, respectively, perforated the left hull and penetrated the left fuel tank. Impact 33 (Figure 61) perforated the left hull into the engine compartment and penetrated the oil cooler space; if the cooler had been in place it would have been damaged or destroyed. One other perforation into the engine compartment had no behind-the-plate effects. Cumulative damage to the track and suspension system from 10 other impacts contributed to the kill.

FIGURE 60. Impact Twenty-One, Target 31, Perforation of Hull and Penetration into Left Fuel Tank.

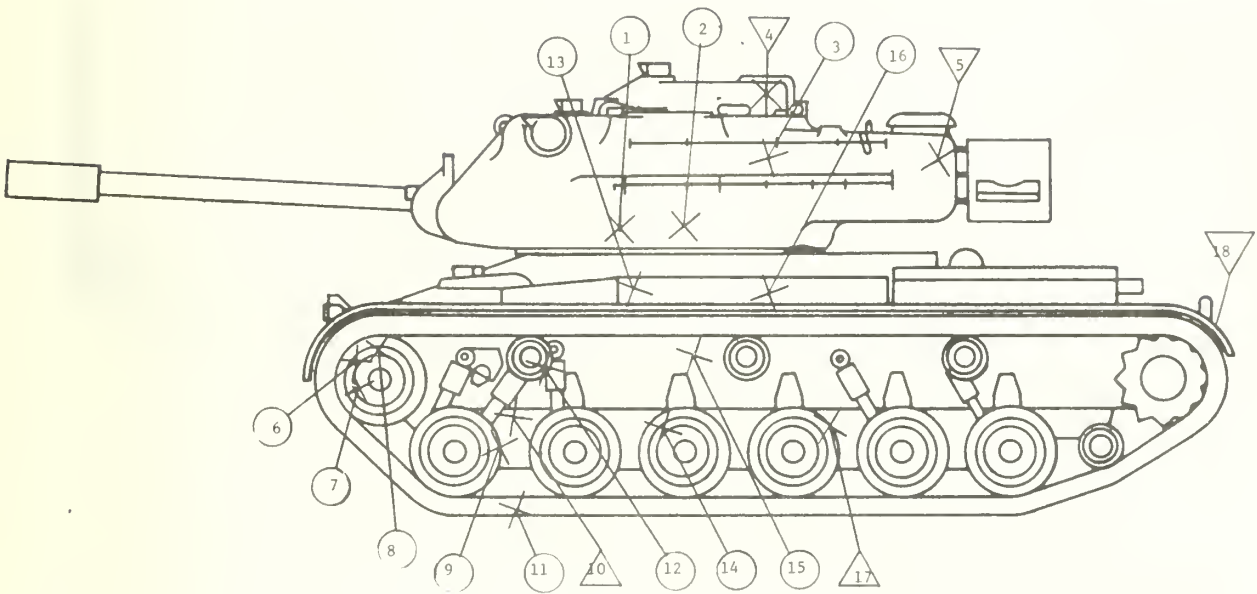
FIGURE 62. Impact Diagram, Target 32.

100% K-Kill, resulting from the following projectile impacts, shown in Figure 62:

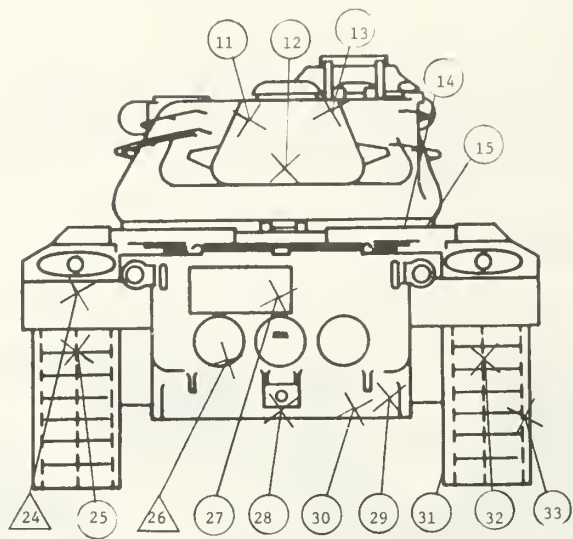
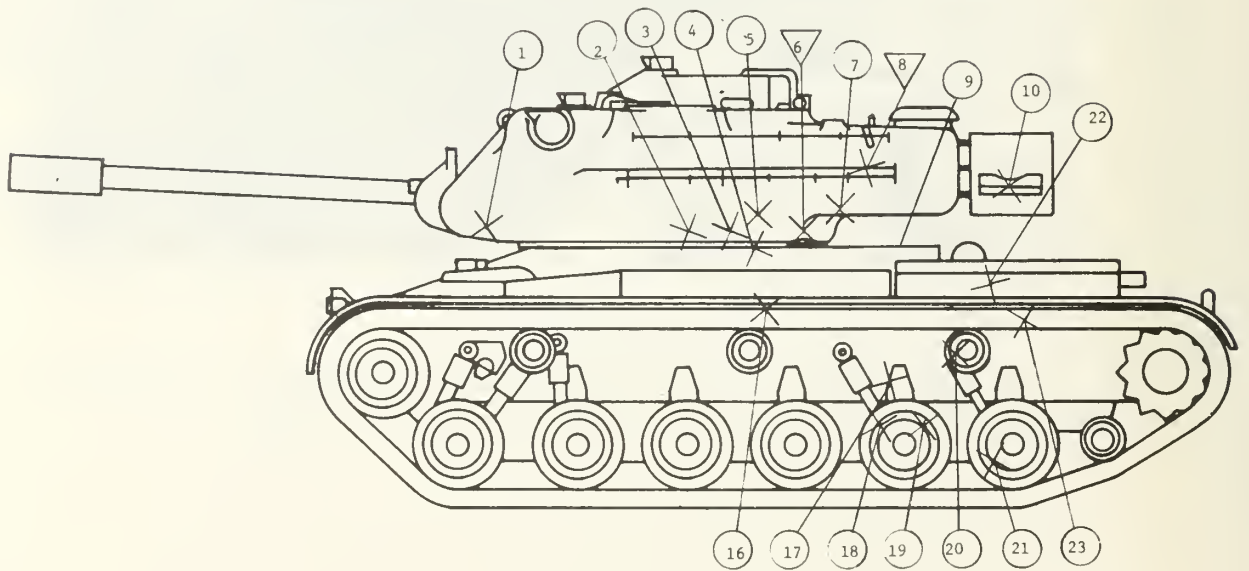
FIGURE 64. Impact Diagram, Target 33.

100% M-Kill and 95% F-Kill resulting from the following projectile impacts, shown in Figure 64:

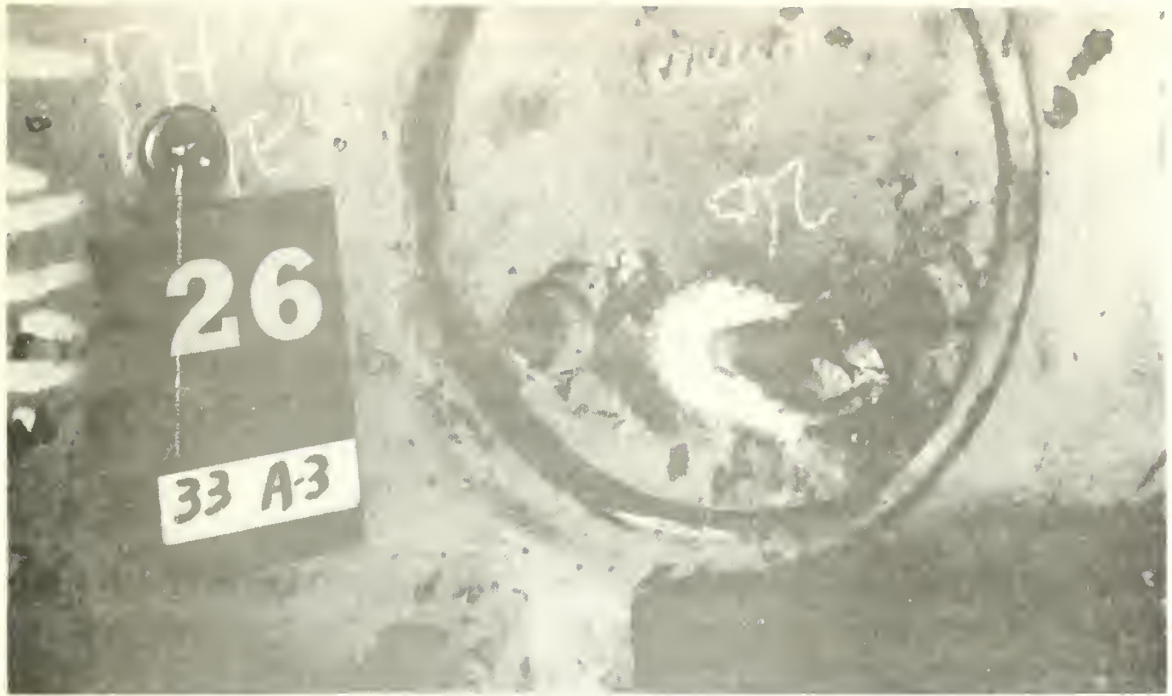
- a. M-Kill: This target suffered 4 perforations, two of which were independently capable of causing an M-Kill. Impact 24 perforated the left hull and severed an oil cooler line. Impact 26, shown in Figure 65 and 66, respectively, perforated the rear brake adjust access door and penetrated the transmission case. Cumulative damage to the track and suspension system from 5 other impacts contributed to the kill.
- b. F-Kill: A 95% F-Kill was assessed based solely on crew casualties (tank commander and gunner - Figures 67 and 68) resulting from Impacts 6 and 8 which perforated the left side of the turret.

FIGURE 65. Impact Twenty-Six, Target 33, Perforation of Brake Adjust Access Door into Transmission Compartment.

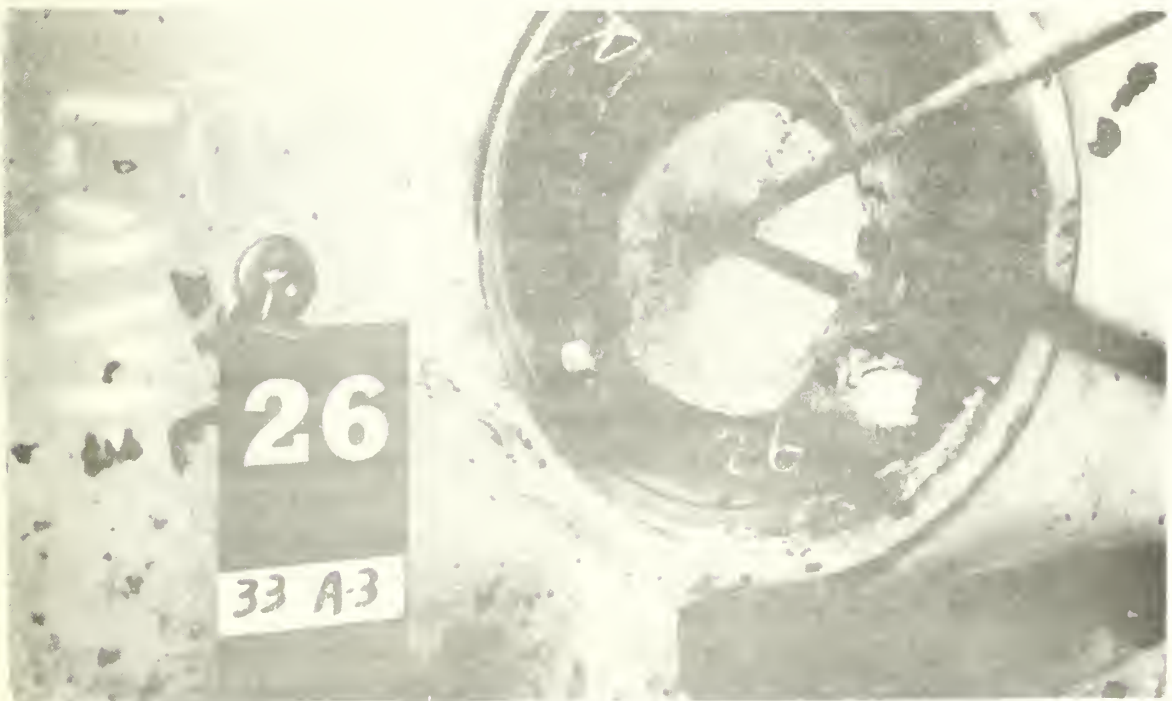
FIGURE 66. Impact Twenty-Six, Target 33, Penetration of Transmission Case (Brake Adjust Access Door Removed).

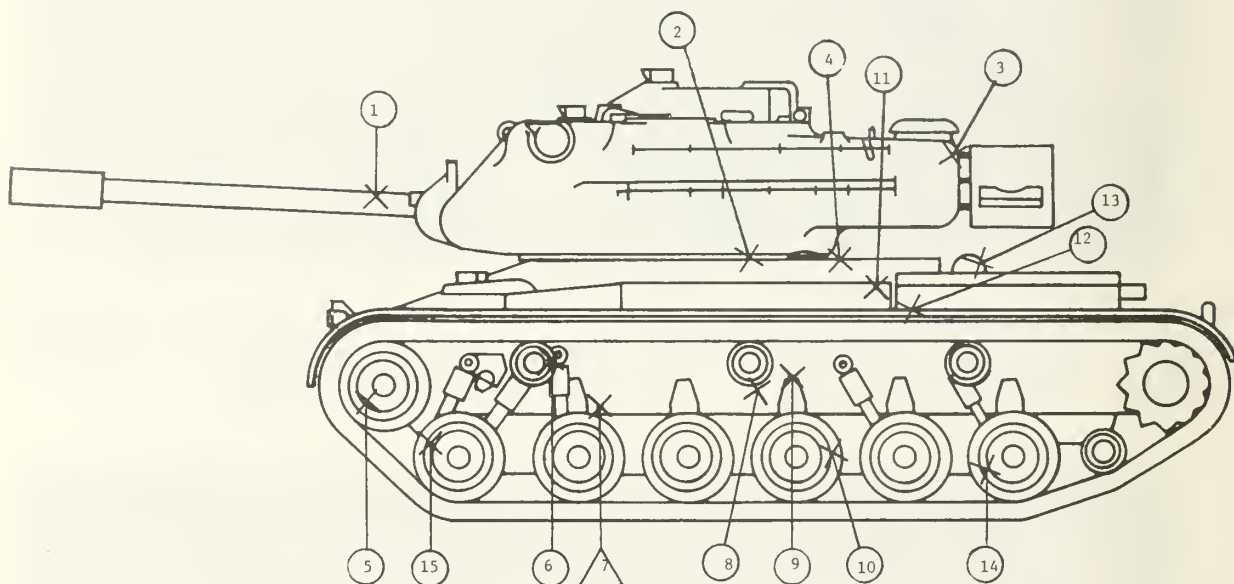
FIGURE 69. Impact Diagram, Target 34.

100% F-Kill, resulting from the following projectile impacts, shown in Figure 69:

NOTE: Roadwheels number 4 and 5 were hit on the right hand side of the tank (Impact number 16), and are not shown in this view.

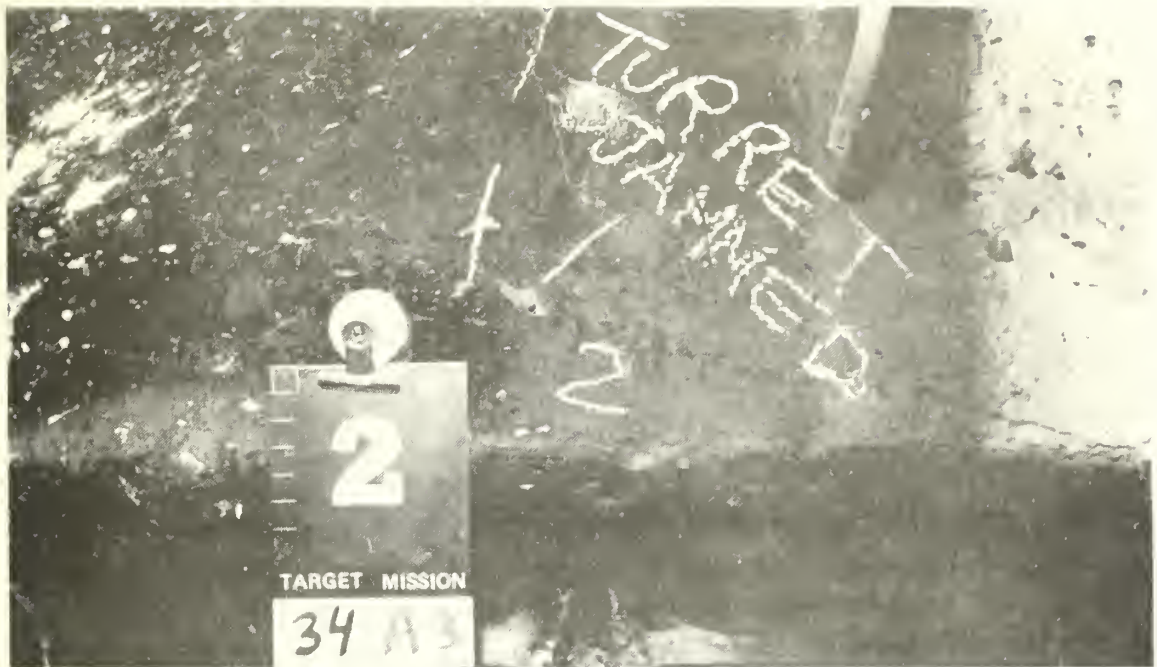
Impact 2 (Figure 70) hit between the turret and hull, bulging the armor on the inside, and jammed the turret so that it would not traverse. The perforation, shown in Figure 71, Impact 7, penetrated into the bulkhead ammunition stowage rack and into the adjacent stowage box, but did not impact any of the stowed ammunition.

FIGURE 70. Impact Two, Target 34, Penetration of Turret Ring between Hull and Turret, Armor Bulged, Turret Jammed.
