# NAVAL POSTGRADUATE SCHOOL

A-10/GAU-8 LOW ANGLE FIRINGS VERSUS  
SIMULATED SOVIET TANK BATTALION  
(HONEYWELL LOT NUMBER 0L78D043-016)  
(ARRAY 3)

2 FEBRUARY 1979

R.H.S. STOLFI  
R.R. MCEACHIN

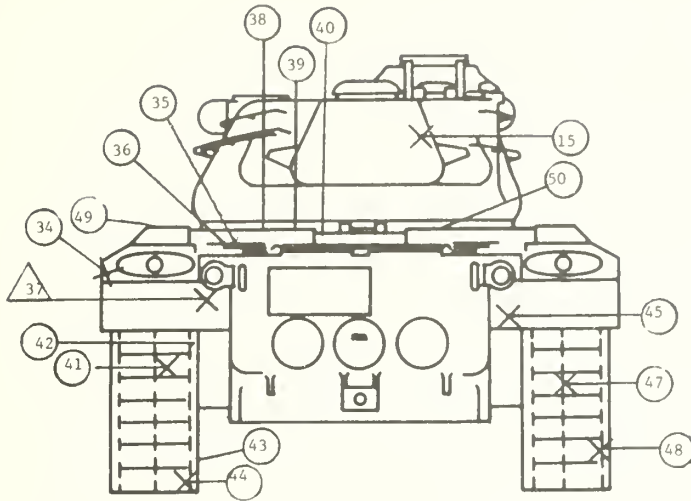
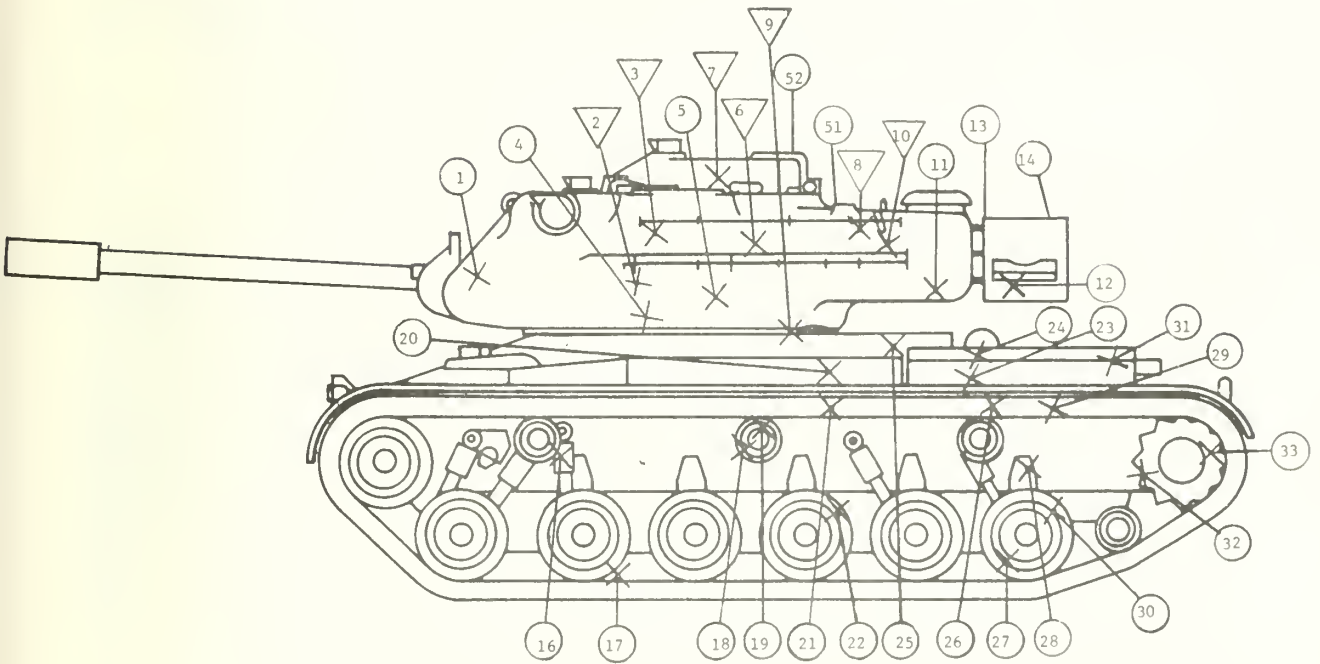
FIGURE 72. Impact Diagram, Target 35.

100% M-Kill and 100% F-Kill, resulting from the following projectile impacts, shown in Figure 72:

IMPACTS 38, 39 and 40 ON EXTENDED FUEL TANK BRACKET

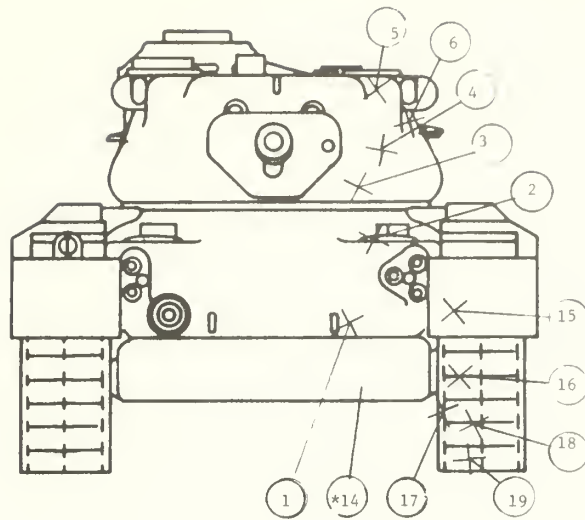
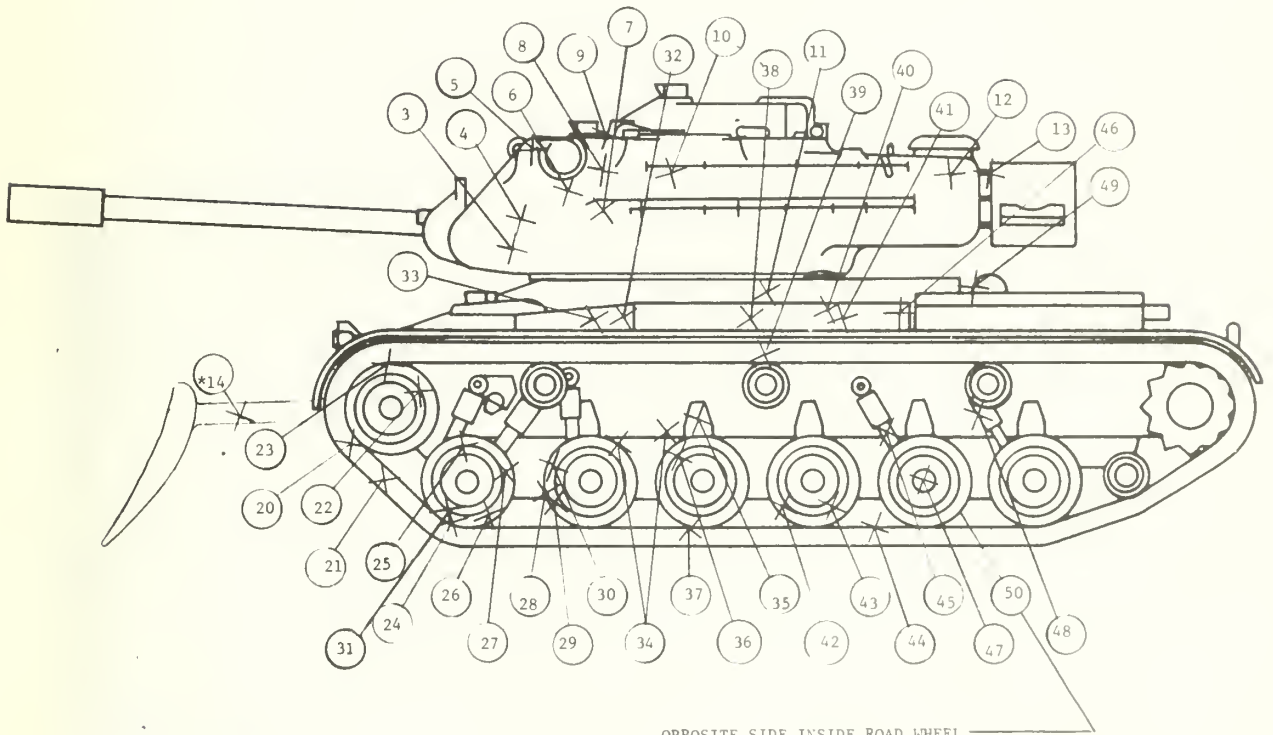
FIGURE 77. Impact Diagram, Target 36.

100% M-Kill, resulting from the following projectile impacts, shown in Figure 77:

\* IMPACT 14 ON LEFT BULLDOZER BLADE MOUNT

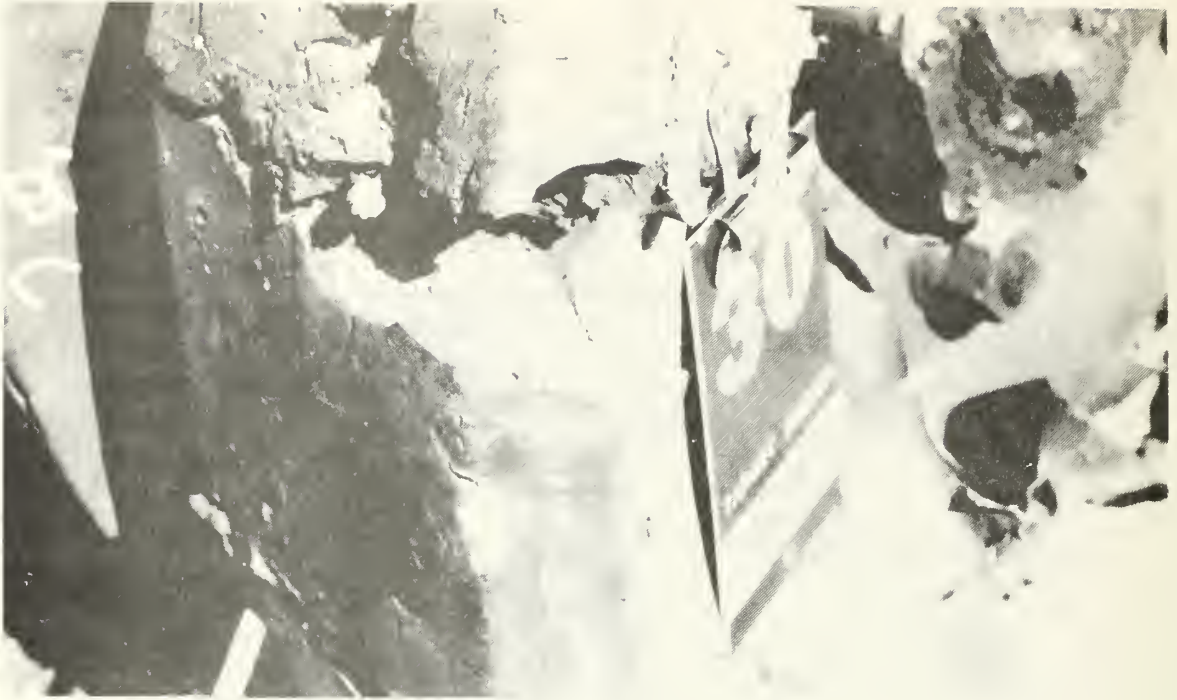
Major damage to the track and suspension system was caused by Impact 30 (Figure 78), which destroyed the left #2 roadwheel hub and bearings; Impact 31 (Figure 79), which destroyed the left #1 track support roller hub; and Impact 47 (Figure 80), which destroyed the left #5 roadwheel hub and bearings; and by twenty-two other impacts, which inflicted a high level of cumulative damage to the track and suspension system.

FIGURE 78. Impact Thirty, Target 36, which Destroyed the Left #2 Roadwheel Hub.

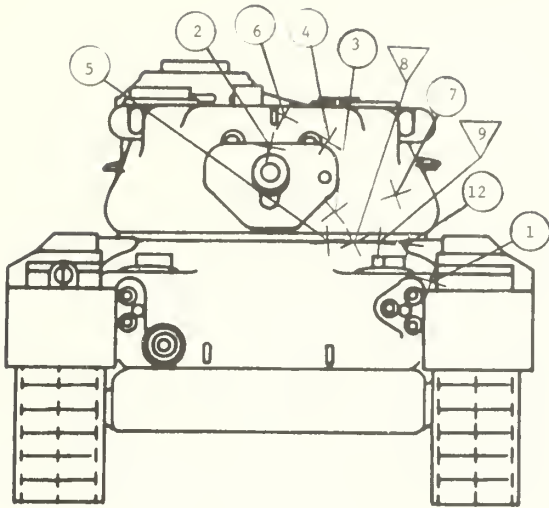
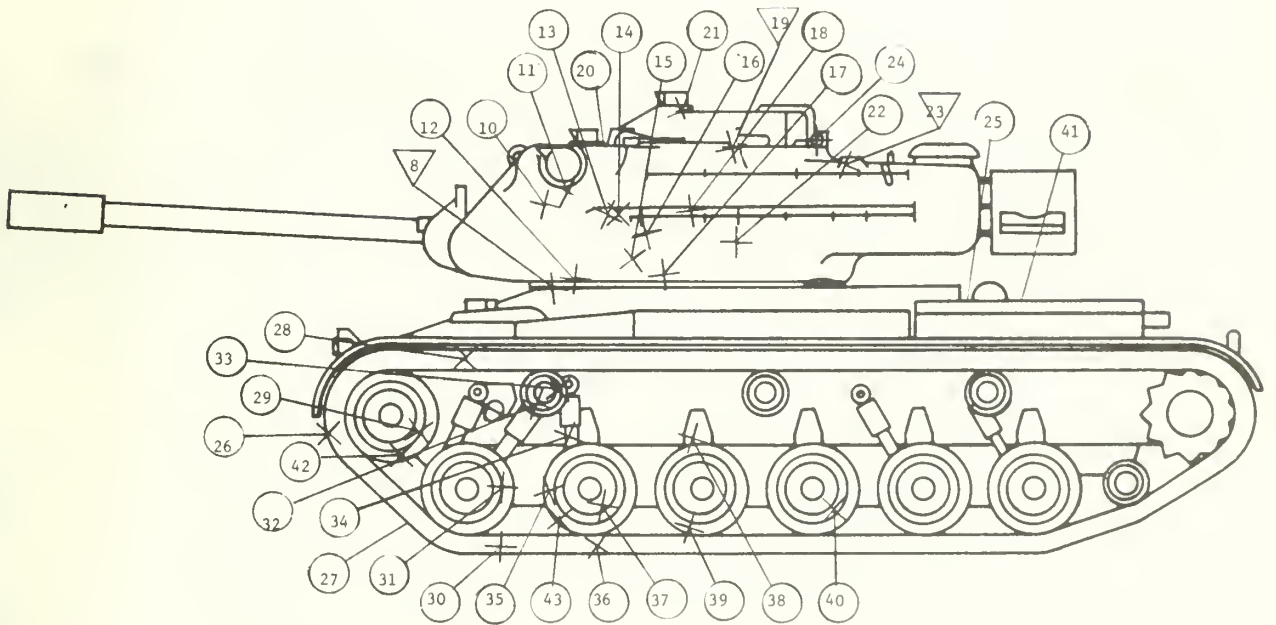
FIGURE 81. Impact Diagram, Target 37.

80% M-Kill and 100% F-Kill resulting from the following projectile impacts, shown in Figure 81:

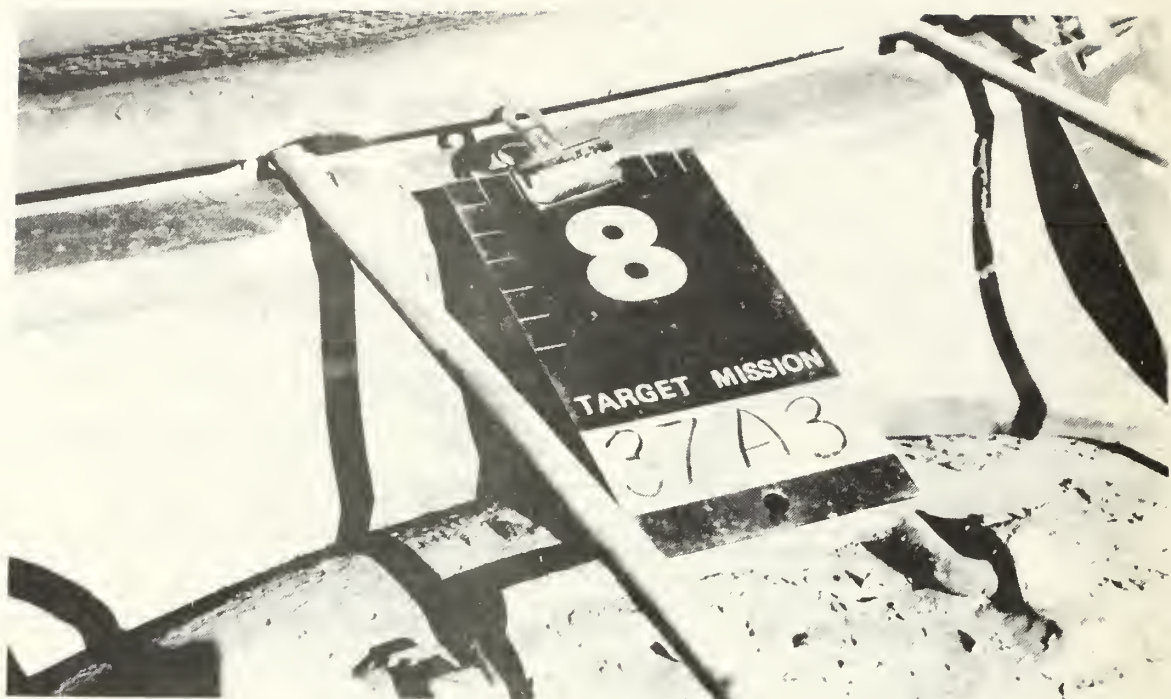
- b. F-Kill: A 100% F-Kill was assessed because of Impact 8, (Figure 82), which perforated the turret ring and jammed the turret; Impact 9 (Figure 83), which perforated the turret ring, jammed the turret, ignited propellant in an ammunition round in the ready rack, and wounded two crewmen (gunner and loader - Figures 84 and 85) and Impact 19, which perforated the lip of the loaders hatch, contributing to the loader casualty. One other perforation (Impact 23) of the antenna base aperture made no contribution to the kill. Two additional hits (Impacts 5 and 12) in the turret ring may have contributed to the jammed turret.

FIGURE 82. Impact Eight, Target 37, Perforations of Turret Ring which Jammed Turret.

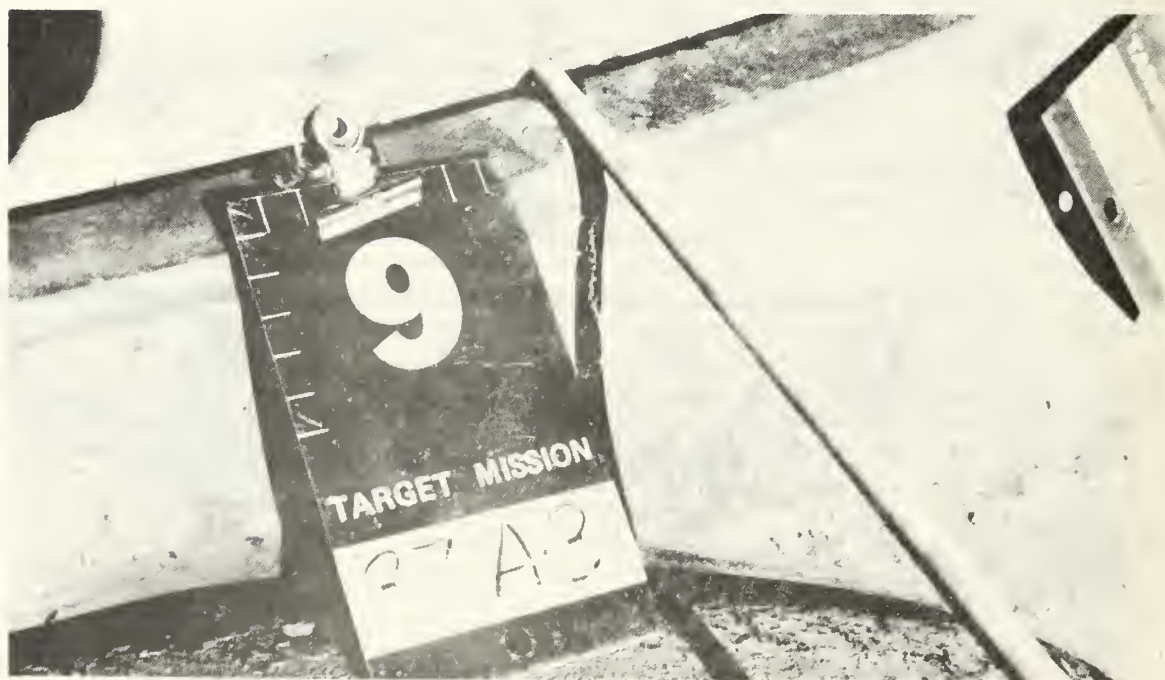
FIGURE 83. Impact Nine, Target 37, Perforations of Turret Ring which Jammed Turret.

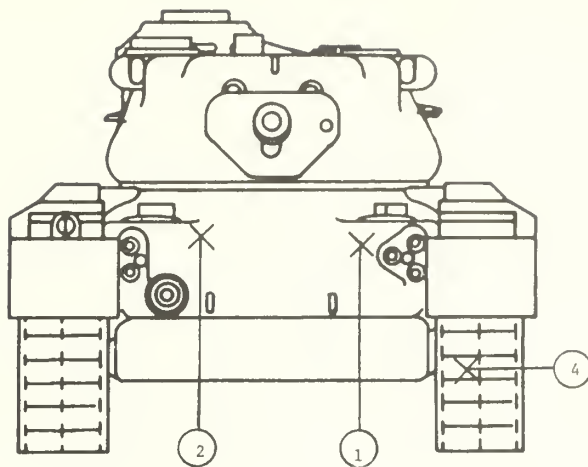
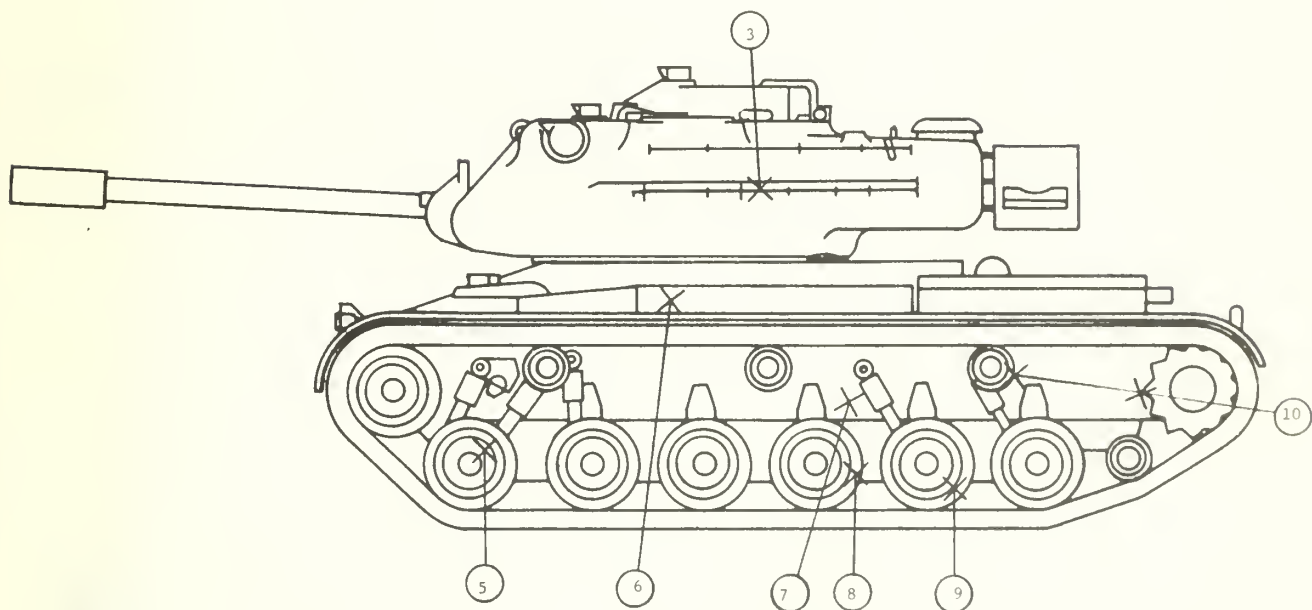
FIGURE 86. Impact Diagram, Target 38.

100% interdiction M-Kill, resulting from the following projectile impacts, shown in Figure 86:

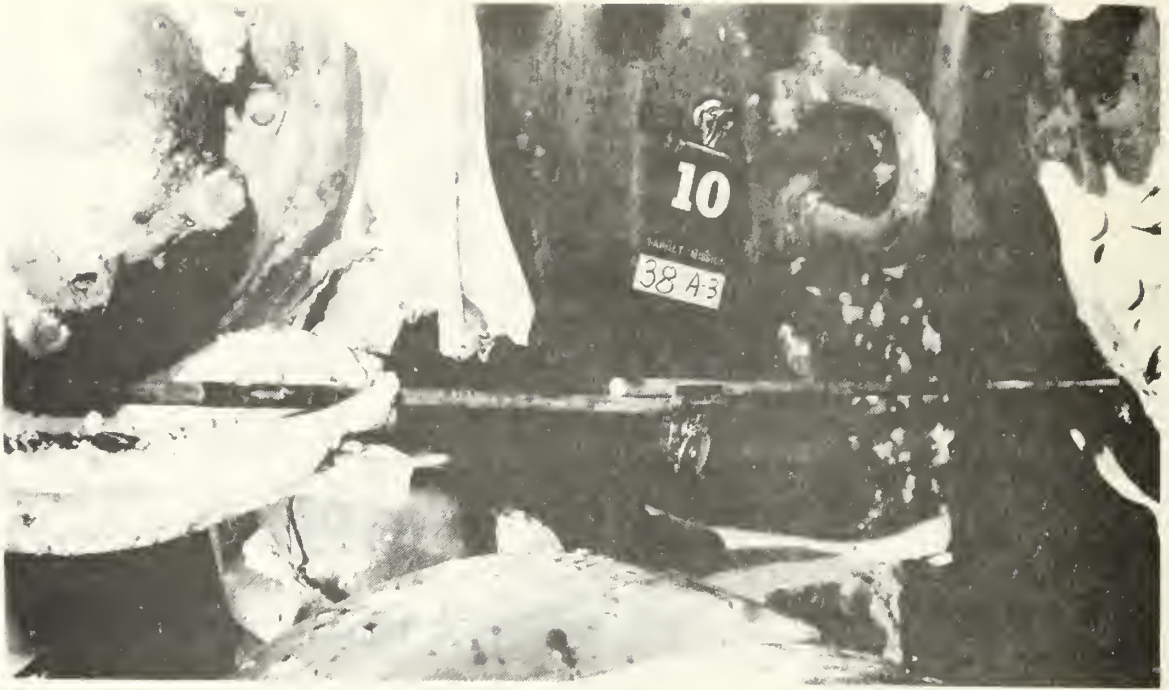
A 100% interdiction type M-Kill after 5km travel was assessed due to impact 10 (Figure 87), which penetrated the left final drive, causing an oil leak (Figure 88) and possibly projectile and/or fragment damage to the gears. Minor track and suspension damage from 4 other impacts contributed to the kill.

FIGURE 87. Impact Ten, Target 38, Showing Initial Impact on the Left #3 Track Support Roller.

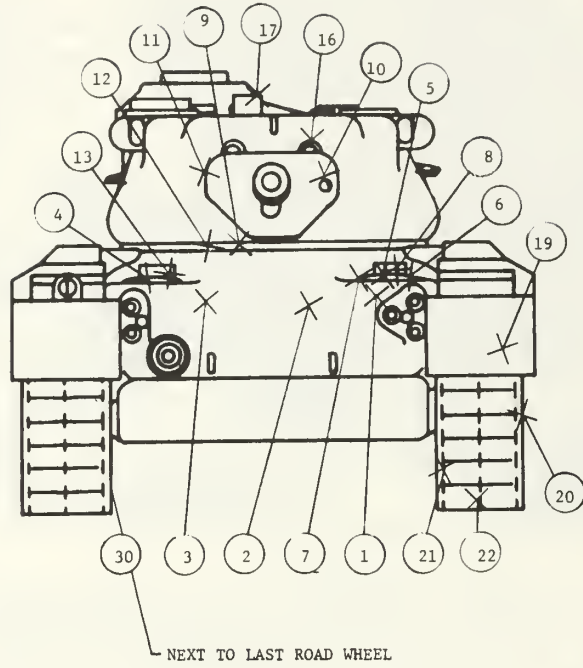
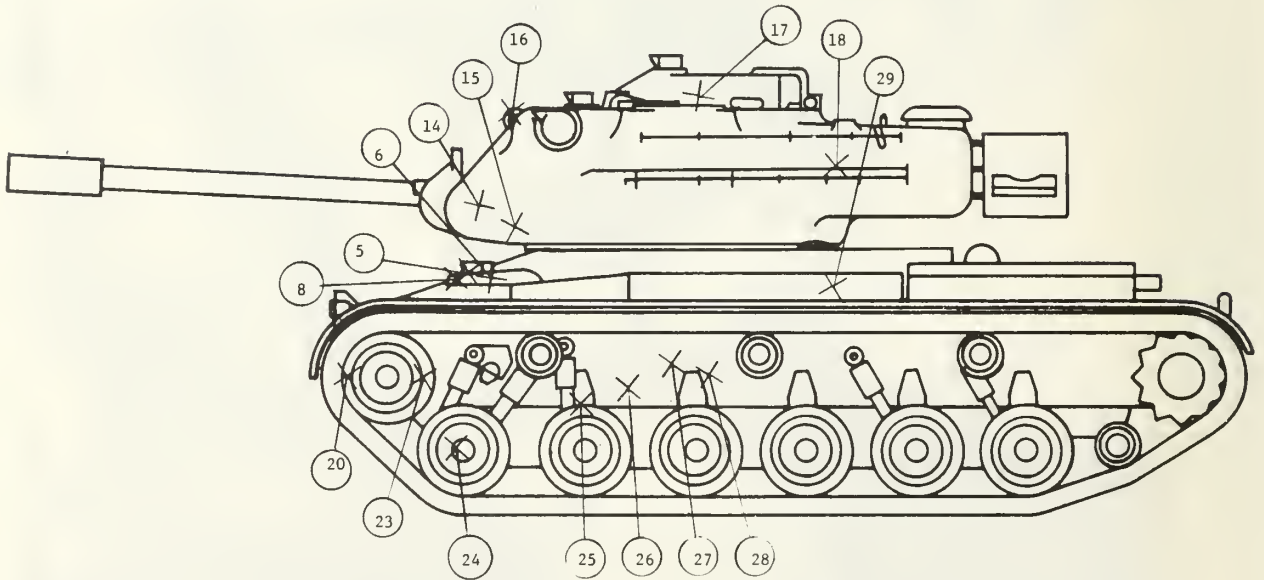
FIGURE 89. Impact Diagram, Target 39.

100% interdiction M-Kill and 50% F-Kill, resulting from the following projectile impacts, shown in Figure 89:

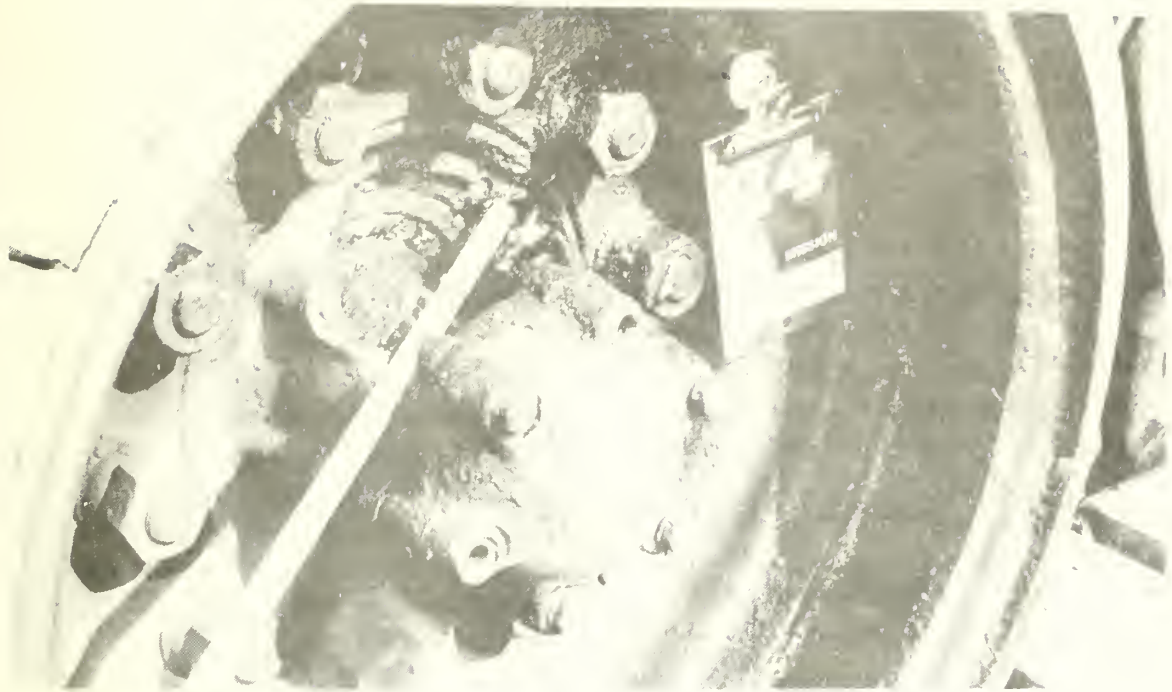
- a. M-Kill: A 100% interdiction type M-Kill after 5km travel was assessed because of Impact 24 (Figure 90), which destroyed the left #1 roadwheel hub, and because of cumulative damage to the track and suspension system resulting from 5 other impacts.
- b. F-Kill: The F-Kill was attributed solely to crew casualties. The tank commander was assessed a casualty from glass fragments because of Impact 17, shown in Figure 91, which shattered a vision block in his cupola.

FIGURE 90. Impact Twenty-Four, Target 39, which Destroyed the Left #1 Roadwheel Hub.

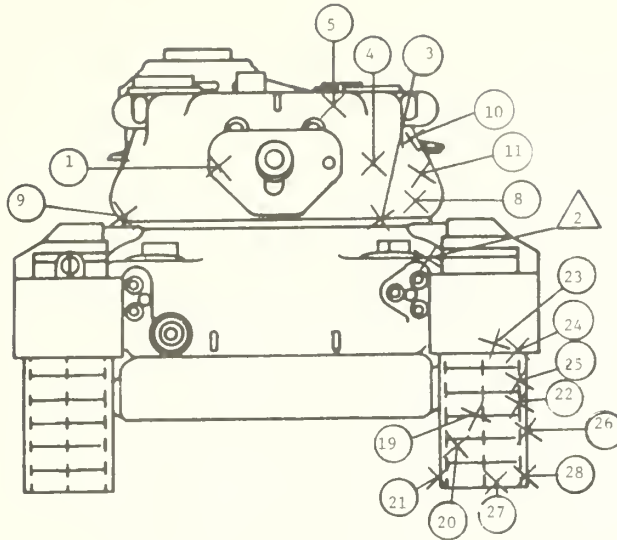
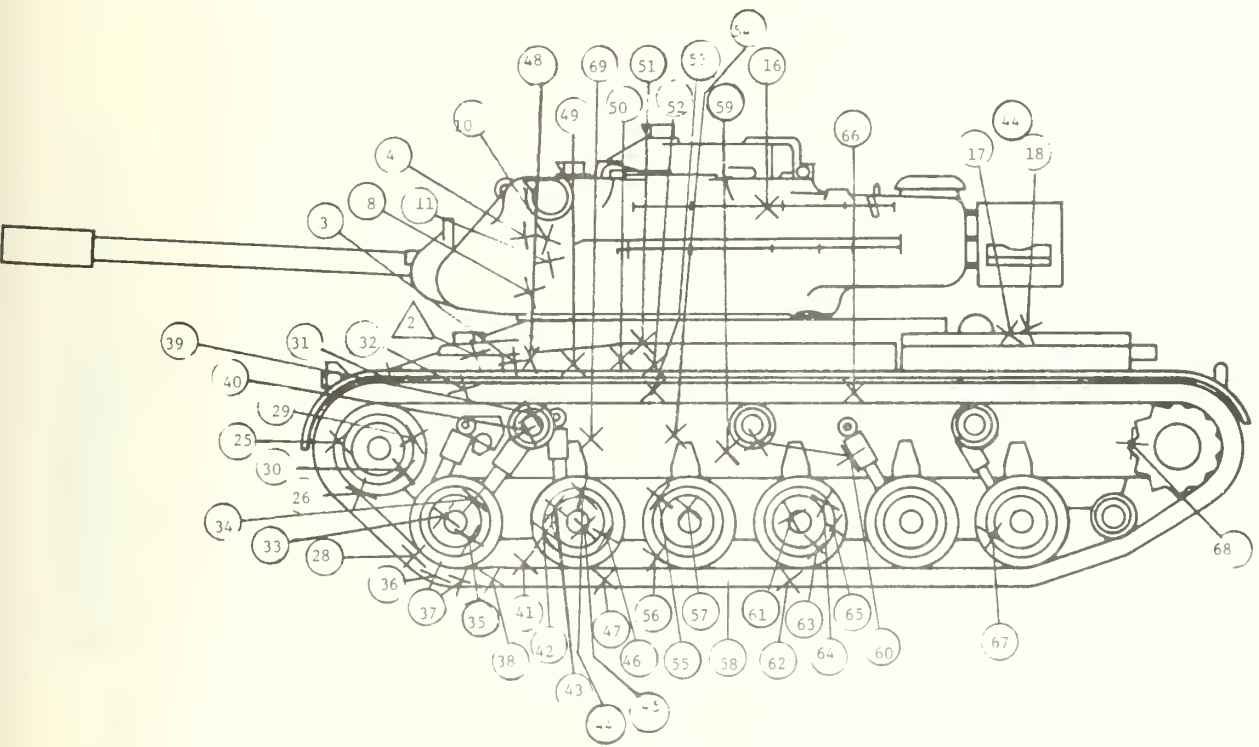
FIGURE 92. Impact Diagram, Front and Side, Target 40.

100% M-Kill, and 100% F-Kill, resulting from the following projectile impacts, shown in Figures 92 and 93:

NOTE: Impacts 69, 70 and 71 not shown.

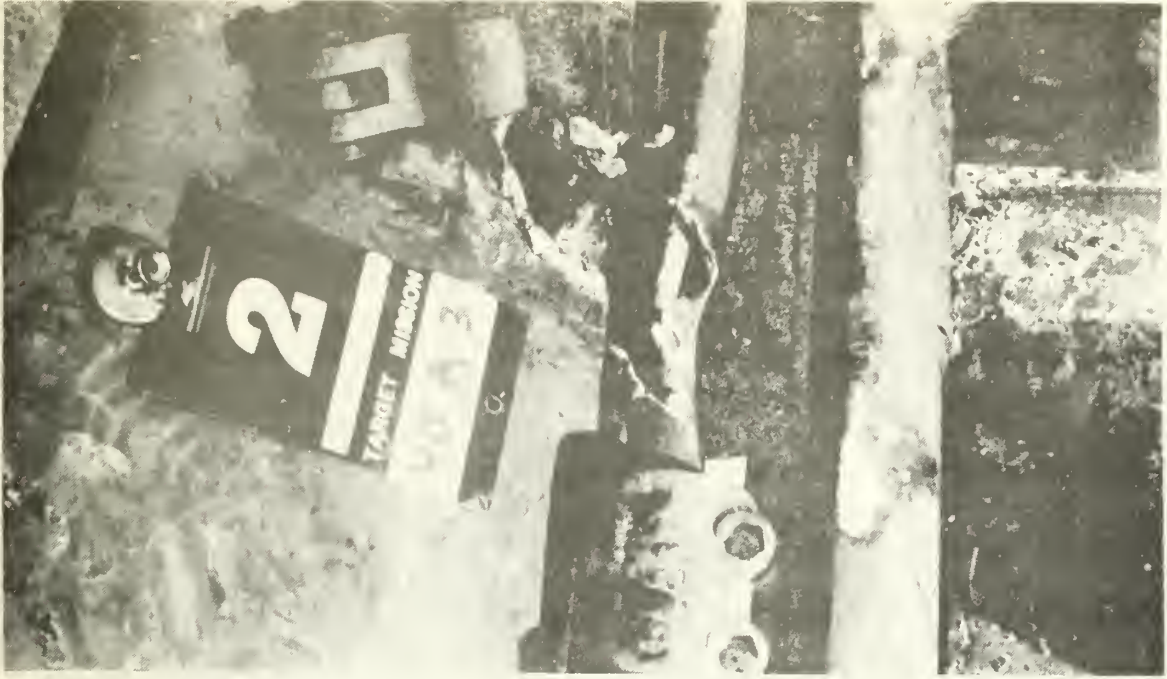
- a. M-Kill: Impact 2, shown in Figure 94, perforated the driver's hatch cover, causing the driver to become a casualty (Figure 95). Impact 33 destroyed the left #1 roadwheel hub, shown in Figure 96. Impacts 42 and 45 destroyed the left #2 roadwheel hub, shown in Figure 97. Impact 57 destroyed the left #3 roadwheel hub, shown in Figure 98. Impact 61 destroyed the left #4 roadwheel hub, shown in Figure 99. Impact 68 penetrated the left final drive, shown in Figure 100. Impacts 39 and 40 destroyed the left #1 track support roller, shown in Figures 101 and 102. Cumulative damage to the track and suspension system from 19 other impacts contributed to the kill.

FIGURE 94. Impact Two, Target 40, Perforation of Left Hull into Driver's Compartment.

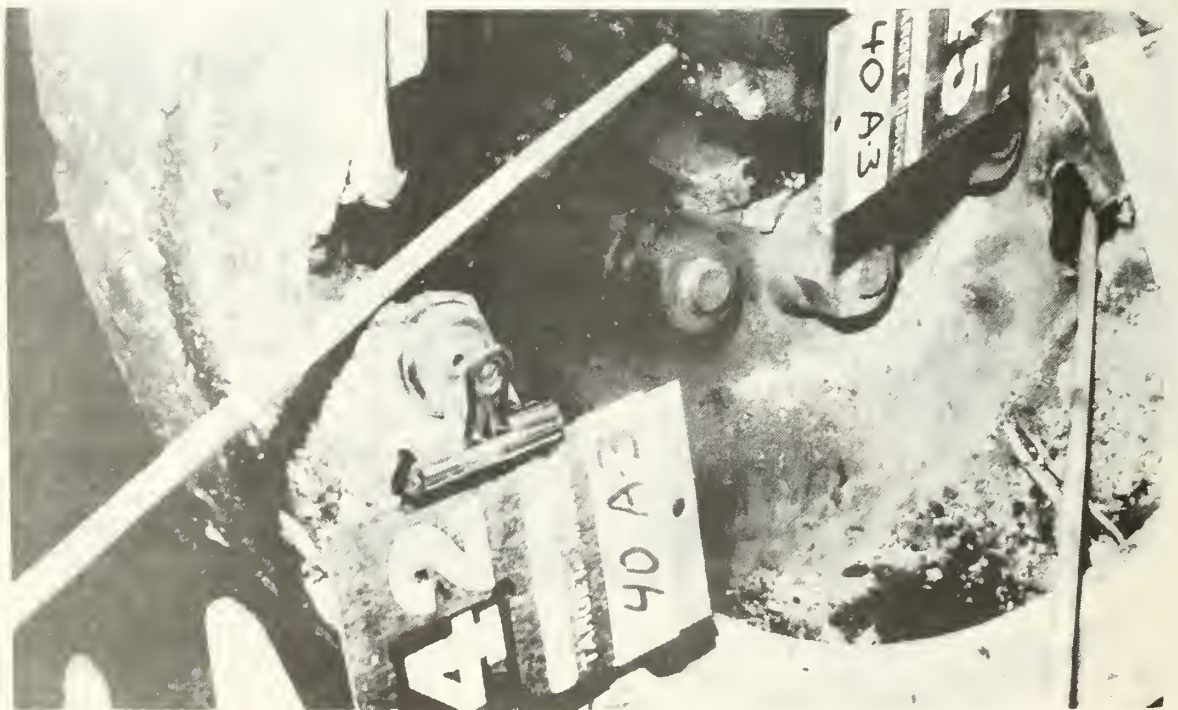
FIGURE 97. Impacts Forty-Two and Forty-Five, Target 40, which Destroyed the Left #2 Roadwheel Hub.

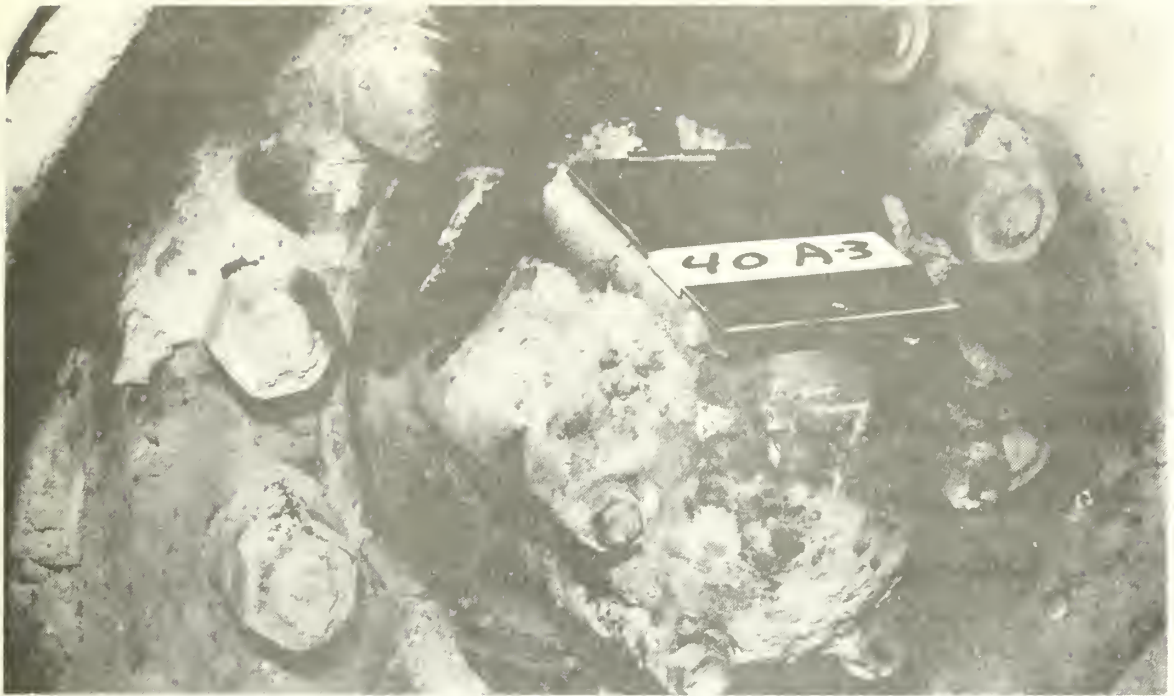
FIGURE 98. Impact Fifty-Seven, Target 40, which Destroyed the Left #3 Roadwheel Hub.

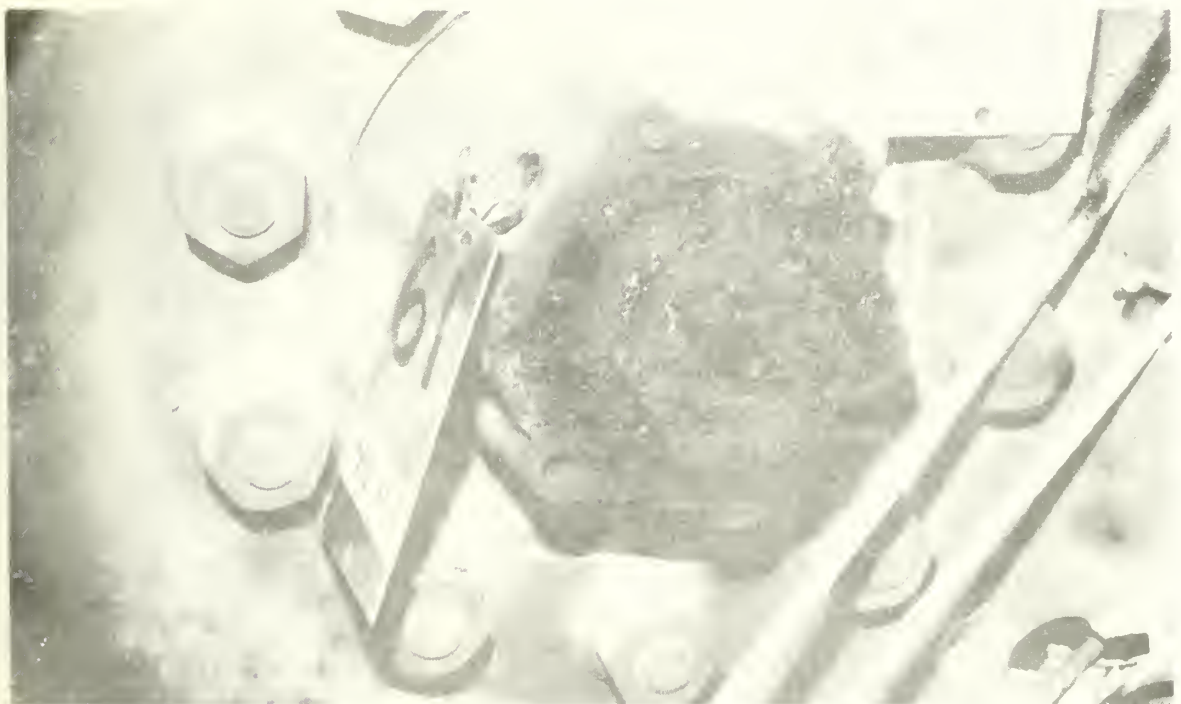
FIGURE 99. Impact Sixty-One, Target 40, which Destroyed the Left #4 Roadwheel Hub.

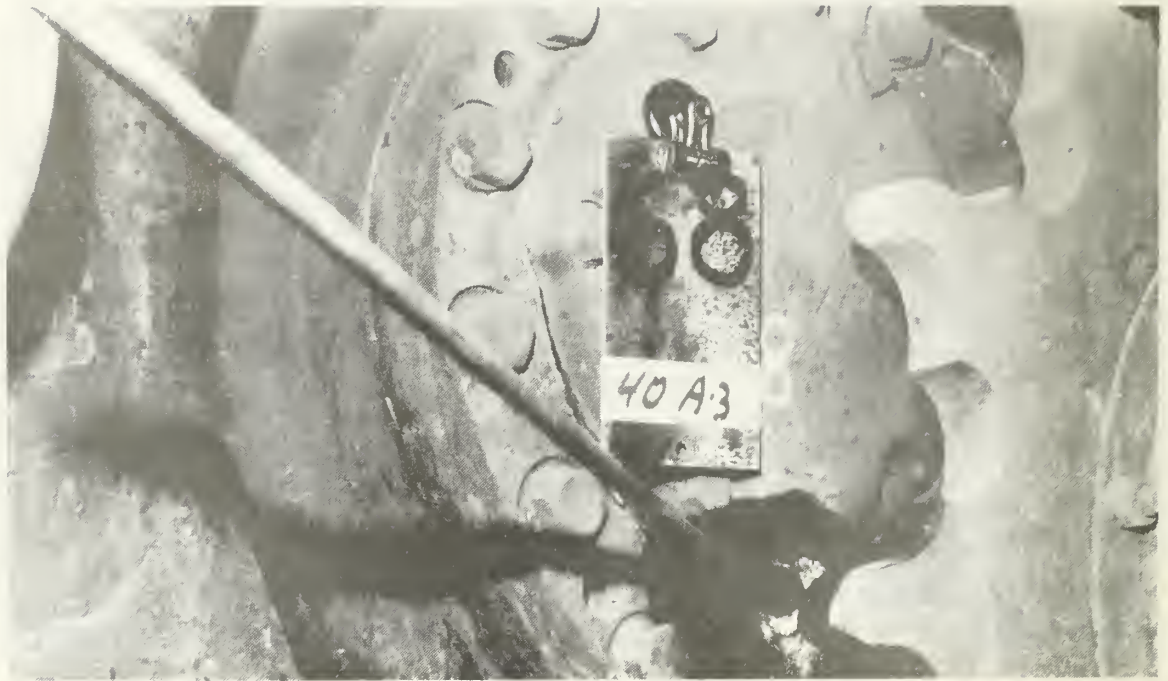
FIGURE 100. Impact Sixty-Eight, Target 40, which Perforated the Left Final Drive.

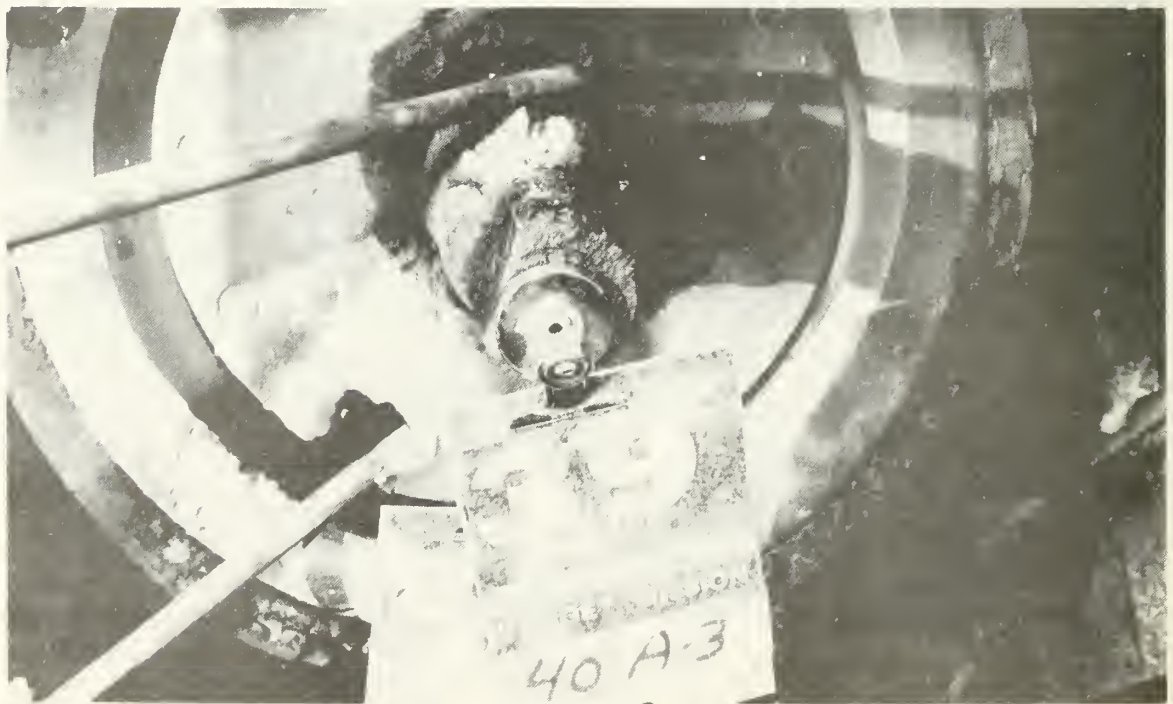
FIGURE 101. Impact Thirty-Nine, Target 40, which Destroyed the Left #3 Track Support Roller.

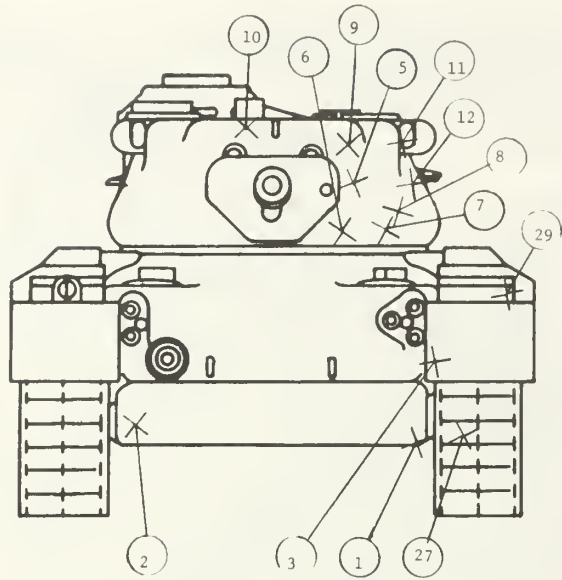
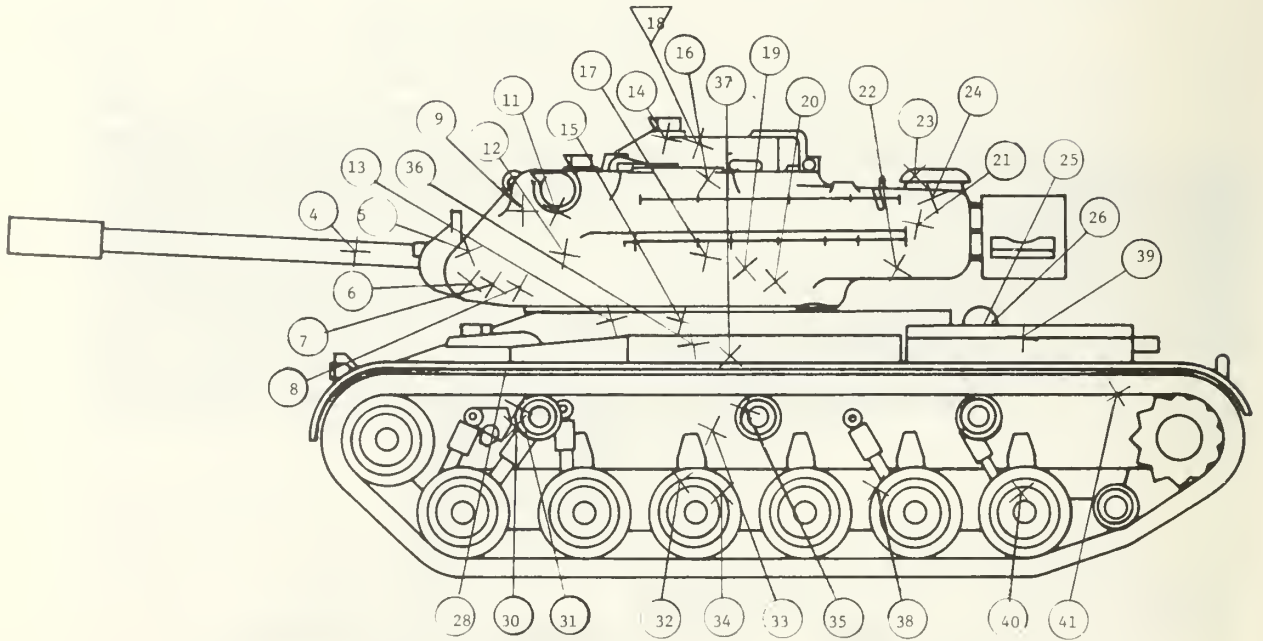
FIGURE 106. Impact Diagram, Target 41.

- a. M-Kill: Mobility was estimated to have been degraded by 65% due to crew casualties caused by Impact 18. Minor damage to the track and suspension system, caused by Impacts 27, 30, and 32, also made a contribution to the kill.
- b. F-Kill: A 95% F-Kill was assessed for Impact 18, shown in Figure 107, which perforated the commander's cupola into the fighting compartment and caused commander and gunner casualties. Impact 11, which destroyed the range finder blister, also made a significant contribution to the kill.

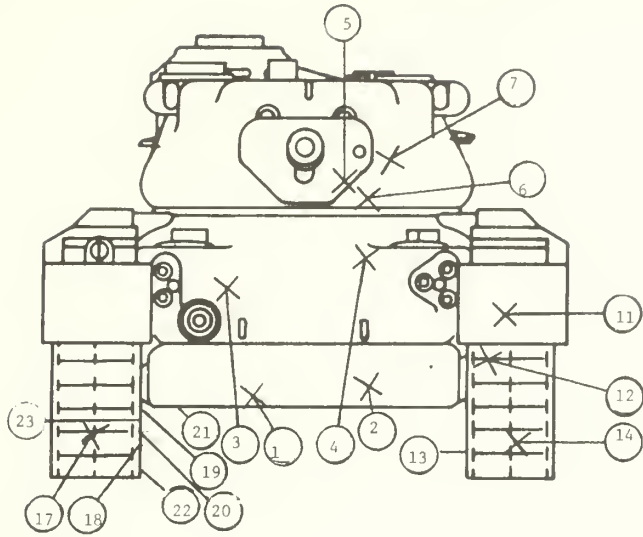
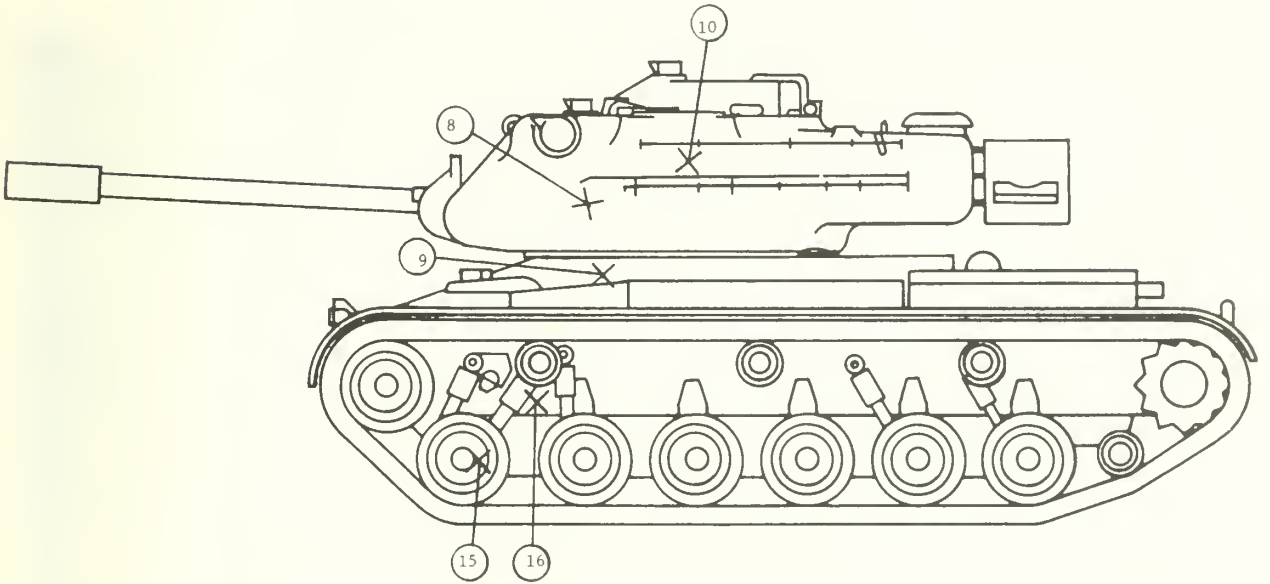
FIGURE 108. Impact Diagram, Target 42.

A 100% interdiction type M-Kill, after an estimated 2000 meters travel, was assessed for Impacts 17 and 18, shown in Figures 109 and 110, respectively, which destroyed two (2) end connectors on opposite ends of the same track pins, leaving only the track center guide to hold the track together. Cumulative damage to the track and suspension system by 5 other impacts contributed to the kill.

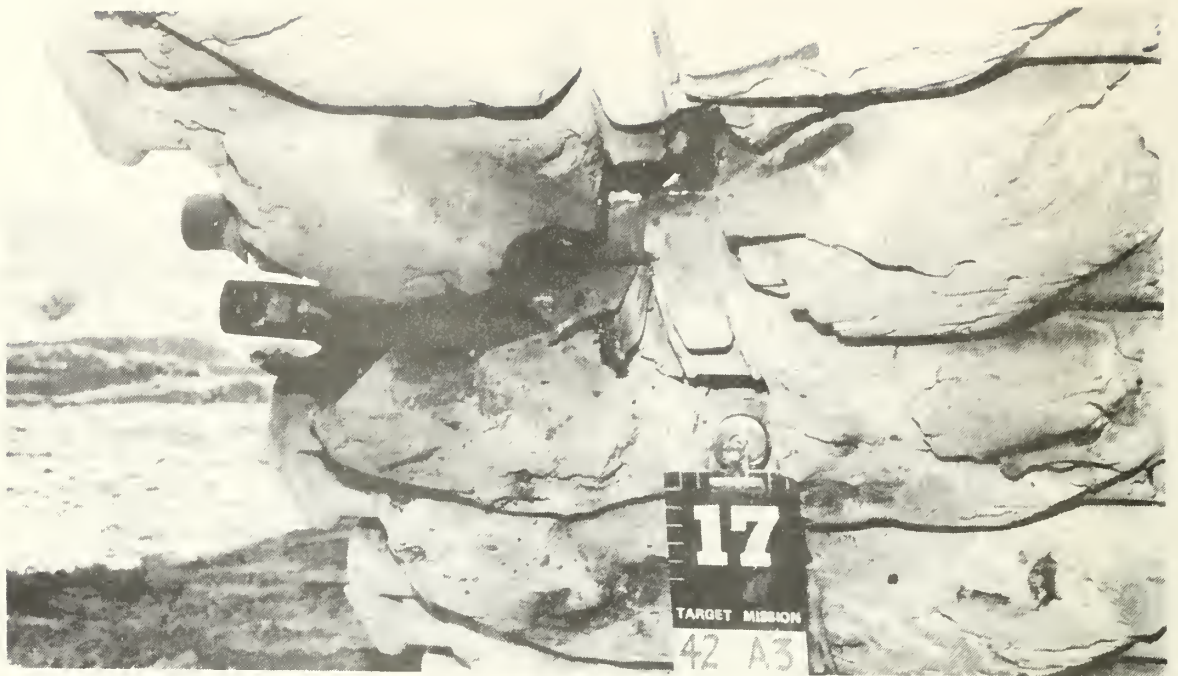
FIGURE 109. Impact Seventeen, Target 42, Showing Destroyed End Connector.

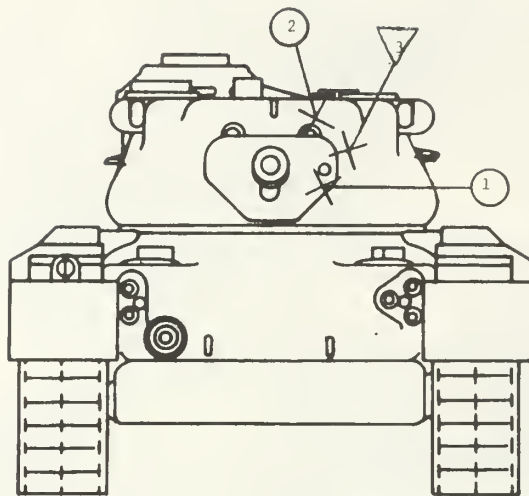
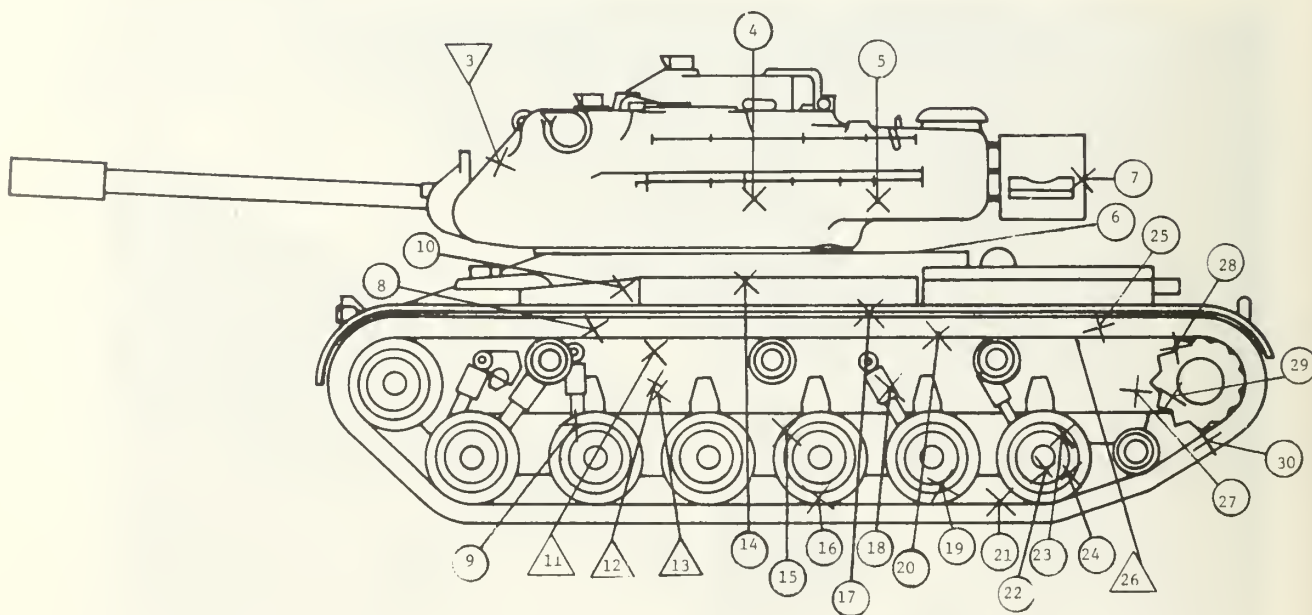
FIGURE 111. Impact Diagram, Target 43.

- a. M-Kill: Impacts 25 and 28 penetrated the left final drive, shown in Figures 112 and 113, respectively. Impact 22 destroyed the left #6 roadwheel hub (Figure 114). Cumulative damage to the track and suspension system, resulting from 10 other impacts, contributed to the kill.
- b. F-Kill: Impact 3 (Figure 115) perforated the left front turret, severed the recoil cylinder/replenisher flexible hose, and wounded the tank commander and gunner (Figures 116 and 117). Four (4) other perforations of the hull had little or no behind-the-plate effects.

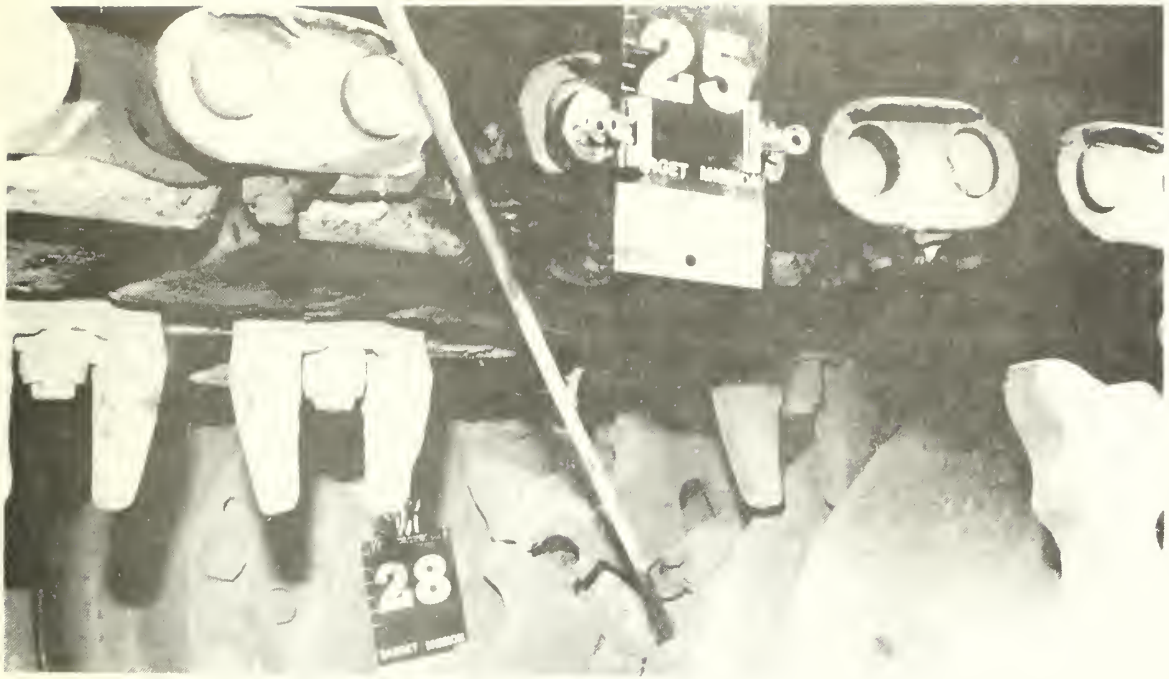
FIGURE 112. Impact Twenty-Five, Target 43, Showing Penetration of the Left Final Drive.
