# NAVAL POSTGRADUATE SCHOOL

A-10/GAU-8 LOW ANGLE FIRINGS VERSUS  
SIMULATED SOVIET TANK BATTALION  
(HONEYWELL LOT NUMBER 0L78D043-016)  
(ARRAY 3)

2 FEBRUARY 1979

R.H.S. STOLFI  
R.R. MCEACHIN

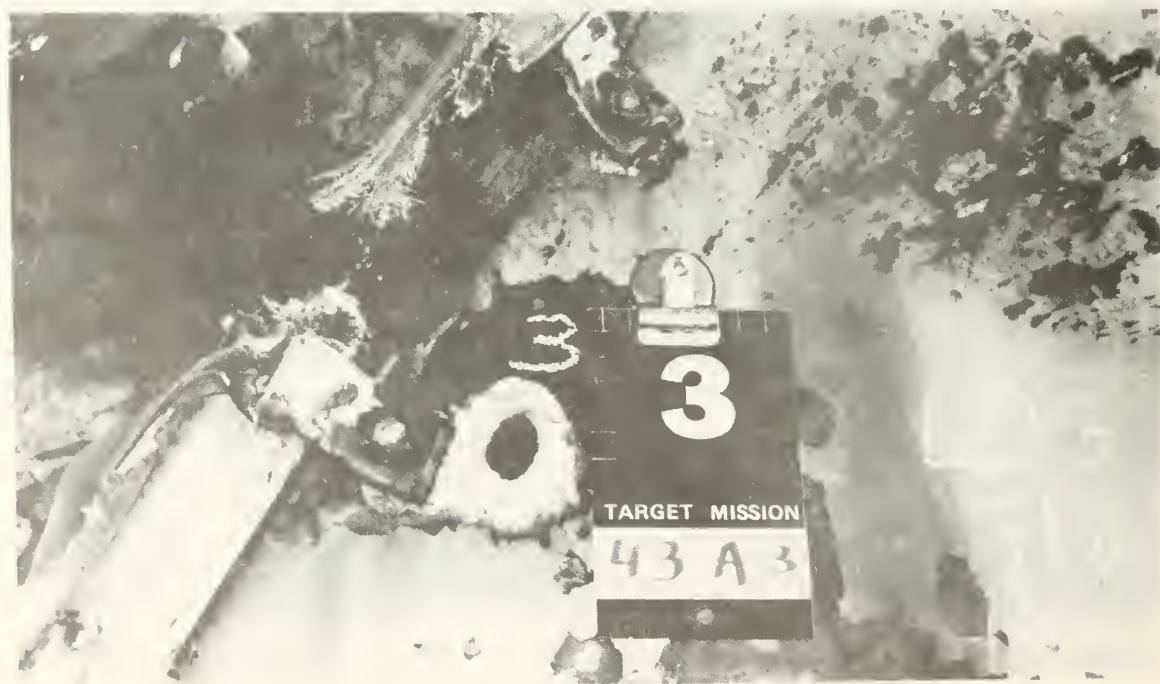
- a. M-Kill: Impacts 25 and 28 penetrated the left final drive, shown in Figures 112 and 113, respectively. Impact 22 destroyed the left #6 roadwheel hub (Figure 114). Cumulative damage to the track and suspension system, resulting from 10 other impacts, contributed to the kill.
- b. F-Kill: Impact 3 (Figure 115) perforated the left front turret, severed the recoil cylinder/replenisher flexible hose, and wounded the tank commander and gunner (Figures 116 and 117). Four (4) other perforations of the hull had little or no behind-the-plate effects.

FIGURE 115. Impact Three, Target 43, which Perforated the Left Front Turret into the Fighting Compartment.

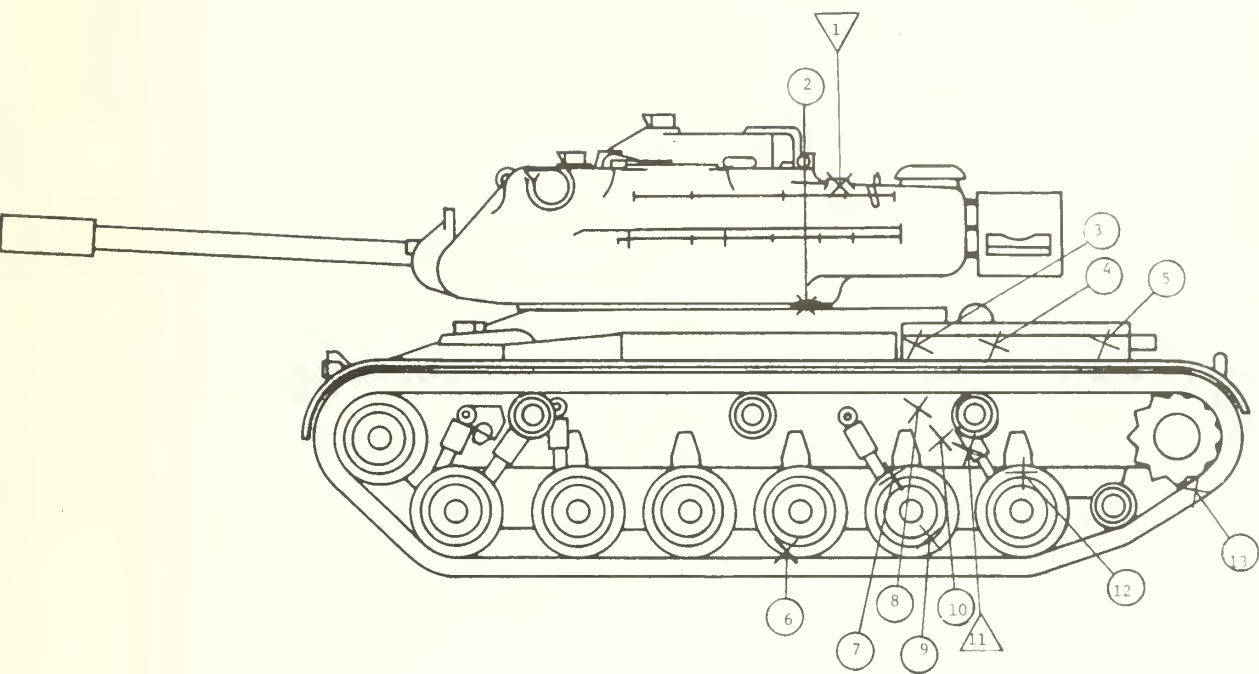
FIGURE 118. Impact Diagram, Target 44.

- a. M-Kill: Impact 11 (Figure 119) perforated the left hull and penetrated the oil cooler area; if the oil cooler had been in place, it would have been damaged or destroyed. Impact 12 ruptured the left final drive causing an oil leak. One other impact on the track destroyed one track center guide, making a minor contribution to the kill.
- b. F-Kill: Impact 1 (Figure 120) perforated the left top of the turret and caused casualties to two (2) crewmen (tank commander and gunner). No mechanical damage that would contribute to an F-Kill was observed.

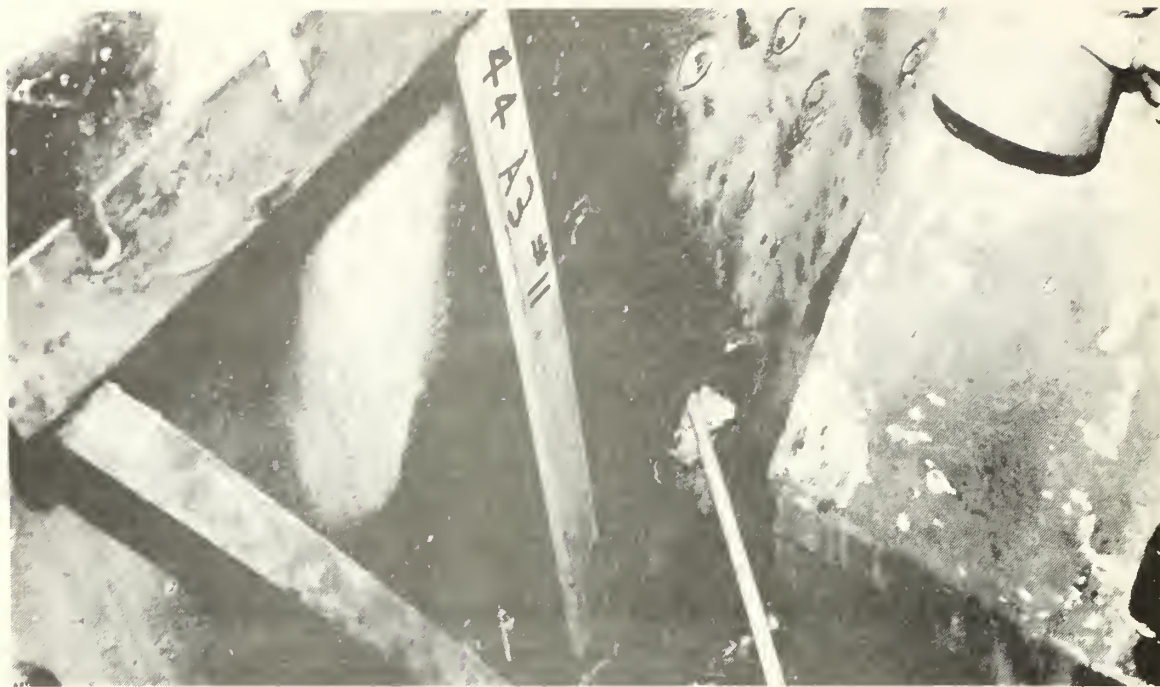
FIGURE 119. Impact Eleven, Target 44, which Perforated the Left Hull Armor into the Engine Compartment.

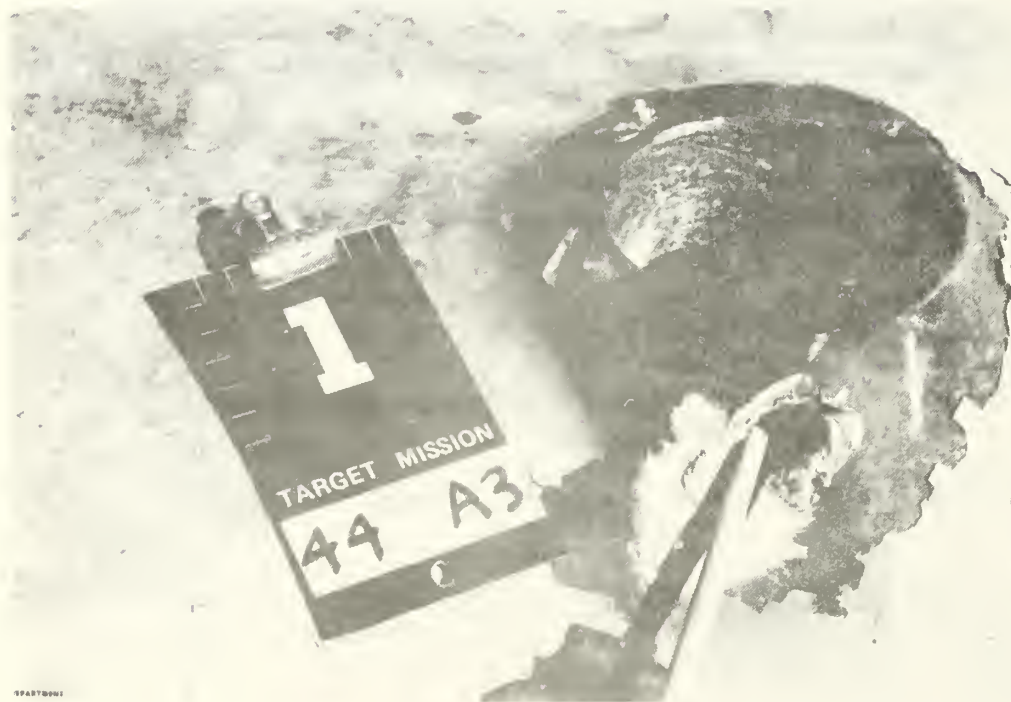
FIGURE 120. Impact One, Target 44, which Perforated the Left Top of the Turret and caused Commander and Gunner Casualties.

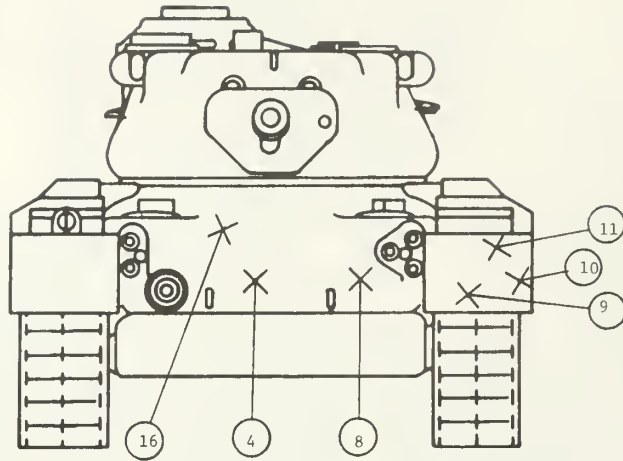
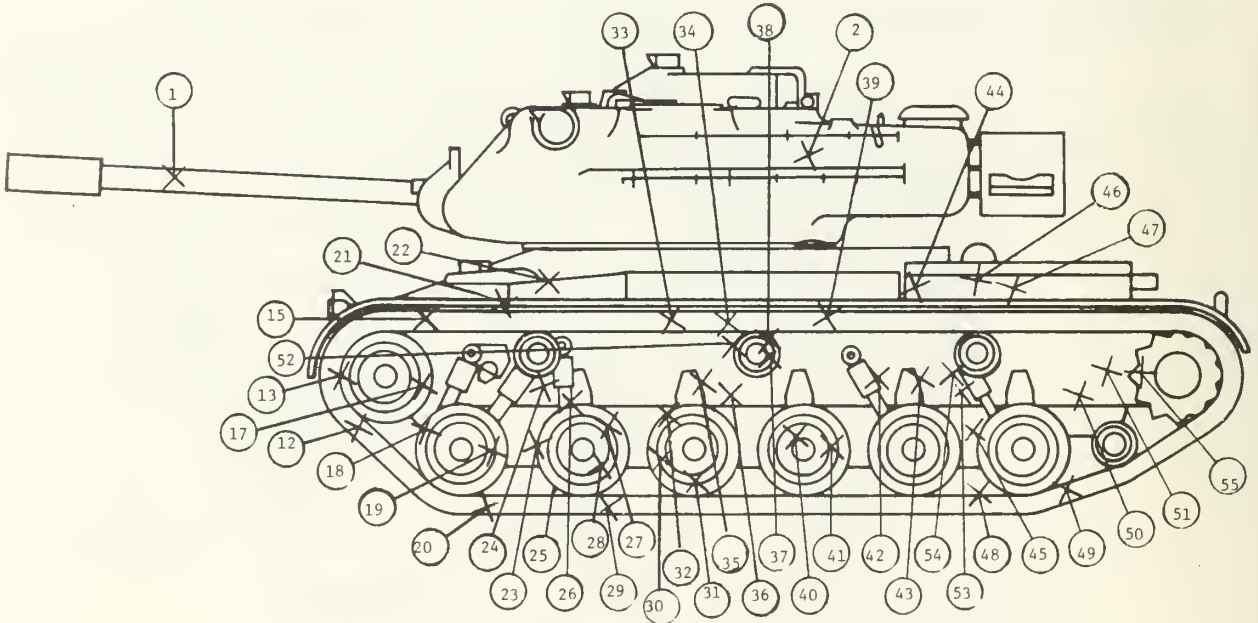
FIGURE 121. Impact Diagram, Target 45.

- a. M-Kill: Impact 28 damaged the hub of the left #2 road-wheel, causing a breach of the seal assembly. Impact 40 (Figure 122) destroyed the left #4 roadwheel hub. Impacts 37 and 38, shown in Figures 123 and 124, respectively, destroyed the left #2 track support roller. Cumulative damage to the track and suspension system from 15 other impacts contributed to the kill.
- b. F-Kill: Impact 1 (Figure 125) penetrated one wall of the gun tube, degrading firepower by an estimated 10%.

IMPACTS 3, 4, 5, 6, 7, and 14 ON BULLDOZER BLADE BRACKETS

NOTE: Not shown in the impact distribution drawing above, but recorded in firing results are hits number 3, 5, 6, 7 and 14 on bulldozer blade, and its mounting bracketry and actuating hydraulic cylinder.
