Collision of passenger train A42 with buffer stop

Richmond, New South Wales | 22 January 2018

ATSB Transport Safety Report
Rail Occurrence Investigation
RO-2018-004
Final – 20 December 2019

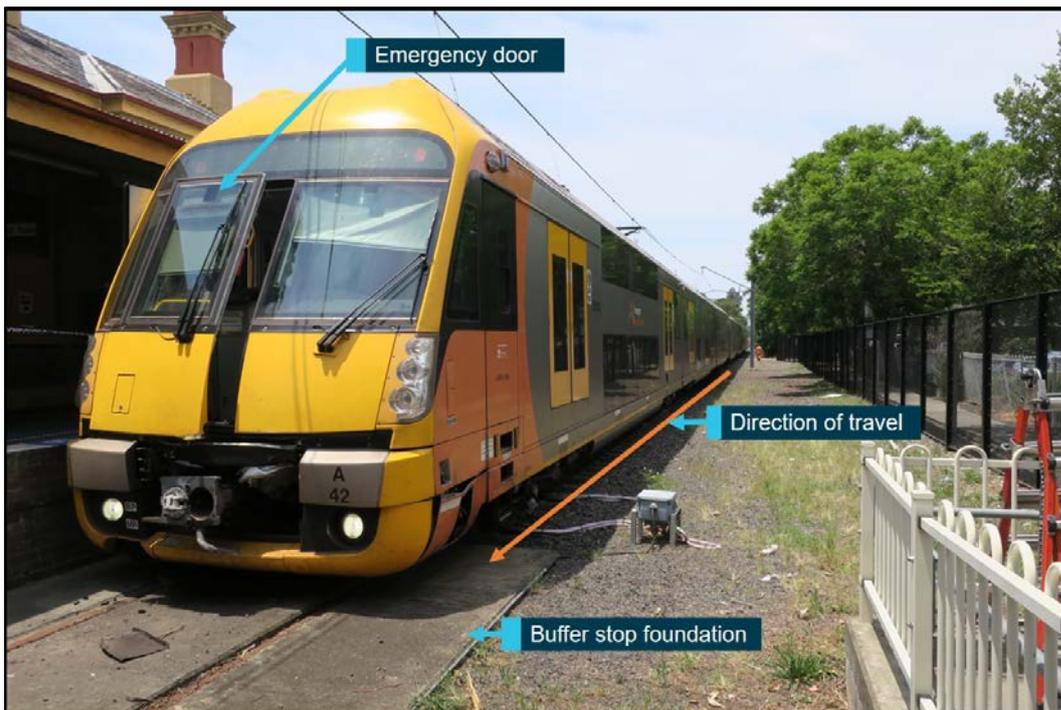
Figure 6: A42 at Richmond Station post-collision

After the impact with the buffer stop, the front of the train came to rest approximately 3 m from the buffer stop and the rear carriages recoiled further due to the partial recovery of the energy absorption elements that are distributed throughout the train. The impact caused all cars to concertina together, with some wheels lifting from the track. A post-incident inspection found, on the rear wheelset of the rear bogie on the third position car one wheel suspended above the rail, the other wheel derailed and all wheels of the rear bogie (No.1 end) on the fifth position car derailed.

There was damage to the front of the train, particularly the head of the Sharfenberg coupler (No.2 end of motor driving carriage D6342), the lower section of the front nose cone and the undercarriage. There was significant damage to the interconnecting areas between cars, the associated door systems and the coupling systems between cars. There was no visible damage to the interior of the driver's cab or to the internal passenger saloon areas. The emergency door at the front of the train had become ajar during of the collision. The exterior stainless steel skin of the carriages, apart from the areas between carriages, sustained no visible damage.² All carriage windows and exterior doors were undamaged. The exterior doors and opening systems were all functioning following the collision.

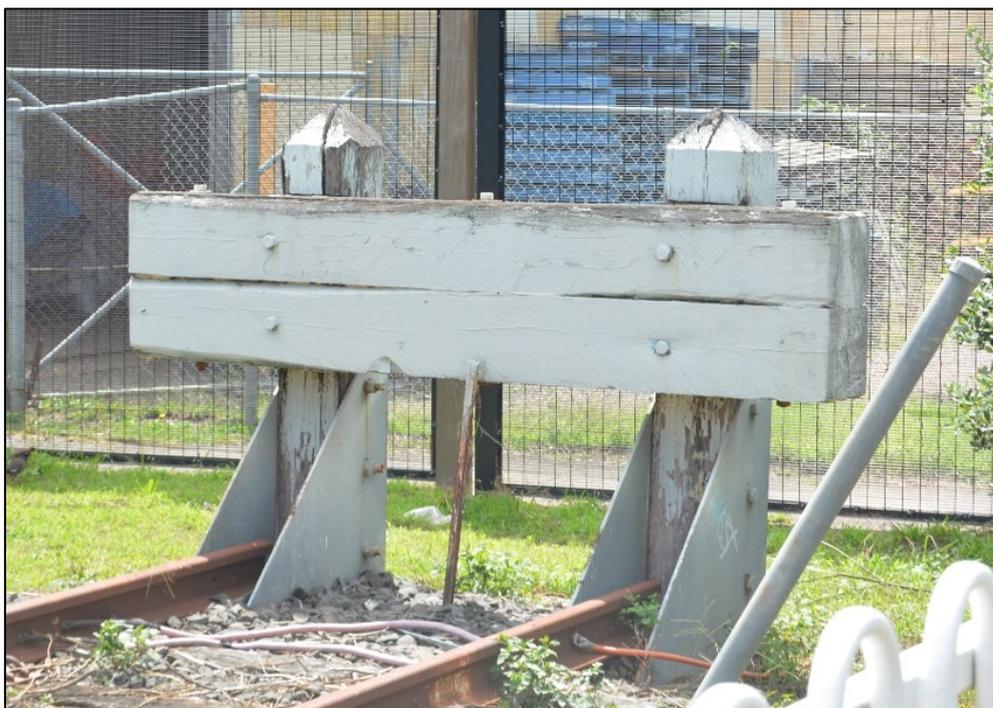
Figure 21: Fixed buffer stop at Carlingford station

The Carlingford buffer stop, when inspected in March 2019 (14 months after the Richmond collision), still had the standard Department of Railways NSW, Way and Works Branch, 1963-designed timber fixed buffer stop bolted to the track (Figure 21). Reviewing the effectiveness of this buffer stop, the 2008 report calculated that timber buffer stops are unable to resist a force of 1000 kN and would break away. The report stated that ‘the current fixed timber buffer stop would not be able to arrest any train effectively at any speed.’⁶¹

This figure shows the buffer stop at the end of the line at Carlingford station on the Sydney rail network.
Source: ATSB

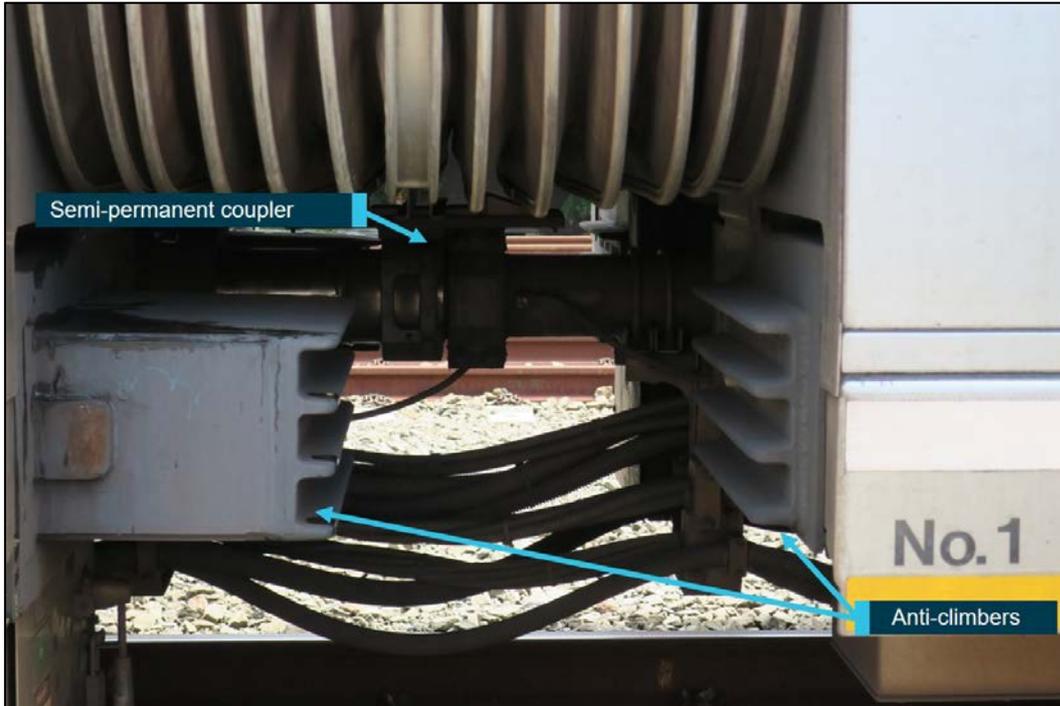
Figure 31: Normal configuration of anti-climbers

The bending of the couplers between the first two car interfaces, and the derailment of all wheels of a bogie (Figure 30), is indicative of vertical pitching that occurred because of the forces being transferred along the train not in a line of action close to the centreline through the couplers. This affected the alignment of the anti-climbers, which reduced their effectiveness in containing vertical movement (Figure 31).

This figure shows the anti-climbers in their normal configuration between the seventh car (N5442) and the eighth car (D6442).
 Source: ATSB
