INVESTIGATION NO. 2597  
THE ATCHISON, TOPEKA & SANTA FE RAILWAY COMPANY  
REPORT IN RE ACCIDENT  
NEAR CALZONA, CALIF., ON  
JUNE 25, 1942

Railroad: Atchison, Topeka & Santa Fe  
Date: June 25, 1942  
Location: Colzosa, Calif.  
Kind of accident: Derailment  
Train involved: Passenger  
Train number: 117  
Engine number: 3520  
Consist: 4 cars  
Speed: 35-40 m. p. h.  
Operation: Timetable and train orders  
Track: Single; tangent; 0.20 percent  
ascending grade westward  
Weather: Clear  
Time: About 10:30 p. m.  
Casualties: 2 killed; 31 injured  
Cause: Accident caused by bridge being  
burned out

Accident near Calzona, Calif., on June 25, 1942, caused by  
a bridge being burned out.

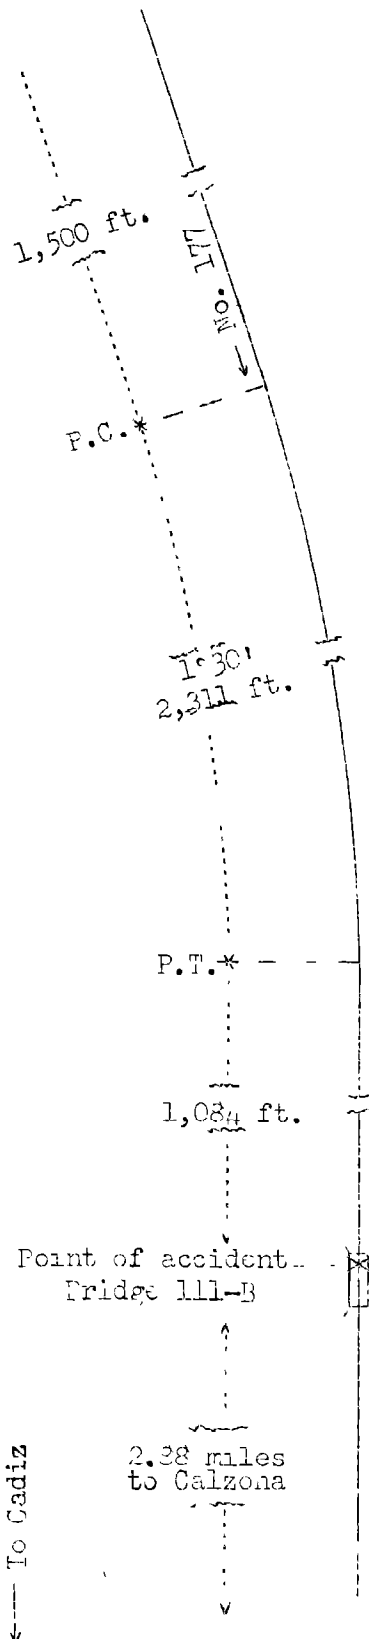
Side view of Bridge 111-B

The investigation disclosed that prior to the time of the accident all the deck and practically all the piles of this bridge had been destroyed by fire. The manner in which the bridge was burned indicated that the fire had started at the bottom of the bents and burned upward. Some of the piles were burned 4 to 5 inches below the ground level. Immediately after the accident occurred no flame was visible, but the abutment bents were still smouldering. Ashes had been blown away by a 35-mile-per-hour wind that had prevailed throughout the evening. Charcoal and ashes from the bridge were found at points 500 feet north of the location of the bridge. The evidence indicates that only the rails remained in place. Because of tangent track throughout a distance of 1,089 feet east of Bridge 111-B, the enginemen could have had an unobstructed view of the bridge. Since both enginemen were killed in the accident it could not be determined when they first became aware of the defective condition of the bridge, but apparently the engine was close to the east end of the bridge as the brakes were not applied until about 2 seconds before the accident occurred.

ground-line. A deputy sheriff who checked conditions in the immediate vicinity of the bridge was of the opinion that the fire was of incendiary origin.
