**Factual Report, Aviation, NTSB Form 6120.4**

**FACTUAL REPORT  
AVIATION  
ACCIDENT/INCIDENT**

FTW-88-M-A109

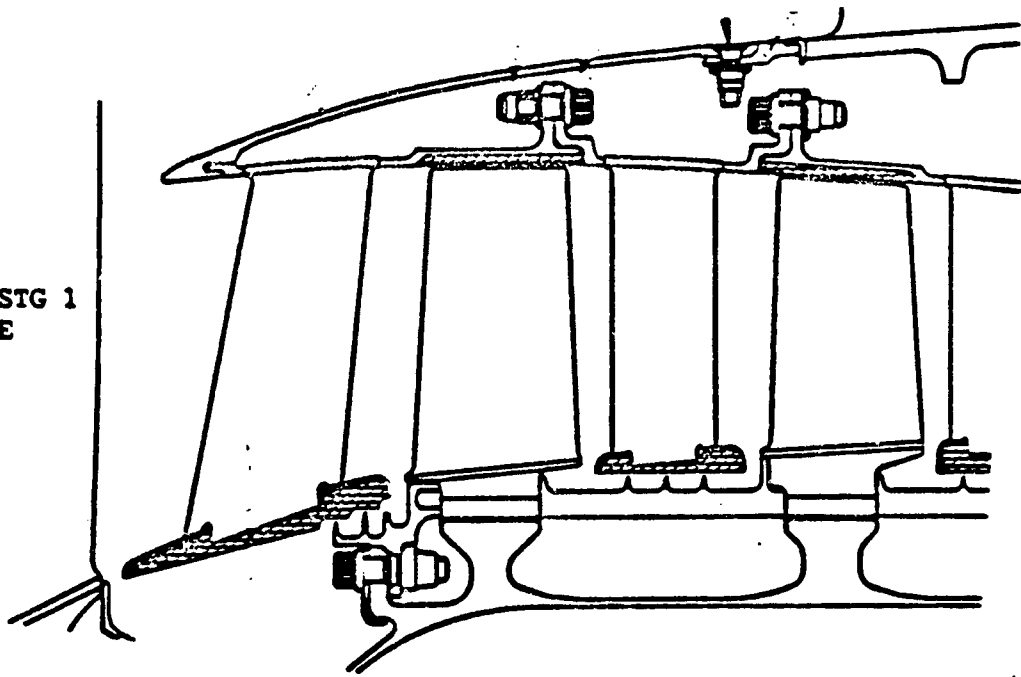
ORIGINAL SPLITTER CONFIGURATION

# EFFECT OF ROTOR-SPLITTER SPACING ON WATER INGESTION CAPABILITY

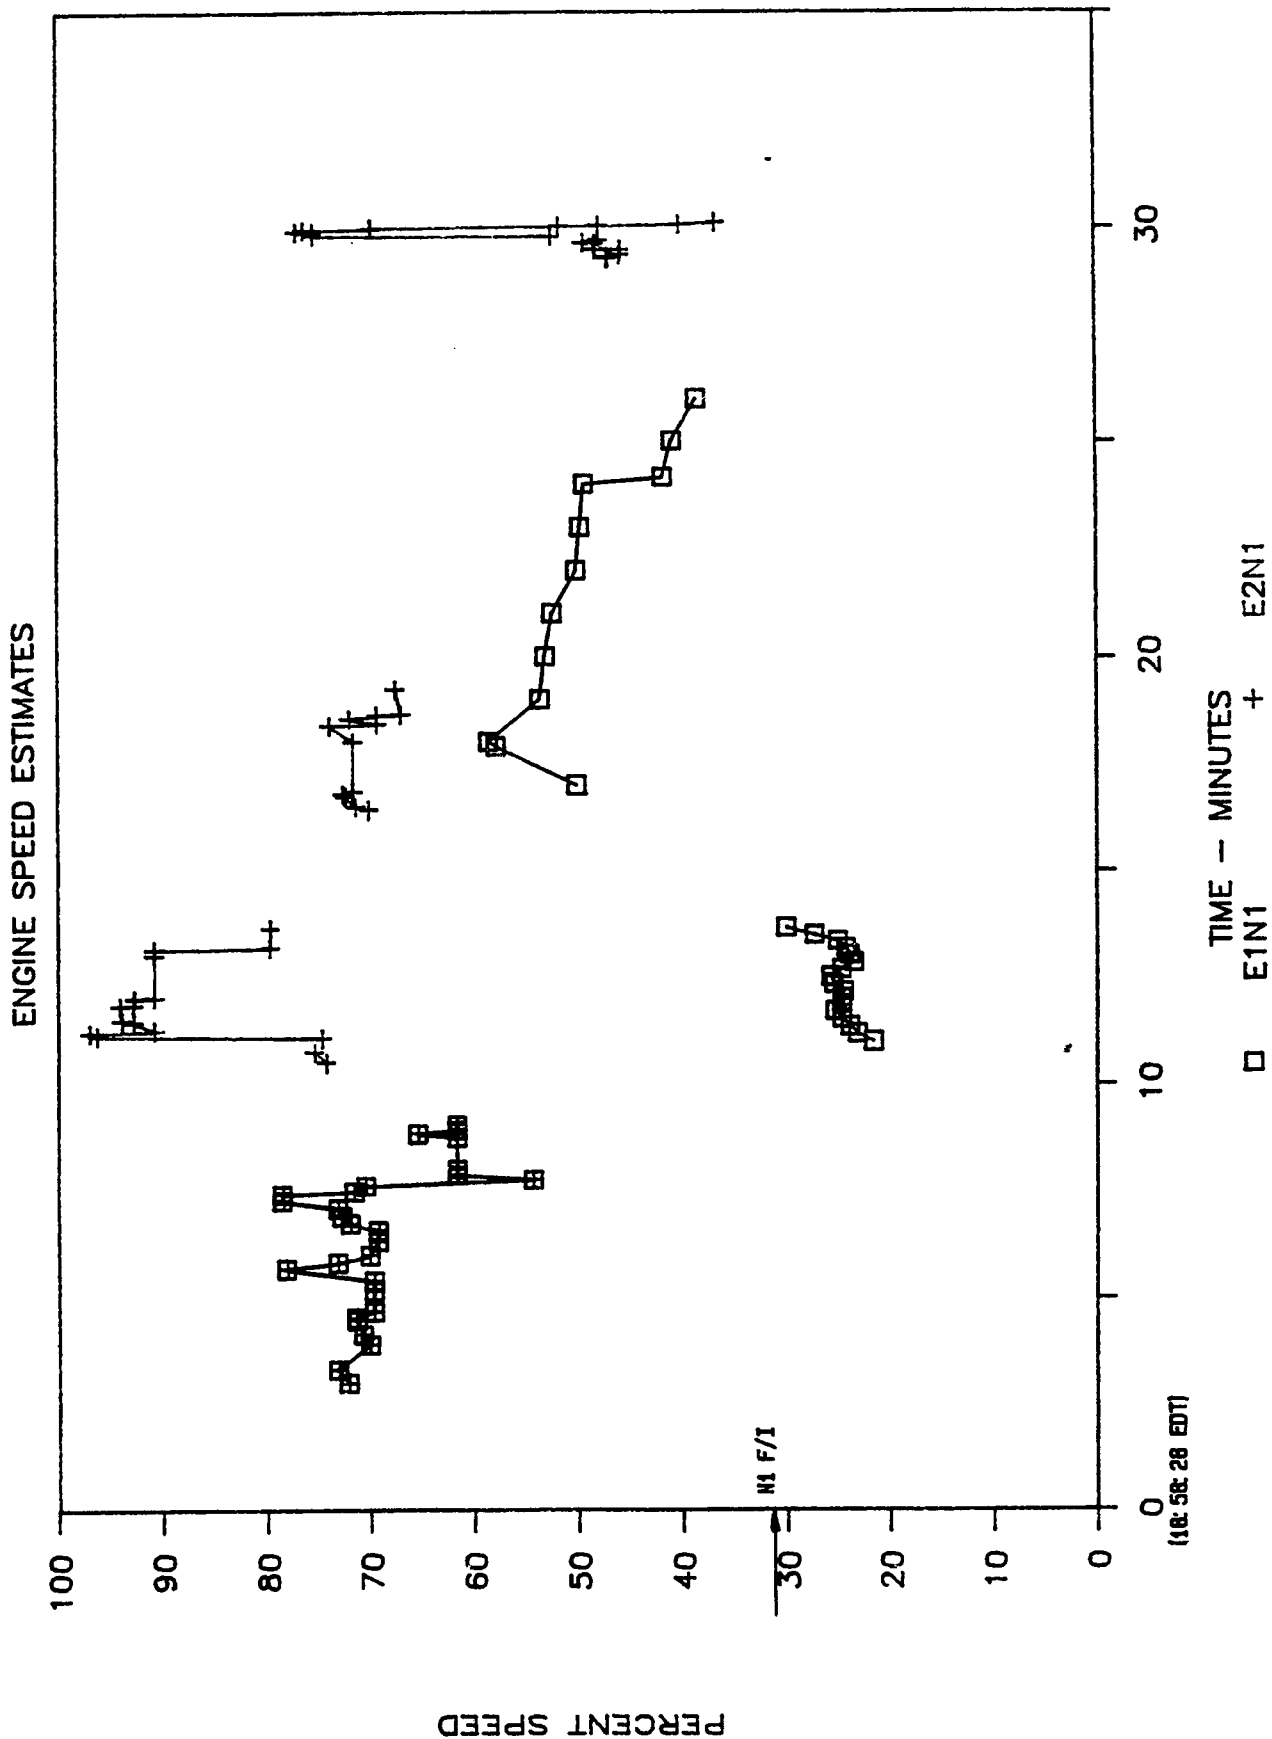
# FIGURE 1 CONTINENTAL FL 522 POWER LOSS

Figure 1 presents, in a condensed form, the engine fan speeds estimated for the entire event.

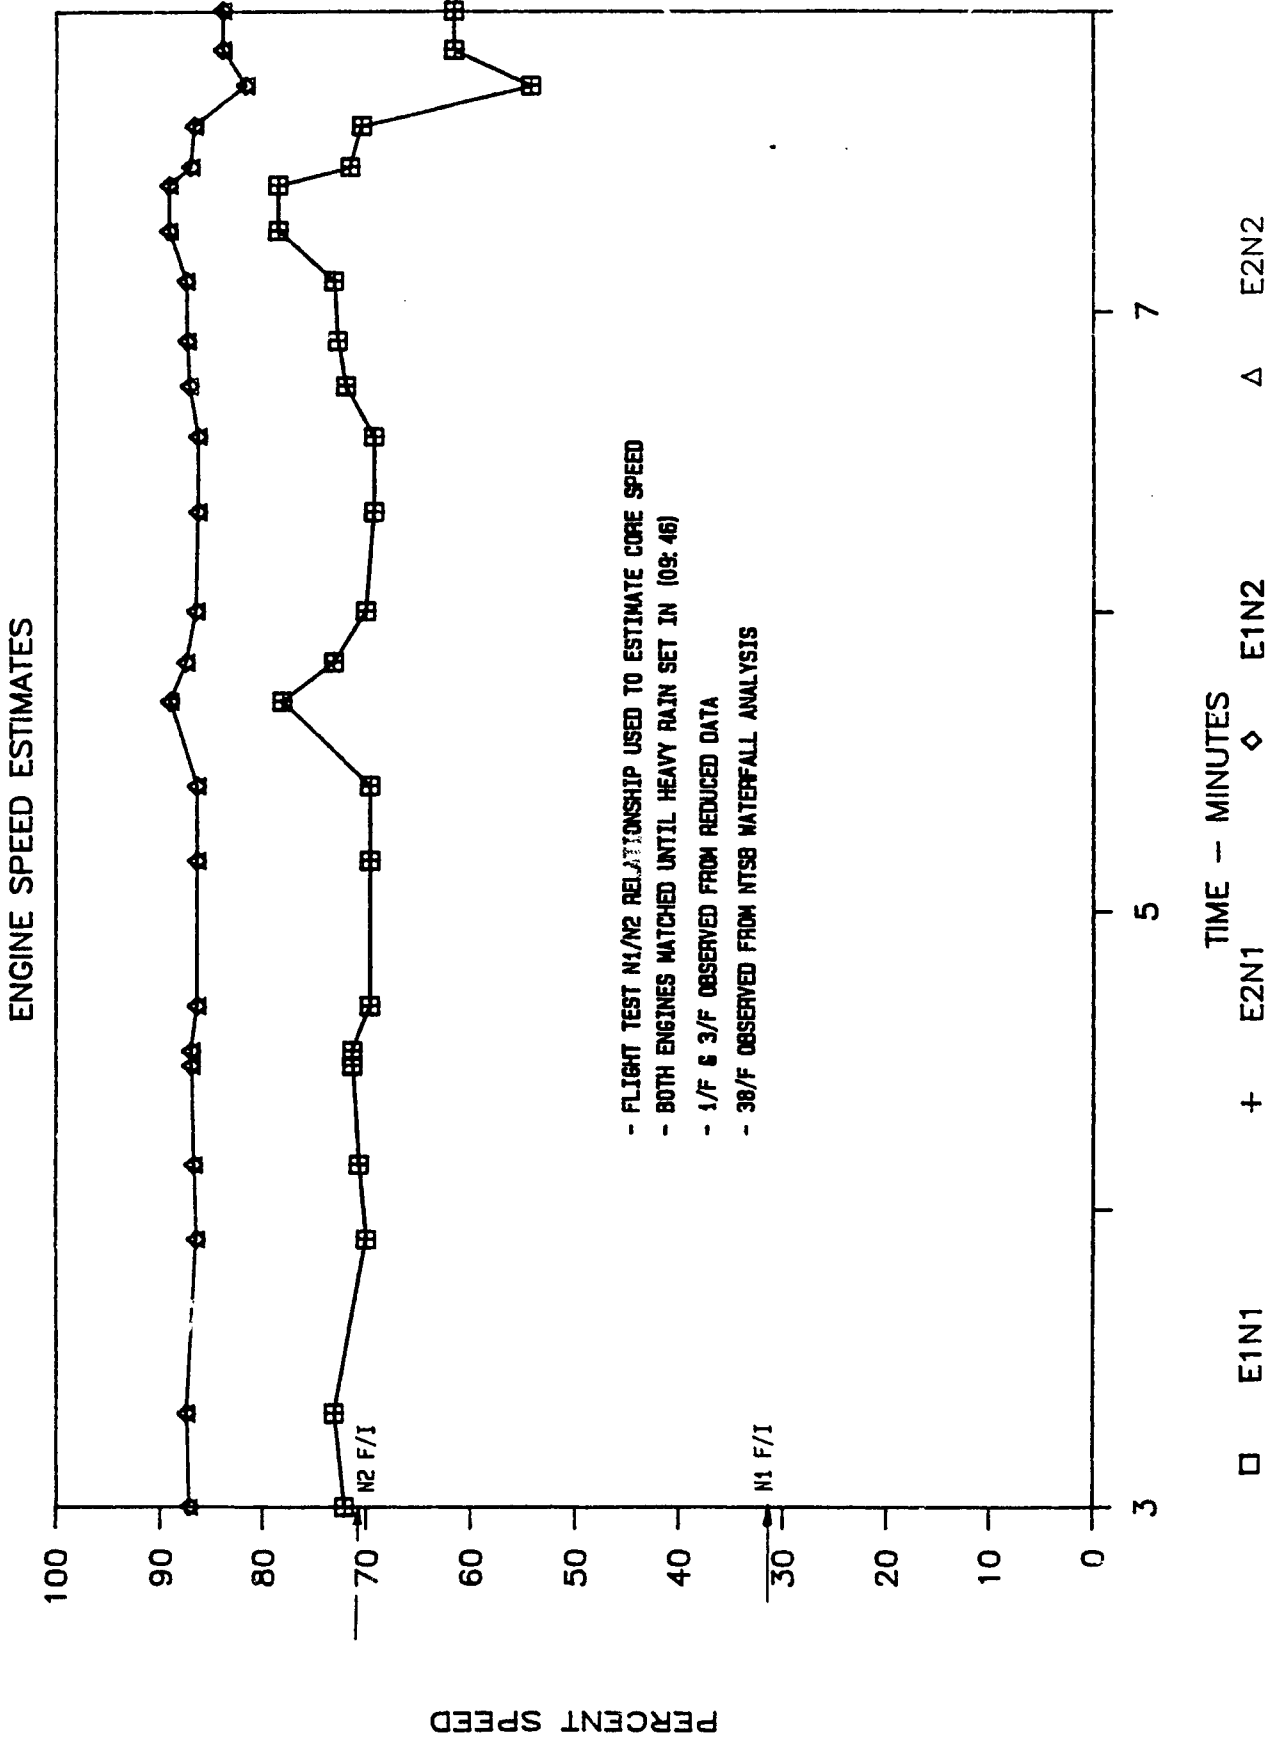
# FIGURE 2 CONTINENTAL FL 522 POWER LOSS

Figure 2 covers the period of time before the heavy precipitation and it is assumed that the engines were matched in speed. As is the case for the remainder of the plots where core speeds are presented (except for the period 11:00 to 17:58), the core speeds were estimated by using fan/core speed relationships derived from Boeing flight test data. Up to the time of 09:02 fan fundamental and 3/f tones were clearly visible in the reduced data.

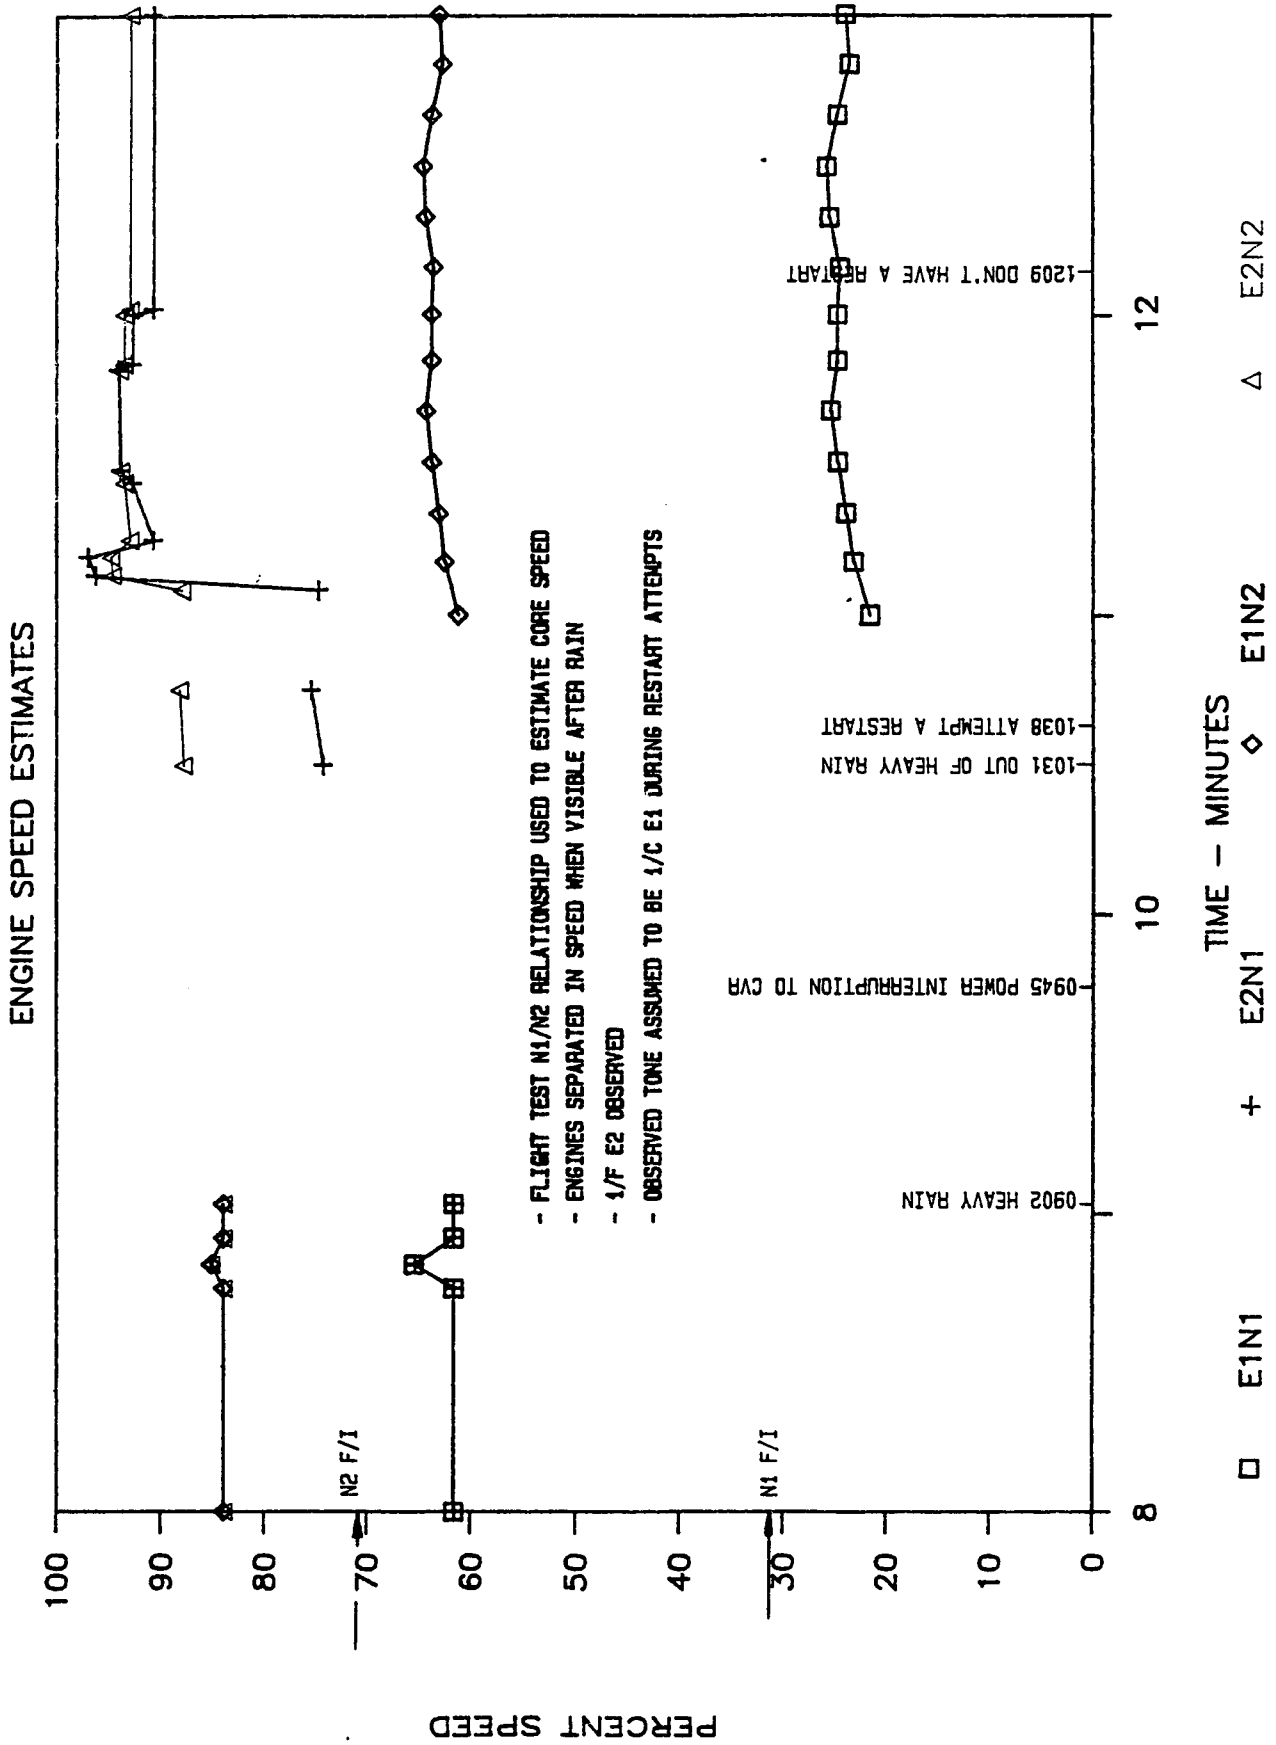
# FIGURE 3 CONTINENTAL FL 522 POWER LOSS

In Figure 3 fan fundamental tones were observed on leaving the heavy precipitation and were attributed to engine No. 2. Tones of approximately 150 Hz were observed during the period of time when engine No. 1 was undergoing a windmill restart. For the period 11:00 to 17:58 (Figures 3 and 4) a trace believed to represent core speed for the No. 1 engine was visible in the data but a corresponding trace of fan speed was not. Fan speed was therefore calculated using the Boeing flight test N1/N2 relationship discussed earlier. The data indicates that as the aircraft exited the heavy rainfall core speed was below flight idle and above normal windmilling speed. While this is inconsistent with what would be expected, there are a number of factors

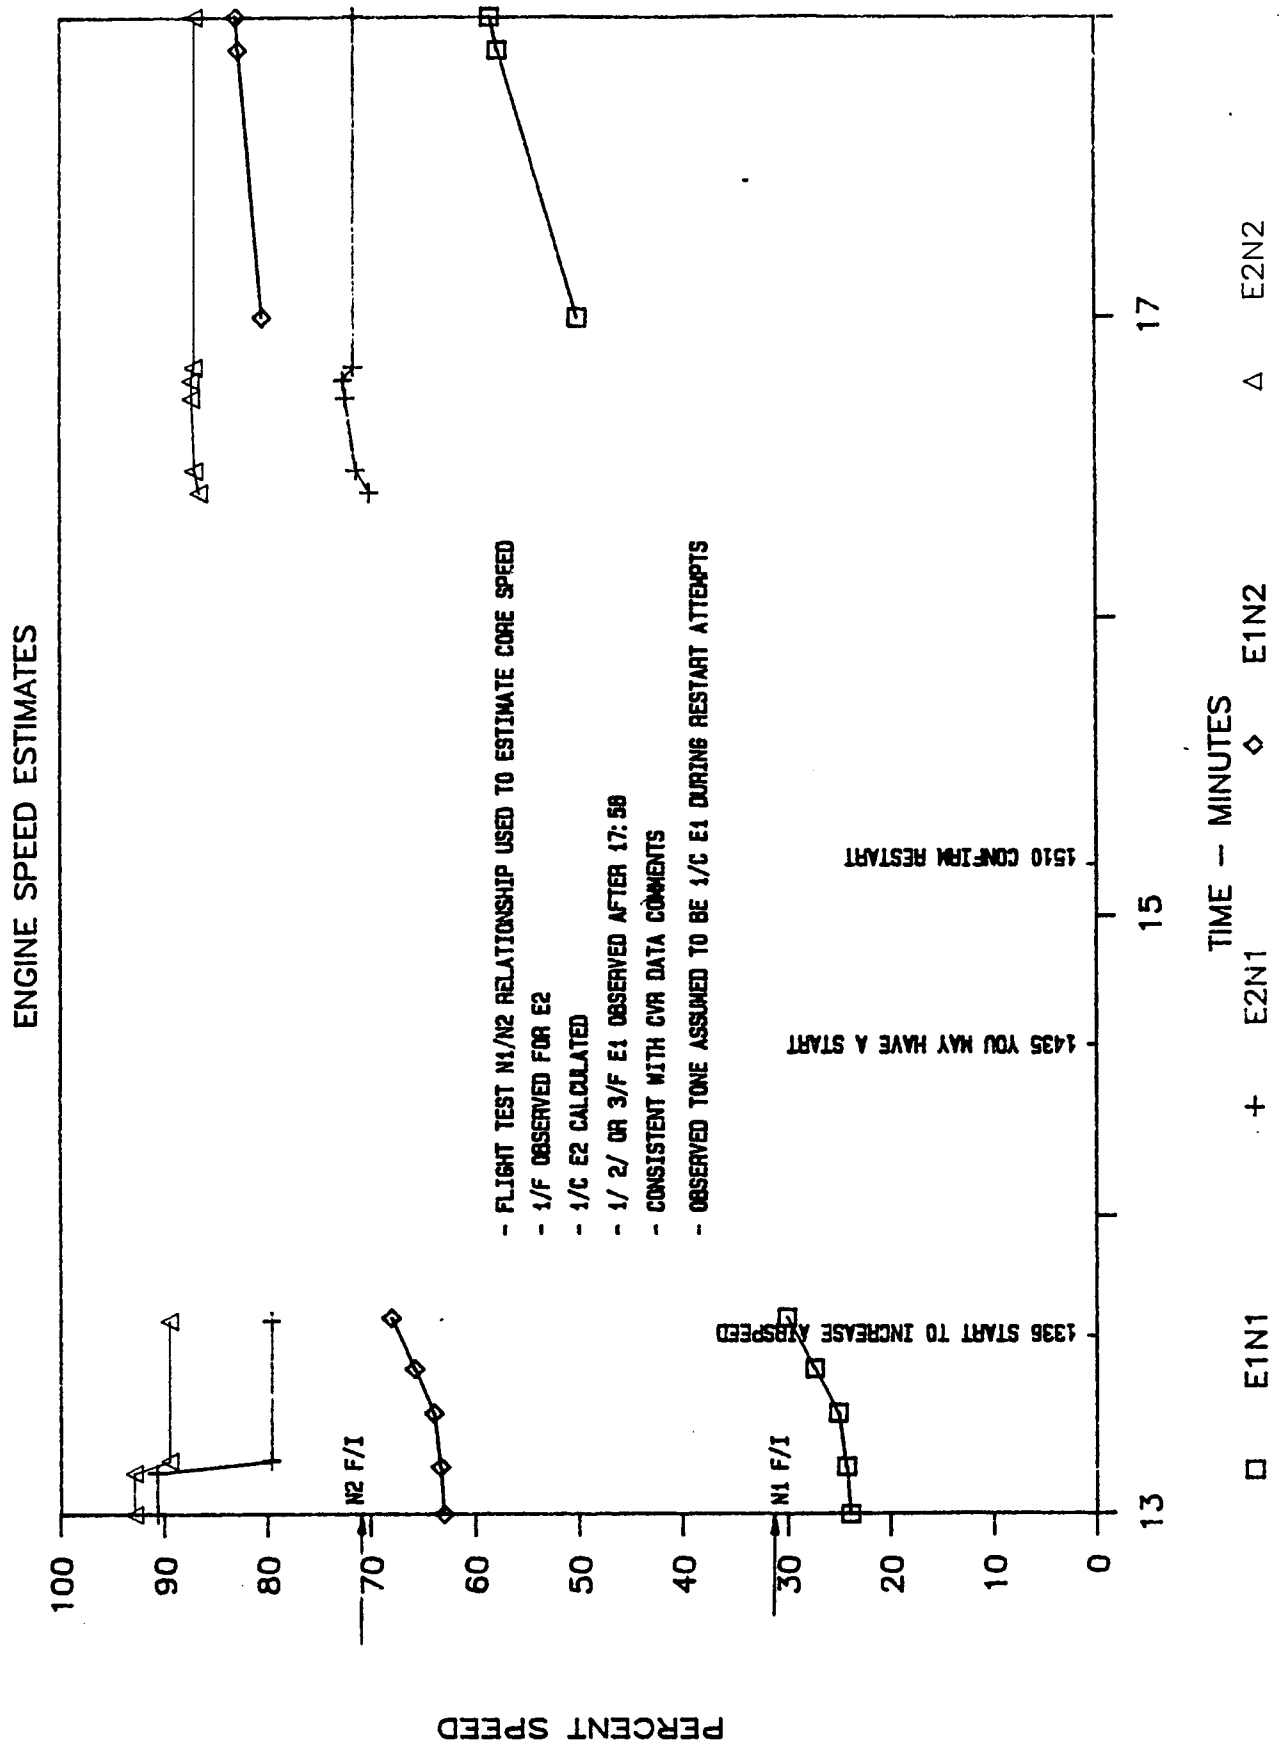
# FIGURE 4 CONTINENTAL FL 522 POWER LOSS ENGINE SPEED ESTIMATES

- FLIGHT TEST N1/N2 RELATIONSHIP USED TO ESTIMATE CORE SPEED
- 1/F OBSERVED FOR E2
- 1/C E2 CALCULATED
- 1/ 2/ OR 3/F E1 OBSERVED AFTER 17:50
- CONSISTENT WITH CVR DATA COMMENTS
- OBSERVED TONE ASSUMED TO BE 1/C E1 DURING RESTART ATTEMPTS

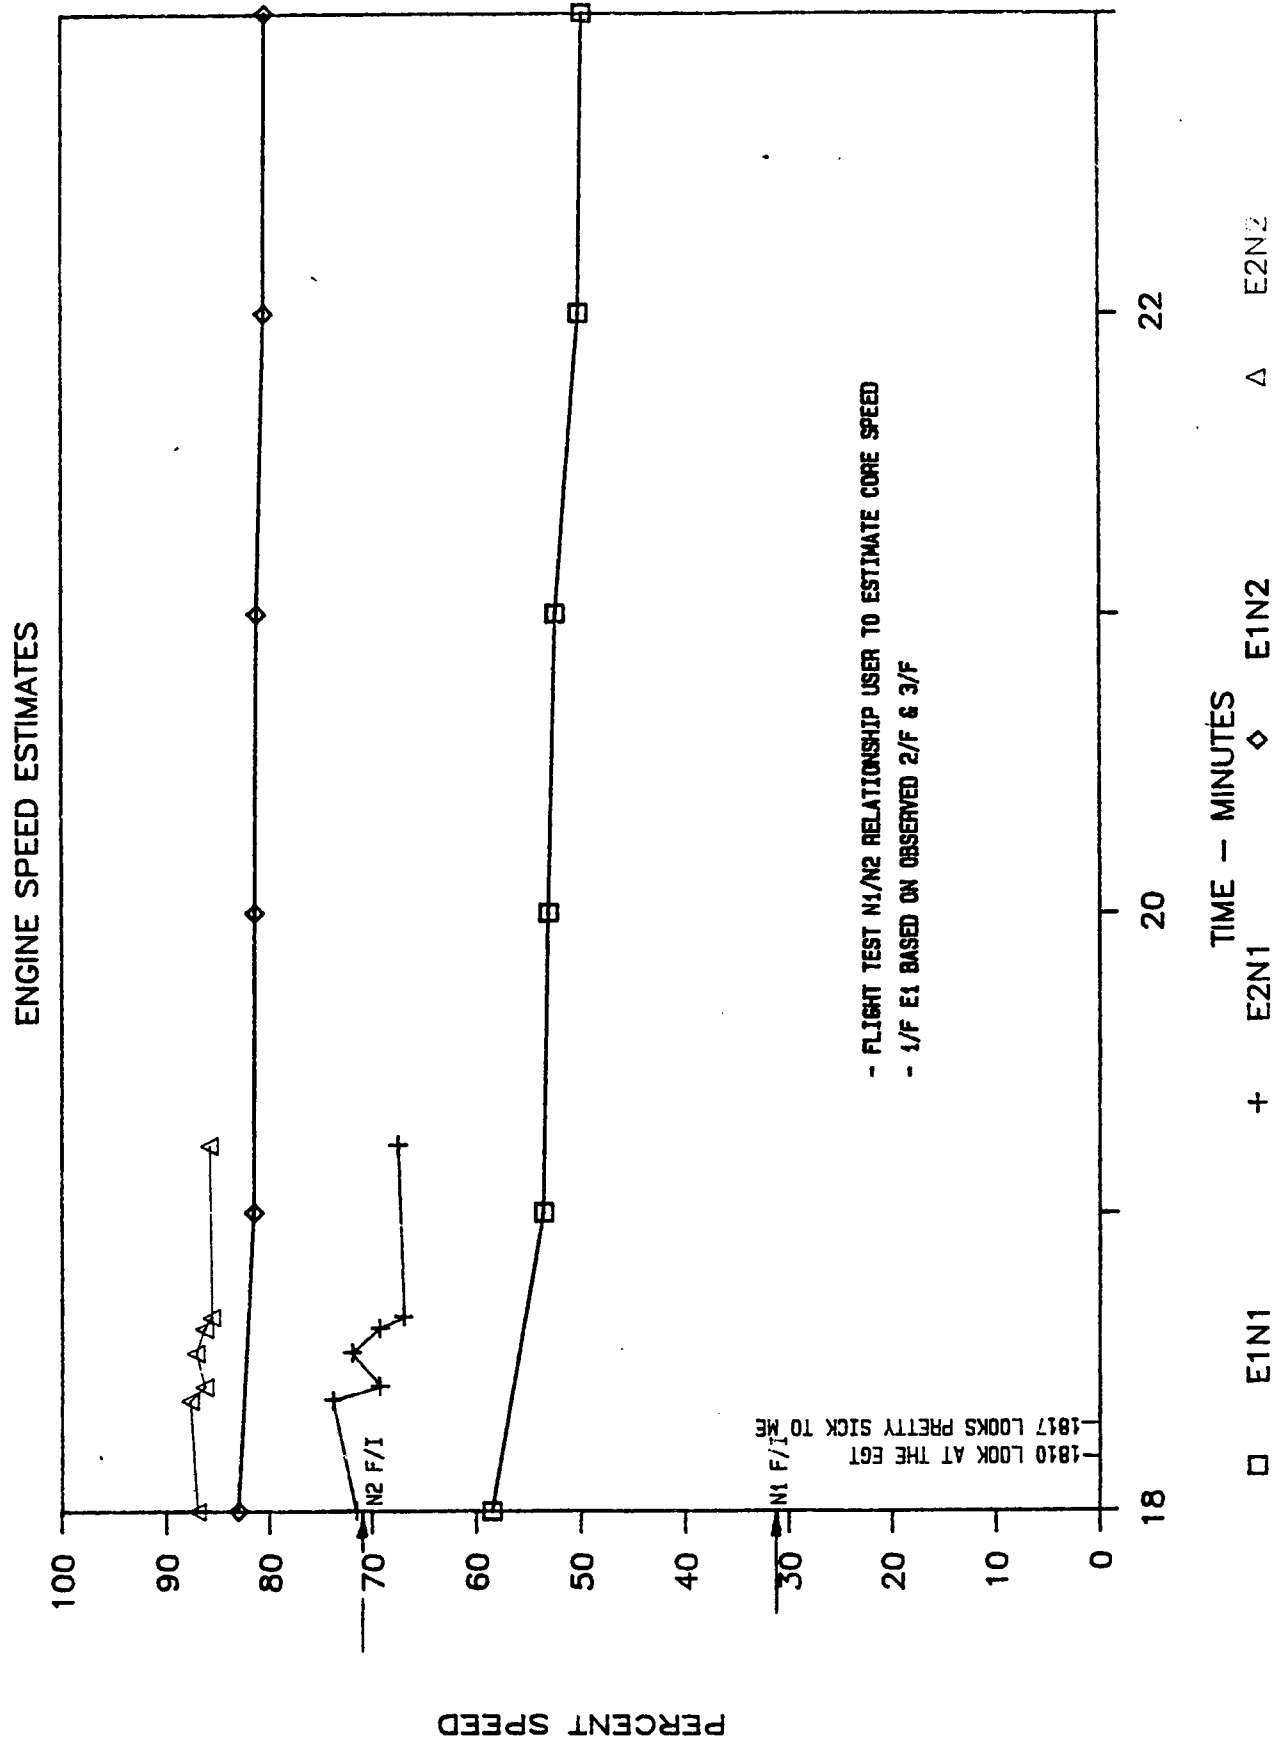
# FIGURE 5 CONTINENTAL FL 522 POWER LOSS ENGINE SPEED ESTIMATES

Estimates of the engine speed during restart attempts have been based on the observed tones in the data. There appear to have been four instances of one engine or the other rolling back without achieving a stabilized idle condition.

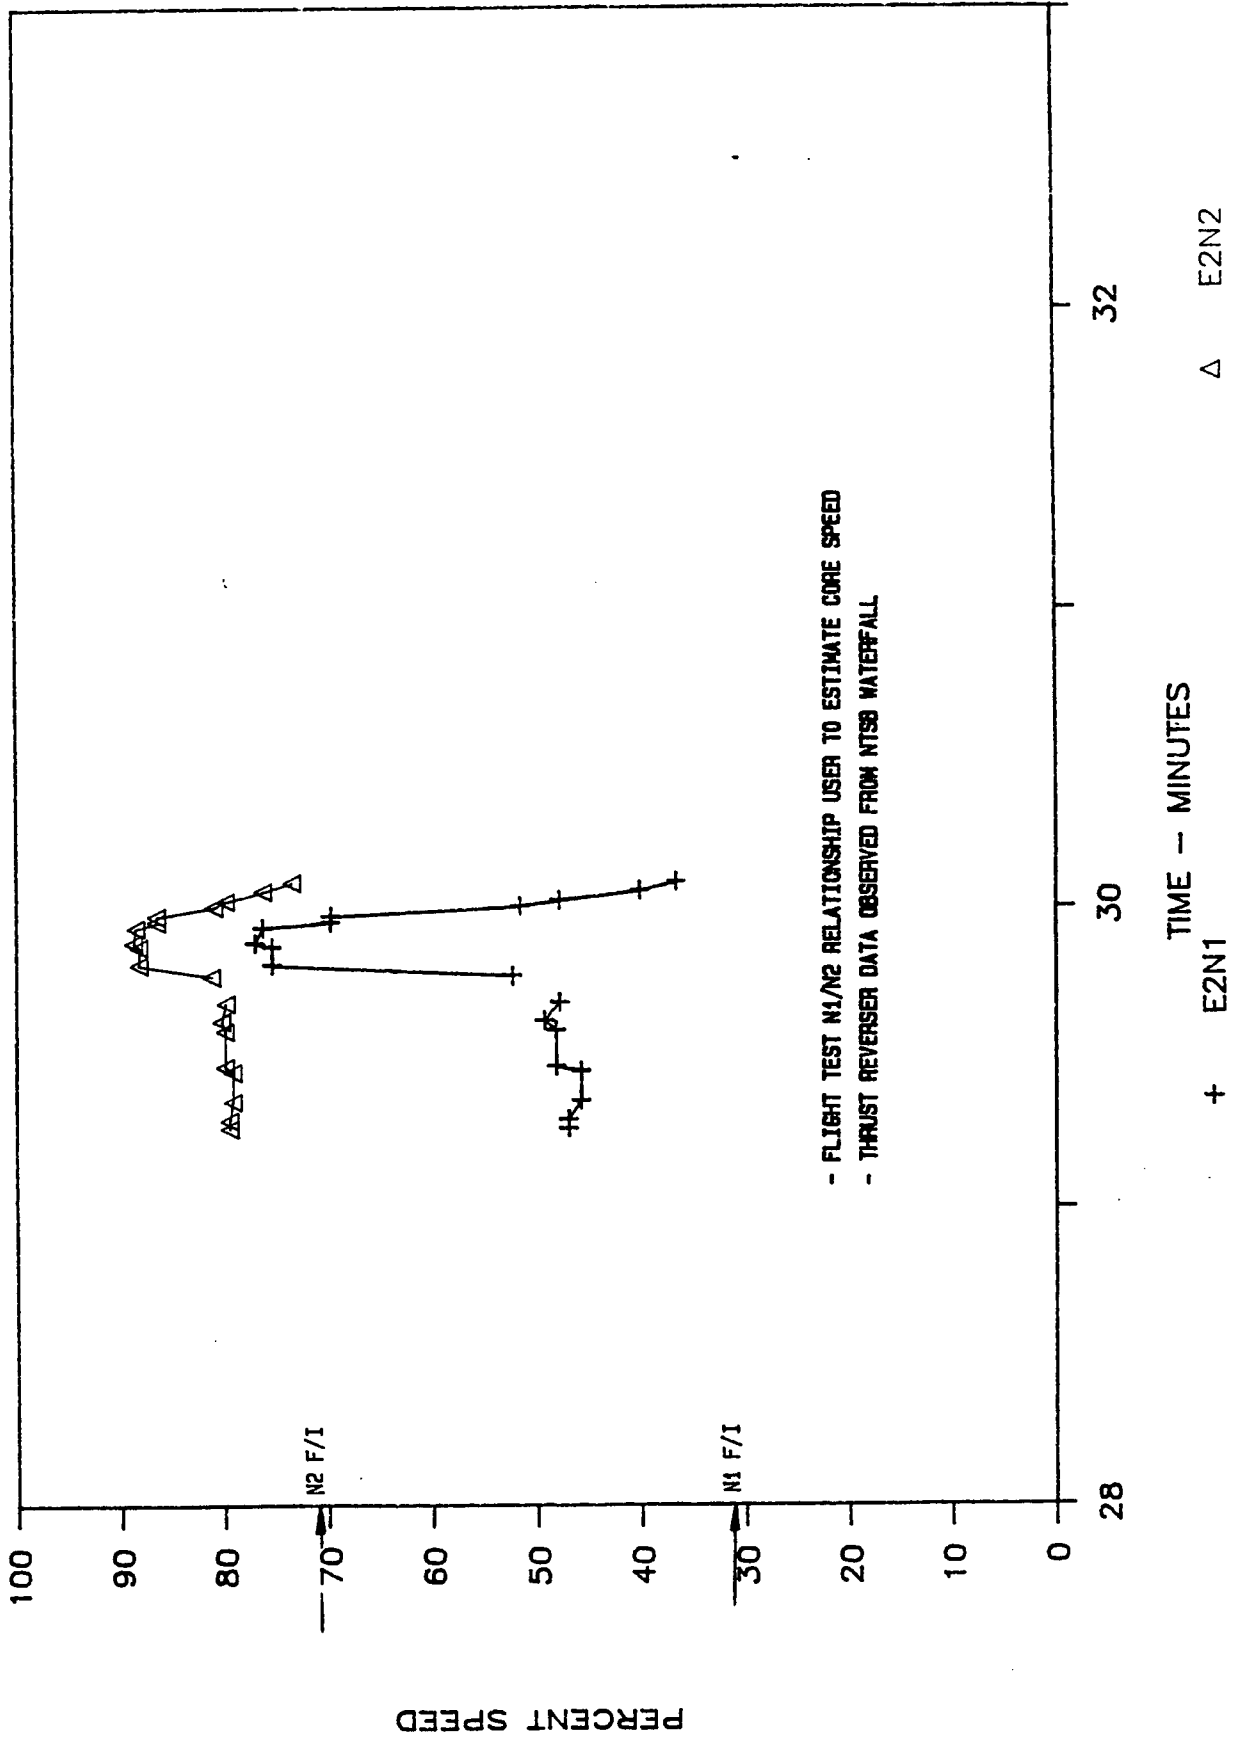
# FIGURE 7 CONTINENTAL FL 522 POWER LOSS

ENGINE SPEED ESTIMATES

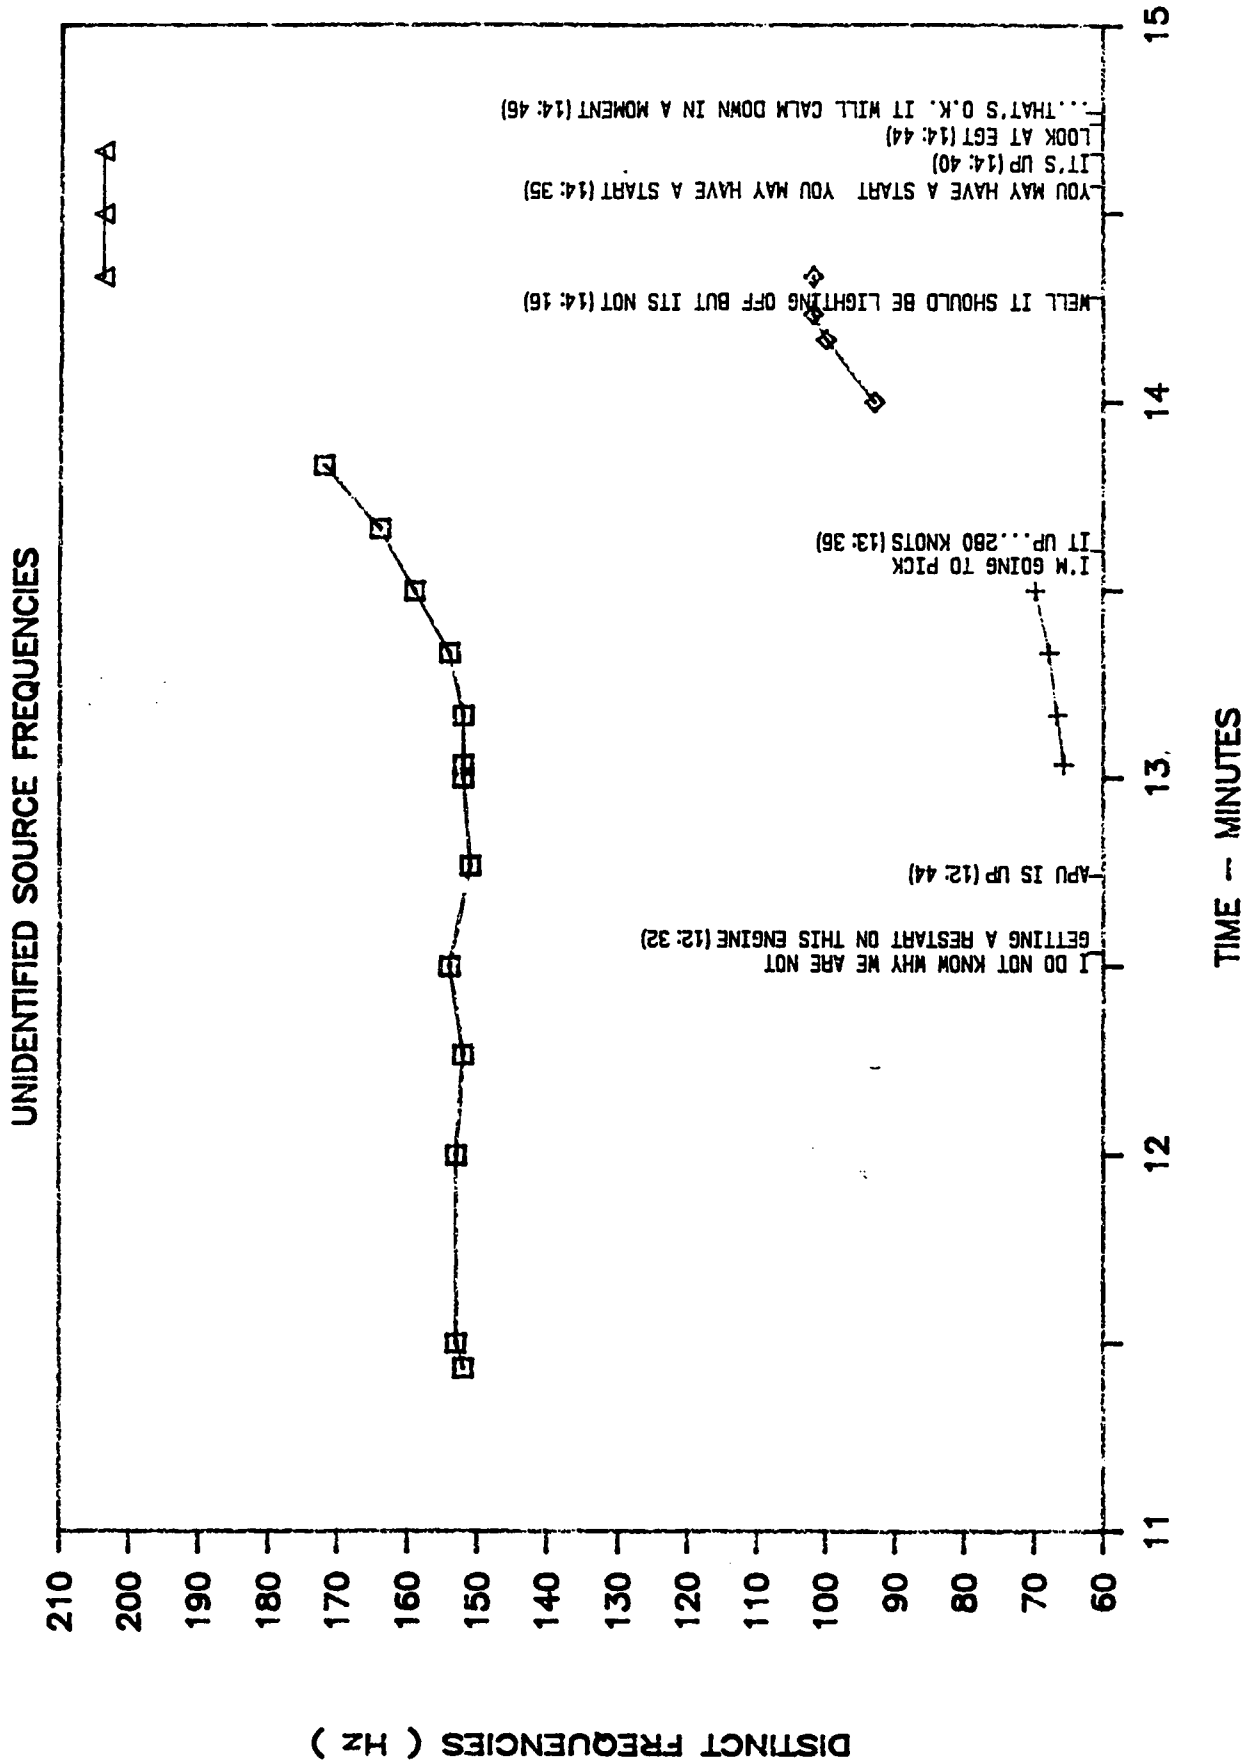
# FIGURE 8

## CONTINENTAL FL 522 POWER LOSS

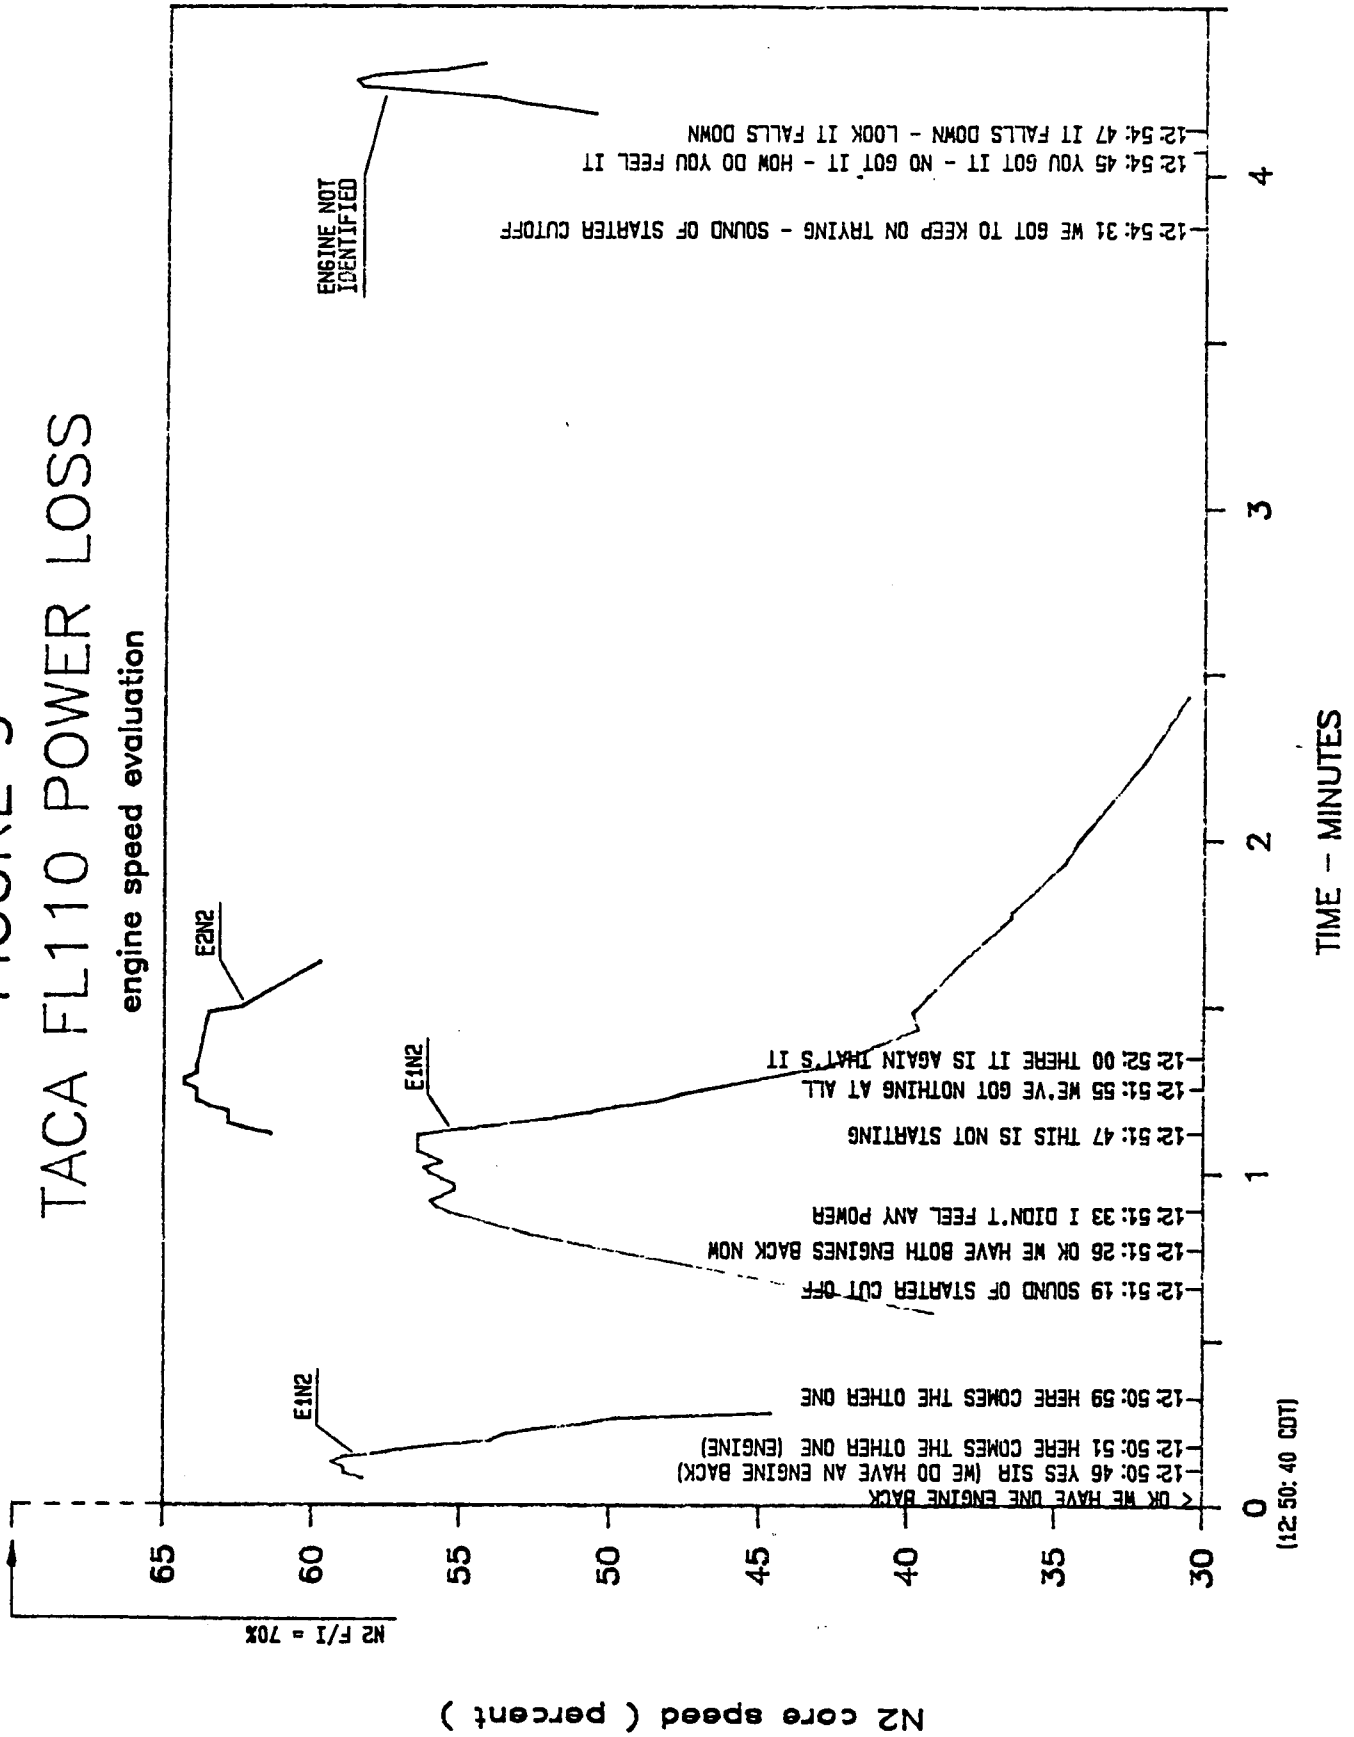
# FIGURE 9 TACA FL110 POWER LOSS

engine speed evaluation

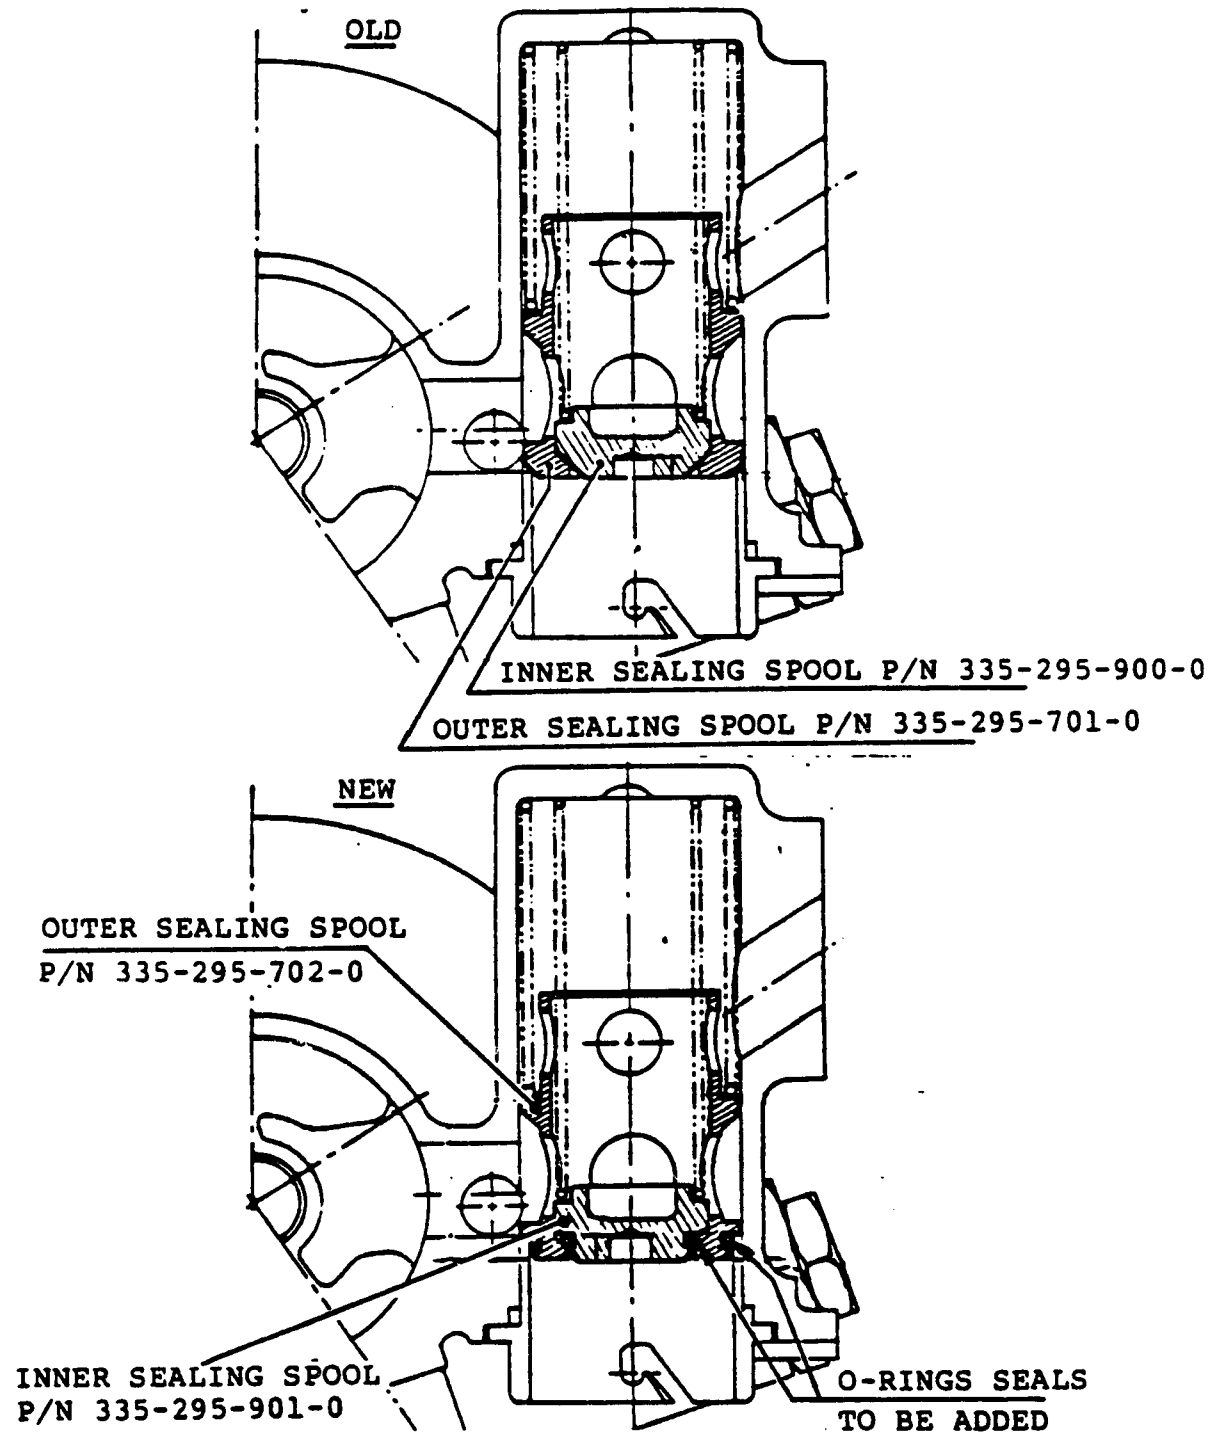
This Service Bulletin announces the introduction of new inner and outer sealing spools with groove to receive new O-ring seals. (See figure 1)

Modification of Inner and Outer Sealing Spools  
Figure 1

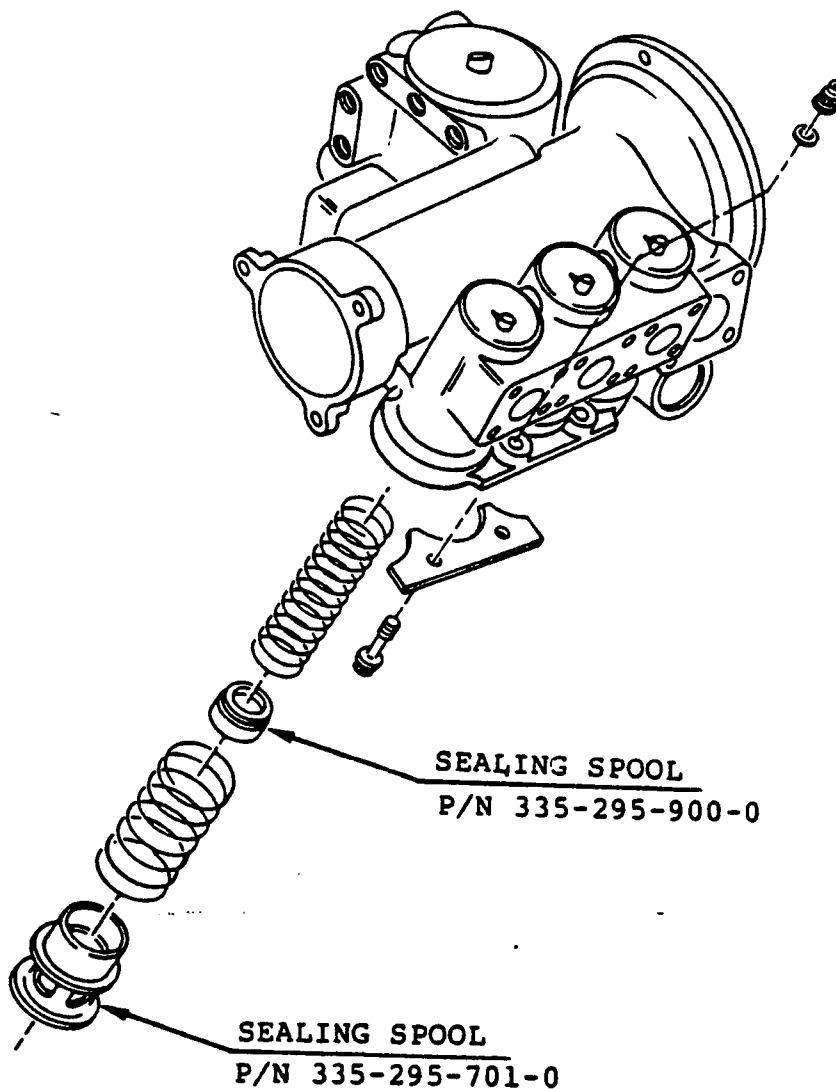
Removal/Installation of Sealing Spools  
Figure 2

- R  
R
- A. Remove the lubrication unit from the engine per Engine Maintenance Manual 79-21-10 page block 201.
  - B. Remove the 3 sealing spools P/N 335-295-701-0 and 3 sealing spools P/N 335-295-900-0 from the lubrication unit per Component Maintenance Manual, 79-21-12. See figure 2.
