**Factual Report, Aviation, NTSB Form 6120.4**

**FACTUAL REPORT  
AVIATION  
ACCIDENT/INCIDENT**

FTW-88-M-A109

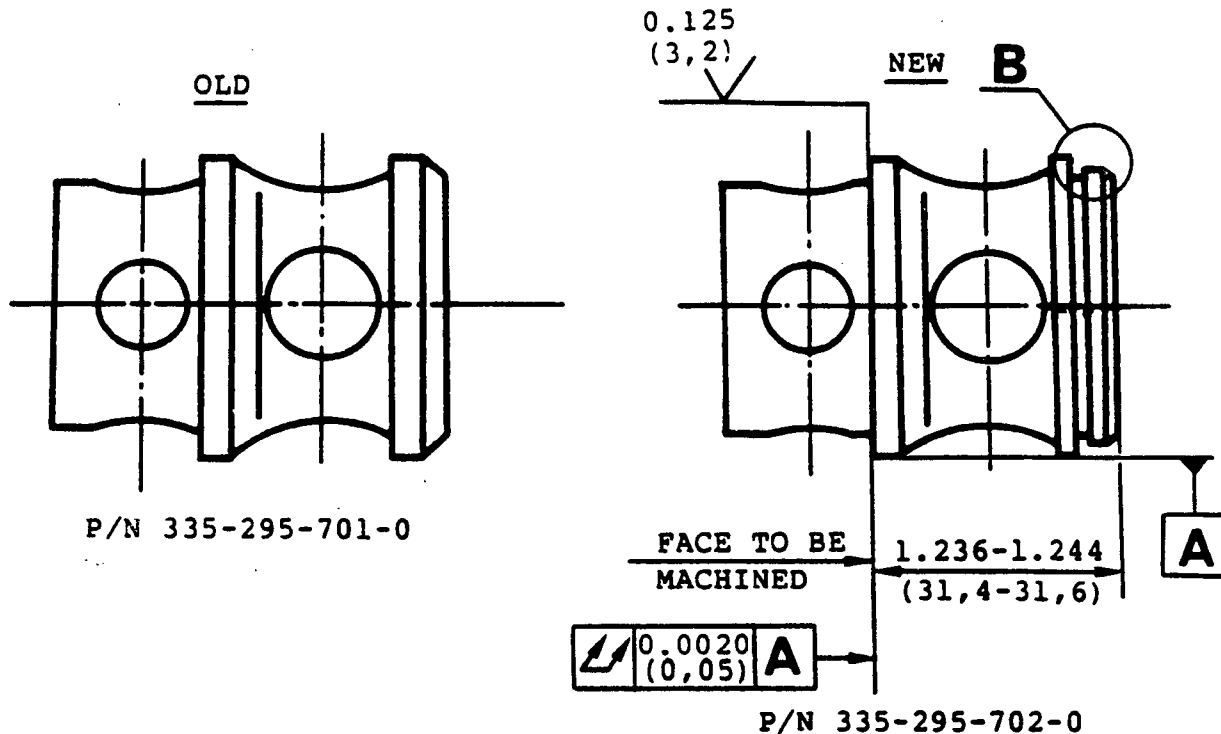
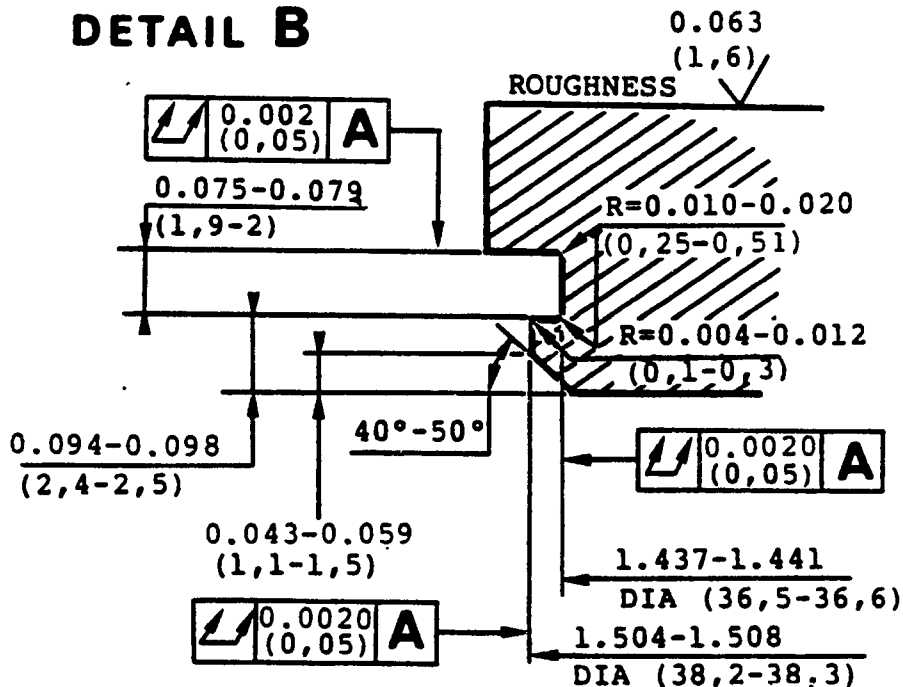
Modification of Outer Sealing Spool  
Figure 3 (Sheet 1 of 2)

- C. Discard the O-rings.
  - D. Modify the 3 outer sealing spools P/N 335-295-701-0 per figure 3 (sheet 1 of 2).
  - E. Modify the 3 inner sealing spools P/N 335-295-900-0 per figure 3 (sheet 2 of 2).

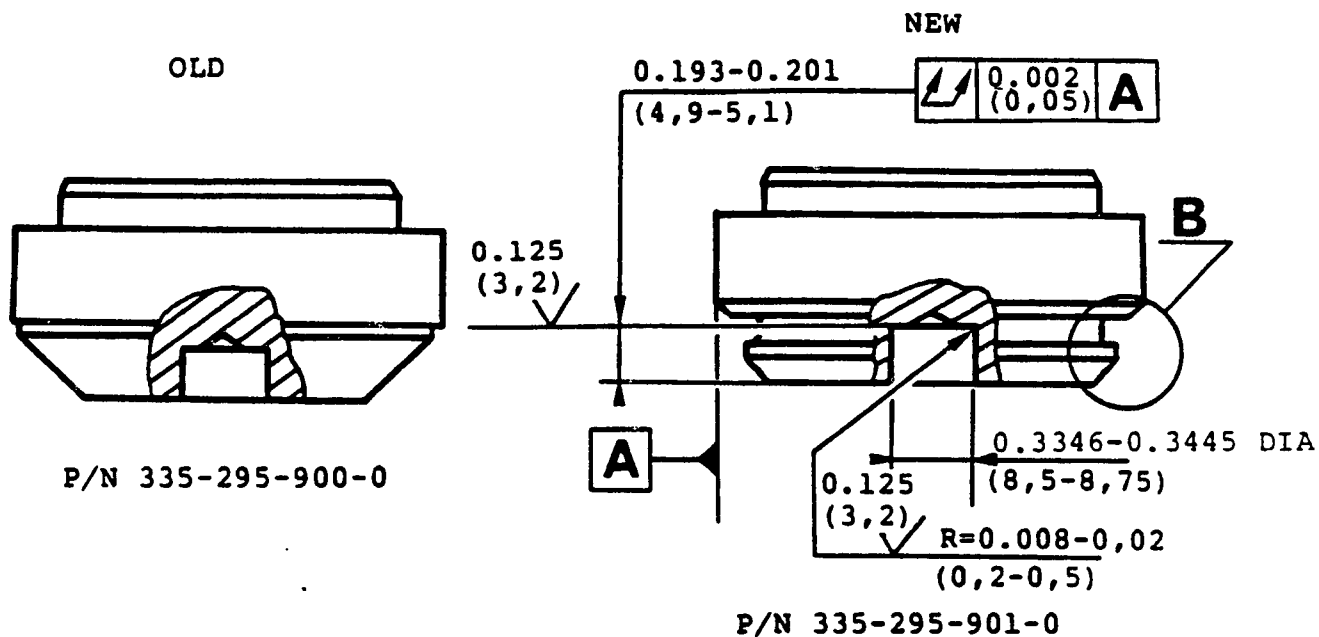
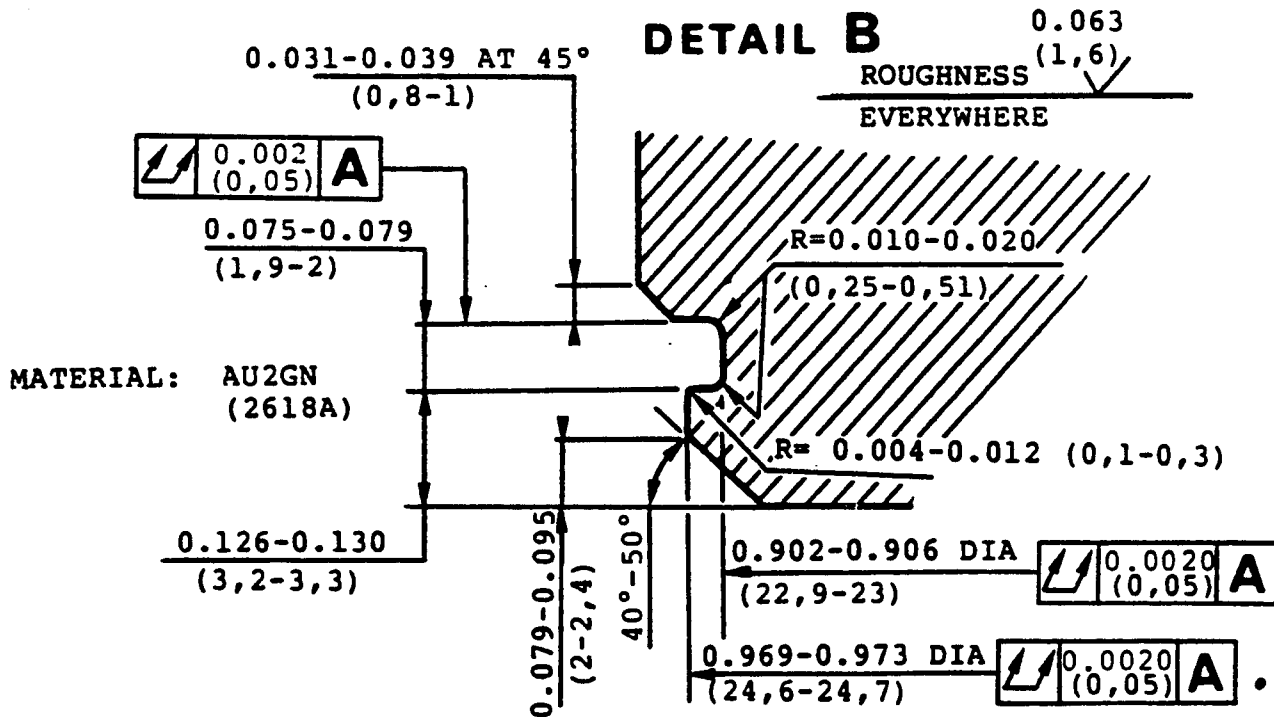
Modification of the Inner Sealing Spool  
Figure 3 (Sheet 2 of 2)

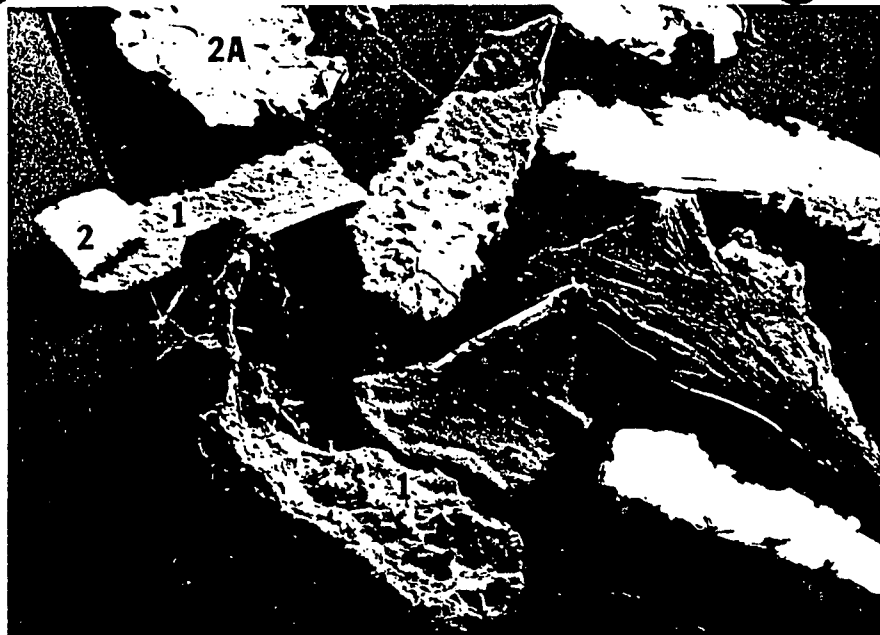
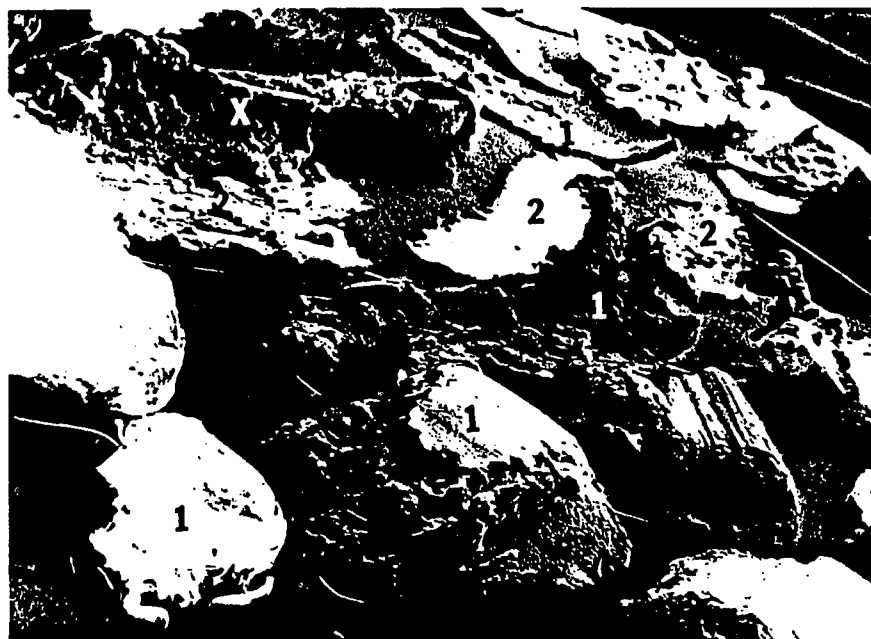
SEM photographs of most of the particles are shown in Figures 2 and 3. In order to get a qualitative overview as to whether or not the debris contained more than one alloy, they were examined in the backscatter mode (BSE). This mode accentuates differences in compositions. As seen in Figure 2, all of the particles have essentially the same grey-black tones; this indicates that they are all probably the same alloy. The same observation was also made for the larger particles.

Figure 3. SEM photograph of the larger particles after dividing the debris, shown in Figure 1, into coarse and fine samples. Numbers refer to SEM-EDS spectrum in Figure 4 which was measured for the individual particles.

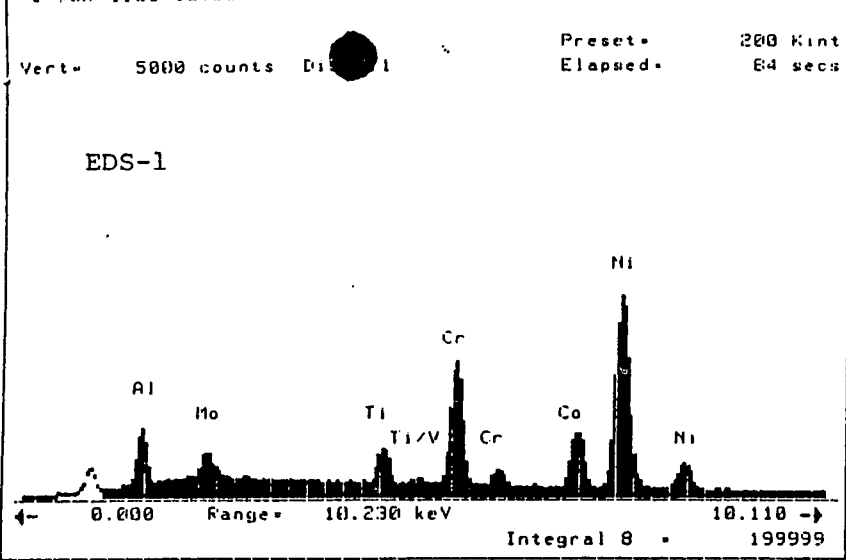
In order to verify this observation, SEM-EDS spectra were obtained for most particles. The spectra all were quite similar. A computer match of the acquired spectra with standards in the system library indicated that the best match was with Rene'77 and Waspaloy; their spectra are shown in Figure 5. In neither case was the match perfect; however, this is not unusual when dealing with debris since there is almost always some oxidation, smearing, etc. to contaminate the sample. A close scrutiny of the acquired spectra with the particles' spectra indicates that the debris is more likely to be Rene'77. This is based on examination of the relative heights of the Mo and Ni peaks. The Cr, Al, and Ti peak heights are not too reliable because they are easily affected by oxidation and engine generated rub debris from coatings, blades, etc.

Figure 4A. SEM-EDS spectra of particles as indicated in Figures 2 and 3.

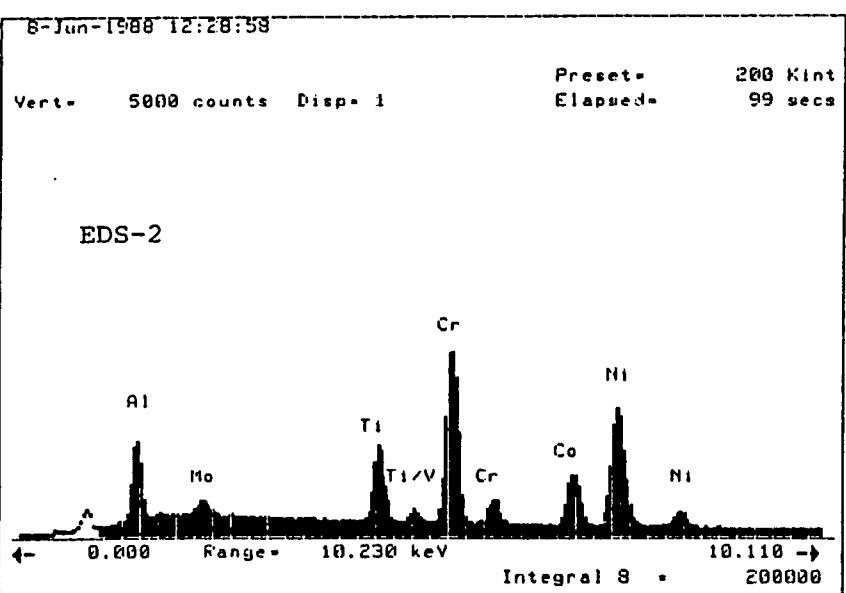
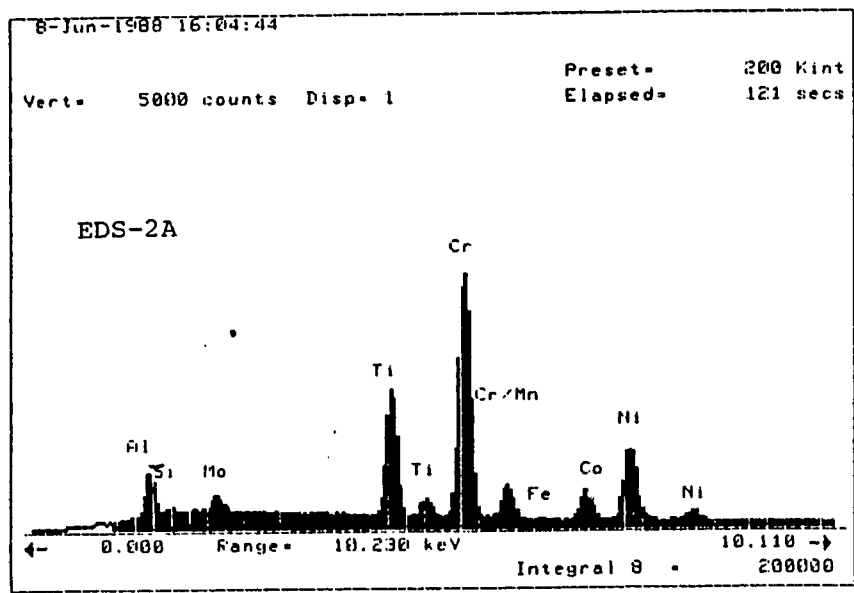
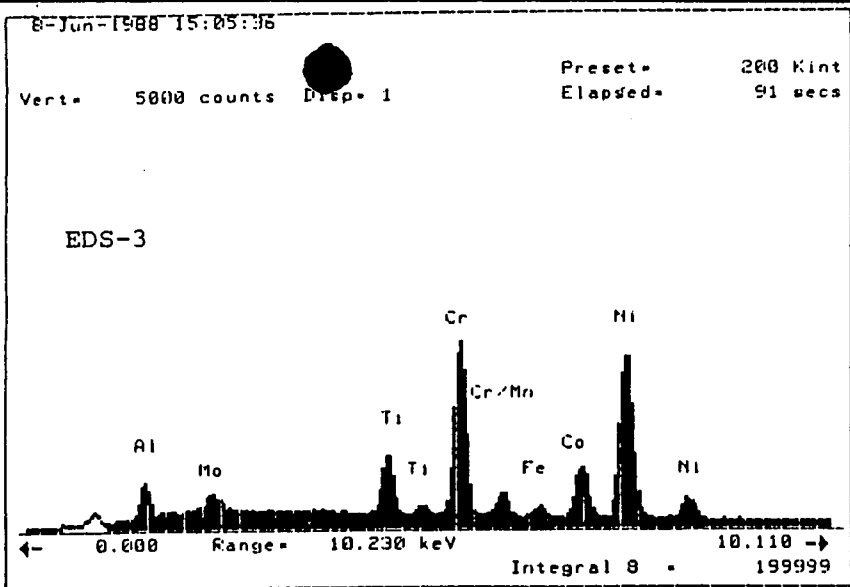
Figure 4B. SEM-EDS spectra of particles as indicated in Figures 2 and 3.

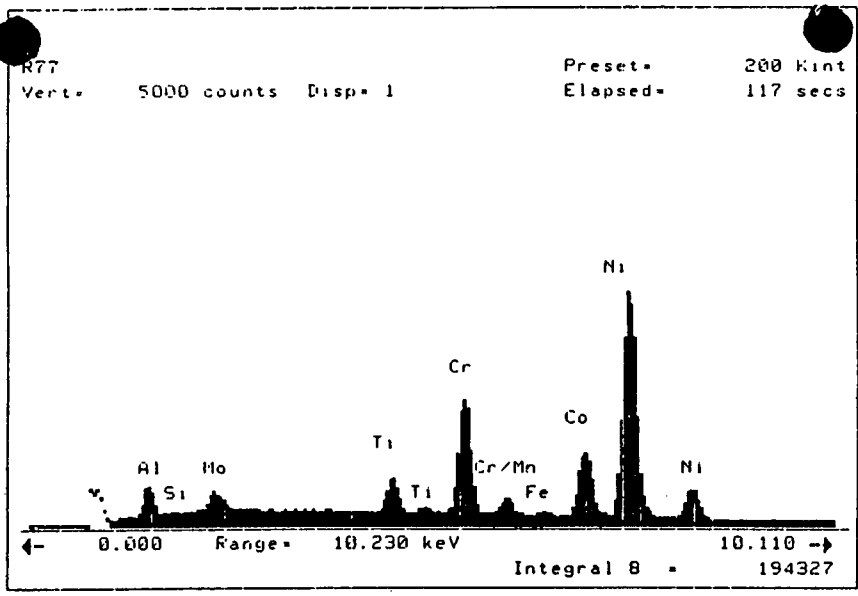
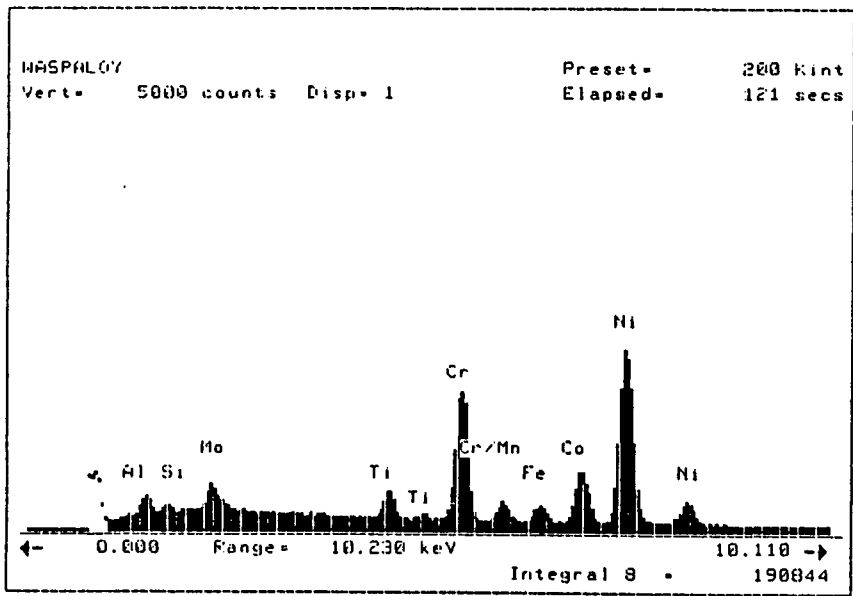
Based on SEM-EDS analysis of the debris it is concluded that the particles are either Rene'77 or Waspaloy; Rene'77 is the more likely of the two. The particles have been exposed at temperatures of at least 2490°F.

Figure 5. SEM-EDS spectra for Rene' 77 (upper) and Waspaloy (lower).

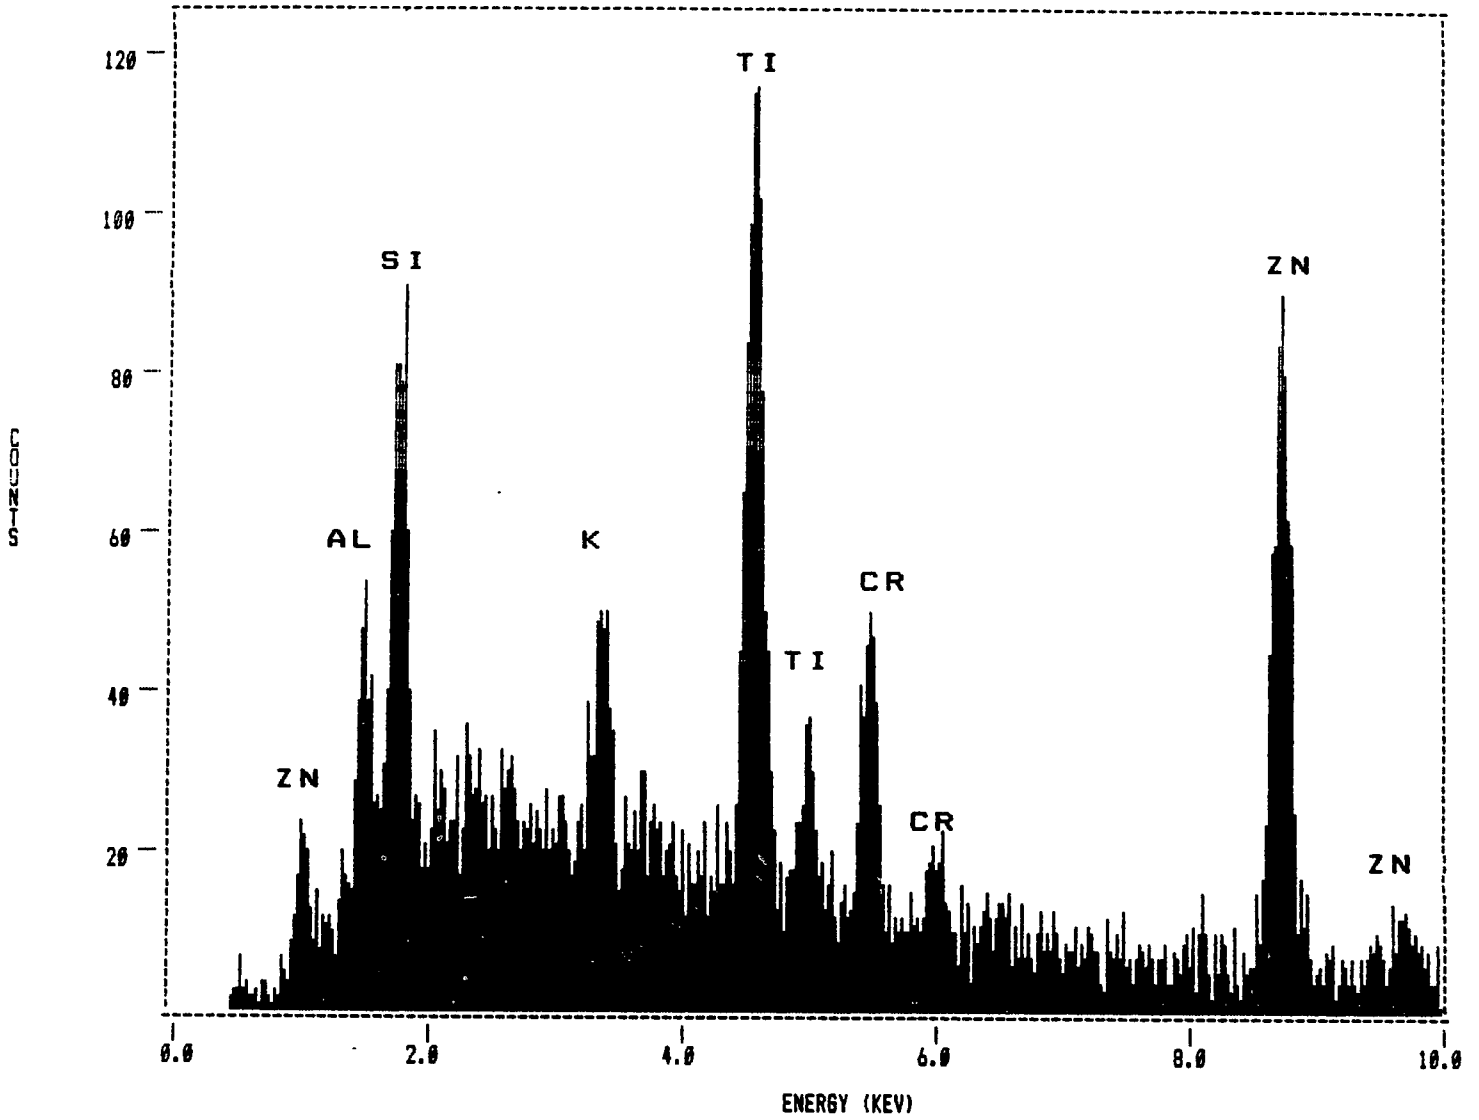
■ PIC095120 PARTICLE ON FIBER

ANALYSIS: Patch filter I showed no contamination except for one Al particle. Patch filter II had only one black sliver/fiber on it. Main engine filter #1 had 53 pleats in it. The total weight of contaminants (based on an average of two pleats) on the filter was 630 mgs. The debris was concentrated in the bottom of the pleats in the lower third of the filter opposite the ink printing of TRW#. Main engine filter #2 was constructed with 55 pleats. The total debris was estimated to be approximately 170mgs. The debris was evenly distributed from one end of the filter to the other. The debris was again mainly in the bottom of the pleats. The make-up of the debris was similar in both filters. Thirty-five percent (by apparent volume) was aluminum metal shavings (see pictures 095108, 10 and 13) ranging in size from 200um to 1200um with an average size of 500um. Forty percent of the debris consisted of yellow flakes and yellow coated yellowish green material (see picture 095100). X-ray spectra of these particles match those for known fuel tank sealants previously studied (see spectra 095101, 004500 and 004501). The remaining twenty-five percent of the contaminants consists of loose fibers similar to the filter itself, several cotton-like fibers, chunks of material similar to the fillers used in the fuel tank sealants, and black shiny straight slivers/fibers. The black slivers (pic 095103) range in size from 1mm to 20mm in length with an average between 8 and 10mm. They have an x-ray spectrum (095103) indicative of an organic polymer of some sort perhaps a rubber which contains carbon, oxygen, sulfur, and possibly elements lower in atomic number than carbon. Every pleat examined had at least some of these slivers. The sealant fillers were smaller than 100um but stuck to other objects (see picture 095120 and spectrum

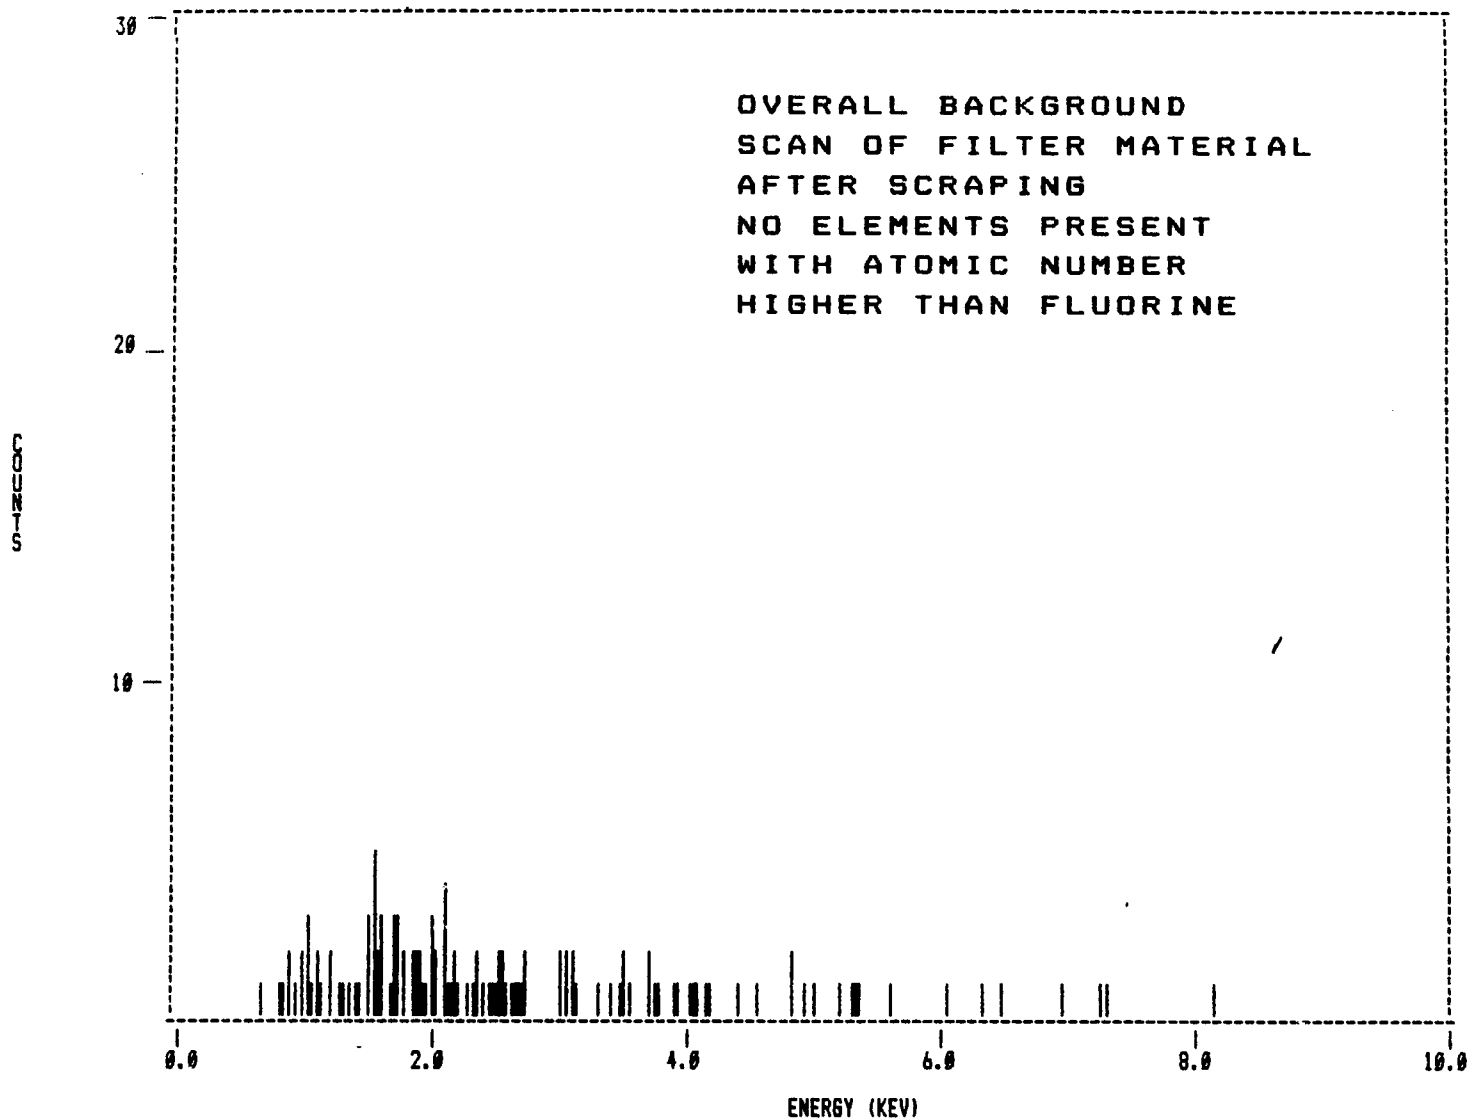
■ PIC095122 AREA SCAN

095107). The filters were examined after the debris had been removed in order to verify that they were not clogged (pic095122 G 23). Large area scans of the filter showed only background (spectrum 095108) with no elements above fluorine in atomic number present.

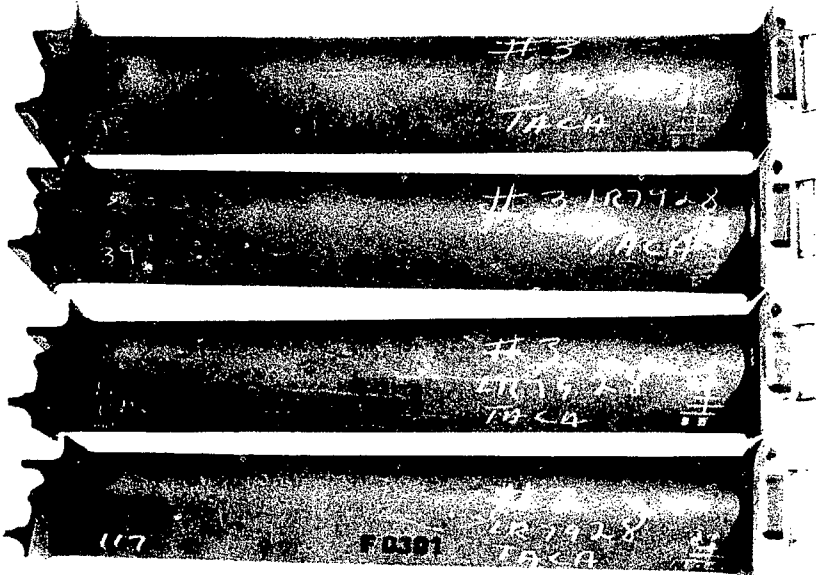
- The 2nd stage airfoils displayed a debris build-up on the leading edges but all four of the airfoils were intact, Fig. 1. The 3rd and 4th stage airfoils were also intact, Figs. 2 and 3.
- Microsections were prepared from the airfoils and roots of each blade in accordance with the CFM56 Engine Shop Manual, 72-54-00, Special Procedure #1. The estimated temperatures experienced by each of the airfoils was determined as follows:

Fig. 2 - 3rd stage blades from engine S/N 721973.

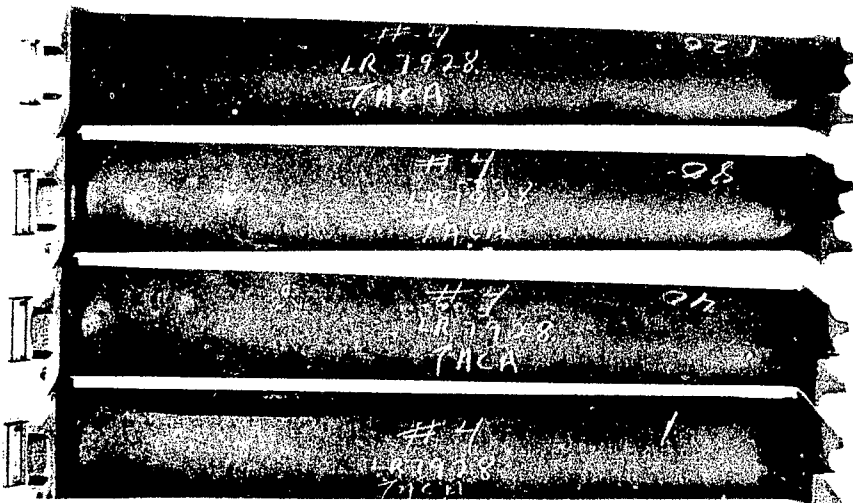
Fig. 3 - 4th stage blades from engine S/N 721973.

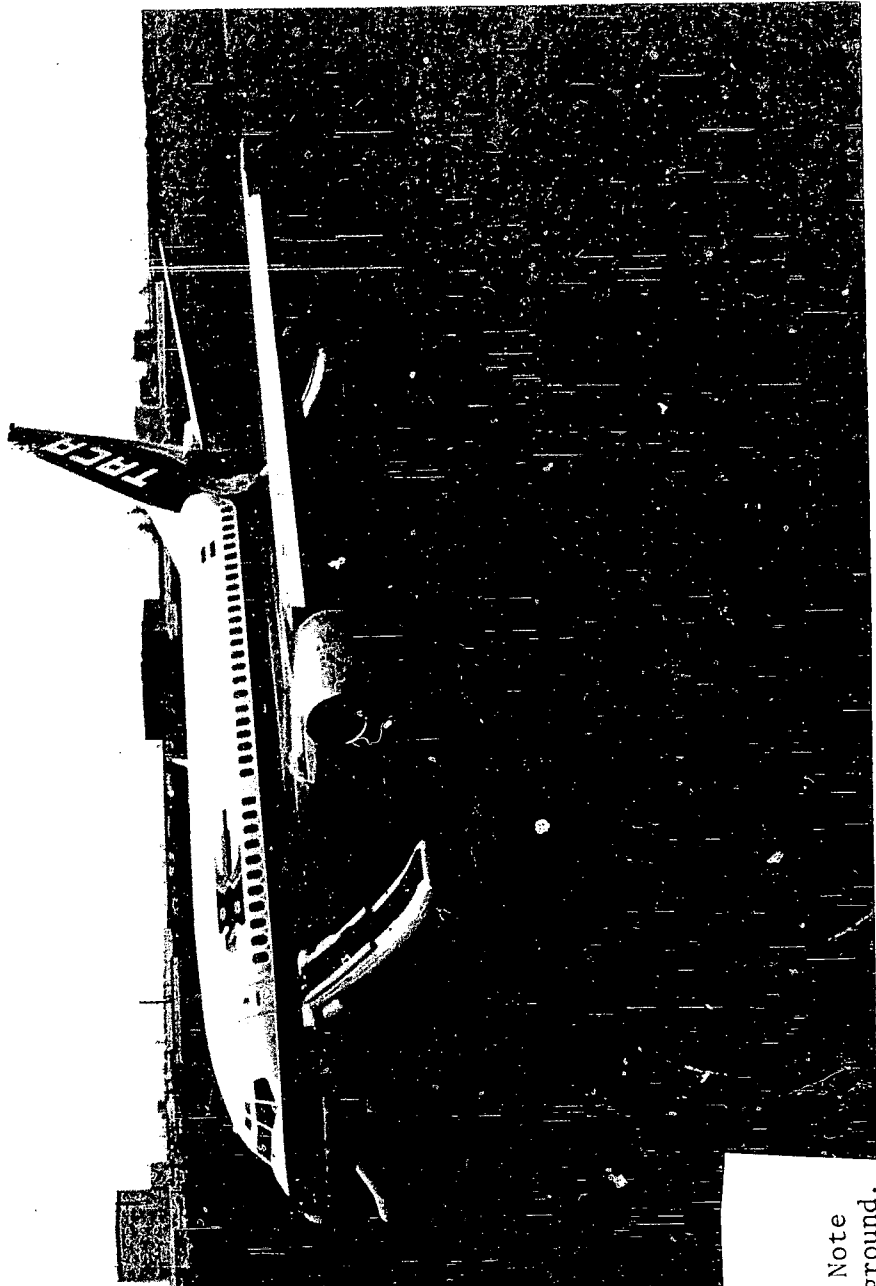
2. View of airplane as it came to rest. Note dissipating thunderstorms in the background. NASA photograph, negatives are not available for photos 1, 2, and 3.

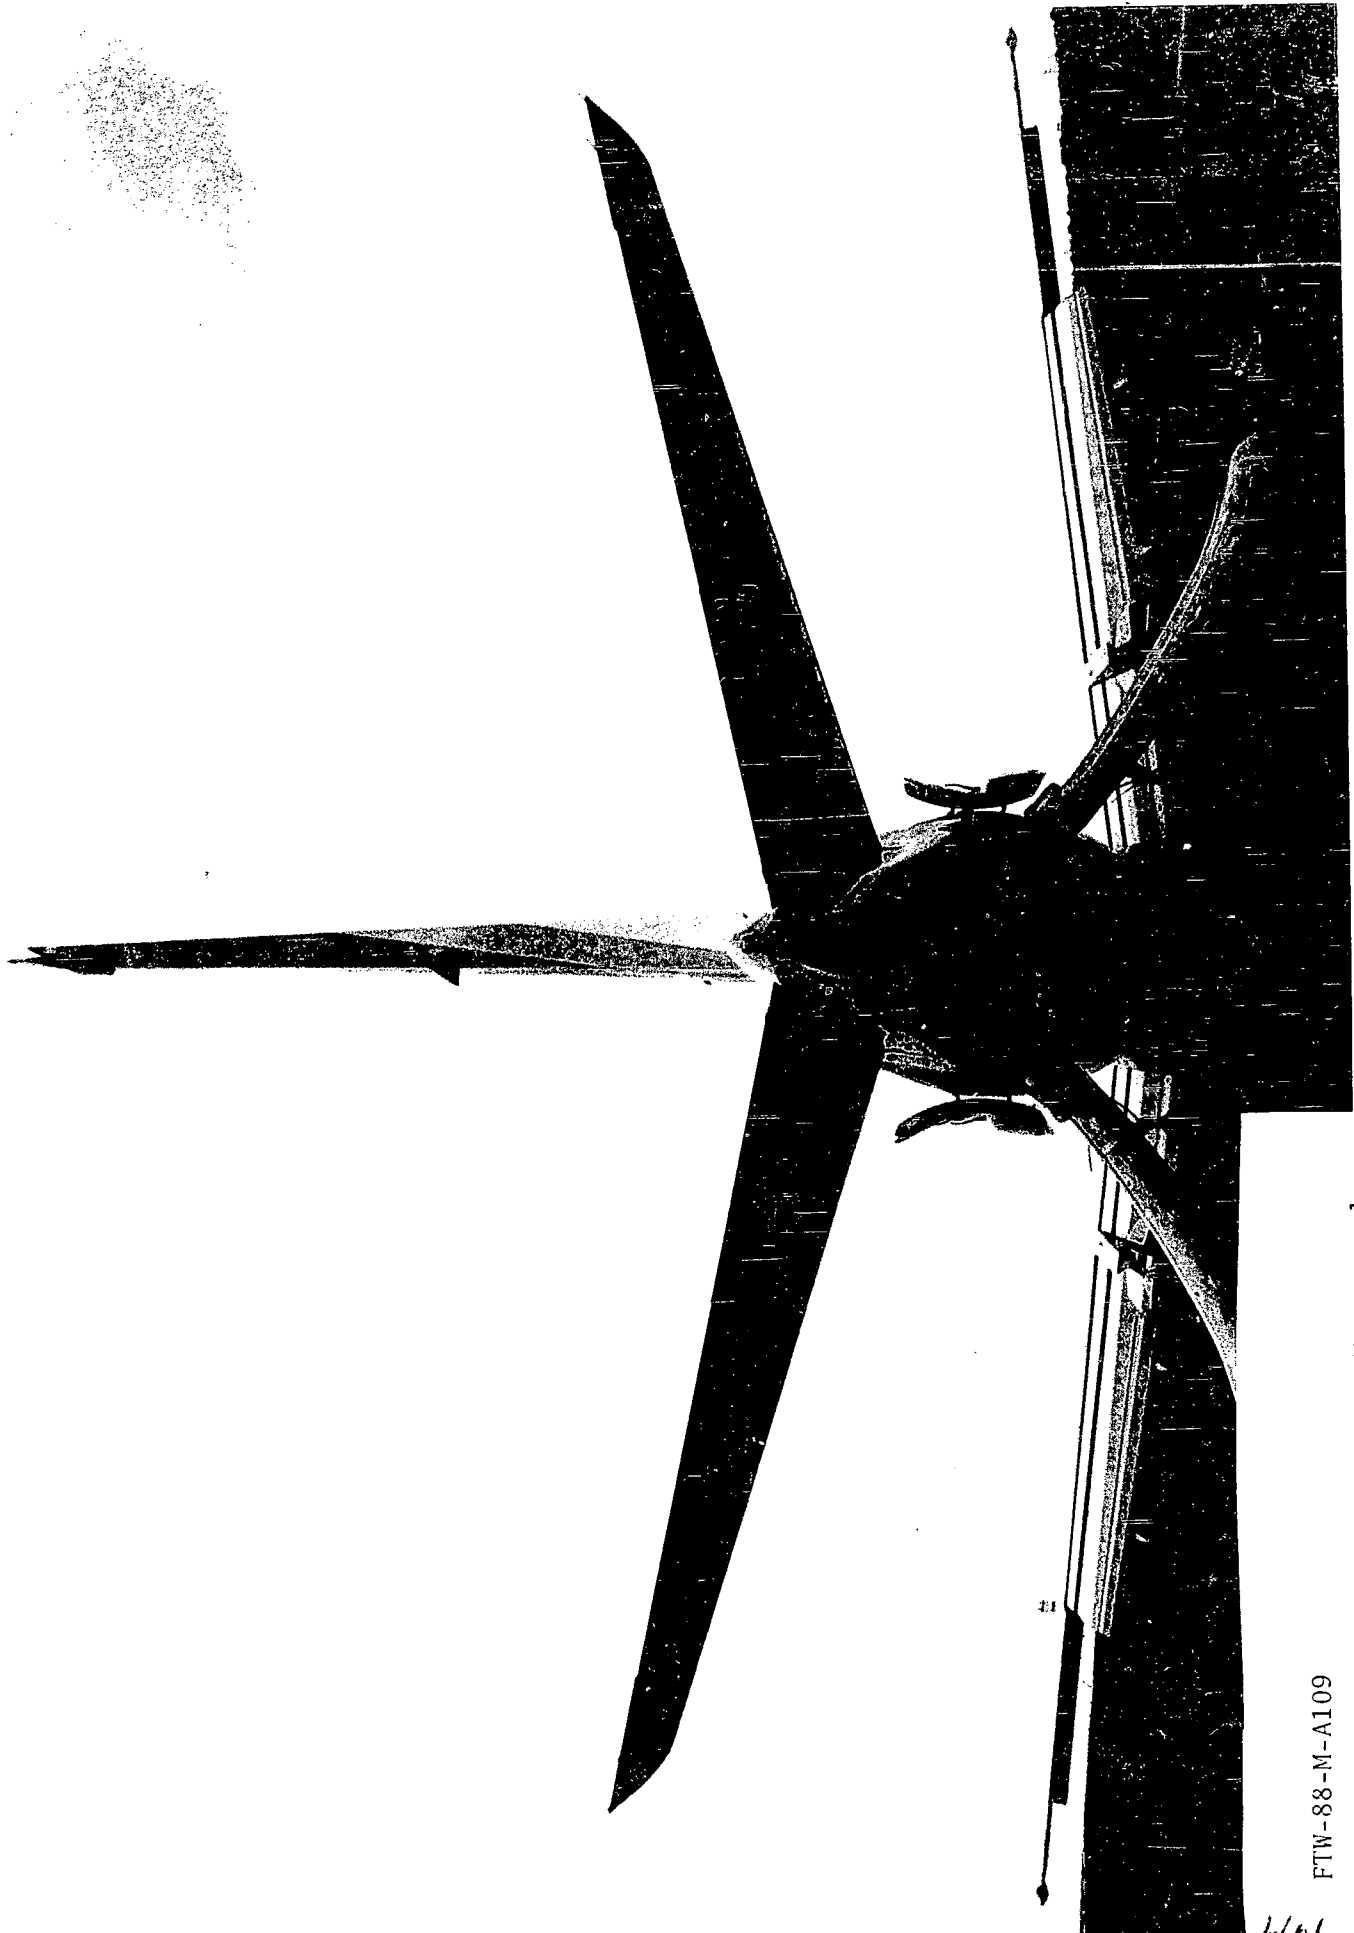
FTW-88-M-A109

5. Airplane as seen from the rear. Note canal on right side and levee on left side.

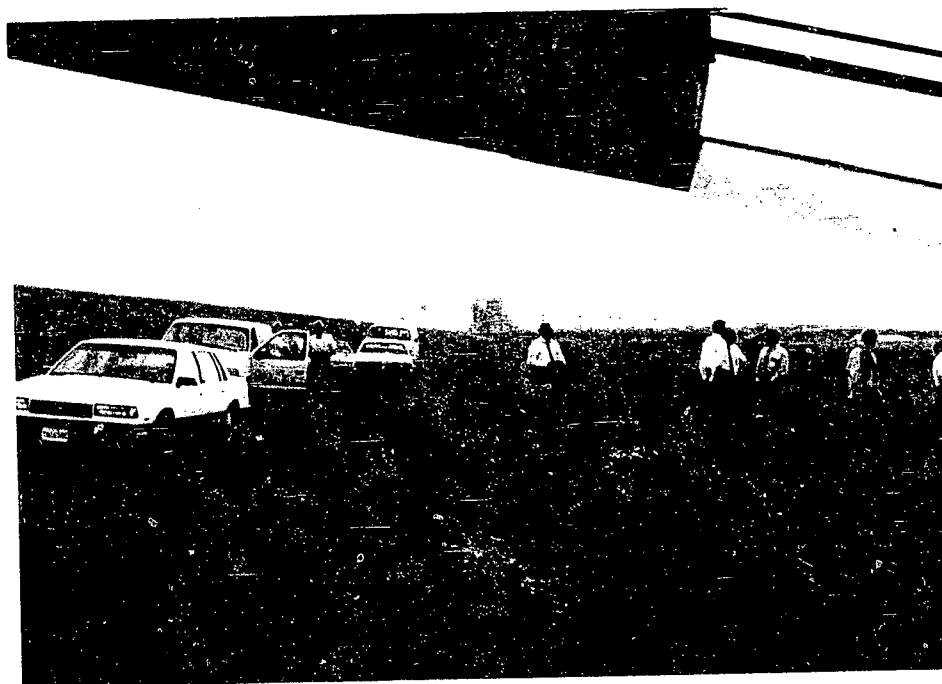
FTW-88-M-A109

5. View from airplane looking in the direction of landing.

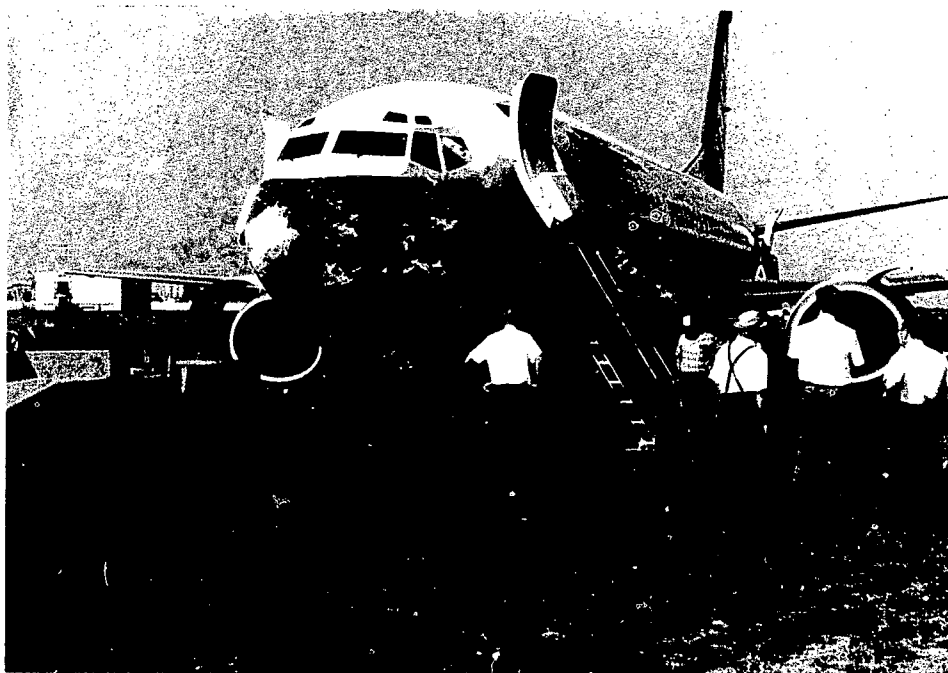
13. Engines and airframe systems were examined prior to moving the airplane.
