UMTA-MA-06-0156-86-1
DOT-TSC-UMTA-86-8

Water Intrusion Problems in Transit Tunnels

Paul Parks and Associates, Inc.
Engineering & Management Consultants
100 Boylston Street
Boston MA 02116

September 1986
Final Report

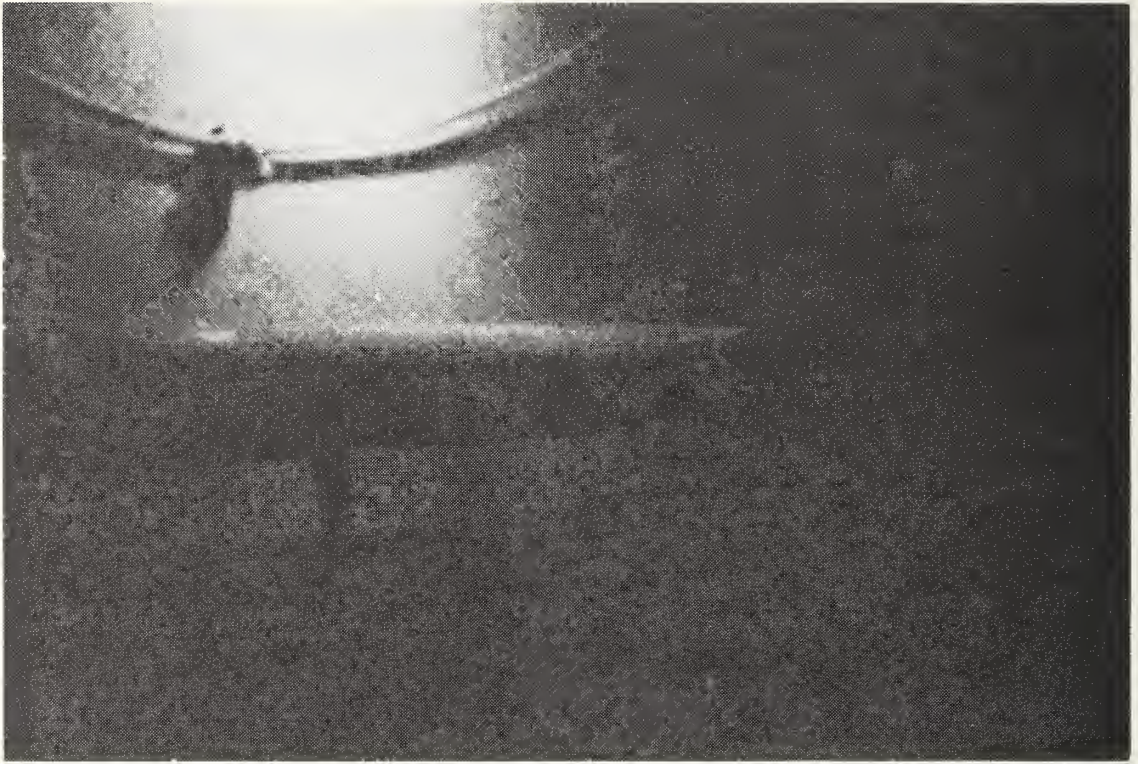
FIGURE 5.5 WATER PUMPING IN THE TUNNEL OF HUMBOLT STATION

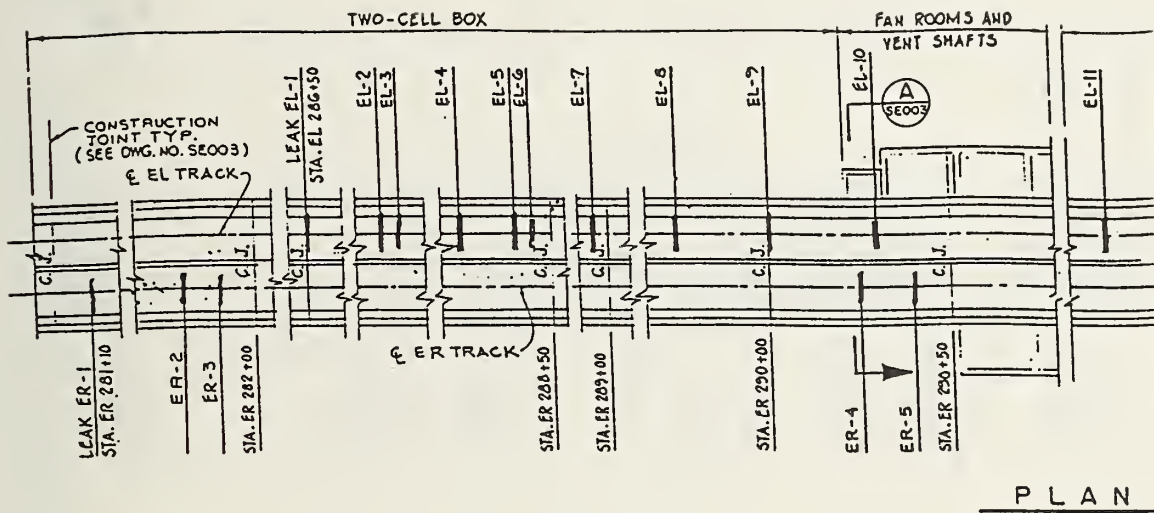
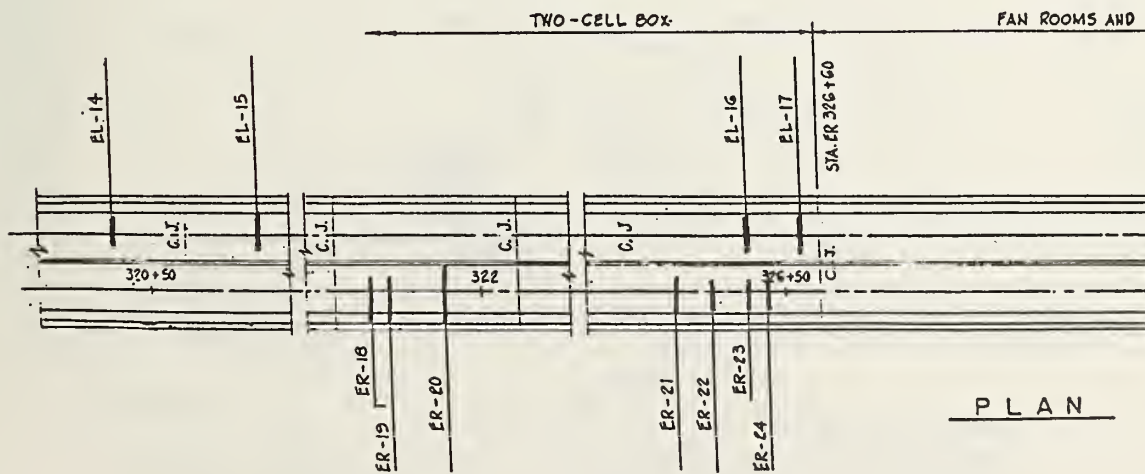
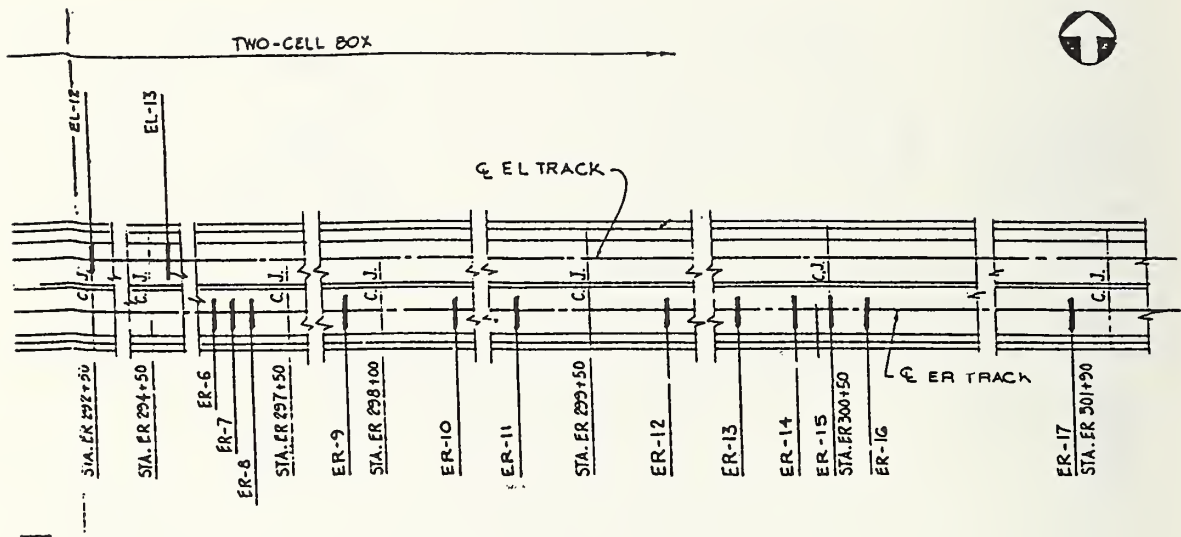
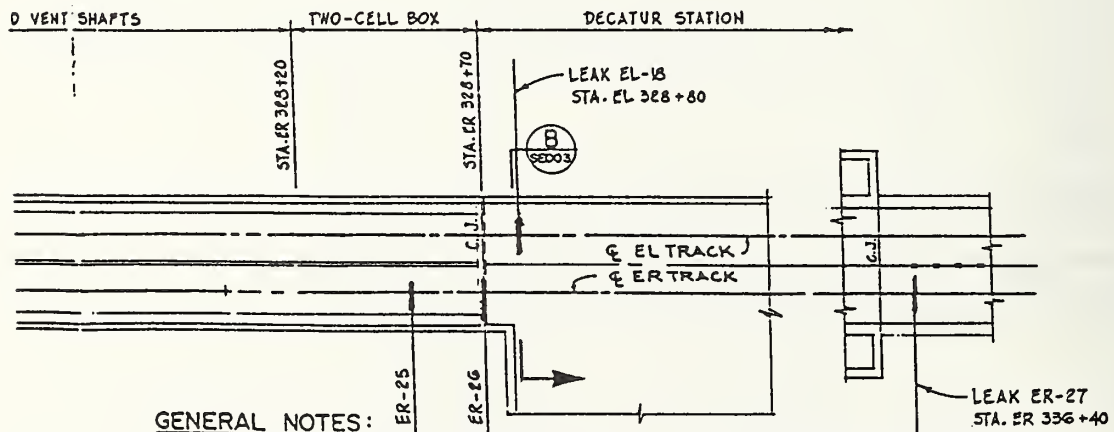
FIGURE 6.2 EAST LINE SUBWAY STRUCTURE - LEAK LOCATIONS

Figures 6.2 and 6.3 show the number of leak locations. As can be seen, the frequency of leaks at some tunnel segments reaches a magnitude of 15-20 leaks per 100 ft.

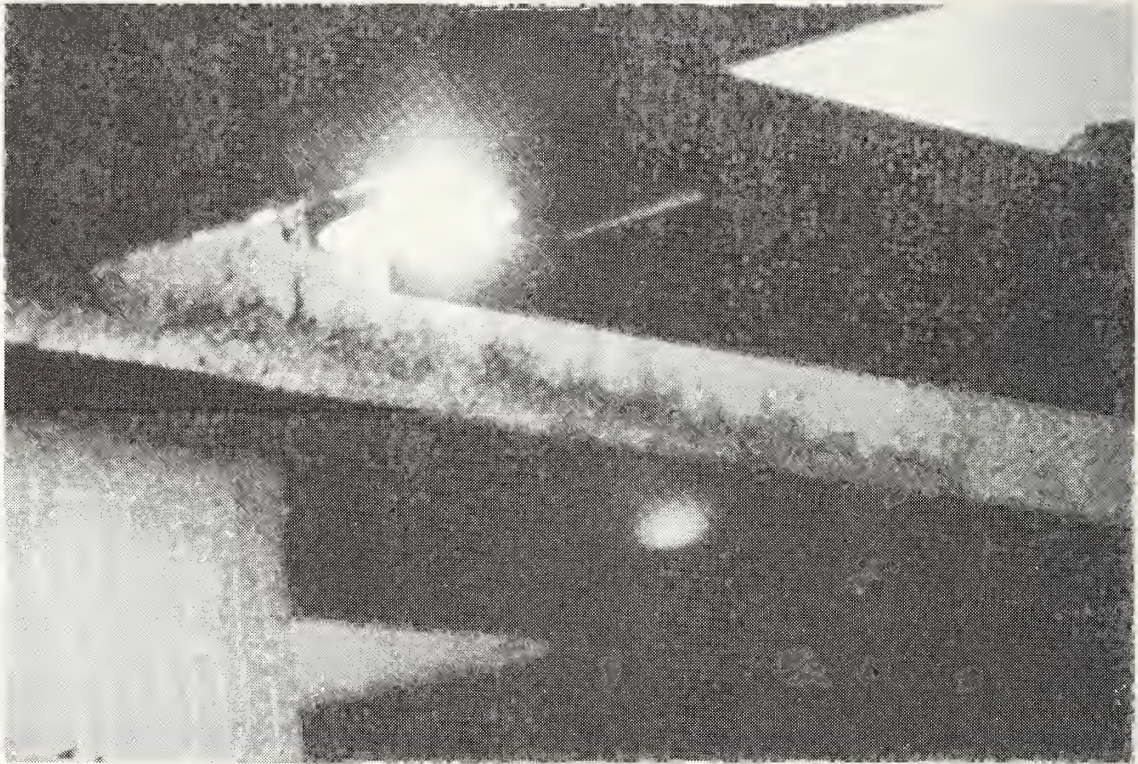
The surface of some structural concrete elements such as ceiling beams remains permanently wet due to hidden water leaks behind the finish of walls and ceilings, as shown in Figure 7.8.

FIGURE 7.8 WET CEILING BEAMS (BLUE LINE, AQUARIUM STATION)

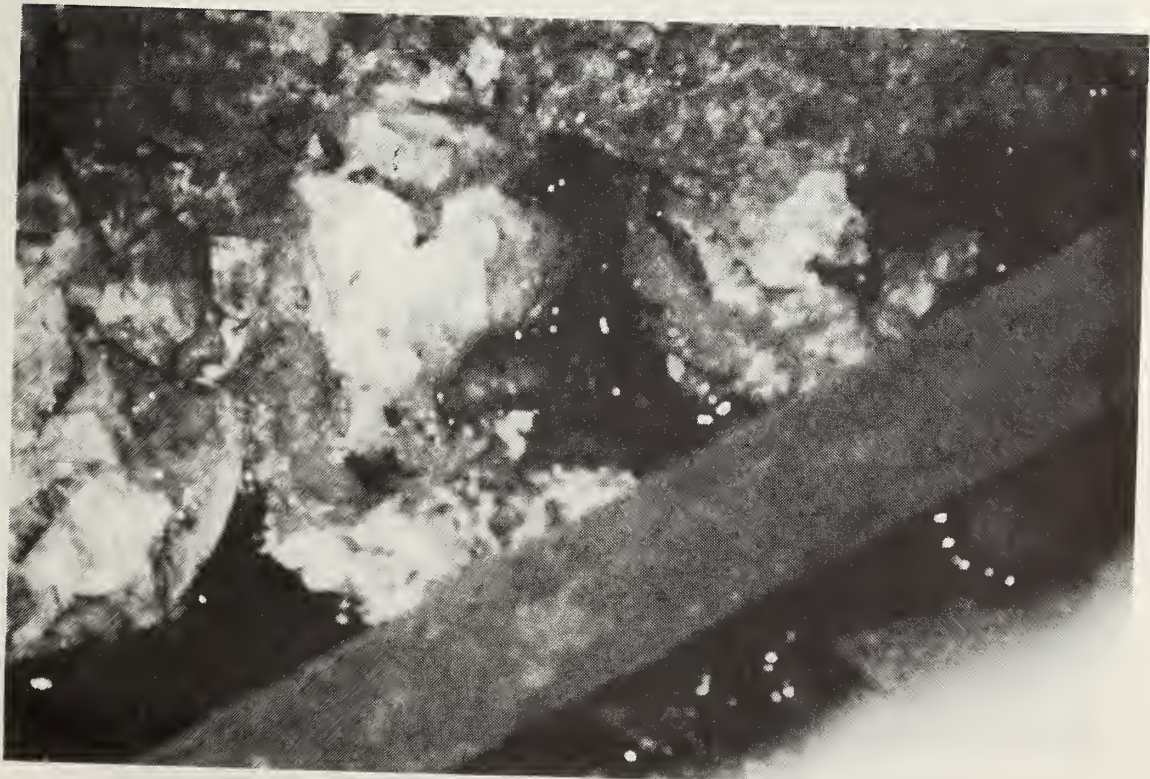
FIGURE 7.13 BALLAST WASHED OUT (BLUE LINE, AQUARIUM STATION)

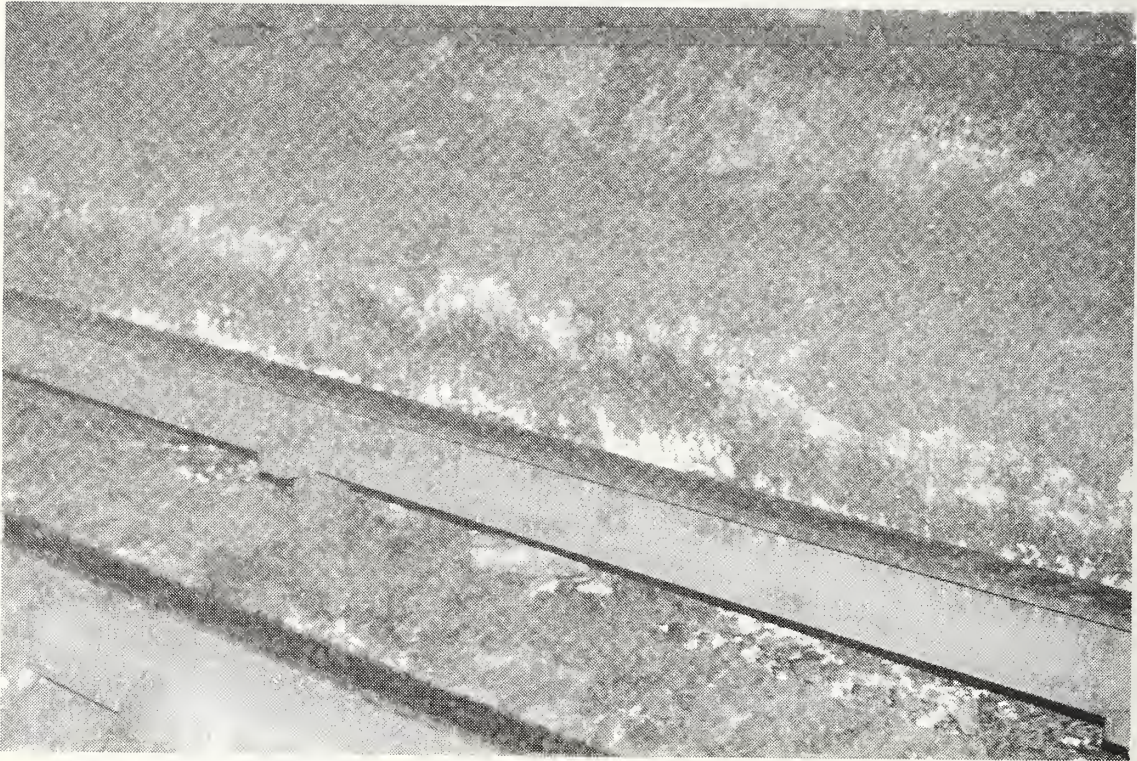
Figures 7.17 and 7.18 demonstrate the conditions of the station tracks. In Figure 7.17 one can see a heavy precipitation in the area of the third rail. Figure 7.18 shows part of the track bed where the ballast was washed out almost

FIGURE 7.17 CALCIFICATION IN AREA OF THIRD RAIL (ORANGE LINE, ESSEX STATION)

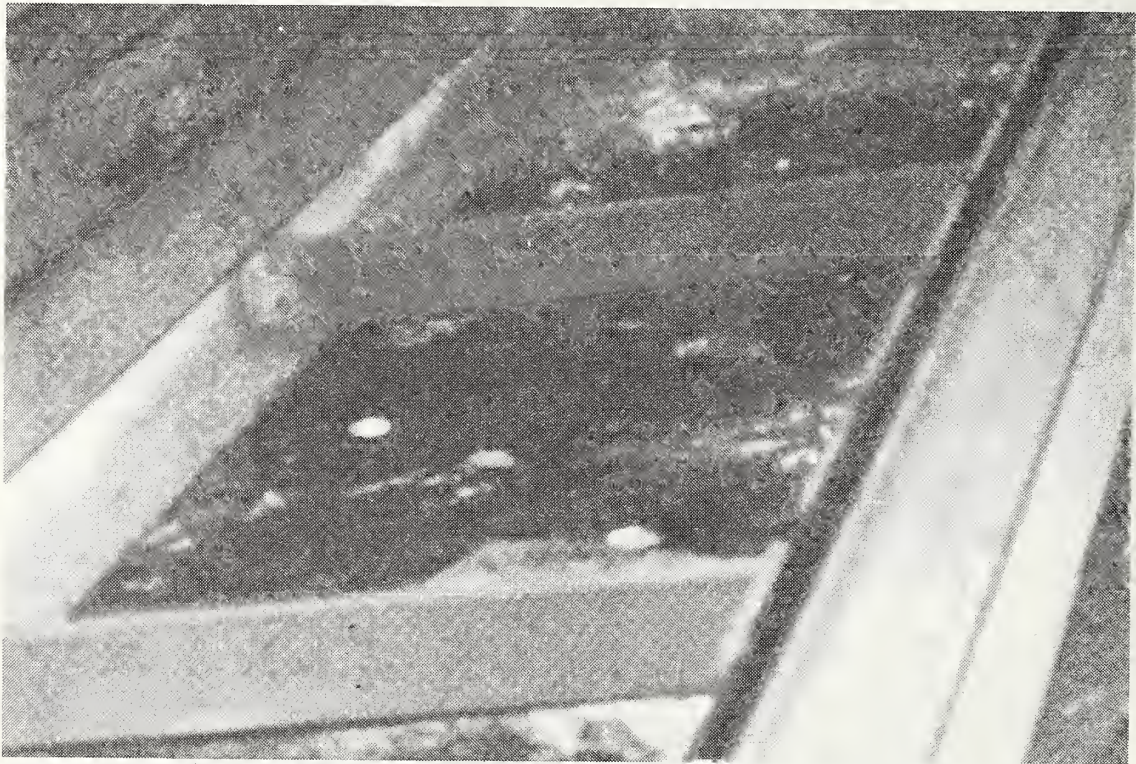
FIGURE 7.18 AREA WHERE BALLAST IS WASHED OUT COMPLETELY (ORANGE LINE, ESSEX STATION)

entirely. To prevent disintegration of the rail track due to the absence of ballast, both rails were bolted together with the transverse beam (see Figure 7.18).

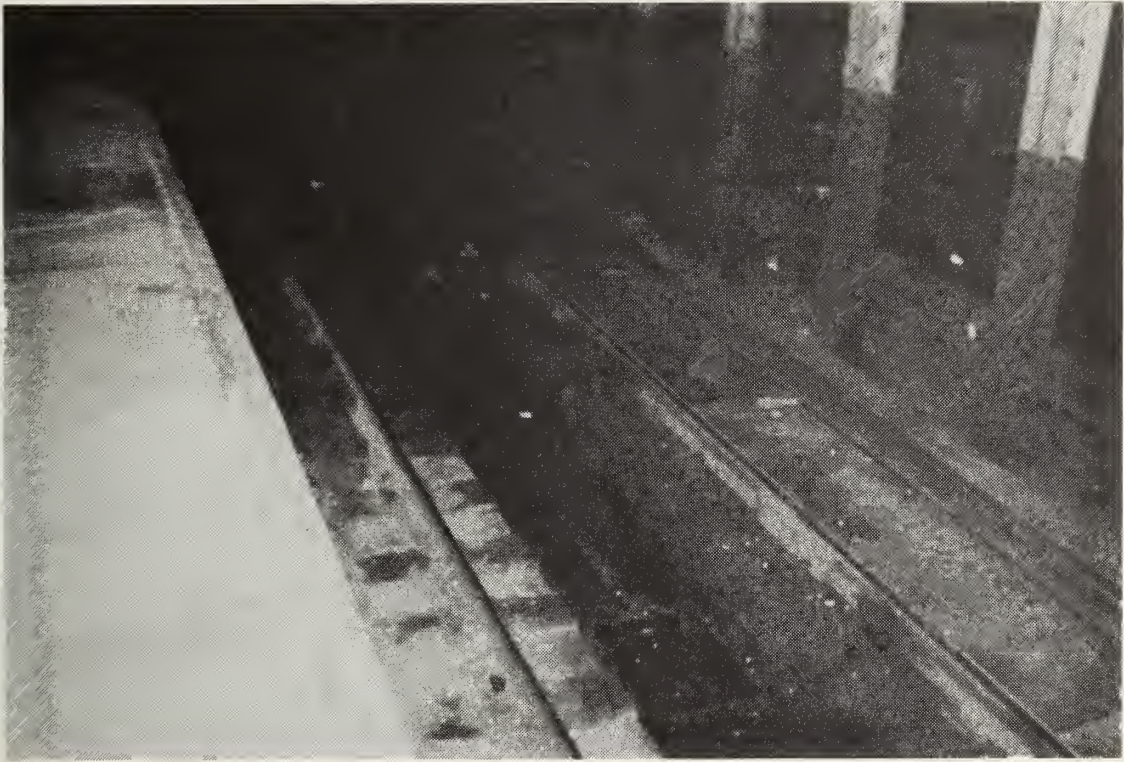
- o Total invert failure of structures - see Figure 9.10 of Case No. 5.
- o Deterioration of tunnel walls and ceilings due to calcification and precipitation - see Figure 6.4, Case No. 2; Figures 7.4, 7.5, 7.7, 7.10, Case No. 3; Figures 8.6, 8.7, 8.8, Case No. 4; and Figures 9.11, 9.12, 9.16, 9.21, Case No. 5.
- o Deterioration of rail, trackbed and other track as shown on Figure 6.4, Case No. 2.
- o Pump Deterioration.

Figures 9.10 and 9.11 show a water inflow onto rail tracks and a corrosion of the arch beams.

FIGURE 9.10 WATER INFLOW ON THE RAIL TRACK (BERGEN STREET STATION)

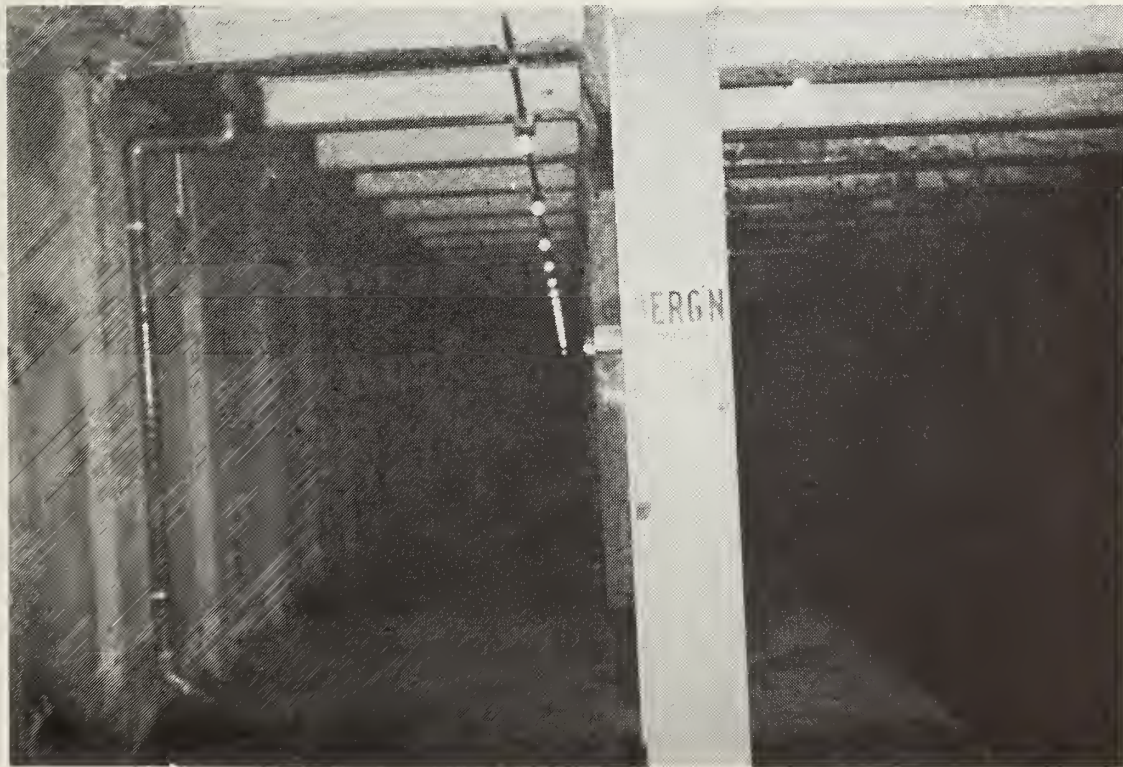
FIGURE 9.13 WATER CHANNELING (BERGEN STREET STATION)

Rehabilitation procedures include drilling holes in walls to locate water leaks. A heavy water inflow, if encountered, shall be channeled away, as is shown in Figures 9.12 and 9.13.

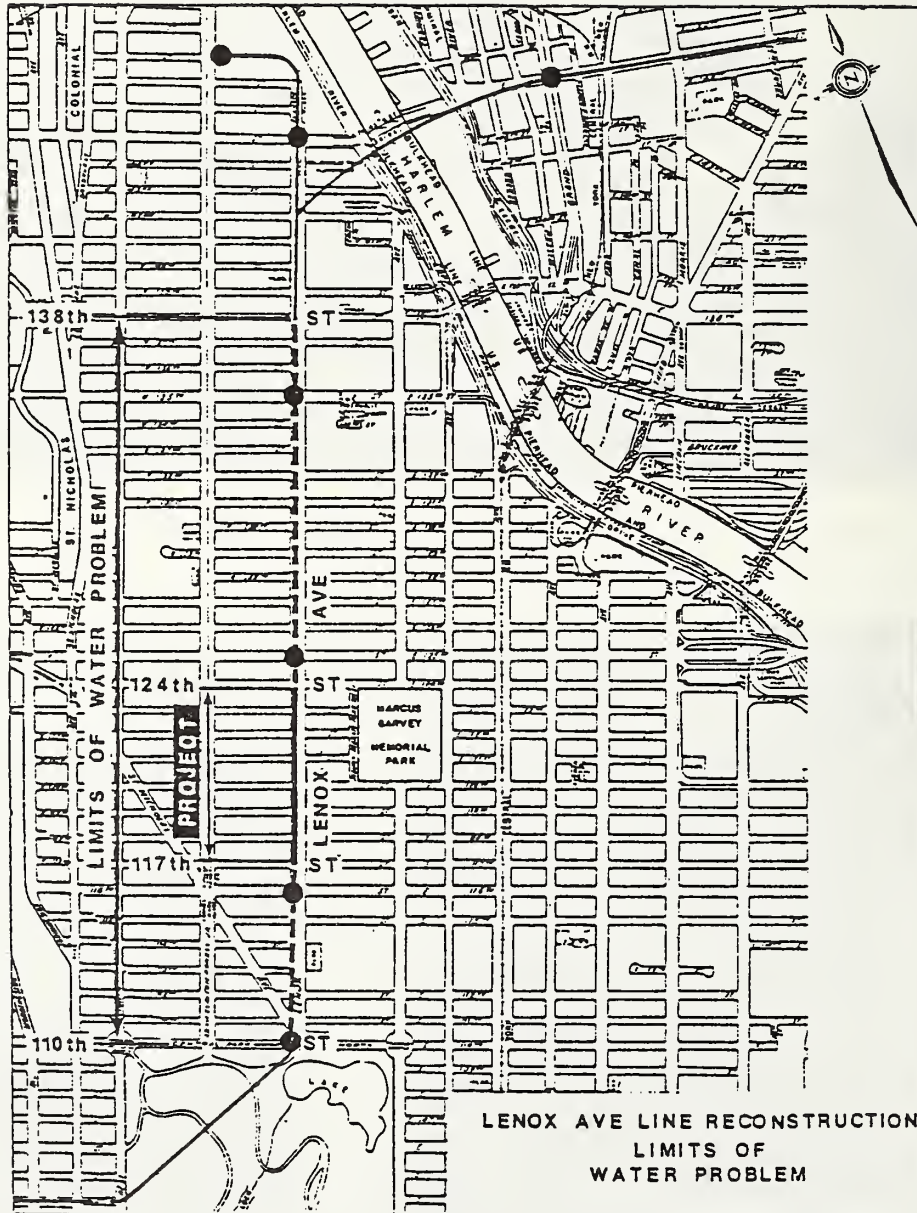
FIGURE 9.14 LENOX AVENUE LINE - PROPOSED RECONSTRUCTION

Over the years of operation the tunnel structures have seriously deteriorated (see Figure 9.6), allowing a tremendous water inflow. Due to this problem, NYCTA proposes to rebuild the invert and to repair tunnel structures on the Lenox Line between 117th Street and 124th Street. The proposed Lenox Line reconstruction is shown on Figure 9.14.
