# Aviation Investigation Preliminary Report

<b>Location:</b>	Freeland, WA	<b>Accident Number:</b>	DCA22MA193
<b>Date &amp; Time:</b>	September 4, 2022, 15:09 Local	<b>Registration:</b>	N725TH
<b>Aircraft:</b>	DEHAVILLAND DHC-3	<b>Injuries:</b>	10 Fatal
<b>Flight Conducted Under:</b>	Part 135: Air taxi & commuter - Scheduled

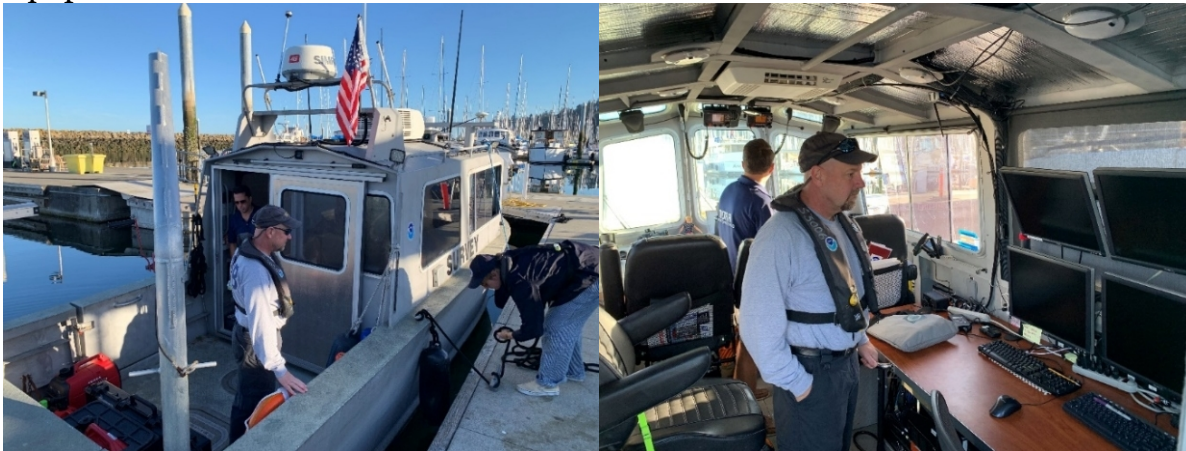
The NTSB structure's group chairman went on board vessels provided by the Washington Department of Fish and Wildlife, the National Oceanic and Atmospheric Administration (NOAA) and the University of Washington to collect data using varying types of sonar equipment.

Figure 2: NTSB onboard NOAA S3006 survey boat
