MARINE CASUALTY REPORT

MOBILE OFFSHORE DRILLING UNIT (MODU) OCEAN RANGER, O.N. 615641, CAPSIZING AND SINKING IN THE ATLANTIC OCEAN, ON 15 FEBRUARY 1982 WITH MULTIPLE LOSS OF LIFE

REPORT NO. USCG 16732/0001 HQS 82

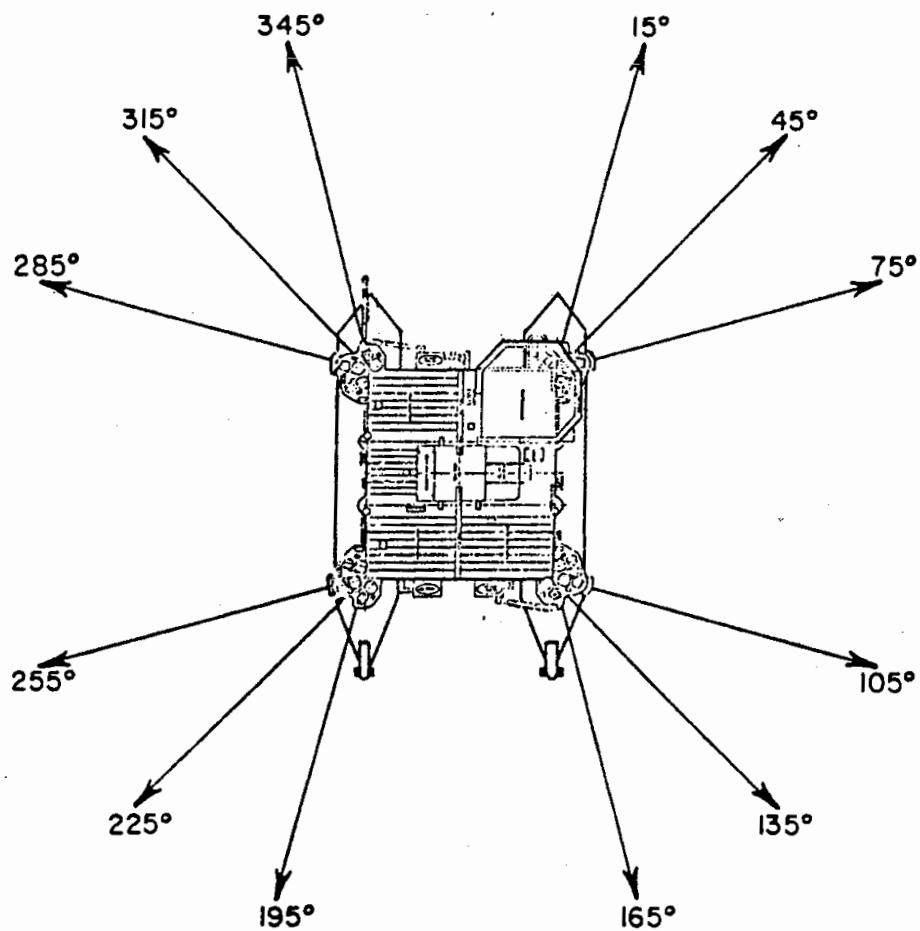
The OCEAN RANGER was maintained in position at a drilling site by means of a 12 point, spread mooring system, consisting of 12-45,000 lb. anchors, ranged three each from the four corner columns: PC-1, PC-4, SC-1, and SC-4 (please see figure 4 on page 9). Each anchor was attached to 1600 ft of 3 1/4 inch link chain, which in turn was connected to 4500 ft of 3 1/2 inch wire rope. The anchor chains were stored in chain lockers in the corner columns, and ranged through individual chain pipe openings at the tops of the columns, each measuring approximately 6 sq ft. The connecting wire ropes were stored on drums located atop the columns, and were led down into the chain lockers through individual wire trunk openings at the tops of the columns, each measuring approximately 25 sq ft, to lower sheaves and out through the chain pipes (please see figure 5 on page 10). Each chain/wire rope was then led though hawse pipes, down the side of the column to a fairlead sheave, and away from the rig to the deployed anchor. Control of the chain/wire ropes was maintained through 12 winch-windlass units mounted atop the corner columns, each of which had a stall pull equal to half the breaking strength of the mooring lines, and a brake capacity exceeding the breaking strength of the mooring lines. The breaking strength of the wire rope was approximately 1,200,000 lbs. Remote read-out devices located in the Ballast Control Room (inoperative at the time of the casualty) and in

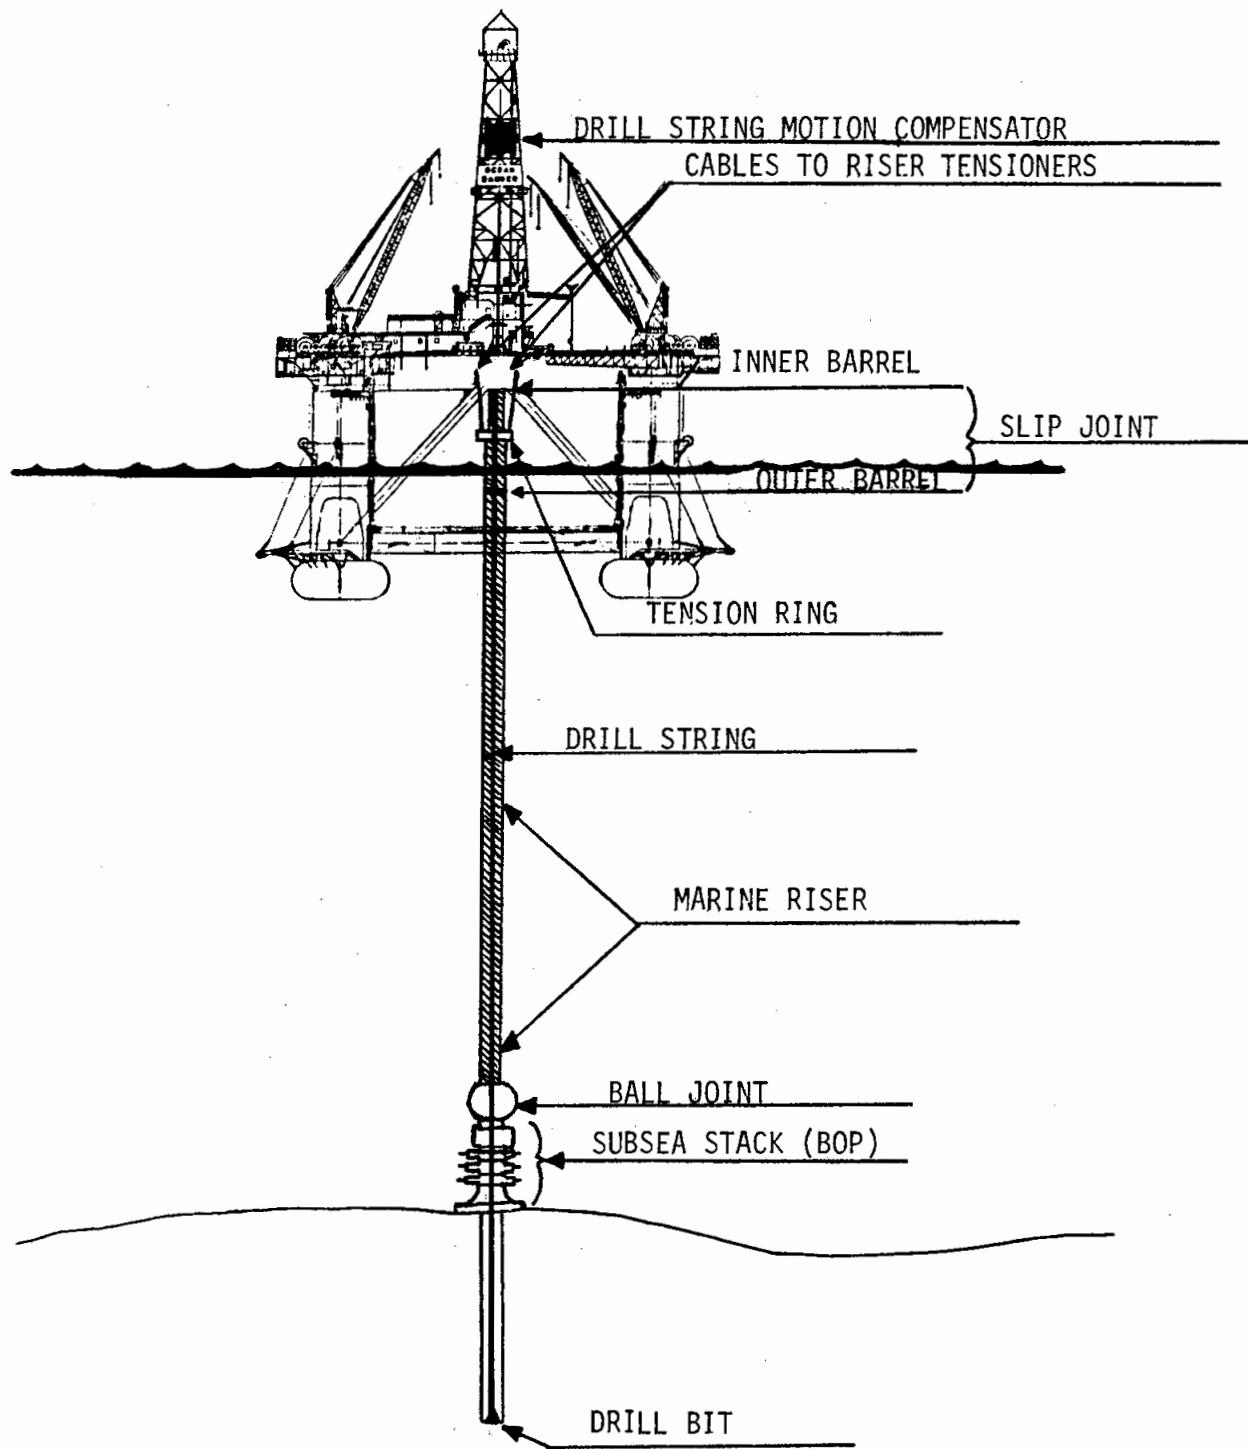
The drill string ran through the marine riser and into the well. The marine riser was connected to the well head by means of a "connector" located atop the blowout preventers (BOP). The well head, the blowout preventers, and their associated hydraulic equipment are collectively referred to as the "subsea stack". The marine riser in use on board the OCEAN RANGER was a 21" O.D. (outside diameter) by 1/2" wall (wall thickness) X-52 VETCO W/MR-6B CONNECTOR (please see figure 6 on page 12).

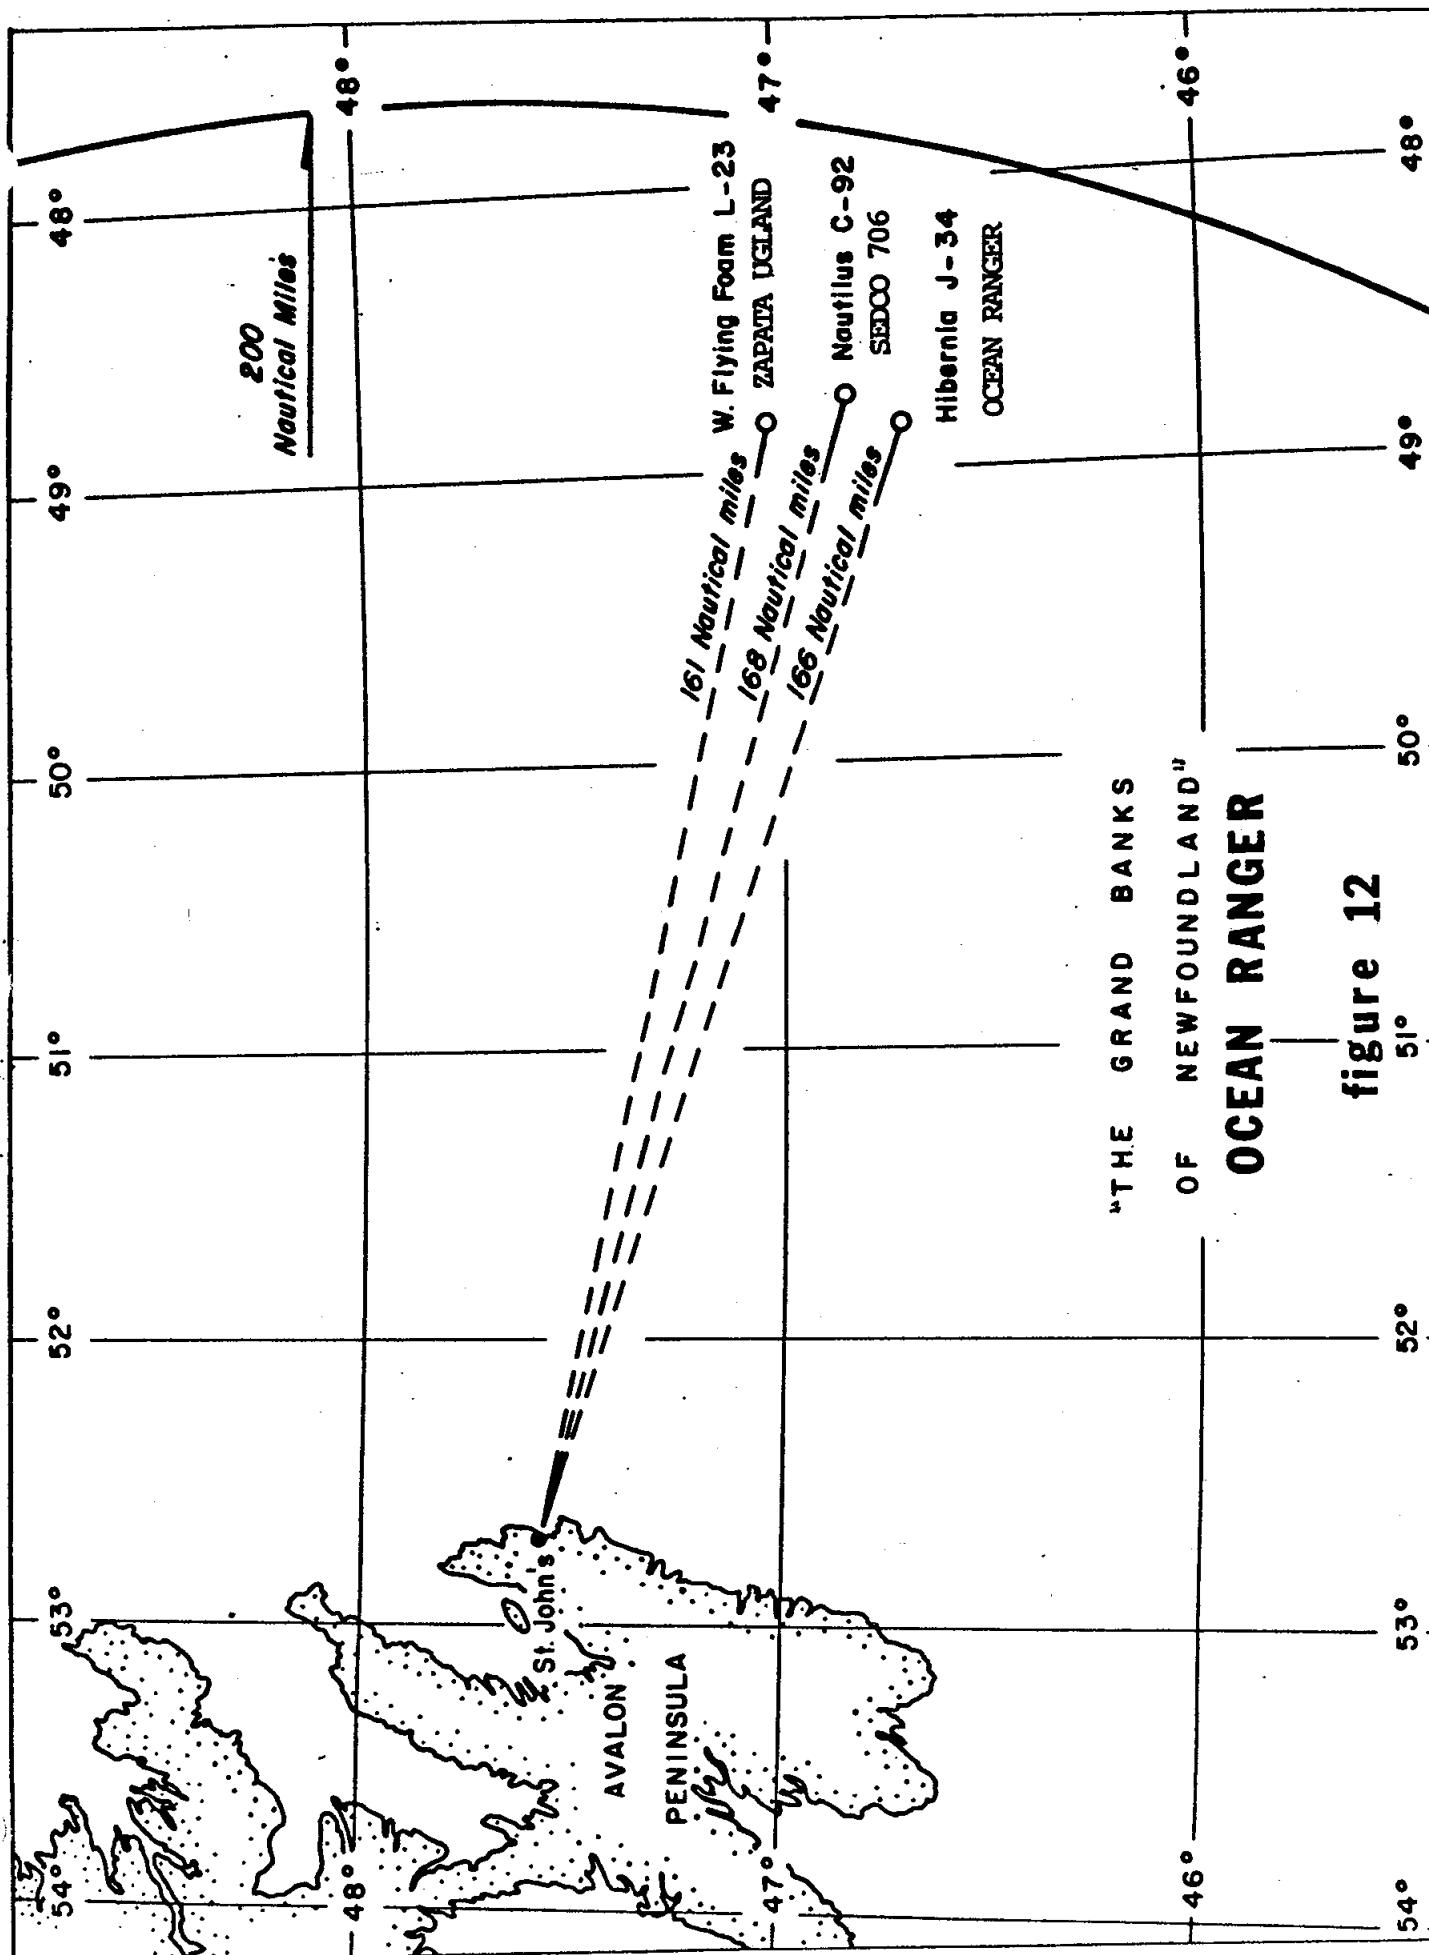
figure 12

OCEAN RANGER began drilling operations on 6 November 1980 on the Grand Banks off Newfoundland under contract to MOCAN. It worked at two well sites in the Hibernia Field before drilling the well designated Hibernia J-34 on 26 November 1981. The location, shown on figure 12, was in approximately 260 ft of water with the OCEAN RANGER on a heading of 310 degrees. Figure 12 also shows the location of two other semi-submersible rigs, SEDCO 706 which was 8.5 miles NxNE and ZAPATA UGLAND which was 19.2 miles N of OCEAN RANGER. Drilling operations continued around the clock by two crews alternately working a tour of 12 hours. Generally the rig's complement of personnel worked 21 days on and 21 days off.
