Air Conditioning Modifications for the GMC RTSII Series 01 Coach (Model TH-8201)

Prepared by:
Transportation Systems Center
Urban Systems Division

October 1982
Final Report

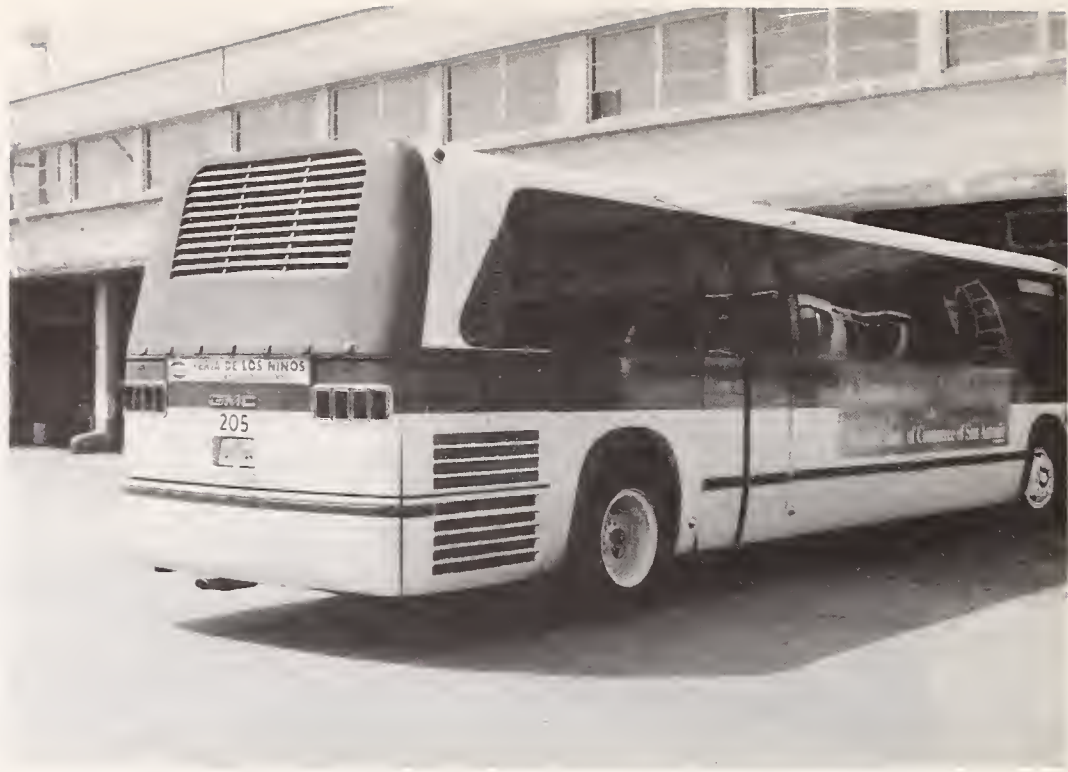
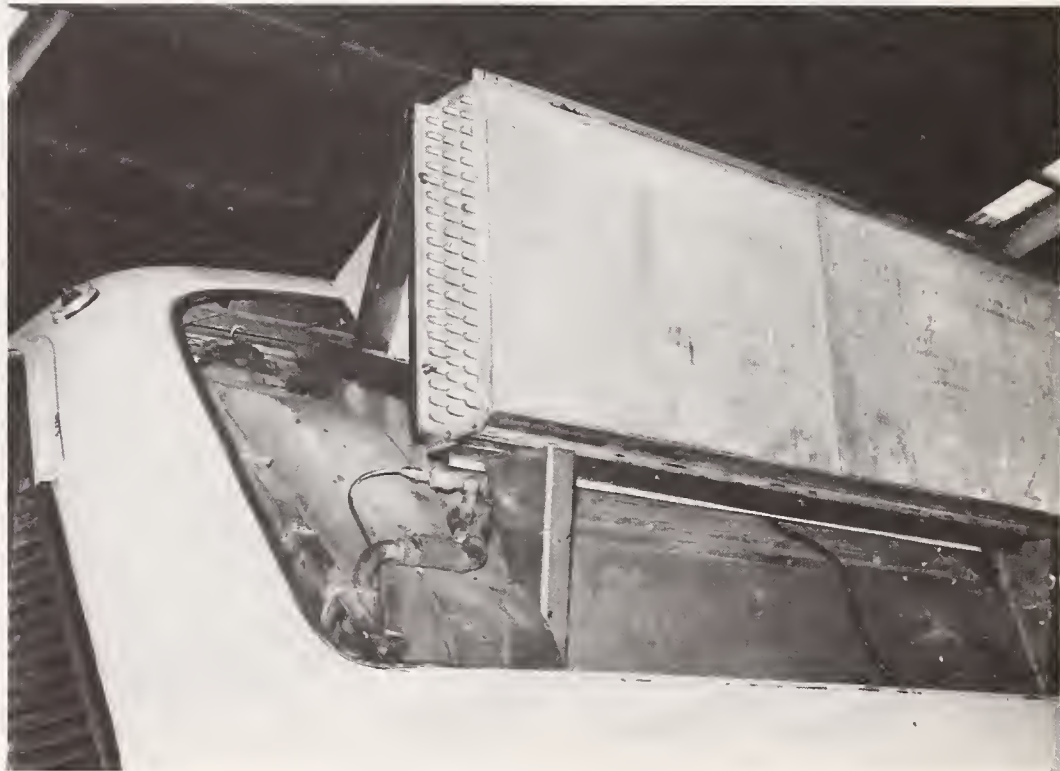
FIGURE 2

In an effort to alleviate these problems, San Antonio VIA Metropolitan Transit maintenance personnel have developed and implemented modifications to some of the RTS II subsystems. The major air conditioning modification involved replacing the refrigerant condenser with a smaller unit and relocating it outside the engine compartment. The new condenser was mounted along with 2 electric-motor-driven cooling fans just below roof level at the rear of the bus. This modification is illustrated in Figures 1 and 2, which show both the unmodified and modified versions of the RTS II Series 01 coach.

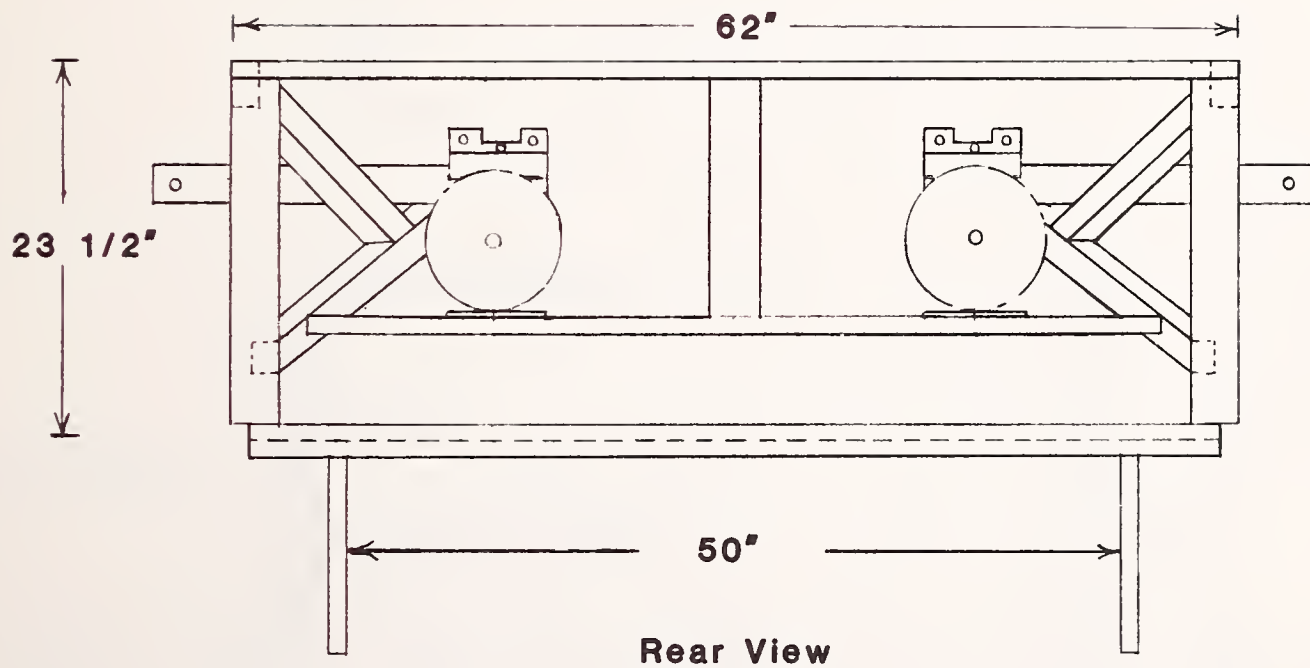
FIGURE 7

The condenser blower motors are cradled on a cross member in the mounting frame. The assembly of the mounting frame and blower motors is shown in Figures 7 and 8. The blowers consist of two GE motors with cast aluminum fans of four blades each. The motors are each less than one-third horsepower and operate directly from the main power supply. The addition of a circuit breaker is the only modification to the electrical system.
