FDD #6 NAKAJIMA MUSASHINO (9)

Pack 3 PHOTO LOG - NAKAJIMA - MUSEUM

PHOTO LOC - NAKAJIMA - MUSEUM -

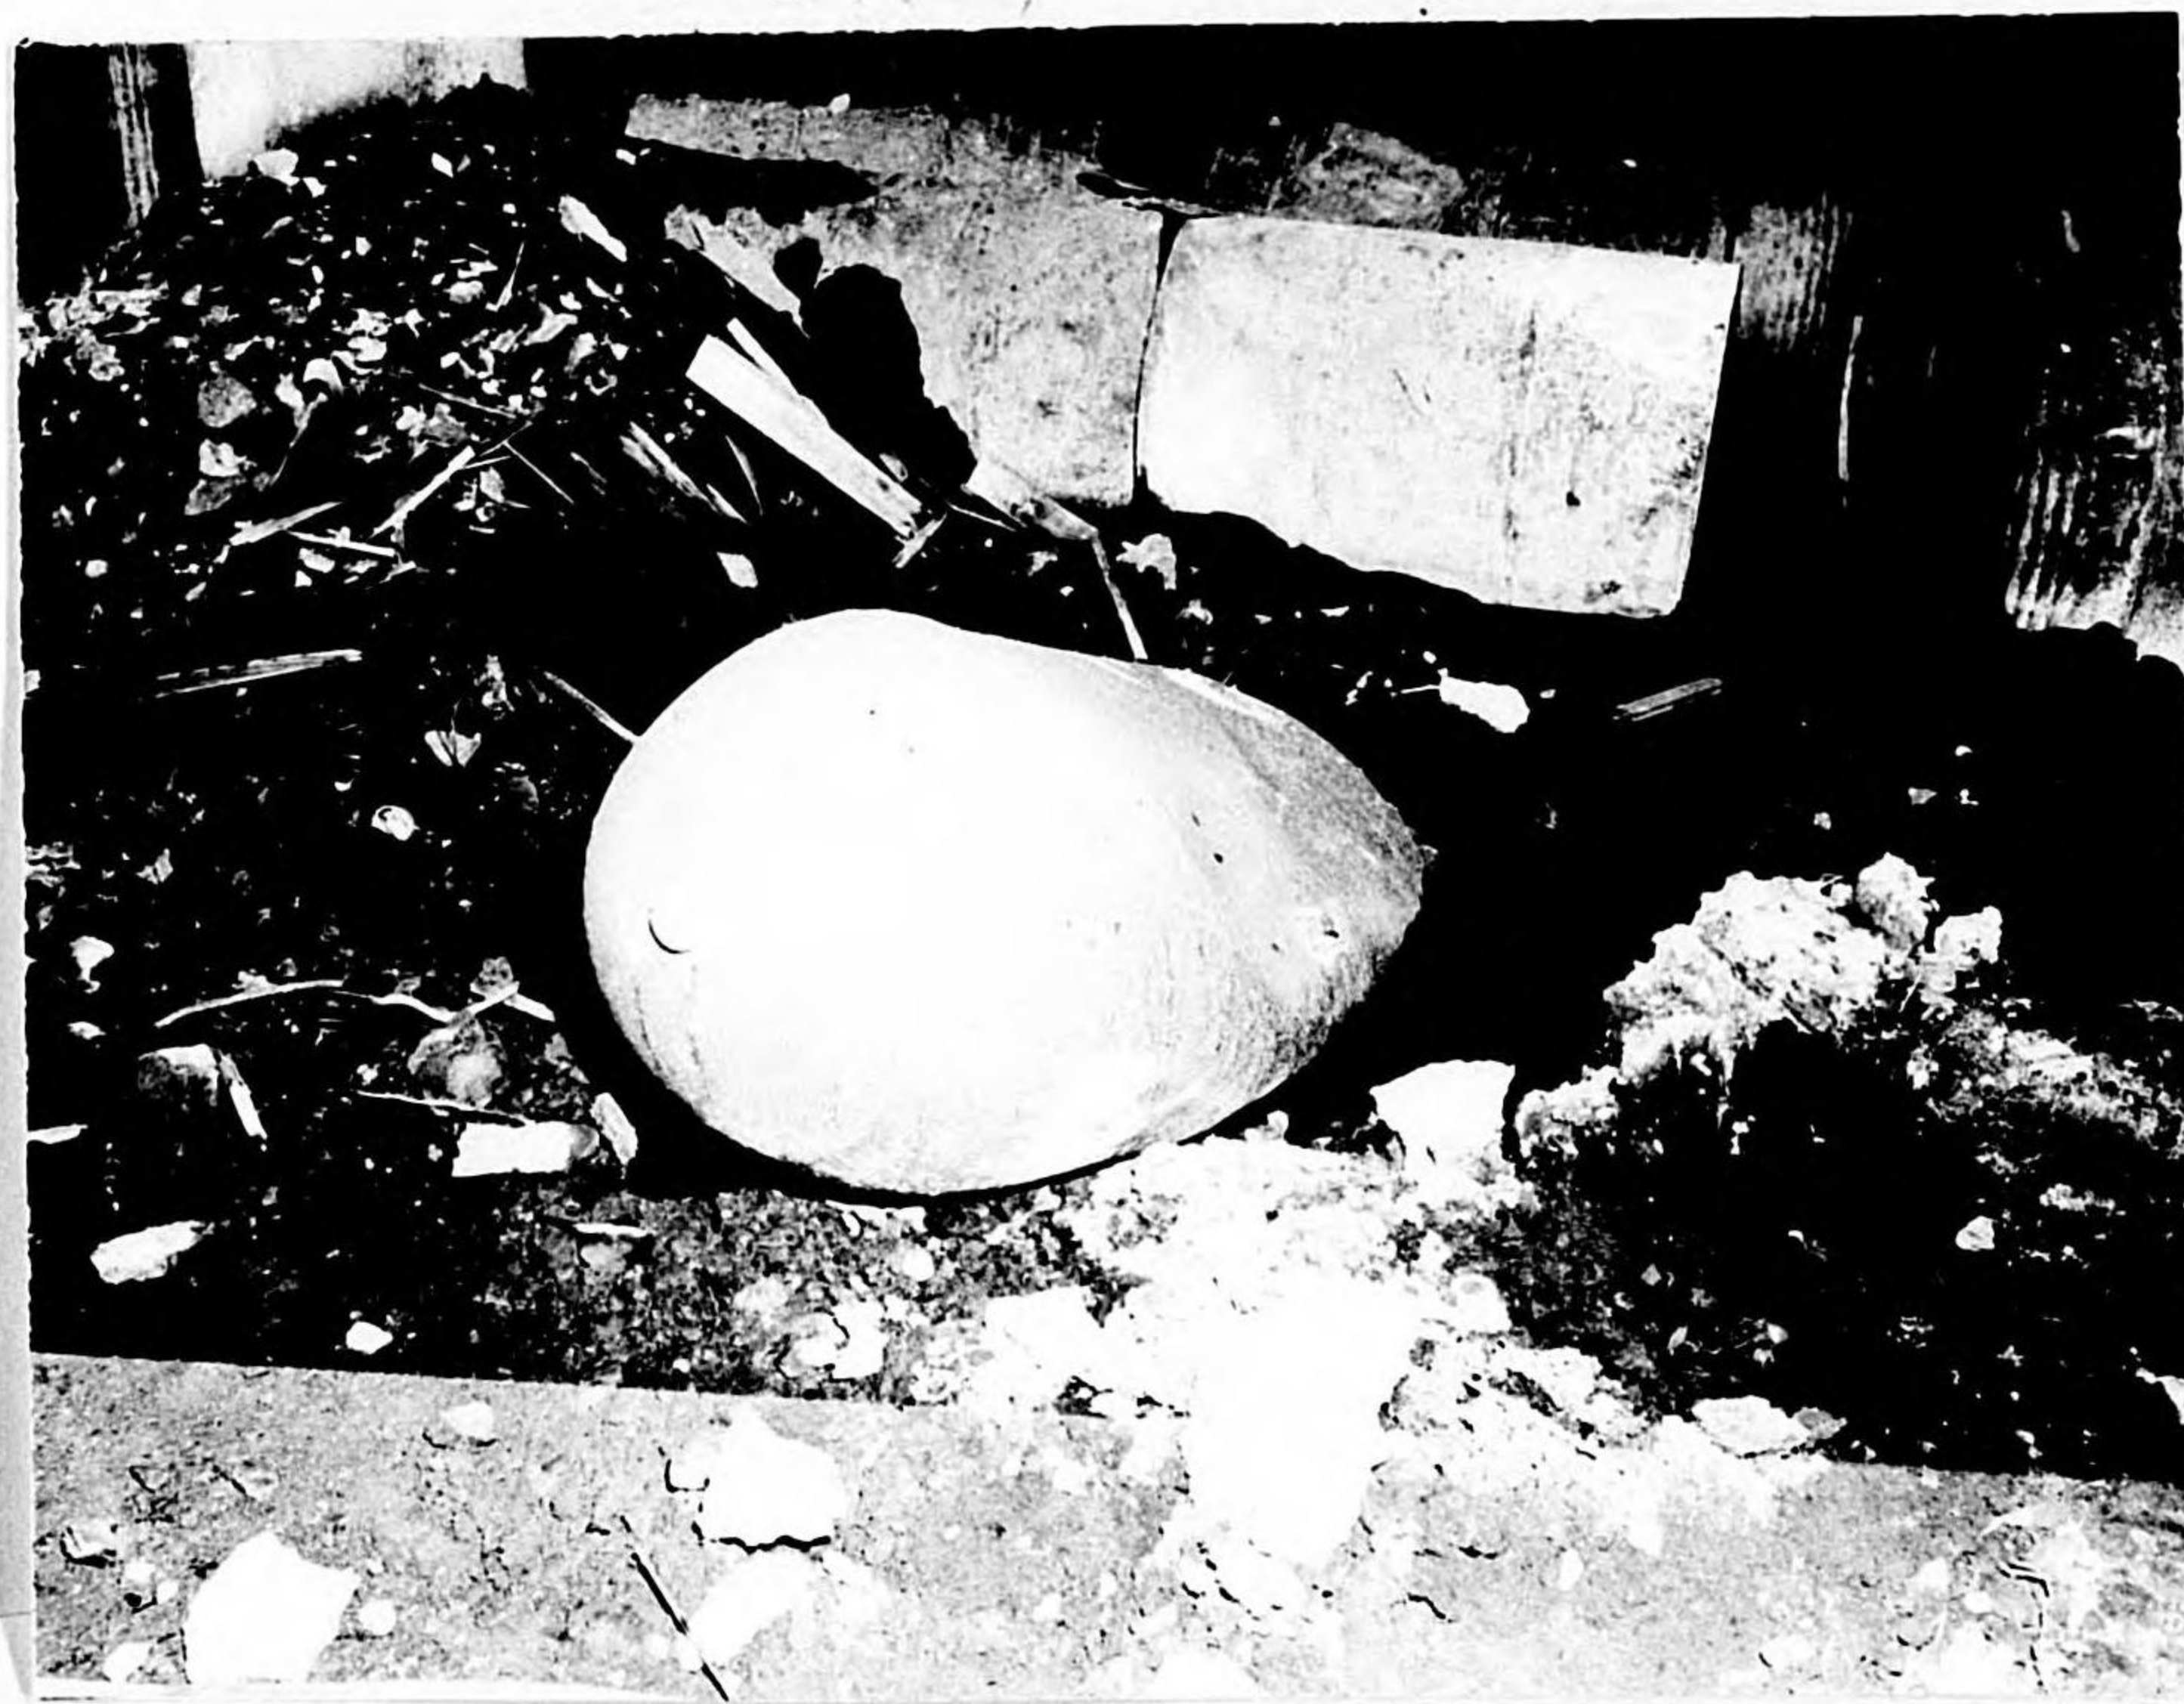
End view of UXB casing shown above.
