## CIVIL AIRCRAFT ACCIDENT

Report of the Second Independent Review  
appointed to consider the Accident to  
Elizabethan Aircraft G-ALZU at Munich  
on 6th February 1958 and to Report whether blame for  
the Accident is to be imputed to Captain Thain

1969

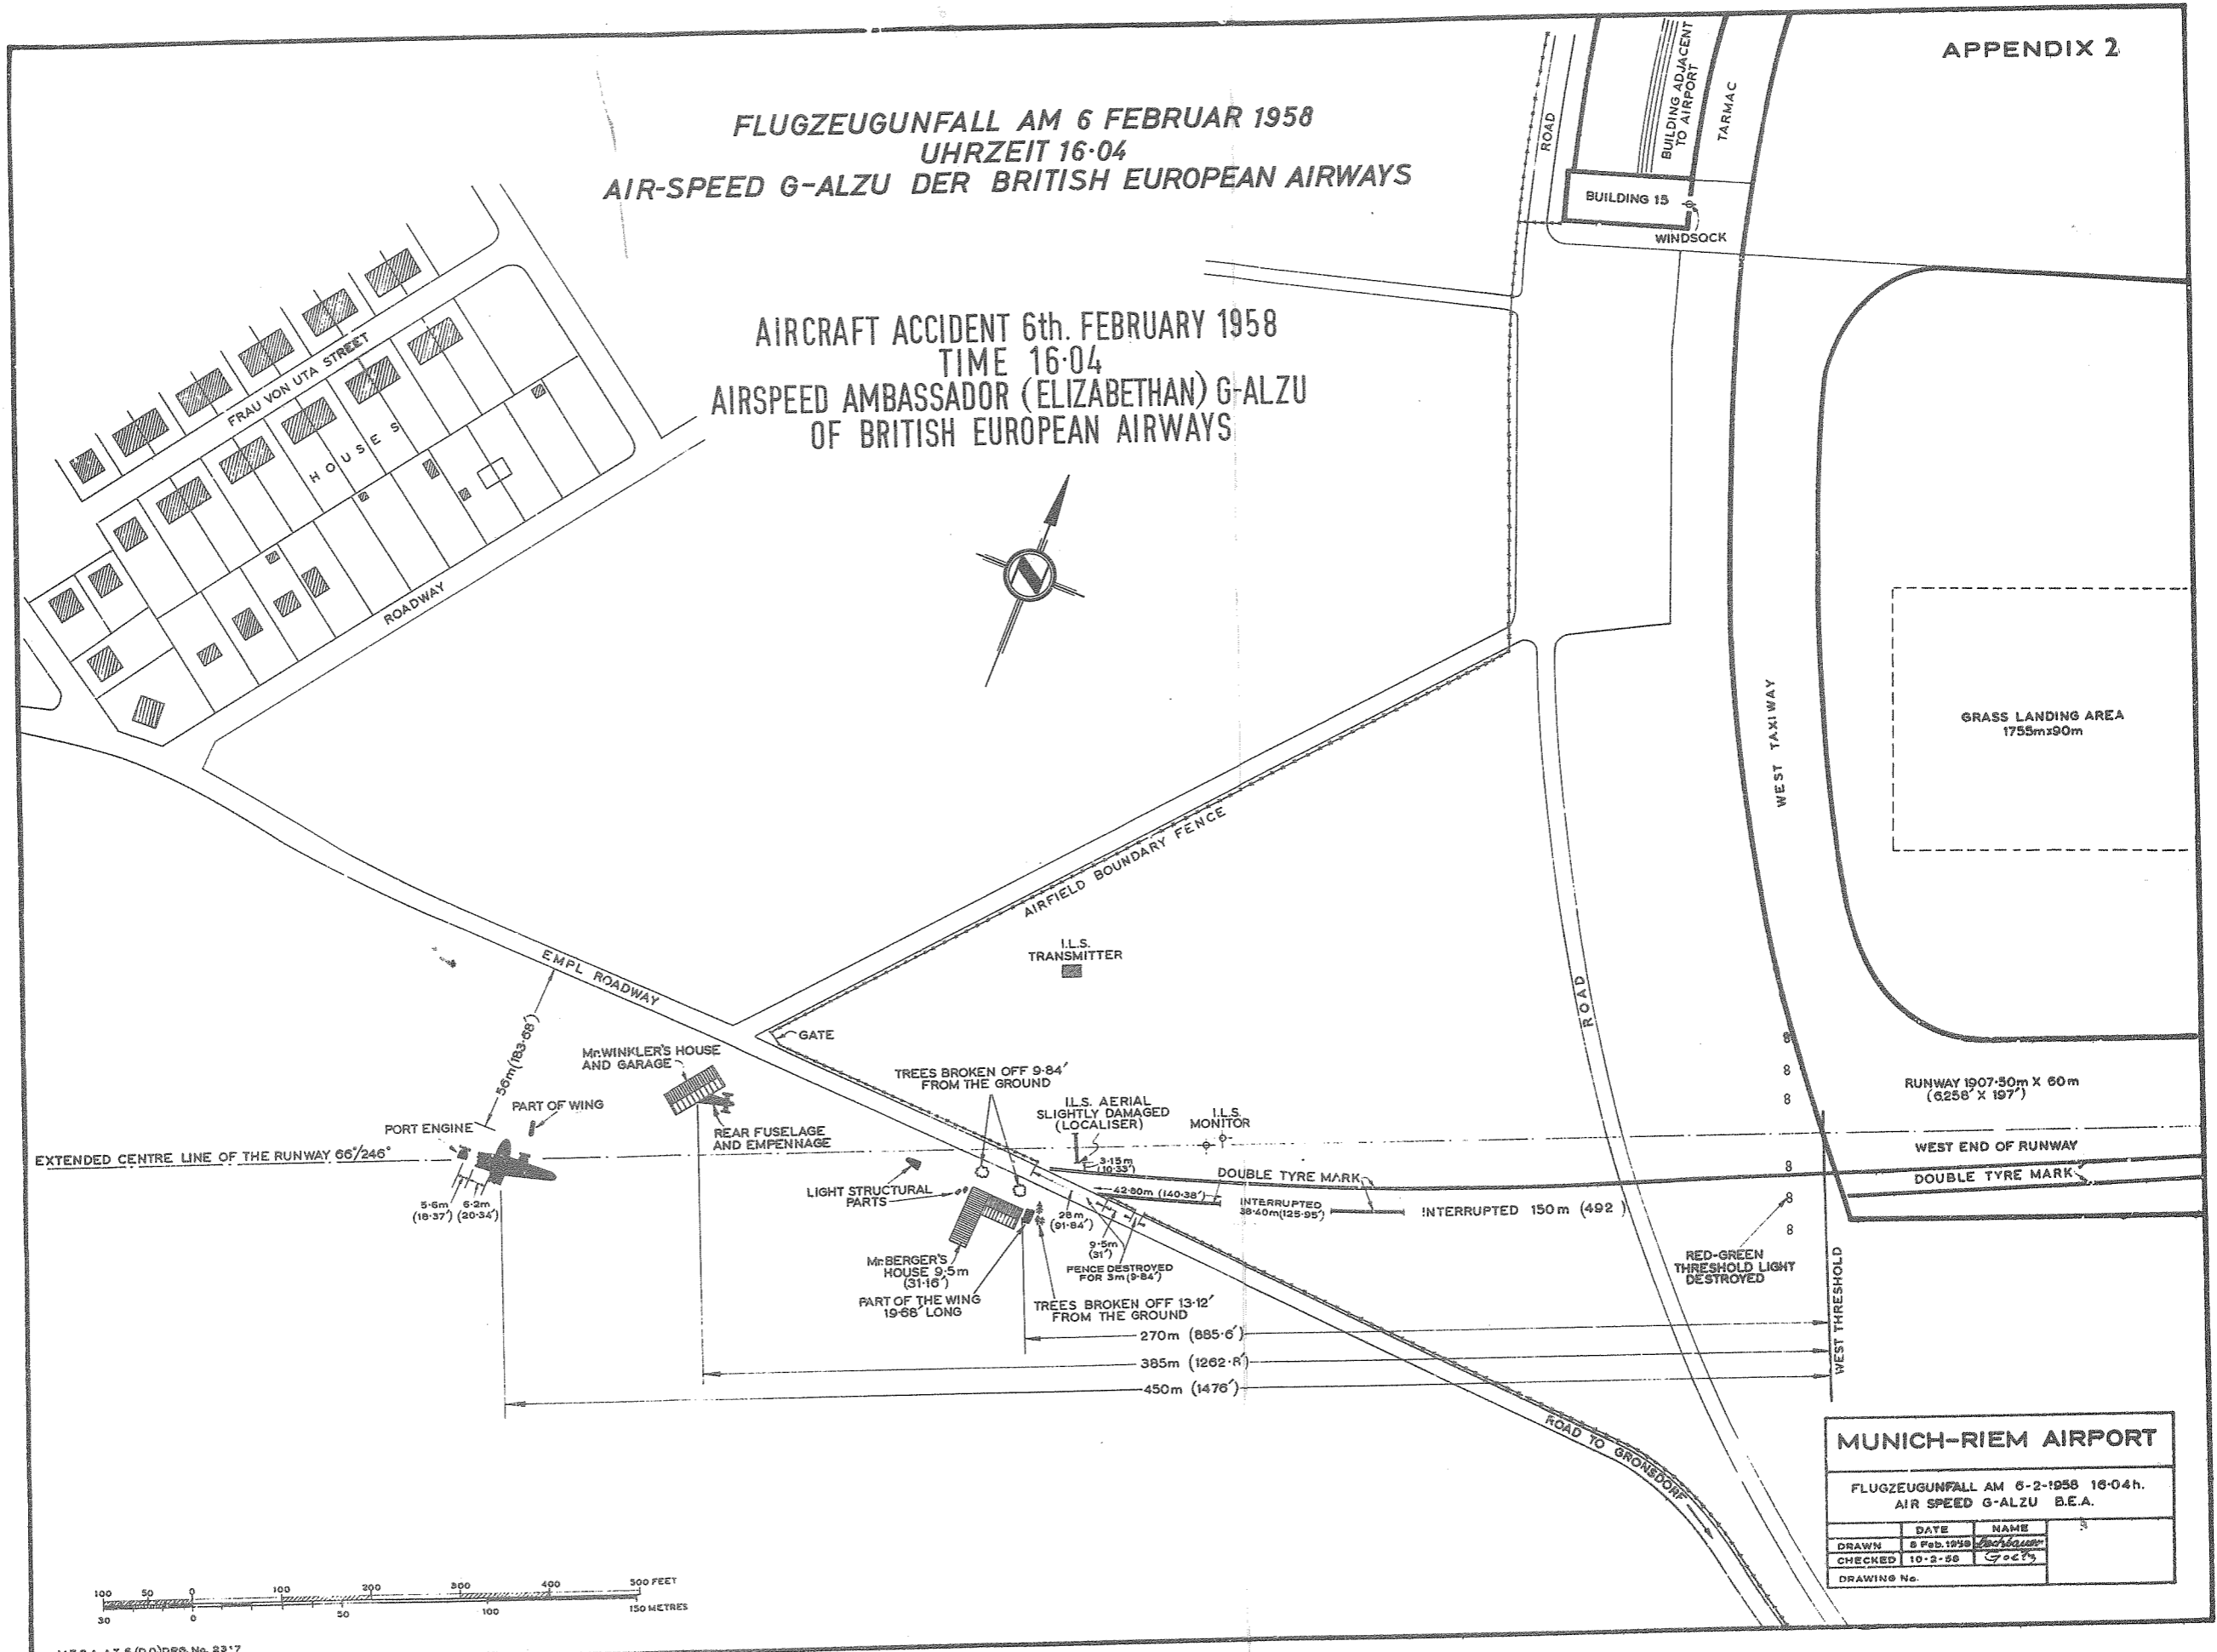
AIRCRAFT ACCIDENT 6th. FEBRUARY 1958  
 TIME 16:04  
 AIRSPEED AMBASSADOR (ELIZABETHAN) G-ALZU  
 OF BRITISH EUROPEAN AIRWAYS

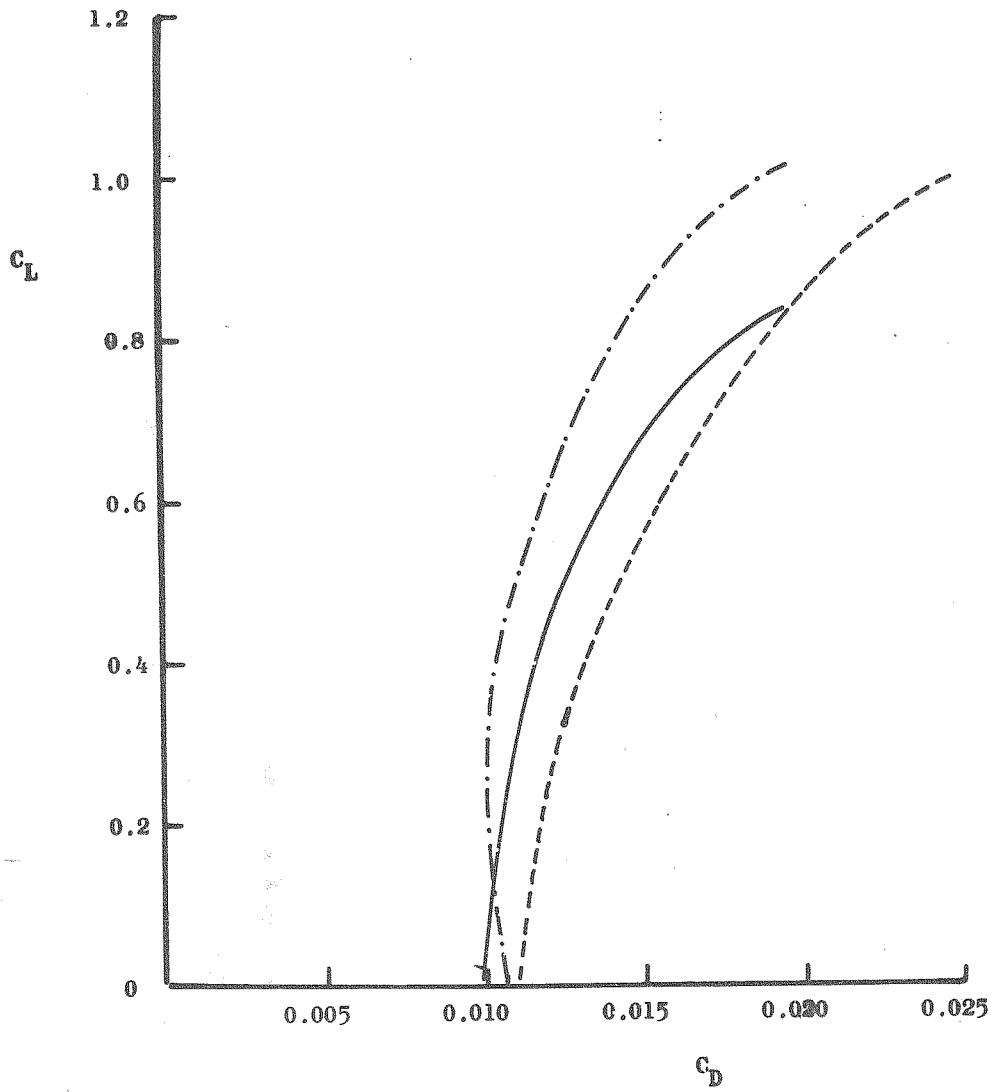
Appendix 3 Figure 2

- (i) low-drag sections, like the NACA 65<sub>2</sub> - 415 used on the Elizabethan appear to be no more sensitive to leading edge roughness, so far as  $C_L$  is concerned, than conventional sections (see Collar's remark in Appendix 2 of the British Reviewing Body's Report); e.g. figure 2.
- (ii) No marked effect on flap performance is discernible (see the remark on page 10 of the Schlichting-Gersten Report).
- (c) Take-off speed. Using my own estimates of profile drag increment, together with Hoerner's curve for the decrement in lift, I found that, even if the entire upper surface of the wing were iced, lift-off would have been possible at a speed between 112 and 113 knots with a roughness height of 2 mm; figure 3.

The fall in  $C_L$  from a  $C_L$  of 1.0 due to roughening the leading edge with grains corresponding to  $k_s/c = 4.6 \times 10^{-4}$  (approximately 1.5 mm on the Elizabethan).

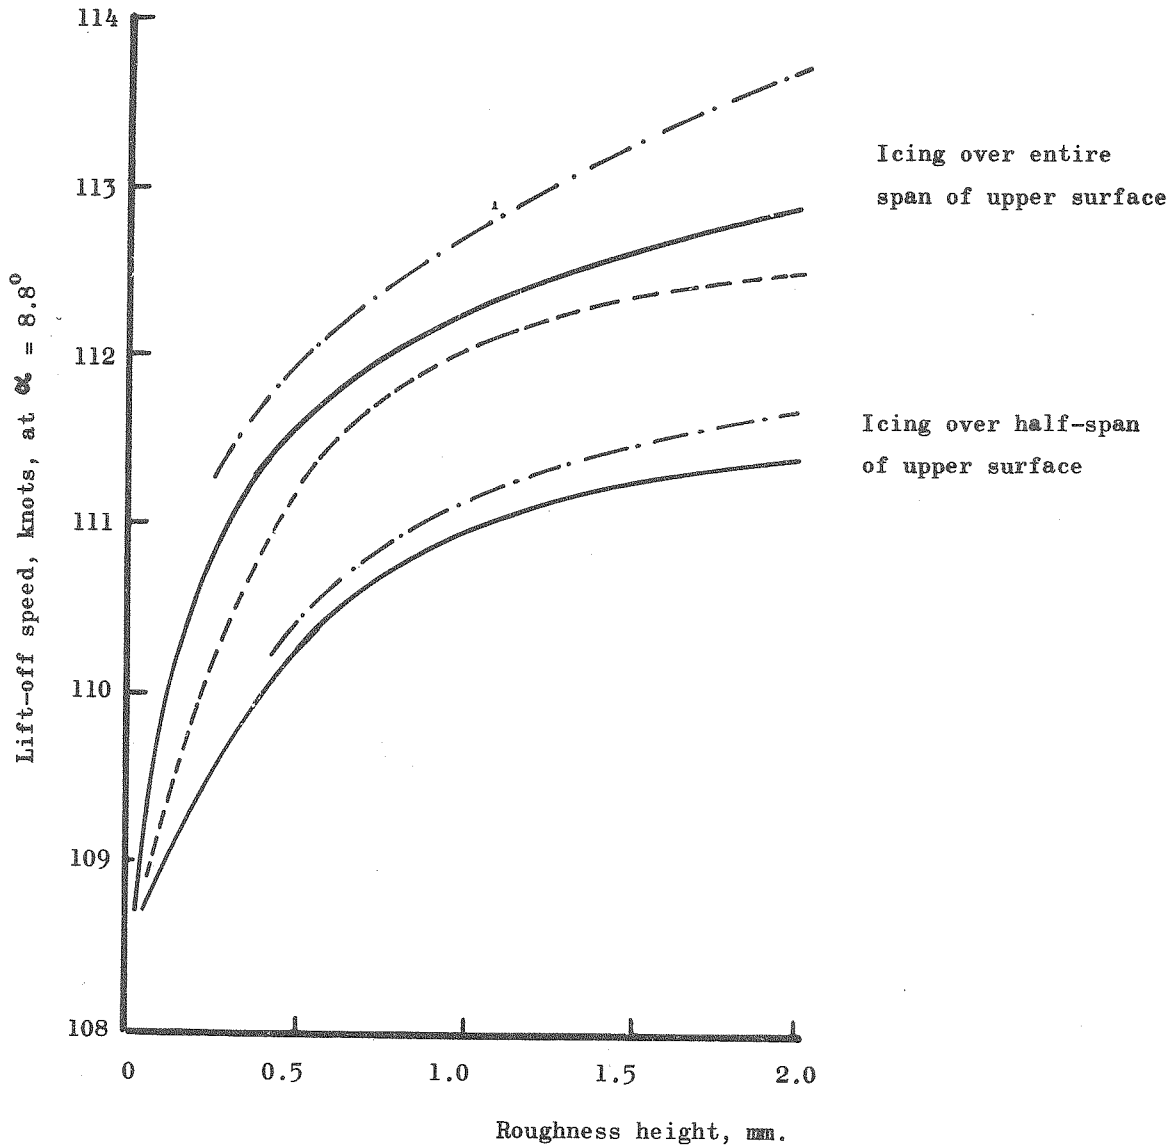
Appendix 3 Figure 3

With a roughness height of 0.5 mm, the corresponding speed range was 110.5 to 111.0 knots; figure 3.

Similar results were obtained on the basis of my own analysis of the effect of roughness on lift, according to the Abbott and von Doenhoff data; figure 3.

Lift-off speed at  $W = 54620$  lb., based on independent estimate of drag increment due to roughness, but on the Schlichting-Gersten curve of  $1/a_0$  against  $C_{D0}$  (fig. 9 of Report 58/21);
