EXPLOSION AT CONSOLIDATED SCHOOL
NEW LONDON, TEX.

INVESTIGATION OF EXPLOSION AT
CONSOLIDATED SCHOOL, NEW LONDON, TEX.

MARCH 18, 1937

Prepared by
DAVID J. PRICE
Principal Engineer in Charge
Chemical Engineering Research Division
Bureau of Chemistry and Soils
U. S. Department of Agriculture
Washington, D. C.

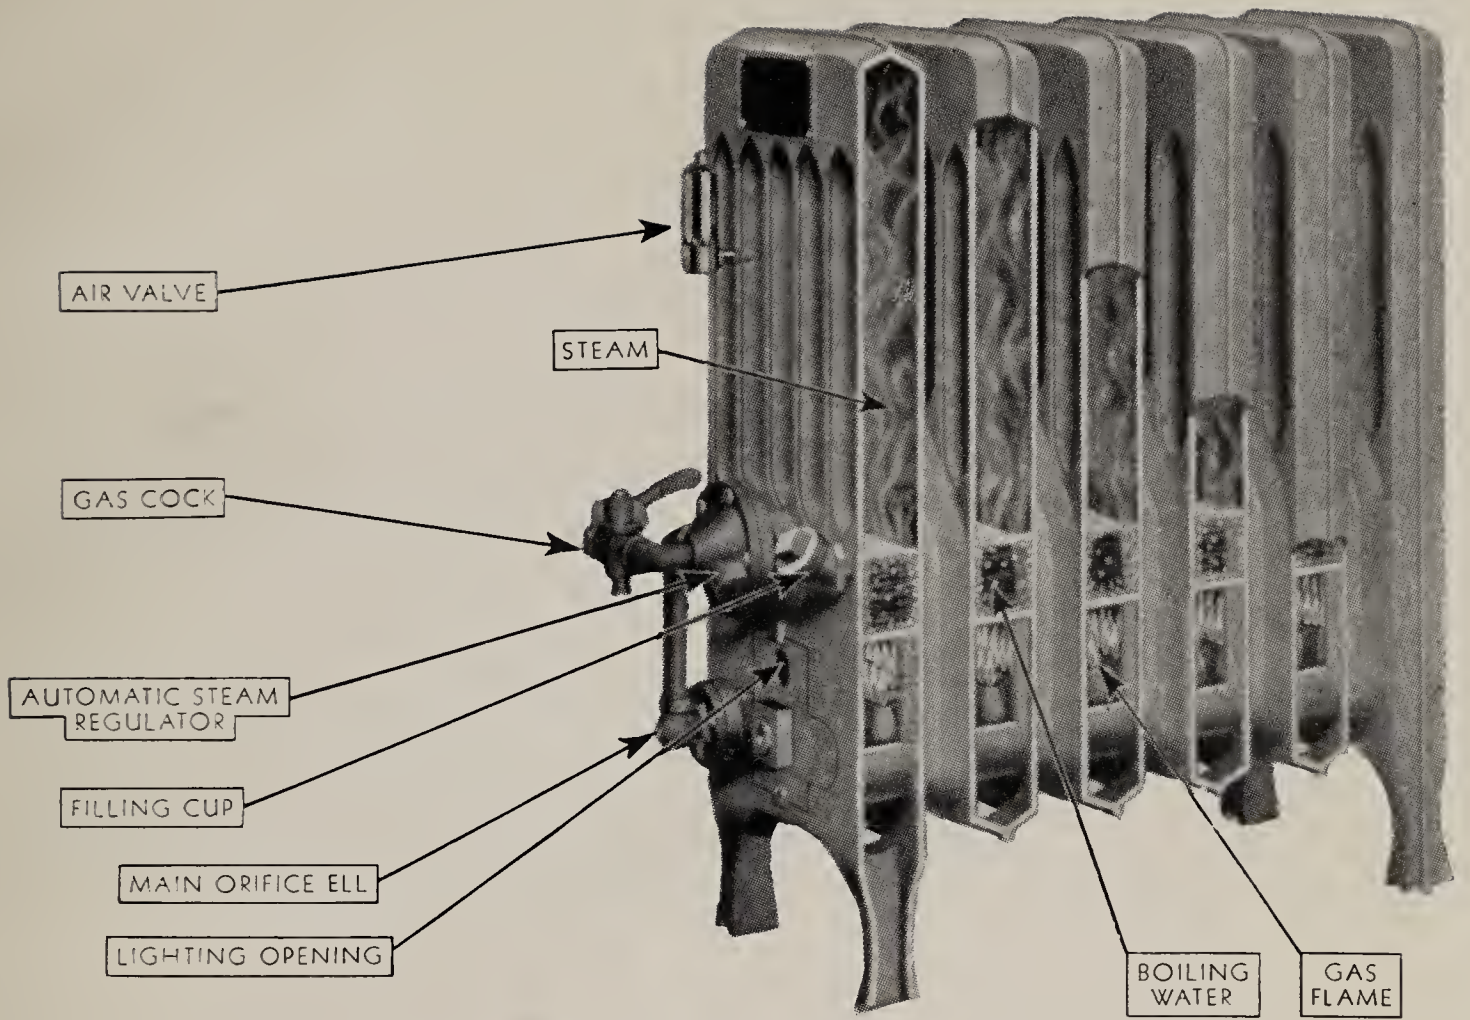
FIGURE 3.—Gasteam radiator.

The operation of a "Gasteam" radiator is illustrated in figure 3. The upper portion forms the steam-heating surface; the lower portion forms a water compartment and combustion chamber which encloses the gas burner. A steam-pressure regulator so operates that when the gas is first lighted a maximum volume of gas is burned to generate

steam quickly. When 5 to 8 pounds pressure is reached the regulator automatically cuts down the supply of gas to maintain just that pressure. The water chamber need be replenished with water only a few times each season. Each radiator is operated independently by merely turning on and lighting the gas at the radiator.

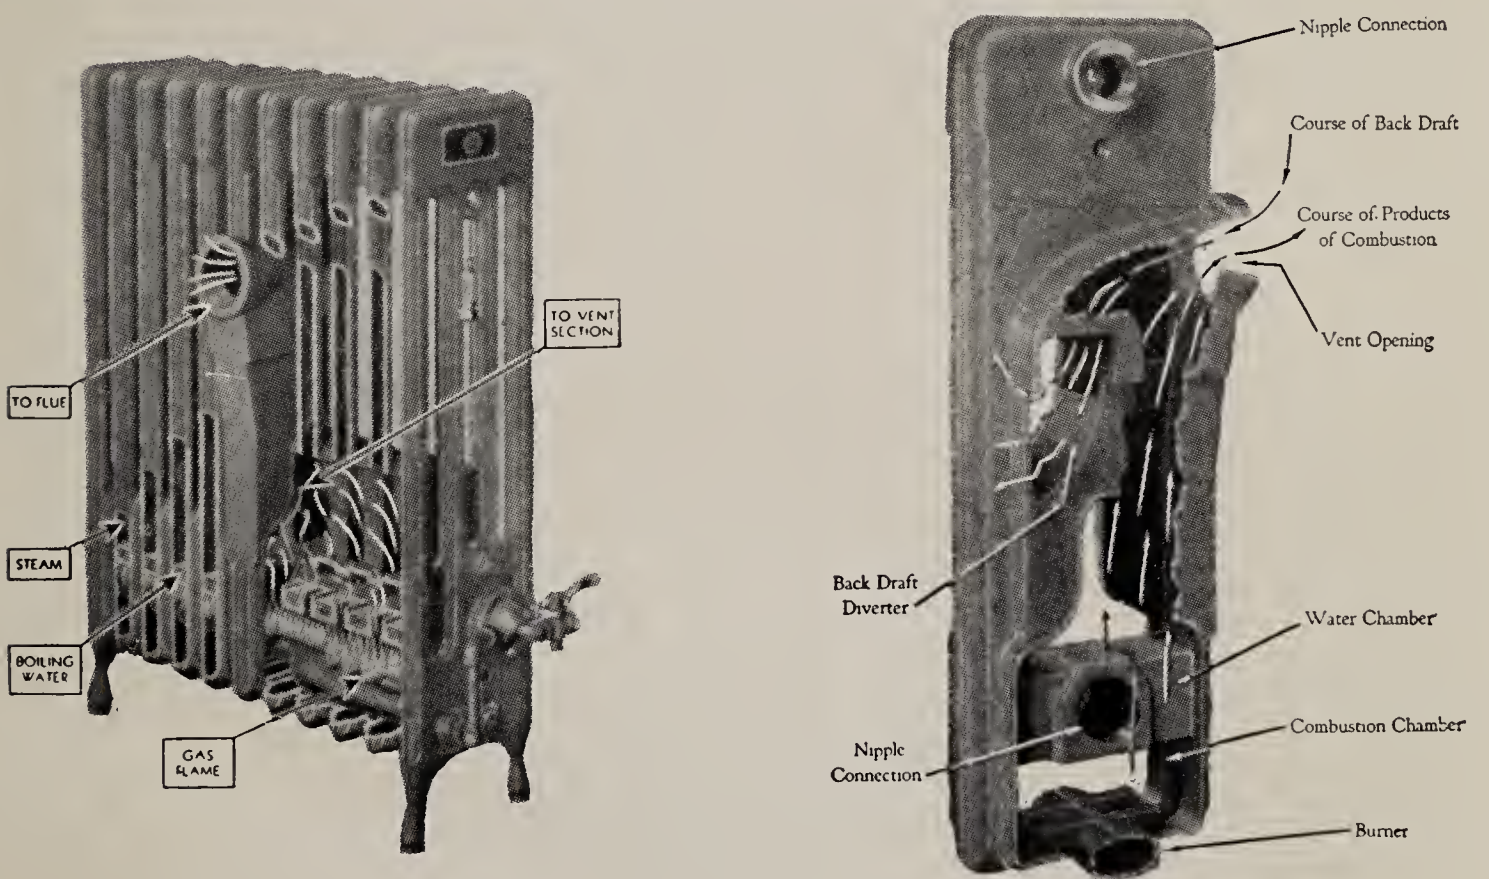
FIGURE 4.—Vented gasteam radiator.

Figure 4 shows a vented "Gasteam" radiator. In discussing the application of vented and unvented "Gasteam" radiators the manufacturing company states:

With vented "Gasteam" radiators the moisture produced by the burning of fuel gas is carried to the outside of the building through vent stacks. When all vented "Gasteam" radiators are used on an installation, there is no humidity from the radiators added to the heated room air, and a very dry condition results.

In addition to the vented radiators carrying off the products of combustion, many engineers feel that they are also desirable and essential to provide a means of escape to outside air of any unconsumed gas that may escape from the burner at the base of the radiator. This precaution is considered essential by the advocates of vented radiator installations to protect against the possible accumulation of gas in the atmosphere of the room.
