PHYSICAL PROTECTION WORKBOOK

dittert site

SEPTEMBER, 1978

DITTERT SITE
(AR-NM-02-085)

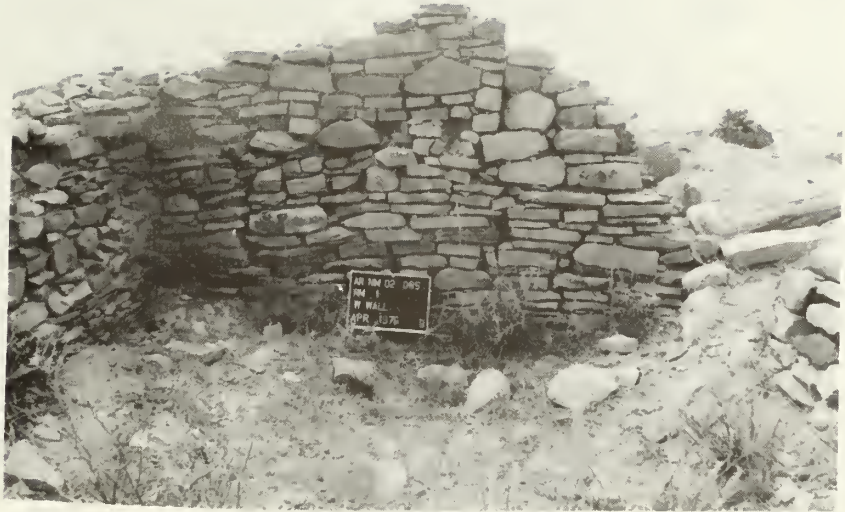
Room 1, west wall: before
stabilization

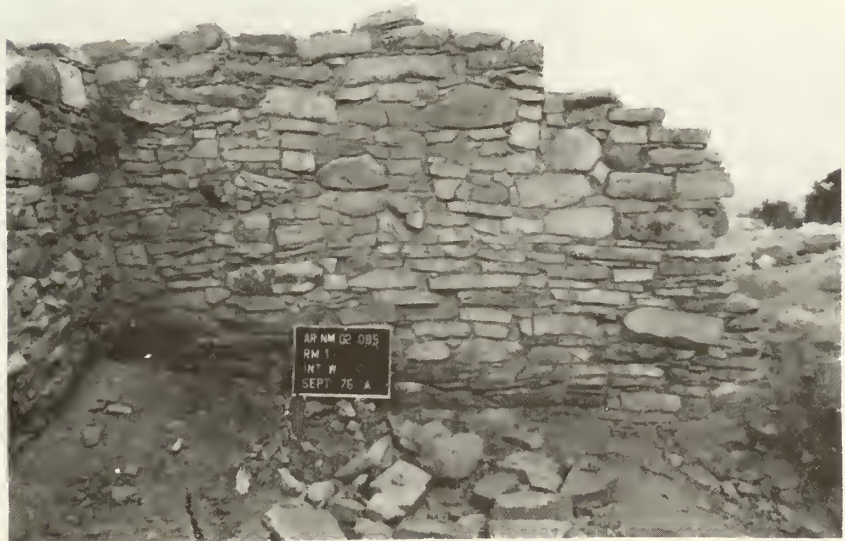
Room 1, west wall: after
stabilization

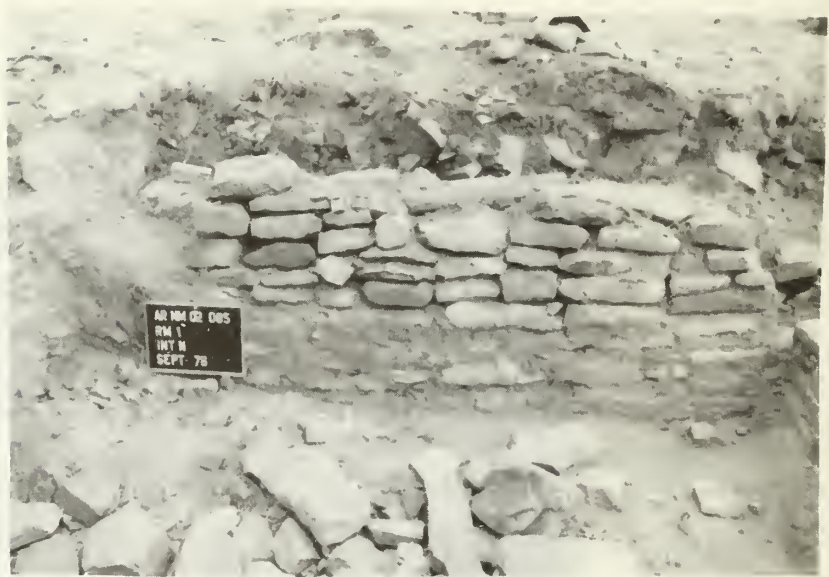
Room 1, north wall: after digging
trenches along both sides of wall.

No photo taken of stabilization
completed.

All four walls in this room were cleared of loose material then capped and grouted. The south wall was reconstructed where it once caved in. The north wall was leaning and the northeast corner of the room was caved in before stabilization procedures began. Special attention was given to all walls in Room 1. Unfortunately, there was not adequate time to completely excavate the room, and therefore, the north wall, as completed, is still in a leaning position. It was found that if the wall were straightened, it would destroy all fabric, and the wall would have to be completely reconstructed. The decision was made to leave the wall in it's leaning position, and adequately backfill on both sides of the wall to insure sufficient stability.

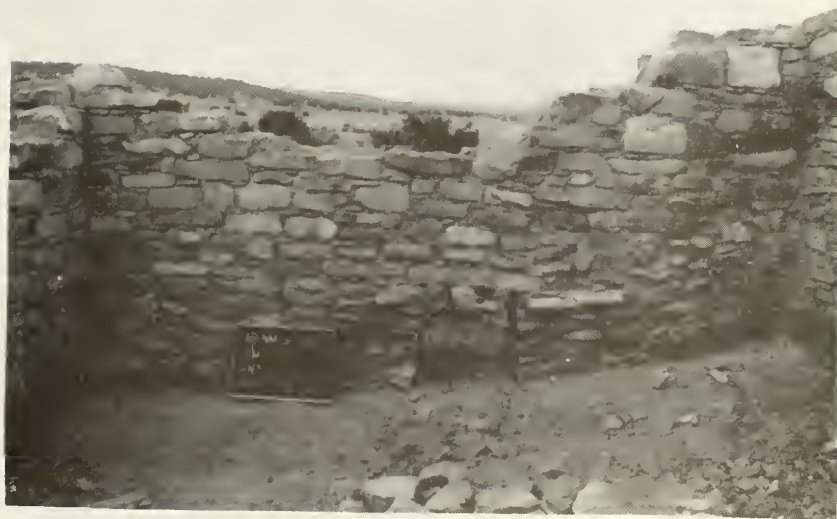
Room 1, south wall: after
stabilization

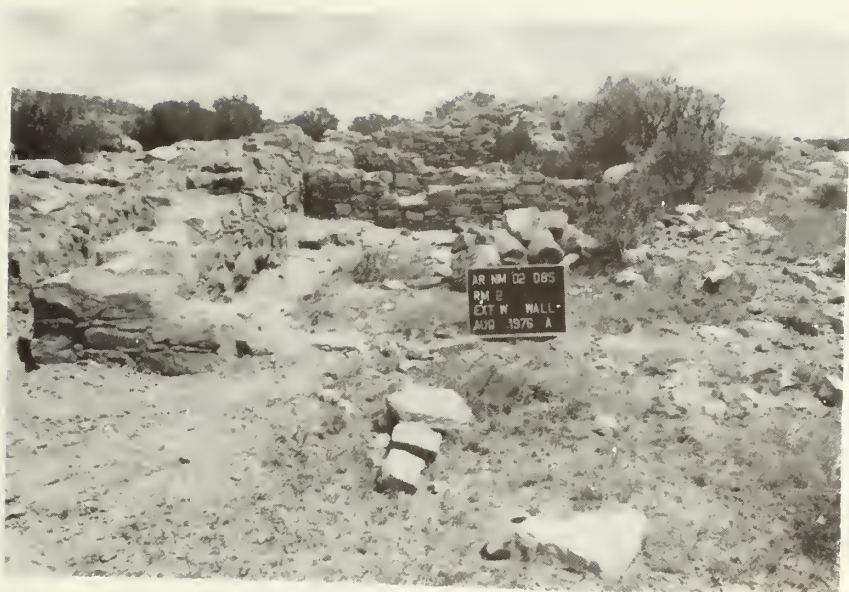
Room 2, west wall: after
stabilization

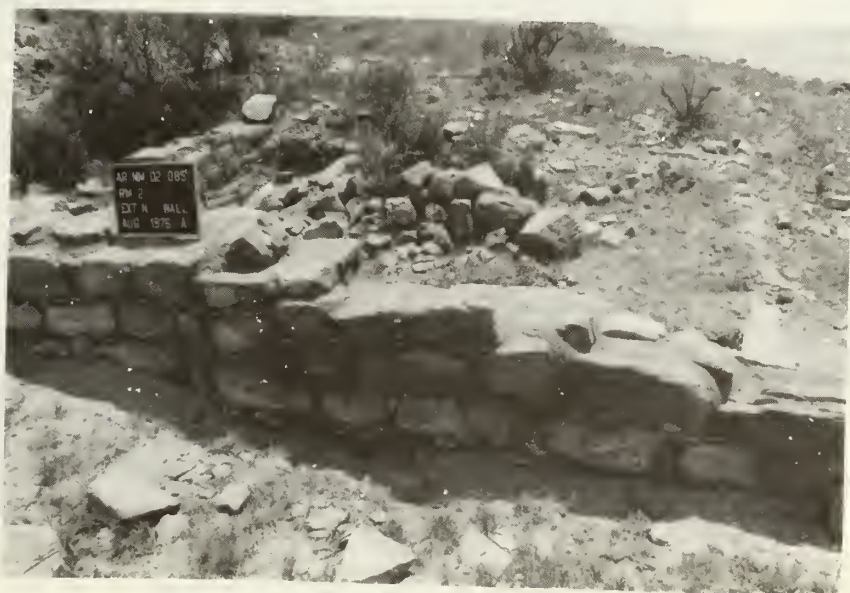
Room 2, north wall: after
stabilization

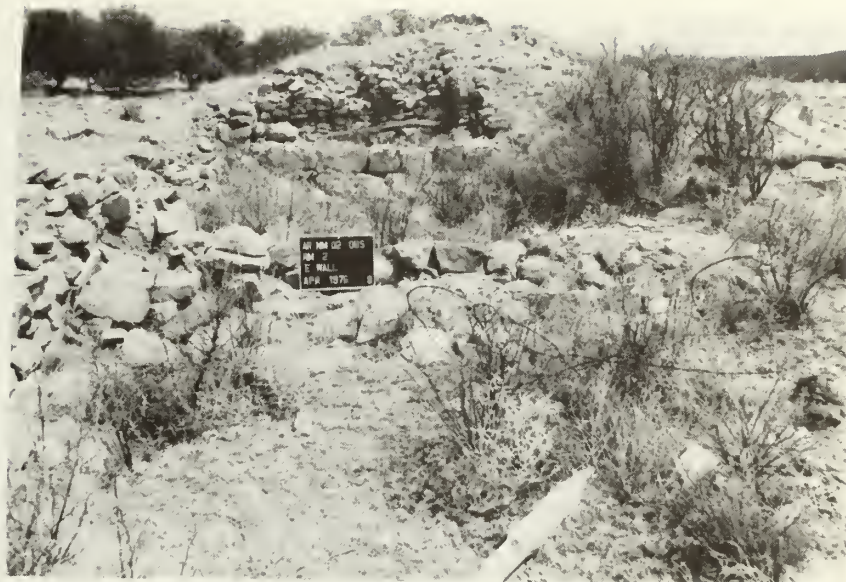
Room 2, east wall: before
stabilization

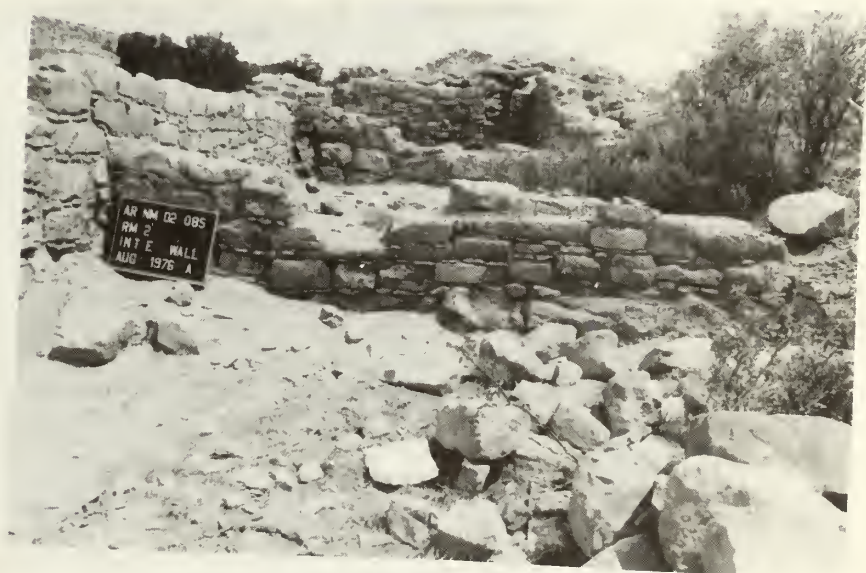
Room 2, east wall: after
stabilization

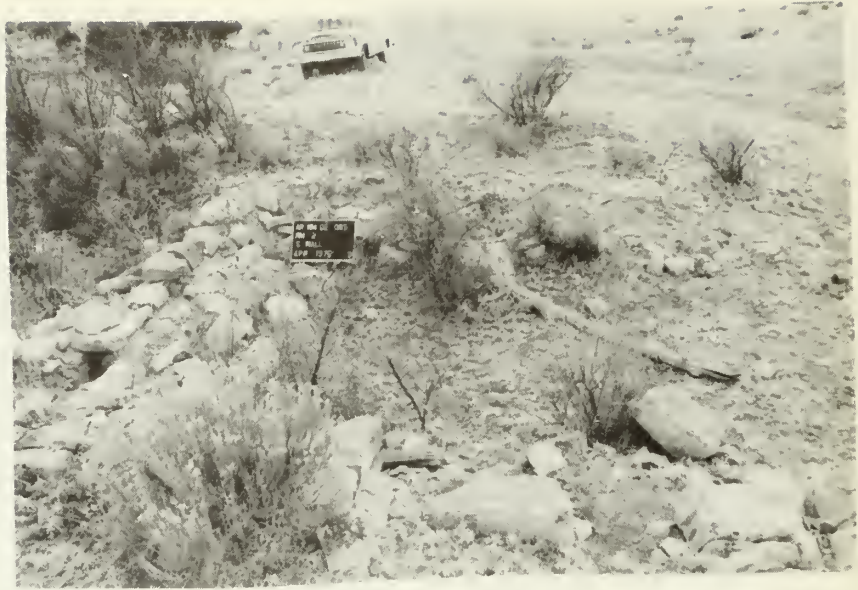
Room 2, south wall: before
stabilization

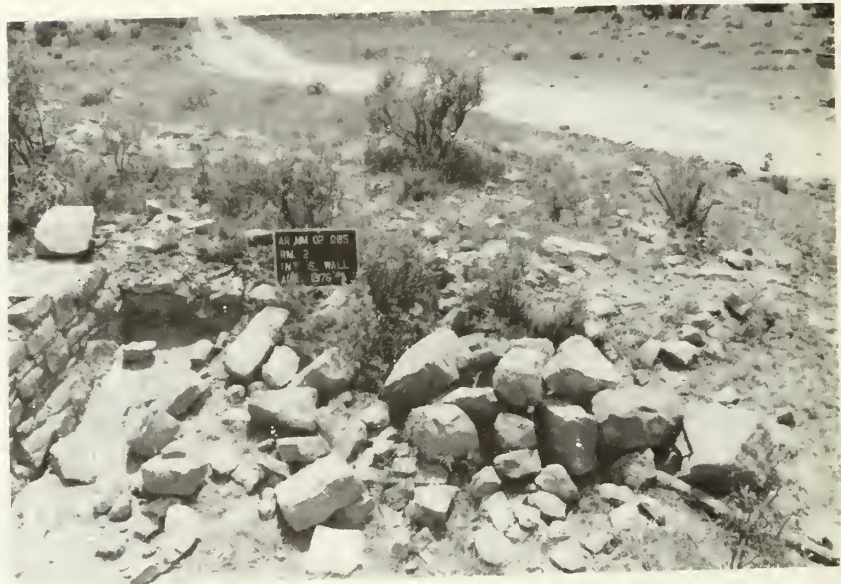
Room 2, south wall: after
stabilization

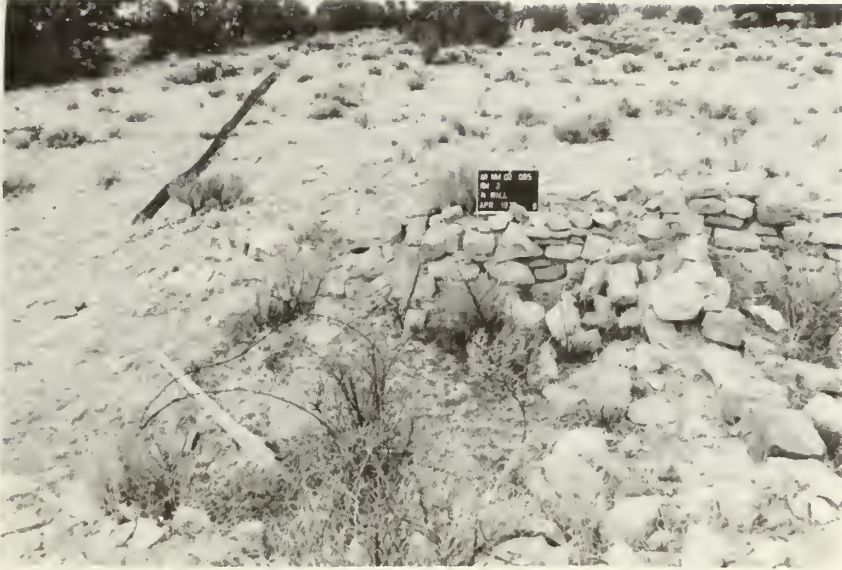
Room 2, north wall: before
stabilization

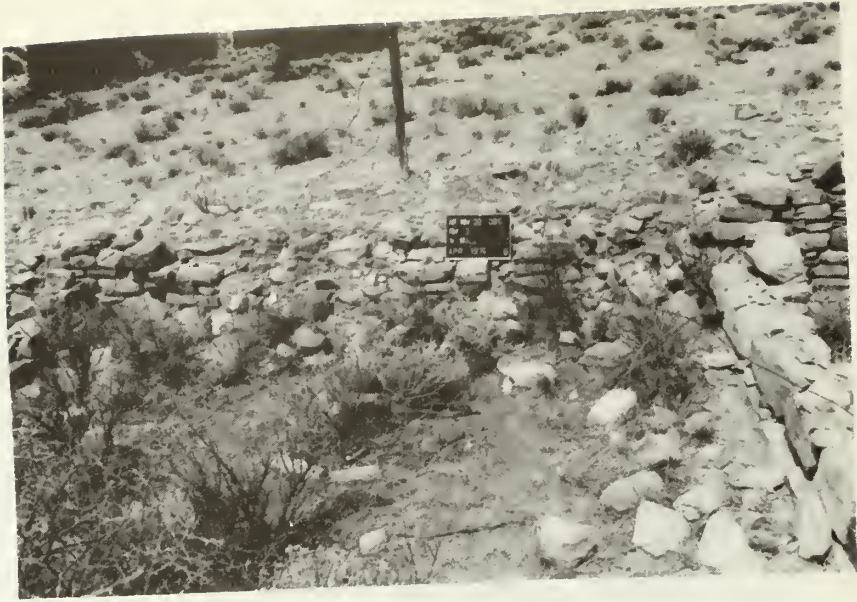
Room 3, north wall: before
stabilization

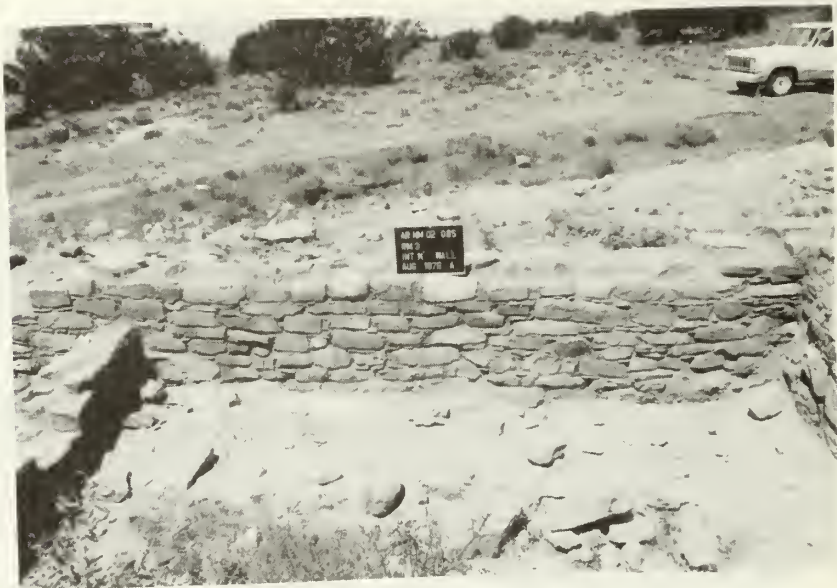
Room 3, north wall: after
stabilization

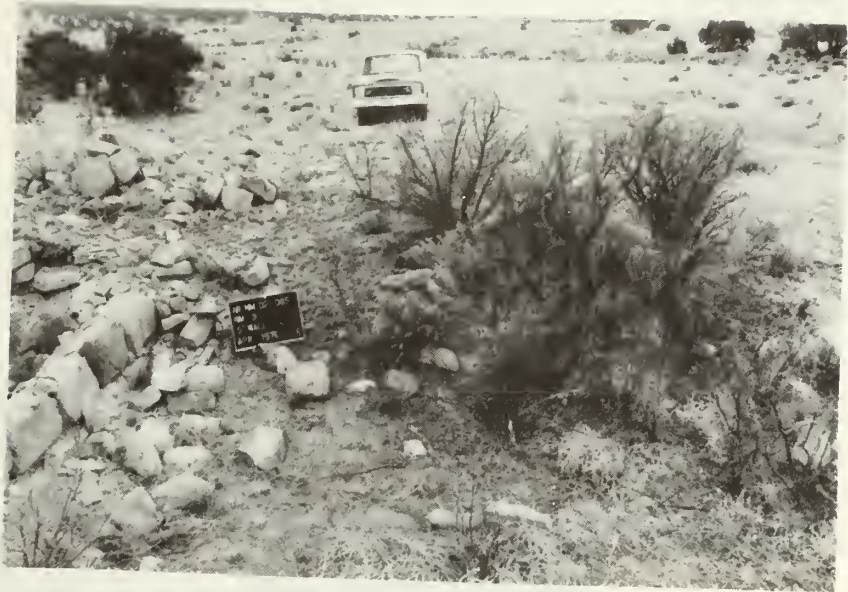
Room 3, south wall: before
stabilization

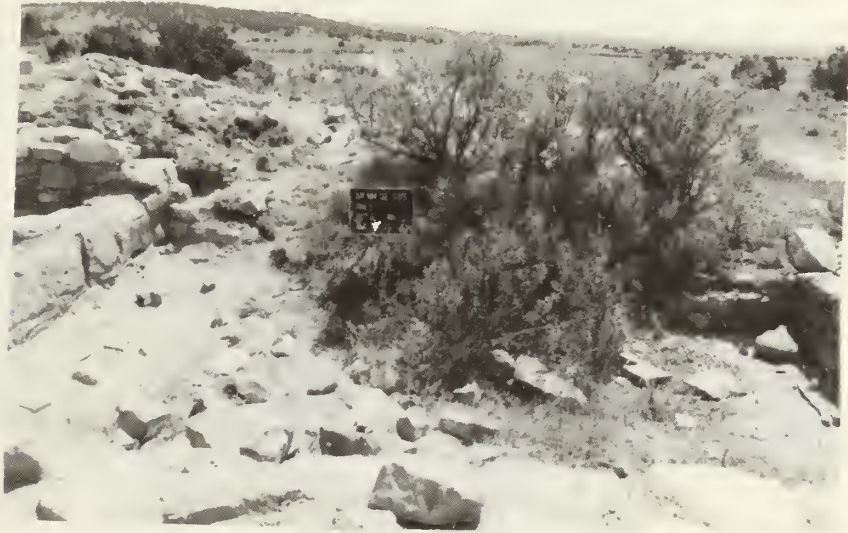
Room 3, south wall: after
stabilization

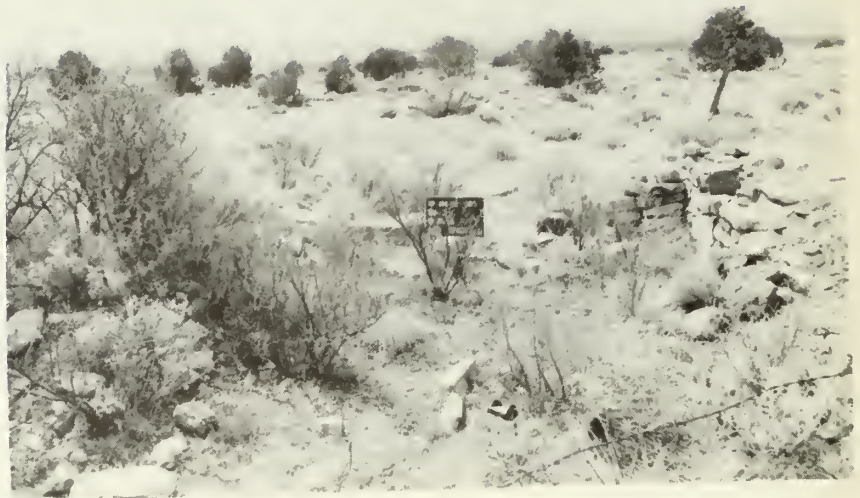
Room 3, west wall: before
stabilization

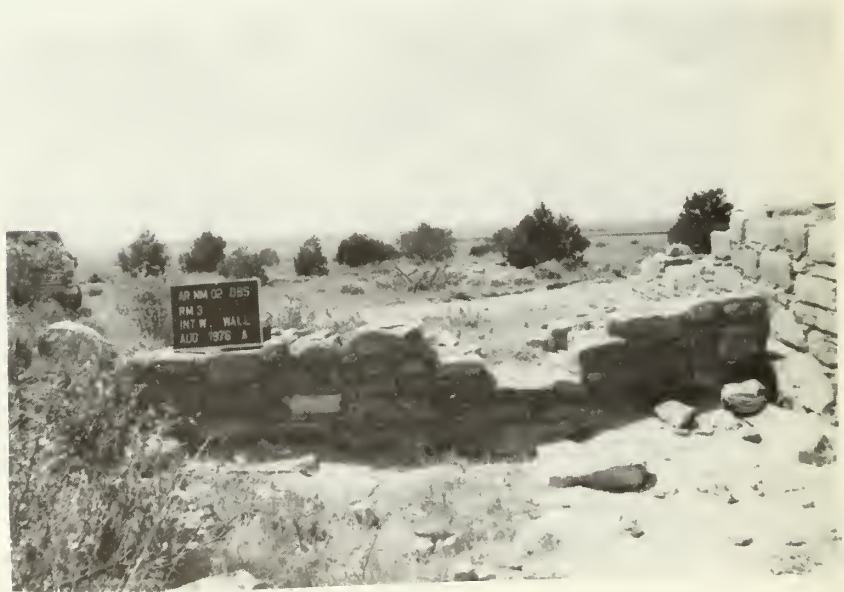
Room 3, west wall: after
stabilization

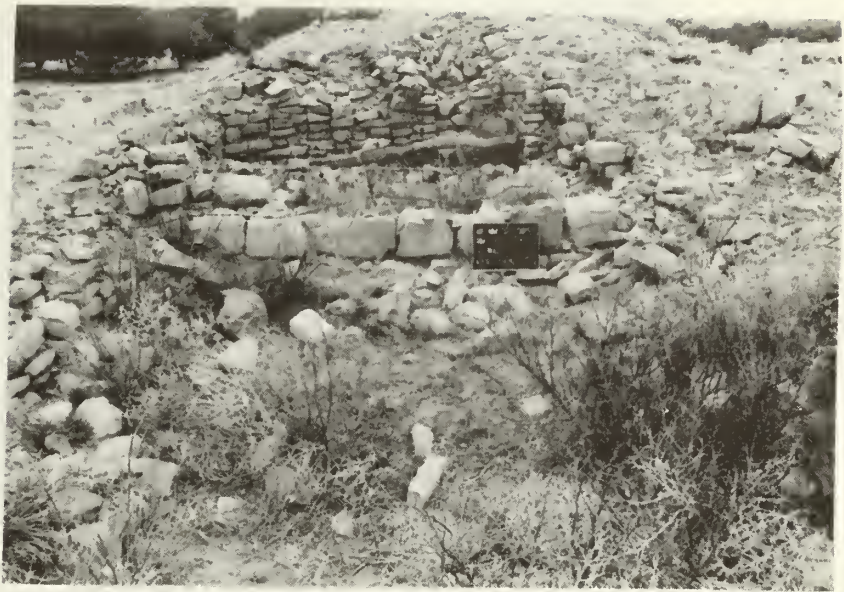
Room 3, east wall: before
stabilization

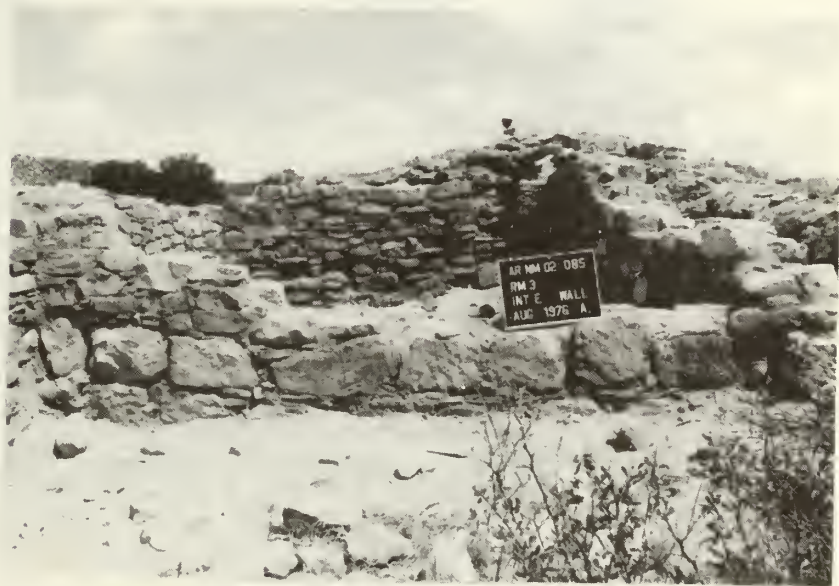
Room 3, east wall: after
stabilization

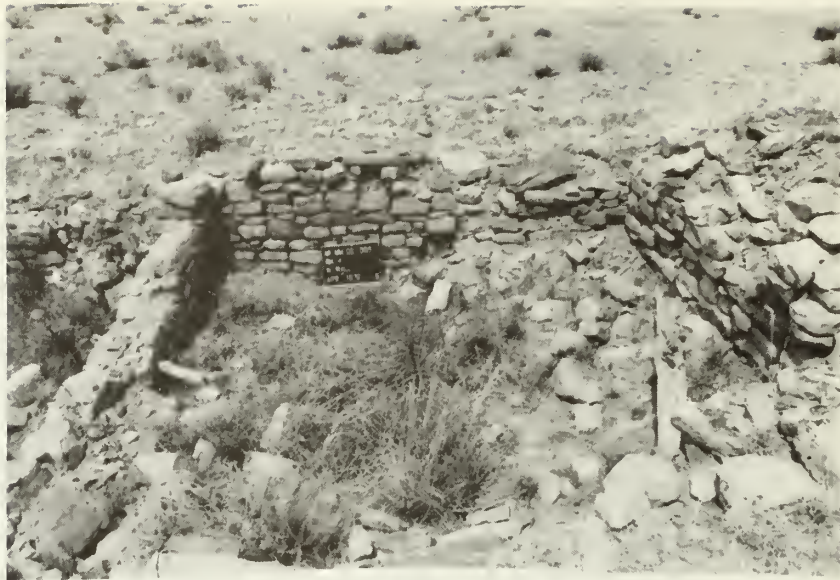
Room 4, north wall: before
stabilization

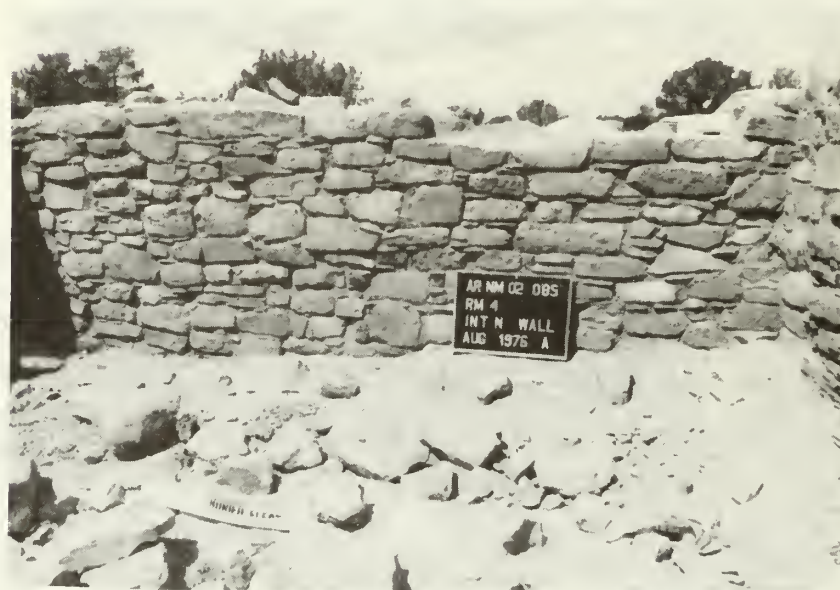
Room 4, north wall: after
stabilization

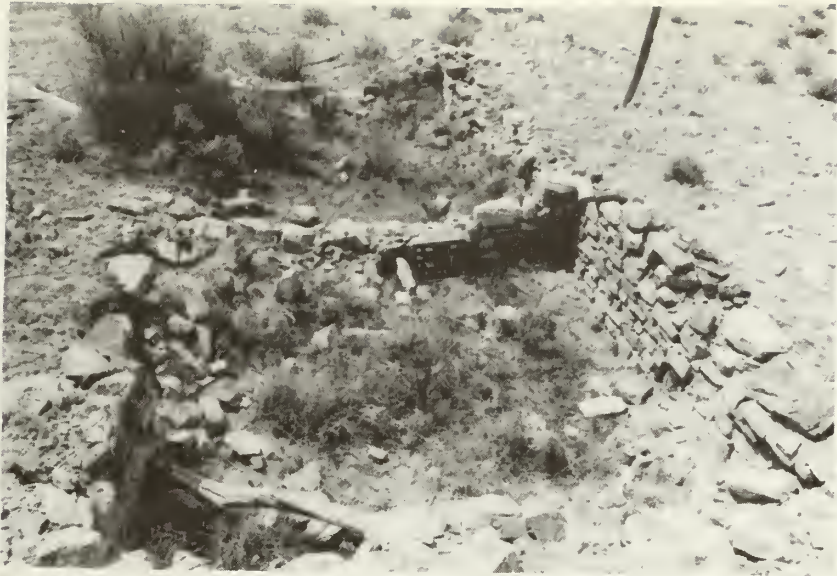
Room 4, west wall: before
stabilization

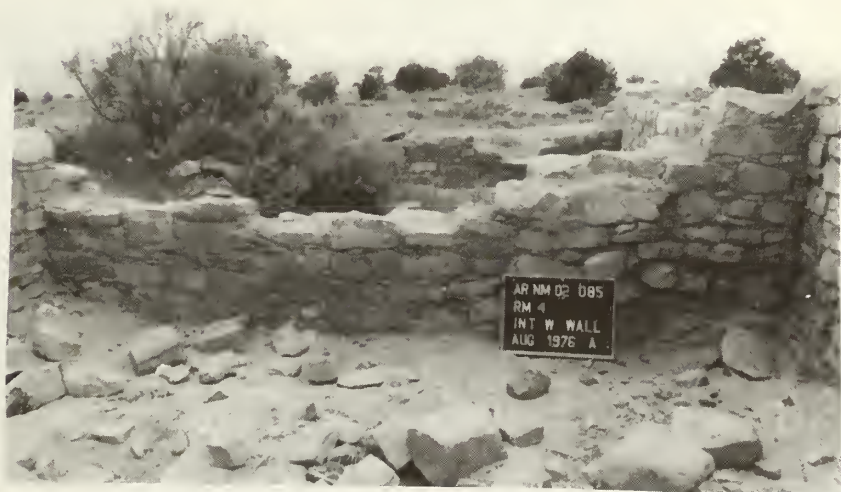
Room 4, west wall: after
stabilization

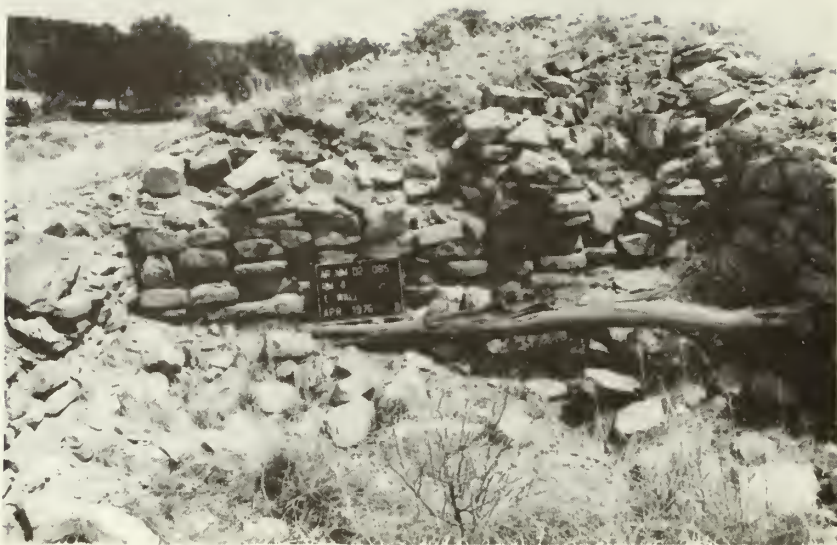
Room 4, east wall: before
stabilization

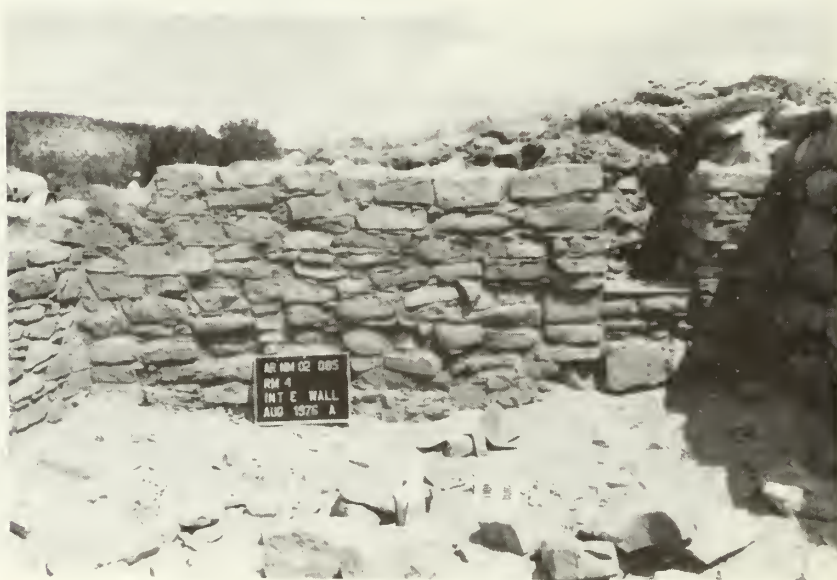
Room 4, east wall: after
stabilization.

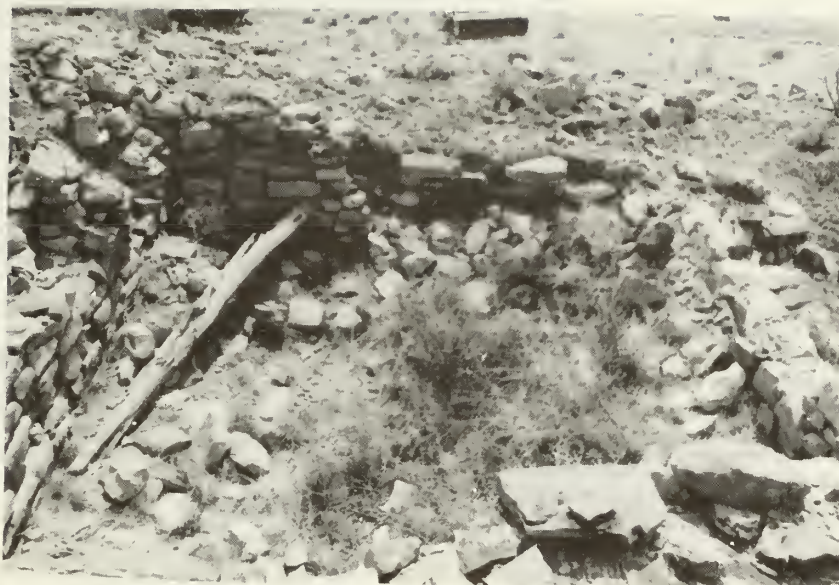
Room 4, south wall: before
stabilization

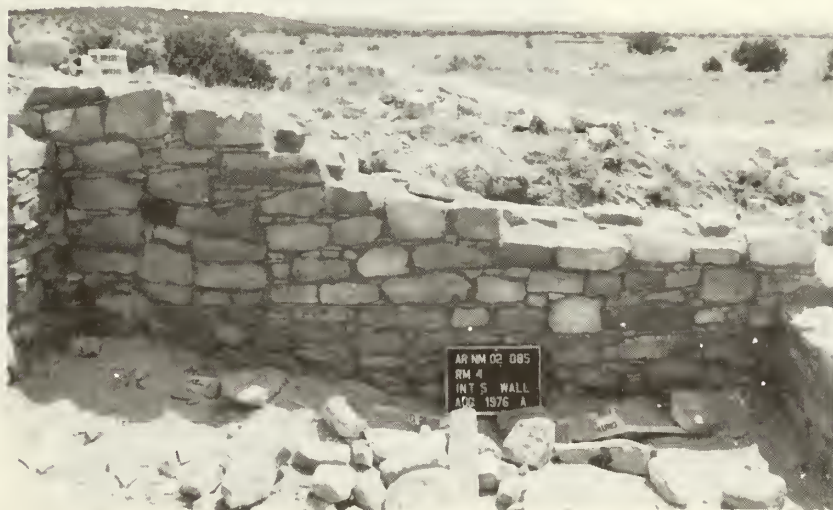
Room 4, south wall: after
stabilization

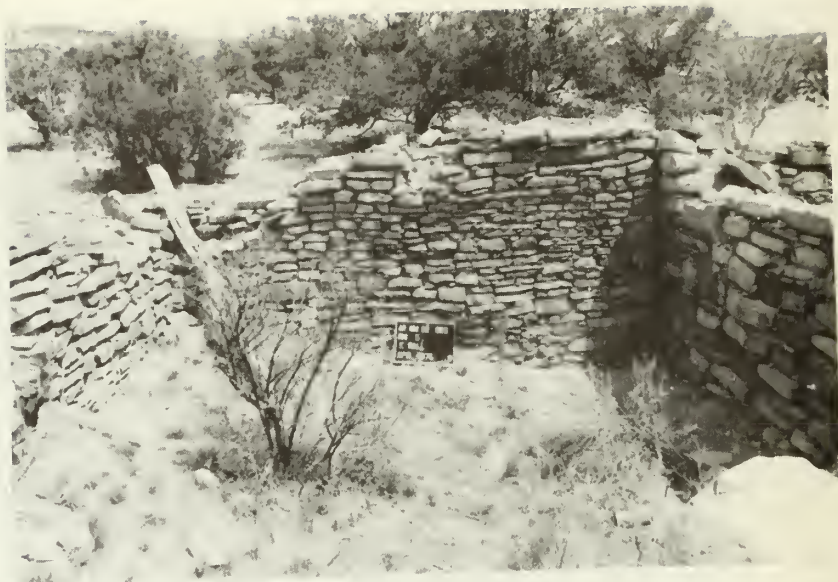
Room 5, east wall: before
stabilization

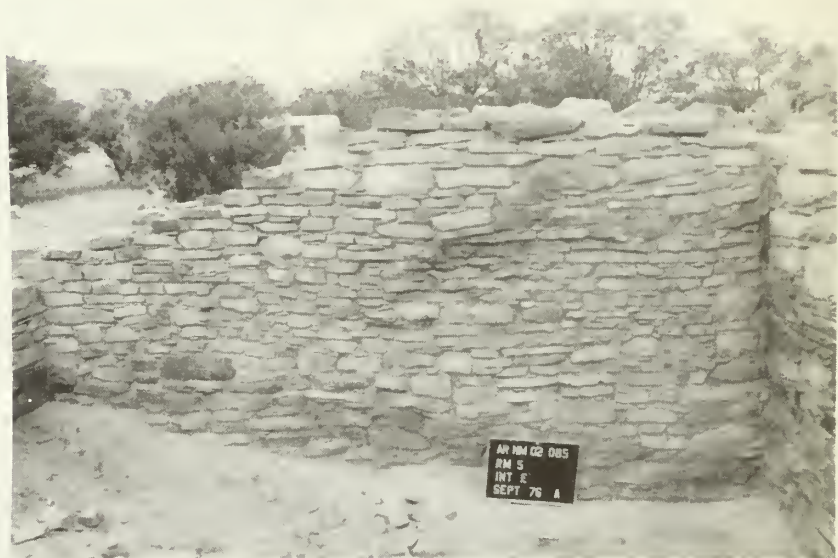
Room 5, east wall: after
stabilization

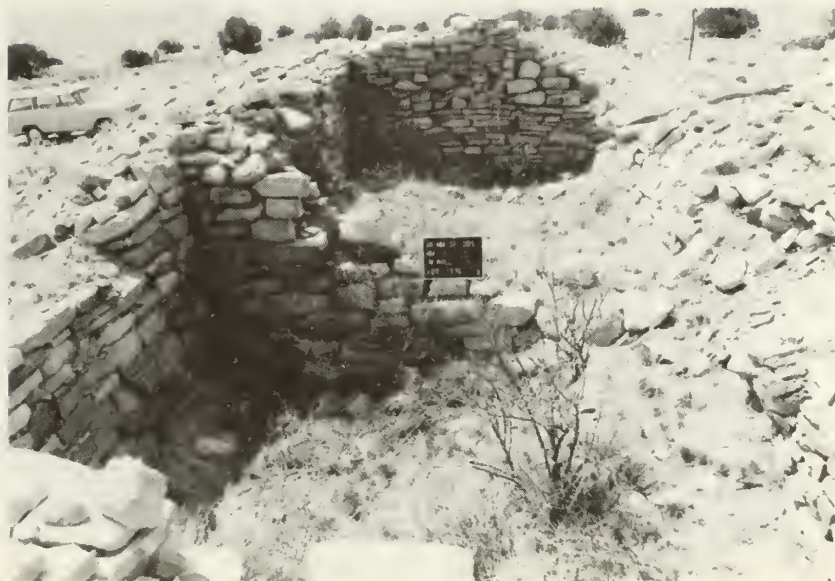
Room 5, west wall: before
stabilization

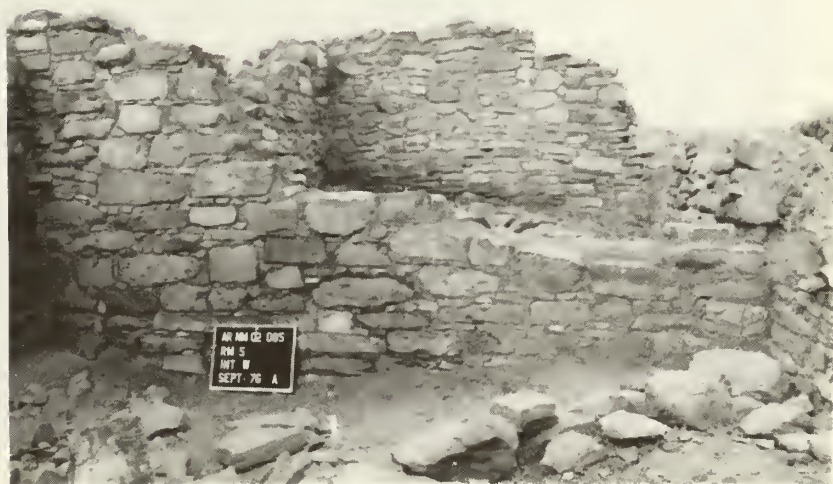
Room 5, west wall: after
stabilization

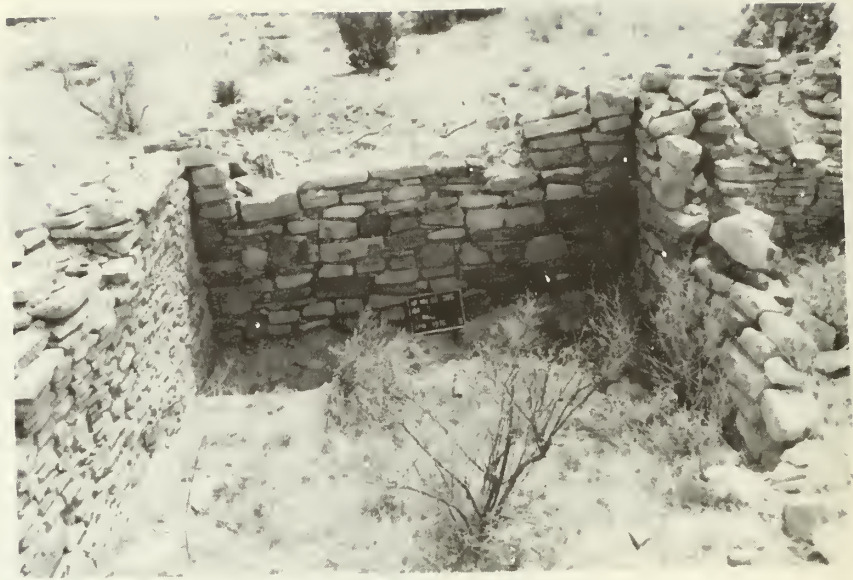
Room 5, south wall: before
stabilization

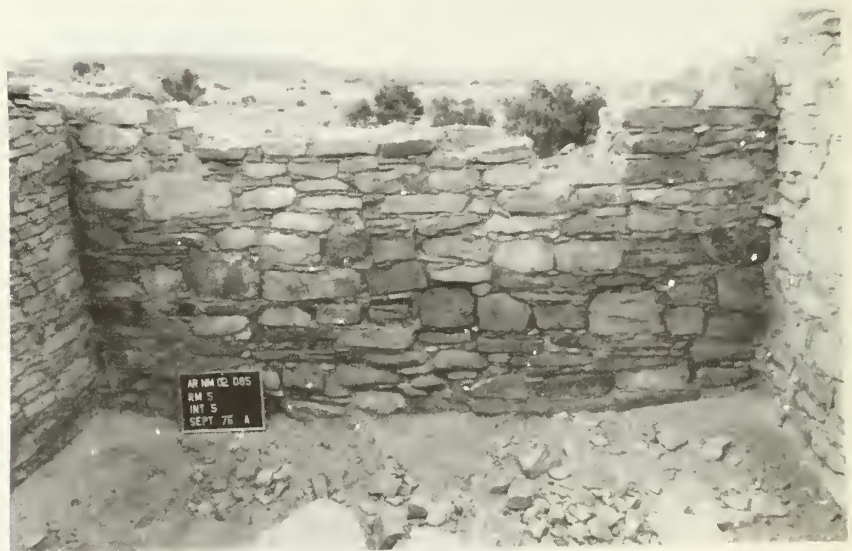
Room 5, south wall: after
stabilization

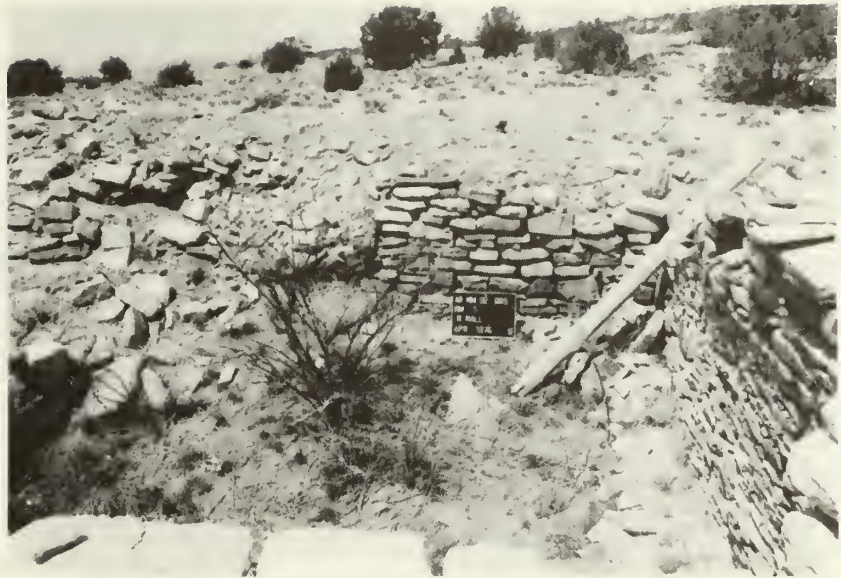
Room 5, north wall: before
stabilization

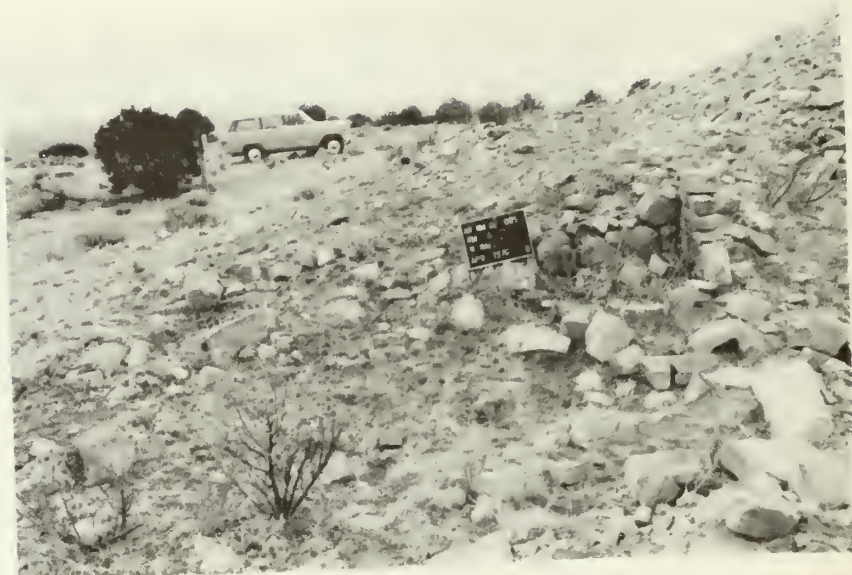
Room 6, west wall: before
stabilization

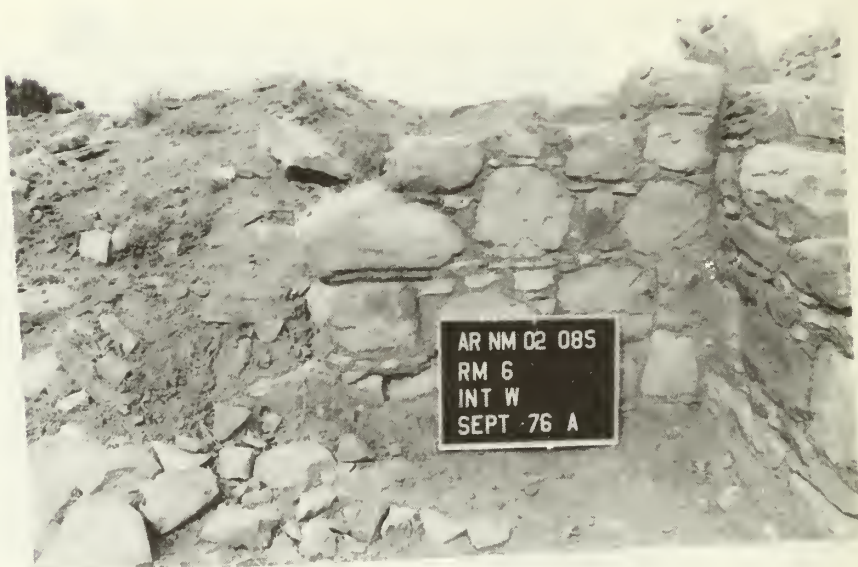
Room 6, west wall: after
stabilization

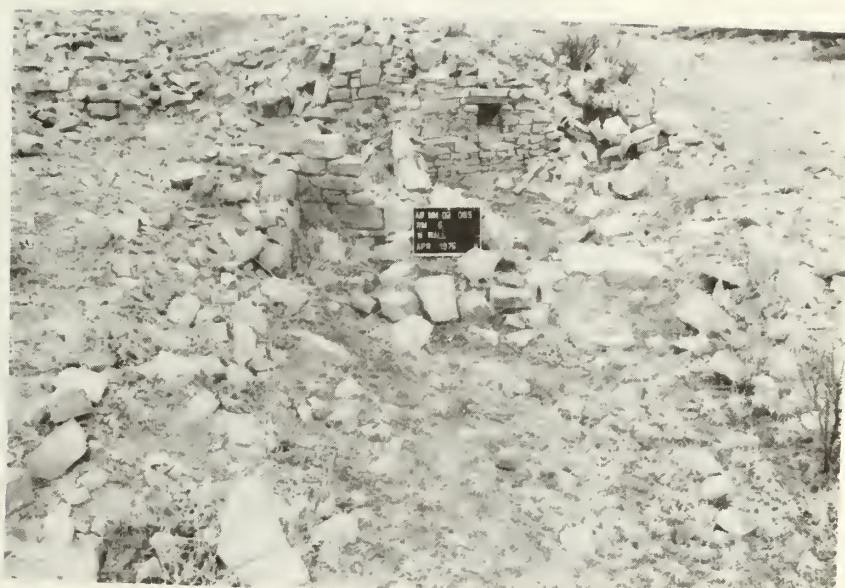
Room 6, north wall: before
stabilization

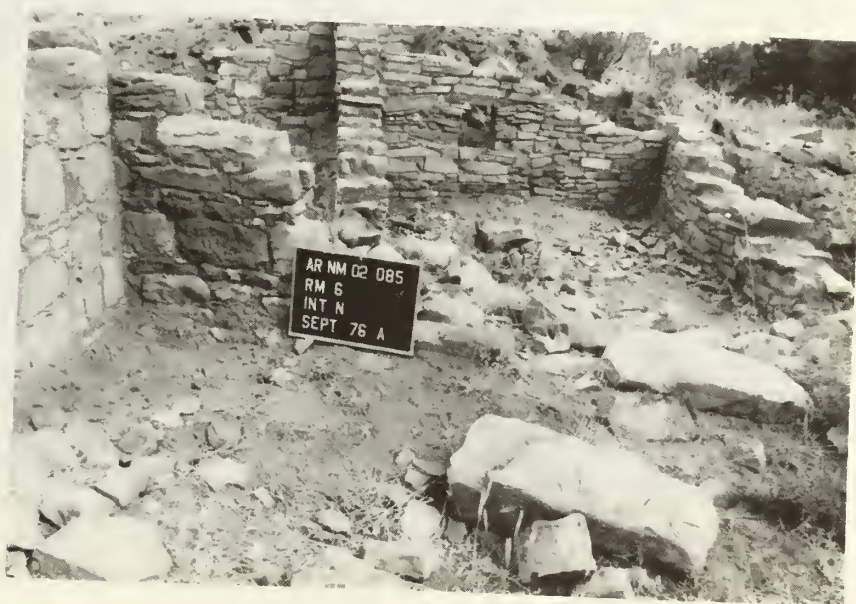
Room 6, north wall: after
stabilization

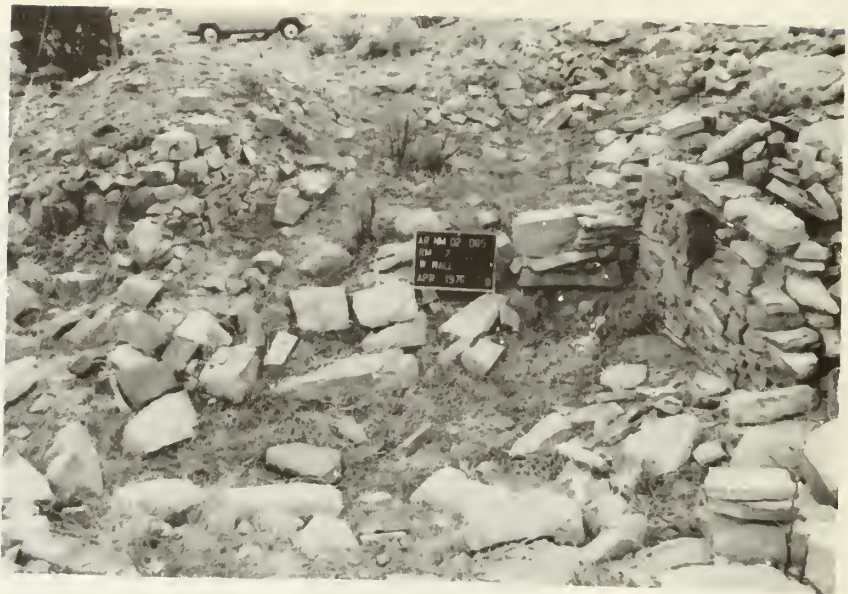
Room 7, west wall: before
stabilization

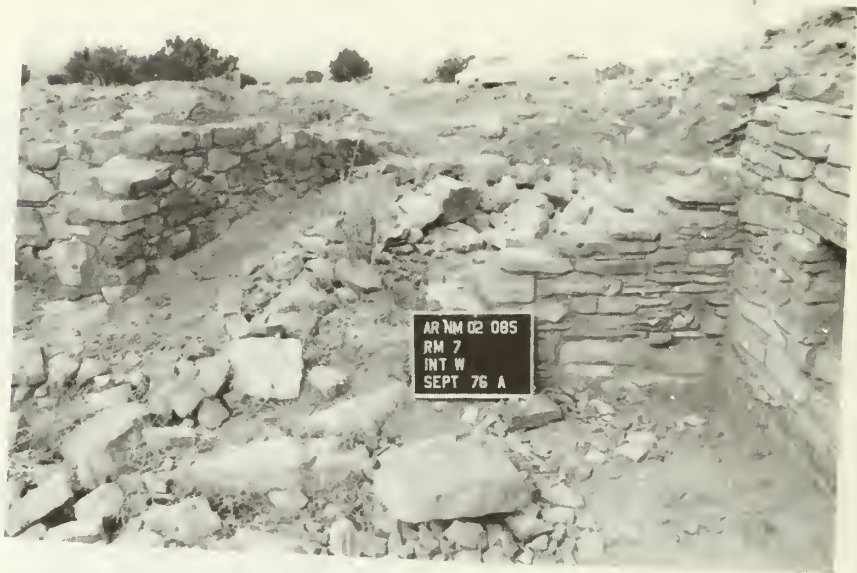
Room 7, west wall: after
stabilization

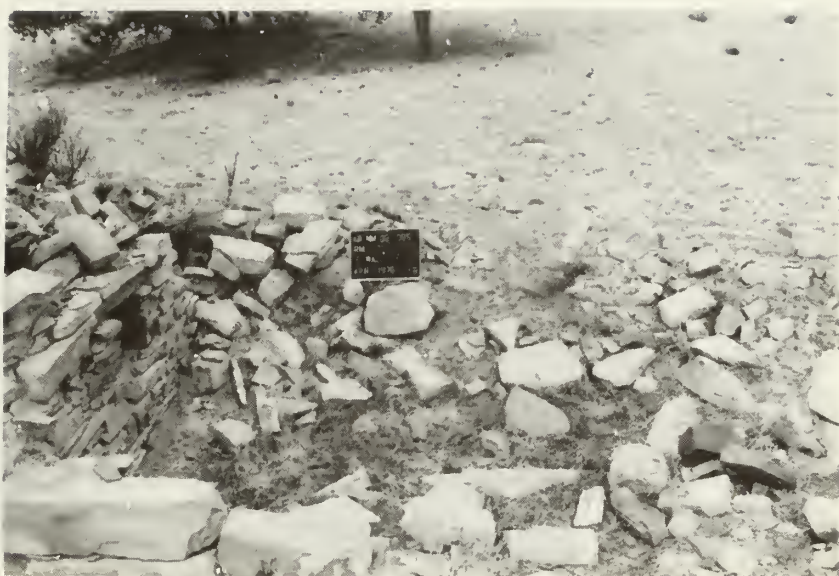
Room 7, east wall: before
stabilization

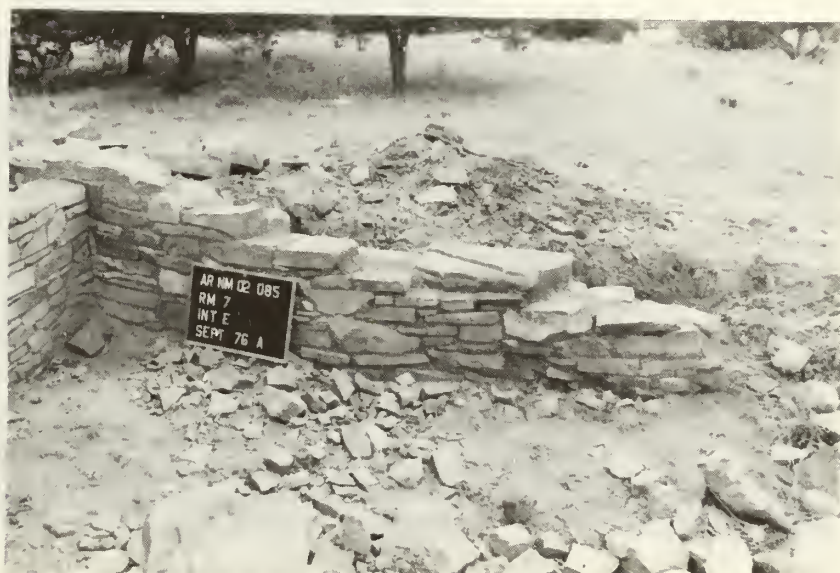
Room 7, east wall: after
stabilization

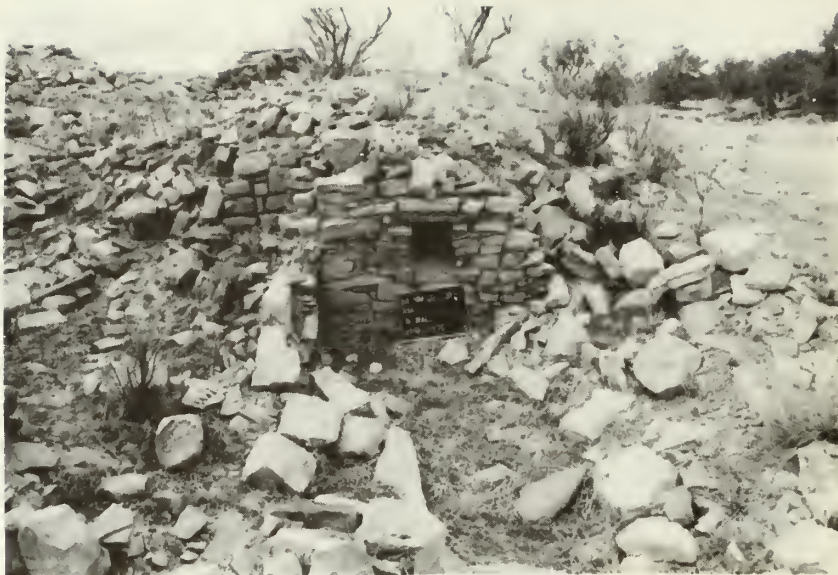
Room 7, north wall: before
stabilization

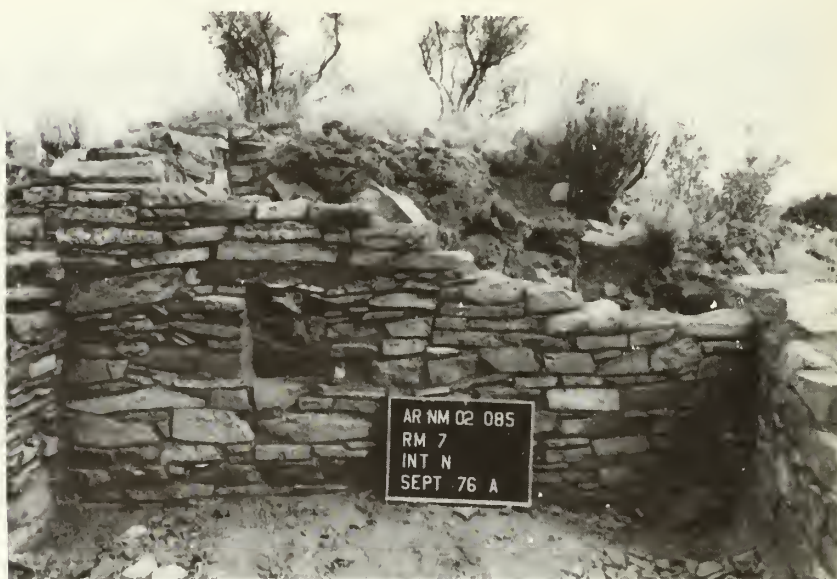
Room 7, north wall: after
stabilization

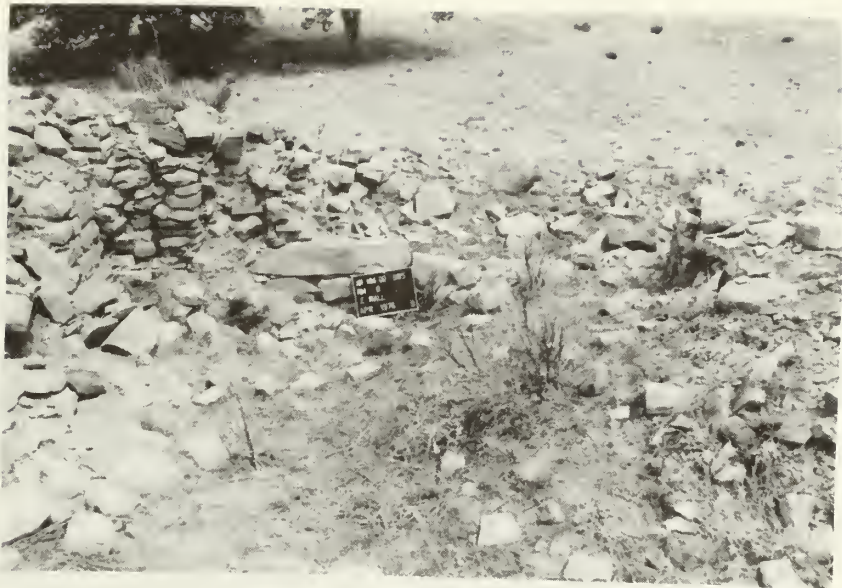
Room 8, east wall: before
stabilization

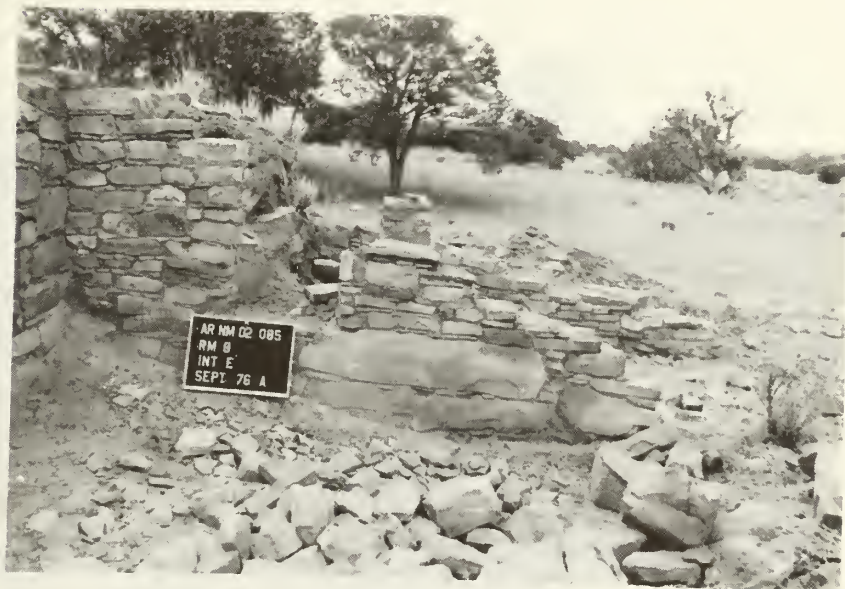
Room 8, east wall: after
stabilization

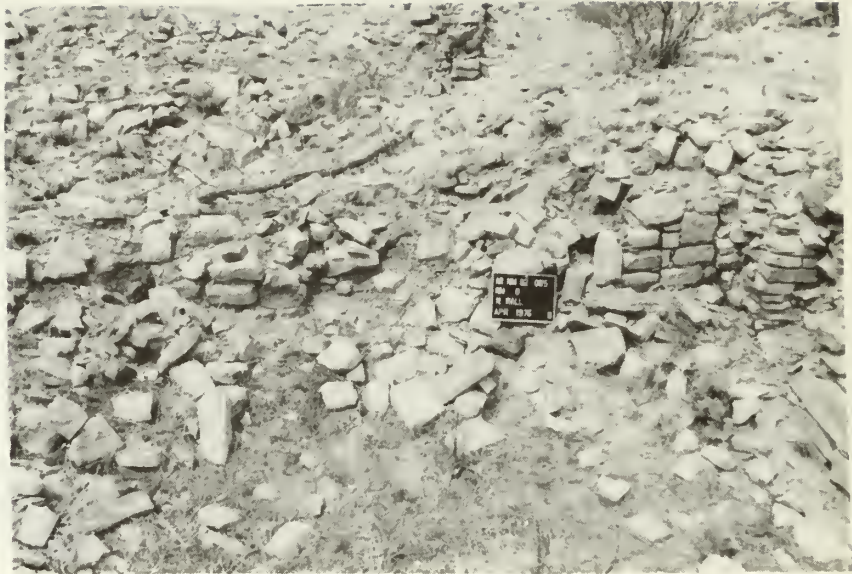
Room 8, north wall: before
stabilization
