PHYSICAL PROTECTION WORKBOOK

dittert site

SEPTEMBER, 1978

DITTERT SITE
(AR-NM-02-085)

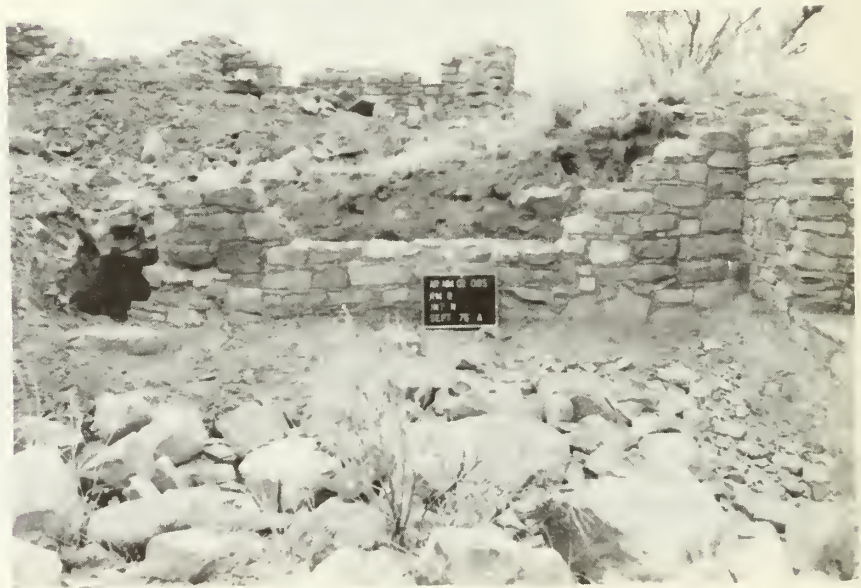
Room 8, north wall: after
stabilization

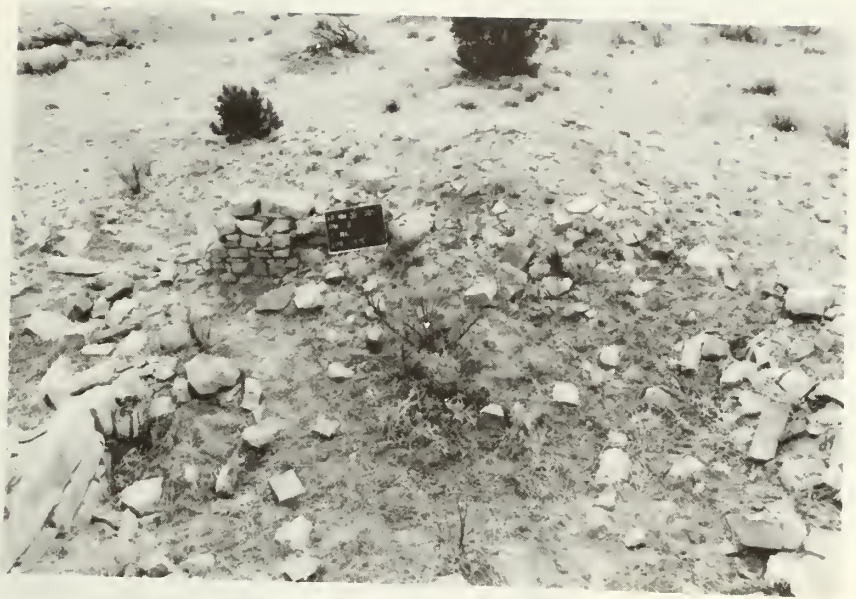
Room 8, south wall: before
stabilization

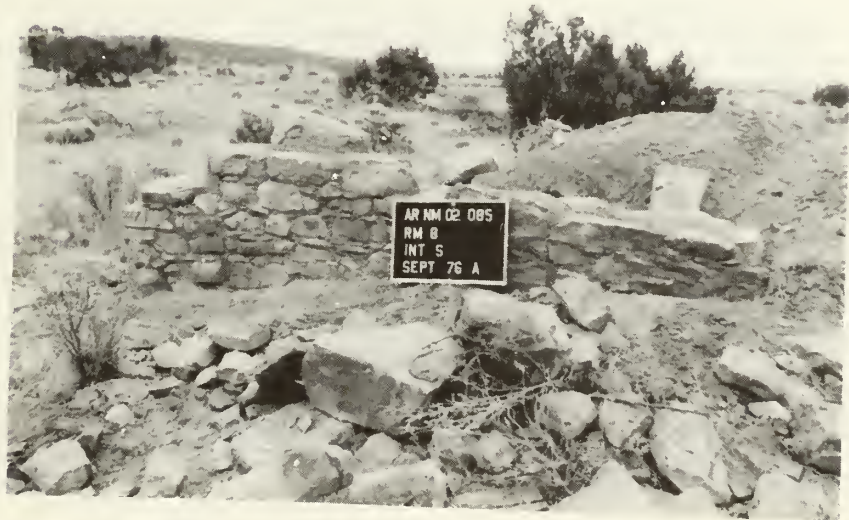
Room 8, south wall: after
stabilization

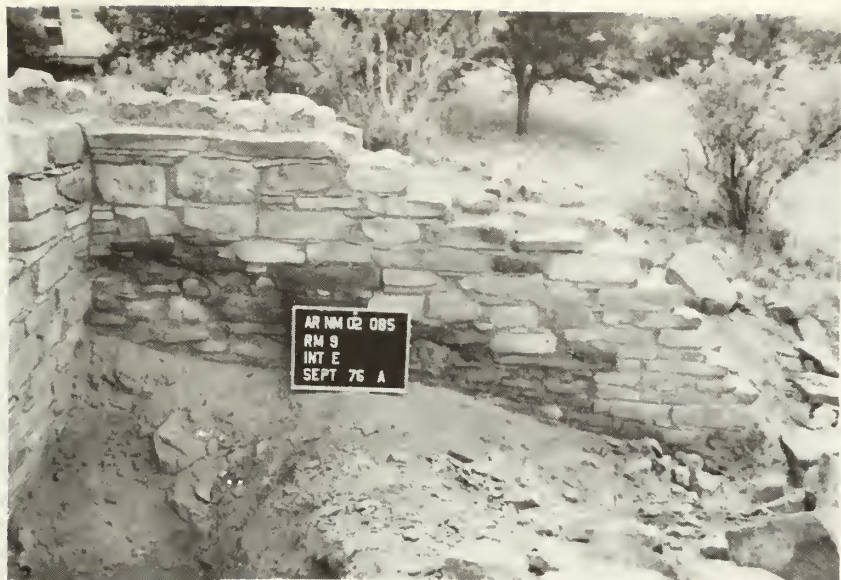
Room 9, east wall: after
stabilization

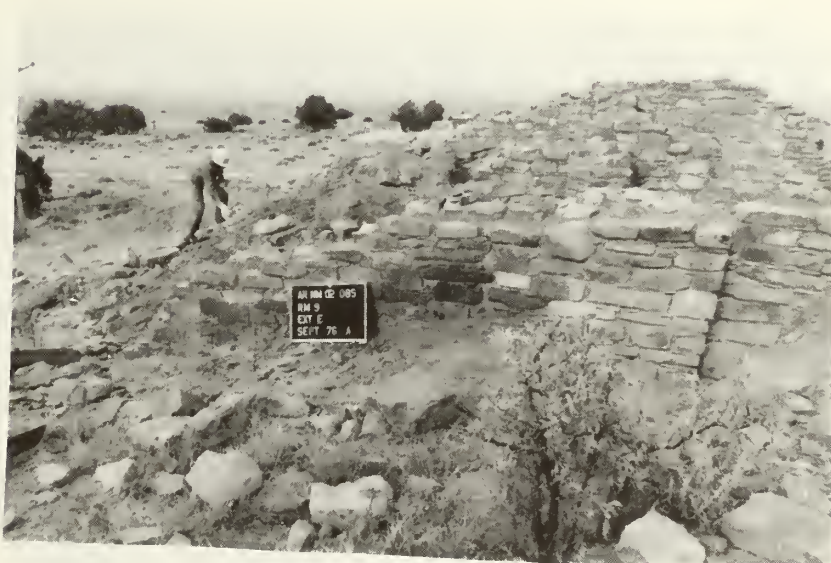
Room 9, exterior of east wall:
after stabilization

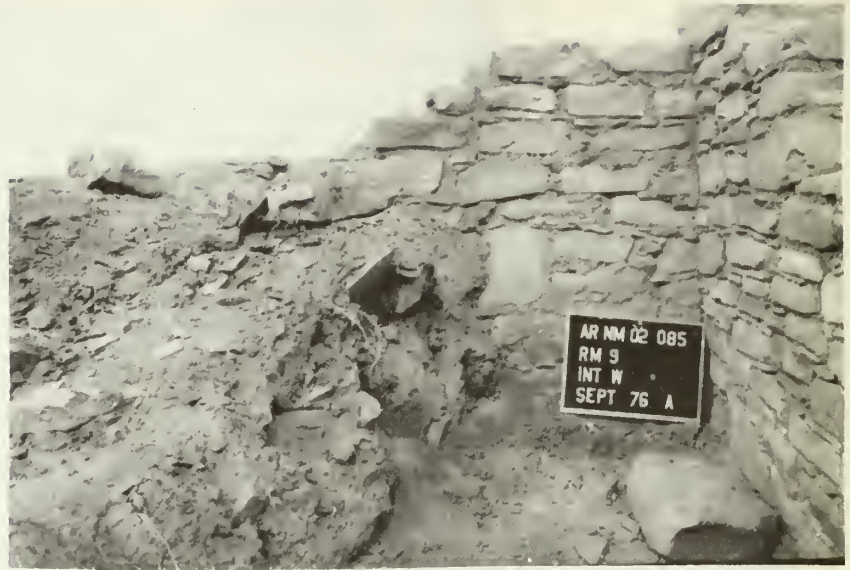
Room 9, west wall: after
stabilization

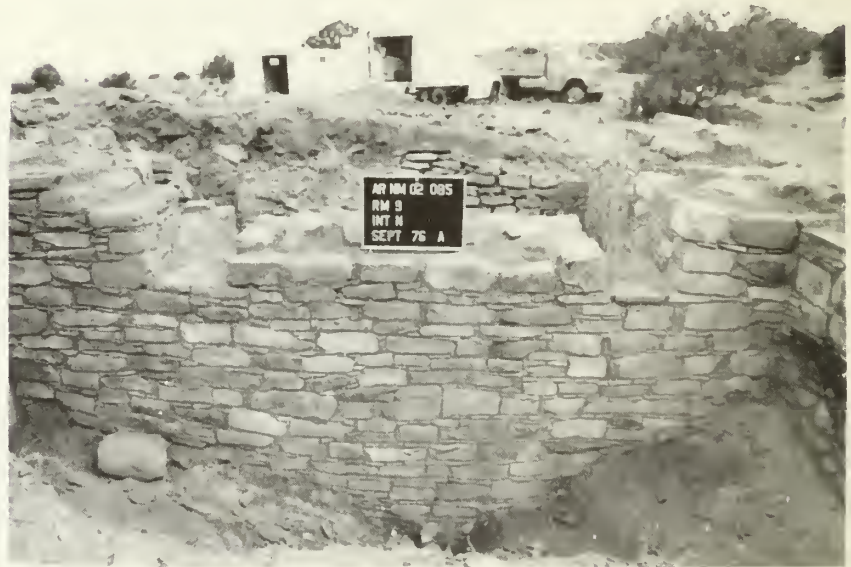
Room 9, north wall: after
stabilization

Photo shows two windows in the stabilized north wall. According to Dittert's notes, there were no windows in this wall, but there were two roof beam niches in the opposite side of the wall, 6" deep.

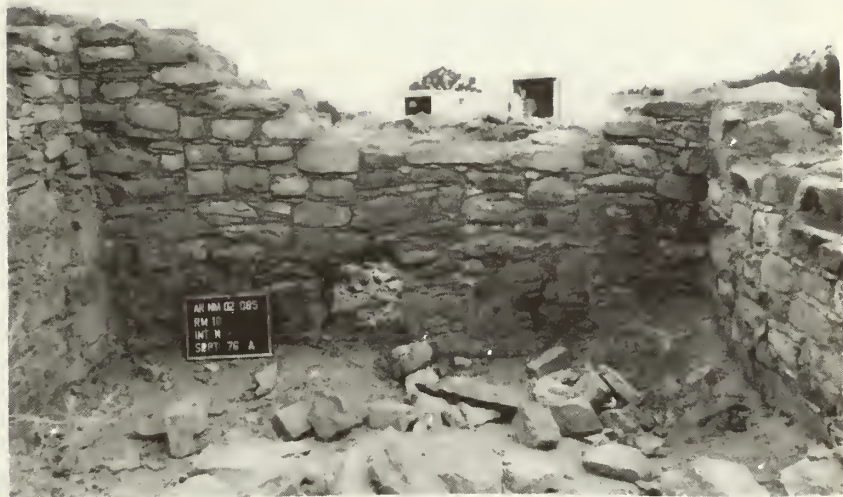
Room 10, north wall: after
stabilization

Note that plugged doorway in north
wall is somewhat obscured.

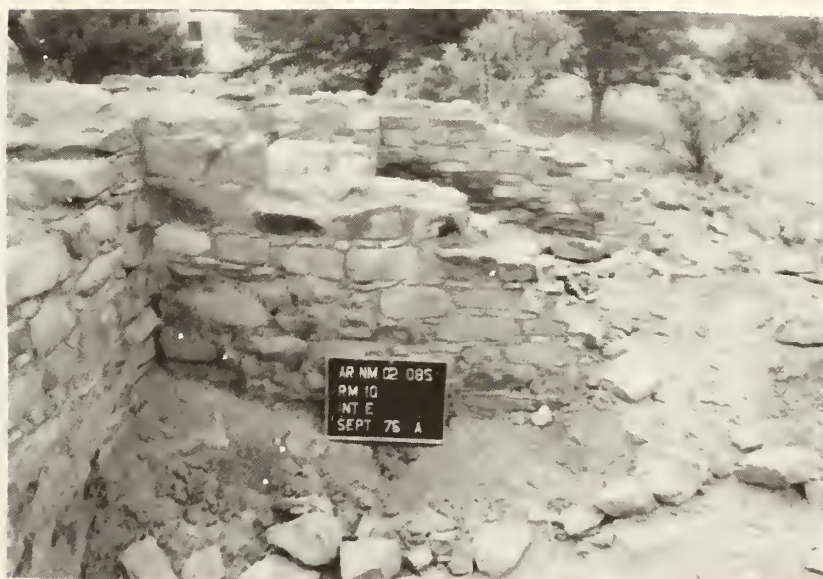
Room 10, east wall: after
stabilization

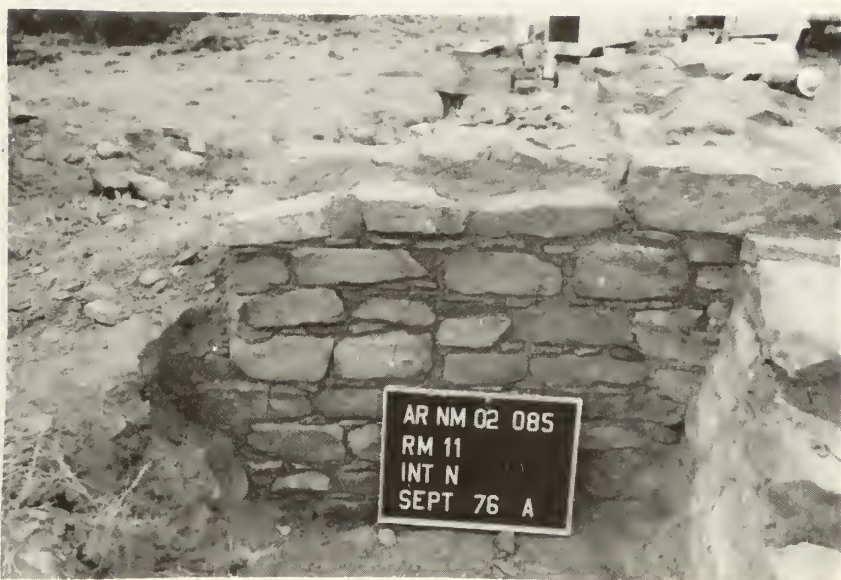
Room 11, north wall, after
stabilization

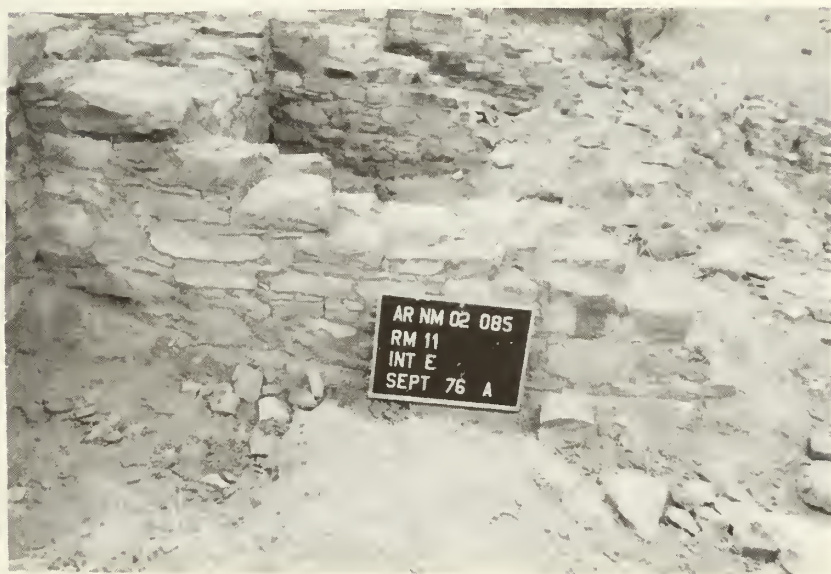
Room 11, east wall: after
stabilization

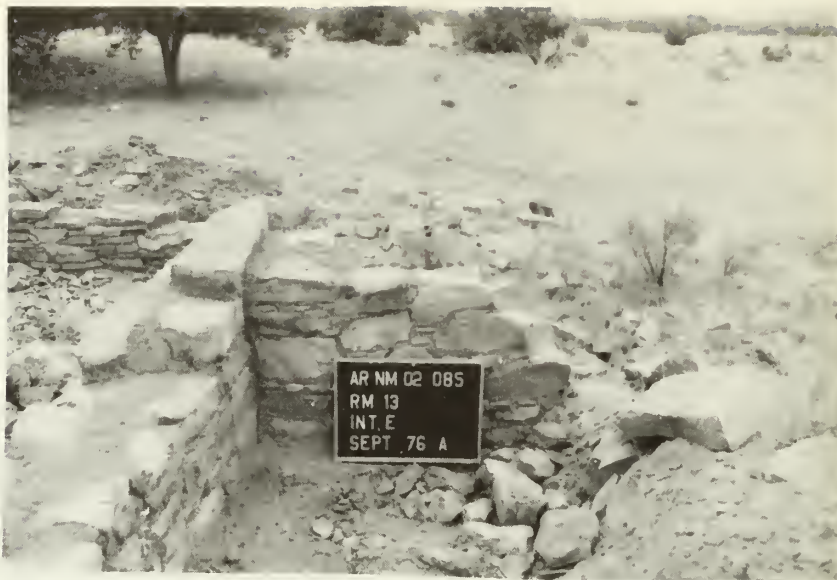
Room 13, east wall: after
stabilization

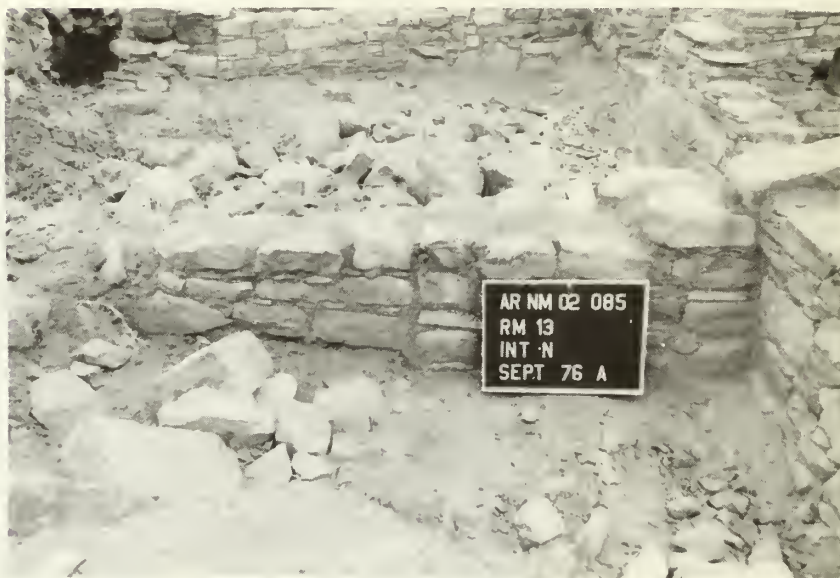
Room 13, north wall: after
stabilization

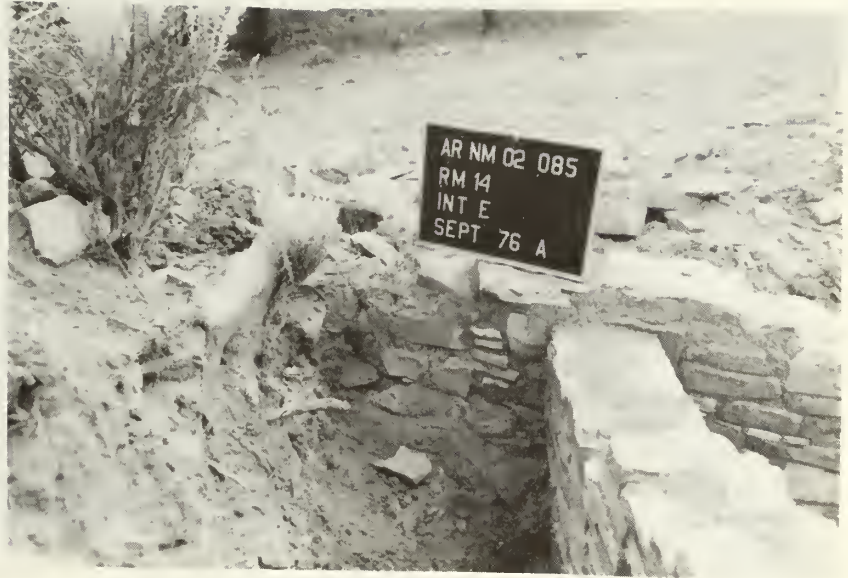
Room 14, east wall: after
stabilization

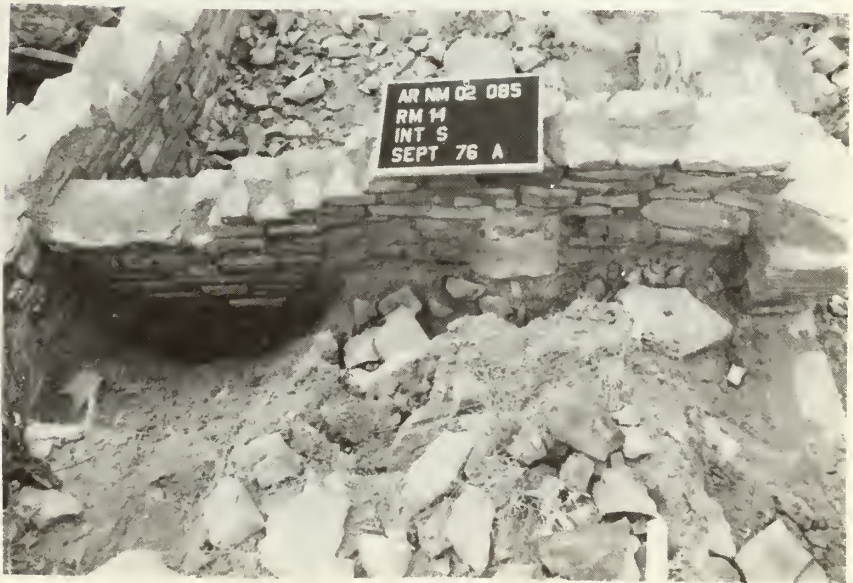
Room 14, south wall: after
stabilization

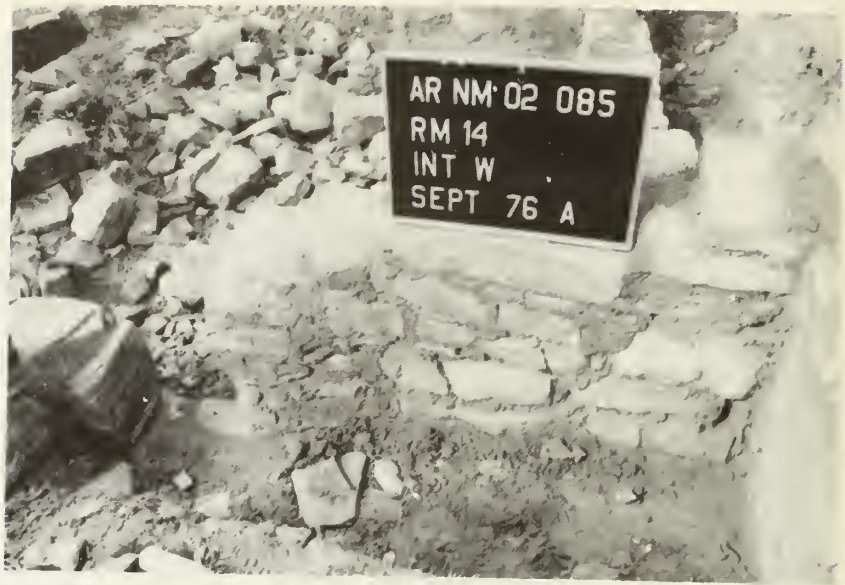
Room 14, west wall: after
stabilization

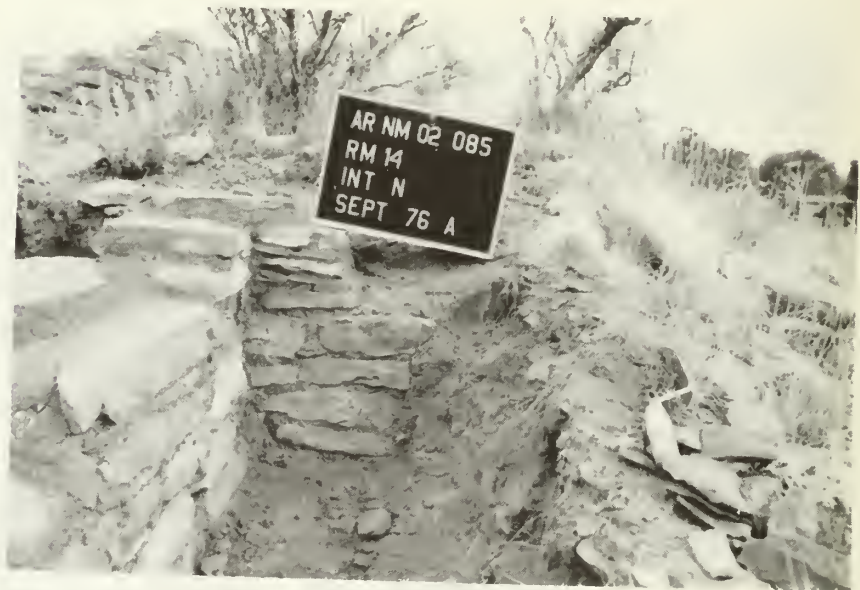
Room 14, north wall: after
stabilization

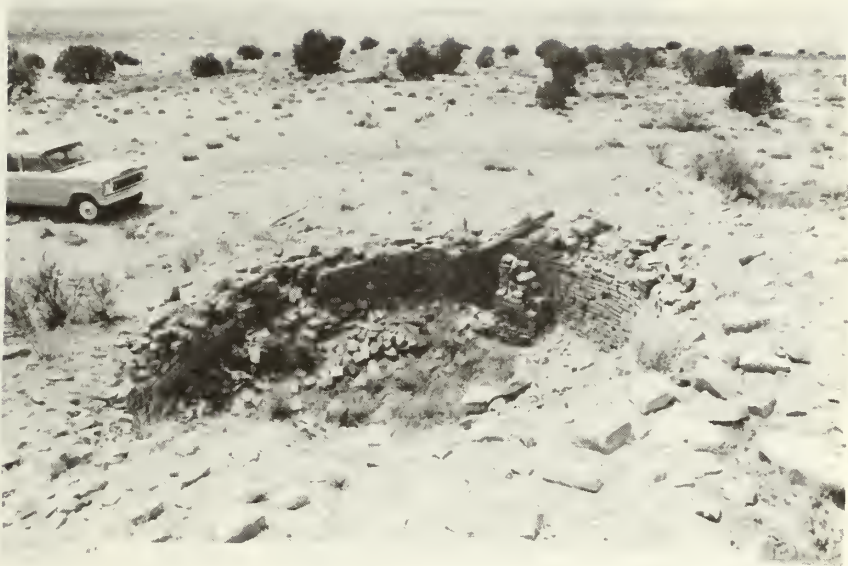
Kiva, west wall: before
stabilization

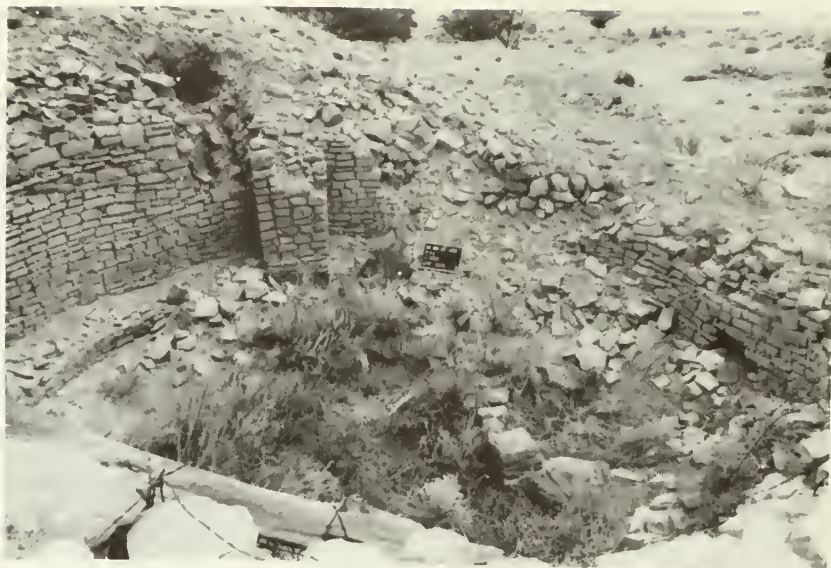
Kiva, east wall: before
stabilization

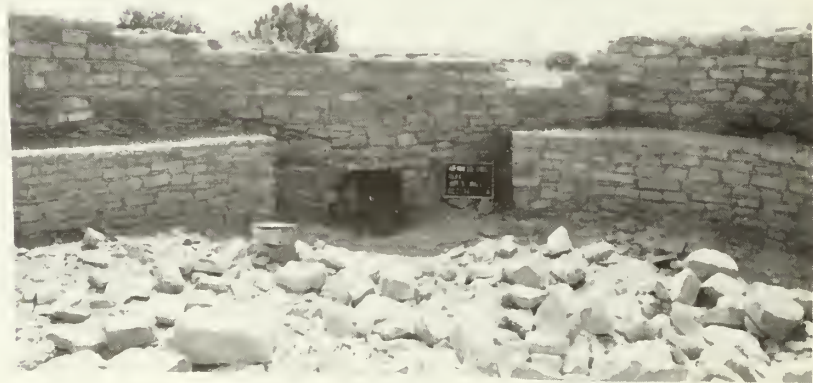
Kiva, south wall: after
stabilization

Wall collapse to right of photo
board is location of kiva window.
The location and orientation of
window are crucial data for archaeo-
astronomy studies.
