# NATIONAL TRANSPORTATION SAFETY BOARD

REAR-END COLLISION OF  
AMTRAK PASSENGER TRAIN 94, THE COLONIAL  
AND CONSOLIDATED RAIL CORPORATION  
FREIGHT TRAIN ENS-121,  
ON THE NORTHEAST CORRIDOR  
CHASE, MARYLAND  
JANUARY 4, 1987

NTSB/RAR-88/01

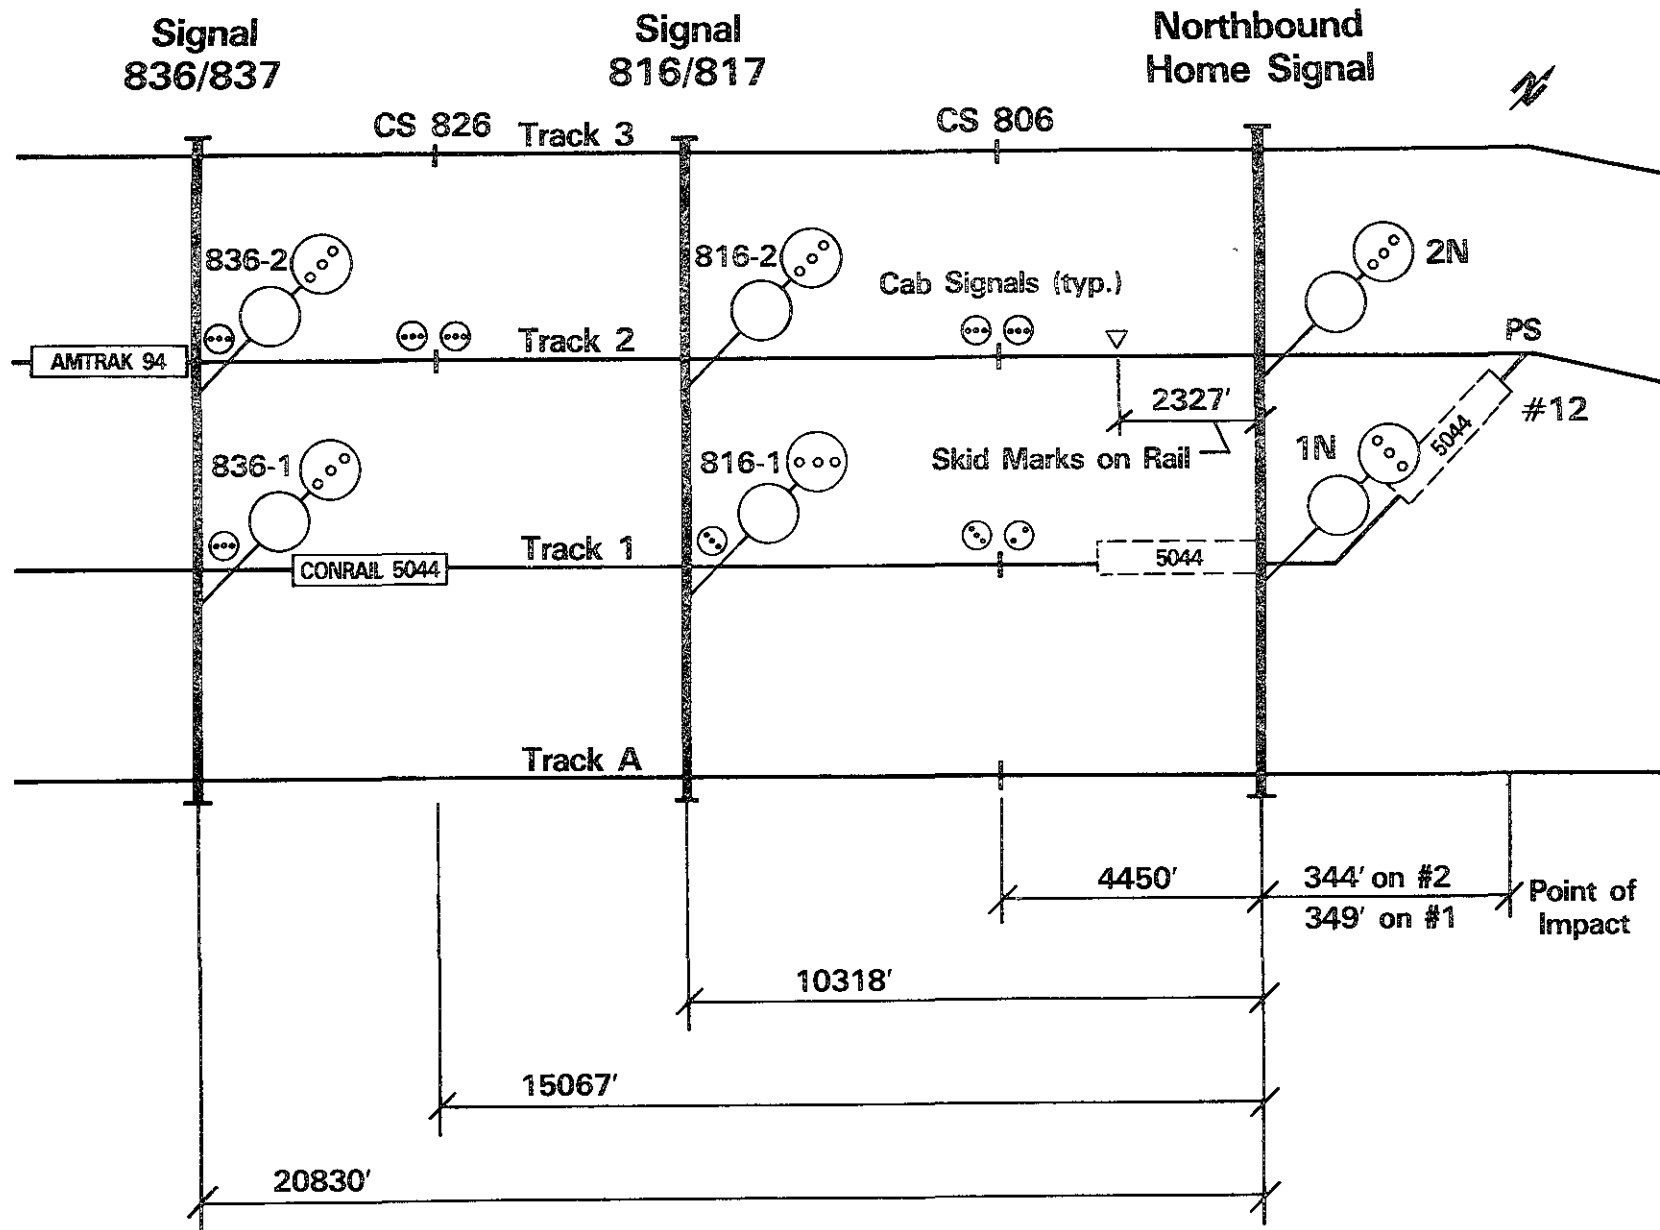
Figure 2. Plan view of the track layout and signals of Gunpow interlocking.

Leaving Bay View, train ENS-121 was routed over Amtrak's main track 1 for the 12.2 miles to Gunpow, a remote-controlled interlocking south of the Gunpowder River where the four-tracked NEC converged to the two tracks on the bridge spanning the river (see figure 2). Gunpow marked the north end of track 1, where it converged with the adjacent track 2 by what Amtrak identified as switch 12.

The Amtrak dispatcher had given precedence to trains 94 and 112 over Conrail train ENS-121 north of Gunpow. As a result, the block station operator at Edgewood requested the automatic setting up of a route for train 94 through Gunpow interlocking by way of track 2. 2/ This process involved clearing the northbound home signal 3/ for track 2 at Gunpow. Because of safeguards built into the system, the home signal would not display a "clear" aspect until all switches along the route were properly positioned. According to the operator, switch 12, connecting track 1 to track 2, was already aligned for through movement on track 2 (see figure 2).

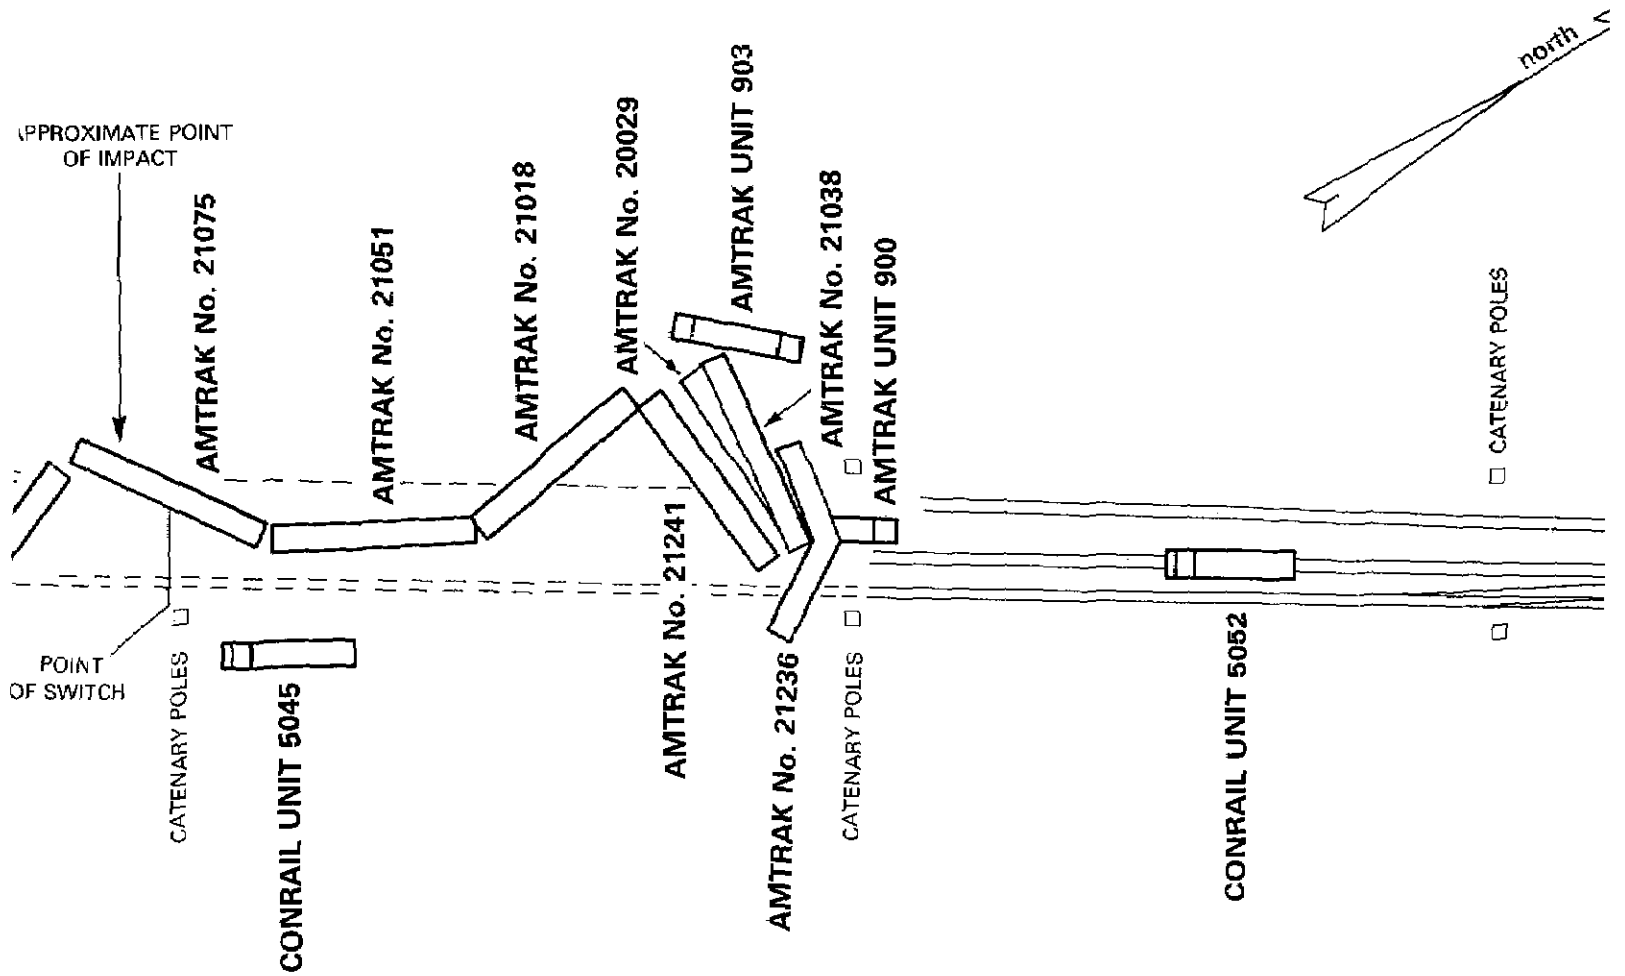
# "GUNPOW" INTERLOCKING WRECKAGE DISTRIBUTION PLAN CHASE, MARYLAND

The rear Conrail unit was virtually disintegrated with parts scattered across the tracks and property east of the tracks. The largest piece of wreckage came to rest about 150 feet northeast of the collision point. The rear of the middle Conrail unit was crushed by the rear unit. Uncoupled from the lead unit, it was propelled forward on track 2 for about 700 feet. Only the rear truck of this unit derailed. The lead Conrail unit sustained relatively superficial damage, although driven forward about 900 feet, it was the only piece of equipment in the two trains that was not derailed.

The forward cab and superstructure of the lead Amtrak locomotive unit was crushed downward and inward to the underframe. Separated from the trucks, the remains of the car body came to rest west of the tracks about 400 feet north of the collision point. The trailing Amtrak unit remained in line with the track, although separated from its trucks, and came to rest leaning about 45° to the right at a point about 450 feet north of the collision point (see figure 3).

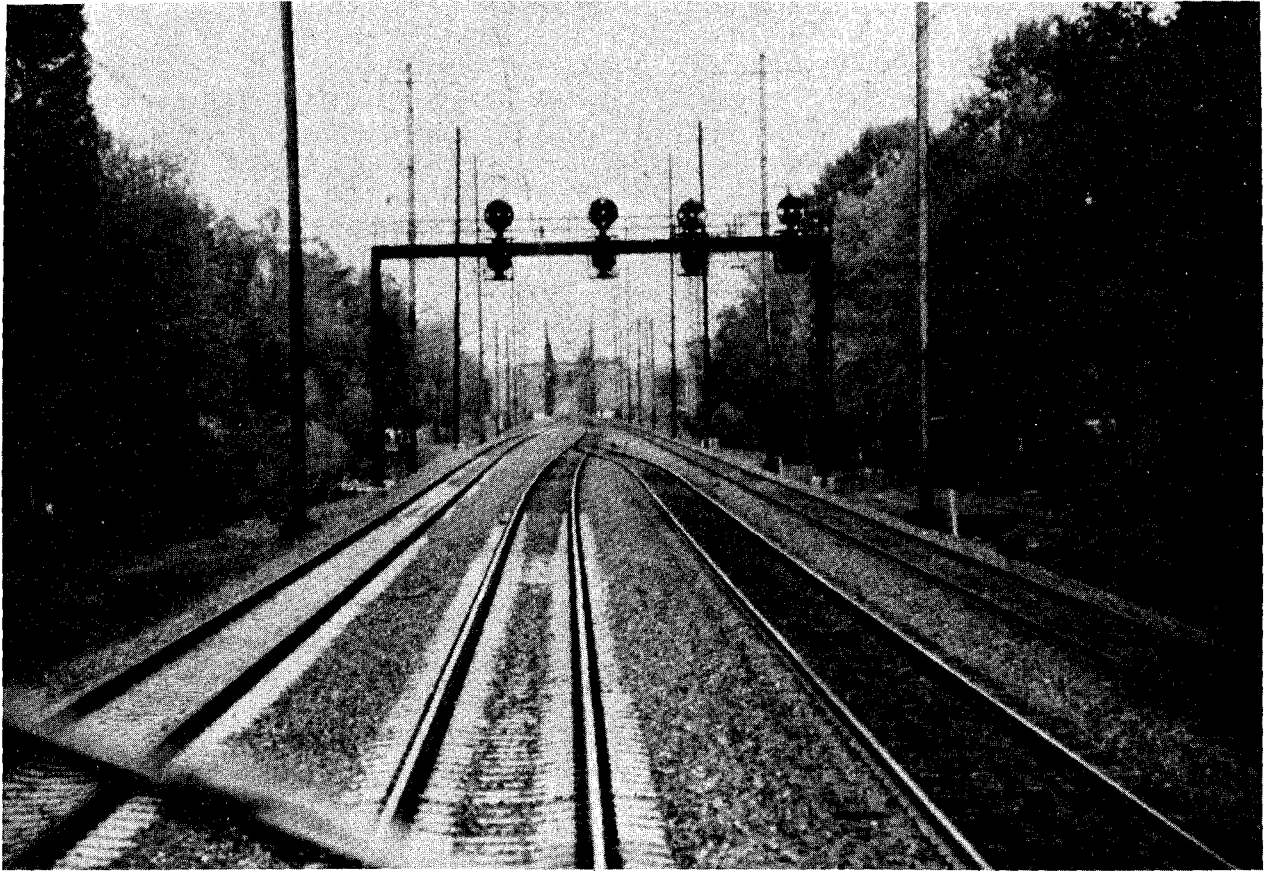
Figure 6. The northbound home signals at Gunpow as viewed from a northbound train moving at 125 mph on track 2. The aspect displayed for the train by signal 2N is "clear;" those displayed for the other tracks are "stop." From left to right, the tracks are 3, 2, 1, and A.

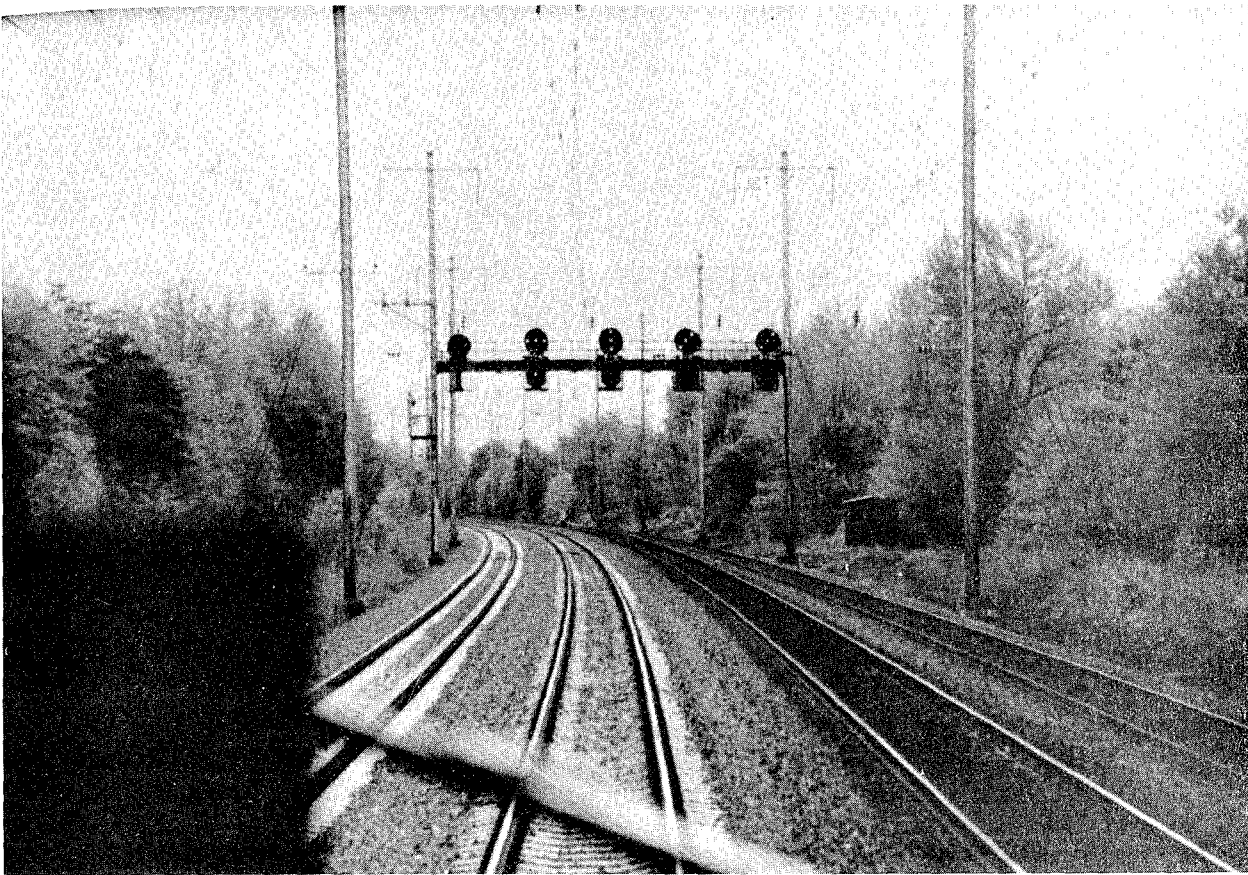
Figure 7. Distant signal 816/817 located 10,318 feet south of the home signals at Gunpow, as viewed from a northbound train moving at 125 mph on track 2. The aspect displayed for the train by signal 816-2 is "clear;" the aspects displayed for track 1 and track A to the right are "approach." A stop aspect is displayed for track 3 because the track is set up for a southbound train.

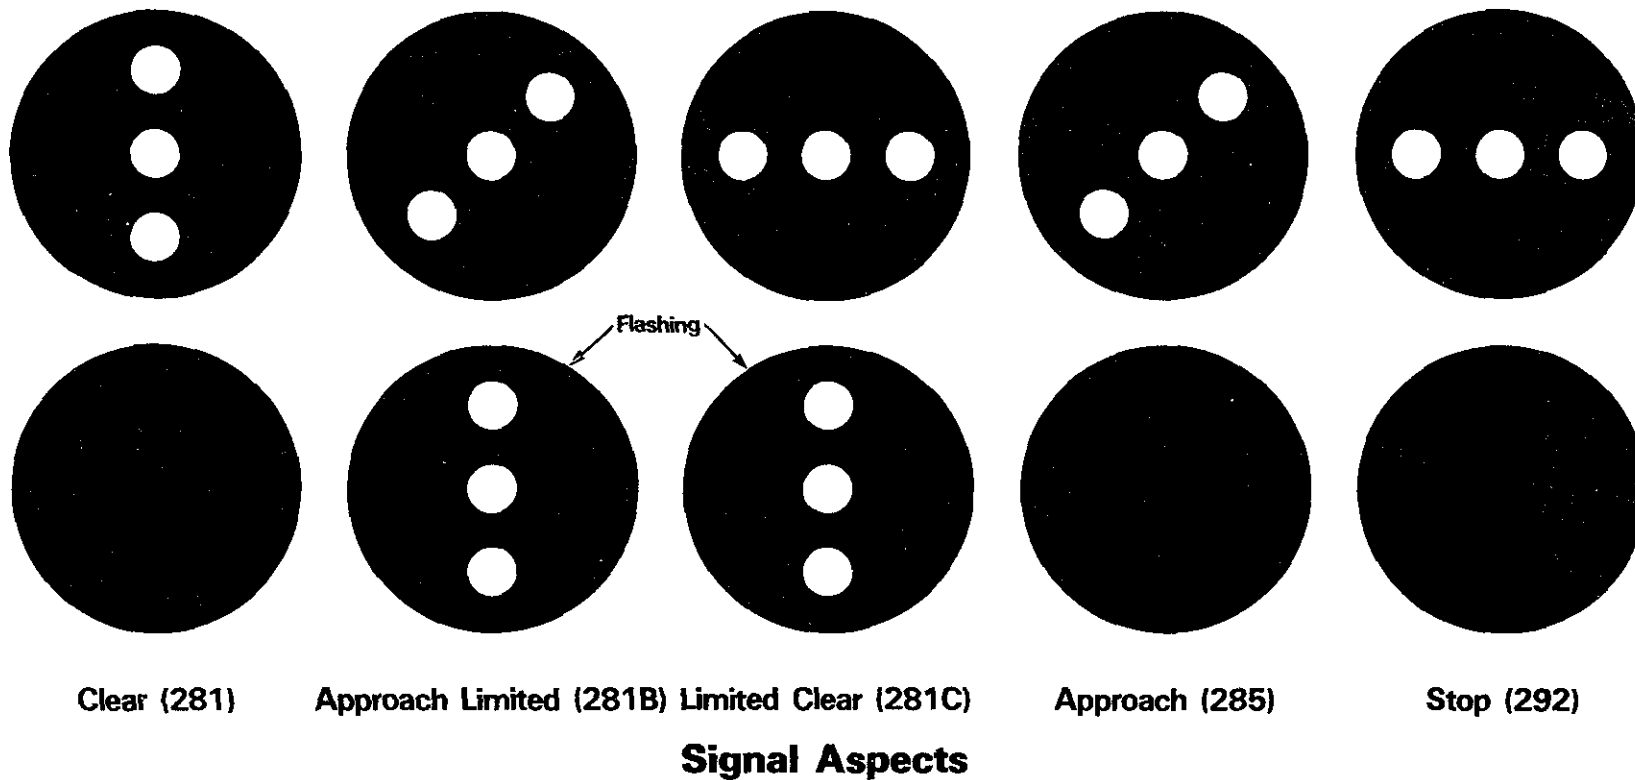
Home signal 2N for track 2 at Gunpow had a top aspect with seven lights arranged to display vertical, horizontal, and diagonal configurations. The bottom aspect had five lights and could display vertical and diagonal configurations. Home signal 1N had three lights in the top aspect arranged horizontally. The five-light bottom aspect was the same as signal 2N. Signal 816-2, the approach signal for track 2, had a seven-light top aspect identical to signal 2N and a vertical three-light bottom aspect. Signal 816-1, the distant signal on track 1, also had a vertical three-light lower aspect, but its upper aspect had five lights arranged horizontally and diagonally (see figure 8). (Appendix C also provides more details on the signal aspects.)

Figure 8. Aspects that could be displayed by home signals 1N and 2N and distant signals 816-1 and 816-2 at Gunpow. (The numbers in parentheses refer to the relevant operating rules.)

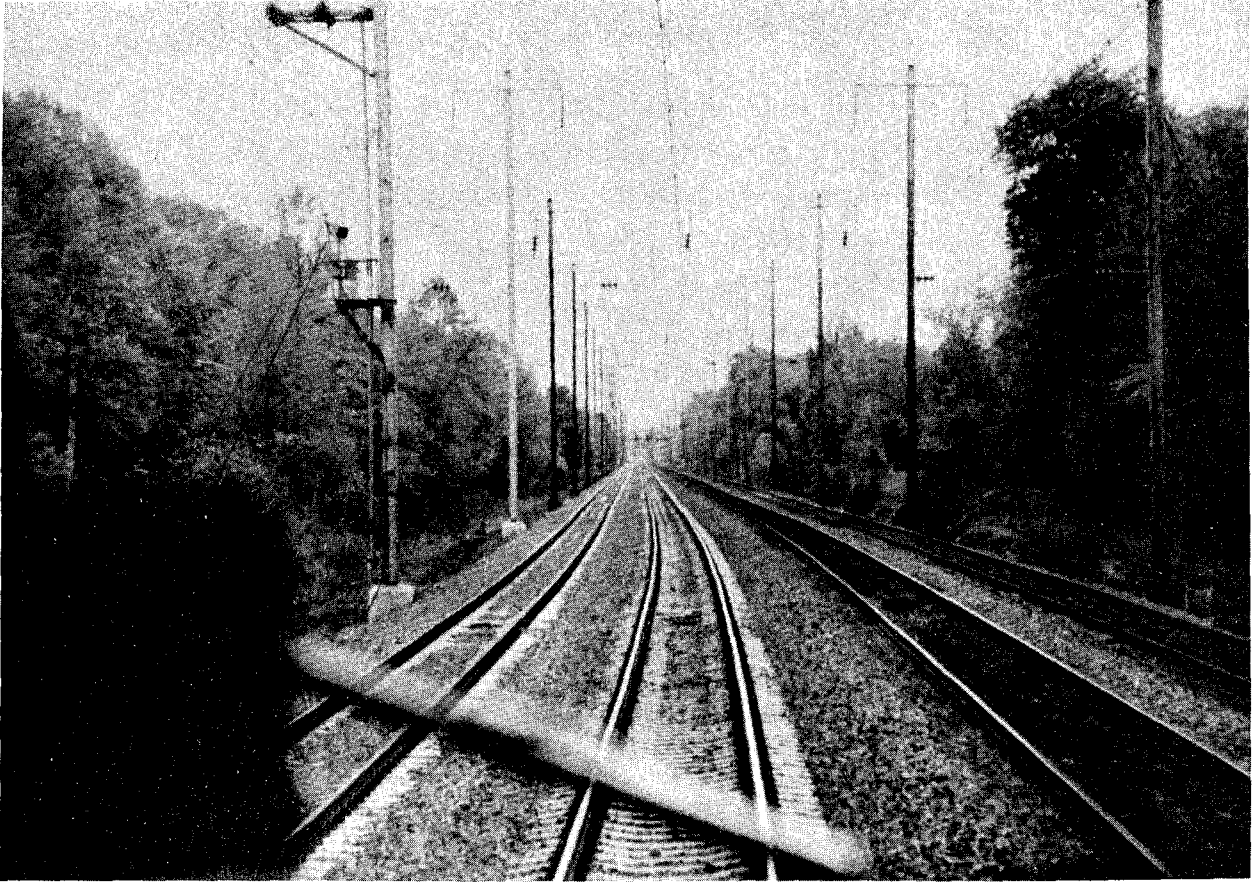
Figure 10. Code change point CS-806 as seen from a northbound train on track 2. The nearest catenary support poles mark the location of the code change point. The Gunpow home signals are in the distance.

A northbound train on track 1, having received an "approach limited" aspect displayed by distant signal 816-1 and thus concurrently displaying an "approach medium" on the cab signals, would have had the cab signals change to "approach" if home signal 1N changed to "stop" before the train reached CS-806. When the train reached CS-806, the cab signals would change to "restricting." If the train was already past CS-806 when the home signal changed to "stop," the cab signals immediately would have changed to "restricting" as a result of the loss of the code rate.

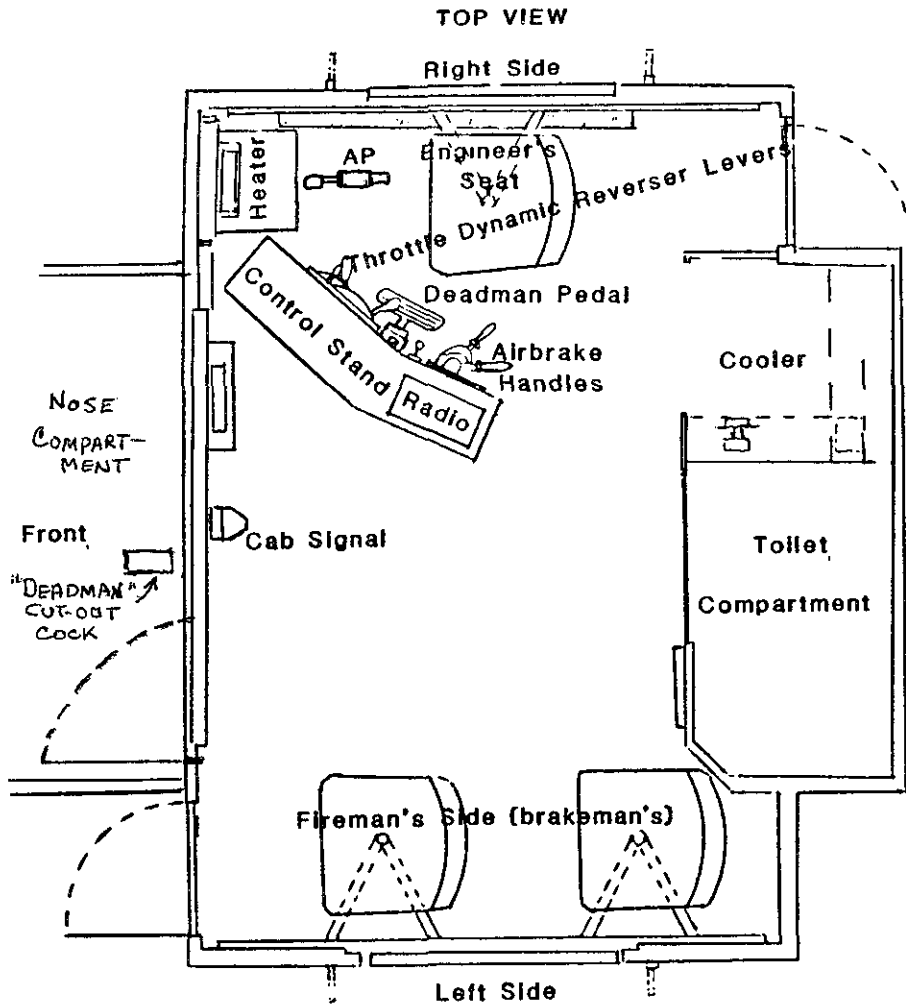
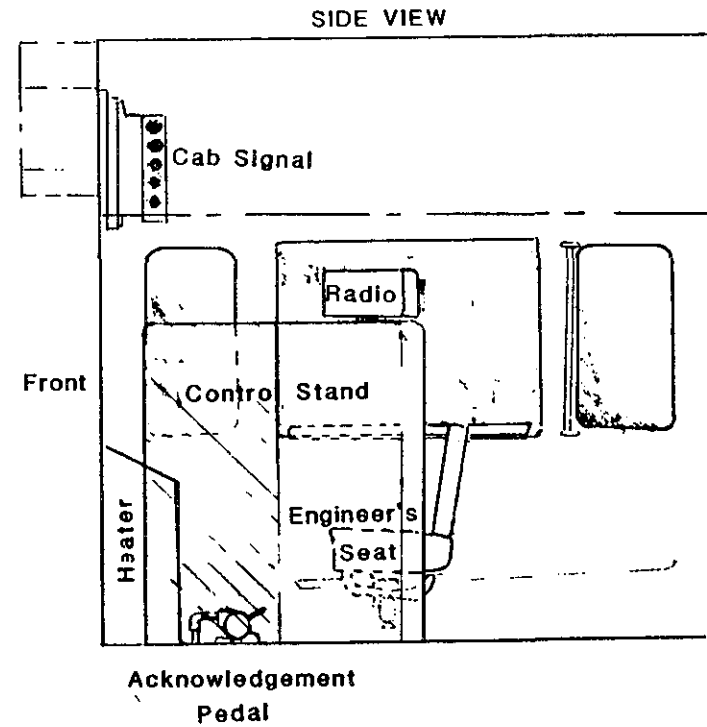
Figure 12. Floor plan and side elevation of the cab of Conrail locomotive unit 5044.

The control and airbrake stands were in the right side of the cab, and the throttle, dynamic brake, and reverser levers were in front of the engineer's seat with the airbrake handles and radio handset to the left of the seat (see figure 12). An emergency brake valve was located on the left side of the cab.

An elongated safety control or "deadman" foot pedal was on the floor in front of the control stand, forward and to the left of the engineer's seat. This pedal had to be kept depressed to prevent a "penalty" full-service airbrake application. The penalty airbrake application could also be prevented by cutting the deadman feature out of the airbrake system. A cut-out cock for this purpose was located inside the nose compartment and could be accessed without leaving the cab (see figure 12). According to Conrail, the deadman cut-out cocks are kept sealed in the "in" or operative position. After the accident, the deadman cut-out cock of unit 5044 was found unsealed and in the "out" position.
