CADASTRAL SURVEY MONUMENTATION
MANUAL

To: Director, DSC
From: Richard B. Case, Mechanical Engineer, Division of
of Scientific Systems Development (D-440)
Subject: Field Trip Report

Covering Travel To:
Salt Lake City, Utah

To inspect and report on conditions of Cadastral Survey Monuments located at Utah Test sites No. 1A and No. 2.

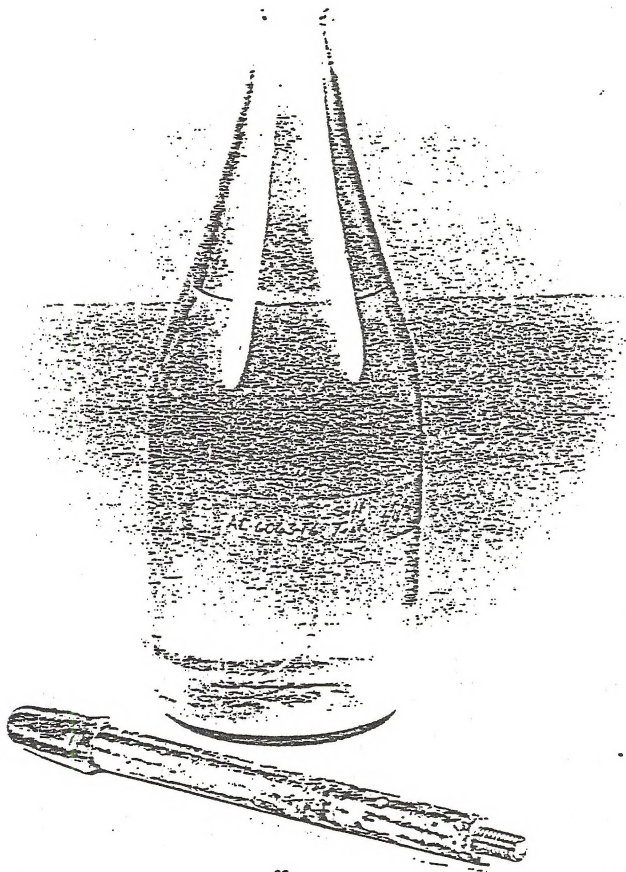
Note the pitting on the aluminum sample
