## A Prefabricated Flume for Gaging Ephemeral Streams

Earl F. Aldon<sup>1</sup> and Fletcher J. Brown, Jr.<sup>2</sup>

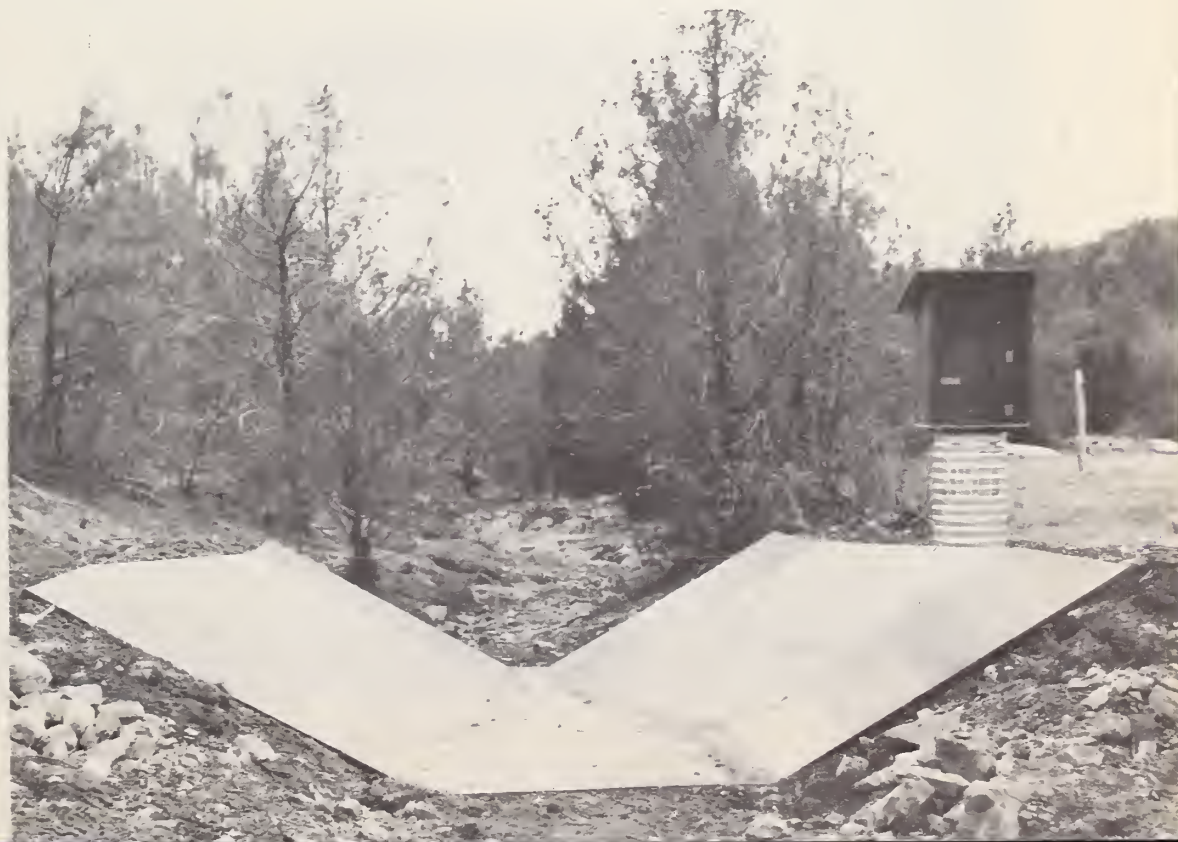
Figure 1.--A modified trapezoidal flume made with prefabricated components. Dimensions are 5 feet wide in the approach section (foreground), constricting to 1 foot in the measuring section. Sidewalls are at 30° from the horizontal, and the flume is on a 5-percent slope. Depth is 3 feet, accommodating a maximum discharge of 222 cfs.

ly challenging problems for research to solve. Such devices should include, of course, the use of the most economical materials and methods. Fiberglass is one such low-cost material that warranted testing under field conditions. Its use in boats and for automobile body repairs is widely known--as is its durability. This Note outlines the steps taken to reduce costs by fibreglassing plywood panels and prefabricating other components of a trapezoidal flume (fig. 1).

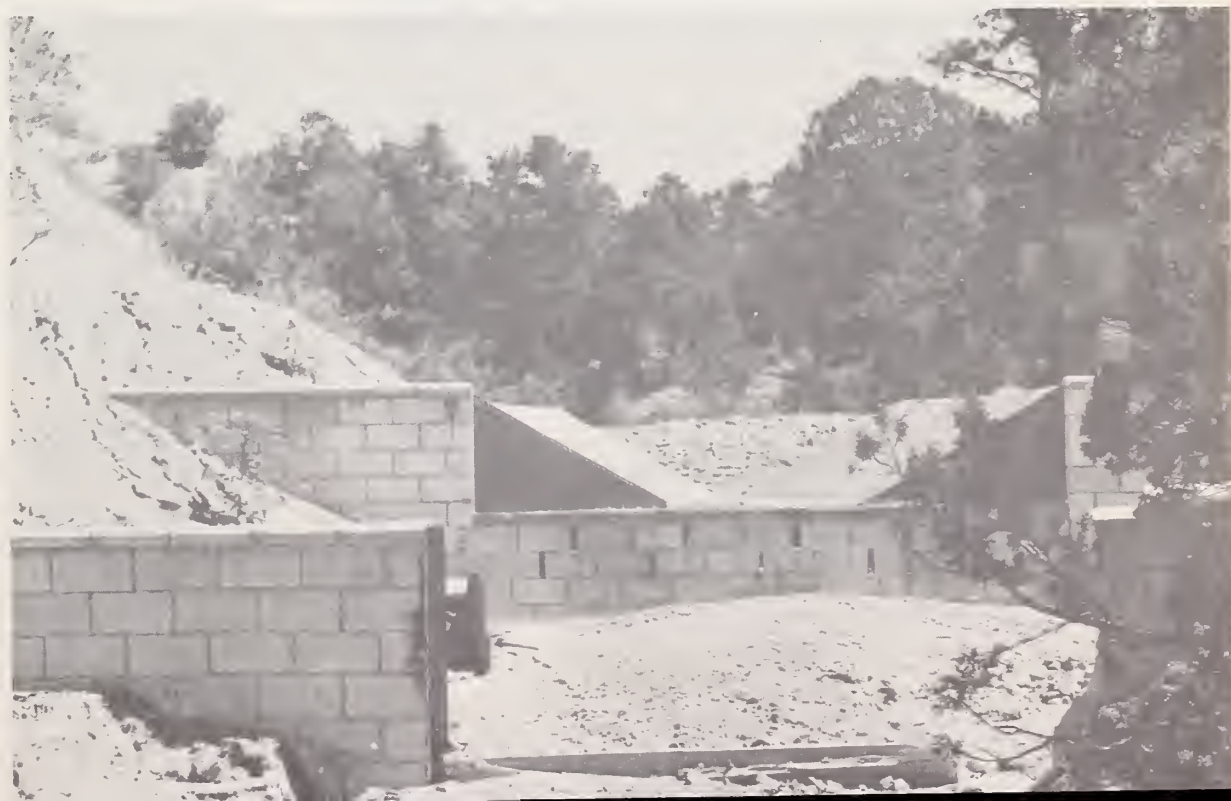
Figure 8.--A view looking upstream into the sediment basin after at least 18 tons of sediment had passed through the flume in a single flow. (The downstream sediment basin wall failed.) Flume sidewalls were scratched, but there were no dimensional changes.

vective storm released 1.57 inches of precipitation in about 20 minutes. The maximum flow was 1-1/2 feet in the flume, with a peak of 38 cubic feet per second (c.f.s.). This flow, and the resulting high sediment load it carried, sheared the downstream sediment basin wall with a resultant loss of some of the sediment in the trap (fig. 8). The 18 tons of sediment that remained, however, were cross sectioned

in the basin after the flow. Boulders, small rock, and sand comprised the bulk of this sediment. No damage to the flume, except for minor scratching of the resin finish, was found. There were no dimensional changes in the flume. The scratched areas were easily re-covered.
