TACTICAL MISSION REPORT
OF
500TH BOMB GR.
BATISTA MISSION
OCT. 13, 1944

CONSOLIDATED MISSION REPORT

PRACTICE MISSION F.O. NO. 10

500TH BOMB GROUP

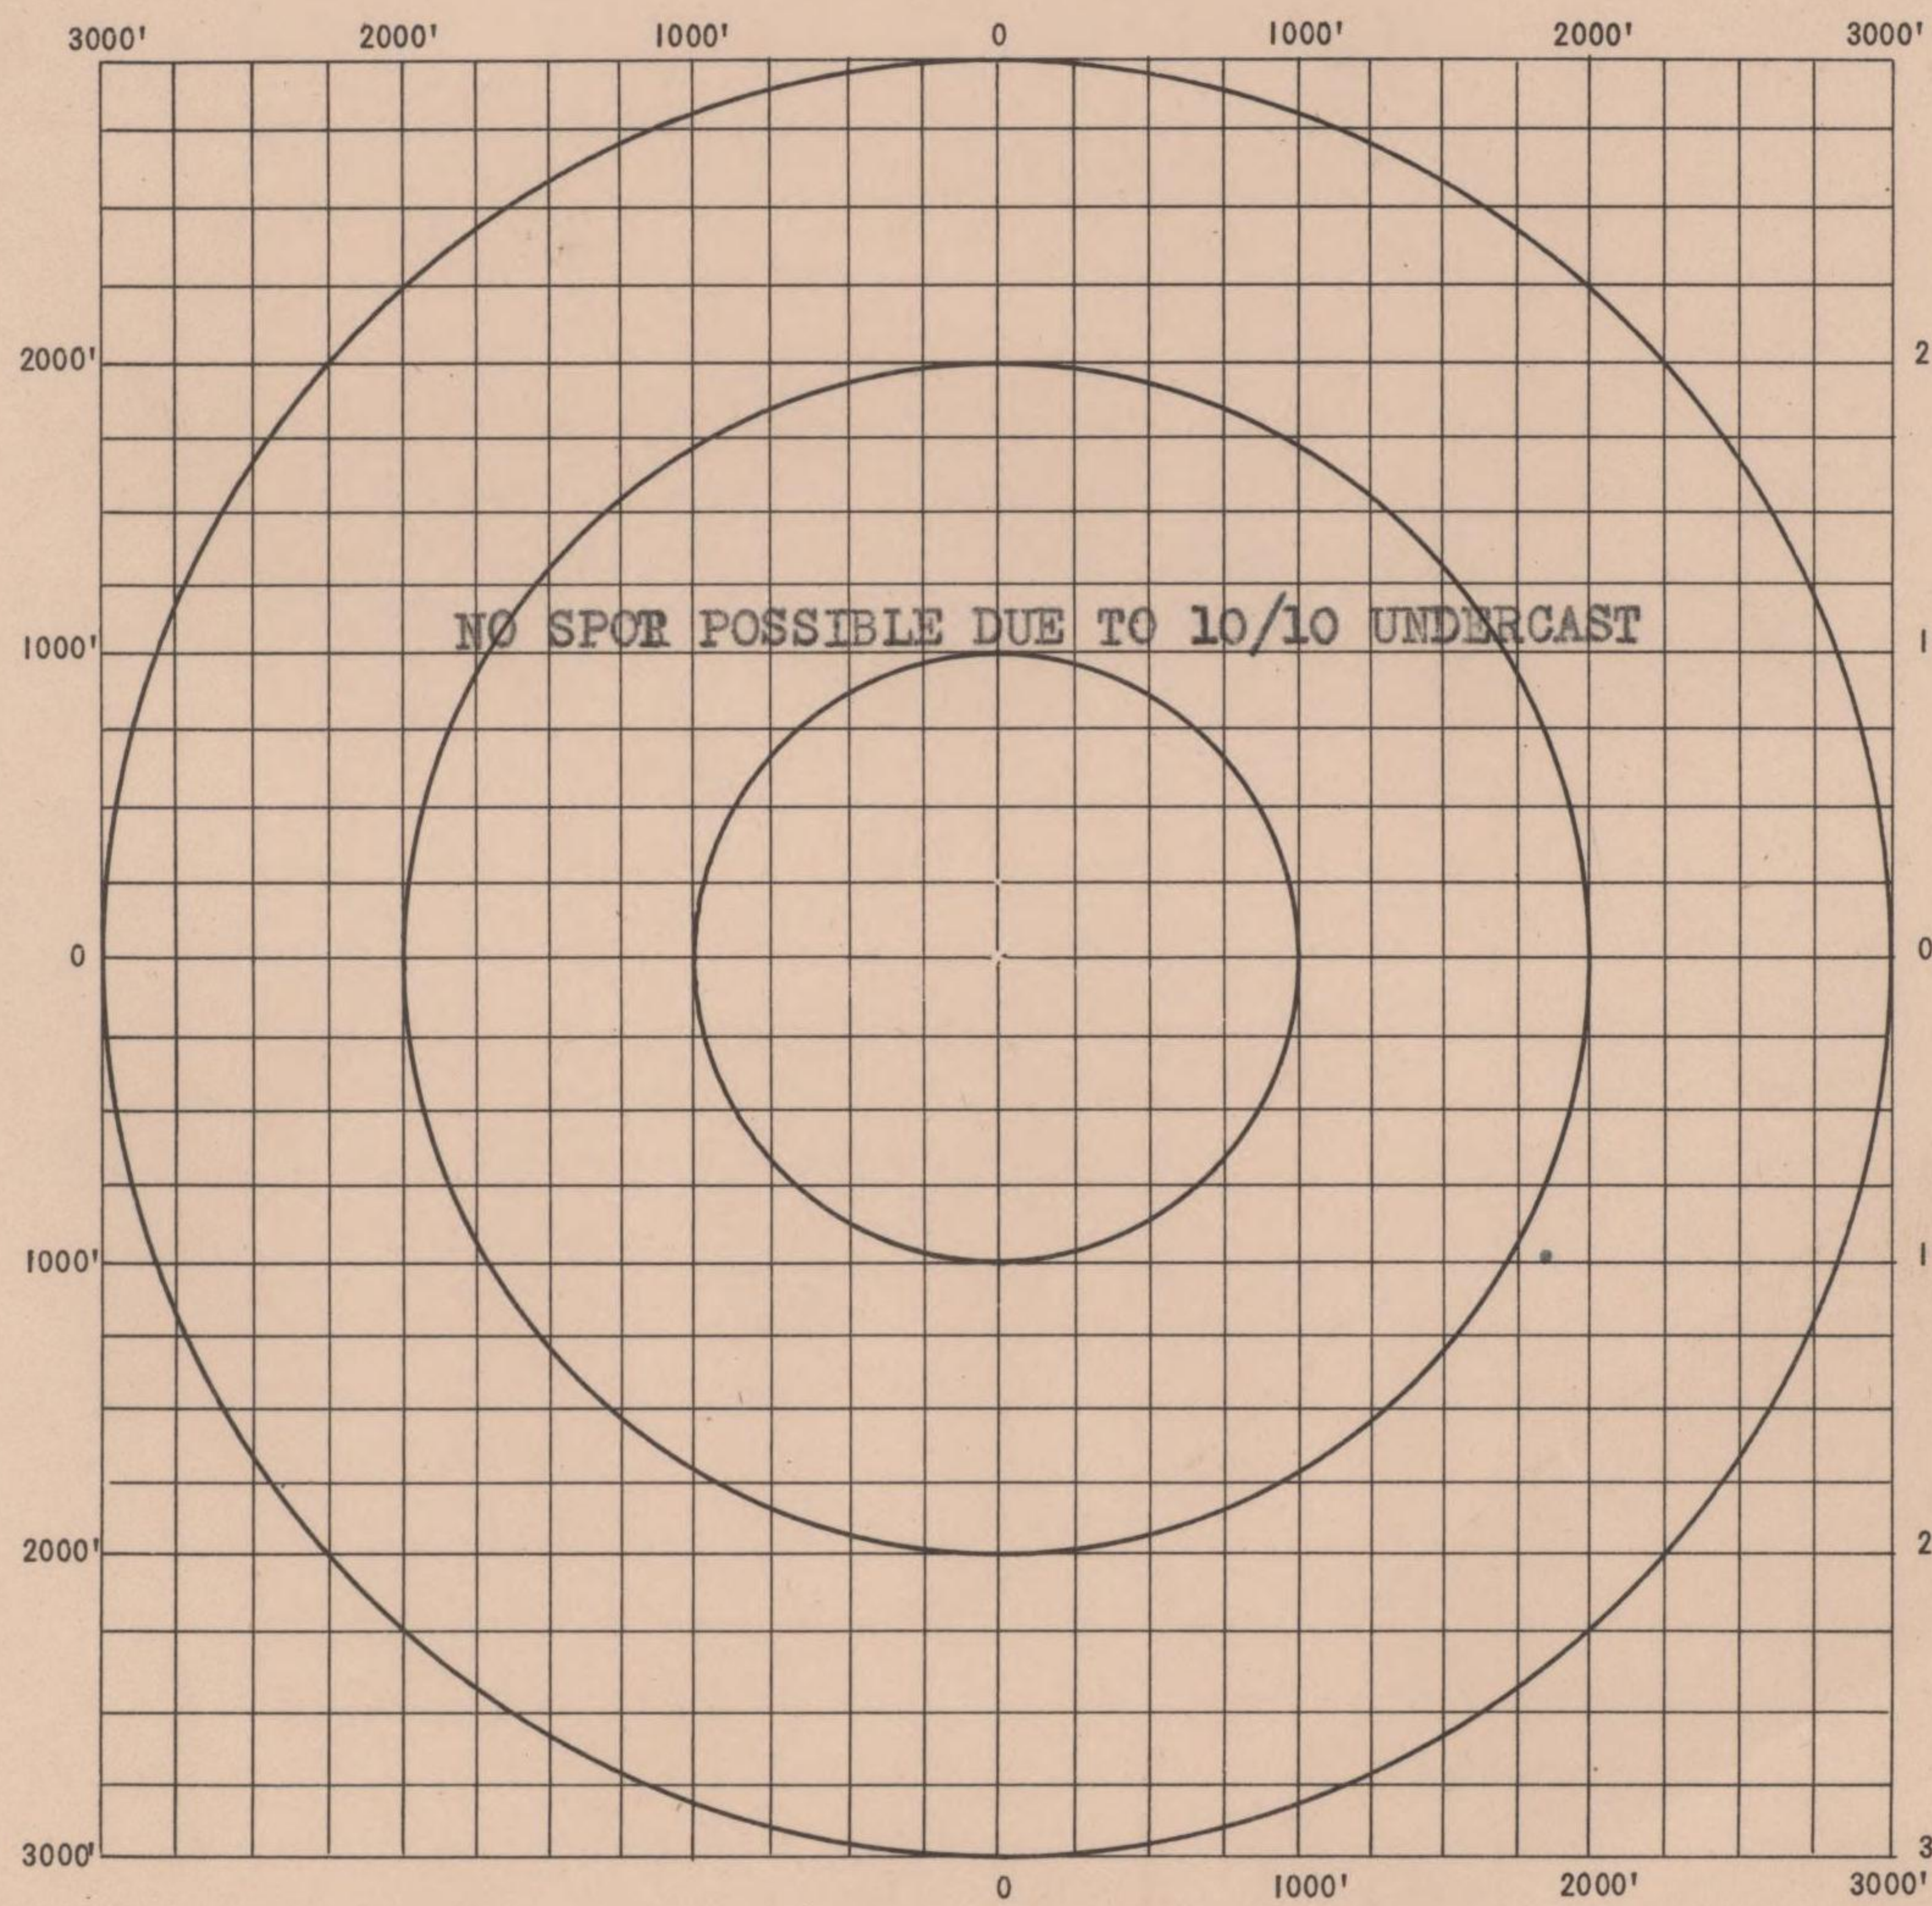
Center of Cross

50. B O M B P L O T (COMPILED FROM BOMBING DATA & PHOTOS)
