Cite this article: Mol L, Gomez-Heras M, Brassey C, Green O, Blenkinsop T. 2017 The benefit of a tough skin: bullet holes, weathering and the preservation of heritage. *R. Soc. open sci.* **4**: 160335. <http://dx.doi.org/10.1098/rsos.160335>

The benefit of a tough skin: bullet holes, weathering and the preservation of heritage

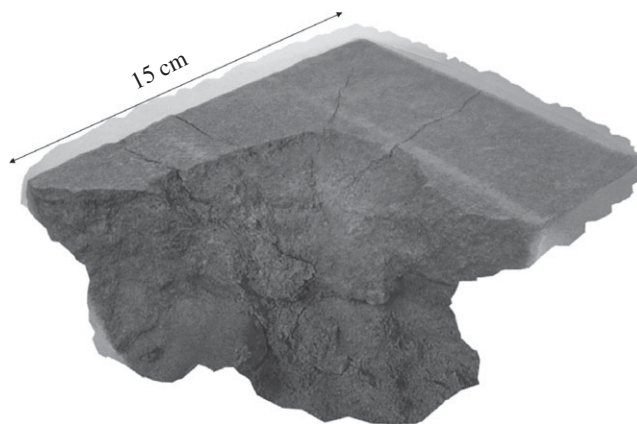
Figure 1. Three-dimensional model of sample block remnant after AK-47 impact.

As illustrated in figure 1, the extent of destruction wrought by the AK-47 impact on our sample blocks ensured the remaining fragments were not suitable for a full examination of the interactions between impact sites, surrounding fracture networks and any unharmed material in the periphery. Impacts were therefore scaled down to ensure a full impact was contained within the test blocks, thus permitting high-resolution imaging of the entire sample (see Methodology section). The low-powered rifle used herein undoubtedly underestimates the potential damage associated with contemporary warfare. It does, however, allow for the full impact structure network, its response to environmental stress and the effect of pre-existing hardening of the surface to be mapped within the constraints of sample size. While this discrepancy in scales must be noted, here we lay the methodological foundations for future investigations of larger impacts, and highlight the pressing need for further research into endangered built heritage.

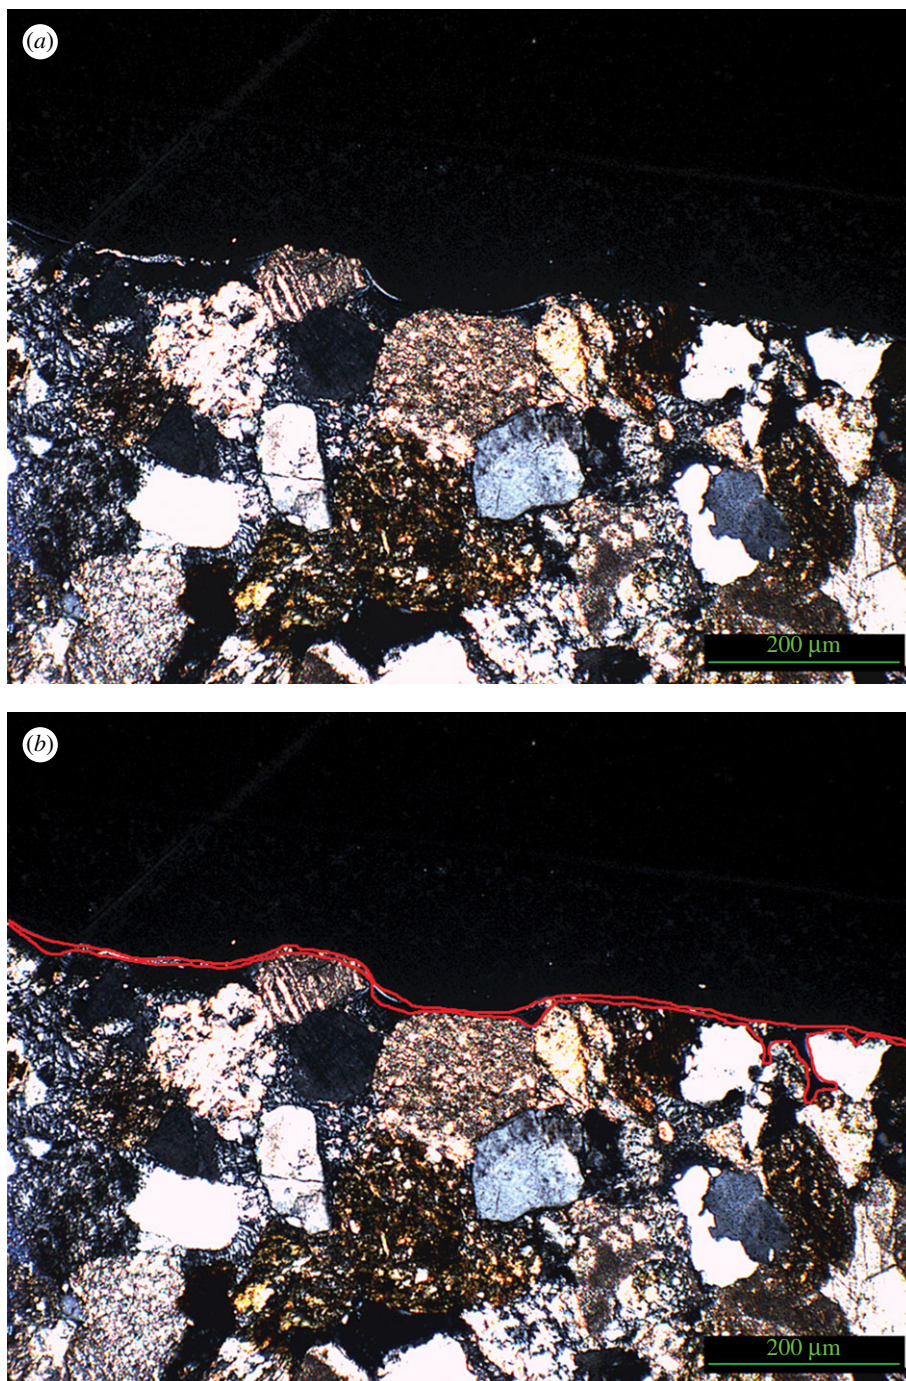
Figure 3. (a) Wacker OH 100 gel layer in original image. (b) Wacker OH 100 gel layer with accentuated observation of gel deposition.

Cementation of the surface, referred to as 'case hardening' and manifested as a surface crust, often develops after freshly cut building stone is exposed to environmental factors such as precipitation and temperature fluctuations [19,20]. This cementation can consist of multiple phases such as carbonate, calcite or iron oxide crusts, and while stabilizing the top surface can also enhance deterioration of the stone matrix owing to subsurface moisture accumulation and subsequent dissolution of the cement matrix as well as increasing pressure on the surface [21–23]. To address this change in surface hardness and porosity, half the samples were treated with Wacker SILRES BS OH 100, an ethyl silicate-based consolidant which forms a silica-based gel upon contact with moisture in the stone pores, and subsequently dries within the pore system [24], by pipetting the substance onto the surface (figure 2). This consolidant is also used in conservation of stone artefacts to increase hydrophobicity and decrease bioinfestation potential [25–27]. One layer was applied to mimic surface consolidation, as it is used here as an analogy for natural case hardening, rather than multiple applications which might have resulted in consolidation of the majority of the sample [28]. After curing, a thin layer of consolidant was observed at the surface of the block but, as anticipated, this layer was mostly restricted to the surface and immediate subsurface (figure 3*a,b*). Case hardening under natural circumstances results in the deposition of a

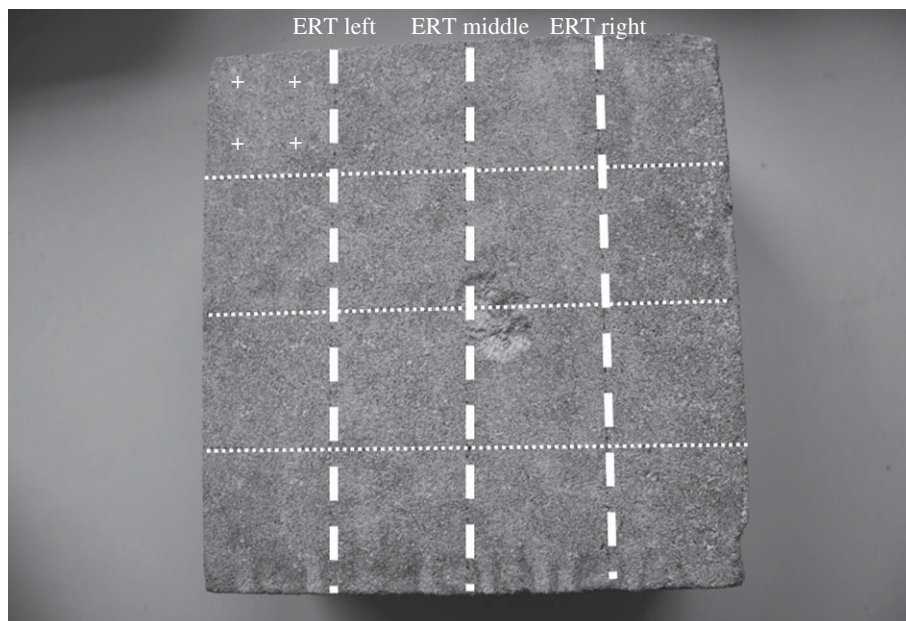
Figure 4. Impact area at sample 6, also showing sampling strategy for the Piccolo and ERT.

Resistivity measurements were taken along three transects across the stone sample (for sampling strategy, see figure 4). The middle transect covers the impact area and it was expected that the most noticeable changes would be seen in this area. Figure 8 shows the distribution of moisture in sample 3 after the environmental cabinet treatment. This sample was not treated with Wacker OH 100. The areas of low resistivity (light greys and whites) are assumed to indicate higher moisture content, whereas the

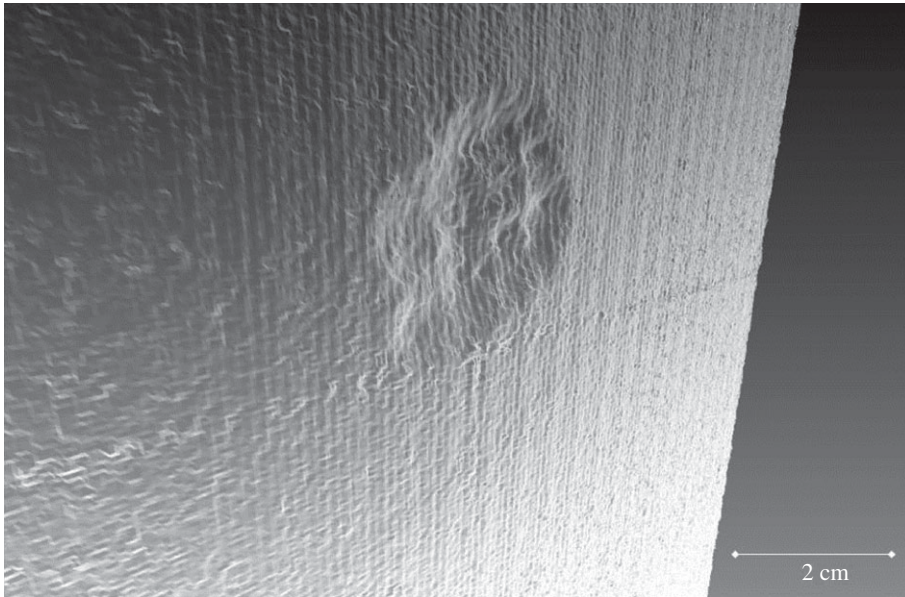
Figure 5. Mephisto Eos 3D scan of a bullet impact on the stone surface (not treated with Wacker OH 100).

Material loss from the surface after the bullet impact was almost negligible, as it averaged 2.57 g (0.05% of total weight) per sample (table 2), though loss of surface was clearly visible, as illustrated by figure 5. Interestingly, there was no noticeable difference reported between loss of mass from Wacker OH 100 treated surfaces and non-treated surfaces.

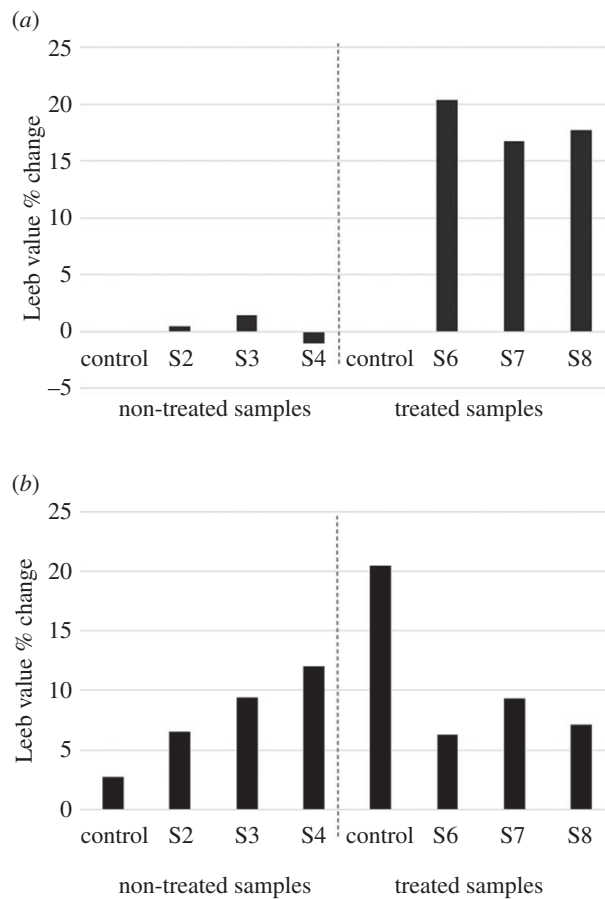
Figure 6. (a) Loss of strength of rock surface as measured after bullet impact and (b) loss of strength of rock surface as measured after environmental stress cycles in cabinet.

The repeated measurements of the sample surfaces are shown in figure 6. The initial Wacker OH 100 treatment shows a significant increase in the measured surface hardness at samples 5–8. This fits the

A further investigation of the overall results on strength loss (figure 6) indicates some unexpected results, while the impact of the initial bullet had a far greater impact on loss of strength on the surface-hardened samples, this trend reversed under the environmental strains placed upon the stone samples in the environmental cabinet, where environmental strain as recorded by surface strength loss had a greater impact on the non-treated samples. The presence of water at the foot of the block (samples 3, 4, 7 and 8) was detrimental irrespective of the presence of case hardening.

As can be seen in figures 6 and 7, all samples were negatively affected by the environmental cabinet treatment. However, the extent to which the samples were affected by the treatment appeared to be strongly related to the nature of fracture network developed at the time of impact, as based on the research set out by Momber [34]: The rigid, Wacker OH 100 treated, fractured surface appears to be more vulnerable to temperature changes overall, whereas the untreated and more plastic surface appears to cope far better with the thermal stresses placed upon the samples in the environmental cabinet but suffered noticeable degradation of the impact area, leaving it vulnerable to potential cavernous weathering. The pre-impact condition of the surface is therefore instrumental in determining the impact of a projectile, such as a bullet, and projecting future deterioration patterns.

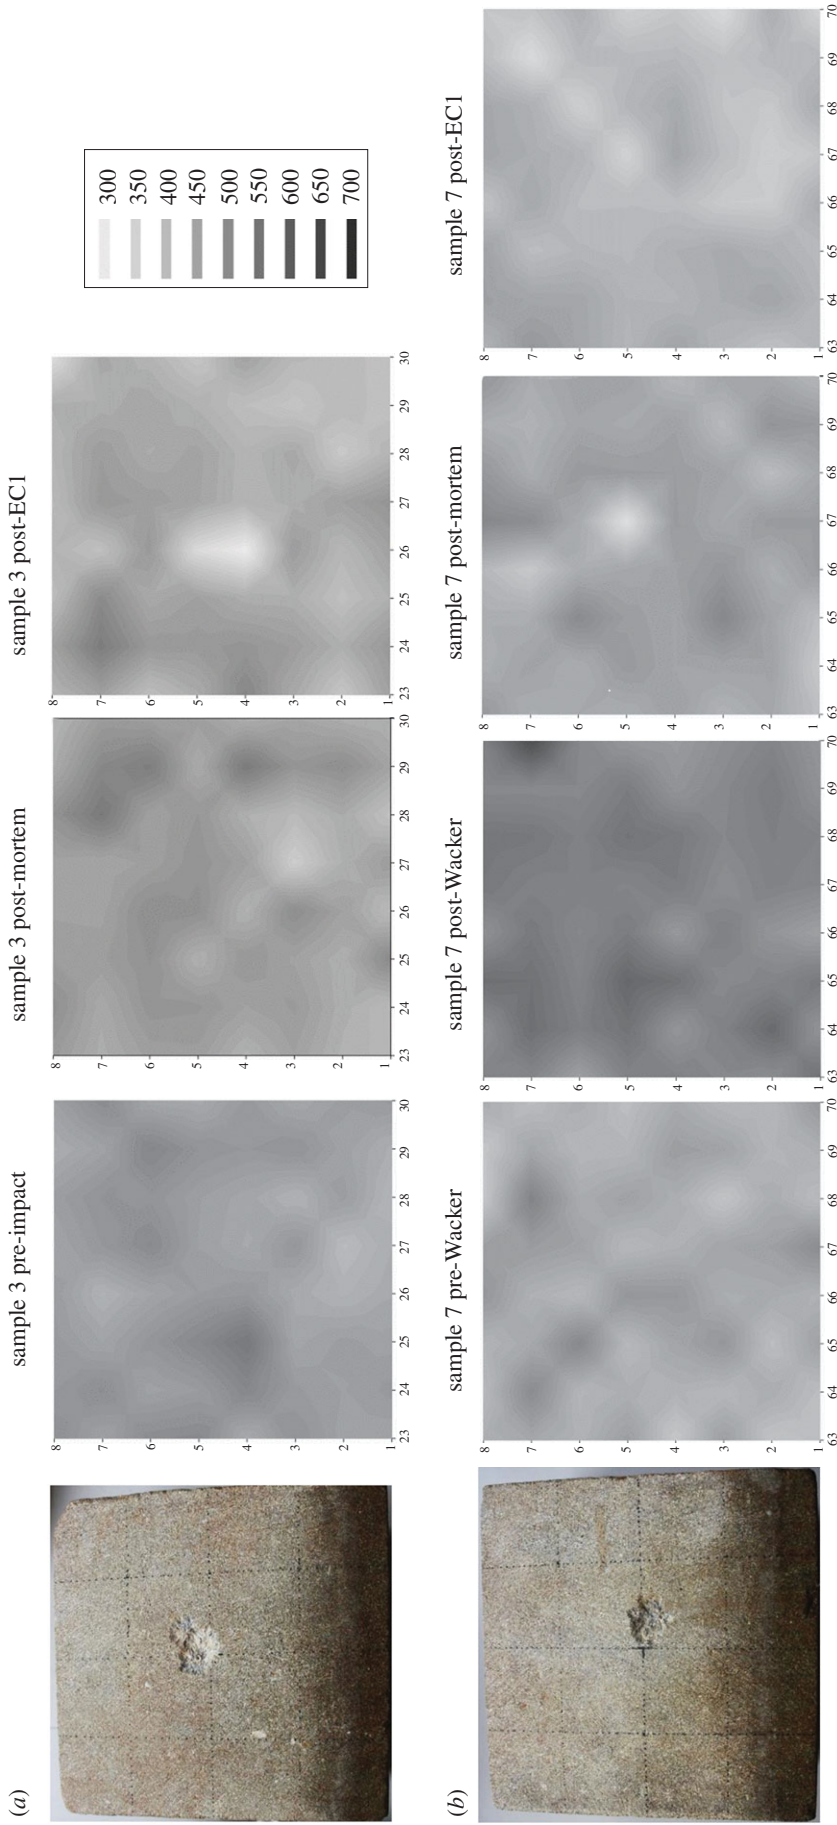
Figure 7. Piccolo data from samples 3 (a), sample not treated with Wacker OH 100 and shot) in Leeb value. Values were interpolated using SigmaPlot area plot.

However, mean values cannot adequately describe spatial variations in elastic properties. Therefore, the Piccolo data from samples 3 and 7 measured across the surface of the block have been plotted in figure 7 to show change during the various stages of the experiment. Here, two interesting trends emerge. Firstly, sample 3, which was not treated with Wacker OH 100, does not show weakening directly corresponding to the impact area, although damage is apparent elsewhere. This follows the trend of the absorption of the impact by the more elastic nature of the surface (compared with the Wacker OH 100 treated surface). However, after the environmental cabinet treatment there is a clear weakening of the impact area, as represented by the lighter coloured area and relatively stable measurements around the impact area. This trend is reversed in sample 7 where initially the impact area is clearly identifiable post-impact (the very light grey area that corresponds with the location of the impact), accompanied by a general deterioration of the surface strength across the surface of the block. This impact area is much less visible after the environmental cabinet treatment. Instead there appears to be a general but less severe deterioration of the surface.

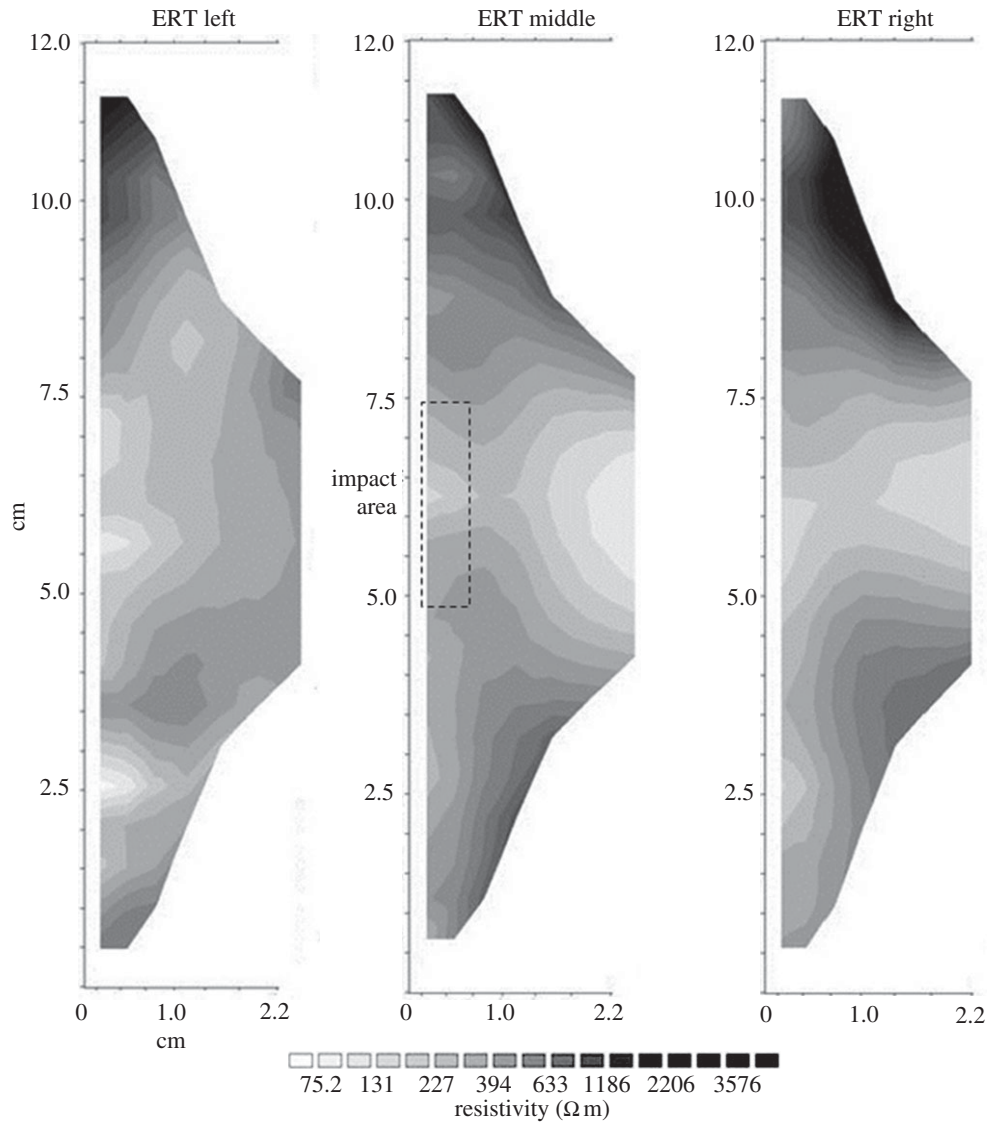
Figure 9. ERT transects of sample 7 (Wacker OH 100 treated) after the environmental cabinet treatment.

Sample 7 (figure 9) shows a very different pattern; moisture is drawn throughout the face of the stone, rather than drawn up towards the impact area. The impact area, while visible, is less clearly defined. However, the area behind the surface impact area clearly draws moisture in to a much greater degree than that seen in sample 3. Towards the foot of the block the moisture appears to be drawn up rather than into the block, as visible in sample 3, indicating more rapid capillary rise along the surface.

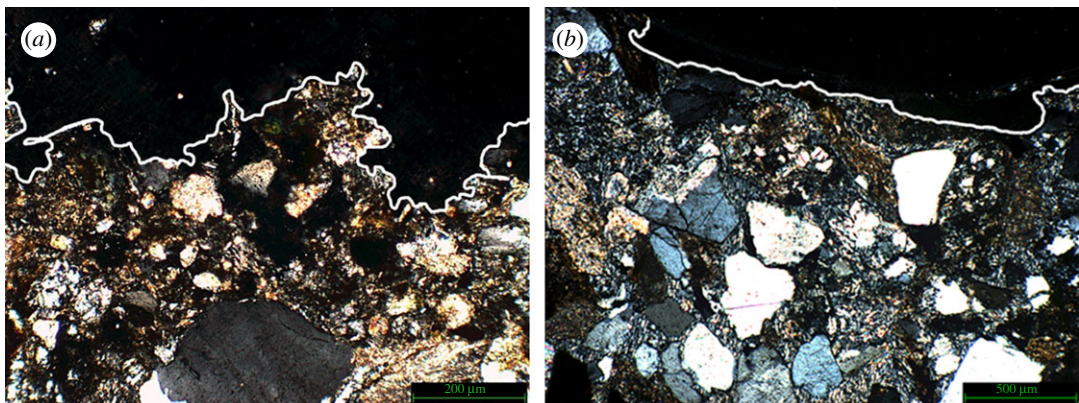
Figure 10. (a) Non-consolidated impact area ($\times 4$) and (b) consolidated impact area ($\times 4$) White line has been added to emphasize shape of impact area.

observed that in the impacts created in non-consolidated stone the impact area was far more ‘jagged’, as illustrated by figure 10*a*, in contrast with the consolidated stone where the impact created a shallower and smooth curve (figure 10*b*).

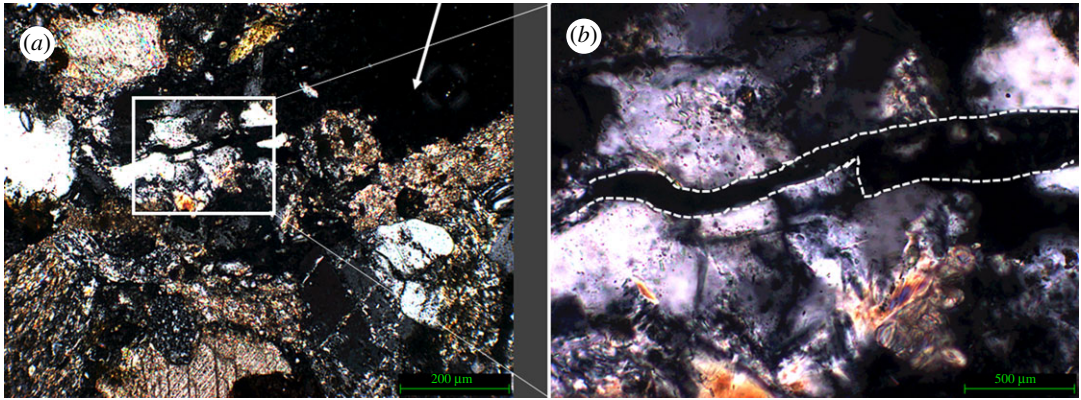
Figure 11. (a) Part of the impact area of sample 2 (not Wacker OH 100 treated); arrow indicates direction of impact. (b) Close-up of the fragmented and separated quartz found in the impact zone of sample 2, and white dashed lines clarify the position of the separation.

Quartz in the direct impact zone showed noticeable fracturing along the impact area. Figure 11*a* illustrates the fractures observed in the impact zone of sample 2 which was not treated with a consolidant. The absence of this surface support has resulted in the separation of the quartz fragment along the fracture line. Figure 11*b* shows a close-up of the area.

The bullet impacted in the area directly to the right of the fractured quartz, therefore, the conclusion could be drawn that the fracture and subsequent separation of the crystal is the result of the shockwaves generated at impact travelling sideways through the near-surface of the stone sample. The absence of a consolidant, and therefore a higher relative elasticity of the surface, facilitates sideways movement of the crystals. This type of separation was not observed in the samples treated with consolidant. This observation supports the notion that the nature of a micro-fracture network created upon impact is as dependent on the state of the material pre-impact as it is on the type of impact. As figure 12*a* illustrates, sample 3 exhibits this type of fracture network in the area directly adjacent to the impact. Figure 12*b,c* illustrates the geometric nature of the fracture network.

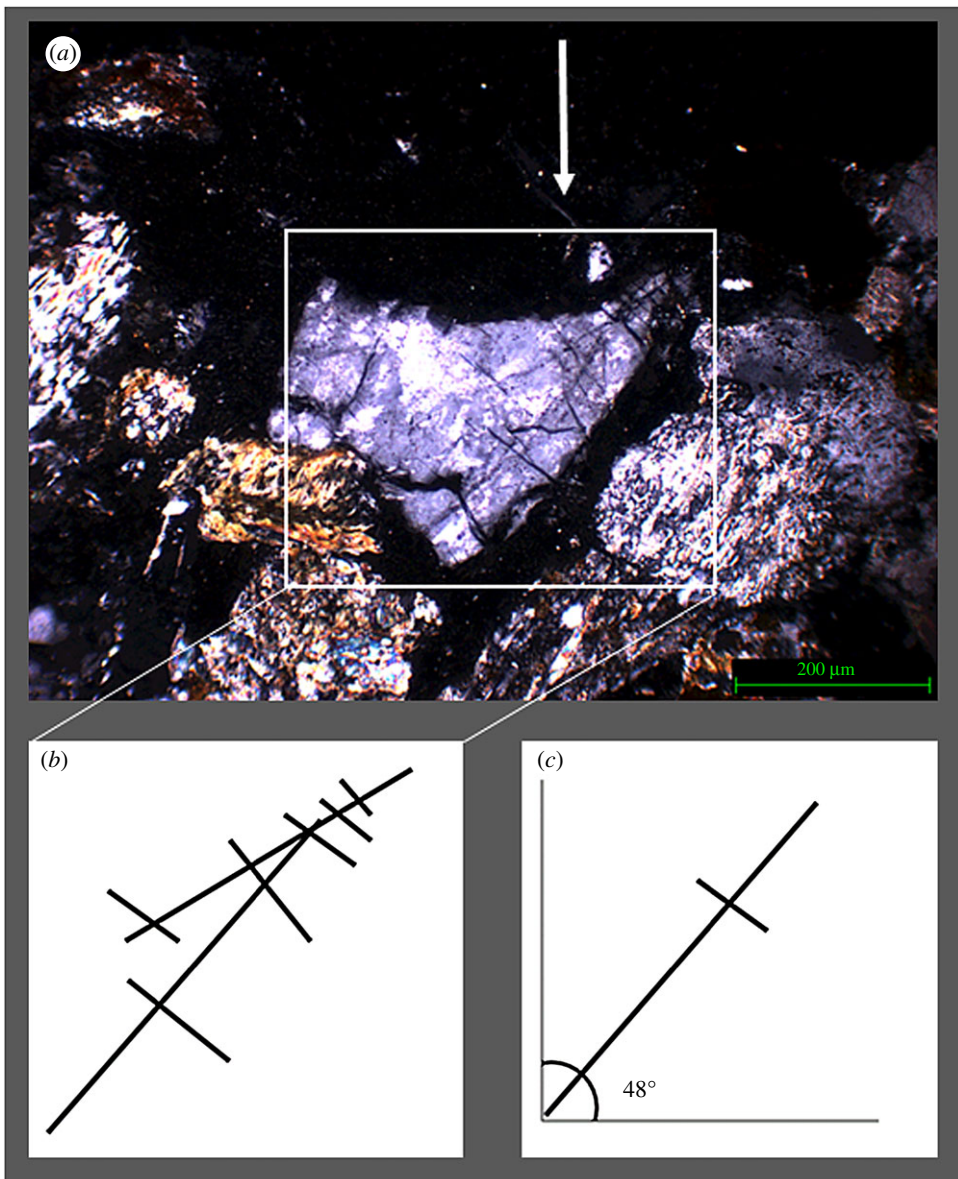
Figure 12. (a) Sample 3 (not treated with Wacker OH 100) impact area, white arrow indicates impact direction, (b) schematic of geometric fracture pattern and (c) schematic of angle of fracture network.

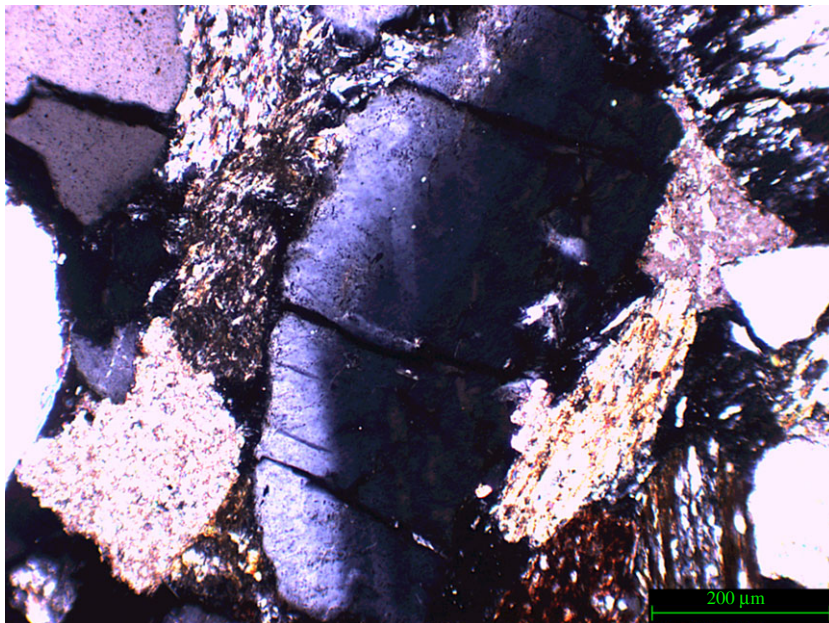
Figure 13. Sample 3, example of grain bruising.

Figure 13 illustrates further the fracture networks which were observed in sample 3 around the zone of impact. This sample also exhibits 'bruising' where part of the grain appears to have been reduced in refractive index (also noted by Fratanduono *et al.* [35] in shocked quartz), resulting in partial extinction as observed using cross-polarized light. This discoloration was not observed in grains outside of the direct impact area, indicating that this 'bruising' is closely connected to the shock generated on impact.

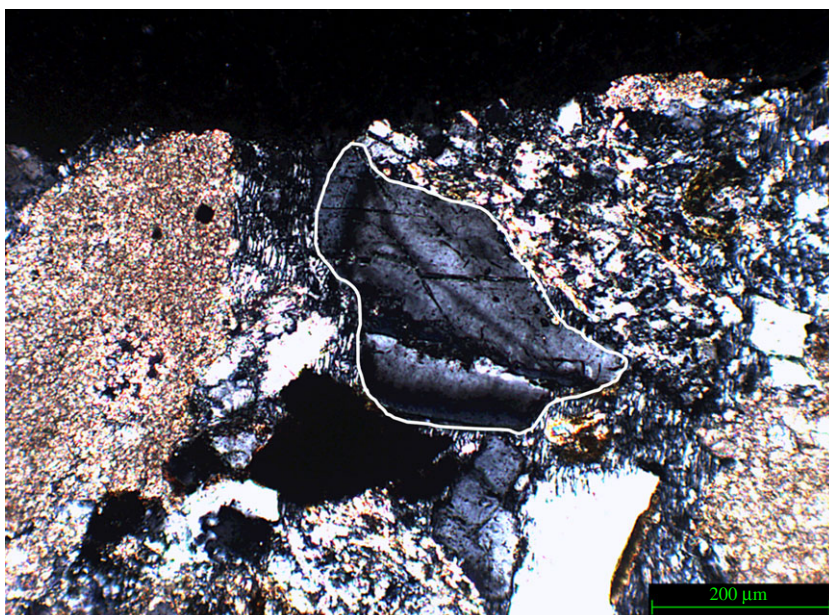
Figure 14. Sample 6 showing fractures, similar to those found in the non-consolidated samples. The mineral specifically referred to is outlined in white.

The above examples are observed in non-consolidated material. In consolidated material (samples 5–8) similar fractures were observed, implying that even though impact area development may differ the effects of the impact on mineral grains immediately surrounding the impact area are very similar. Figure 14 shows fractures found on the edge of the direct impact area in a Wacker OH 100 treated block (sample 6).

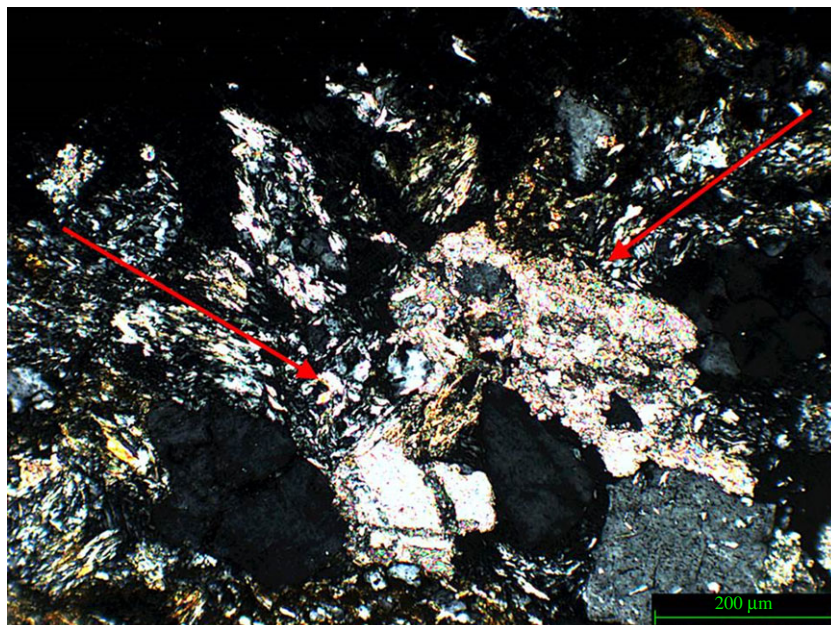
Figure 15. Sample 4, with arrows indicating clay matrix movement. This sample was not treated with Wacker OH 100.

Deformation of the clay (muscovite/kaolinite) cementation indicates a realignment of the general matrix in response to the shock generated on impact. Figure 15 illustrates this realignment in relation to the centre of the bullet impact which is in the area between the two arrows. The arrows indicate the new direction of the clay minerals, an alignment which is not visible in the non-impacted samples

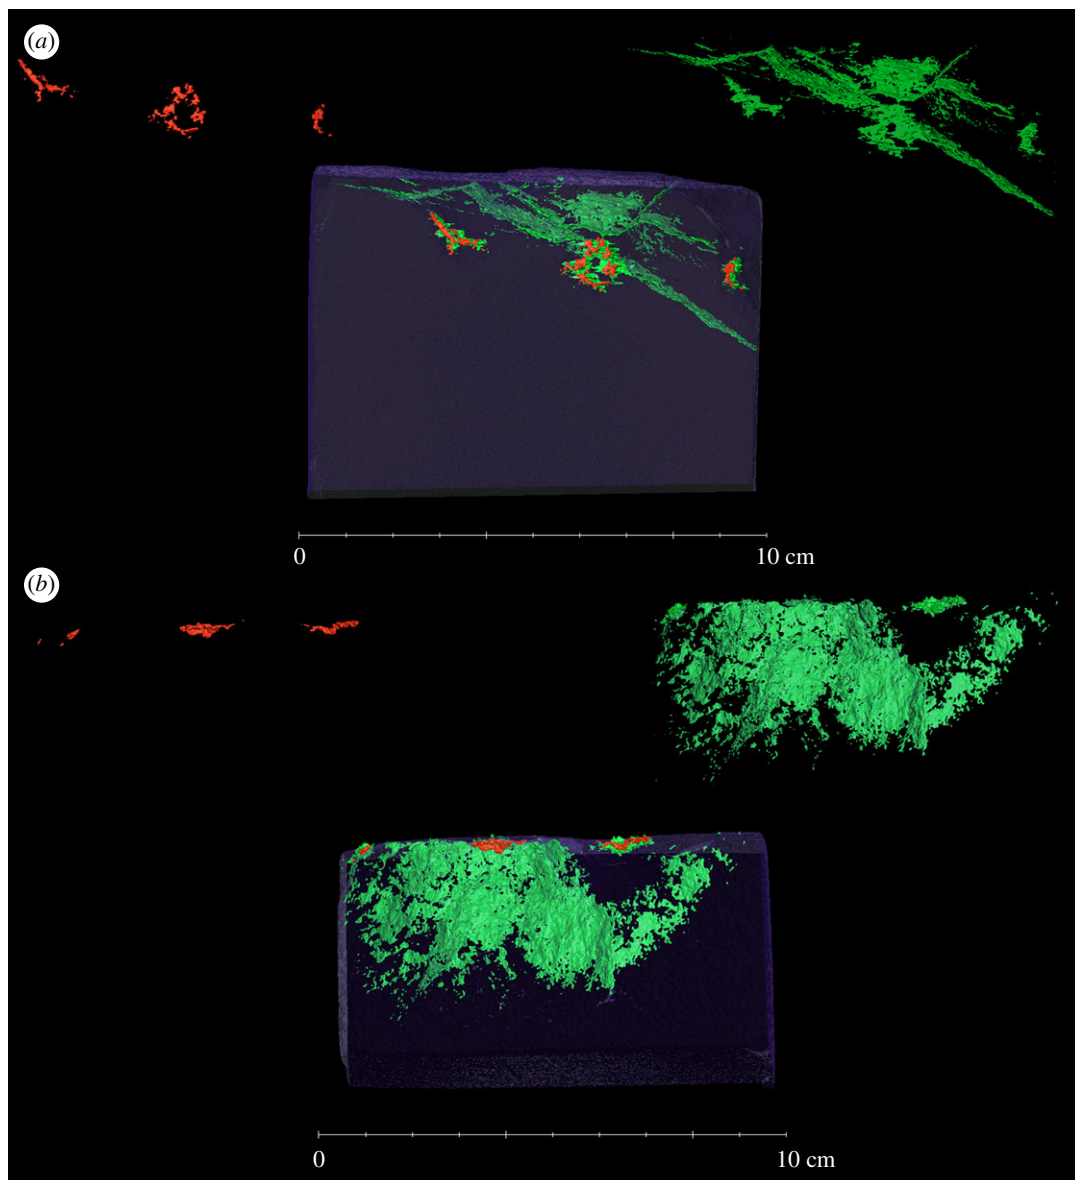
Figure 16. X-ray of impact areas, green demarcates areas of low density (fractured), whereas red indicates areas of higher density, likely to be lead deposits from the bullet encasing. (a) Frontal view (line of sight parallel to travel of bullet) and (b) top-down view. This sample was not treated with Wacker OH 100.

As all previous tests indicated both deformation of minerals around the impact zone as well as consolidation of the clay, a sample was scanned using X-ray tomography to map out compaction and fracture zones. These results are shown in figure 16, where the impacts coincide with compacted areas, whereas the fractured area extends onto the surface, radiating out from underneath the impact zones. The damage appears to have been caused by stress travelling into the block as the bullet hit, towards the

edges of the block while following a bedding plane within the stone sample. This exploitation of a pre-existing weakness is a commonly observed mechanism in stone under environmental stress [36]. These results also confirm the creation of compaction areas at the site of impact, which in turn affects impact site response to environmental stress and potential for long-term deterioration.

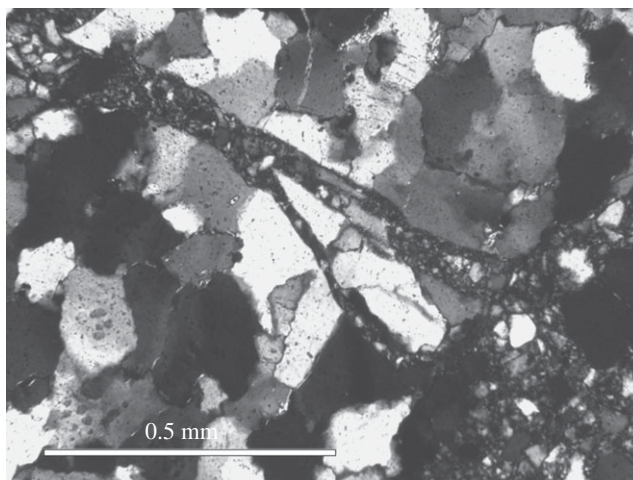
Figure 17. Fractures in a quartz-rich metasedimentary rock from the Ries Impact structure, Germany. Compare fractures with figures 10–14. Crossed polars. Sample from Alte Bürg quarry, 12 km from impact centre.
