REVISED FORM FOR REPORTING A. A. ACTION BY SURFACE SHIPS

Location of ship (area) South of Kyushu U.S.S. MONTELEY CVL-26

Zone Time -7 Date 14 May 1945

TRACK CHART
 0650 TO 0820 14 MAY 1945
 (ZD-9)

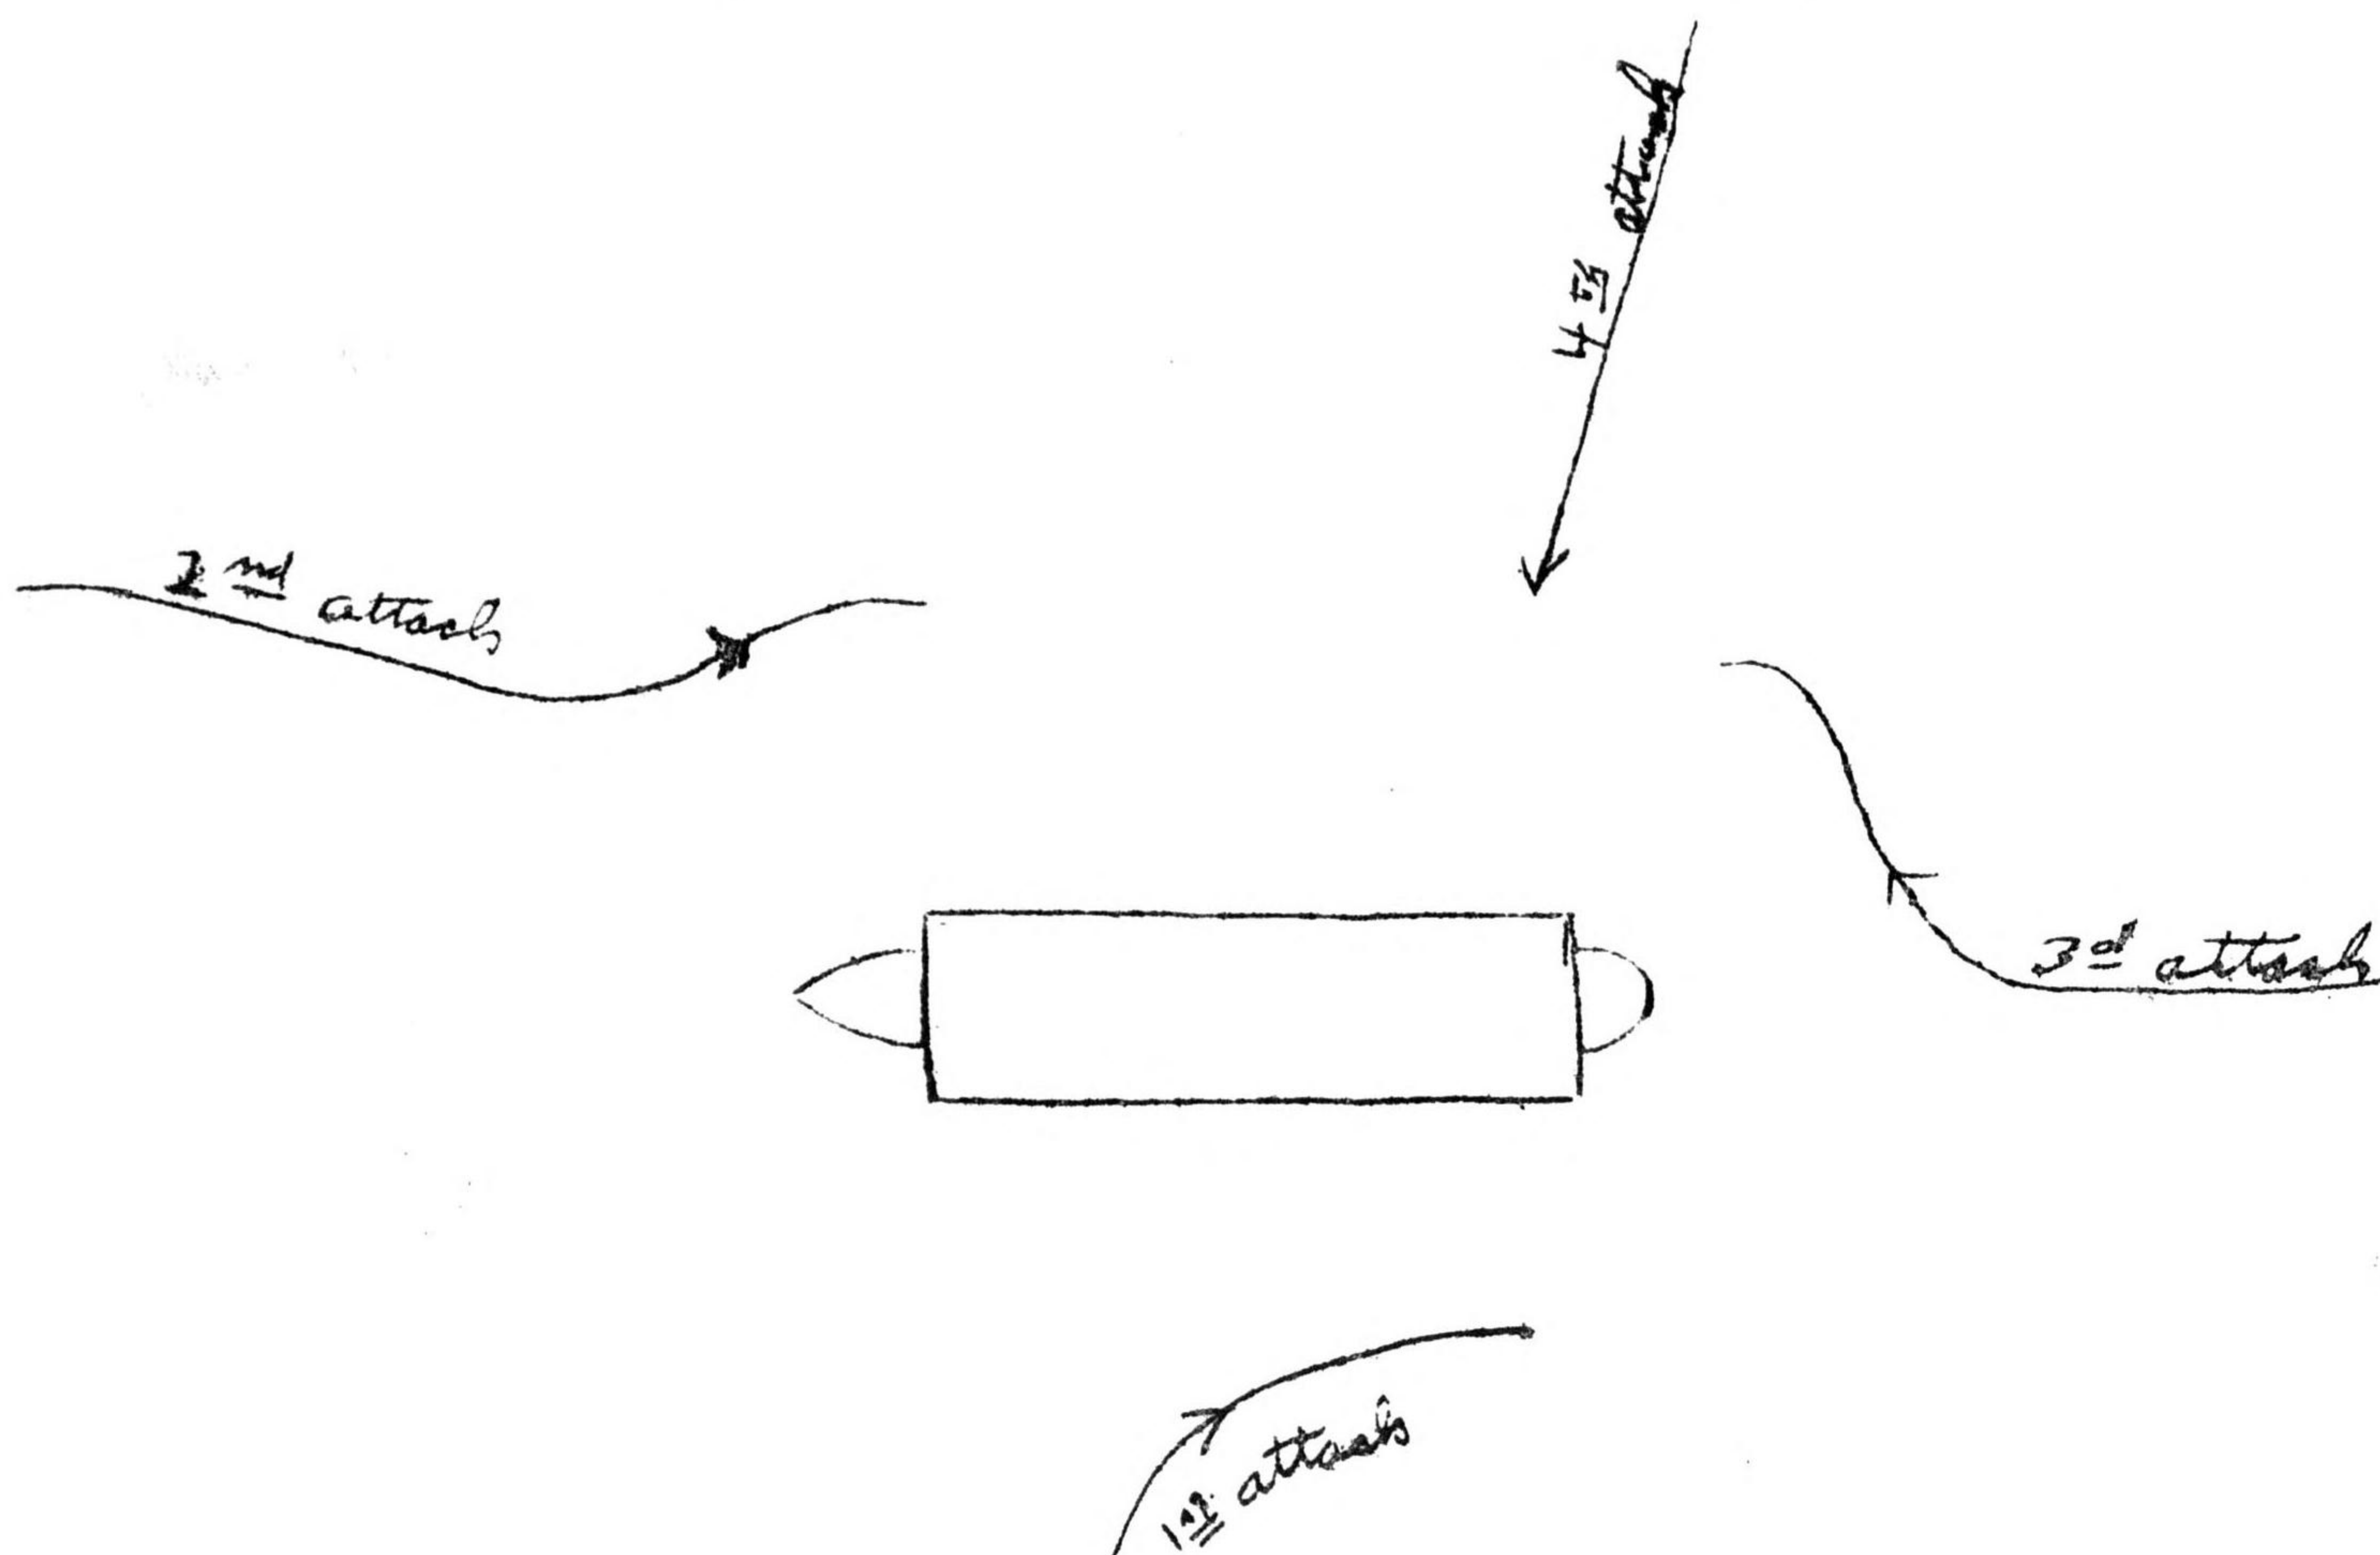
27. Best estimate of size gun or guns responsible for each "Sure" 40mm
28. Performance of ammunition (excellent, good, bad, poor) excellent
29. What failures in material occurred in this action? One broken 40mm extractor.
30. Sketch: (a) Indicate direction of attack relative ship's head.
 (b) Show relative position of sun.
 (c) Indicate own maneuvers.

SUN was on port bow during attack by first plane. Subsequent maneuvers placed it successively in all four quadrants, but only the first plane tried to take advantage of it.

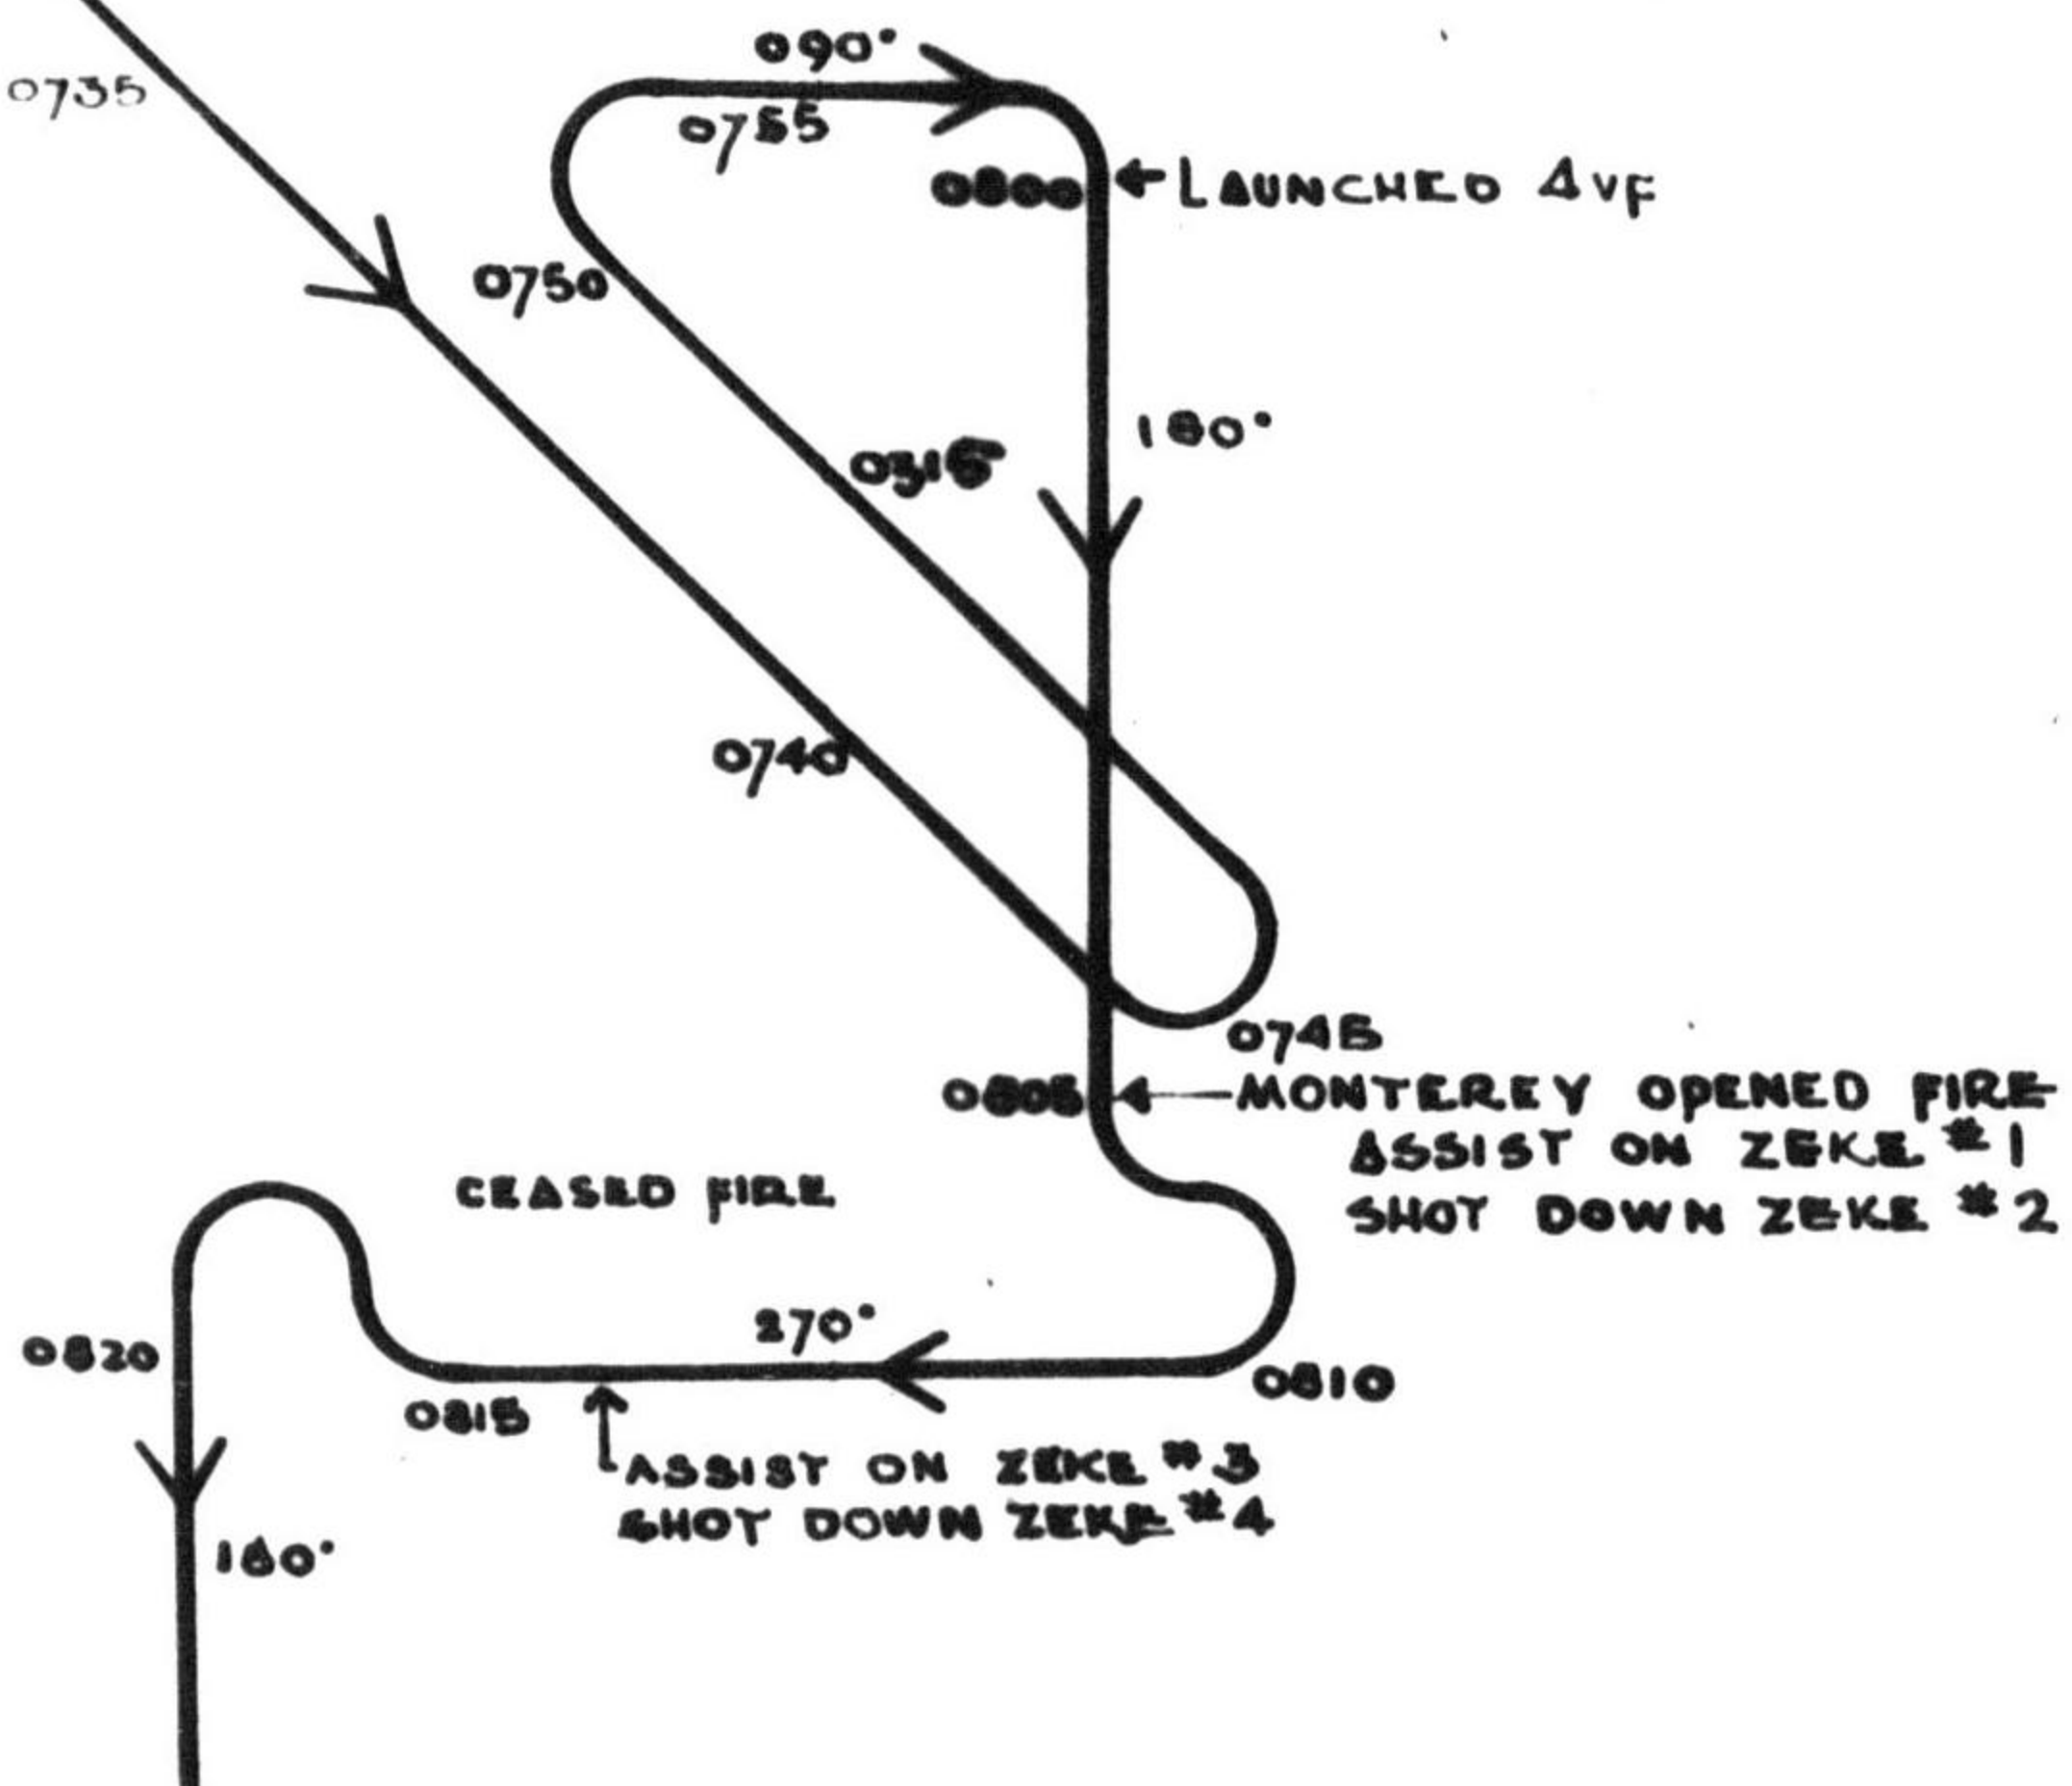
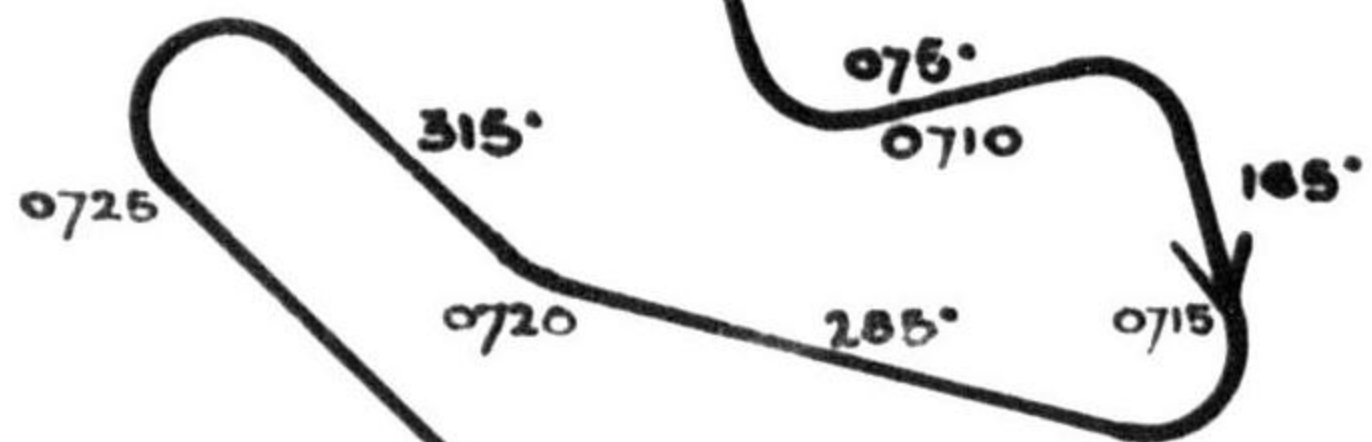
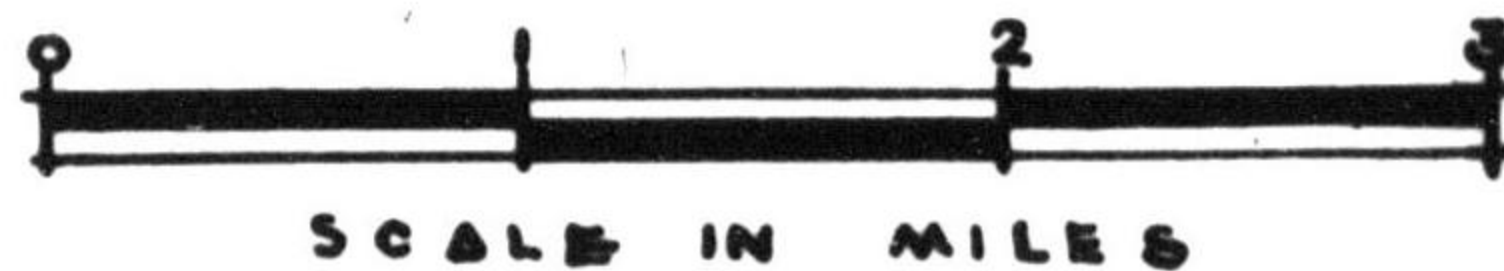
30° 15' N
 135°
 0650
 0655
 0700
 0655 ENTERPRISE OBSERVED STRUCK BY SUICIDE BOMBER. 5000 yds. ON PORT QUARTER.
 0654 PERMATION OPENED FIRE

WIND

0700 090° 8 KNOTS
 0800 083° 8 KNOTS

ALL COURSES & BEARINGS TRUE
