# GUIDE TO REDUCE ROAD FAILURES IN WESTERN OREGON

August 1973

Bureau of Land Management  
Oregon State Office  
P.O. Box 2965  
Portland, Oregon 97208

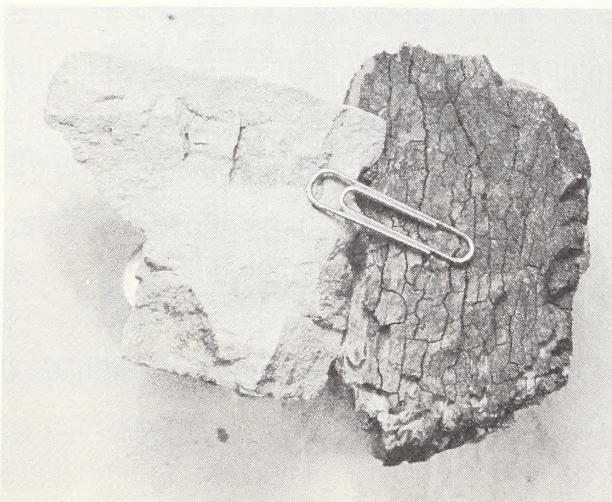
Figure 3e. Siltstone from the Nestucca formation.

The Nestucca formation covers a large block northwest of Salem and is composed of interbedded siltstone (Figures 3e and 8), claystone and sandstone. In many places the Nestucca formation is intersected by flows of volcanic rock.

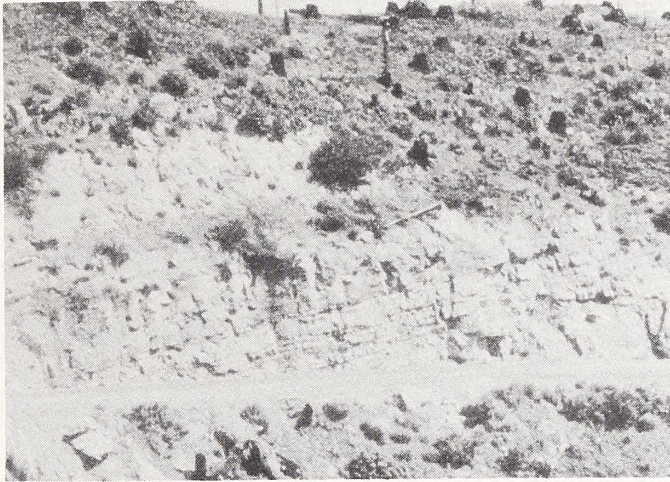
Figure 4. Tye formation

The Tyee occupies the greatest area of any formation in western Oregon (see Figure 2). The Tyee has massive beds, each of which grades upward from sandstone to siltstone. The colors range from medium-gray to bluish-gray on fresh surfaces and may appear tan to gray on weathered surfaces (see Figures 3a and 4).

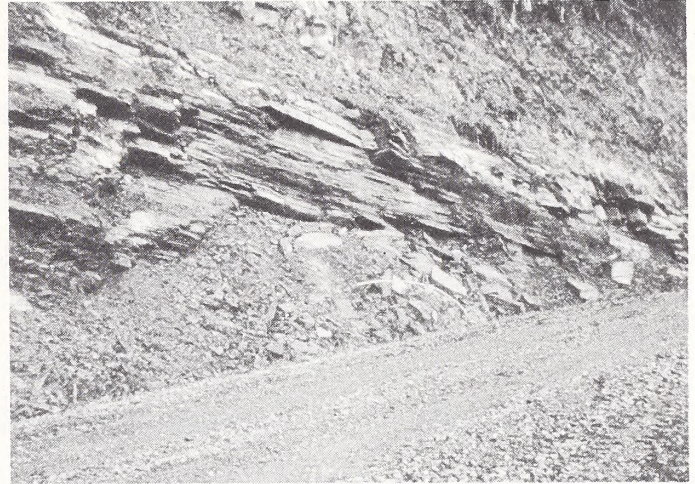
Figure 5. Yamhill formation

The Yamhill formation contains massive gray to greenish-gray sandstone with thinner beds of medium-gray to dark-gray, mudstone, shale, or siltstone (see Figures 3b and 5). The Yamhill is found in two general areas (Figure 2); one west of Salem and another northeast of Coos Bay.

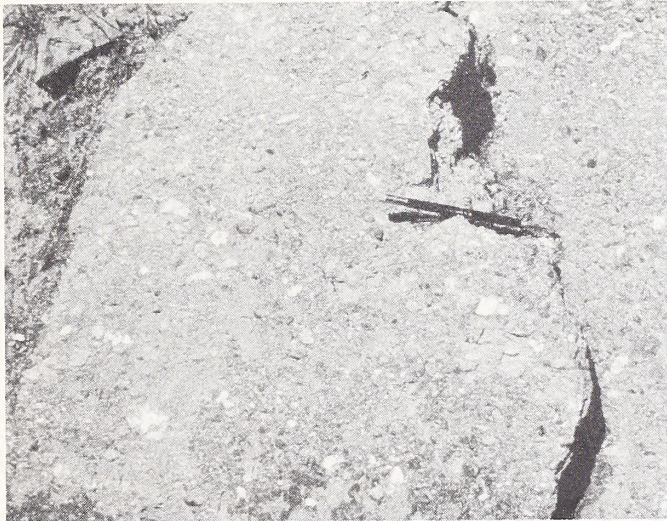
Figure 6. Conglomerate portion of the Umpqua formation

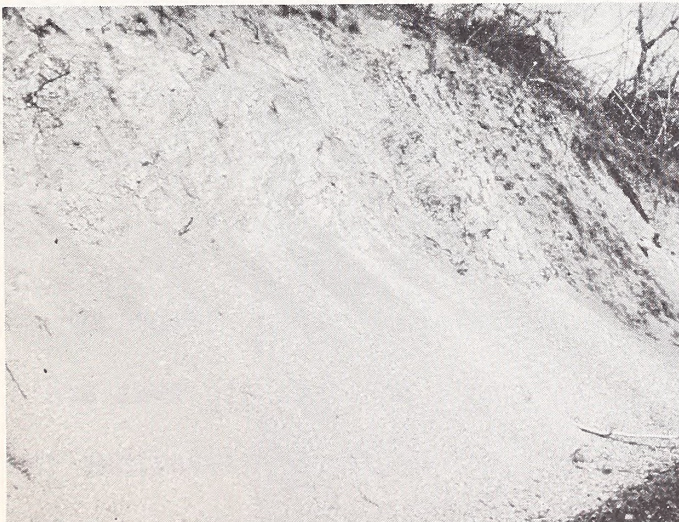
Figure 8. Nestucca formation showing weathered siltstone

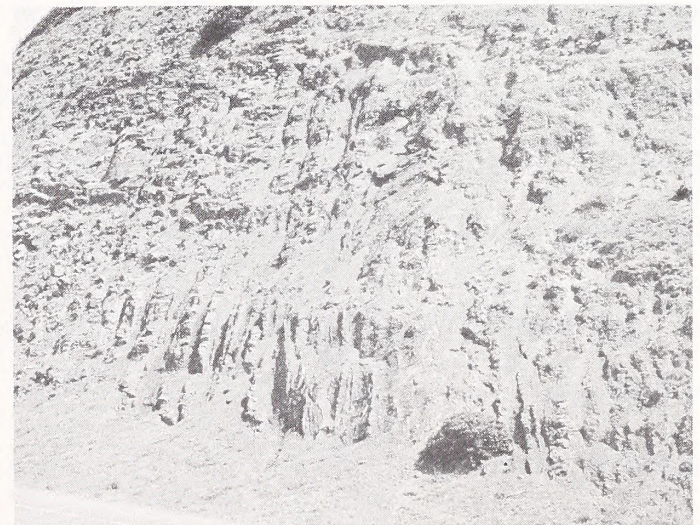
Figure 9. Otter Point formation

The appearance of the Otter Point formation, and associated formations with similar characteristics, is that of highly sheared, tan, dark-gray or black sandstone with interstratified thin mudstone, minor conglomerate, and volcanic material (Figures 3f and 9). This material occurs in small areas from Myrtle Creek (south of Roseburg) on west to a large block along the southwest Oregon coast.

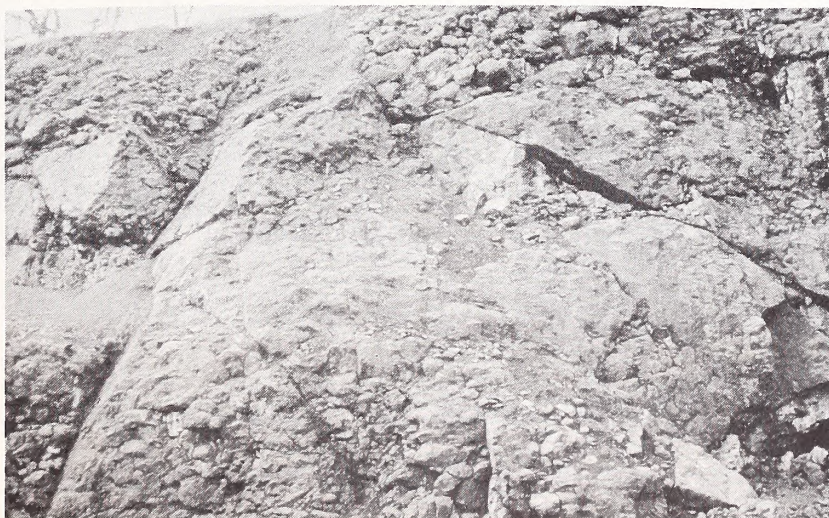
*Figure 10. Pillow lava showing characteristic rounded shapes*

marine basalt or pillow lavas because of their characteristic shape (Figure 10) and these tend to be relatively soft and easily eroded. This material is common in a large block of igneous rock in the Coast Range northeast of Tillamook (Figure 2).

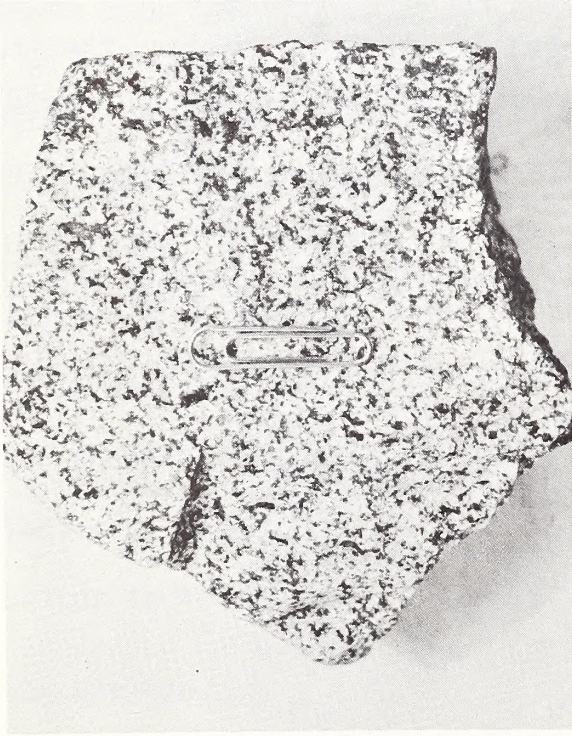
LIGHTER COLORED

COARSER  
TEXTURED

DIORITE

DARKER COLORED

GABBRO

FINER  
TEXTURED

ANDESITE

BASALT

Figure 11. Four common intrusive and extrusive igneous rocks

Photographs of four common extrusive and intrusive rocks are shown on Figure 11.

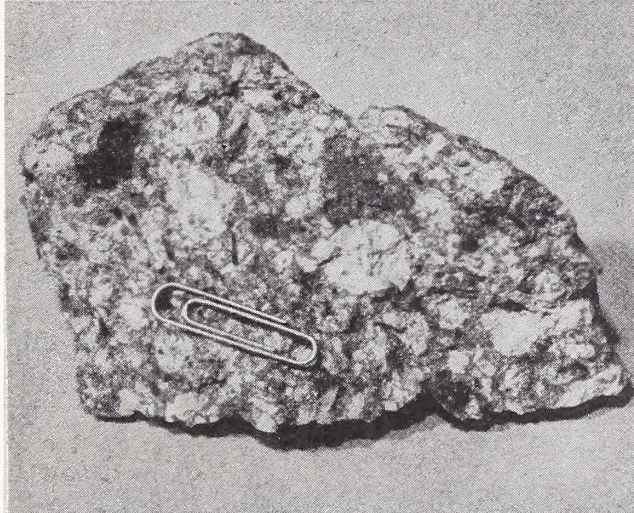
*Figure 12. Volcanic breccia with coarse, angular fragments 1/4" to 2" in size*

Pyroclastic rock is a type of extrusive igneous rock that was expelled from volcanic vents. This material is partially molten when it is expelled and the individual pieces may fuse together to form a weak, porous rock. More commonly, the angular fragments are deposited with volcanic ash to form volcanic breccia (pronounced "breshia") that appears as coarse, angular fragments 1/4 inch to 2 inches in size within a matrix of fine volcanic ash (Figure 12). If the size of the fragments imbedded in the ash are about 1/4 inch or smaller, then the resulting pyroclastic rock is known as tuff (pronounced "tough"); a photograph of this material is shown in Figure 13.

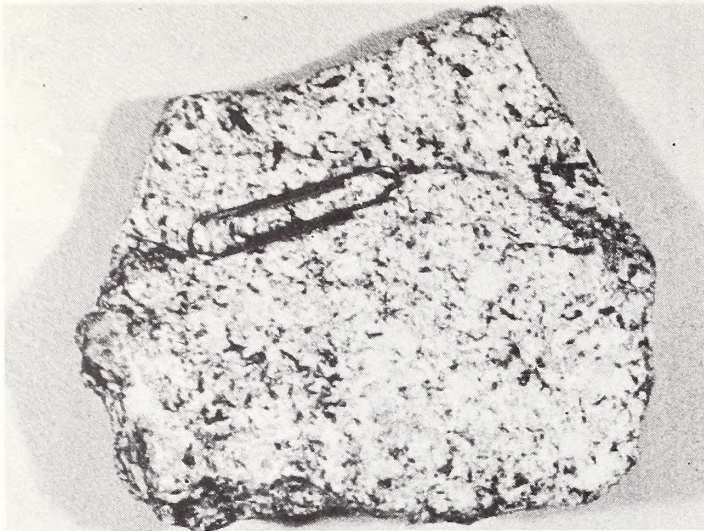
Figure 14. Granite is light colored and coarse-grained

Granite is a light-colored, coarse-grained rock (Figure 14) which is formed when molten material is intruded into surrounding rock; the rate of cooling is very slow and mineral crystals grow large. Variations in the chemical composition of this intrusive material creates a wide spectrum of granitoid (or granite-like) rocks (Figure 15). Weathered granitoid rock tends to crumble easily into a coarse "sand" as the weathering process degrades the grain-to-grain contact that holds the large crystals together. Granitoid rocks are found in the Klamath Mountains (also known as the Siskiyou Mountains) and in isolated spots in the Cascades (Figure 2).

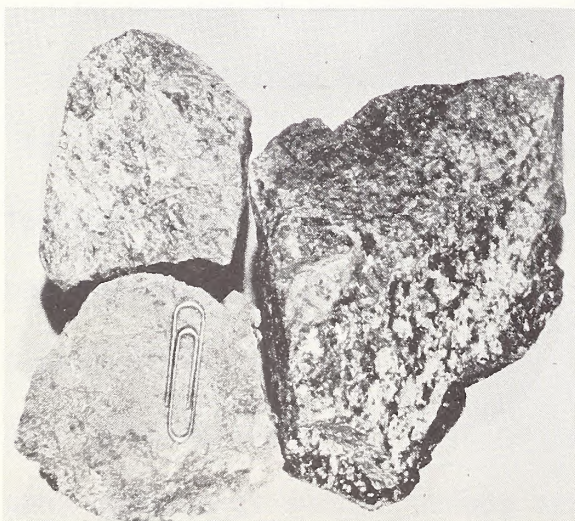
Figure 19. Serpentine may range from yellow-green, through bluish-white, to black

The color of serpentine ranges from yellow-green, bluish-green, or olive-green to almost black (Figures 19 and 20). Note in Figure 2 that serpentine appears as extensive areas and also quite frequently as thin belts or streaks, oriented southwest to northeast in the Klamath Mountains and along the southwest coast.

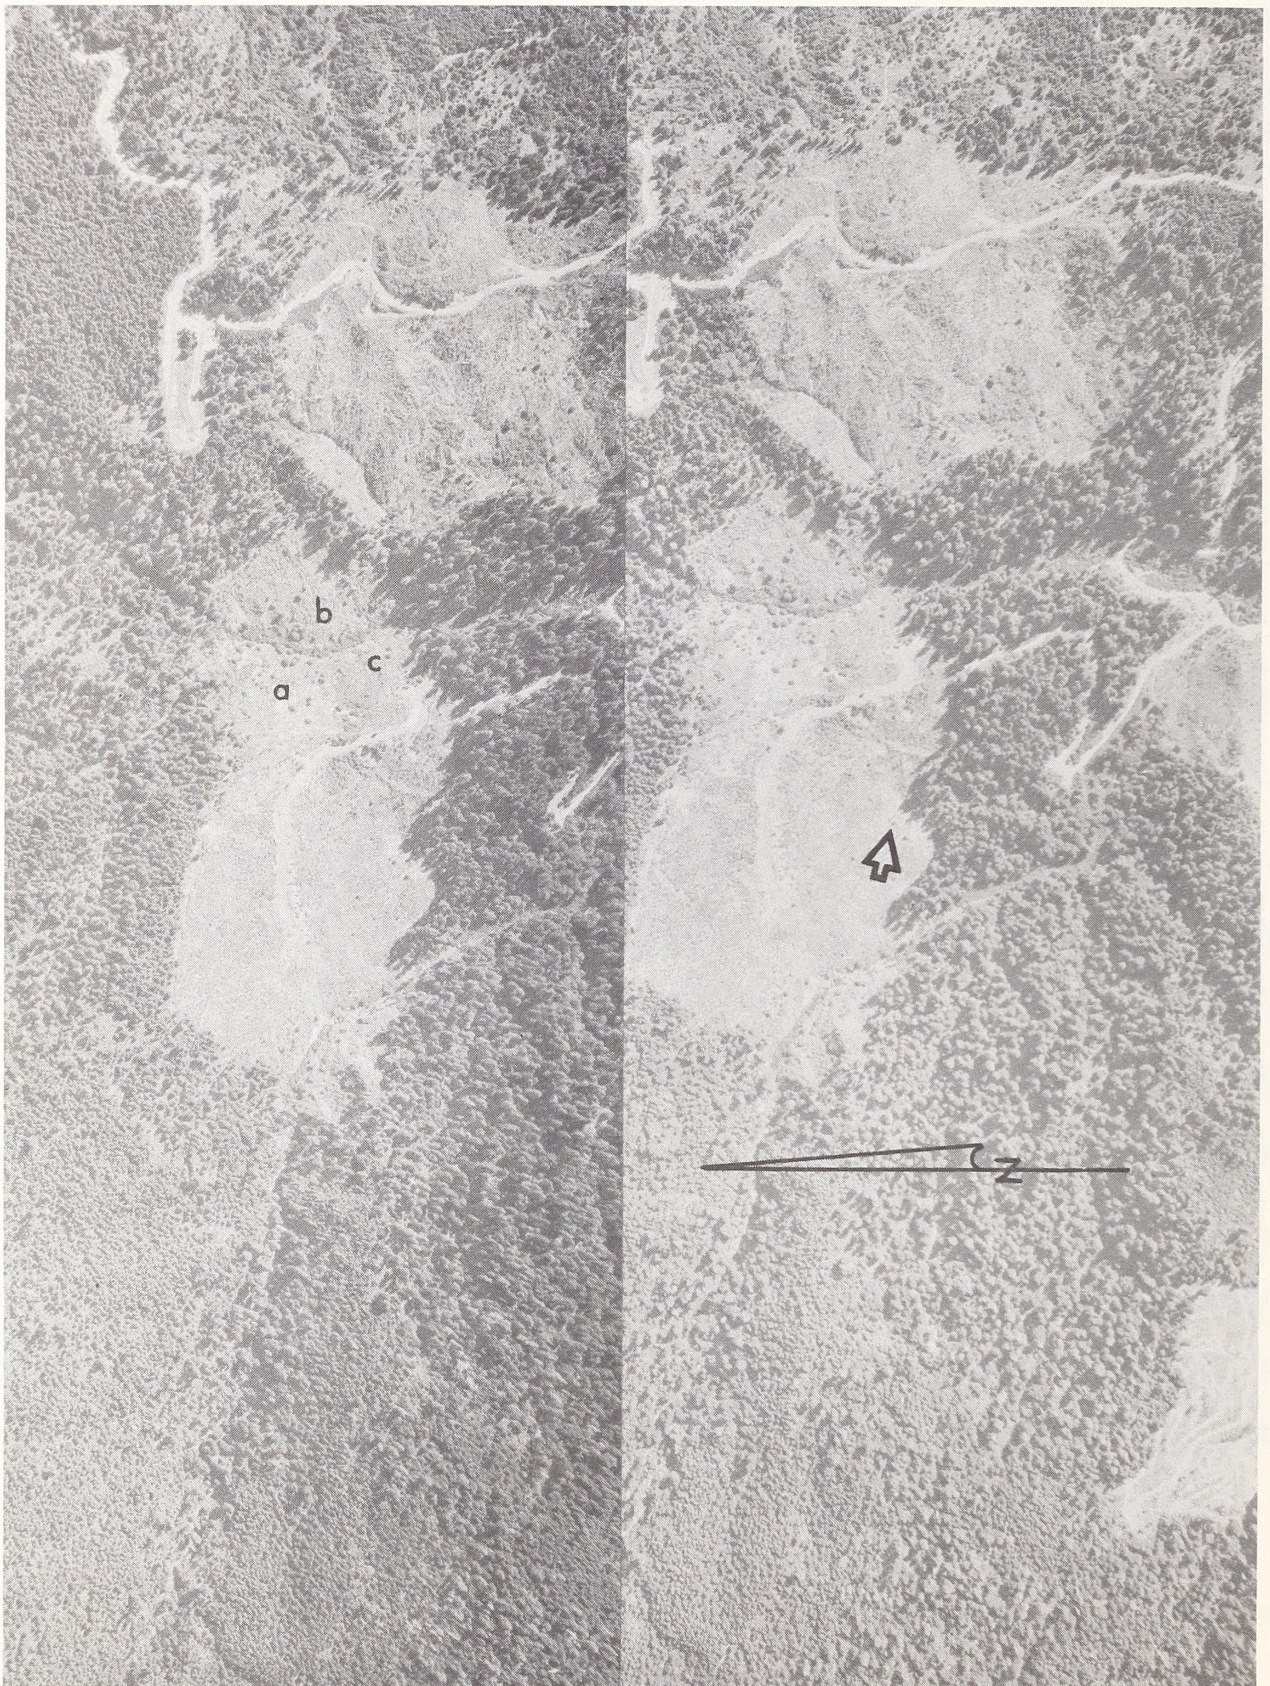
Figure 22. Stereogram of fault zone outlined in Section 27 of Figure 21. Large slump in center of photo; actively failing slopes at a and b. Arrow points to a dry sag pond below the slump.

A rectangular area is outlined on the topographic map in Section 21, and a stereogram that was developed from aerial photography of this area is shown in Figure 22. The locations of the fault zones were transferred from the topographic map to the stereogram. An examination of the stereogram through a stereoscope will show that there is a large slope failure on the fault zone. This is an old failure as indicated by the lack of exposed soil and by the fact that mature timber was harvested from this area. An examination of this area on the ground showed that igneous rock had intruded into the fault, that the slopes at A and B are actively moving, and that the slope at C has slid into the stream since these photographs were taken.

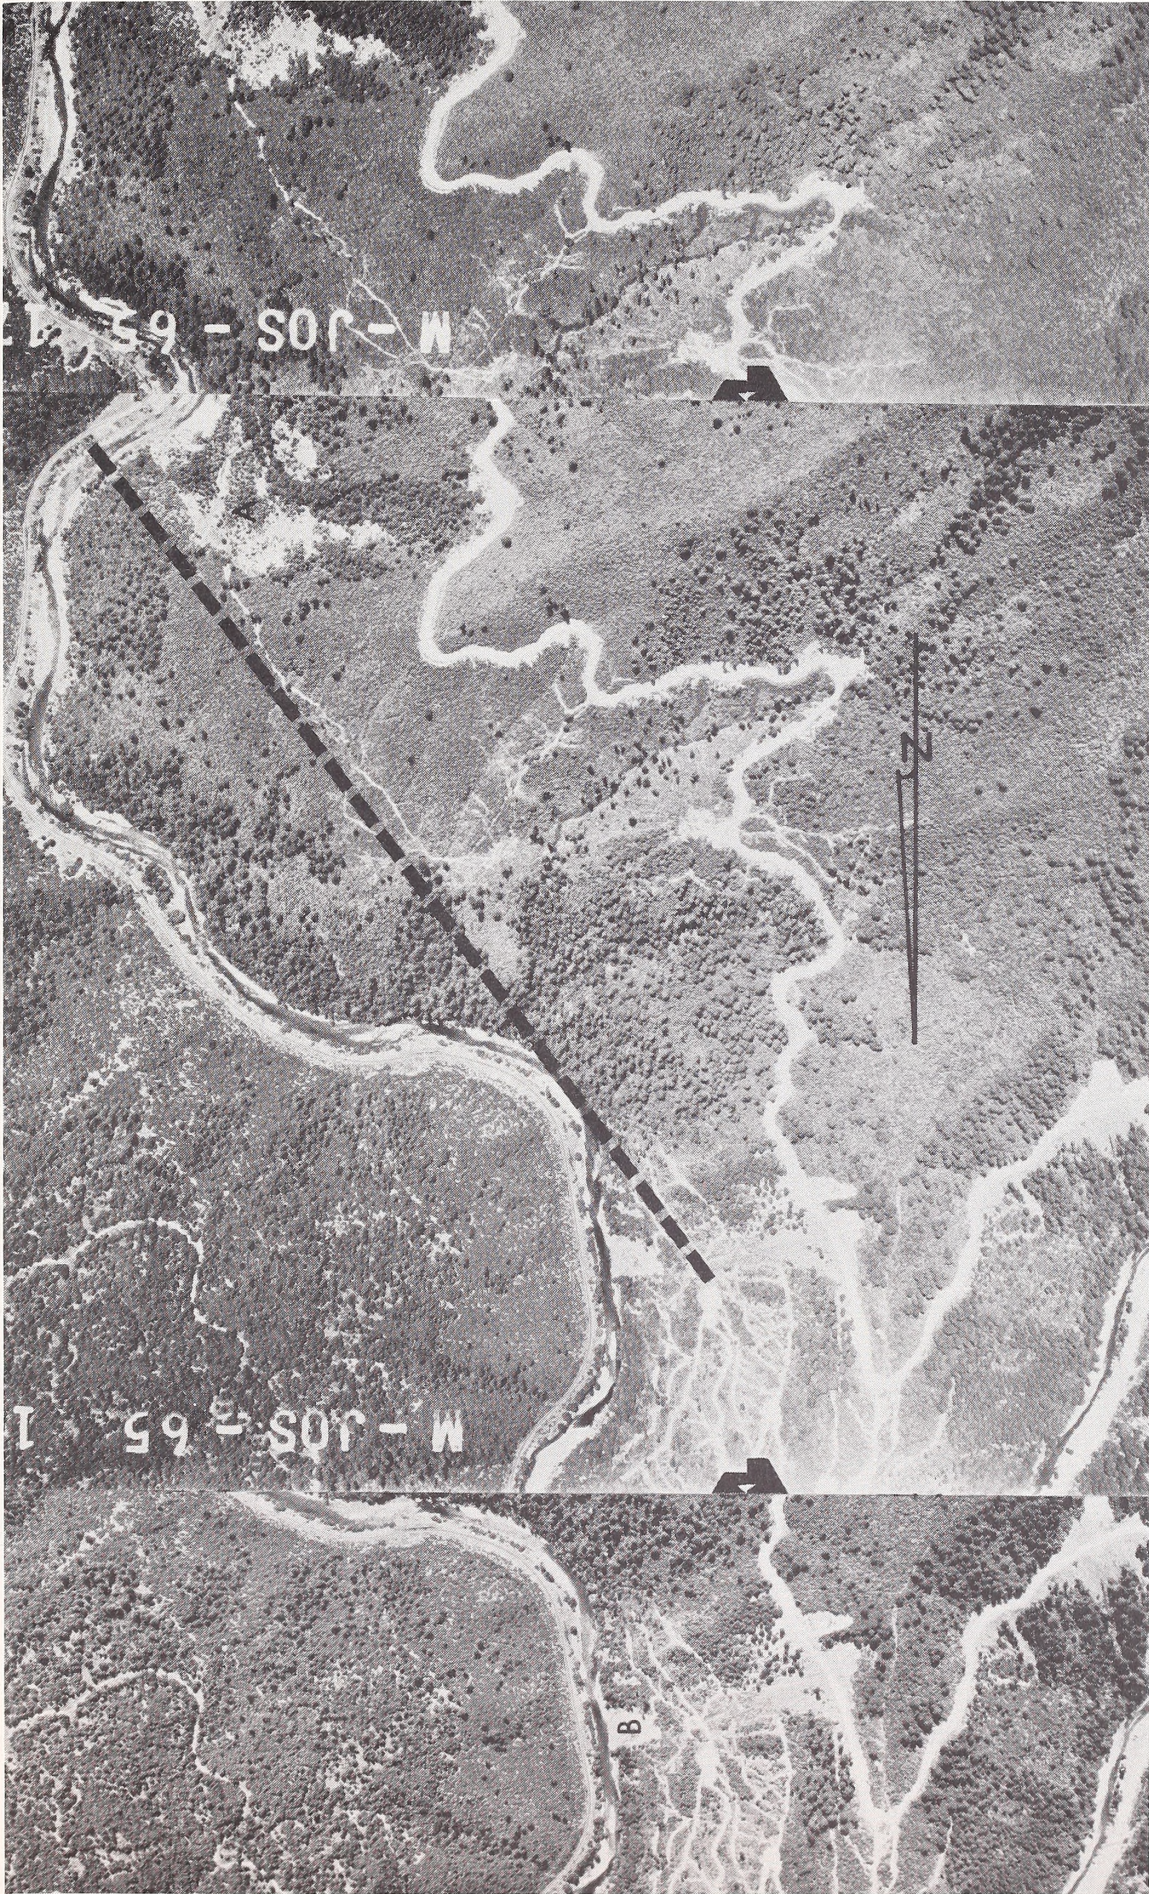
Figure 23. Stereogram of a possible fault zone. The location of the fault is indicated by the dashed line through the low saddle between the large, older slump at A and the newer slope failure at B.

Aerial photographs should be carefully examined for possible fault zones when neither geologic maps nor topographic maps offer any clues. Figure 23 is a stereogram of a portion of Cow Creek, south-southwest of Roseburg, together with a portion of the topographic map of this area. A possible fault zone is indicated

on the stereogram; note that it passes through several saddles and begins and ends in Cow Creek. Also note the large, old slide at A and the newer slide at B. These photographs were taken in 1965; since then a highway has been constructed along Cow Creek on the bank across from the railroad. The slide at B has enlarged, has been actively moving, and has buckled the highway at the base of the slide. Further evidence of a fault zone through this area is shown in the photograph of a rock from the slide at B (Figure 24). The important feature is the slick, shiny surfaces, called "slickensides", that are caused by the intense heat developed by friction on sliding surfaces within a fault zone.

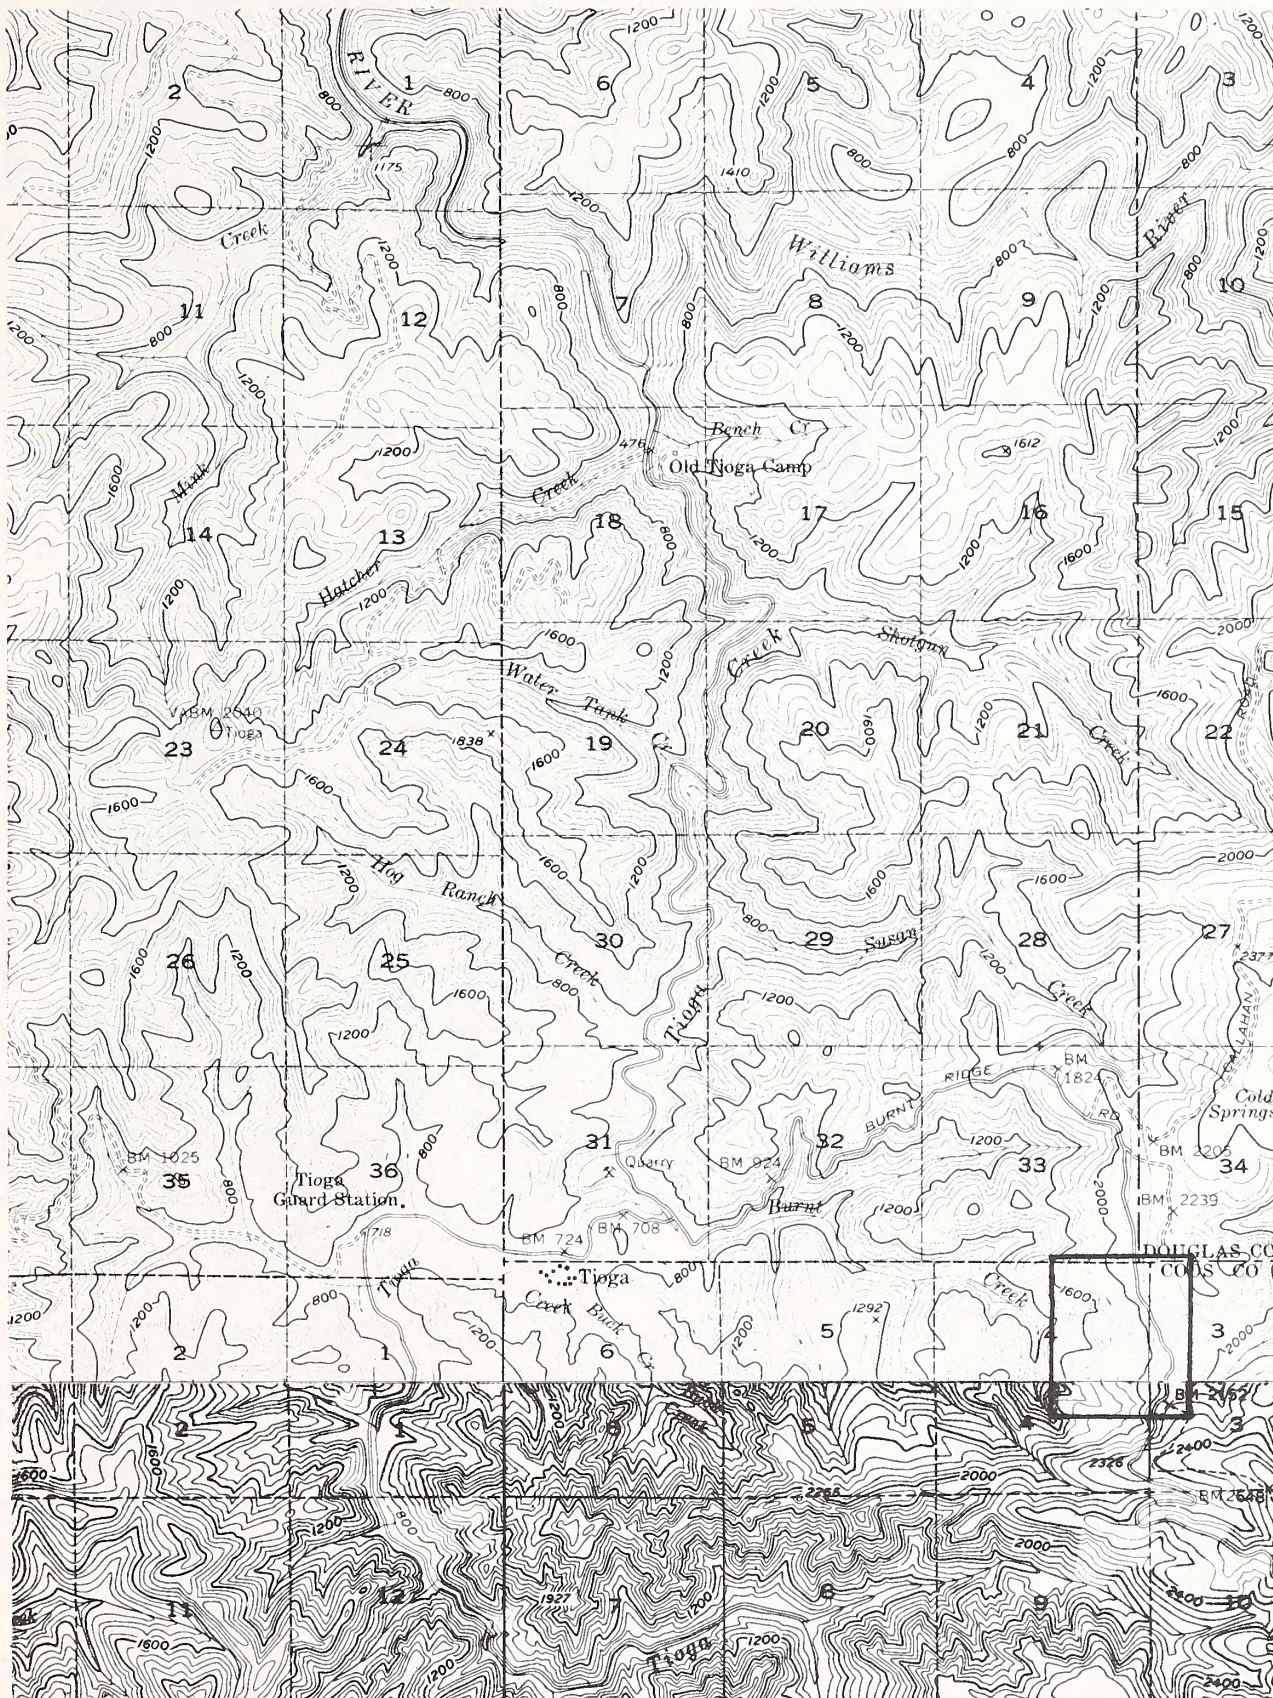
Figure 25. A portion of the Ivers Peak and Sitkum Quadrangle topographic map (T. 26 and 27 S., R. 9 and 10 W.). There is no indication of a fault zone on these maps. The outlined area identifies the stereo coverage on Figure 26.

Field personnel should be alert for on-the-ground evidence of faulting when neither geologic maps nor topographic maps provide definite clues to the location of faults. For example, Figure 25 contains portions of the Sitkum and the Ivers Peak quadrangle topographic maps. Note that these maps do not show any definite indication of a fault zone. Figure 26 is a stereogram of a suspected fault zone; this stereo coverage is outlined in black on Figure 25. Timber has been harvested from several of the small drainages and fractured and uptilted rock may be seen at Point A. Figure 27 shows a photo of Point A taken from the spur road at B. This direct evidence of faulting probably could not have been

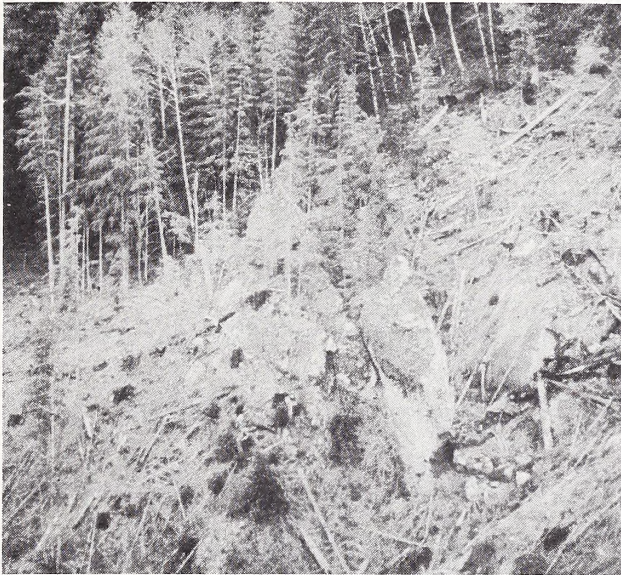
*Figure 27. Photograph of the fault zone shown at point A on Figure 26*

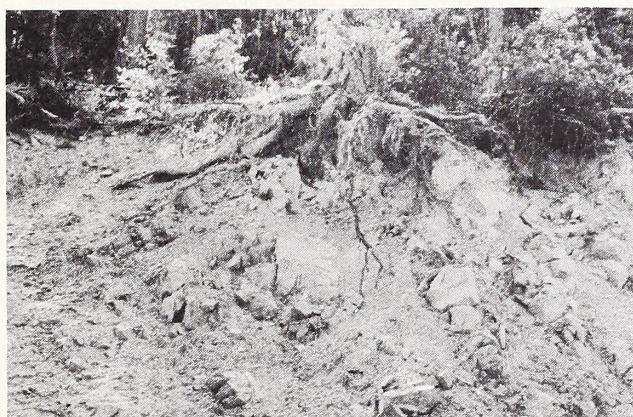
*Figure 34 (left). This illustrates how tree roots act to hold shallow soil to fractured bedrock.*

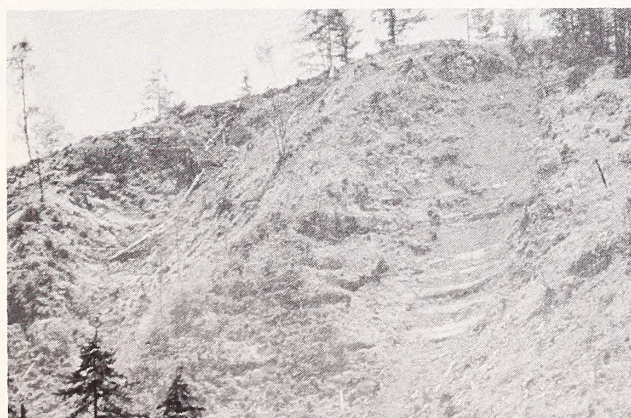
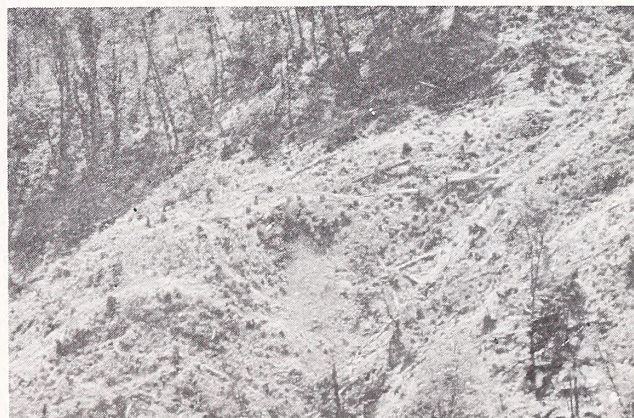
*Figures 35 and 36 (below). These photographs show shallow landslides that originate on clearcut areas. They often occur in small drainages where ground water may accumulate.*

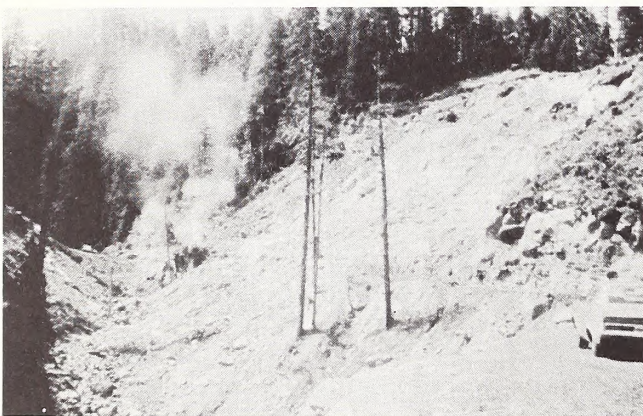
*Figure 38. A rockslide in bedded sedimentary material*

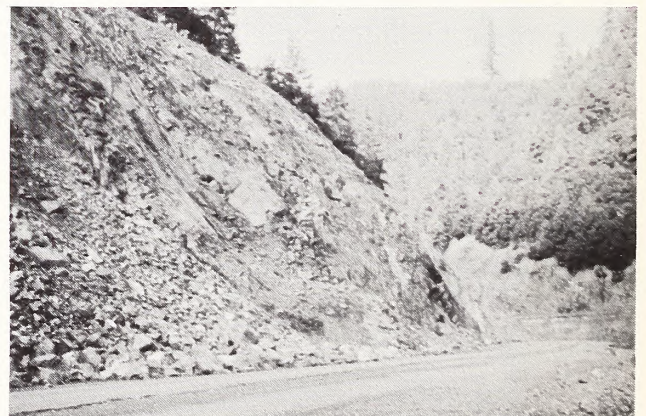
*Figure 39. A photo of the rockslide illustrated at point B in Figure 23. Note how the shifting rock is lifting the road and moving it to the right towards Cow Creek*

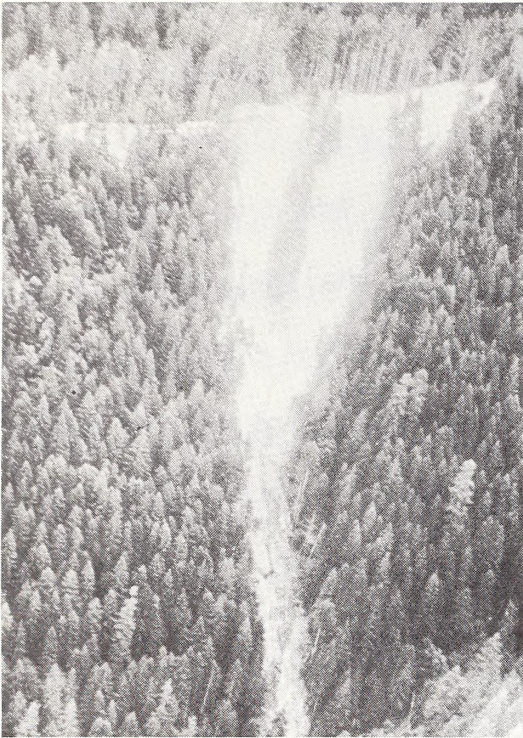
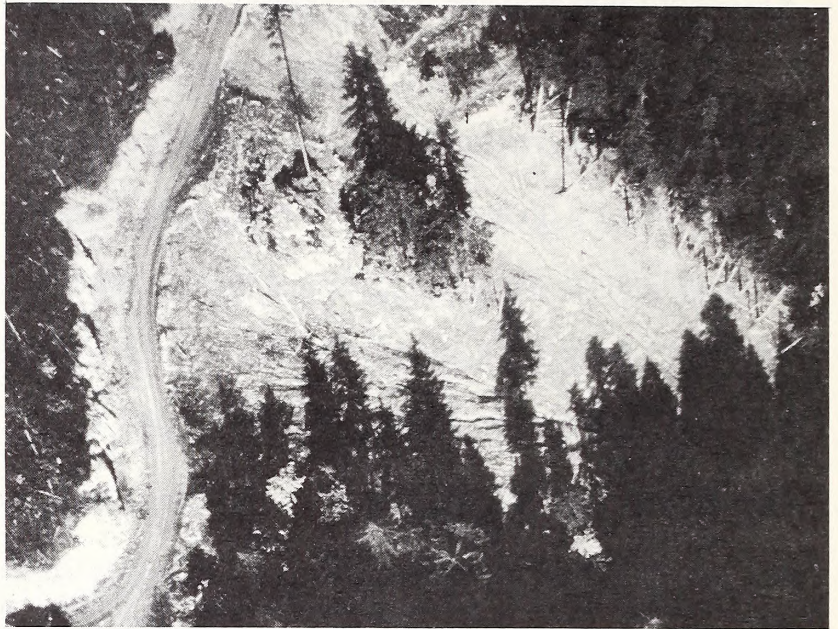
Figure 40 (left) and Figure 41 (above). These are two examples of debris avalanches in shallow soils on steep slopes.

These two closely related types of slope failures usually originate on shallow soils relatively low in clay content on steep (>65%) slopes (Figures 40 and 41). In southeast Alaska, the Forest Service has found that debris avalanches develop on slopes greater than 65 percent on shallow, gravelly soils and that this type of slope failure is especially frequent on slopes over 75 percent (Swanston, 1969 and 1970). An excellent description of debris avalanches and flows is given in Bailey, parts of which are quoted below:

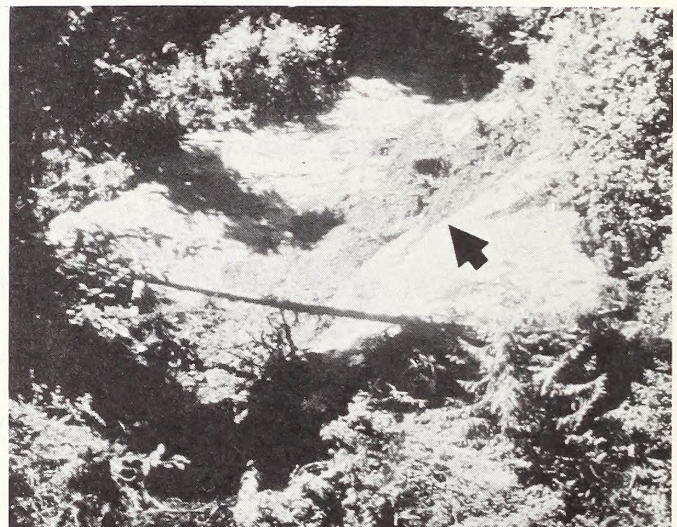
Figure 43 (below). The arrow shows loose material, dark with ground water.

There are two situations where these types of slope failure are most common. The first situation is an area of the bedded sediments where stream development and geologic erosion have formed high ridges with long slopes, and steep, V-shaped drainages. The gradient of many of these streams increases quite sharply from the main stream to the ridge, and erosion has created headwalls in the upper reaches. The headwall region is often the junction for ephemeral stream channels which begin at the ridgetop. This leads to a quick rise in ground water levels during winter rains. Past debris avalanches may have scoured round-bottomed chutes, or troughs, into the relatively hard bedrock (Figure 42). The headwall region is covered with only a shallow soil mantle of precarious stability, and it may show exposed bedrock often dark with ground water seepage (Figure 43).

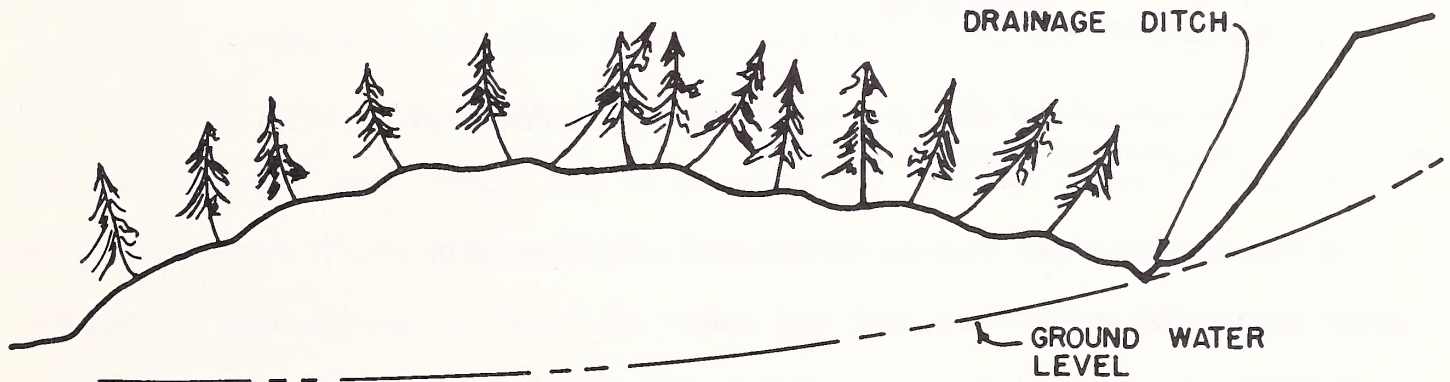
*Figure 49. Drainage of surface water can increase slope stability by lowering the ground water level*

# HOW DRAINAGE OF SURFACE WATER CAN INCREASE SLOPE STABILITY

SAG PONDS ADD WATER TO THE GROUND WATER RESERVOIR AND INCREASE THE POTENTIAL FOR FURTHER SLUMPING.

DITCHES CAN DRAIN SAG PONDS, LOWER THE GROUND WATER LEVEL, AND INCREASE SLOPE STABILITY.

Assuming that it is absolutely necessary to locate a road through terrain with a potential for slumping, there are several techniques that may be considered to prevent slumps and earthflows. Improved surface drainage is one of the cheapest and most effective techniques and one that is often overlooked. Sag ponds and depressions can be connected to the nearest stream channel with ditches excavated by bulldozer or ditching powder. Figure 49 shows the theoretical effect on the ground water reservoir of a surface drainage project. Improved surface drainage removes water quickly, lowers the ground water level, and helps stabilize the slump.

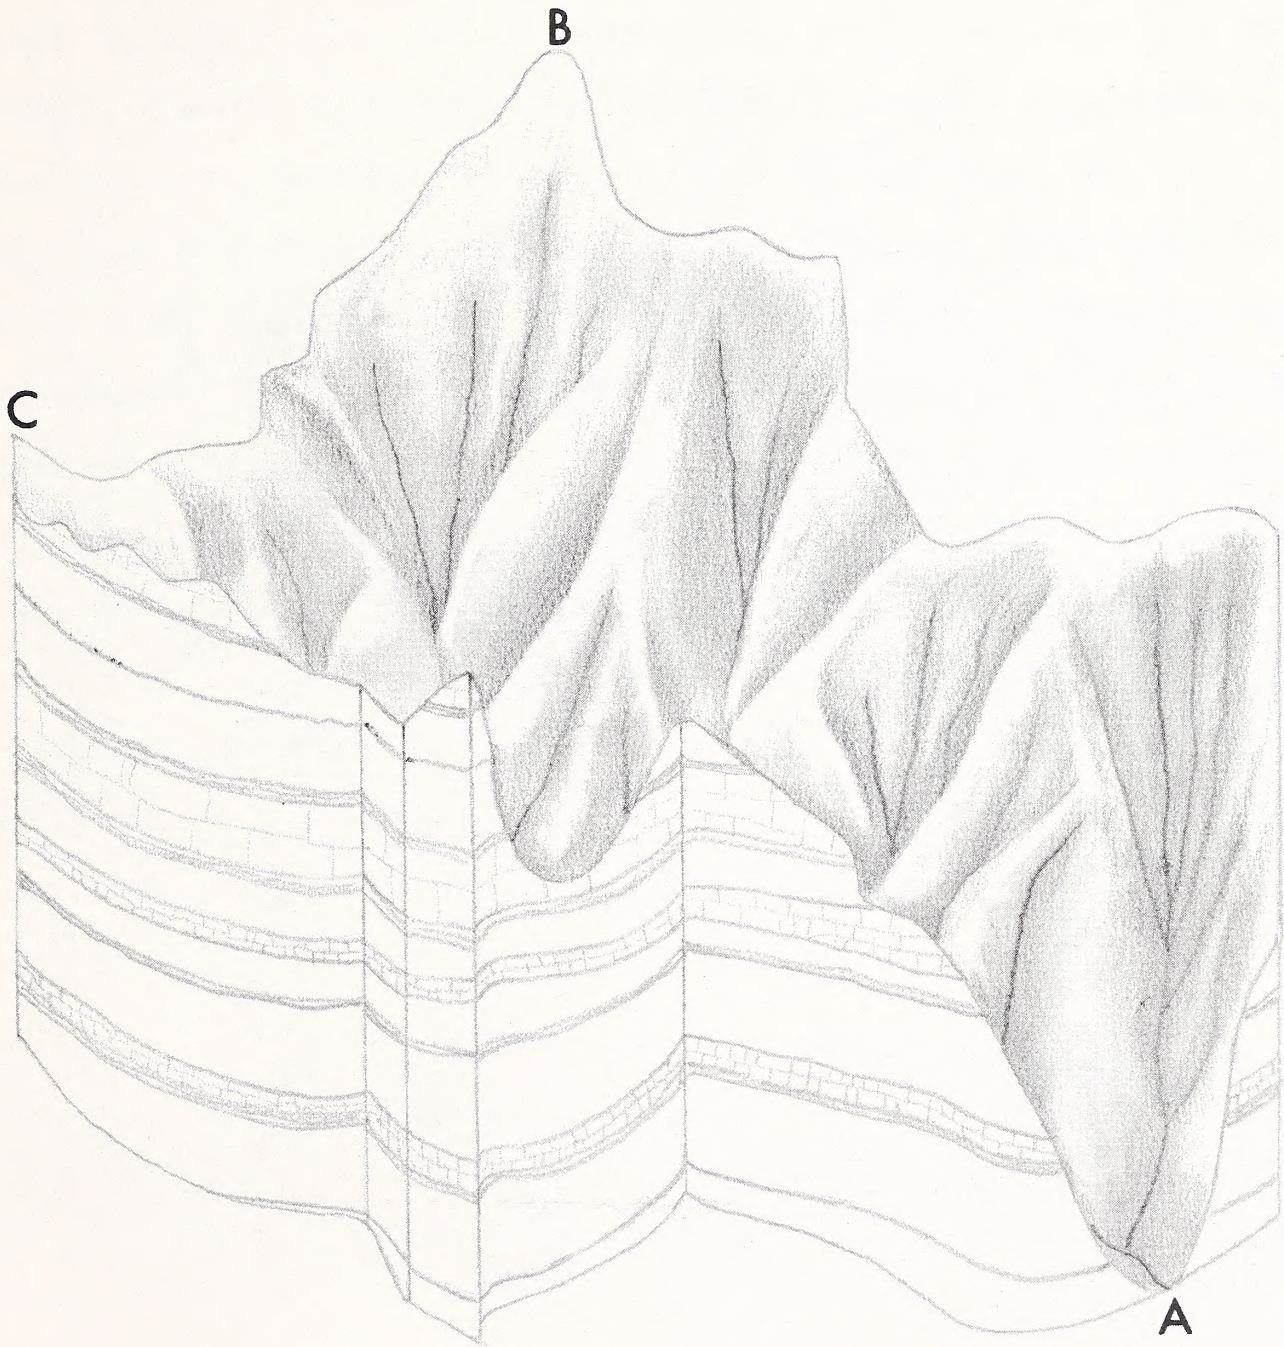
Figure 52. A block diagram of Type I sites, the steep, highly dissected terrain with sandstone bedrock where debris avalanches are the most common kind of slope failure. This diagram was made from the topographic map of the drainage basin outlined in Figure 53. The mouth of the basin is at point A, and two high points are identified as points B and C. The vertical scale of the block diagram is greatly exaggerated. Note the steep headwall areas below point B and above point A. Compare with Figure 65.

the junction for several ephemeral streams that can cause sharp rises in the ground water levels in the headwall region during winter storms. It is quite common to note ground water seepage on exposed bedrock in the headwall even during the summer. Figure 52 shows a block diagram that illustrates the features of Type I sites. This area was taken from the upper Smith River as shown on the topographic map in Figure 53.

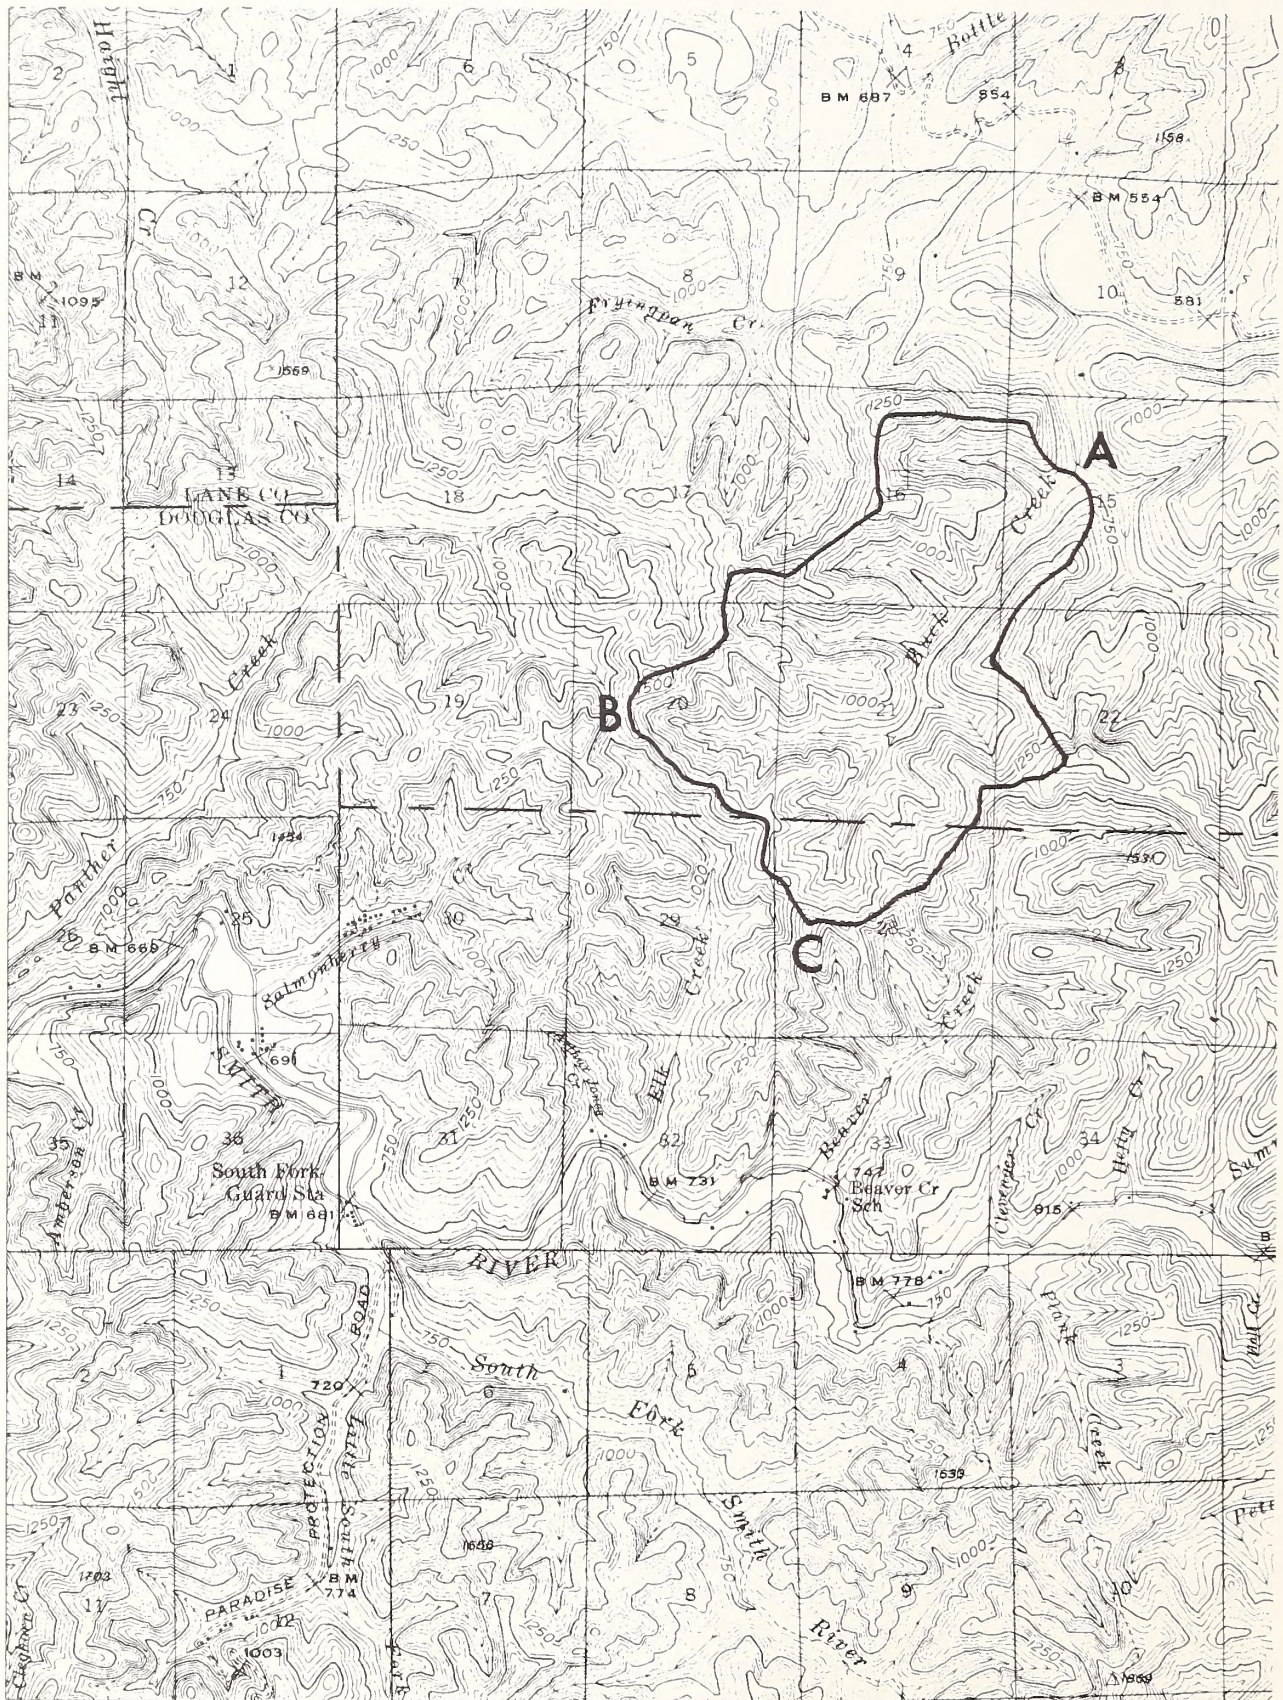
Figure 53. A topographic map of the steep terrain with sandstone bedrock where debris avalanches are the most common type of slope failure. The basin outlined in black is shown in the block diagram in Figure 52. Points A, B, and C may be used for orientation. Note the characteristic drainage pattern. Compare with Figure 66.

Figure 53 shows the steep, highly dissected terrain that is distinctive of Type I sites in western Oregon. Small scale topographic maps (such as the Western United States, 1:250,000 scale) may be used with Figure 2 to outline areas within the bedded sediments that are likely to have Type I slope stability problems. Some of these areas are: tributaries on the north side of the Alsea

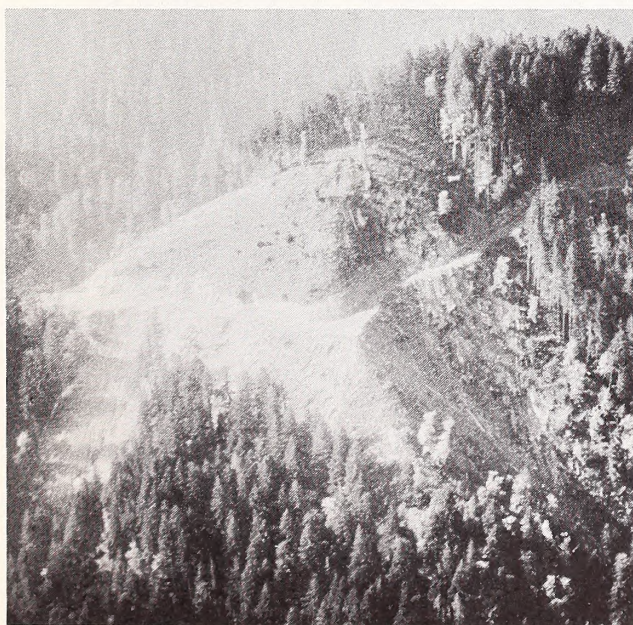
*Figure 54. A photo of two steep headwalls where sidecast material from roads can cause debris avalanches*

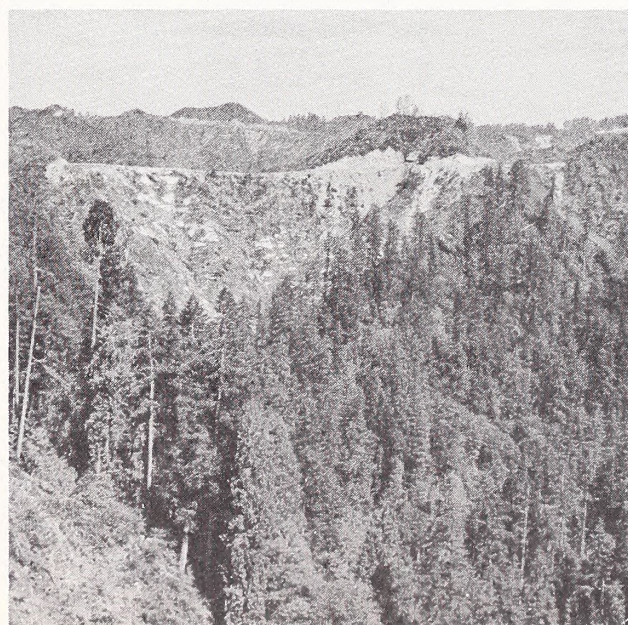
*Figure 55. A view of several headwalls with extremely steep slopes and thin soils*

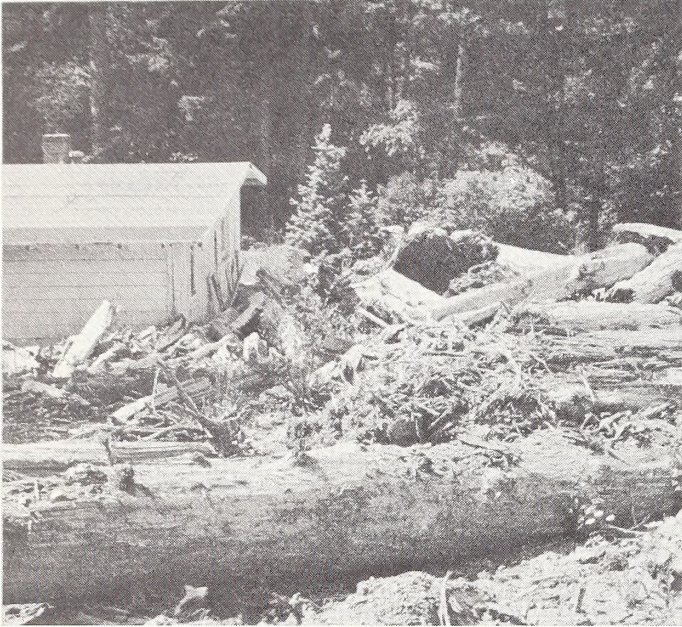
*Figure 56. The result of a debris avalanche from a road fill in a headwall in sandstone material*

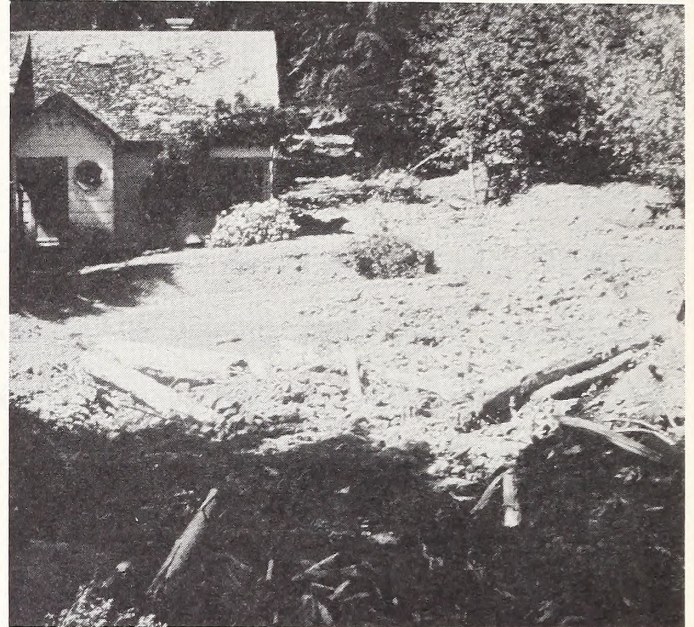
*Figure 57. A debris flow came down the stream channel just to the right of the house*
