# GUIDE TO REDUCE ROAD FAILURES IN WESTERN OREGON

August 1973

Bureau of Land Management  
Oregon State Office  
P.O. Box 2965  
Portland, Oregon 97208

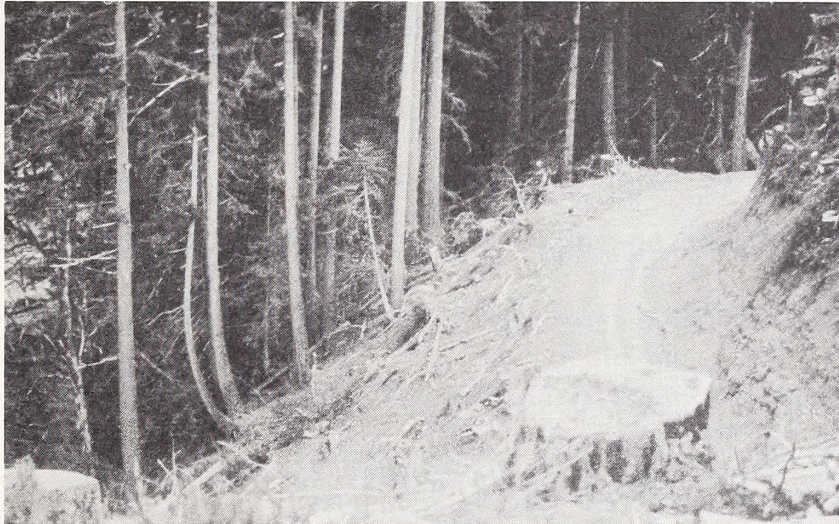
*Figure 58 (left). Pistol-butted trees may be used as an indicator of active soil movement when the trees were young*

Pistol-butted trees (Figure 58). These trees were tipped downslope while small as a result of sliding soil or debris, or as a result of active soil creep. As the tree grew, the top regained a vertical posture. Note, pistol-butted trees may indicate slope instability on other areas throughout western Oregon, but it should be kept in mind that deep, heavy snowpack at high elevations, such as the High Cascades, may also cause this same deformation.

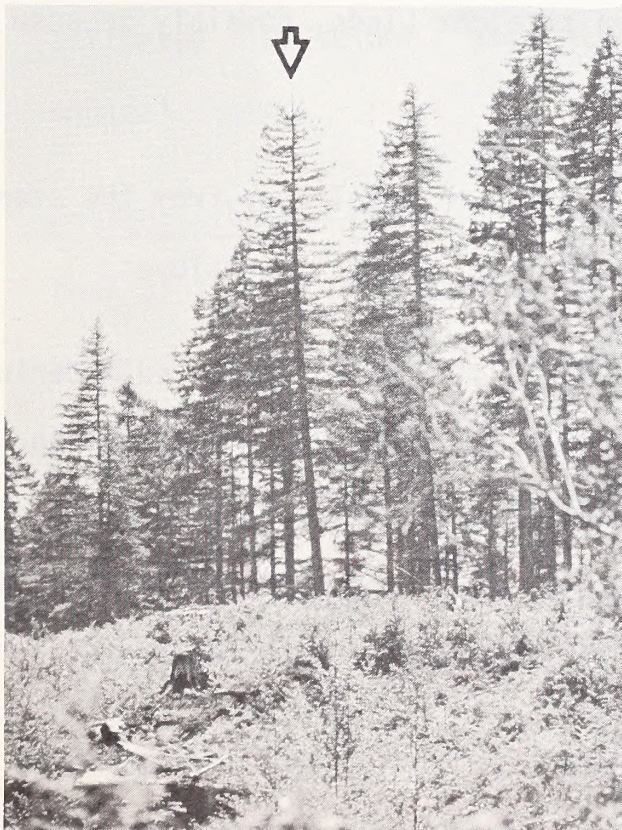
*Figure 59. Tipped trees have a sharp angle in the stem.*

Tipped trees (Figure 59). These trees have a sharp angle in the stem. This indicates that the tree grew straight for a number of years until a small shift in the soil tipped the tree and the angled stem is the result of the recovery of the vertical attitude.

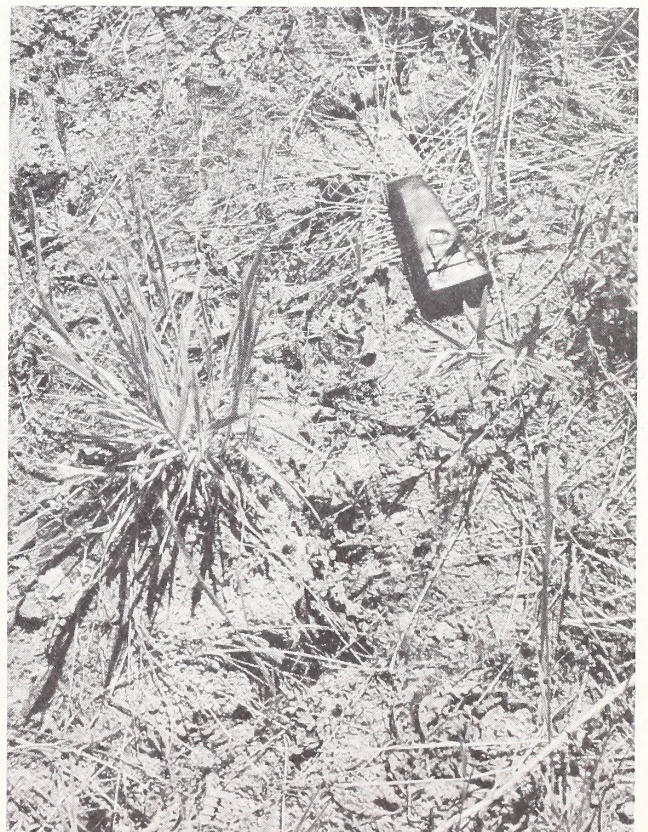
*Figure 60. Tension cracks may be hard to find, but they indicate active soil movement*

Tension cracks (Figure 60). Soil creep builds up stresses in the soil mantle which are sometimes relieved by tension cracks. These features may be hidden by vegetation but they definitely indicate active soil movement.

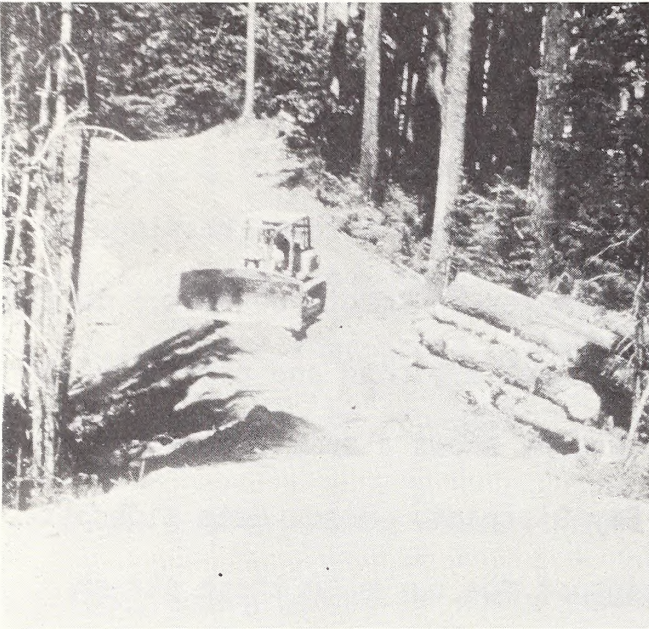
Figure 61. Endhailed material may be compacted on flattened ridges.

Fill saddles. Narrow saddles may be used to hold endhailed material by first excavating narrow bench roads below, and on each side of the saddle. The saddle may then be flattened and the loose material that rolls down-slope will be caught by the benches. Endhailed material may be compacted on the flattened ridge to build up the grade (Figures 61 and 62).

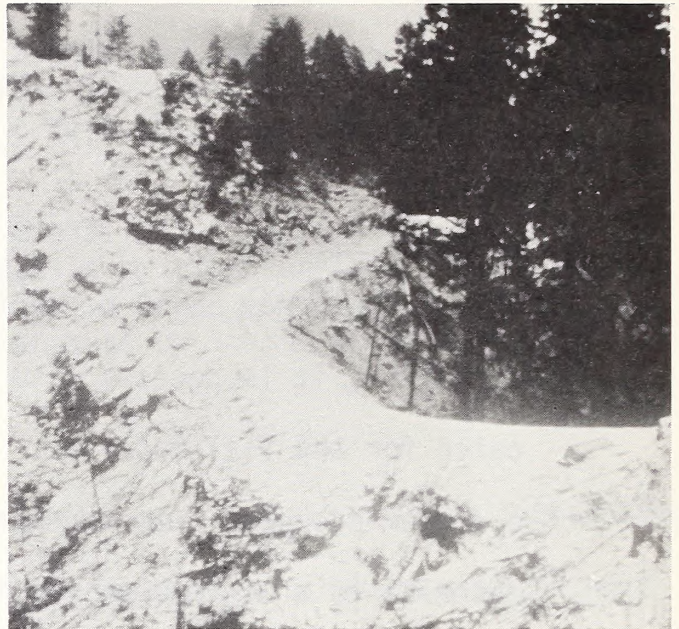
Figure 62. This ridge road has remained stable for two winters.

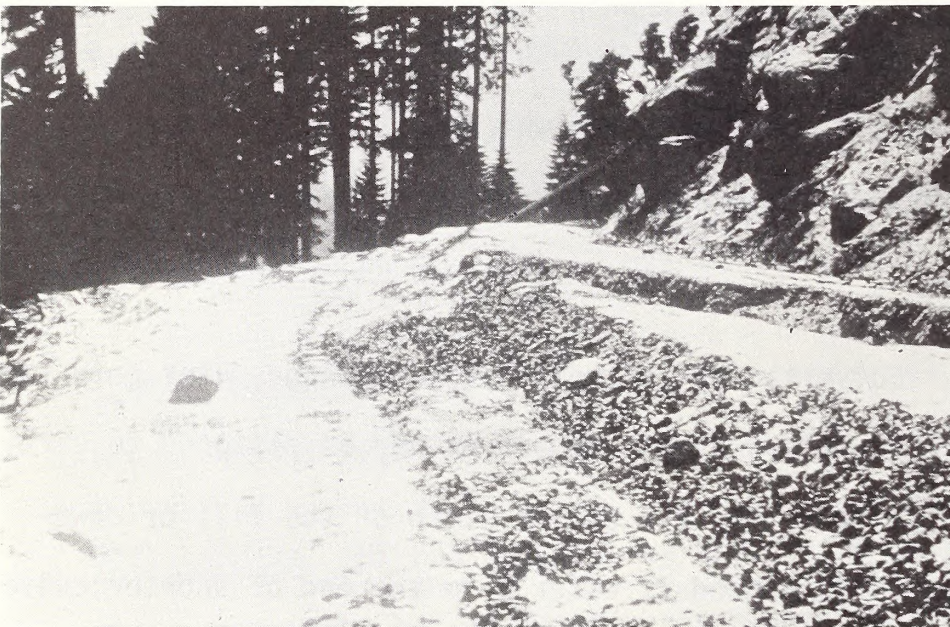
Figure 63 (left). A disposal site for end-hauled material was located to the left of, and below, the road. Note the cracked and sunken grade.

Select safe disposal sites. Disposal sites for endhailed material should be chosen with care to avoid overloading a natural bench or spur ridge and causing slope failure (Figure 63). The closest safe disposal site

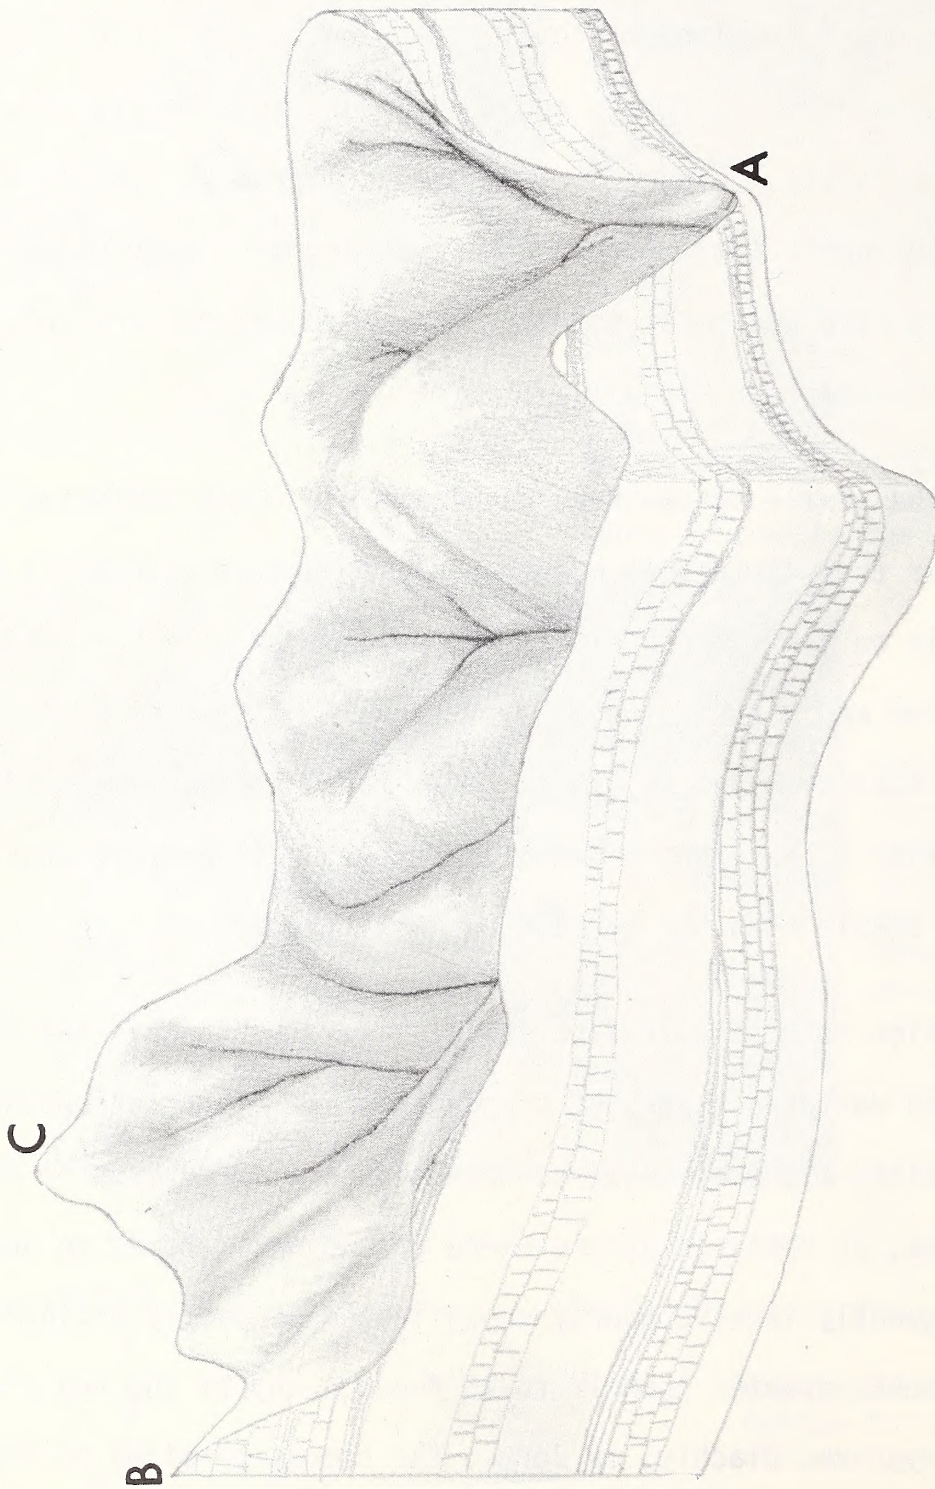
Figure 65. A block diagram of Type II sites. The geologic material is sandstone; the slopes may range from 10% to 80% but the soils are deeper and the ridges are more rounded. Compare with Figure 52. Slumps and earthflows are the most common type of soil failure. This diagram was made from the topographic map of the drainage basin outlined in black on Figure 66. The mouth of the basin is at A, and the high points are at B and C.

Figure 52. A block diagram of Type I sites, the steep, highly dissected terrain with sandstone bedrock where debris avalanches are the most common kind of slope failure. This diagram was made from the topographic map of the drainage basin outlined in Figure 53. The mouth of the basin is at point A, and two high points are identified as points B and C. The vertical scale of the block diagram is greatly exaggerated. Note the steep headwall areas below point B and above point A. Compare with Figure 65.

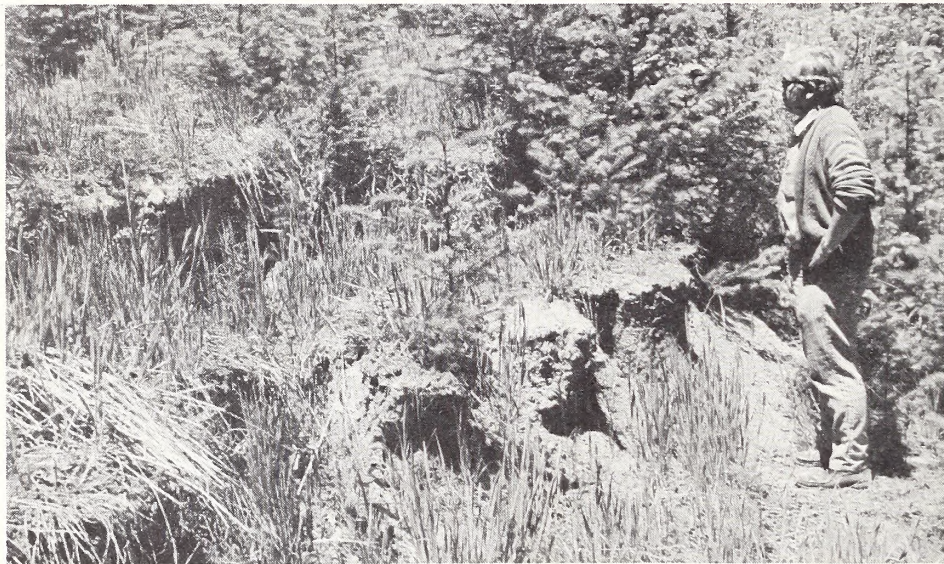
*Figure 67. Cat steps, or small scarps, result from slope failures.*

Vegetative indicators of unstable portions of the landscape include mature trees that tip or lean as a result of minor earthflow or soil creep on the steeper slopes. Tipped or leaning trees may also be found on poorly drained soils adjacent to the stream channels. Actively moving slopes may show tension cracks or cat steps (Figure 67), particularly on the steeper slopes.

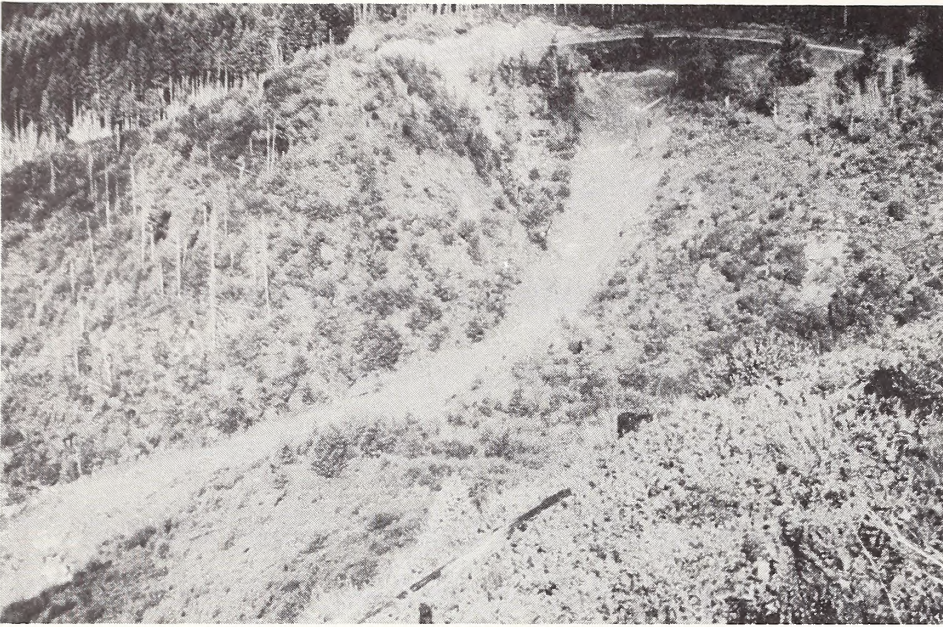
*Figure 68. Failures of saturated, clayey fills may begin as a slump, then continue as a mud flow.*

Special attention to fills. Fills of clayey material over steep stream crossings may fail if the material is not compacted and if ground water saturates the base of the fill. Fill failures in this wet, clayey material on steep slopes tend to move initially as a slump, then may change into a mud flow down the drainage (see Figure 68). To reduce the chance of fill failures, the following alternatives are suggested:

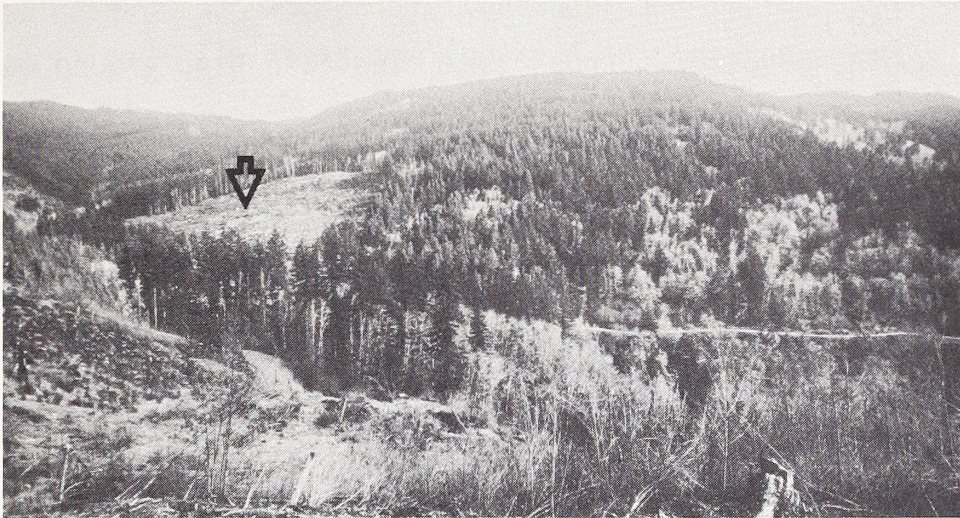
Figure 69. Terrain derived from weathered siltstone of the Nes-tucca formation. Note the hummocky slopes, the large slump in a clearcut area (arrow), and the hydrophytes on the hillside at the right of the photo.

The Nestucca formation contains considerable siltstone and the stability problem originates in the siltstone that is basically incompetent and easily weathered. Slumps and earthflows, both large and small, are very common when this material is subjected to heavy winter rainfall (as much as 100 inches in the Nestucca River basin). The slopes may exhibit a benchy or hummocky appearance and slopes with gradients as low as 24 percent may be considered to be unstable in deeply weathered siltstone with abundant ground water. Many of the higher ridges in the Nestucca formation are composed of intrusive volcanic rock and the siltstone forms the easily eroded basins bounded by the harder material. Bear Creek drainage, a tributary of the Nestucca River, contains examples of these stability problems (Figure 69).

Vegetative and topographic indicators of slope instability are numerous. Large patches of alder, maple, or other hydrophytes<sup>1/</sup> indicate high ground water levels and impeded drainage (see the large patch of alder and big leaf maple in Figure 69). Conifers may be caused to tip or lean by earthflow or soil creep. Slumps cause numerous benches, some of which show sag ponds (Figure 71). Blocks of soil may sag and leave large cracks which gradually fill in with debris and living vegetation. The sharp contours of these features soften in time until these cracks appear as "blind drainages" or sections of stream channel which are blocked at both ends. These cracks collect water, keep the ground water reservoir charged, and contribute to active soil movement.

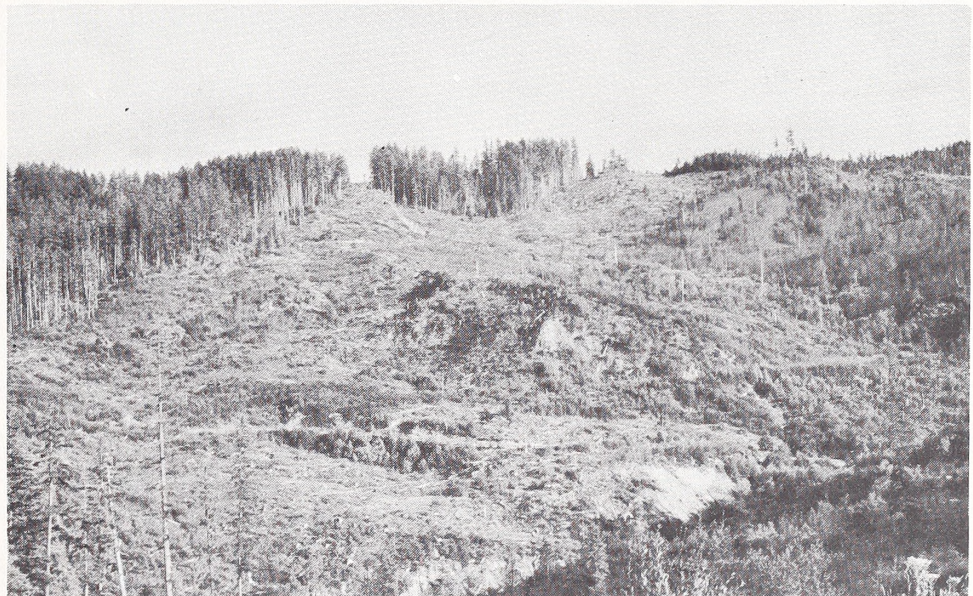
Figure 70. Terrain derived from the Otter Point forma-tion. Note evidence of old slumps, and the recent slump in right foreground.

The Baker Creek area (Figure 70), a tributary of the South Fork of the Coquille River, illustrates these same stability problems in the Otter Point formation. Here, a relatively hard, dark sandstone (Figures 3f and 9) forms the boundary for the basins and the easily weathered siltstone causes slumps and earthflows similar to those in the Nestucca River basin. In Baker Creek, however, the situation is made even worse by the presence of scattered outcrops of serpentine.

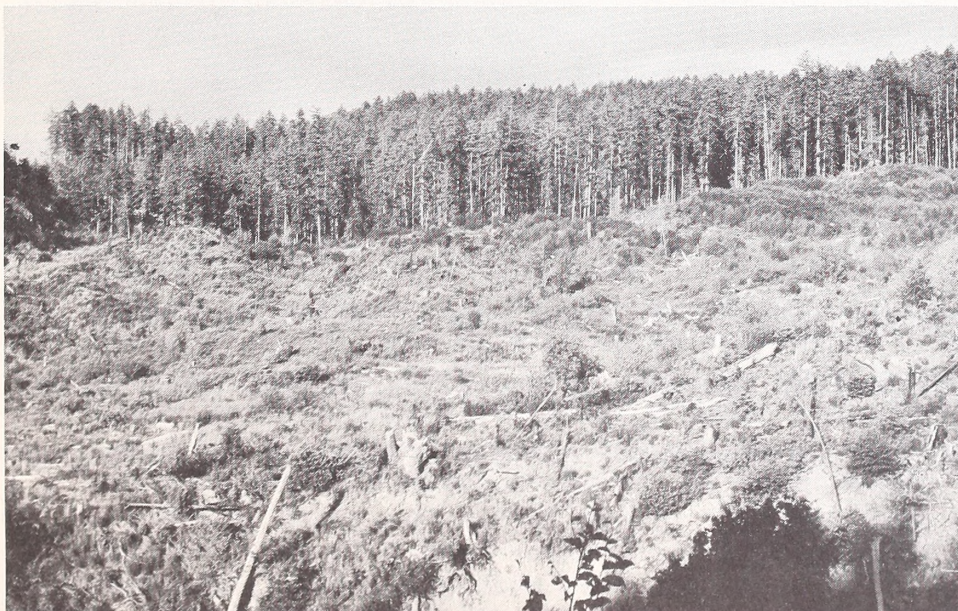
Figure 71. Benchy, hummocky terrain de-rived from weathered siltstone. Many of these depressions collect surface water and this causes con-tinued earth movement.

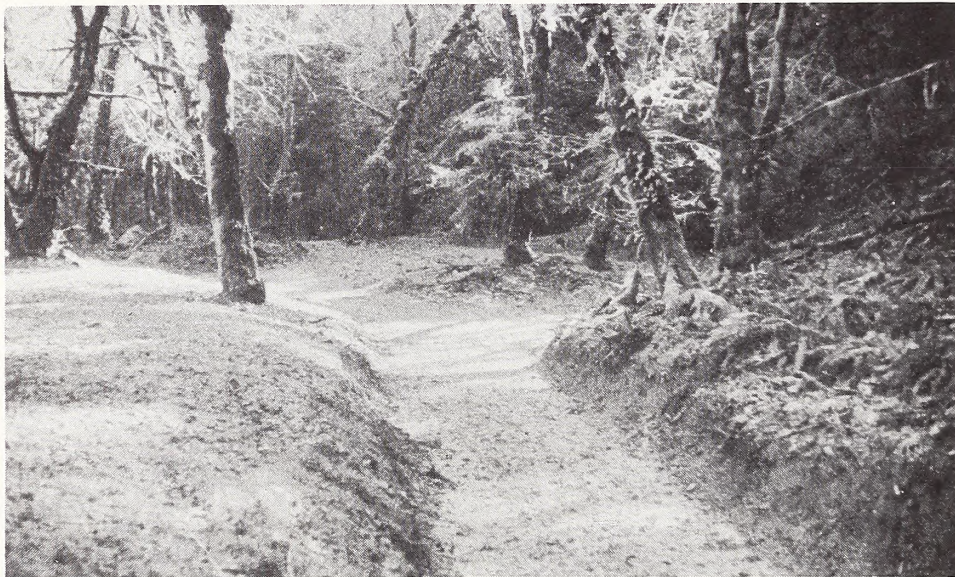
*Figure 73. Ditches can be used to drain sag ponds and depressions.*

Drainage ditches. Every effort should be made to improve drainage, both surface and subsurface, since ground water is the major factor contributing to slope instability for this material. Sag ponds and bogs should be drained by ditches excavated by tractor or by ditching powder, provided the explosion will not trigger a slope failure. Sag ponds and depressions at point A in Figure 72 were connected to the road ditch by a series of tractor excavated ditches as shown in Figure 73.

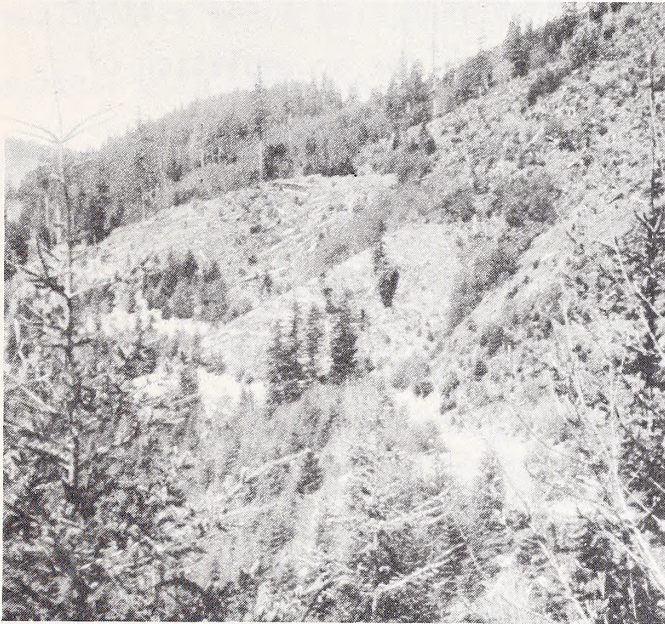
Figure 75. Sandstone ridgenoses on a slope of igneous rock.

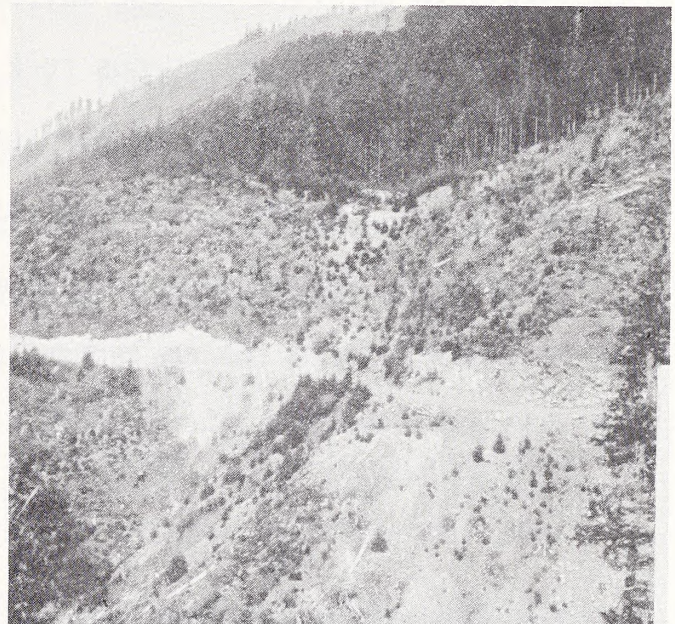
Figure 76. Contact zone between sandstone (l.) and igneous rock (r.).

material involved, and stability problems may be confined to the immediate contact zone (Figure 76). The arrow above A indicates the location of a debris avalanche which occurred since these photos were taken.

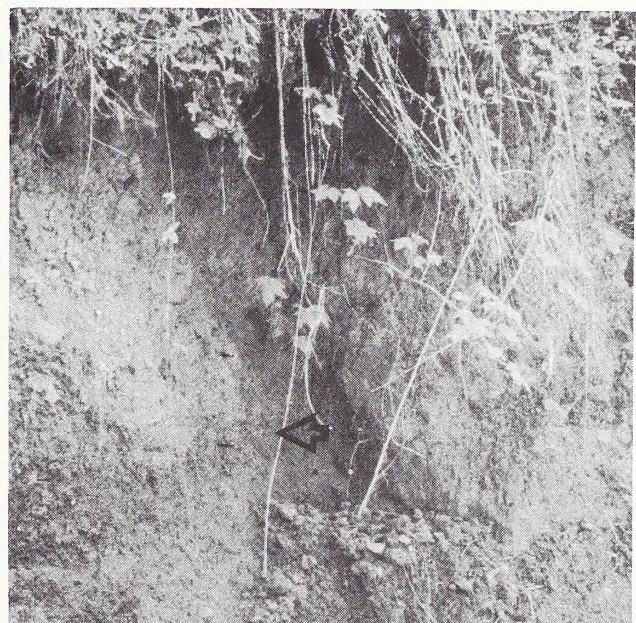
*Figure 78. Arrow shows buried soil layer; pencils show springs.*

the bedded sediments. While the rock itself may be quite stable, the material may weather into deep soils with a potential for slumps and earthflows. The upper slopes are frequently steep with shallow soils while the lower slopes usually have thick soil mantles as a result of erosion from the upper slopes together with deep weathering. These igneous rocks are relatively impermeable and subsurface flow moves rapidly downslope. Much of this ground water appears as springs at the upslope side of benches that are common along the streams in this terrain. The remainder of the groundwater seeps through the deep soils to the streams. Road cuts often expose soil layers buried as a result of ancient slope failures and ground water may move laterally along these zones and appear as springs in the cut face after road construction (Figure 78). These local wet spots are a frequent source of small slumps.

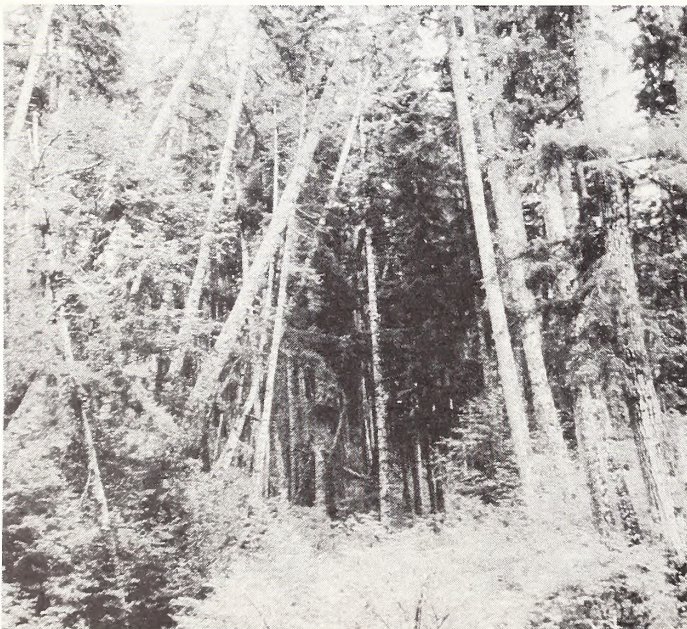
Figure 79. Indicators of ground water.

Massive slumps are often found on the landscape, and sag ponds and hummocky terrain tend to keep the ground water levels high in these areas. Tipped and jackstrawed trees, together with hydrophytes, are the vegetative indicators of abundant ground water (Figure 79). Other features of concern are the steep slopes between the benches and the streams. Erosion of the base of these slopes results in a gradual steepening of the slope with a corresponding

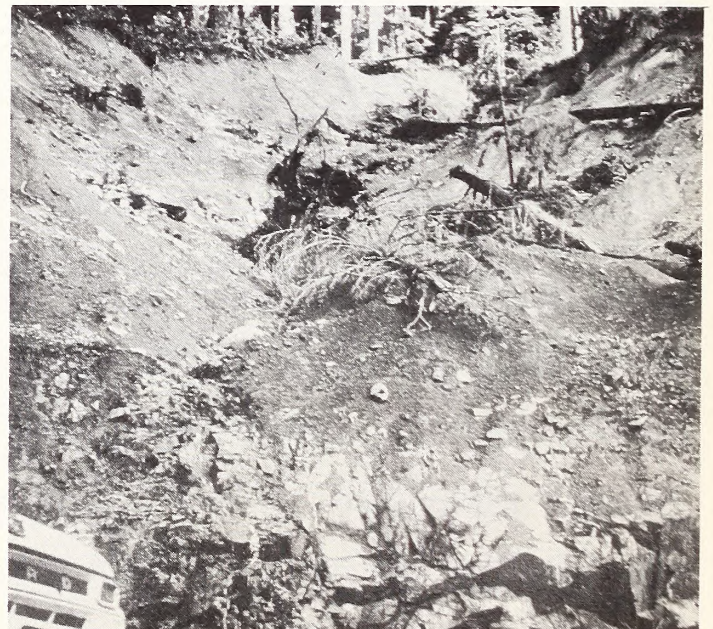
Figure 80. Pyroclastics over basalt.

The alternating layers of pyroclastic and extrusive rocks can create serious stability problems. For example, if basalt caps pyroclastic material, then the slumping of the soft pyroclastic rock can cause the collapse of large portions of the rigid basalt as support is removed. This situation is discussed in a later section on pyroclastic rocks. On the other hand, if pyroclastic rock overlies relatively impermeable basalt, then ground water will infiltrate the pyroclastic material and move laterally along the contact zone. Excavation for a roadway through this material may leave the contact zone halfway up the embankment (Figure 80). In this case the pyroclastics can slide onto the road, but the height of the contact zone creates an awkward situation for placing rock buttresses or perforated pipe. Geophysical exploration techniques should be used, if at all possible, during road location so that this situation can be avoided by changing the road location. If the road location cannot be changed, then rock buttresses and/or perforated pipe may be placed as the contact between these two materials is exposed during excavation.

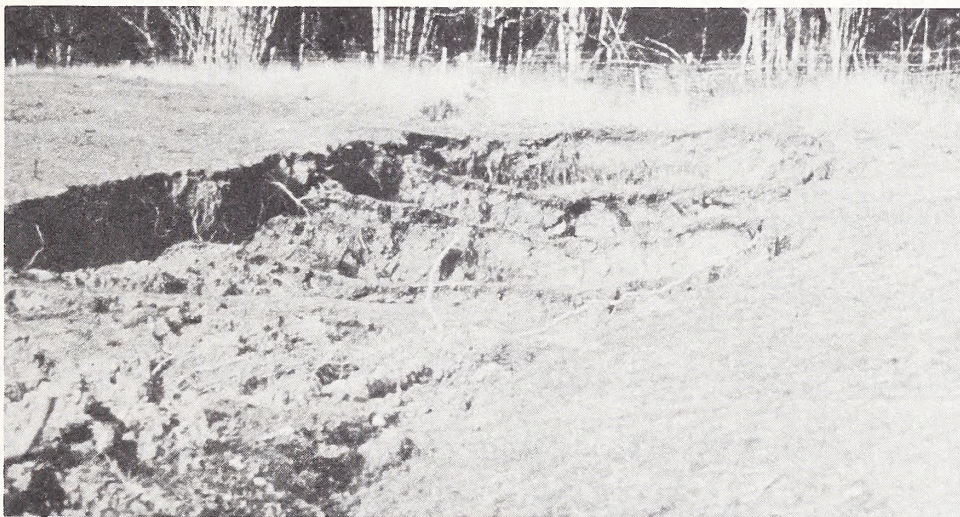
*Figure 81. A progressive slump is a series of slope failures that may extend to the ridge top.*

The "progressive" slope failure is another type of stability problem that is found frequently in deep soils on steep slopes in extrusive igneous material. This failure starts as an ordinary cut bank slump into a road. The removal of support causes failure of the next block of soil immediately upslope, and so forth, until there is a series of slumps one above the other that may extend to the top of the ridge (Figure 81). Ground water is usually abundant at these locations and engineers should be on the lookout for signs of an impending slope failure that could develop into a progressive slump.

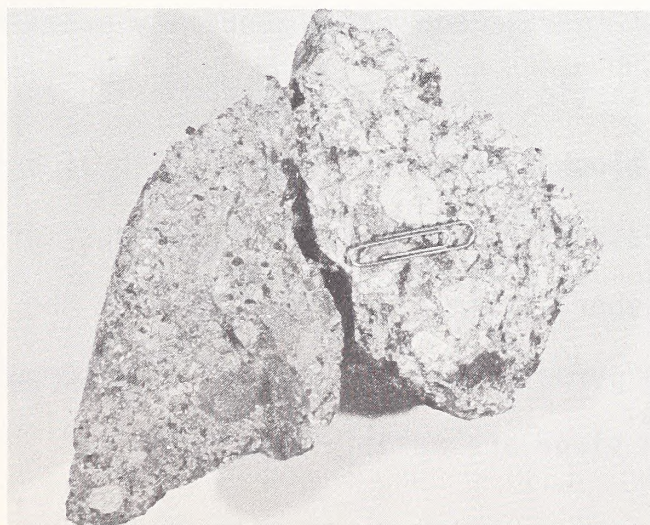
*Figure 82. The color of pyroclastic materials may range from light green to dark reddish-purple.*

Tuffs and breccias can come in a wide variety of colors which range from dark reddish-purple through light yellow to green (Figure 82). While all tuffs and breccias have marginal stability, the green variety is notoriously unstable. Soil and rock colors seem to provide a local field guide for prediction of the clay group and the relative landscape stability. Research by Paeth, et al., has shown that soils with montmorillonite clays have 2.5Y and 10YR color hues and have been derived from greenish rock. Relatively stable soils with 7.5YR hue have been derived from yellowish and reddish rock.

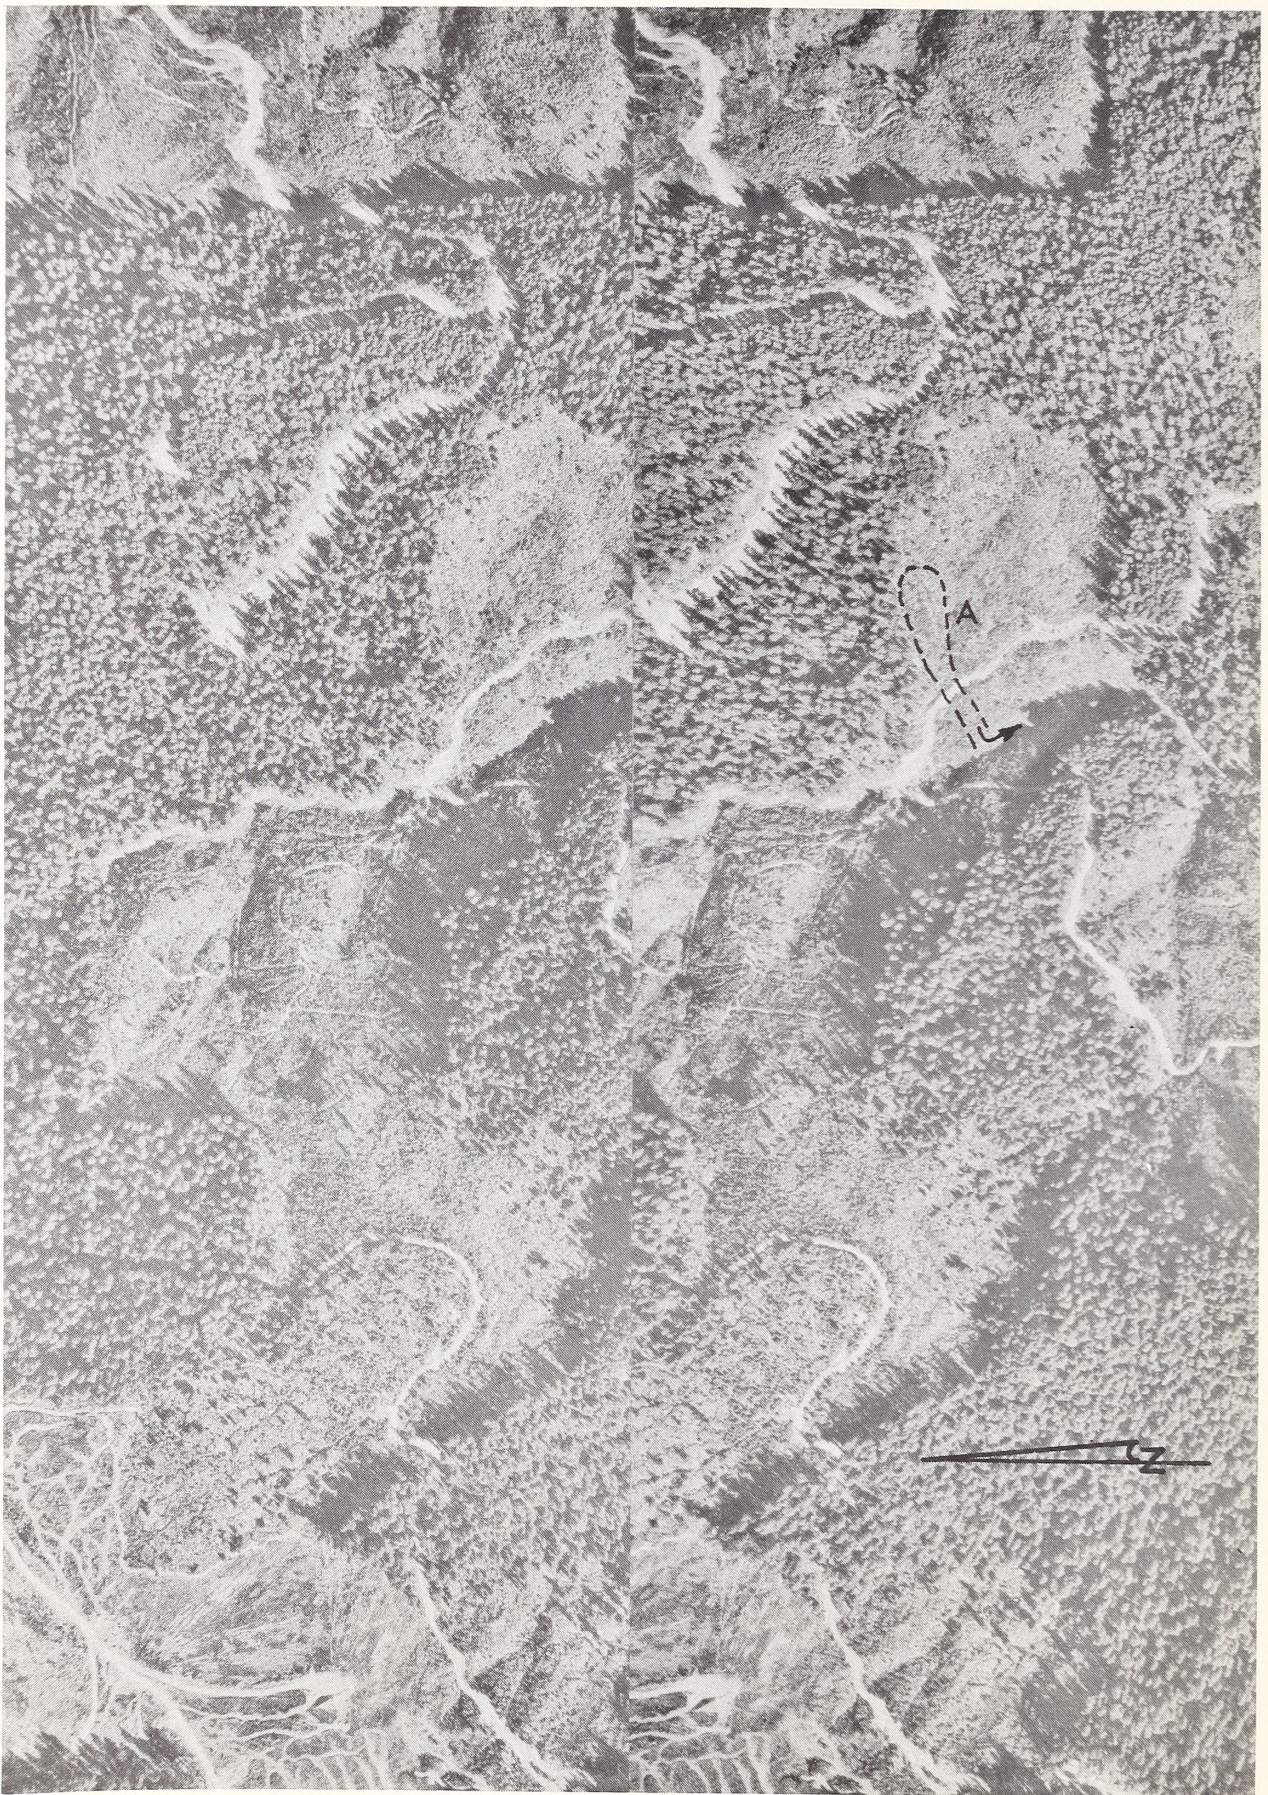
Figure 87. This stereogram shows unstable terrain derived from pyroclastic rock; there is evidence of active soil movement over the entire photo. An old slump is shown at point A and the dashed line outlines a new slump. Figure 88 shows a ground photo of this slump.

Whitcomb Creek, that flows into Green Peter Reservoir on the Middle Santiam River, is an excellent example of unstable terrain associated with pyroclastic rock. Figure 87 is a stereogram that shows an old slump at A. A depression can be seen at the base of the scarp above and to the left of point A. Whitcomb

Creek has steepened the slope below this old slump and excavation for the road has removed even more support. This basin failed by slumping after these photos were taken and debris flowed into the creek. The approximate boundary of the new slump is shown on the stereogram. Damage to Whitcomb Creek from the debris flow down the channel was reported to be severe. Figure 88 shows a portion of the new slump and the presence of ground water at the head of the slump is shown by the dark stain on the exposed bedrock.

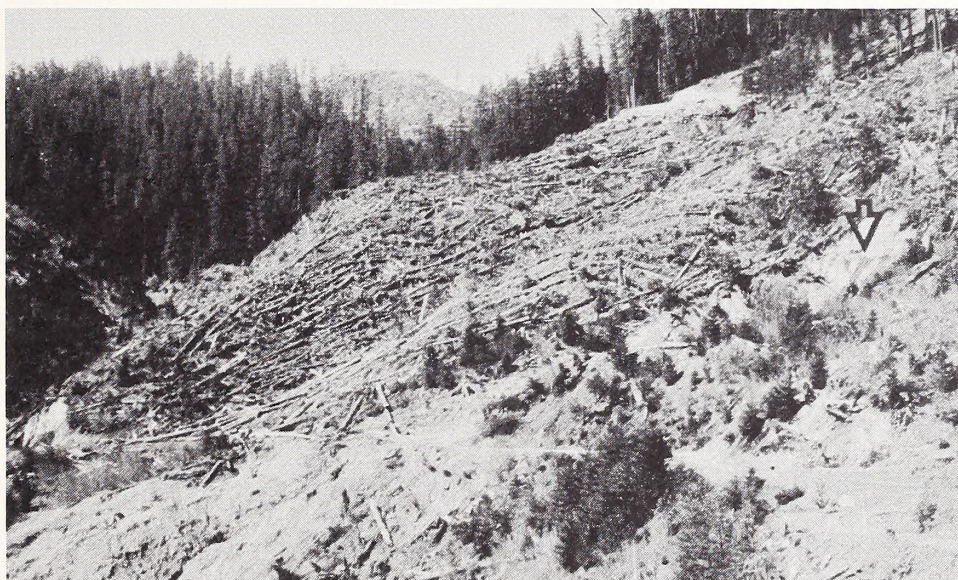
*Figure 88. Ground photo of the new slump outlined in Figure 87. The arrow indicates ground water seeping from the face of the scarp.*

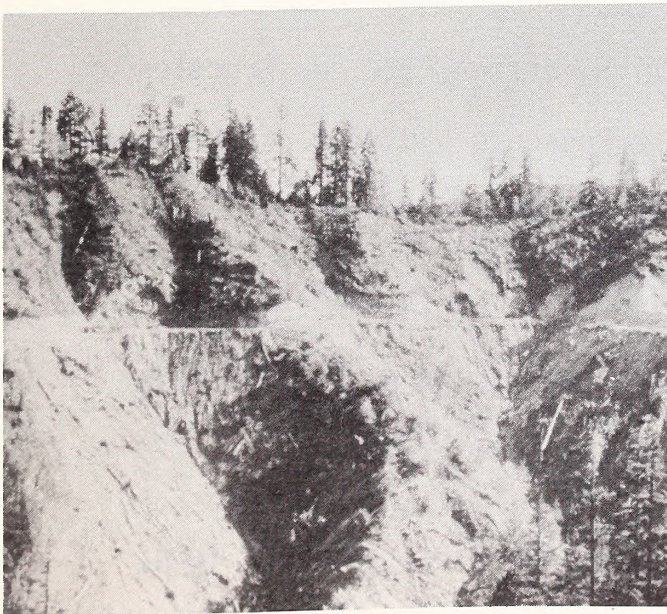
*Figure 89. This shows the steep, sharply dissected slopes which are typical of granitic material.*

Granitoid rock often weathers to a coarse-textured soil that may be low in clay if erosion is rapid. Those soils that develop in place for long periods may have a clay content of as much as 25 percent or more and may be relatively stable. Those soils that are low in clay have a single-grained structure with little cohesive strength that causes them to be easily eroded (Figures 89 and 90). It is these coarse-grained granitic soils that will be considered here.

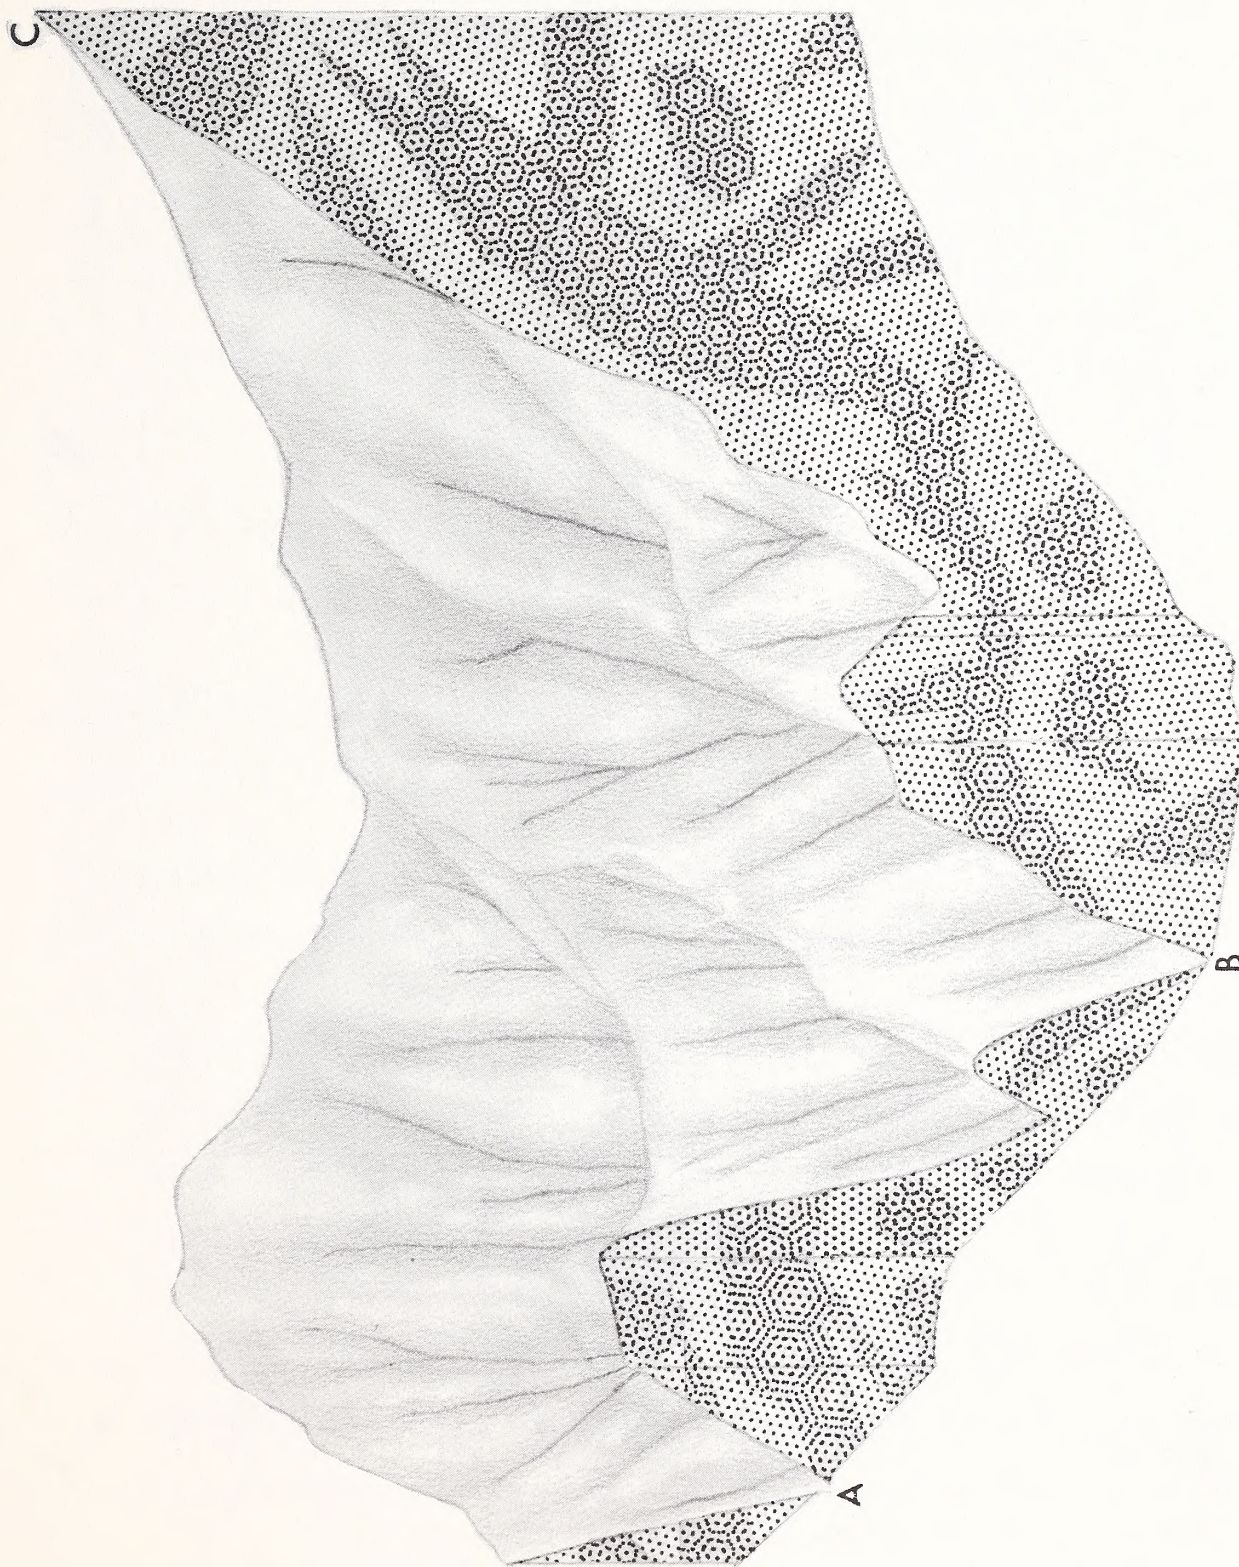
Figure 91. This block diagram of terrain developed from granitoid rock shows the steep slopes, sharp ridges, and sharply dissected slopes that are characteristic of this material. Figure 92 shows the topographic map from which this diagram was developed. Points A, B, and C may be used for orientation.

The nature of the topography that is typical of granitoid bedrock is shown in the block diagram of Figure 91. This area was taken from the East Fork of Stouts Creek, a tributary of the South Umpqua River south of Milo. Note the steep, highly dissected slopes and the sharp ridges in the block diagram and the characteristic pattern of the contour lines on the topographic map (Figure 92).

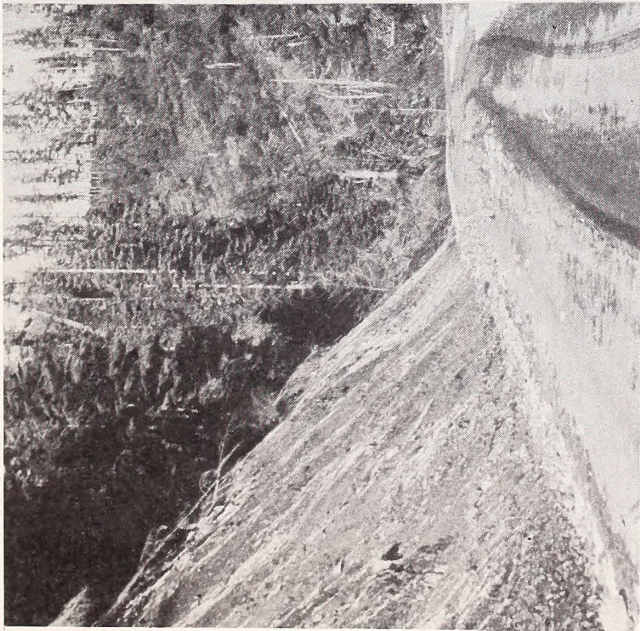
Figure 94. Rockfalls in deeply weathered schist. Note tipped tree.

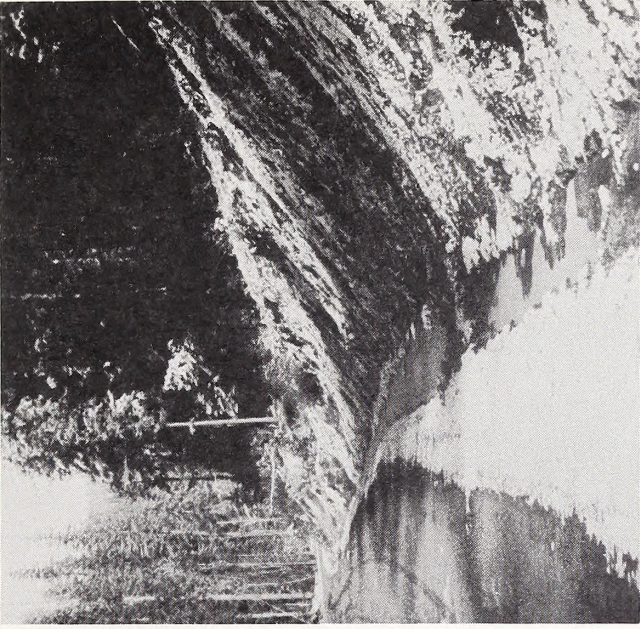
Figure 96. Small slumps cause impeded ditch drainage.

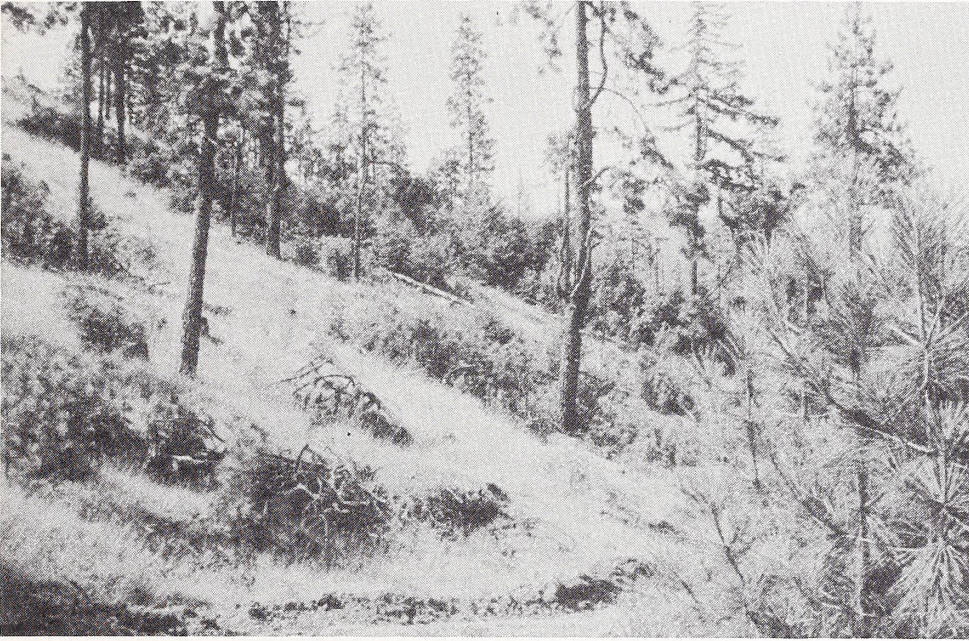
*Figure 98. Sparse stands of Jeffrey pine often indicate the presence of serpentine bedrock.*

The presence of extensive areas of serpentine material may be indicated by vegetation composition and density that is characteristic of these areas. Serpentine and peridotite (from which serpentine is derived) contain an excess of magnesium. Only tolerant plants can grow on these soils when this mineral is present in quantities sufficient to be toxic to many plant species. The major coniferous species under these conditions are Jeffrey pine, with some western white pine and knobcone pine. Tolerant shrubs and forbs are pine-mat manzanita (Arctostaphylos nevadensis) and beargrass (Xerophyllum tenax). Figure 98 shows a typical hillside of serpentine soils in the drier zone that appears as an open woodland with a sparse growth of grasses and shrubs. Figure 99 is an aerial photo of a portion of Cow Creek, southwest of Riddle. The approximate boundary between the serpentine material and the Umpqua formation is shown as a dashed line. This delineation was made on the basis of the difference in density of vegetation.
