# GUIDE TO REDUCE ROAD FAILURES IN WESTERN OREGON

August 1973

Bureau of Land Management  
Oregon State Office  
P.O. Box 2965  
Portland, Oregon 97208

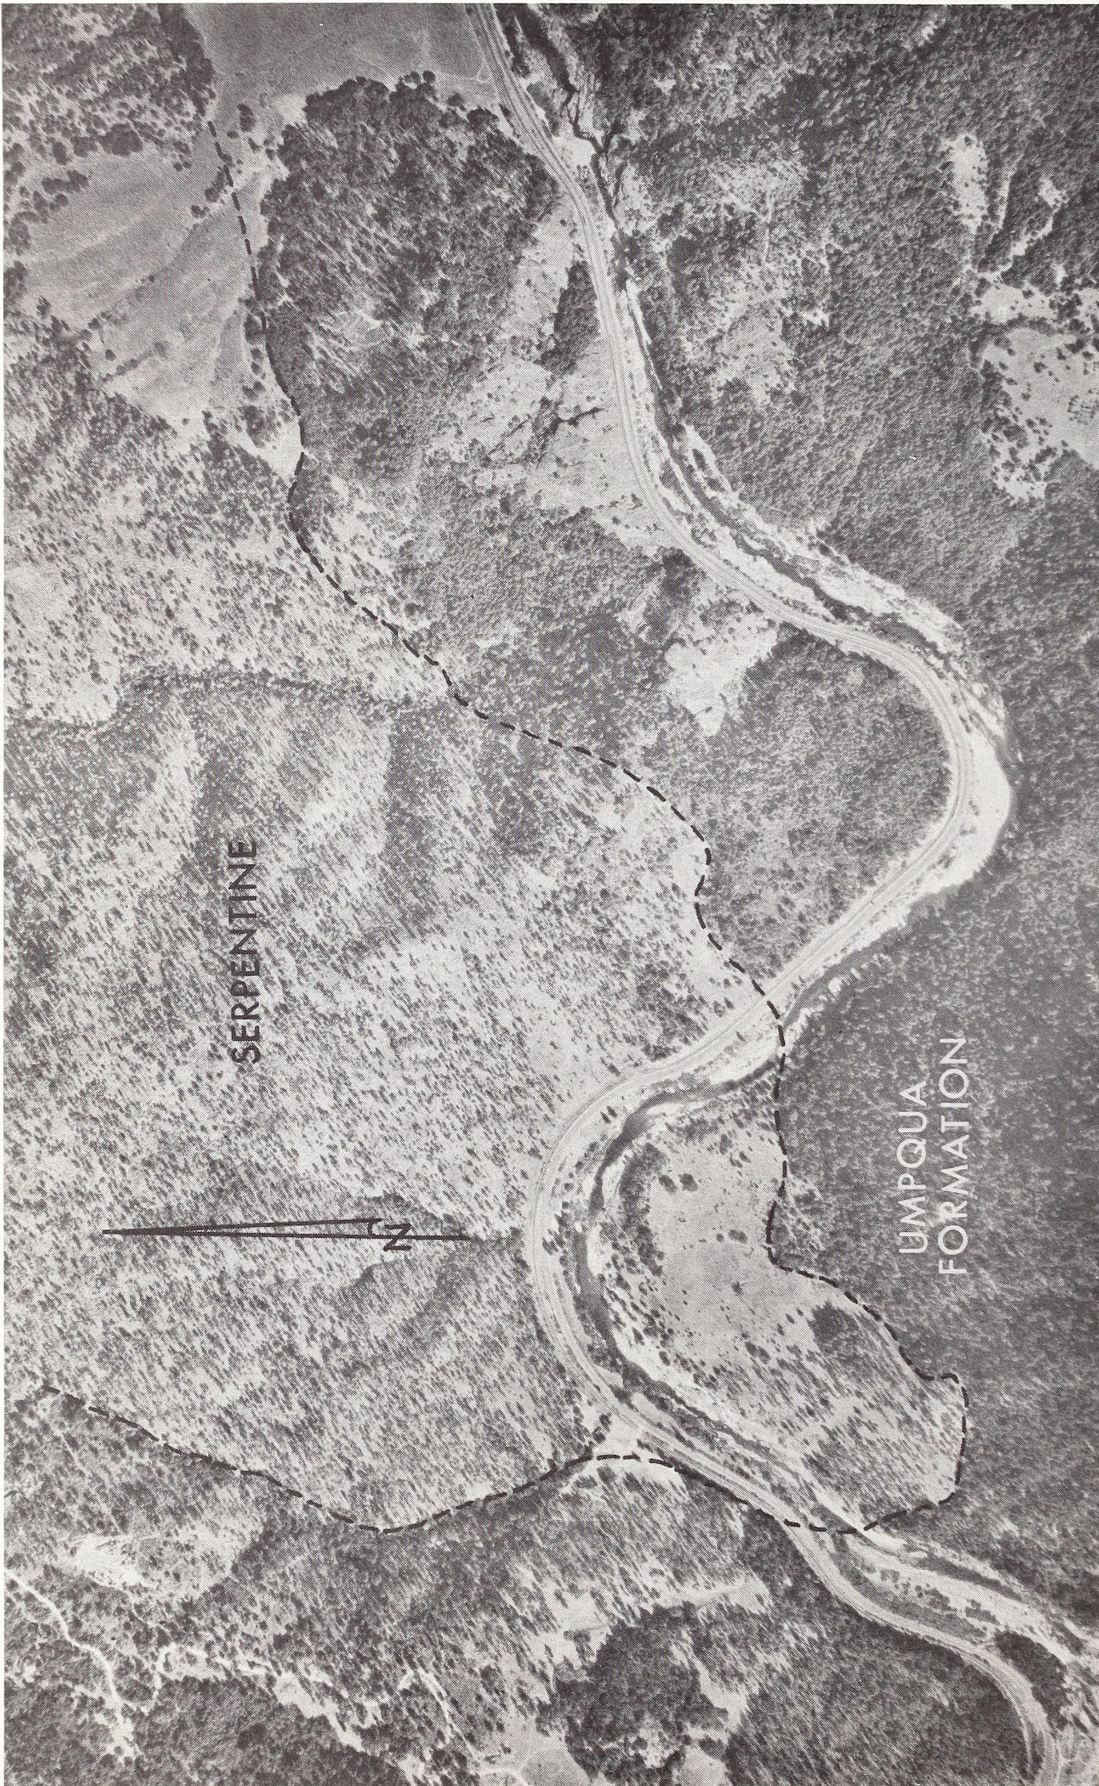
Figure 99. The approximate boundary between serpentine material and the Umpqua formation is shown by the dashed line. This determination is made principally on the basis of vegetation density. Timber on portions of the Umpqua formation have been harvested which accounts for a reduction in vegetation density, particularly in the northwest corner of the photo.

The presence of extensive areas of serpentine material may be indicated by vegetation composition and density that is characteristic of these areas. Serpentine and peridotite (from which serpentine is derived) contain an excess of magnesium. Only tolerant plants can grow on these soils when this mineral is present in quantities sufficient to be toxic to many plant species. The major coniferous species under these conditions are Jeffrey pine, with some western white pine and knobcone pine. Tolerant shrubs and forbs are pine-mat manzanita (Arctostaphylos nevadensis) and beargrass (Xerophyllum tenax). Figure 98 shows a typical hillside of serpentine soils in the drier zone that appears as an open woodland with a sparse growth of grasses and shrubs. Figure 99 is an aerial photo of a portion of Cow Creek, southwest of Riddle. The approximate boundary between the serpentine material and the Umpqua formation is shown as a dashed line. This delineation was made on the basis of the difference in density of vegetation.

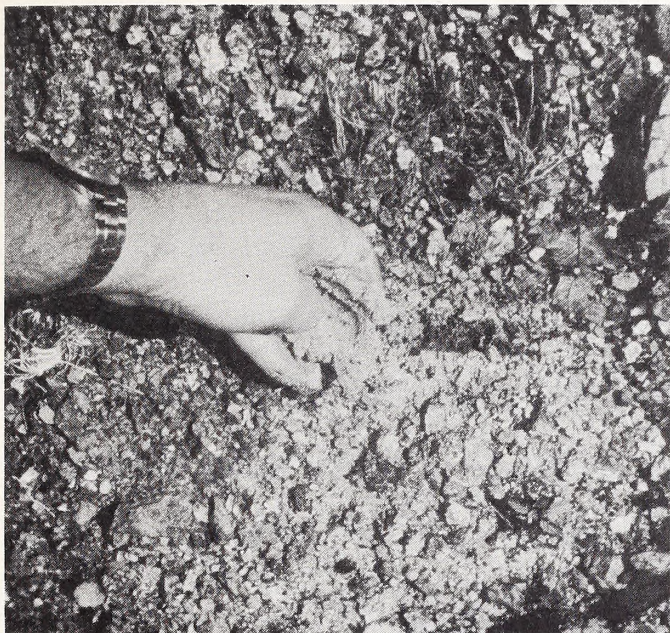
Figure 100. Serpentine often weathers to a sticky clay.

Serpentine material behaves somewhat differently in the wet coastal climate. There is enough rainfall to cause rapid weathering of exposed serpentine to a sticky clay--often referred to locally as a "blue clay" (Figure 100). Small outcroppings of serpentine occur in other geologic materials such as the Dothan formation where vegetative indicators of serpentine may only be a grassy hillside (Figure 101). These grassy openings often show tension cracks and cat steps. Rock riprap for support of the cut bank and control of drainage water may be the only slope stabilization techniques that are possible when roads traverse small areas with serpentine soils. Care should be taken to distinguish between small serpentine outcrops and exposures of thin beds of dark siltstone within the Otter Point formation, the Dothan formation, and other minor sedimentary formations along the southern coast. These beds of siltstone may be tilted to a nearly vertical position, they may be deeply weathered, and they often slump and flow into the roads. These beds may be covered with the same vegetation that is on the surrounding terrain, but the weathered siltstone does not have the high clay content of the weathered serpentine.

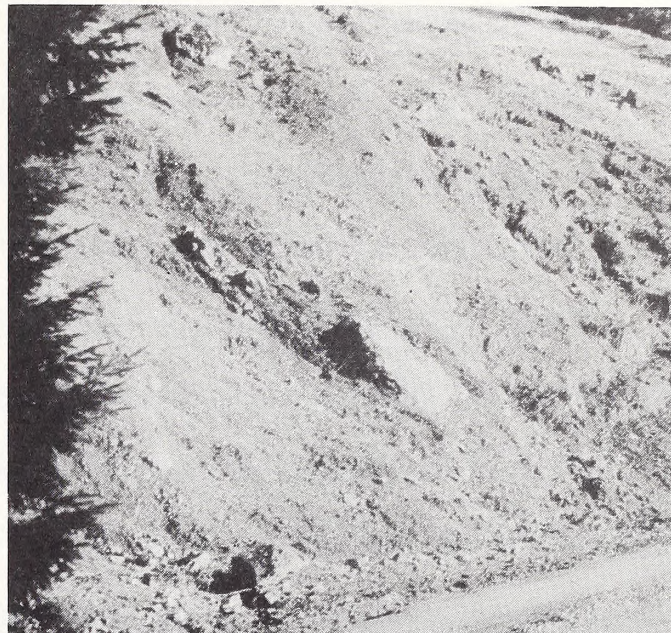
Figure 101. Grassy hillsides often indicate small serpentine outcrops.

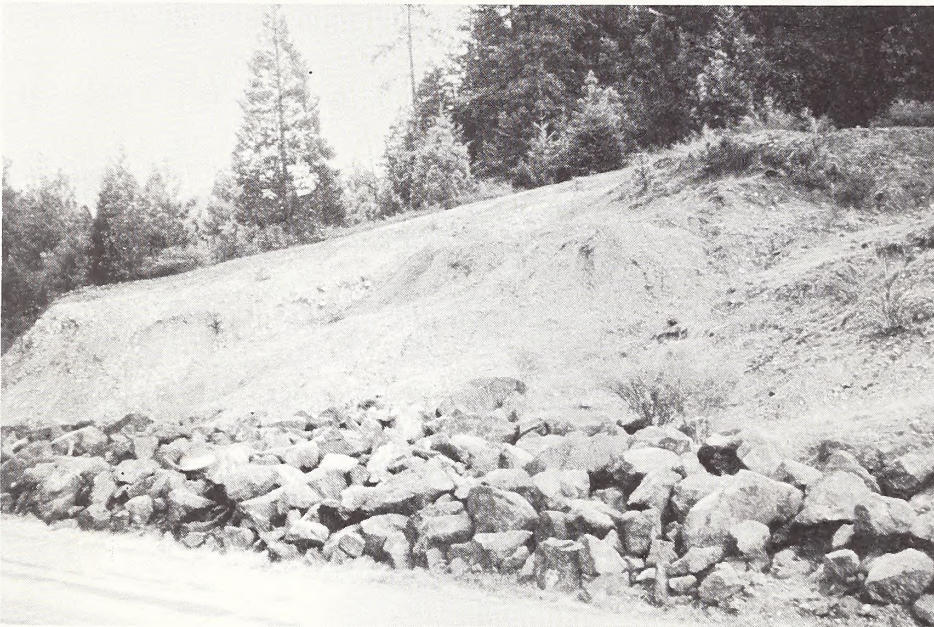
*Figure 102. Heavy riprap may be used to support slumping embankments in serpentine material.*

Embankment support. Be prepared to apply blankets of heavy riprap rock for slumping cut banks (Figure 102).

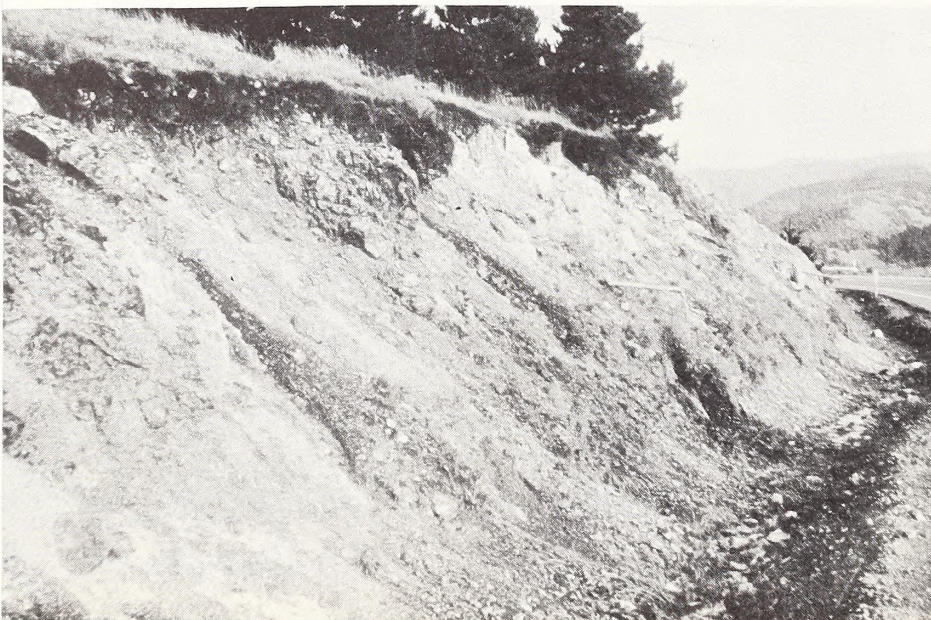
*Figure 103. Perforated pipe may be needed to remove ground water from embankments in serpentine material. Note the volume of water issuing from the pipe at the right of center.*

Ground water drainage. Be prepared to collect and dispose of ground water through extra drainage work as the magnitude of the ground water problems become evident as construction begins. This extra work may include perforated pipe in the cut bank (Figure 103).

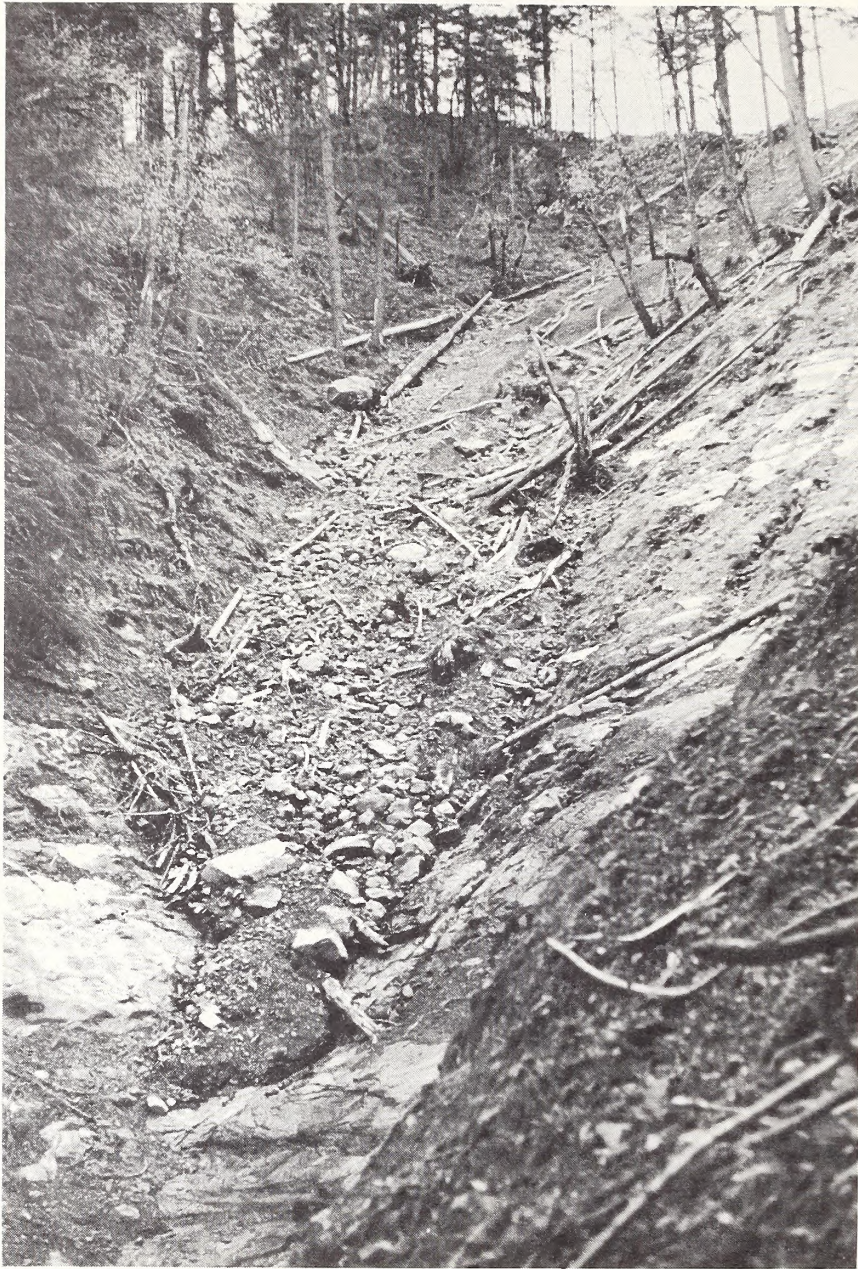
*Figure 104. Rubble from road clearance has been deposited in this steep headwall. This increases the potential for another slide.*

Disposal of debris from avalanches or slumps that falls upon the road is a serious problem. Disposal sites which will safely support rock and soil may be a long distance from the slope failure. Nevertheless, such safe disposal sites should be sought out and used. Never take the expedient approach and dump soil, rocks, and debris into drainages or any other spot where this material will increase the potential for slope failure. Figure 104 shows the result of a debris avalanche in a steep headwall in Tye sandstone. The rubble, which extends from the lower part of the photo to the road which circles the top of the headwall, is a result of disposal of debris from cut bank failures elsewhere along the road. In this case, the headwall is primed for another destructive debris avalanche -- all it needs is a series of heavy winter rains to raise the ground water level.
