# AIRCRAFT ACTION REPORT

VF-45  
REPORT No. **ACA-1 #18**

**XI. ATTACK ON ENEMY SHIPS OR GROUND OBJECTIVES (By Own Aircraft Listed in II Only).**

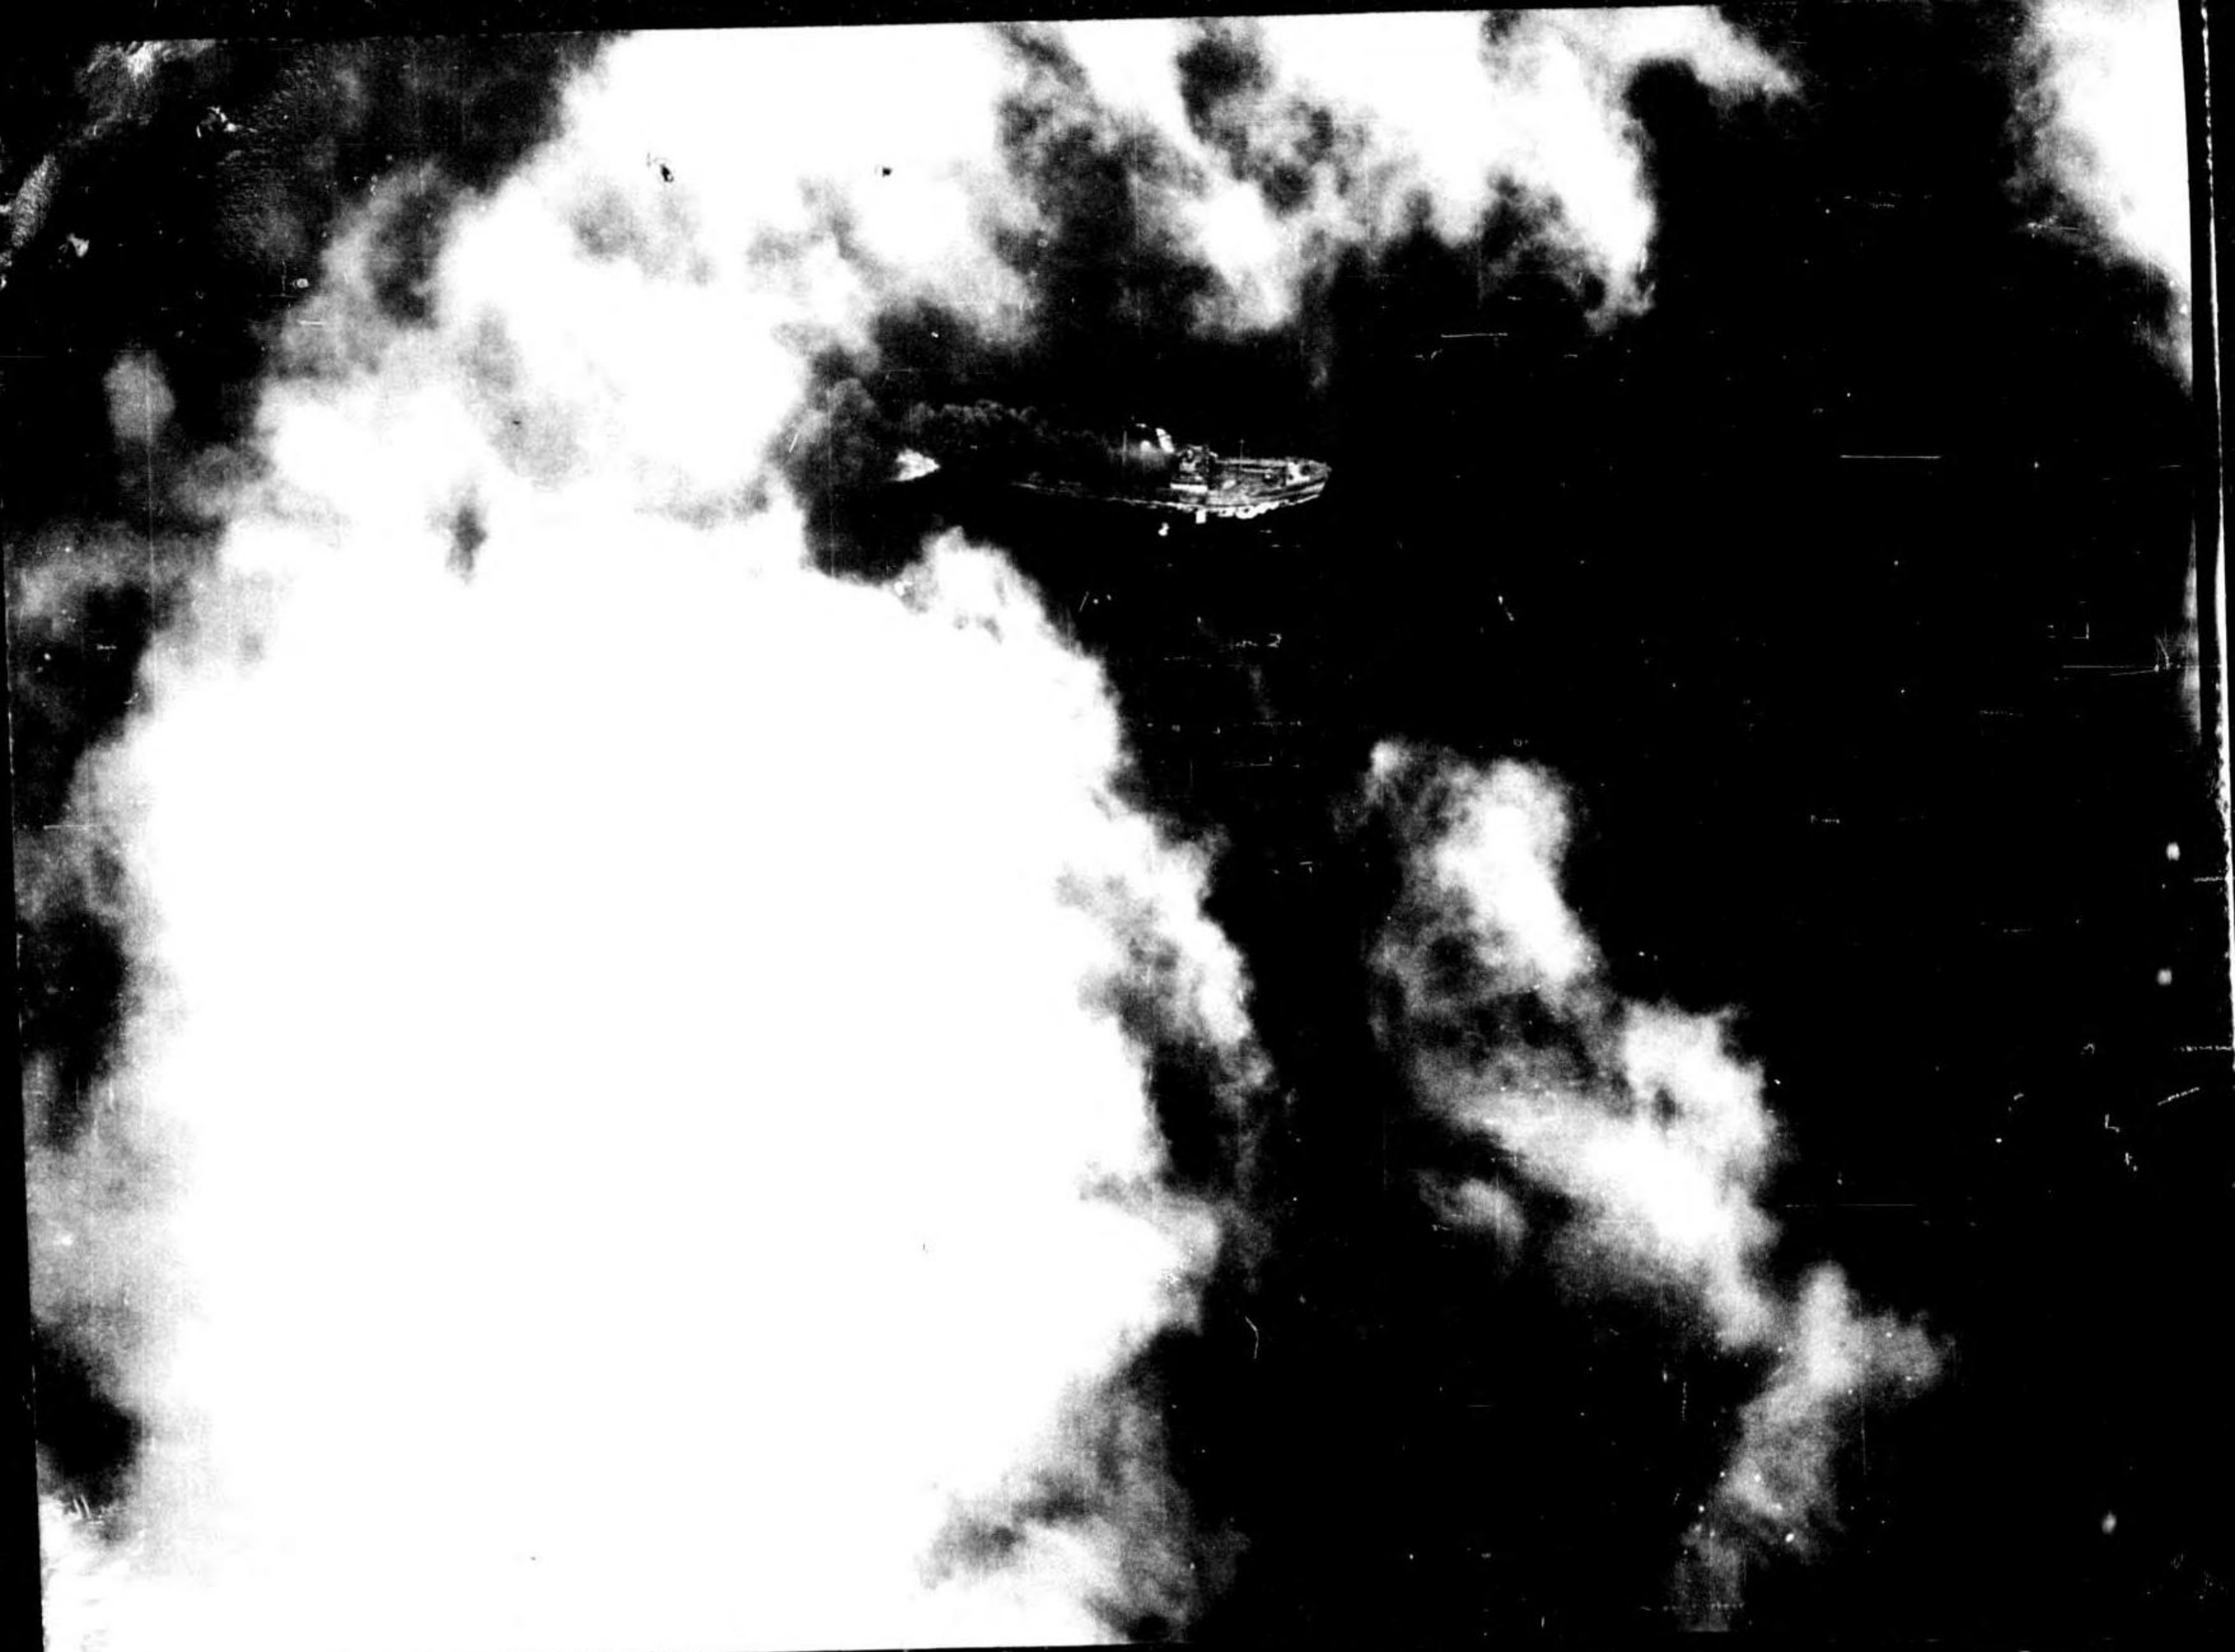
(p) Were Photographs Taken? **Yes** Photographs of Damage, When Taken, Should Be Attached By Staple.

AN JAG P-1X (15 JAN 45, 0945-9) (K25 6 7/8" VAR) (TOSHEN, FORMOSA) (CONF)

(SAN JAC 45)(15 JAN 1945, 0945-9)(K17 24" VAR)(TAKAO-TOSHIEN, FORMOSA)(CONF)
