"VENPET" - Salvage

S T A T E M E N T  
- of -  
MASTER of "BOLTENIOR"

JOERG DIETRICH STRAEUSSLER

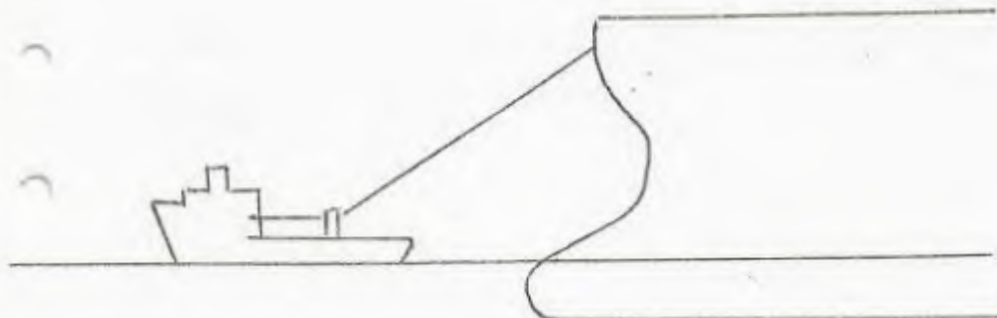
From 1900 hours the wind abated to force 4 from the South West, but the high swell still prevailed. At 1945 hours the stern gate of the "BOLTECTOR", which is secured by bolts, was struck by a heavy downward thrust movement of the towing wire which caused the door to buckle in way of the middle and this in turn caused the door to swing open at one end. In order to enable the Crew to secure the stern door by spot welding the same into position I was required to shorten the towing gear until the same led from our towing bollard in the centre of the Cargo Deck straight up to the bow of the "VENPET" as indicated in the following sketch :-

and this necessitated the stern of the "BOLTECTOR" being brought very close to the very large bulbous bow of the "VENPET" and an inevitable risk of the ships colliding.

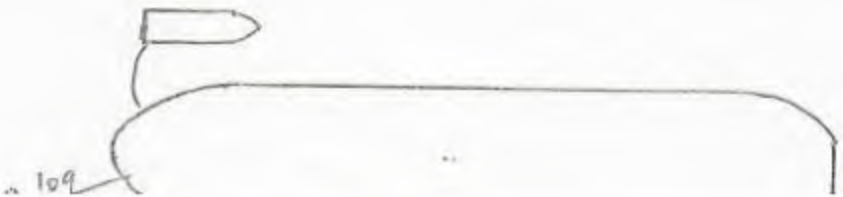
I thereafter began to shorten up our tow line and to take the stretcher aboard the "BOLTENTOR" to replace it with one of our own stretchers, but when I endeavoured to carry out that task by holding the "BOLTENTOR" stern on to the bow of the "VENPET" I found that the "BOLTENTOR" could not, in fact, maintain such position and swung off by the head to starboard until she lay athwart the course line or heading of the "VENPET". As the "BOLTENTOR" obviously could not remain in that position I allowed the "BOLTENTOR" to fall off further to starboard until she was heading towards the stern of the "VENPET" in a position very close off to the starboard bow of the ship and then with the Bow Thruster in use I also maintained sufficient speed astern to keep up with the tow as indicated by attached sketch :-

The above operation was carried out when the wind was West South West 5/6 with a 15 to 20 foot swell and apart from the risks which the Crew ran in working on the stern of the "BOLTENTOR" in such conditions the "BOLTENTOR" was also again exposed to the danger of colliding with the large bulbous bow of the "VENPET".

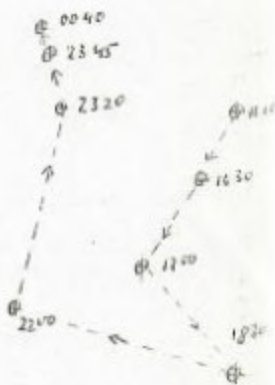
18.12.1977

40 Pos. 34° 39,0' S 24° 40,6' E

distance: 24 nm
