SURVEY REPORT
FOUNTAIN RIVER WATERSHED
COLORADO
1950

ON PROGRAM OF RUNOFF AND WATER FLOW RETARDATION AND
SOIL EROSION PREVENTION FOR FLOOD CONTROL PURPOSES,
FOUNTAIN RIVER WATERSHED, COLORADO //

FLOOD CONTROL SURVEY
 FOUNTAIN RIVER WATERSHED - COLORADO

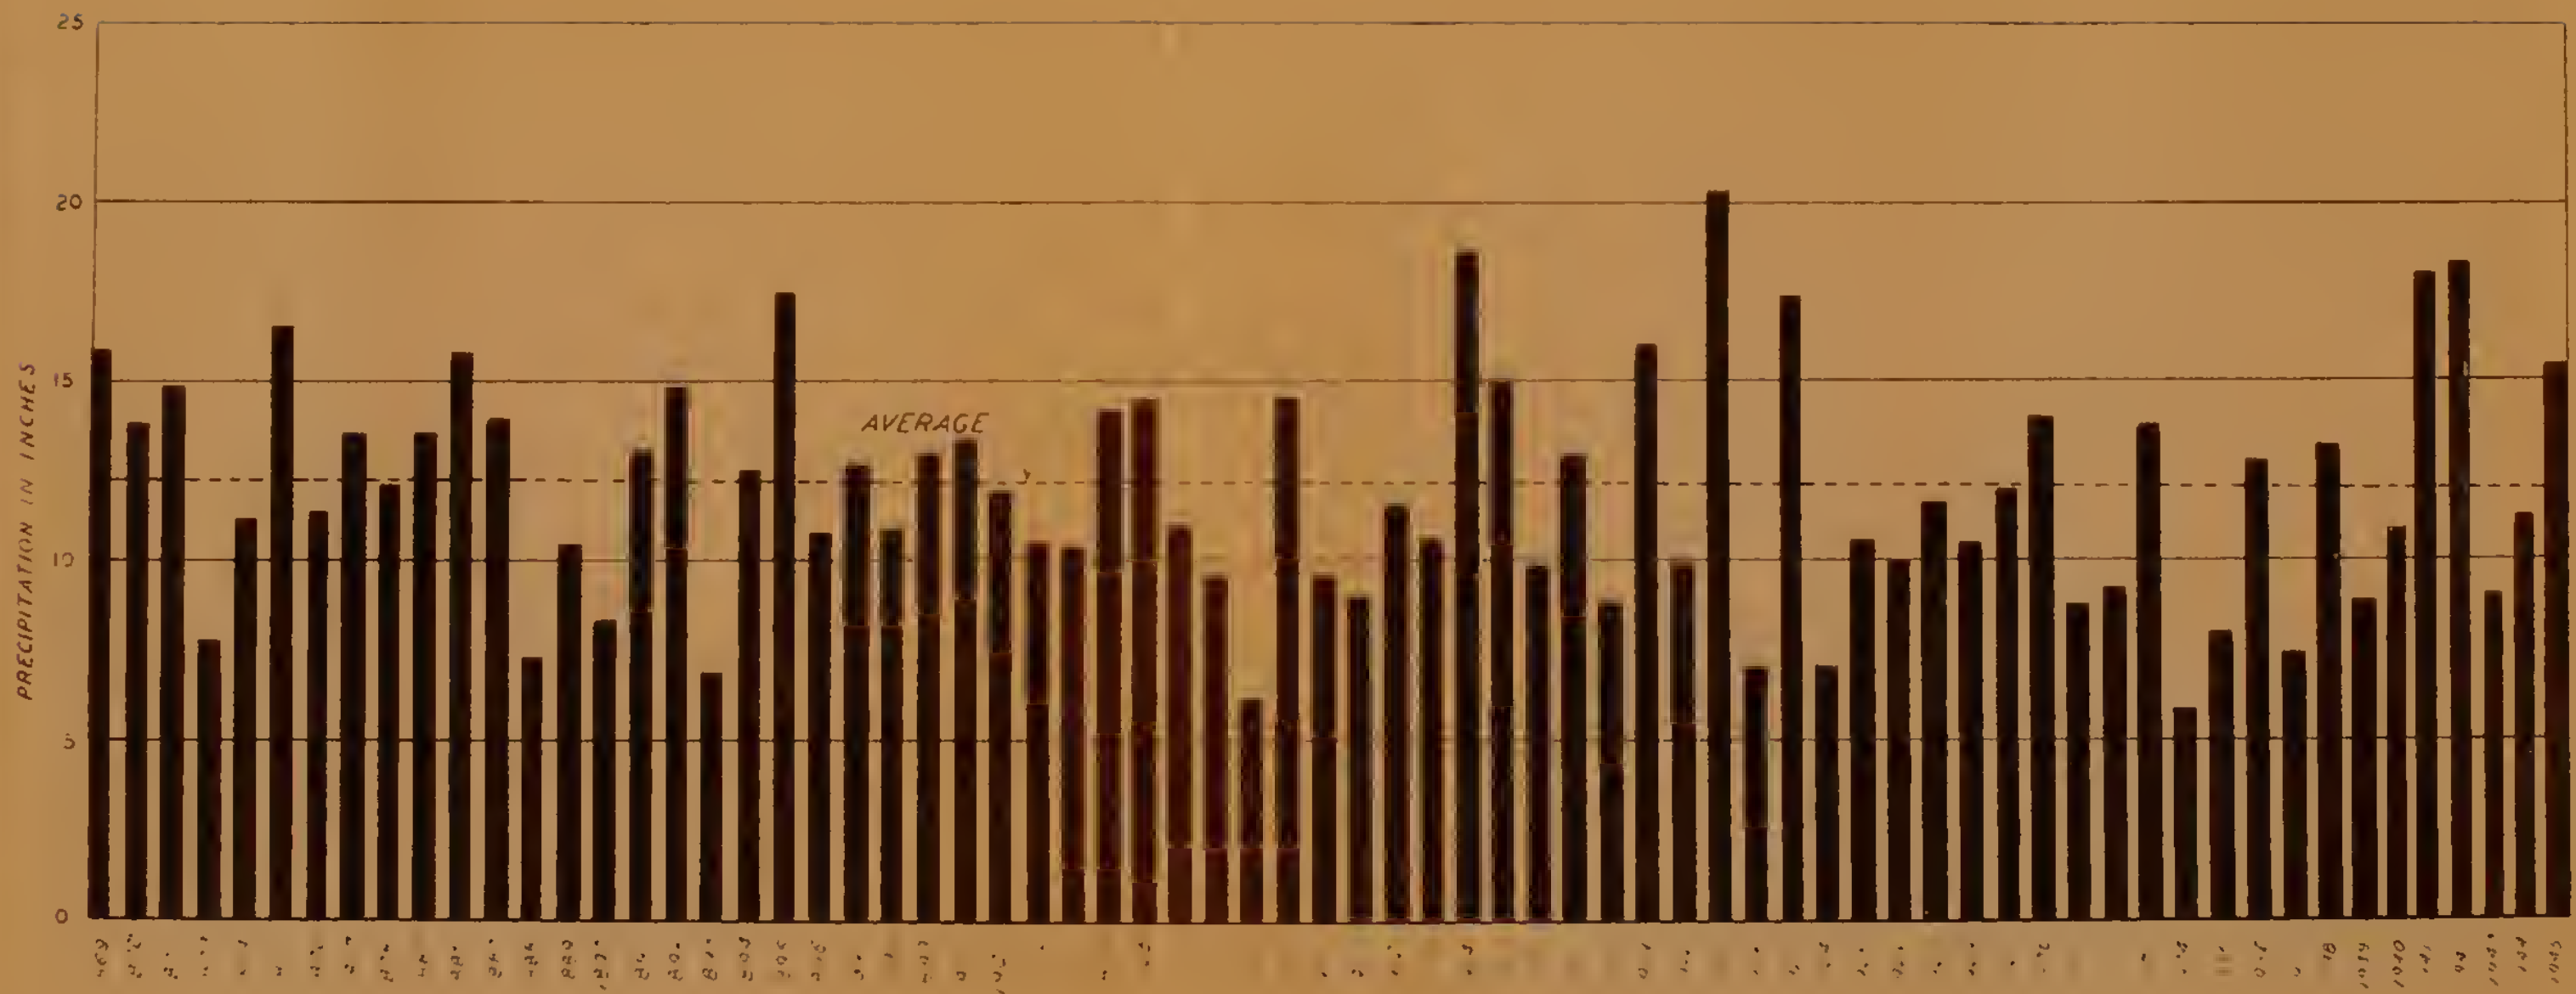
FIGURE 6
 ANNUAL PRECIPITATION AT PUEBLO COLORADO
 FOUNTAIN RIVER WATERSHED
