WORK PLAN

FOR WATERSHED PROTECTION, FLOOD PREVENTION
AND AGRICULTURAL AND NON-AGRICULTURAL
WATER MANAGEMENT

PALUXY RIVER WATERSHED

ERATH, HOOD, AND SOMERVELL COUNTIES, TEXAS

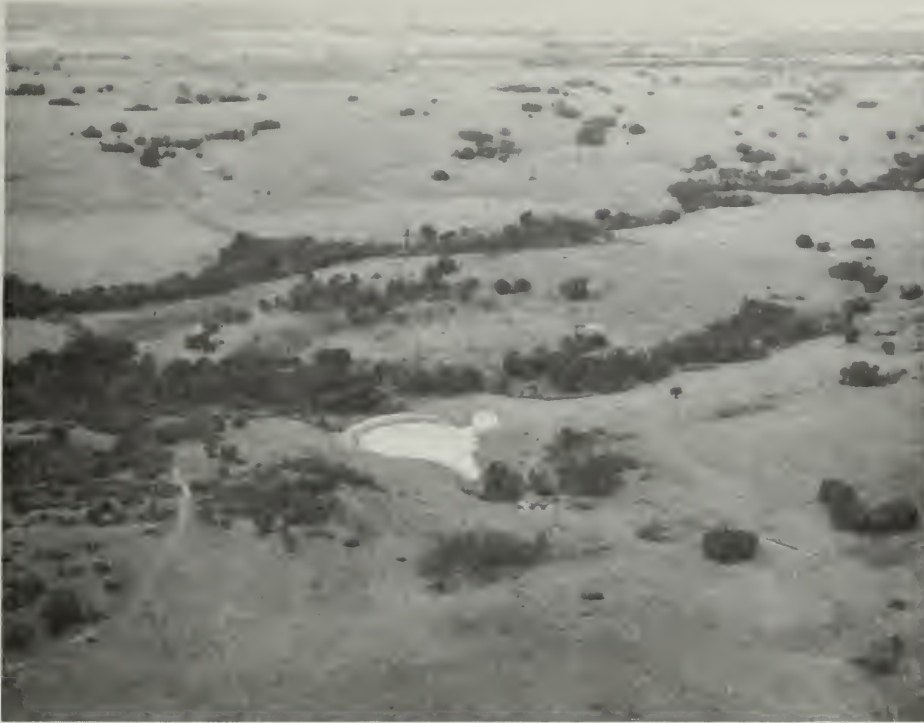
Ponds not only furnish water for livestock but also provide fish habitat and water for wildlife. It is planned to install 204 ponds during the installation period.

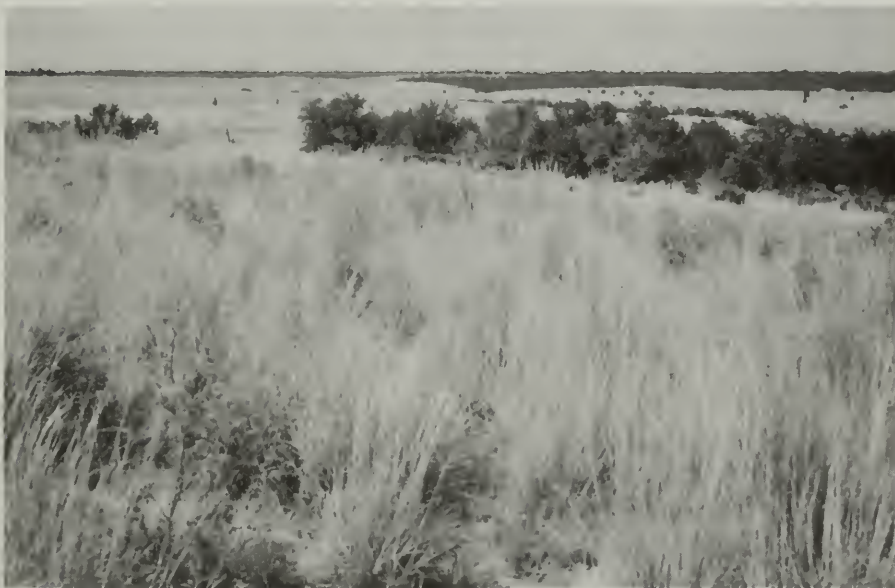
Control of invading brush, when coupled with sound range management practices, results in high quality livestock forage and provides excellent protection to the watershed. Note the brush left for wildlife habitat.

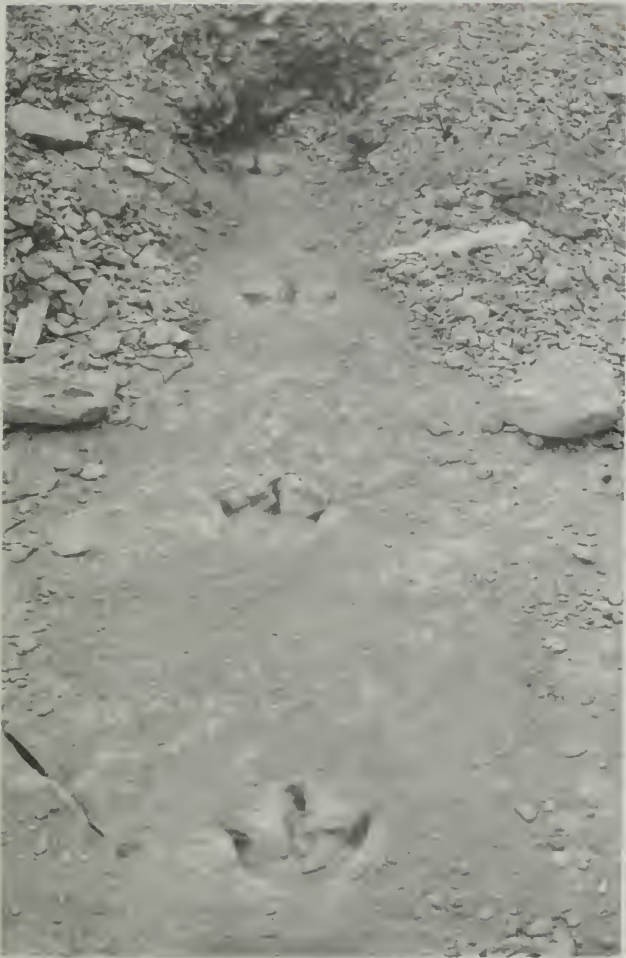
The interpretive complex area to be constructed to display the dinosaur tracks such as these will be protected from flooding by the project. Flooding has damaged many of the tracks which are exposed in the river bed.
