NIST NCSTAR 1-2B

**Federal Building and Fire Safety Investigation of the
World Trade Center Disaster**

**Analysis of Aircraft Impacts into the
World Trade Center Towers
Chapters 1, 2, 3, 4, 5, 6, 7 & 8**

September 2005

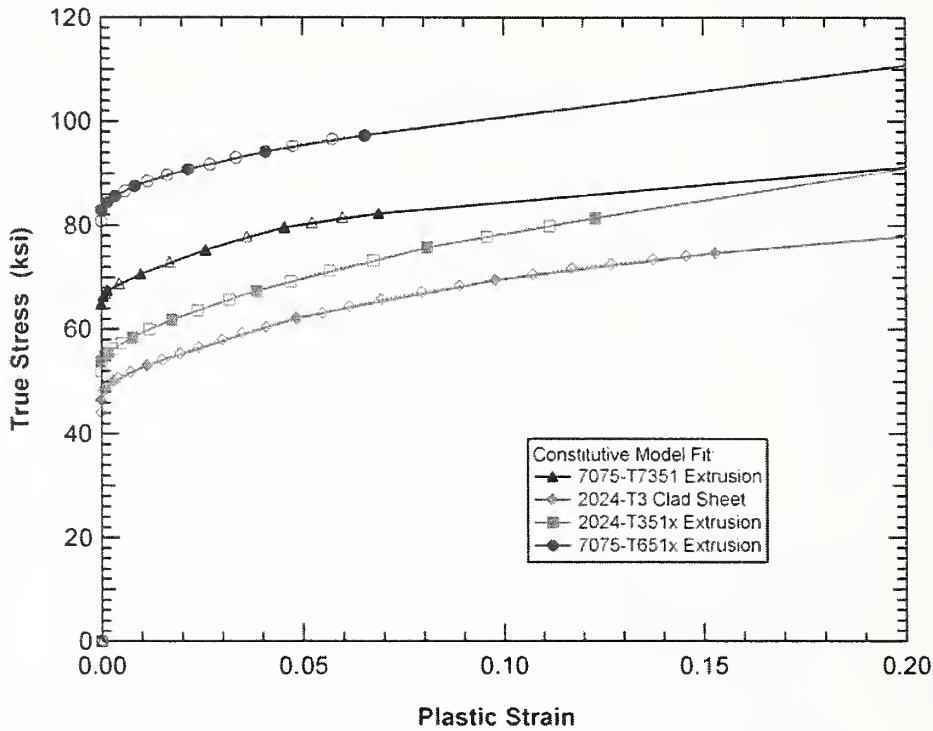
Figure E-6. True stress-strain curves developed for various aircraft aluminum alloys.

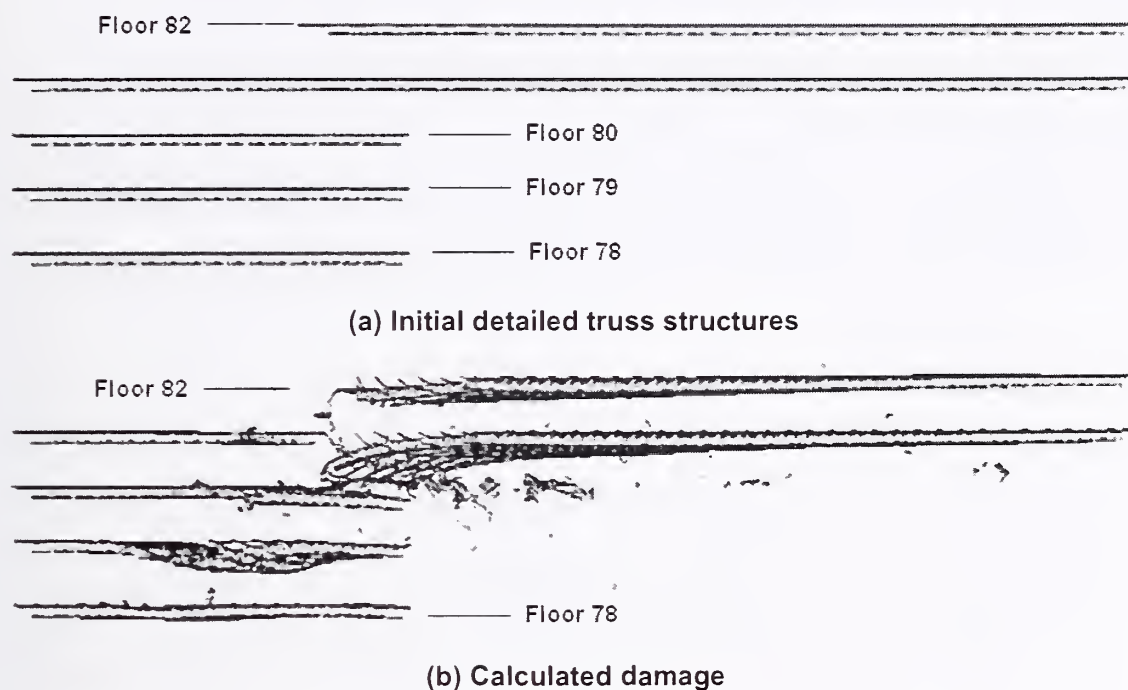
Figure E-40. Base case impact damage to the WTC 2 floor truss (front view).

angle directed more impact energy normal to the floor slab. The vertical component of the impact load in WTC 1 was approximately 40 percent higher than in WTC 2. The secondary factor was that the damage to the long span truss floor in the WTC 1 impact zone produced larger displacements than the corresponding damage to the short span truss region in WTC 2.

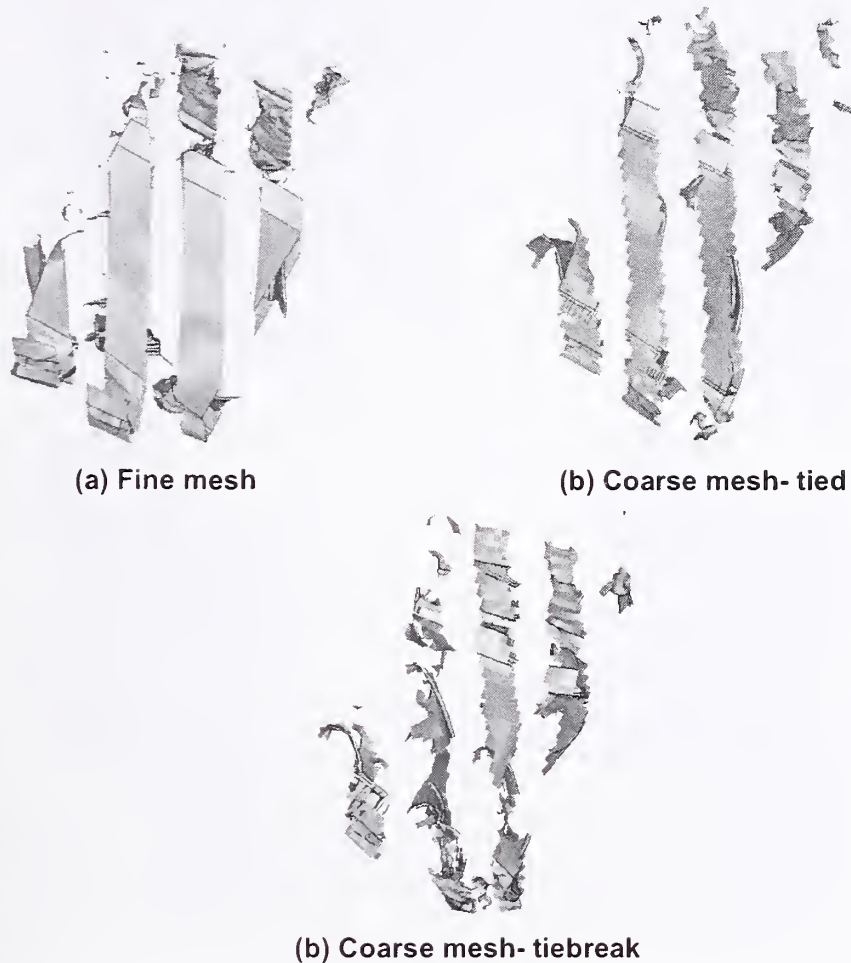
Figure 5–35. Fine and coarse mesh fragmentation.
