TOWN OF KENDUSKEAG FLOODPLAIN MANAGEMENT STUDY

PENOBSCOT COUNTY, MAINE

Prepared By:

May 24, 2000

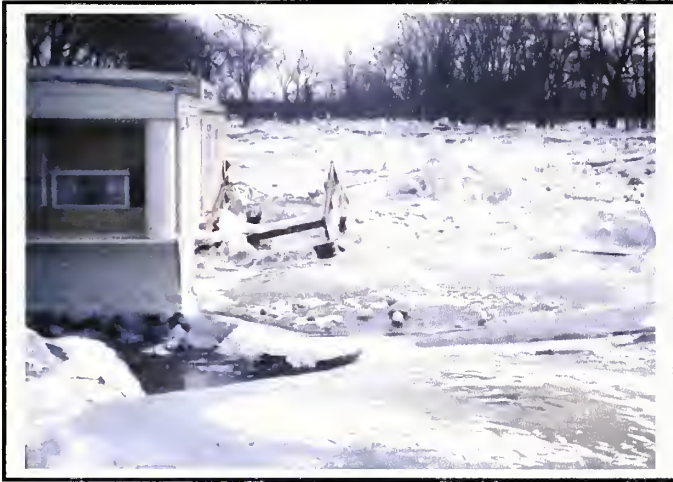
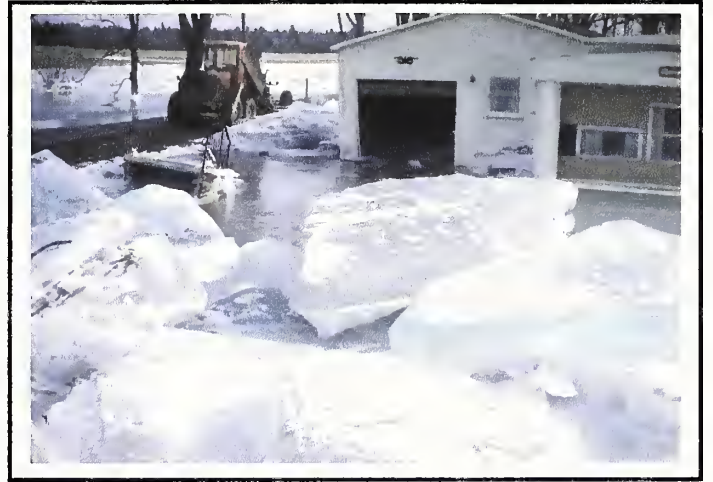
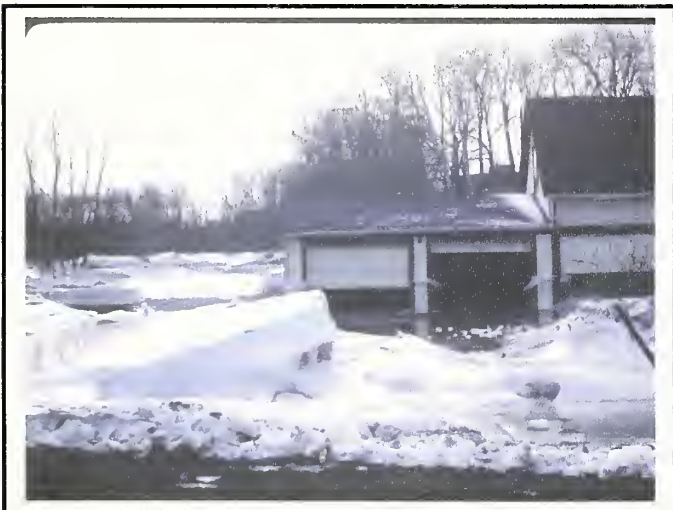
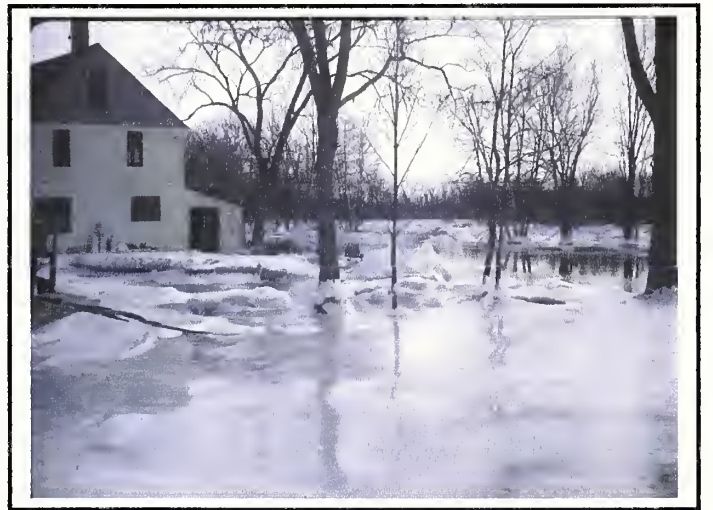
Ice Jam Flood – February 1970

**Kenduskeag Stream
at
Kenduskeag Village**

Kenduskeag's flood history indicates that damages can occur at any time during the year, but particularly in the winter and early spring months following heavy rainfall on snow-covered or frozen ground; in summer following intense thunderstorms; and in summer and fall during tropical hurricanes. Ice jams on Kenduskeag Stream near Kenduskeag Village often compound flood problems (see photos on page 6 of 1970 flood).

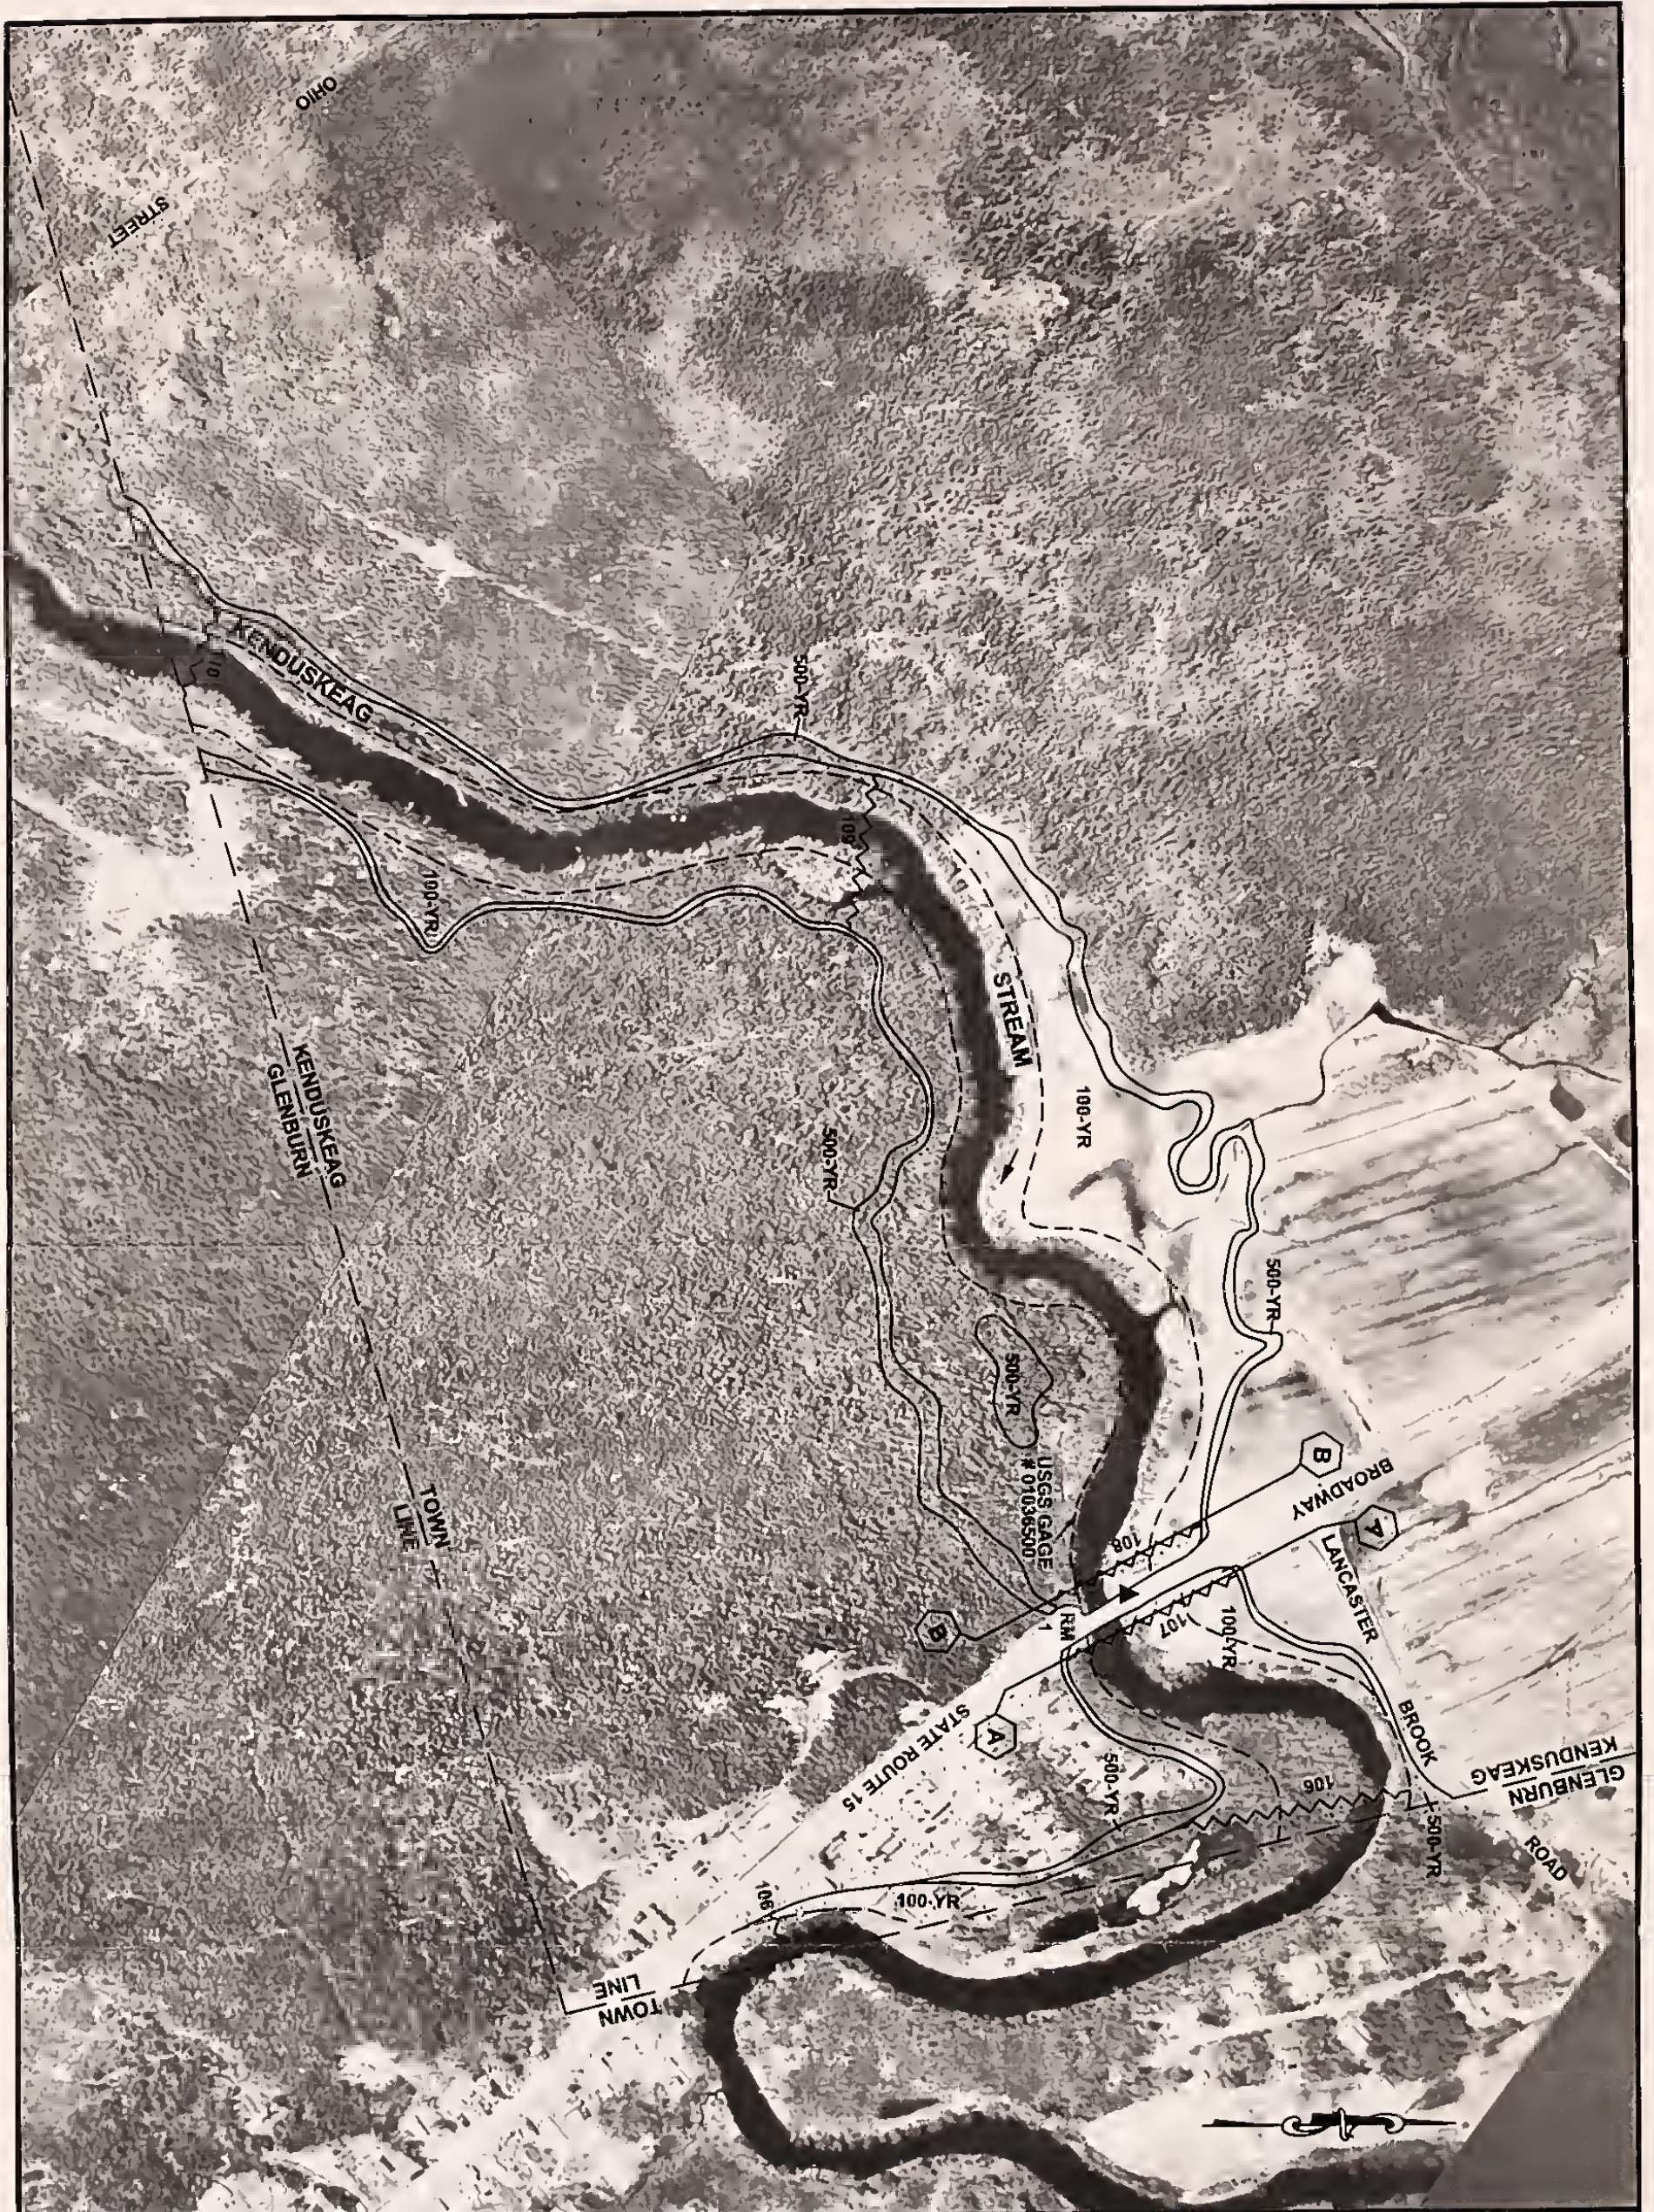
**FLOOD HAZARD AREA
 KENDUSKEAG STREAM**

196 100-Year Flood Elevation
 --- Floodway

The boundaries of the 100-, and 500-year floods shown on the **Flood Hazard Area Maps** were delineated from elevations determined at each cross section. Between cross sections the boundaries were interpolated using topographic maps at a scale of 1:24,000 and contour interval of 10 feet. Field survey information, engineering computations, and other data pertinent to the study are on file and available for review at the following location:

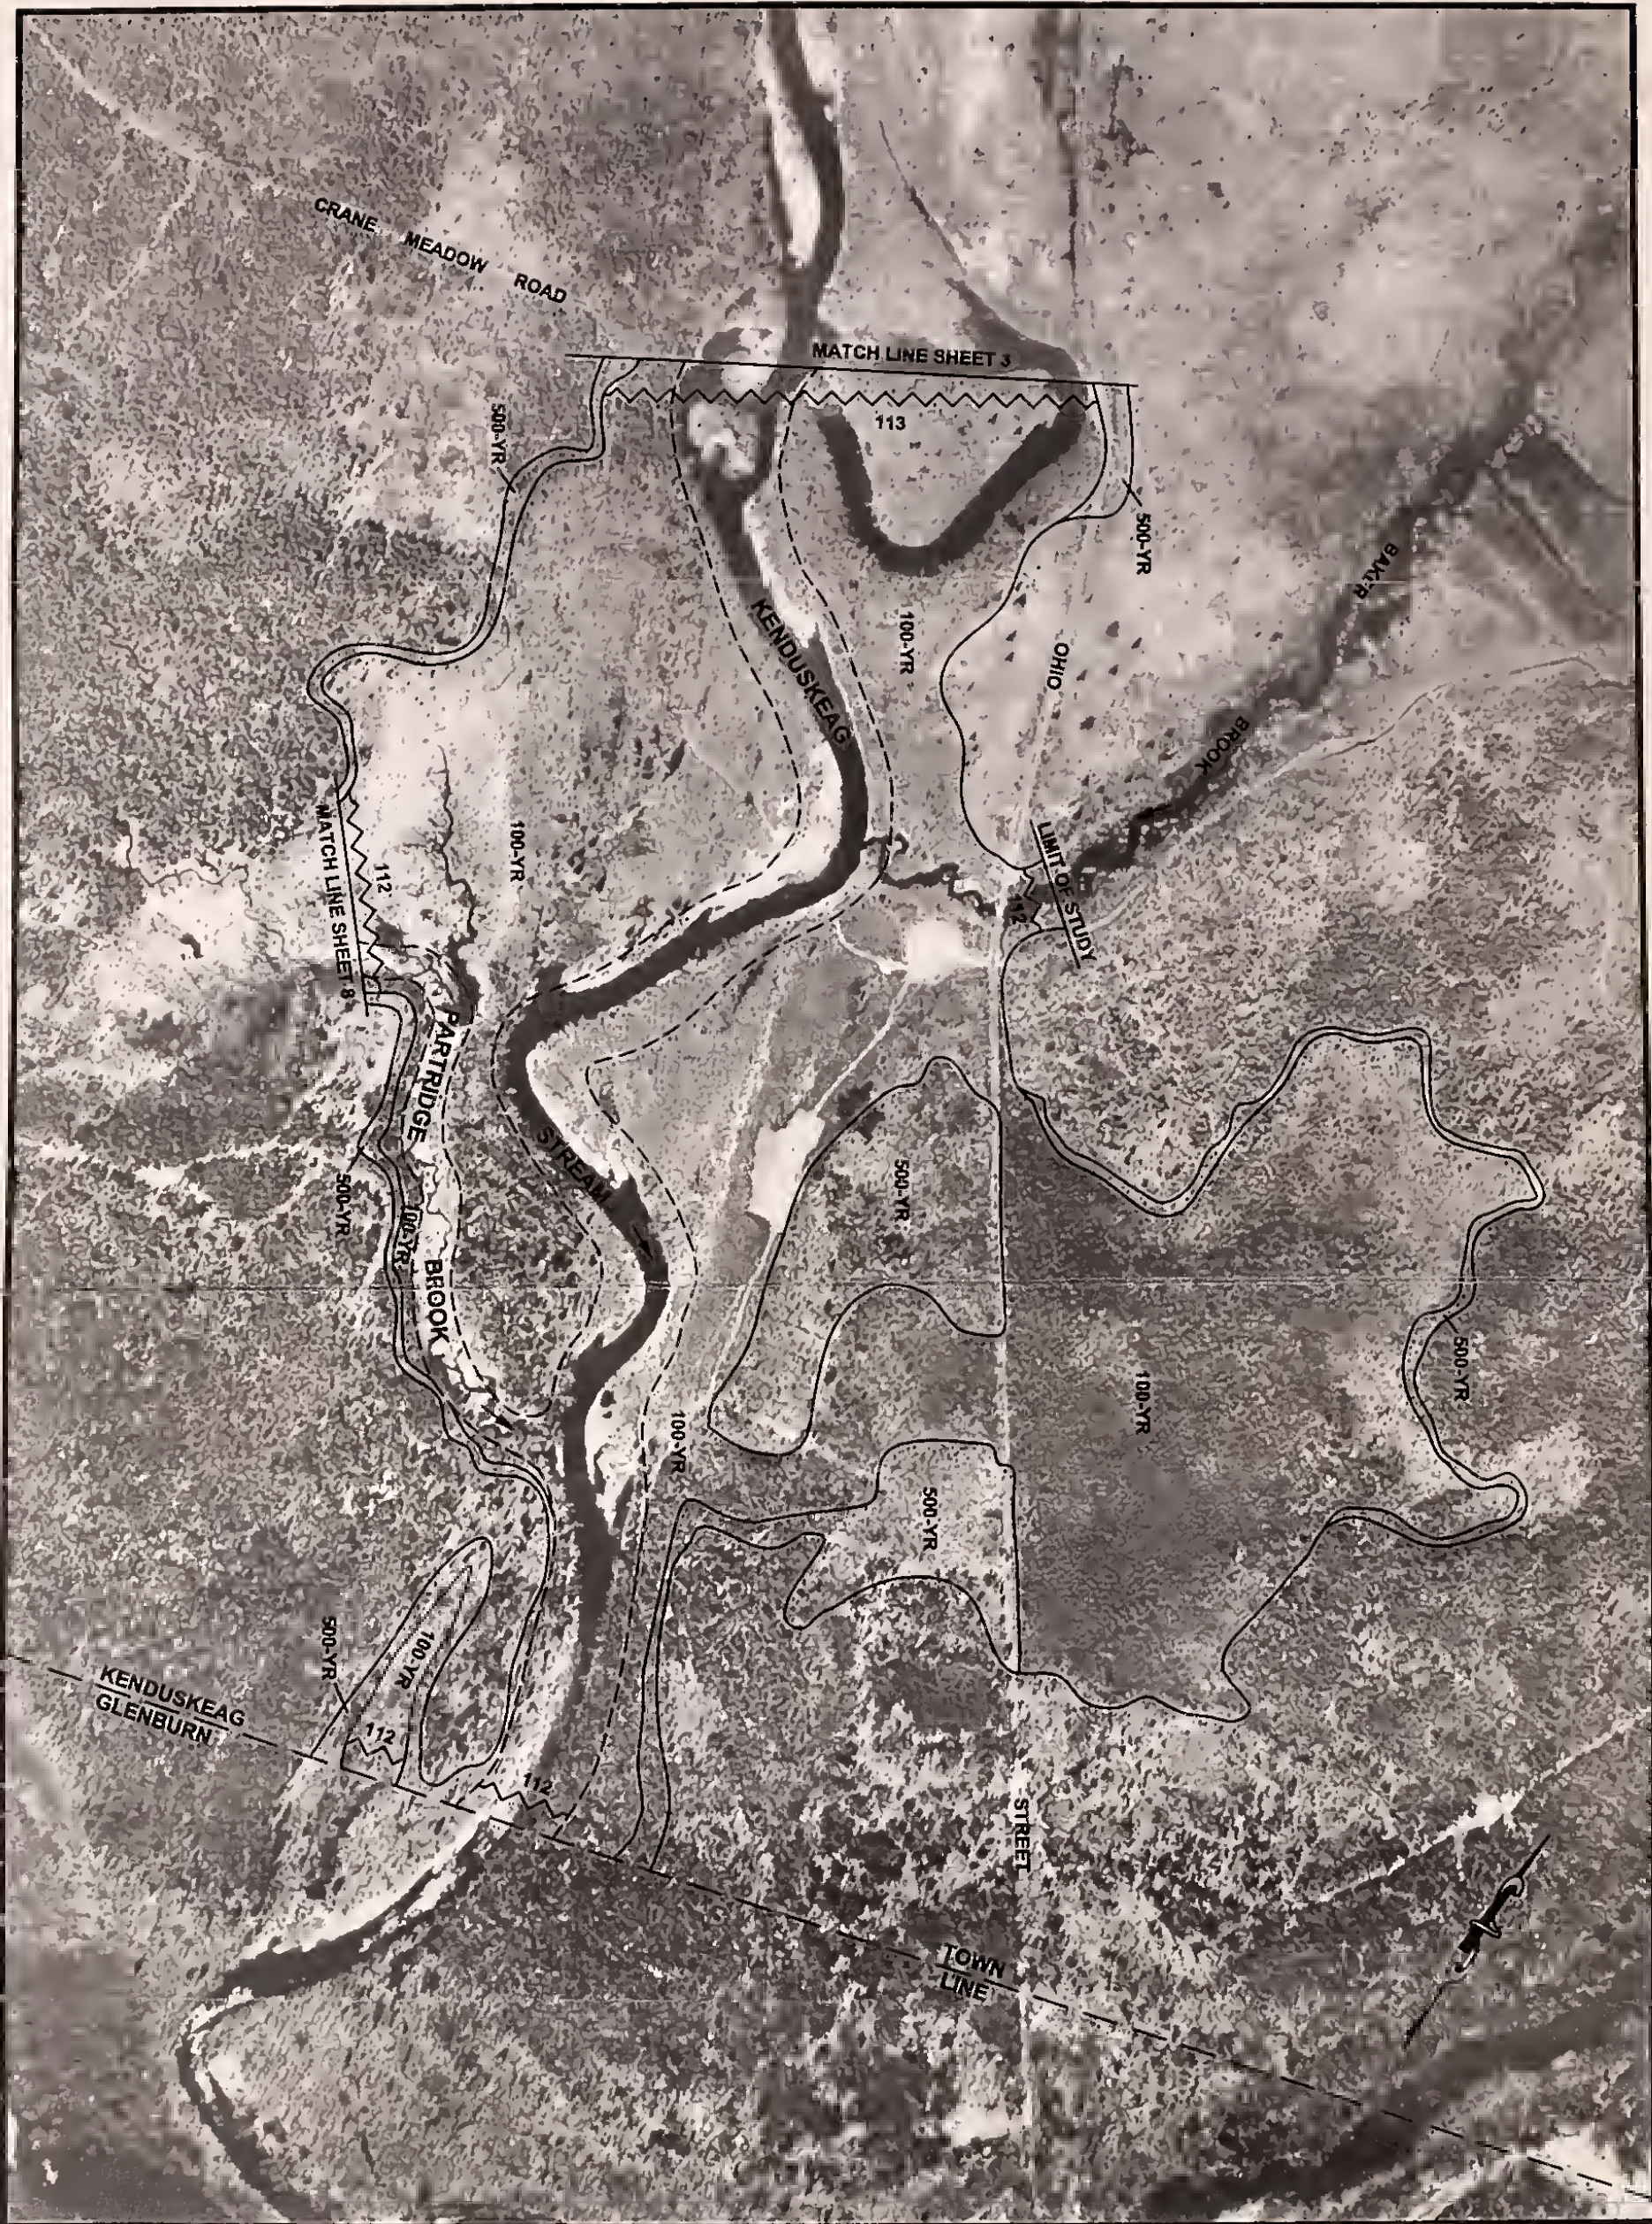
FLOOD HAZARD AREA
KENDUSKEAG STREAM

112 100-Year Flood Elevation
 --- Floodway

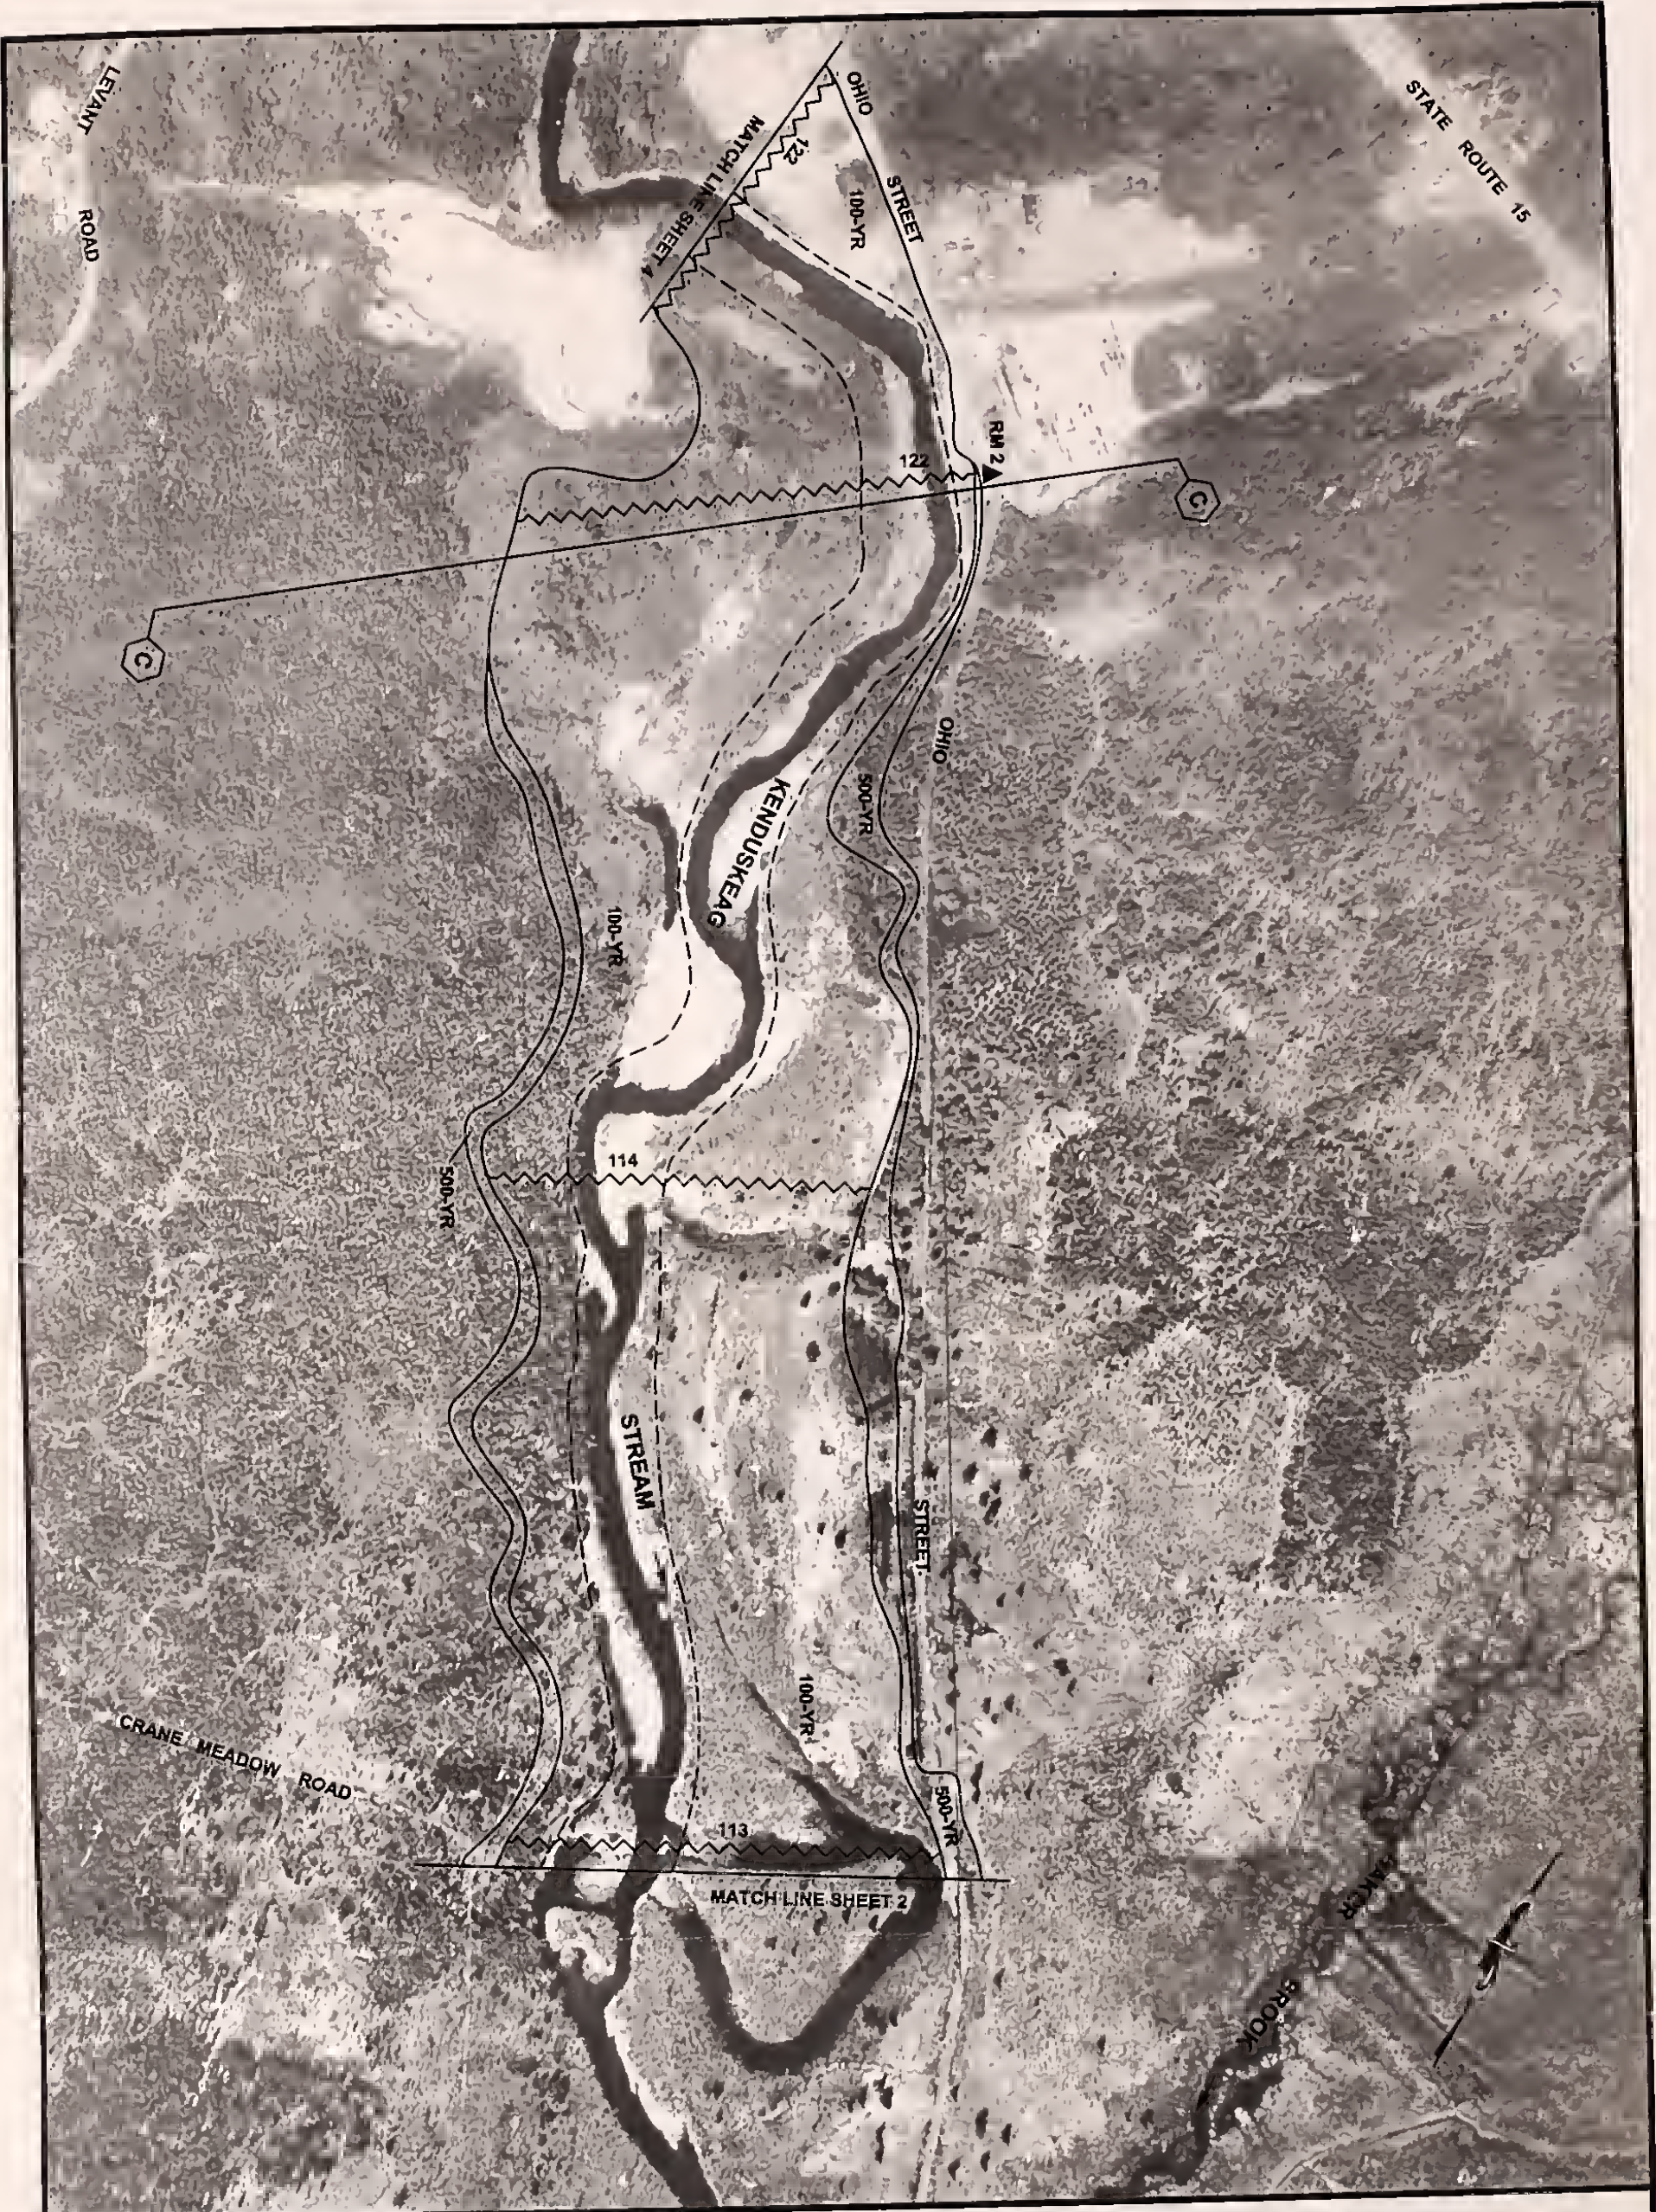
FLOOD HAZARD AREA
KENDUSKEAG STREAM

113 100-Year Flood Elevation
 --- Floodway

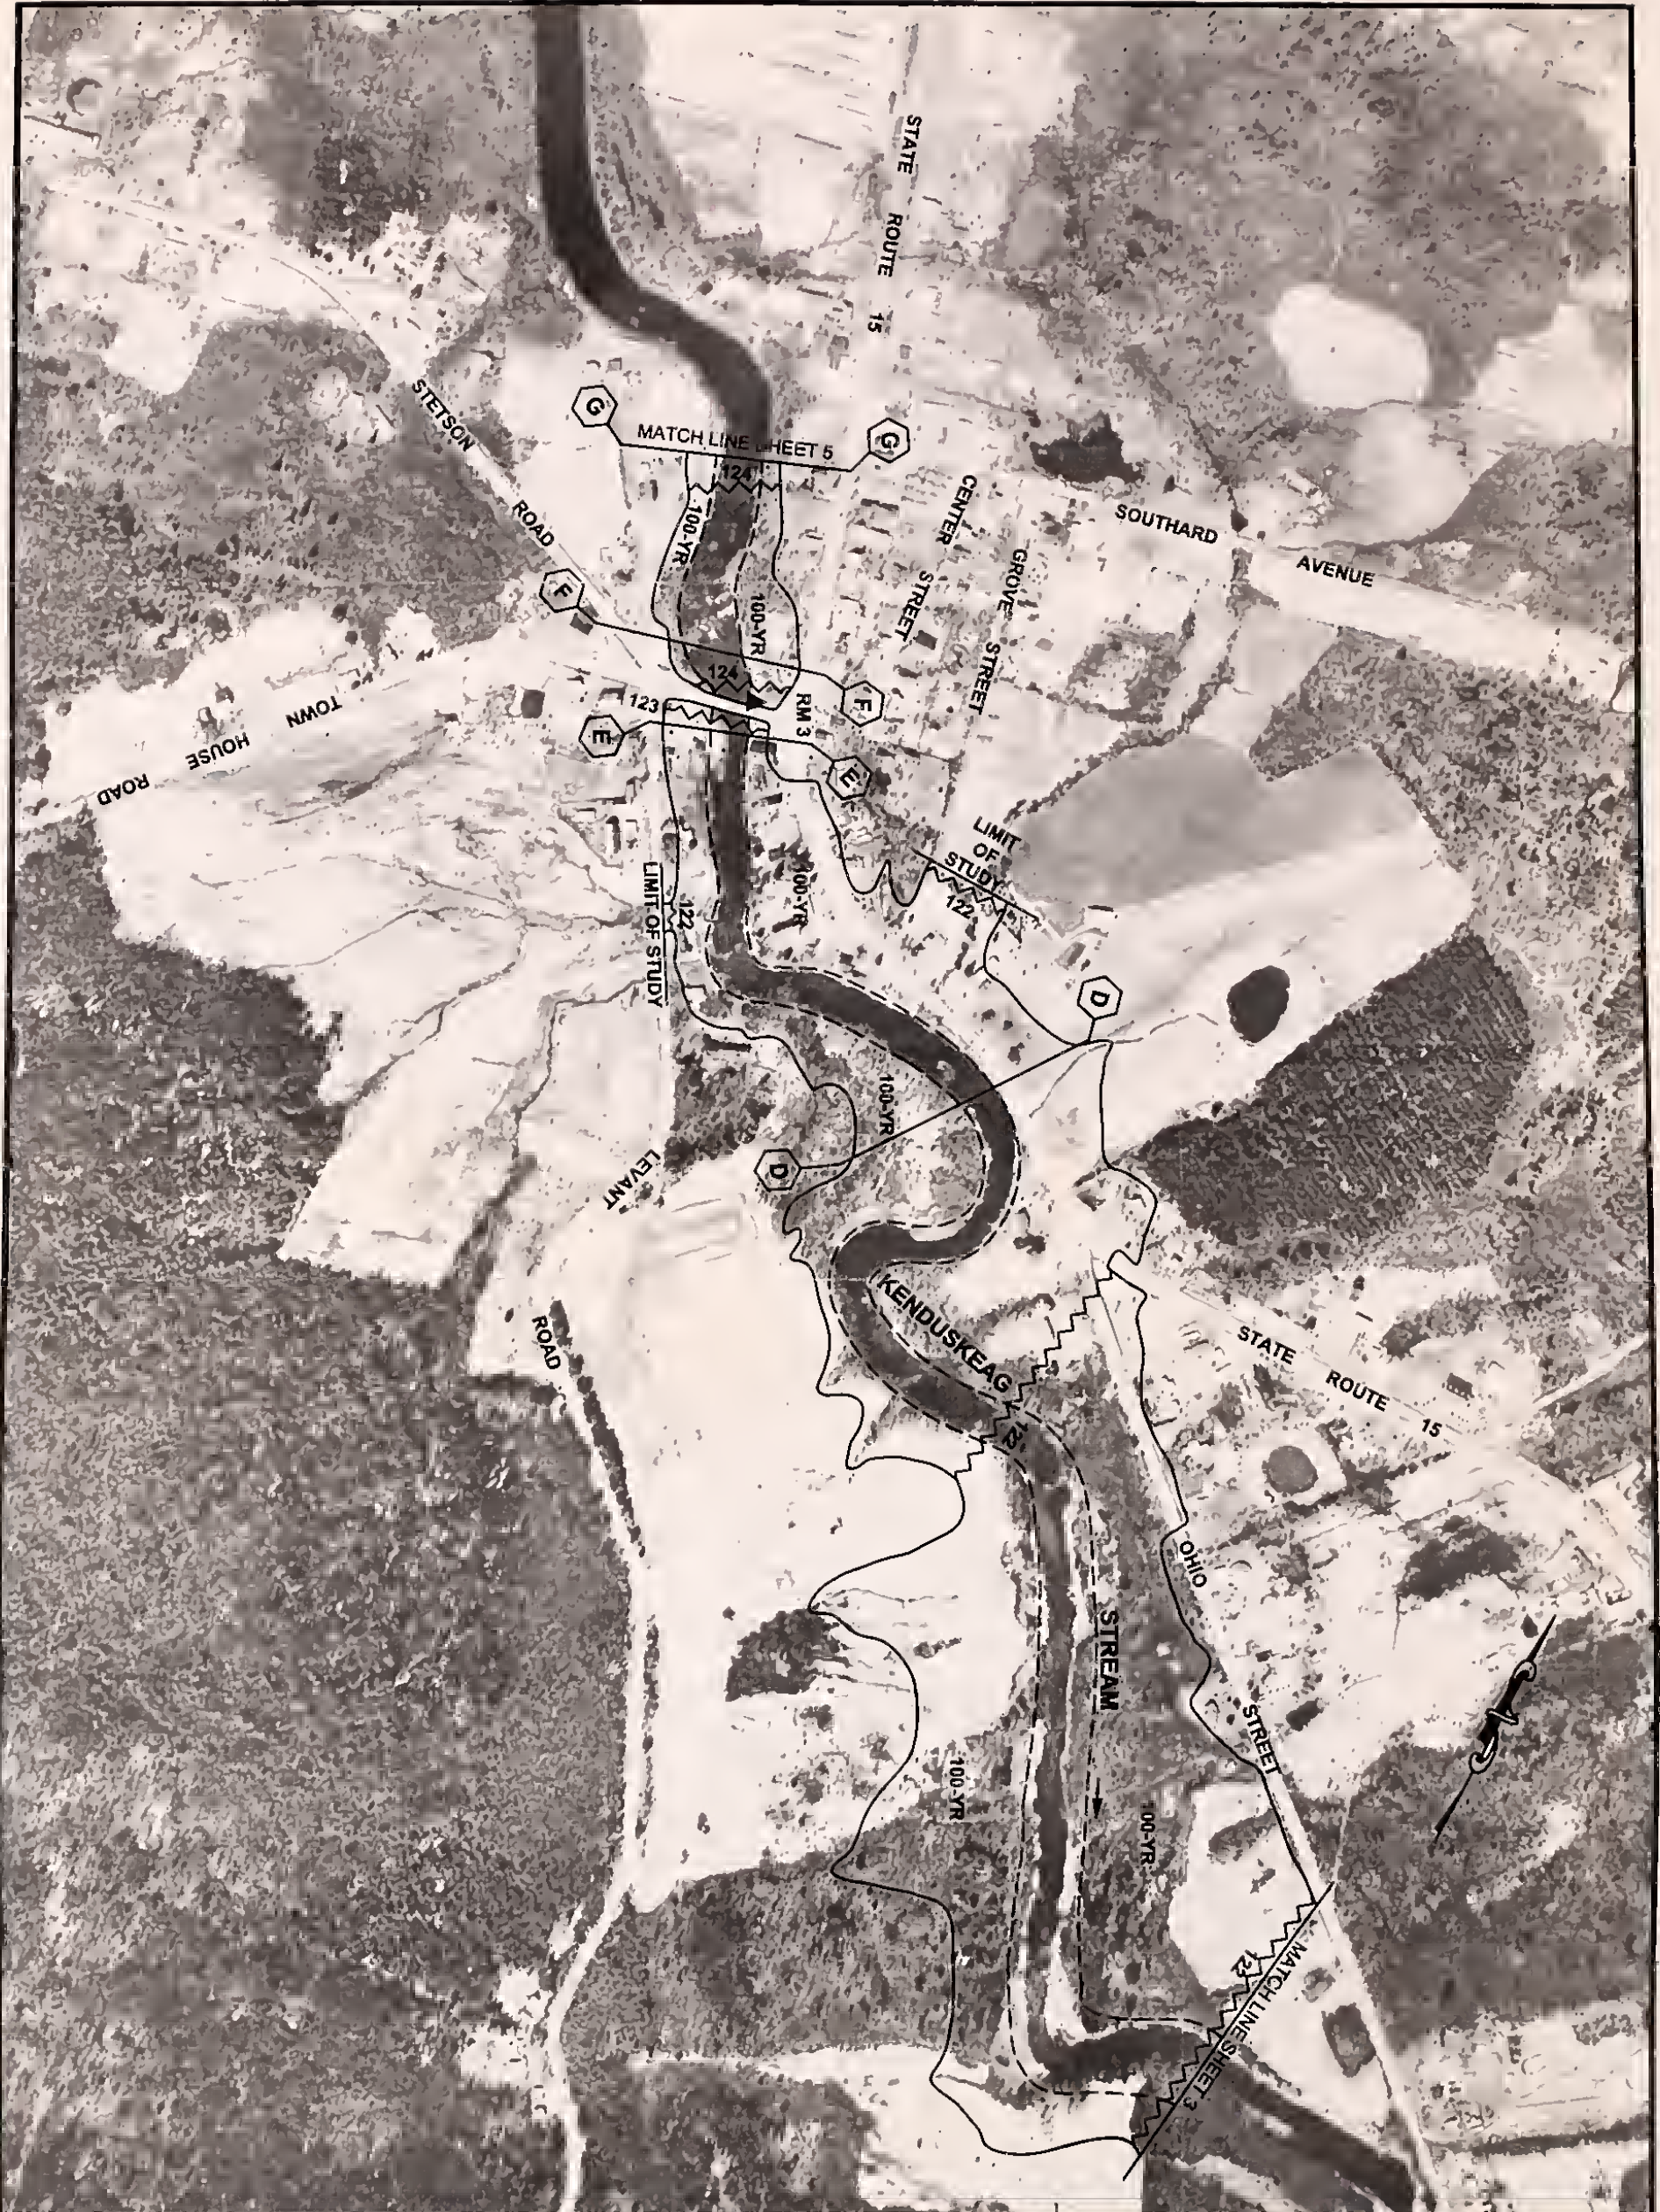
FLOOD HAZARD AREA
KENDUSKEAG STREAM

122 100-Year Flood Elevation
 Floodway

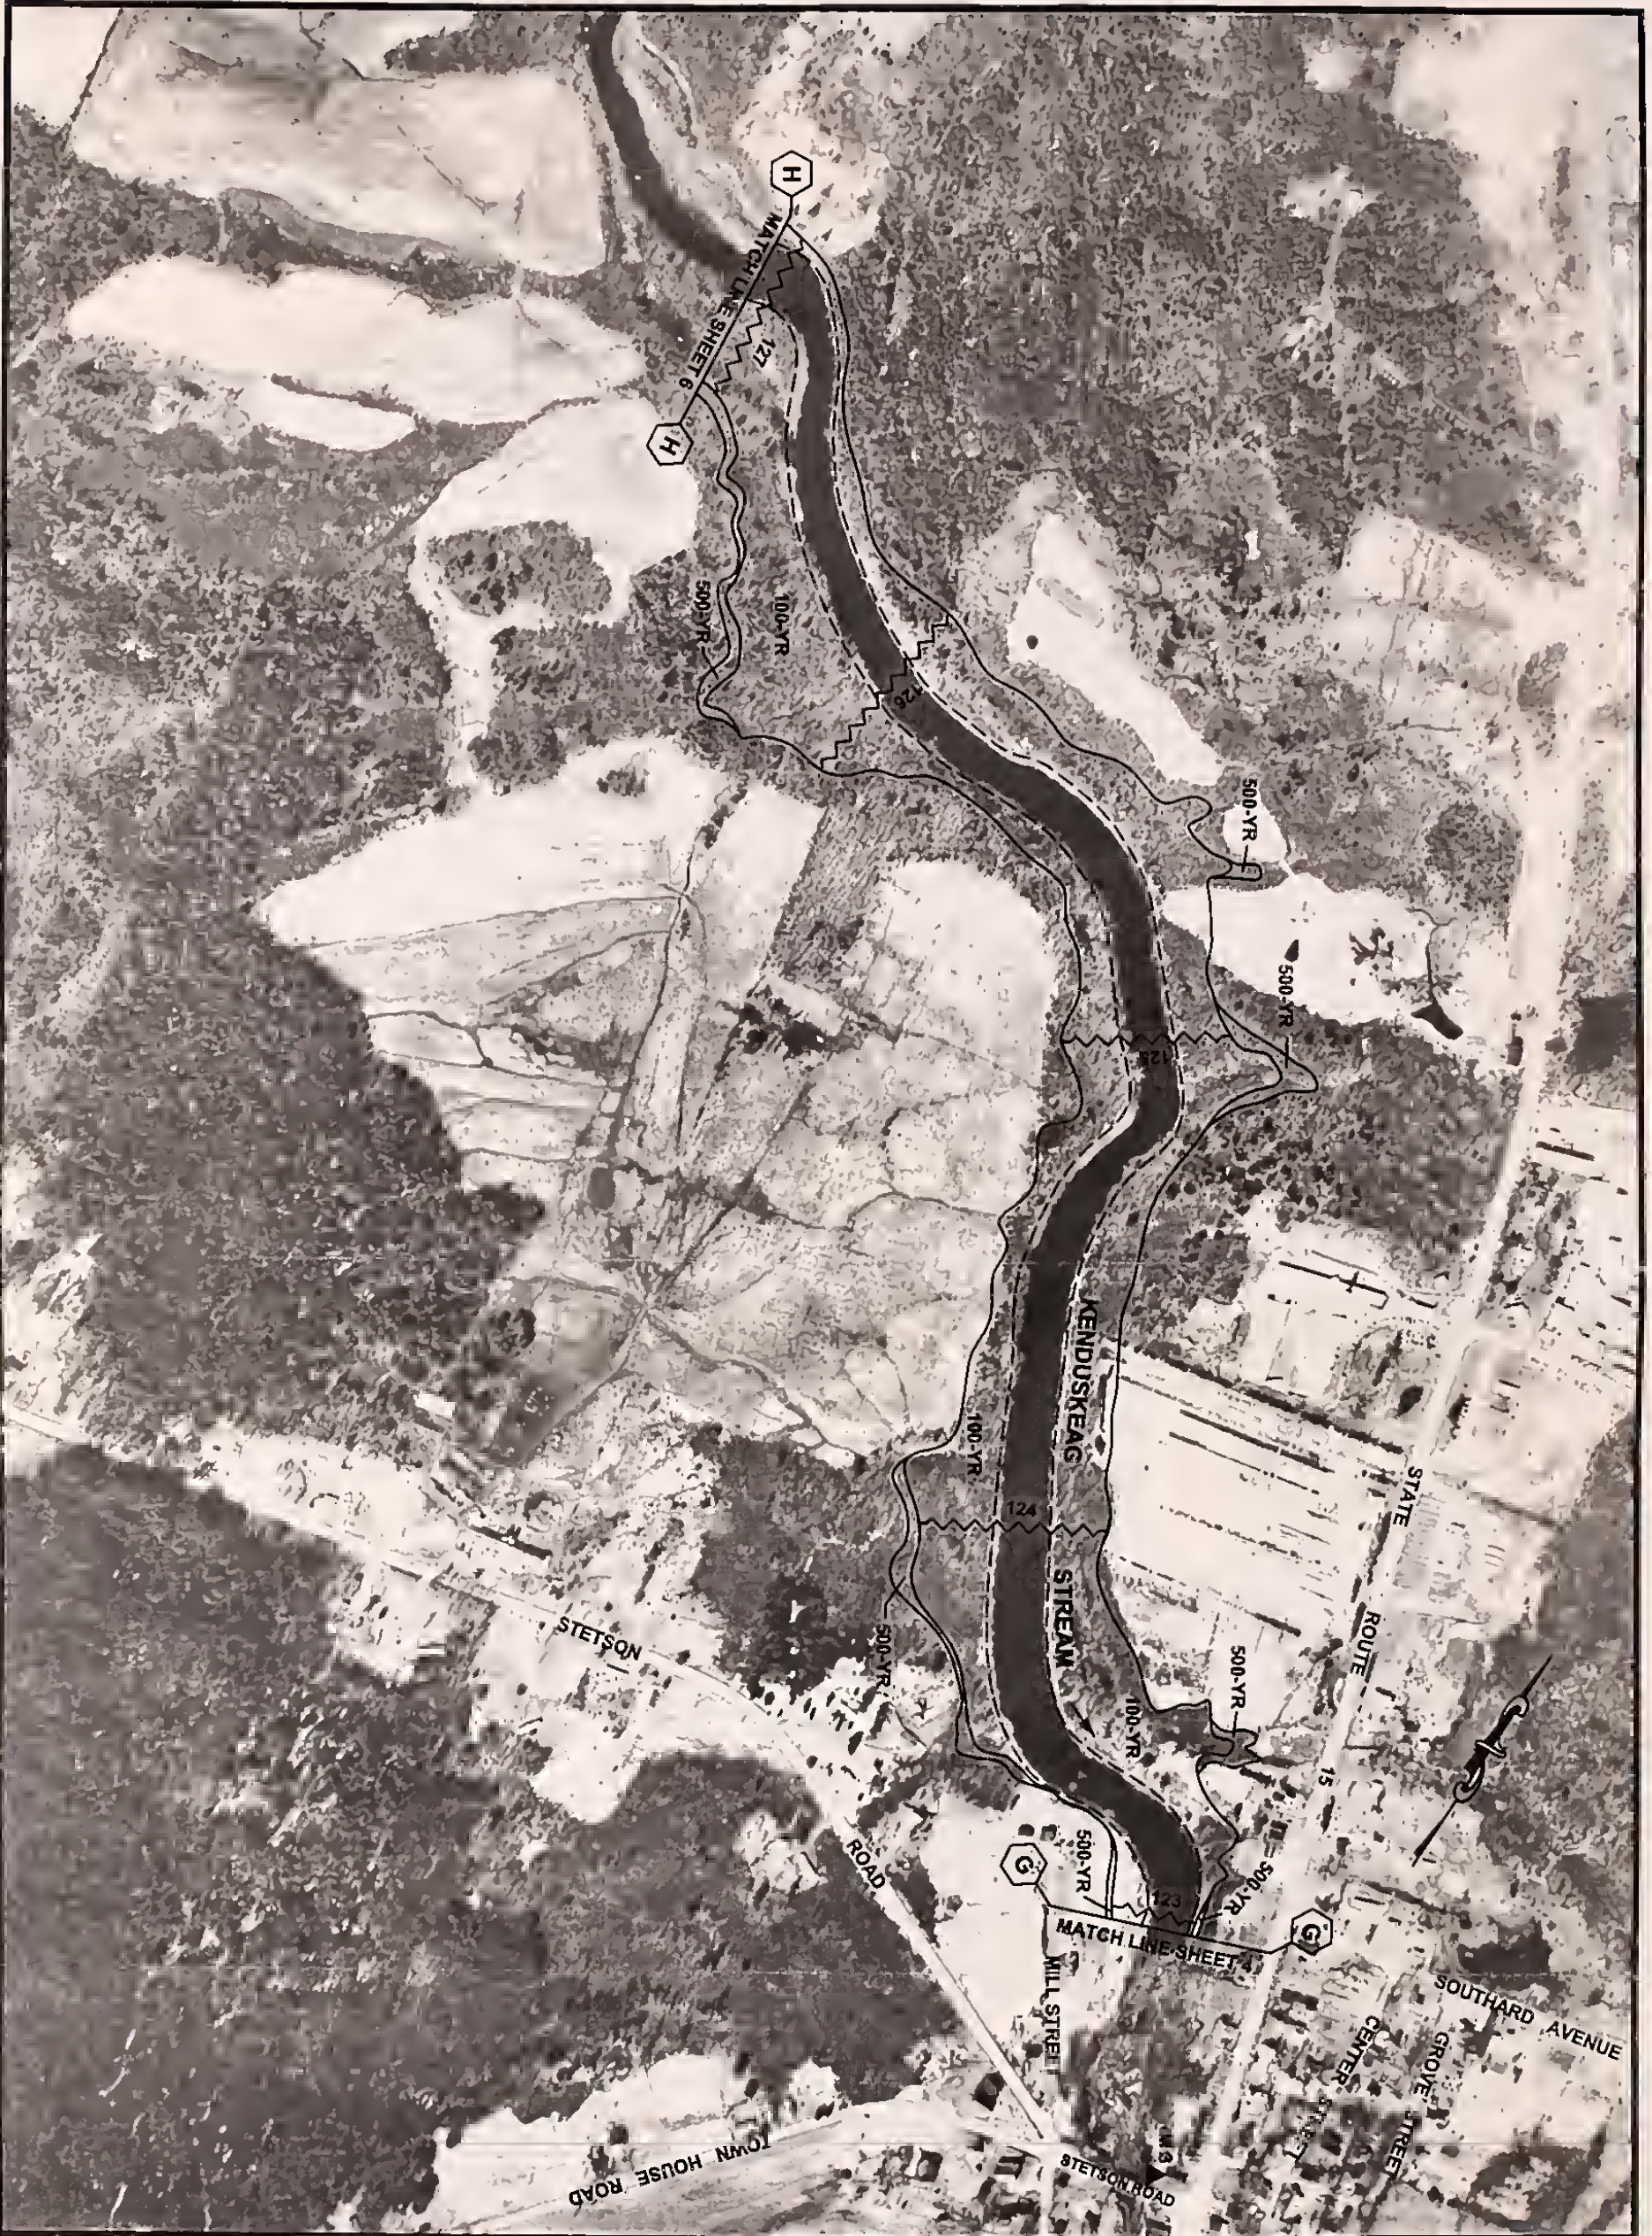
FLOOD HAZARD AREA
KENDUSKEAG STREAM

124 100-Year Flood Elevation
 Floodway
 Valley Section Location
 Elevation Reference Mark
