TOWN OF KENDUSKEAG FLOODPLAIN MANAGEMENT STUDY

PENOBSCOT COUNTY, MAINE

Prepared By:

May 24, 2000

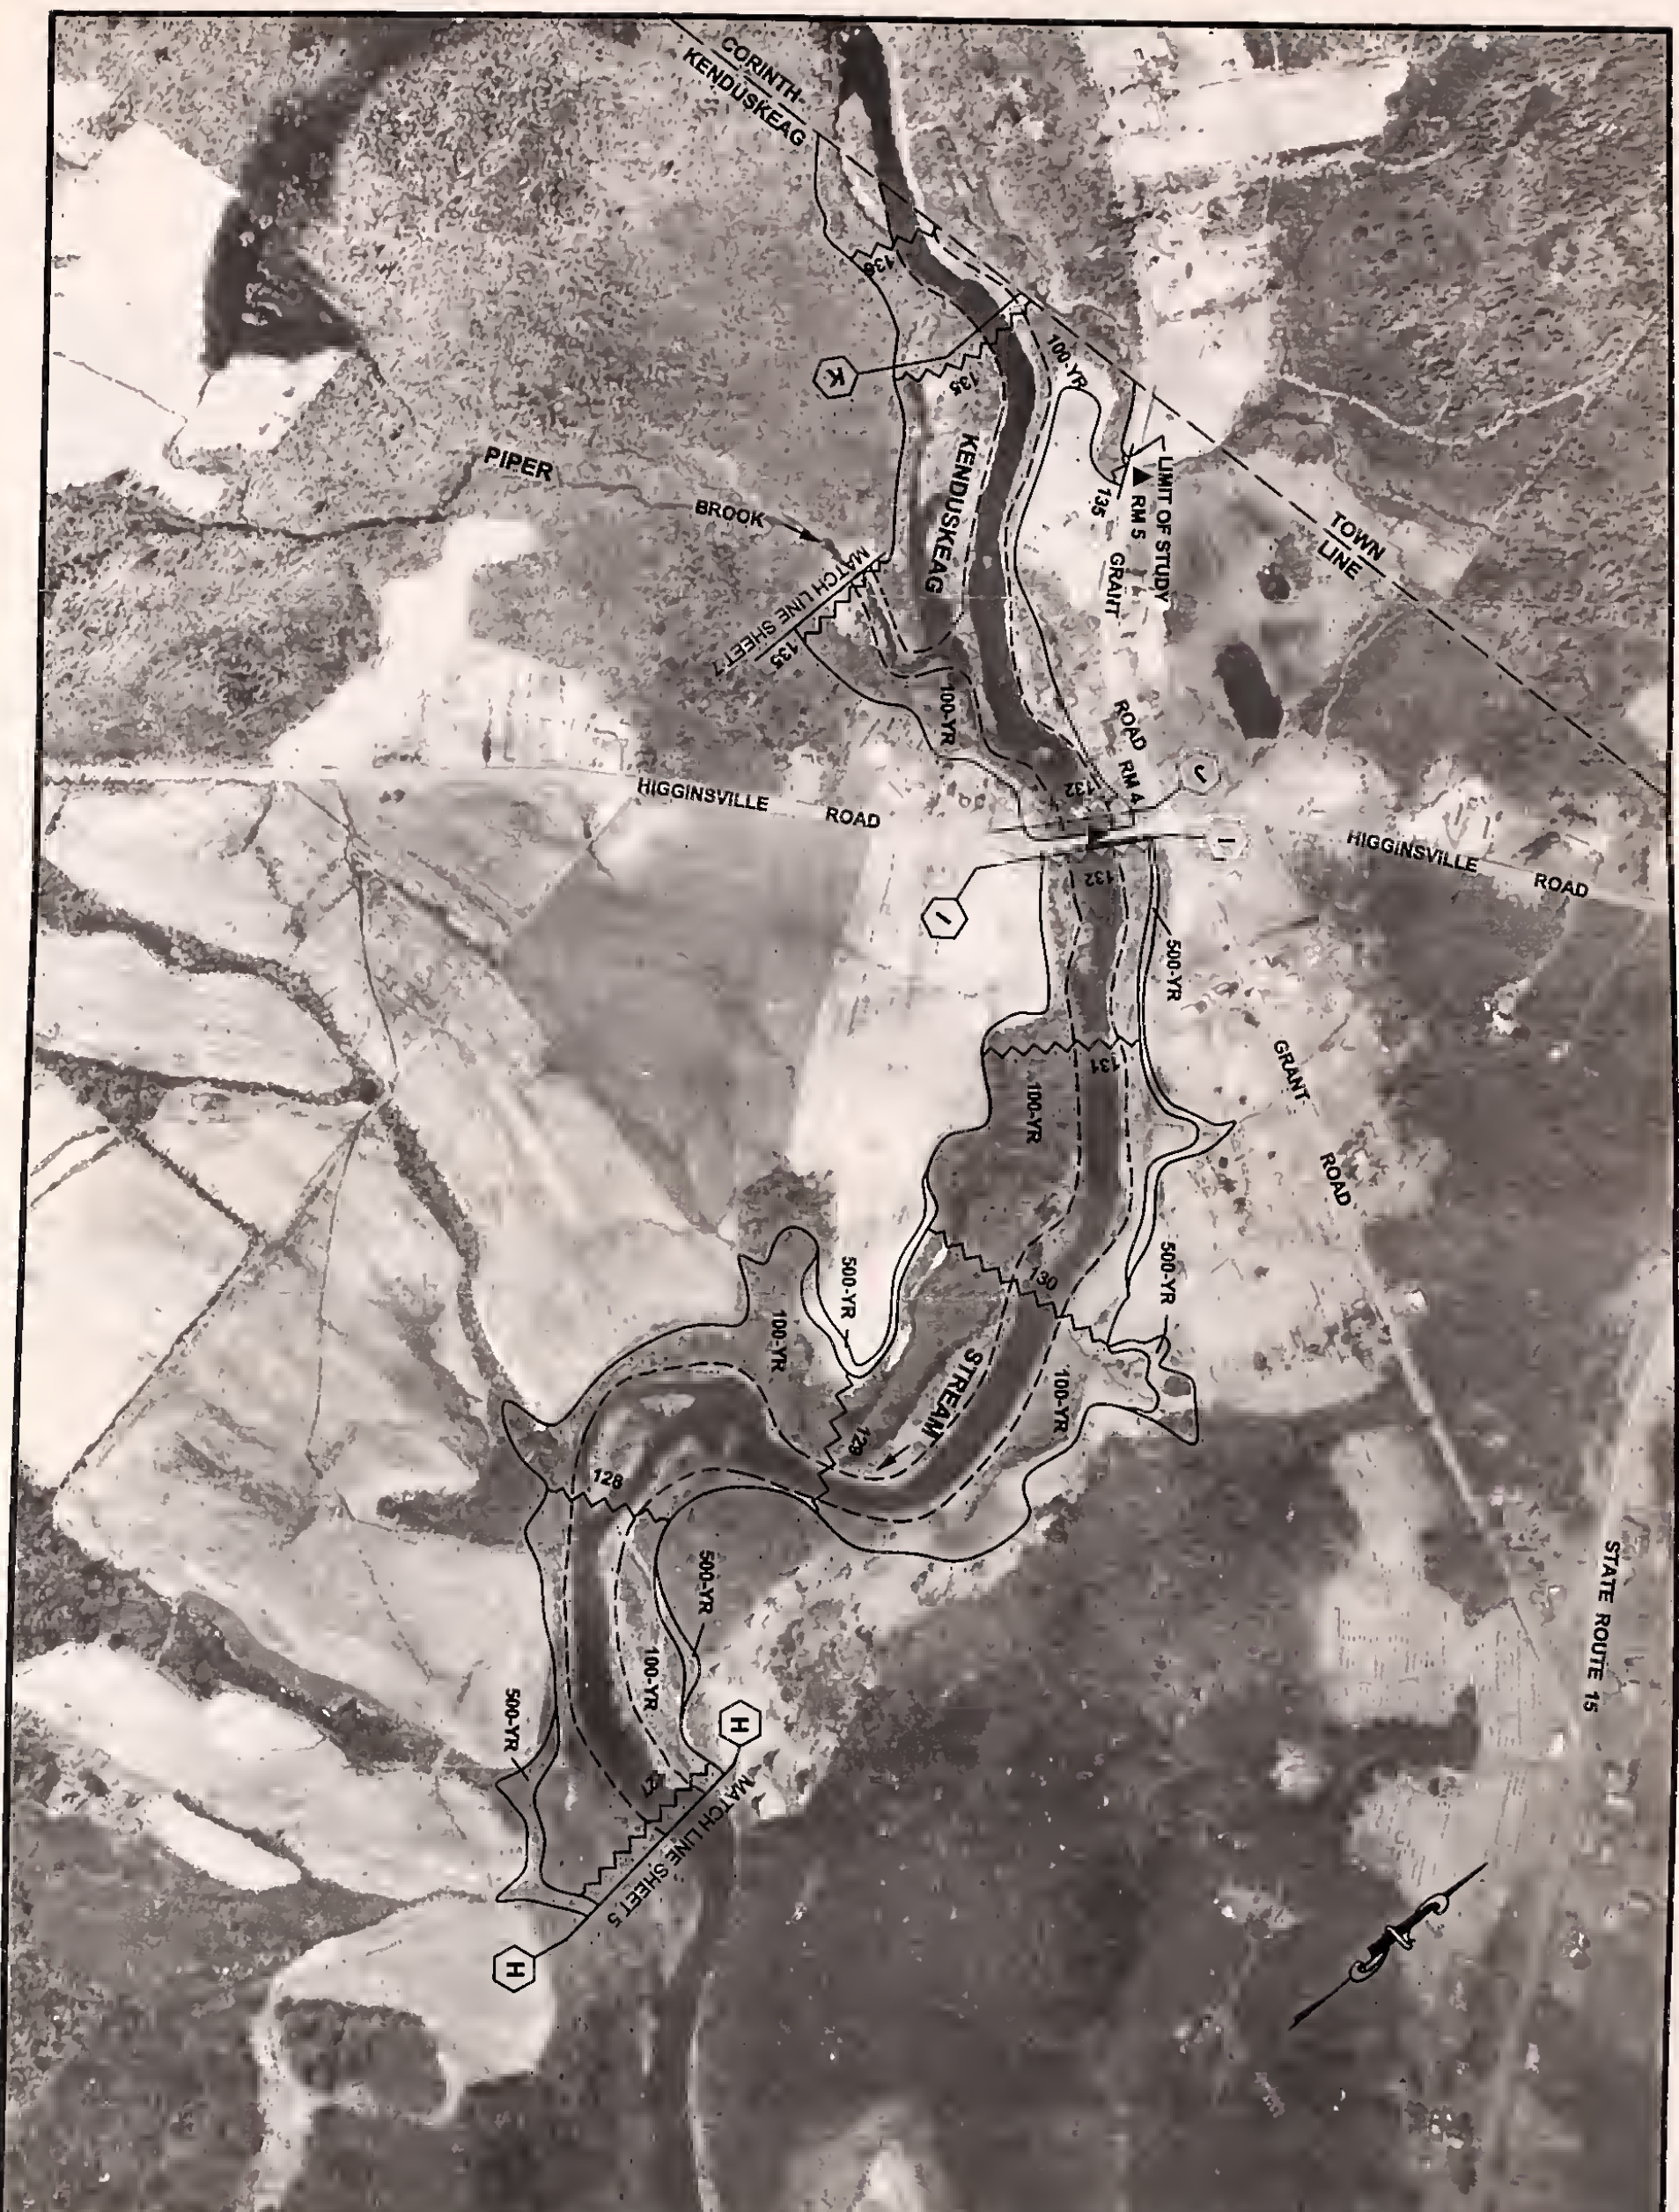
FLOOD HAZARD AREA
KENDUSKEAG STREAM

128 100-Year Flood Elevation
 --- Floodway

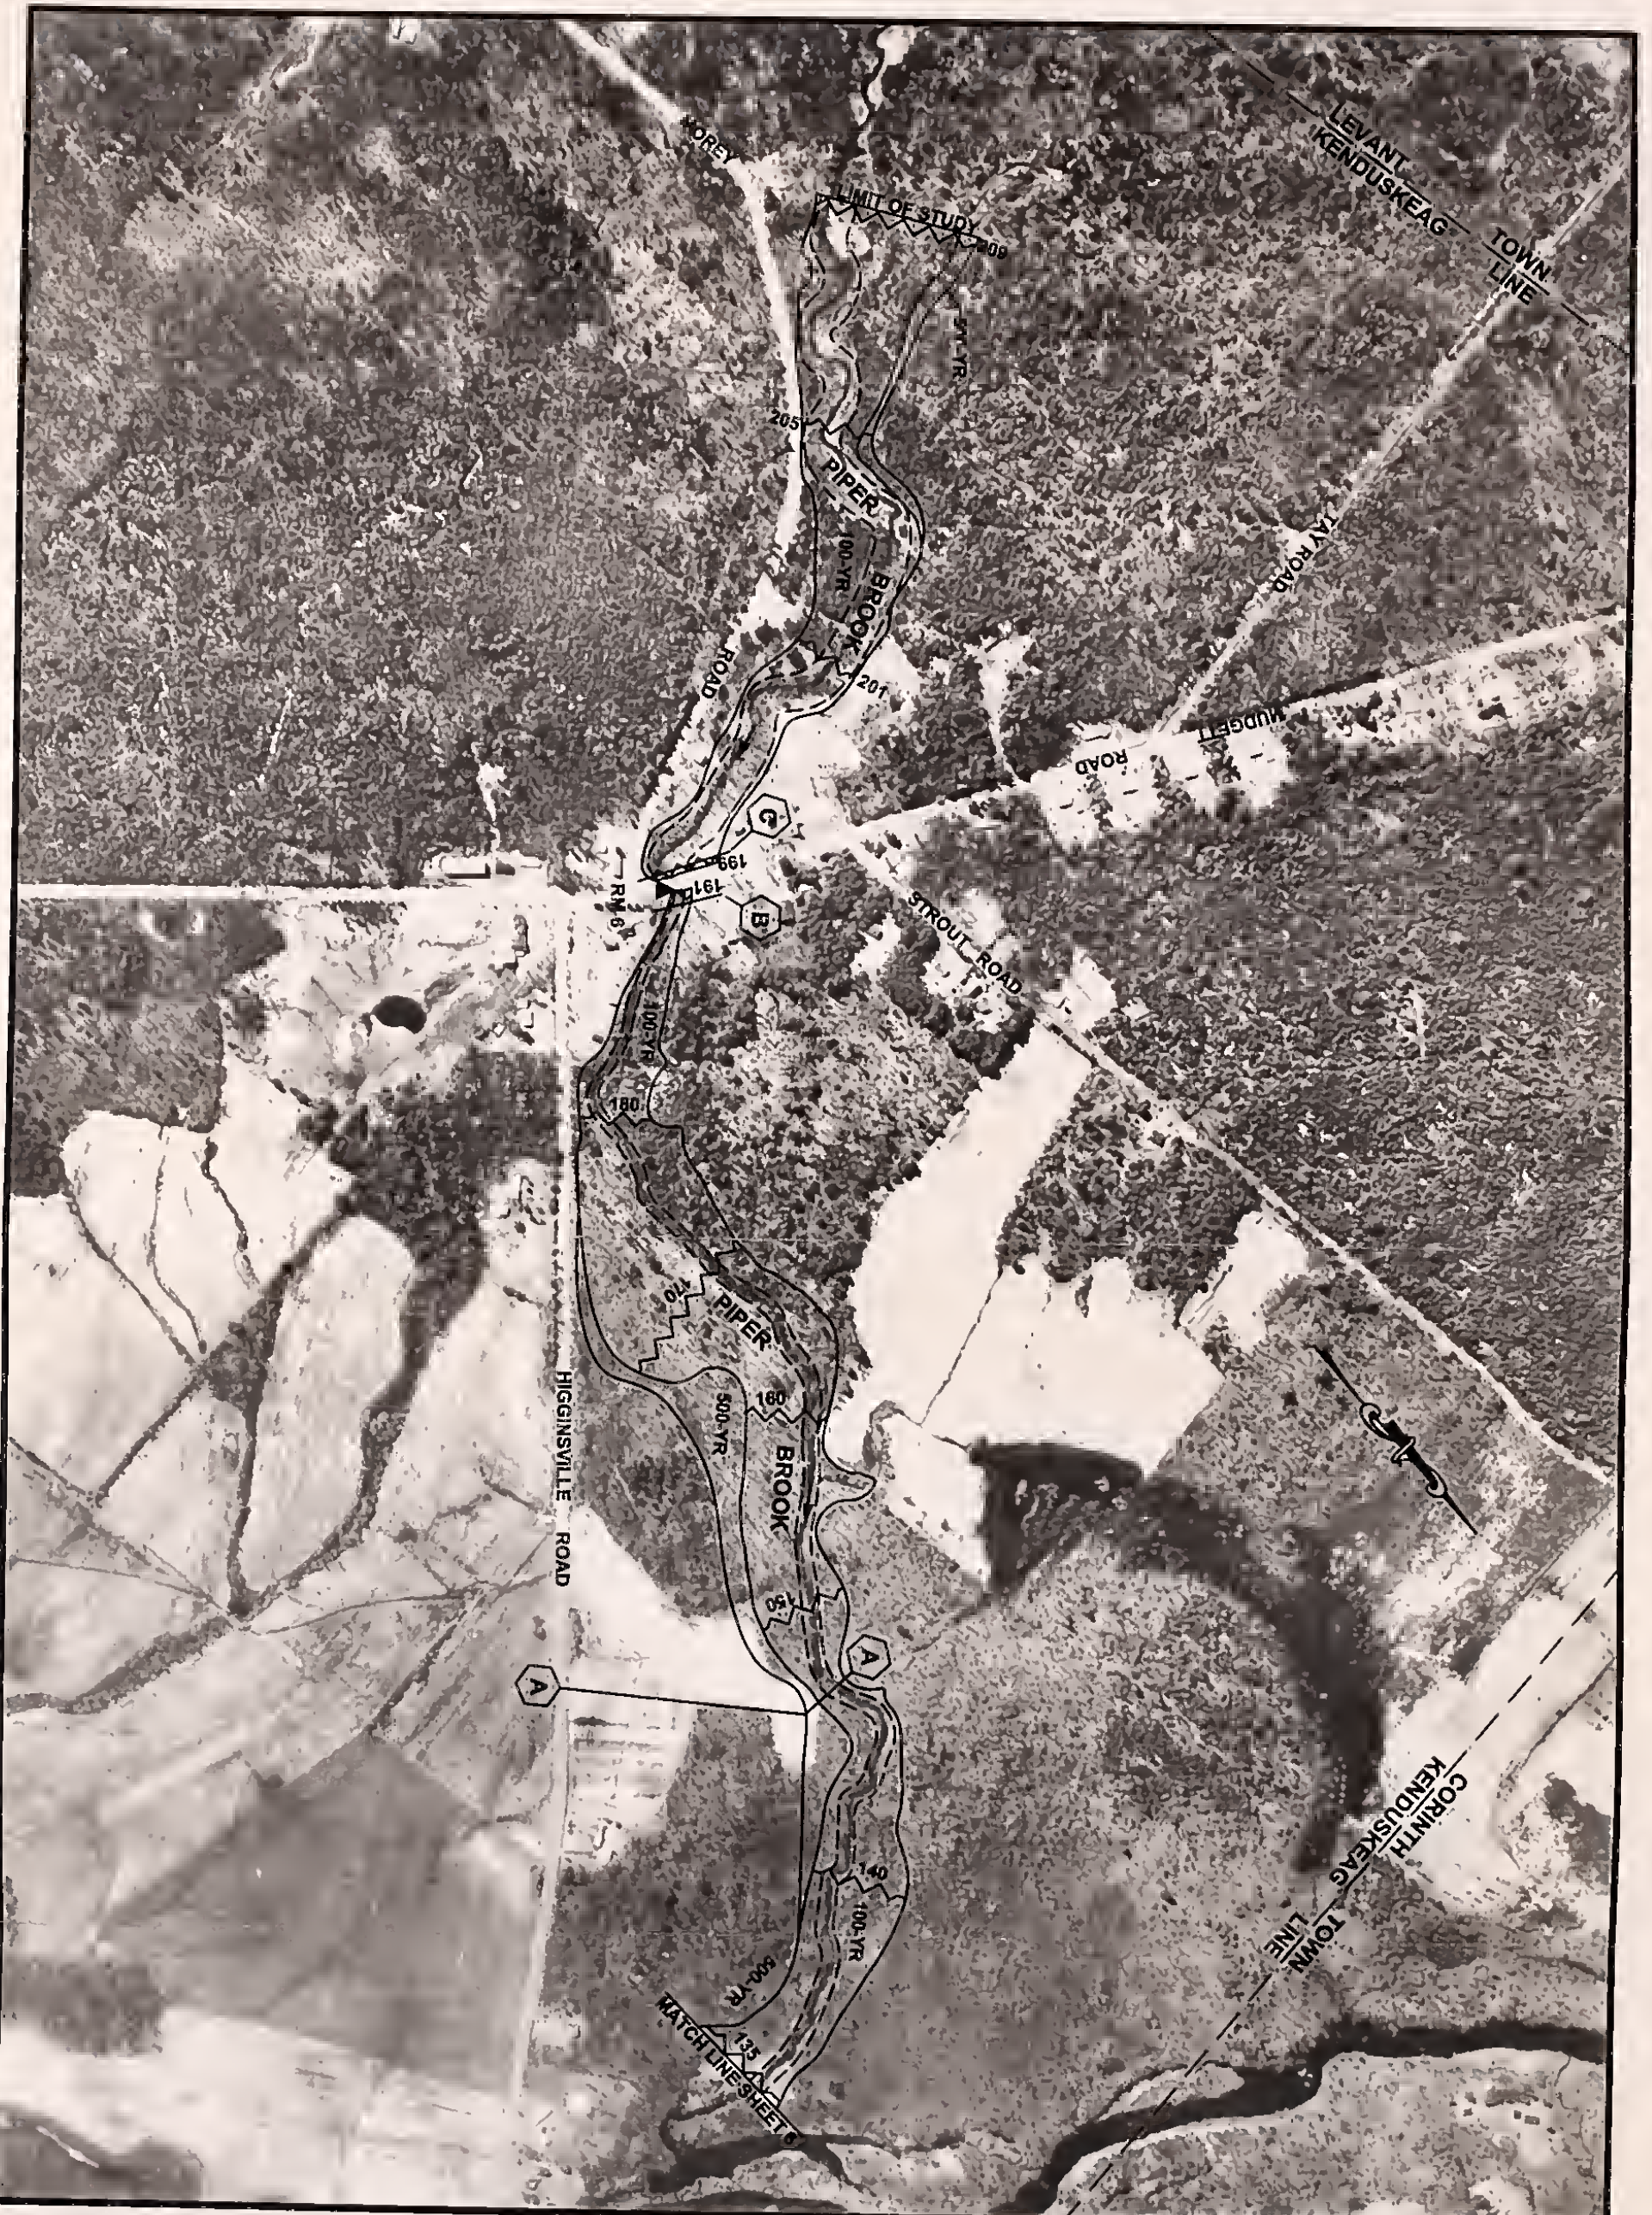
FLOOD HAZARD AREA
PIPER BROOK

135 100-Year Flood Elevation
 --- Floodway

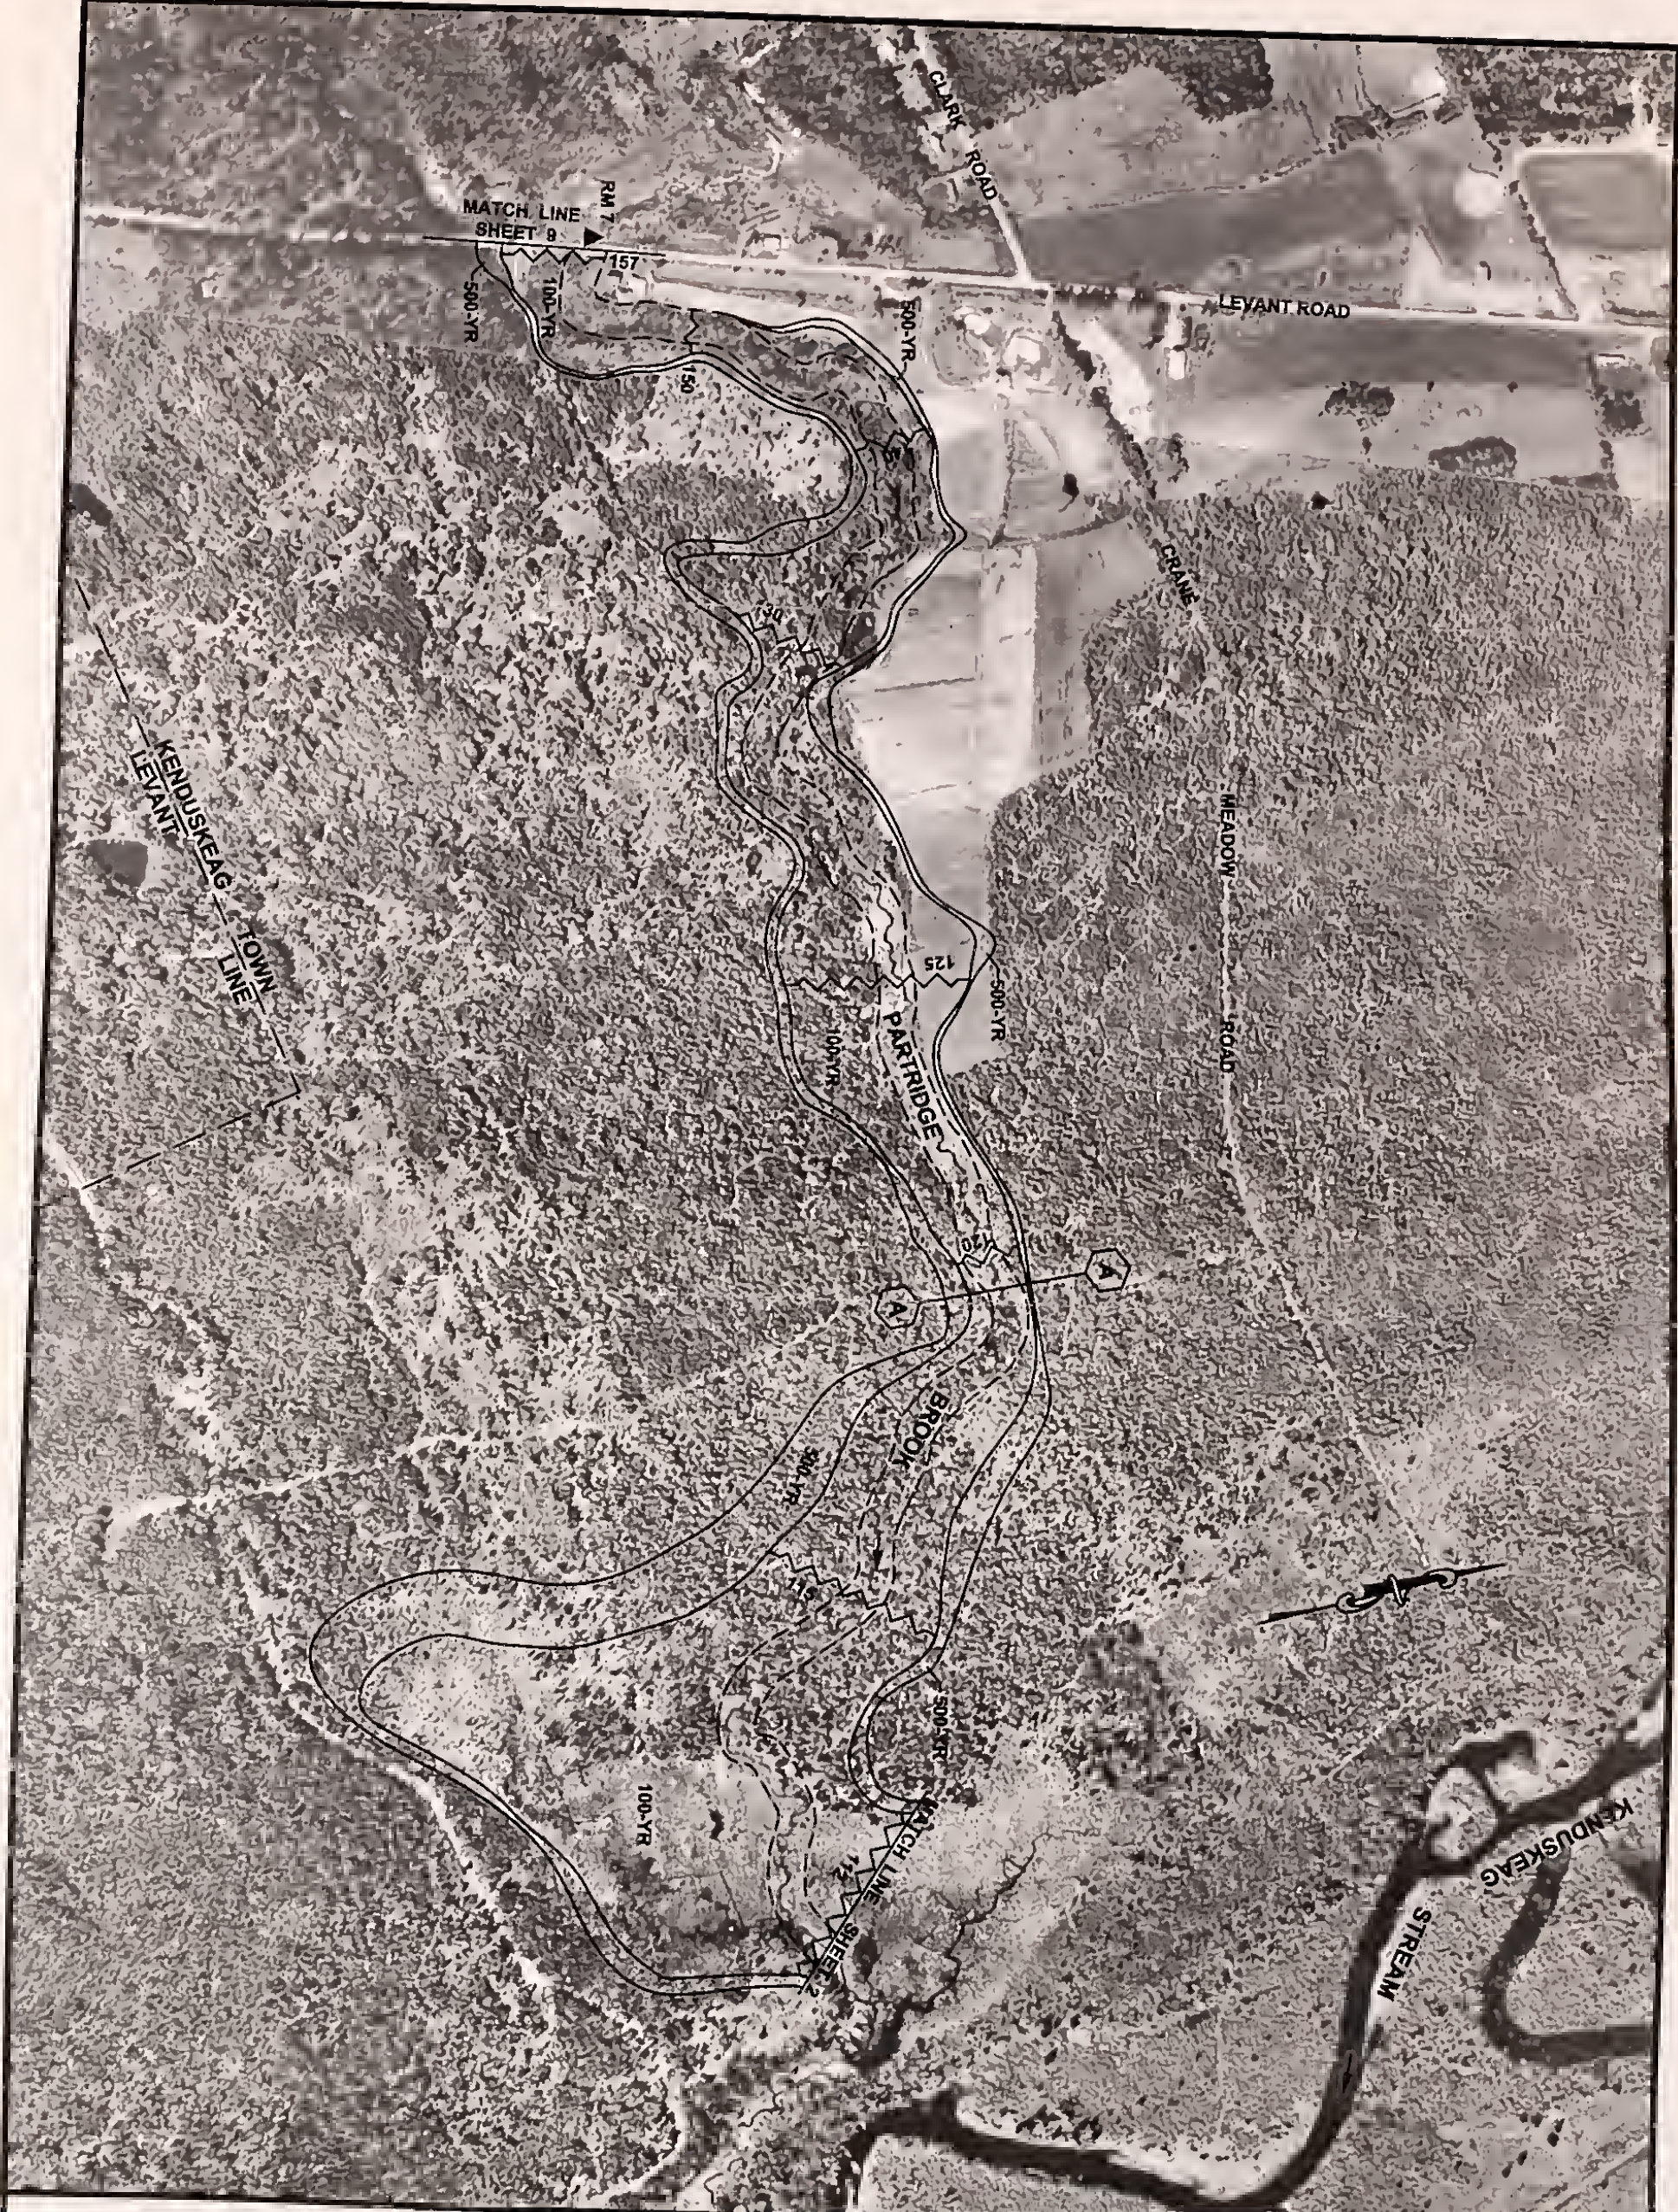
**FLOOD HAZARD AREA
 PARTRIDGE BROOK**

458 100-Year Flood Elevation
 --- Floodway

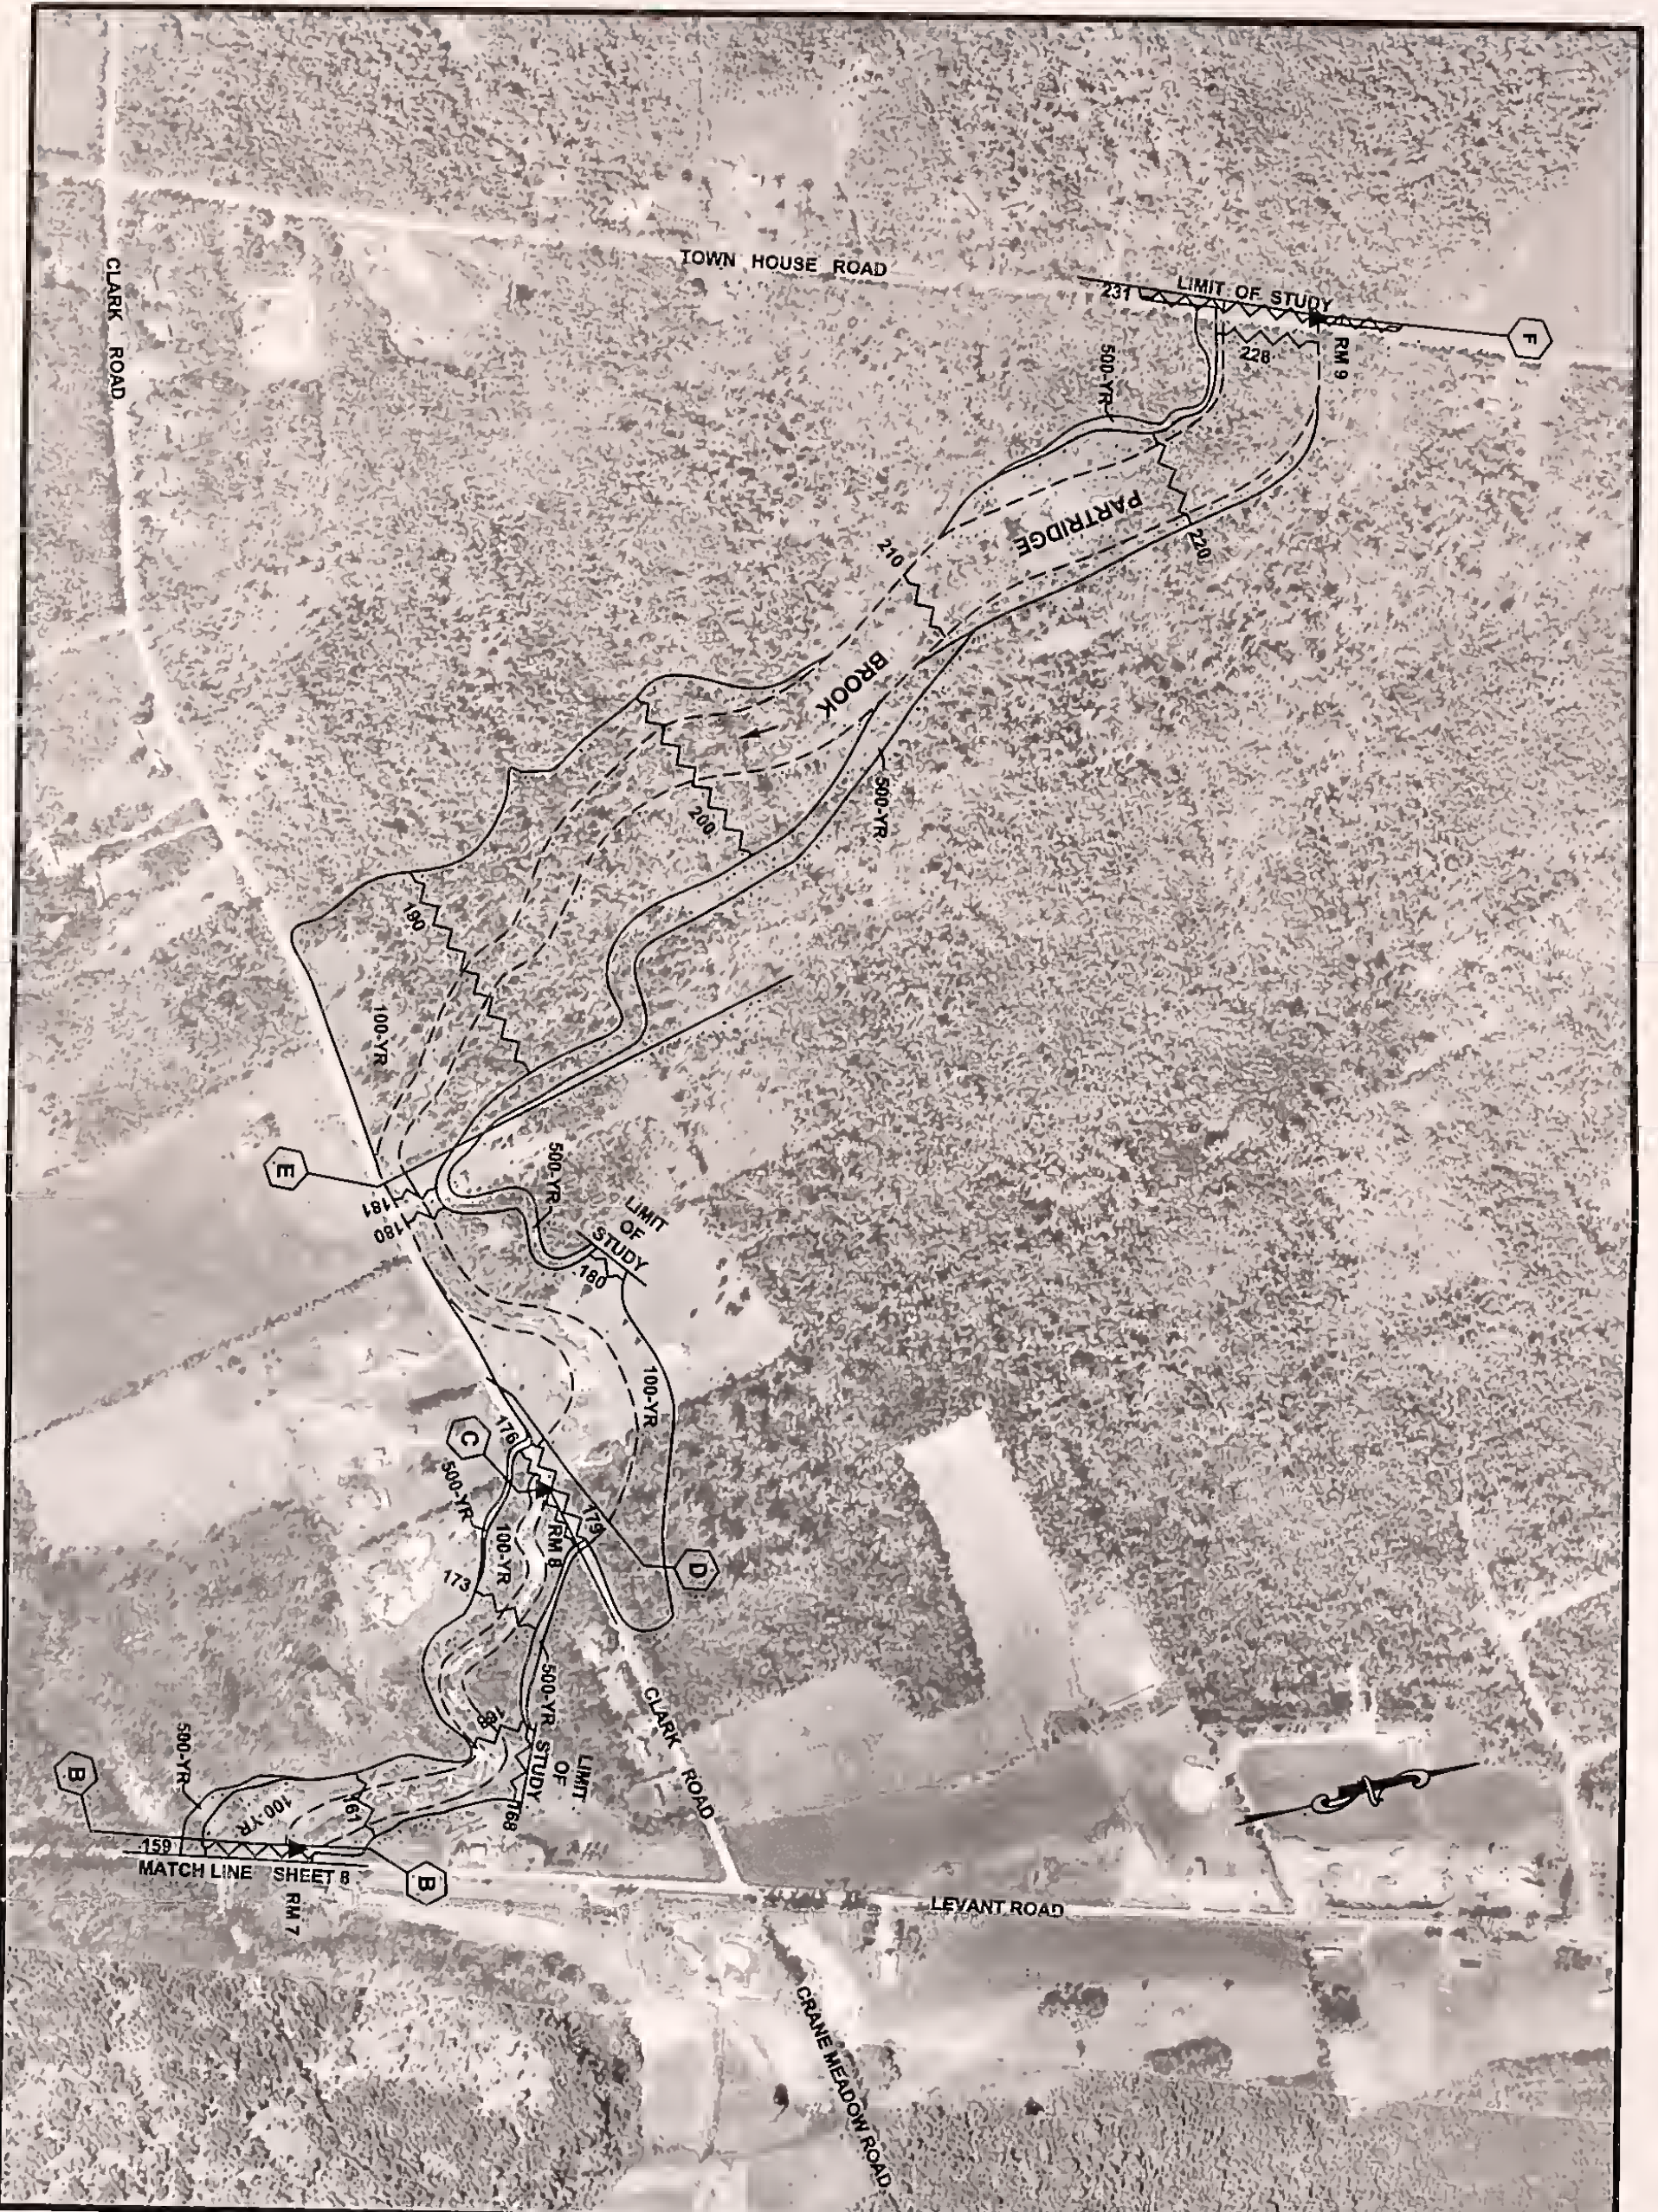
FLOOD HAZARD AREA
PARTRIDGE BROOK

458 100-Year Flood Elevation
 --- Floodway
