DAMAGE ASSESSMENT REPORT NO. 13

Tokyo City Area

Mission No.: 3PR5M 58

Target Area: Tokyo

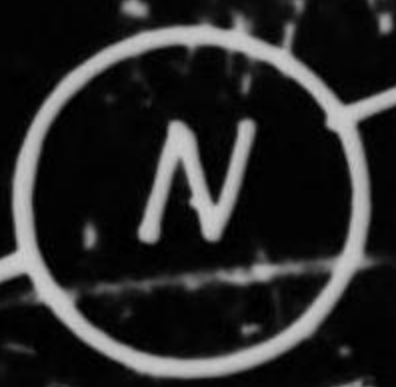
3PR 5 M58 - IV 44

Smaller areas damaged, added to the above, bring the grand total of damaged area to approximately 28,000,000 sq. ft., all of which can be found on print 3PR5M 58 - 1V:44.

No. 1 Residential area - extending from the NE corner of the Imperial Palace grounds to the vicinity of the Royogoku Bridge over the Sendai River - burned.

No. 2 Residential area - about 30,000 sq. ft. destroyed.

- No. 3 Residential area - about 200,000 sq. ft. destroyed.
- No. 4 Residential area - about 1,000,000 sq. ft. destroyed.
- No. 5 Residential area - about 3,200,000 sq. ft. destroyed. The elevated tracks of the Tokaido Line Railroad, between the Ueno and the Okachimachi stations, have been damaged by fire.

- No. 6 Residential area - about 1,800,000 sq. ft. destroyed, NW of the Ryogoku bridge.
- No. 7 Warehouse or factory area - about 118,000 sq. ft. destroyed, on E bank of Sendai River, S of Ryogoku Bridge.

- No. 8 Unidentified industry - about 50,000 sq. ft. destroyed, on the W bank of the Yokojikkengawa Canal, N of Target 913 (35/42 N--139/49 E).
- The main building, having about 130,000 sq. ft. of roof area, was damaged by a direct hit and incendiaries. Numerous small buildings N and adjacent to the main building have been burned.

- No. 9 Residential area - about 720,000 sq. ft. destroyed, on the Katagawa Canal.
- No. 10 Residential area - about 460,000 sq. ft. destroyed, on the Onagigawa Canal.

- No. 11 Residential area - about 250,000 sq. ft. destroyed.
- No. 12 Residential area - about 200,000 sq. ft. destroyed.
- No. 13 Residential area - about 185,000 sq. ft. destroyed, on W bank of Sendai River.

- No. 14 Residential area - about 980,000 sq. ft. destroyed.
- No. 15 Residential area - about 130,000 sq. ft. destroyed.
- No. 16 Residential area - about 80,000 sq. ft. destroyed.

- No. 17 Residential area - about 350,000 sq. ft. destroyed.
- No. 18 Residential area - about 120,000 sq. ft. destroyed.
- No. 19 Residential area - about 48,000 sq. ft. destroyed.

- No. 20 Residential area - about 46,000 sq. ft. destroyed.
- No. 21 Residential area - about 190,000 sq. ft. destroyed.
- No. 22 Residential area - about 1,800,000 sq. ft. destroyed, including approximately 25,000 sq. ft. of the wings of a probable hospital.

No. 23 Residential area - about 35,000 sq. ft. destroyed.

No. 24 Residential area - about 75,000 sq. ft. destroyed.

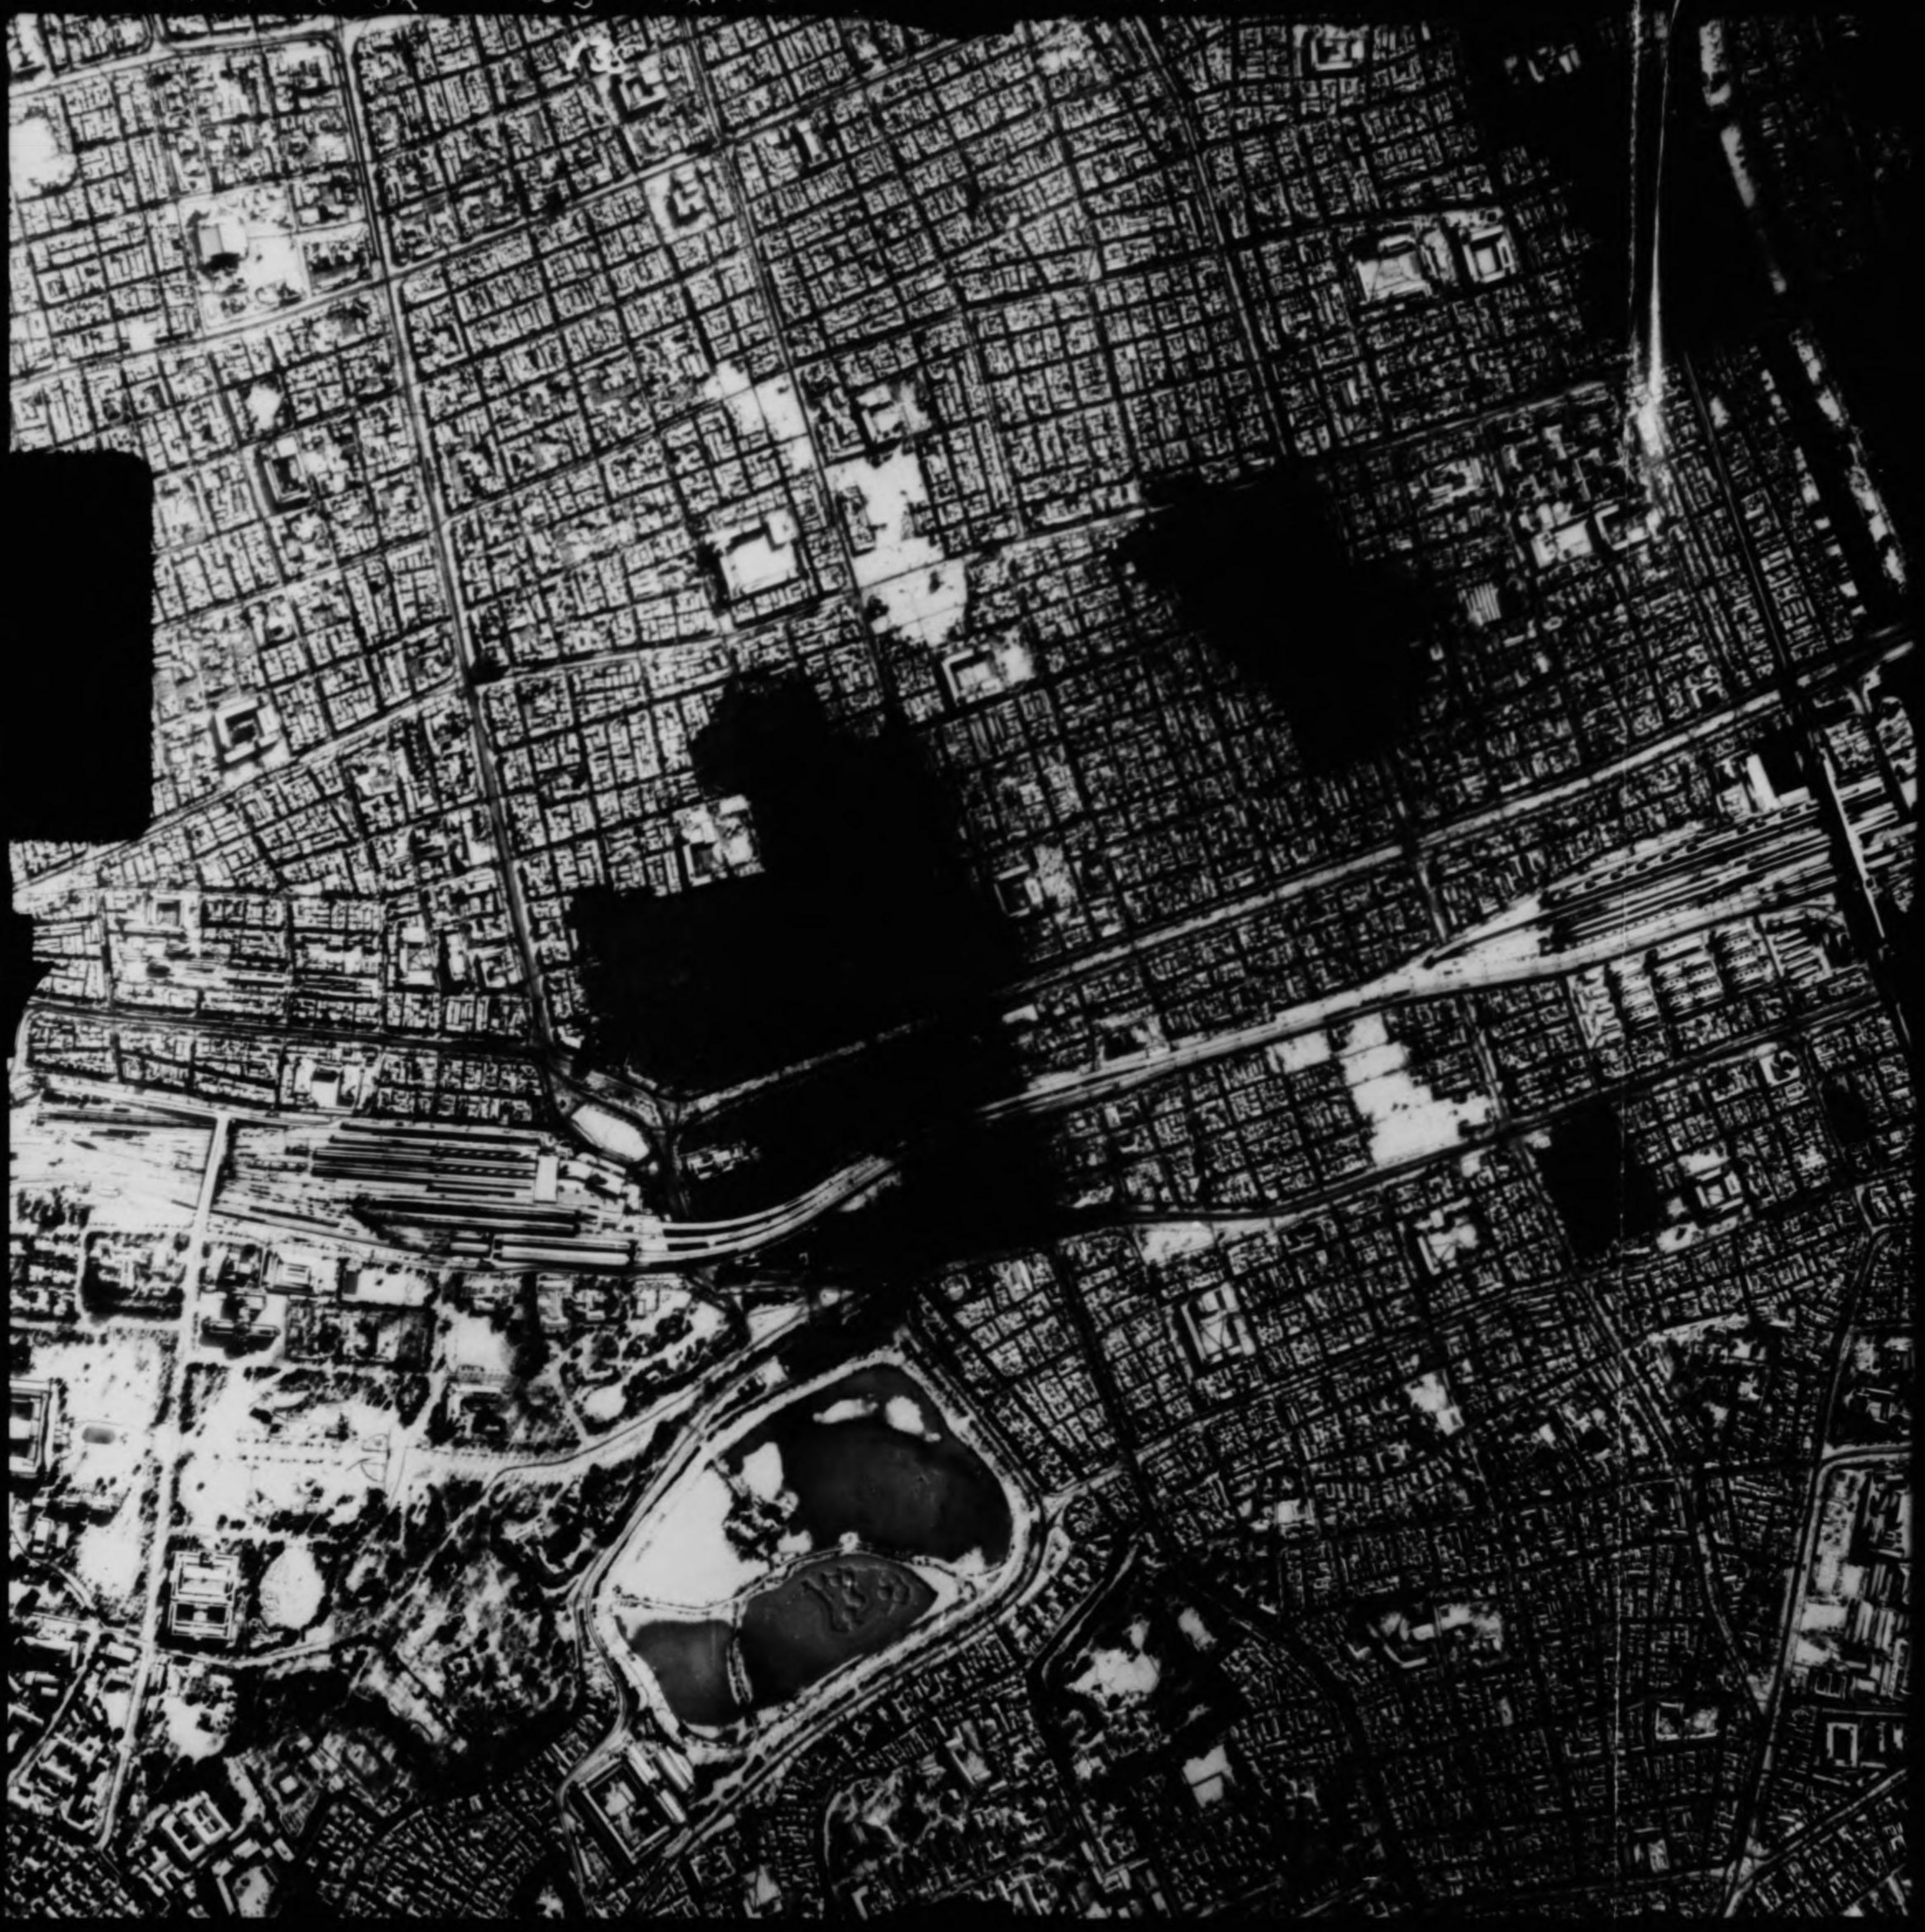
DAMAGE ASSESSMENT REPORT NO. 13  
C.I.W. XXI BOM. COM.

- No. 3 Residential area - about 200,000 sq. ft. destroyed.
- No. 4 Residential area - about 1,000,000 sq. ft. destroyed.
- No. 5 Residential area - about 3,200,000 sq. ft. destroyed. The elevated tracks of the Tokaido Line Railroad, between the Ueno and the Okachimachi stations, have been damaged by fire.
- No. 6 Residential area - about 1,800,000 sq. ft. destroyed, NW of the Ryogoku bridge.
- No. 7 Warehouse or factory area - about 118,000 sq. ft. destroyed, on E bank of Sendai River, S of Ryogoku Bridge.
- No. 8 Unidentified industry - about 50,000 sq. ft. destroyed, on the W bank of the Yokojikkengawa Canal, N of Target 913 (35/42 N--139/49 E).

The main building, having about 130,000 sq. ft. of roof area, was damaged by a direct hit and incendiaries. Numerous small buildings N and adjacent to the main building have been burned.

- No. 9 Residential area - about 720,000 sq. ft. destroyed, on the Katagawa Canal.
- No. 10 Residential area - about 460,000 sq. ft. destroyed, on the Onagigawa Canal.

- No. 11 Residential area - about 250,000 sq. ft. destroyed.
- No. 12 Residential area - about 200,000 sq. ft. destroyed.
- No. 13 Residential area - about 185,000 sq. ft. destroyed, on W bank of Sendai River.

- No. 14 Residential area - about 980,000 sq. ft. destroyed.
- No. 15 Residential area - about 130,000 sq. ft. destroyed.
- No. 16 Residential area - about 80,000 sq. ft. destroyed.

- No. 17 Residential area - about 350,000 sq. ft. destroyed.
- No. 18 Residential area - about 120,000 sq. ft. destroyed.
- No. 19 Residential area - about 48,000 sq. ft. destroyed.

- No. 20 Residential area - about 46,000 sq. ft. destroyed.
- No. 21 Residential area - about 190,000 sq. ft. destroyed.
- No. 22 Residential area - about 1,800,000 sq. ft. destroyed, including approximately 25,000 sq. ft. of the wings of a probable hospital.

No. 23 Residential area - about 35,000 sq. ft. destroyed.

No. 24 Residential area - about 75,000 sq. ft. destroyed.
