# FLOOD HAZARD STUDY

## LITTLE CALFPASTURE RIVER AND GRASSY RUN

AUGUSTA COUNTY, VIRGINIA

JUNE 1979

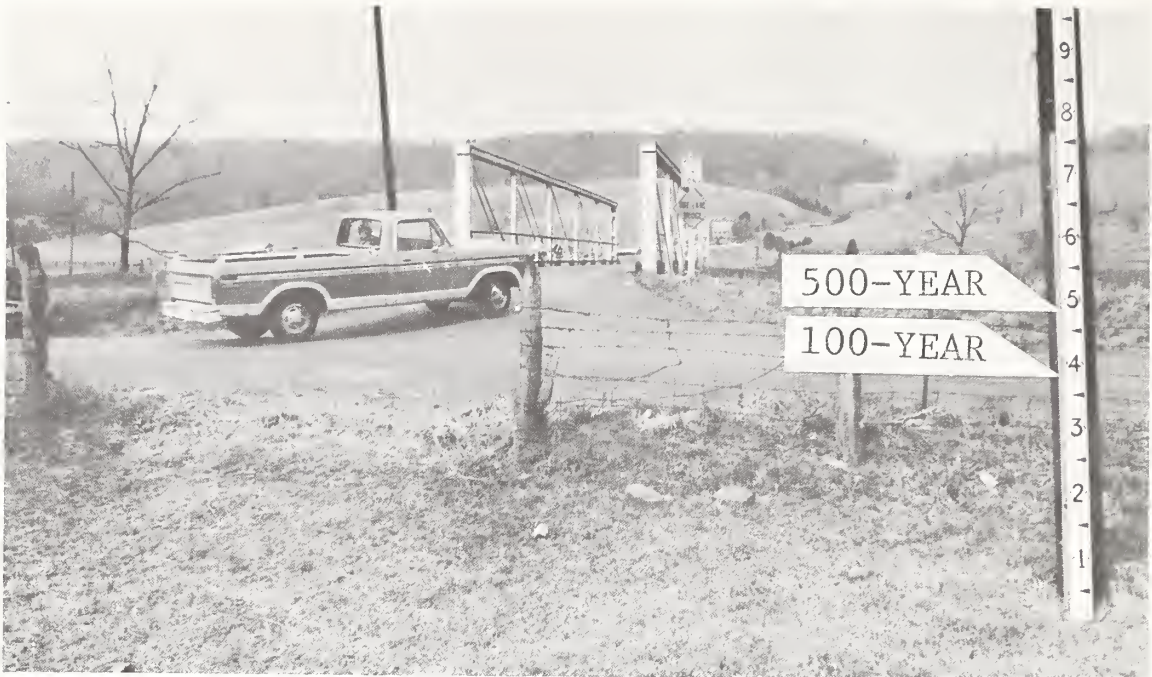
Figure 2. Potential flood stages at State Route 683 crossing of Little Calpasture River.

On the Little Calfpasture River, agricultural damage would accrue on about 360 acres of pasture and cropland during extreme floods. Depths of flooding on these areas would average about two feet, and velocities about three feet per second. Figure 2 shows potential stages of a typical section.

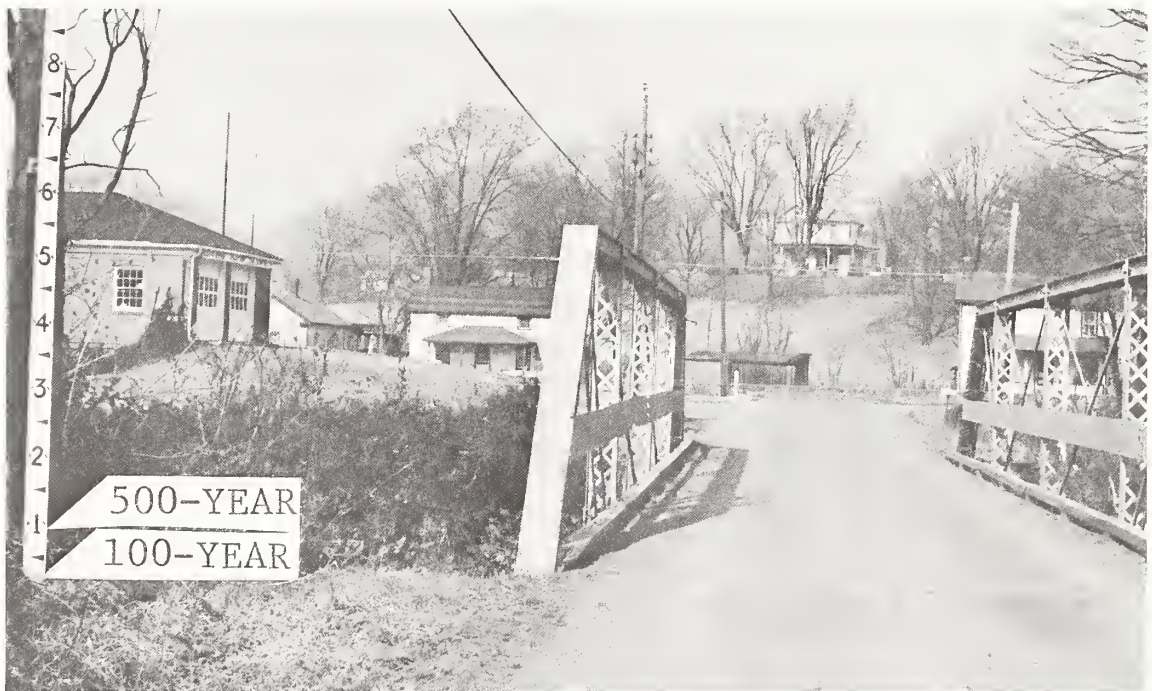
Figure 3. Potential flood stages at State Route 601 crossing of Little Calpasture River at Augusta Springs.

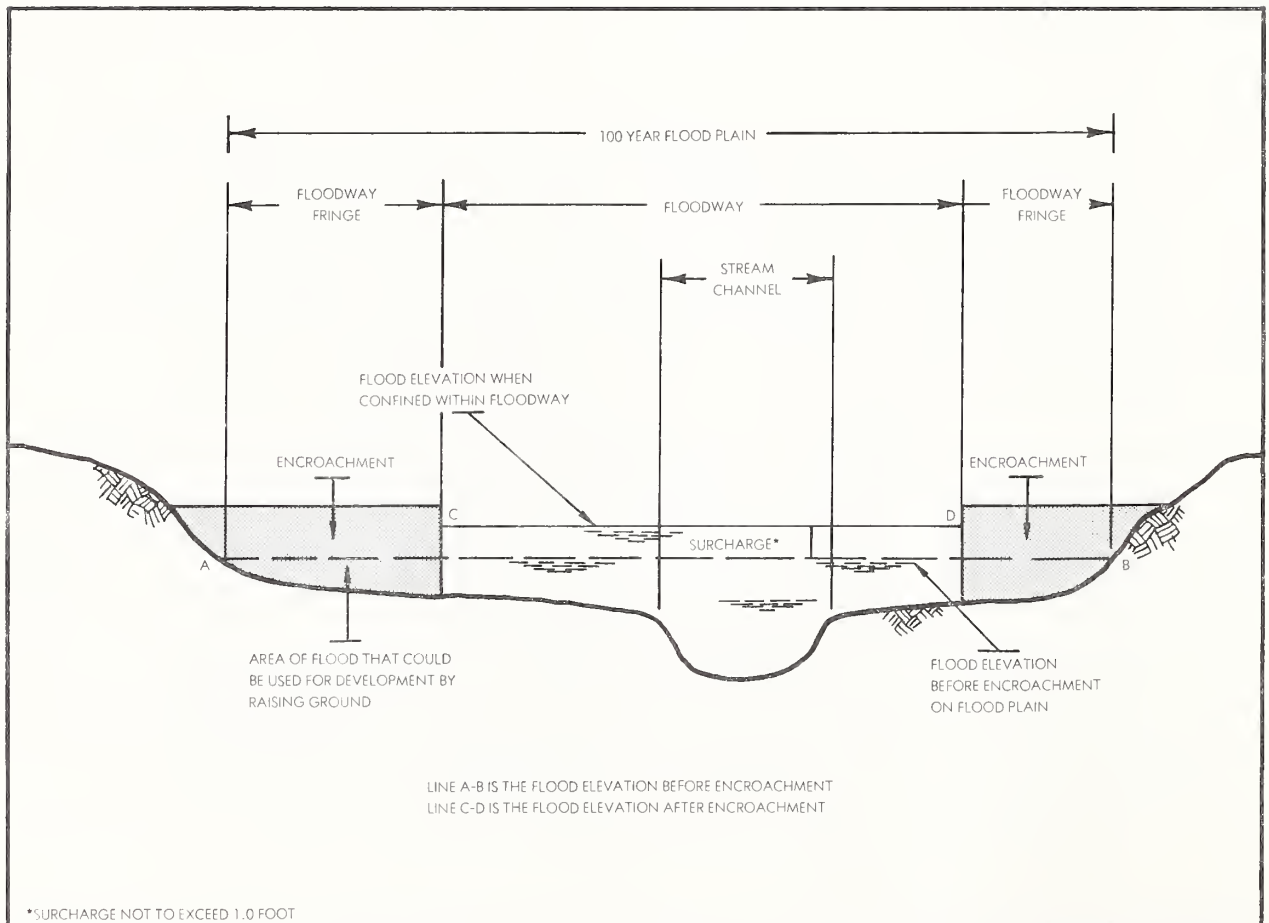
FIGURE 4

FLOODWAY SCHEMATIC

The floodway is the channel plus any adjacent flood plain areas that must be kept free of encroachment so that the 100-year flood may be carried without substantial increases in flood heights (see fig. 4). HUD standards, accepted in Virginia, limit such increases in flood heights to 1.0 foot provided that hazardous velocities are not produced. A close check of field conditions should be made to assure that the designated floodway is practical and manageable. Considerations other than hazardous velocities may indicate that no encroachment should be allowed on some flood plain reaches. No proposed floodway is shown on Grassy Run and its tributaries. SCS personnel will be available to assist local officials to make a thorough study of the complex field conditions to determine if a manageable floodway can be delineated.

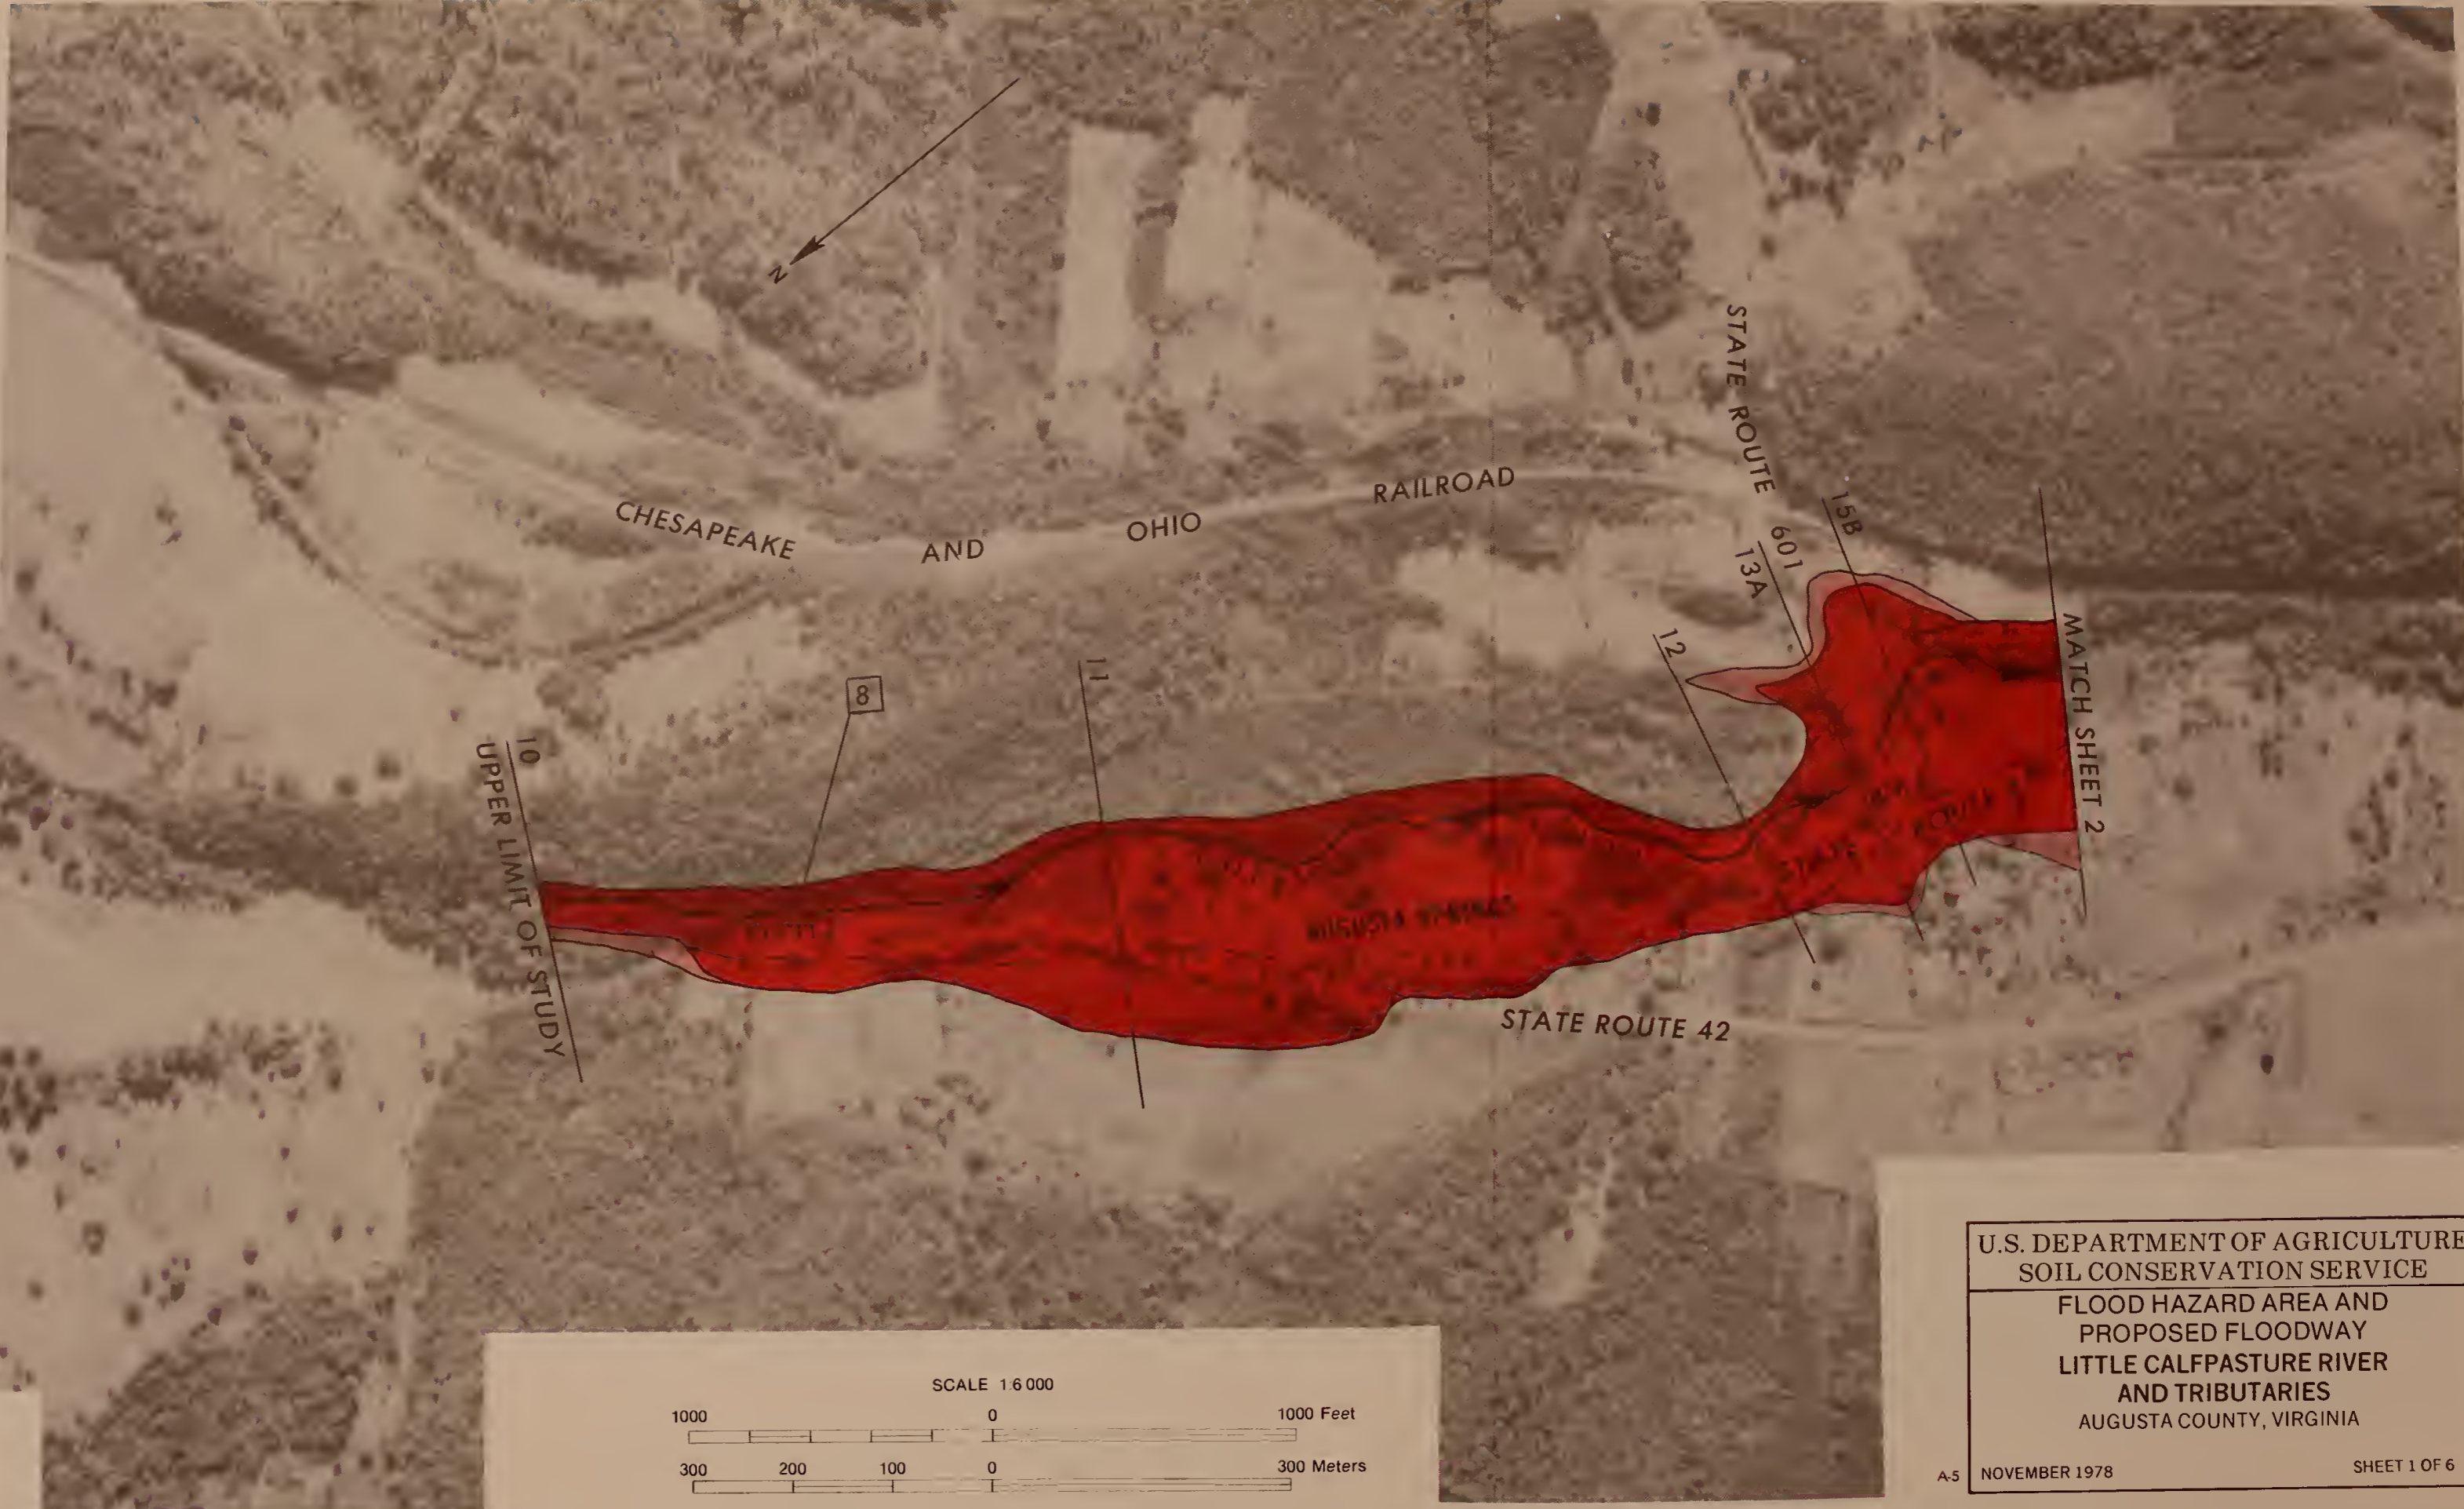
SOURCE Semi-controlled mosaic prepared from USDA-ASCS AERIAL photography flown 1974

FLOOD HAZARD AREA AND  
 PROPOSED FLOODWAY  
 LITTLE CALPASTURE RIVER  
 AND TRIBUTARIES  
 AUGUSTA COUNTY, VIRGINIA

The 100 and 500-year flood areas and a proposed floodway are shown on flood hazard photomaps prepared from a semi-controlled mosaic. These photomaps should only be used to determine the approximate boundaries of the flood areas and the floodway. Dashed lines indicate reach segments where floodway fringe encroachment inside the 100-year flood line might be allowed.

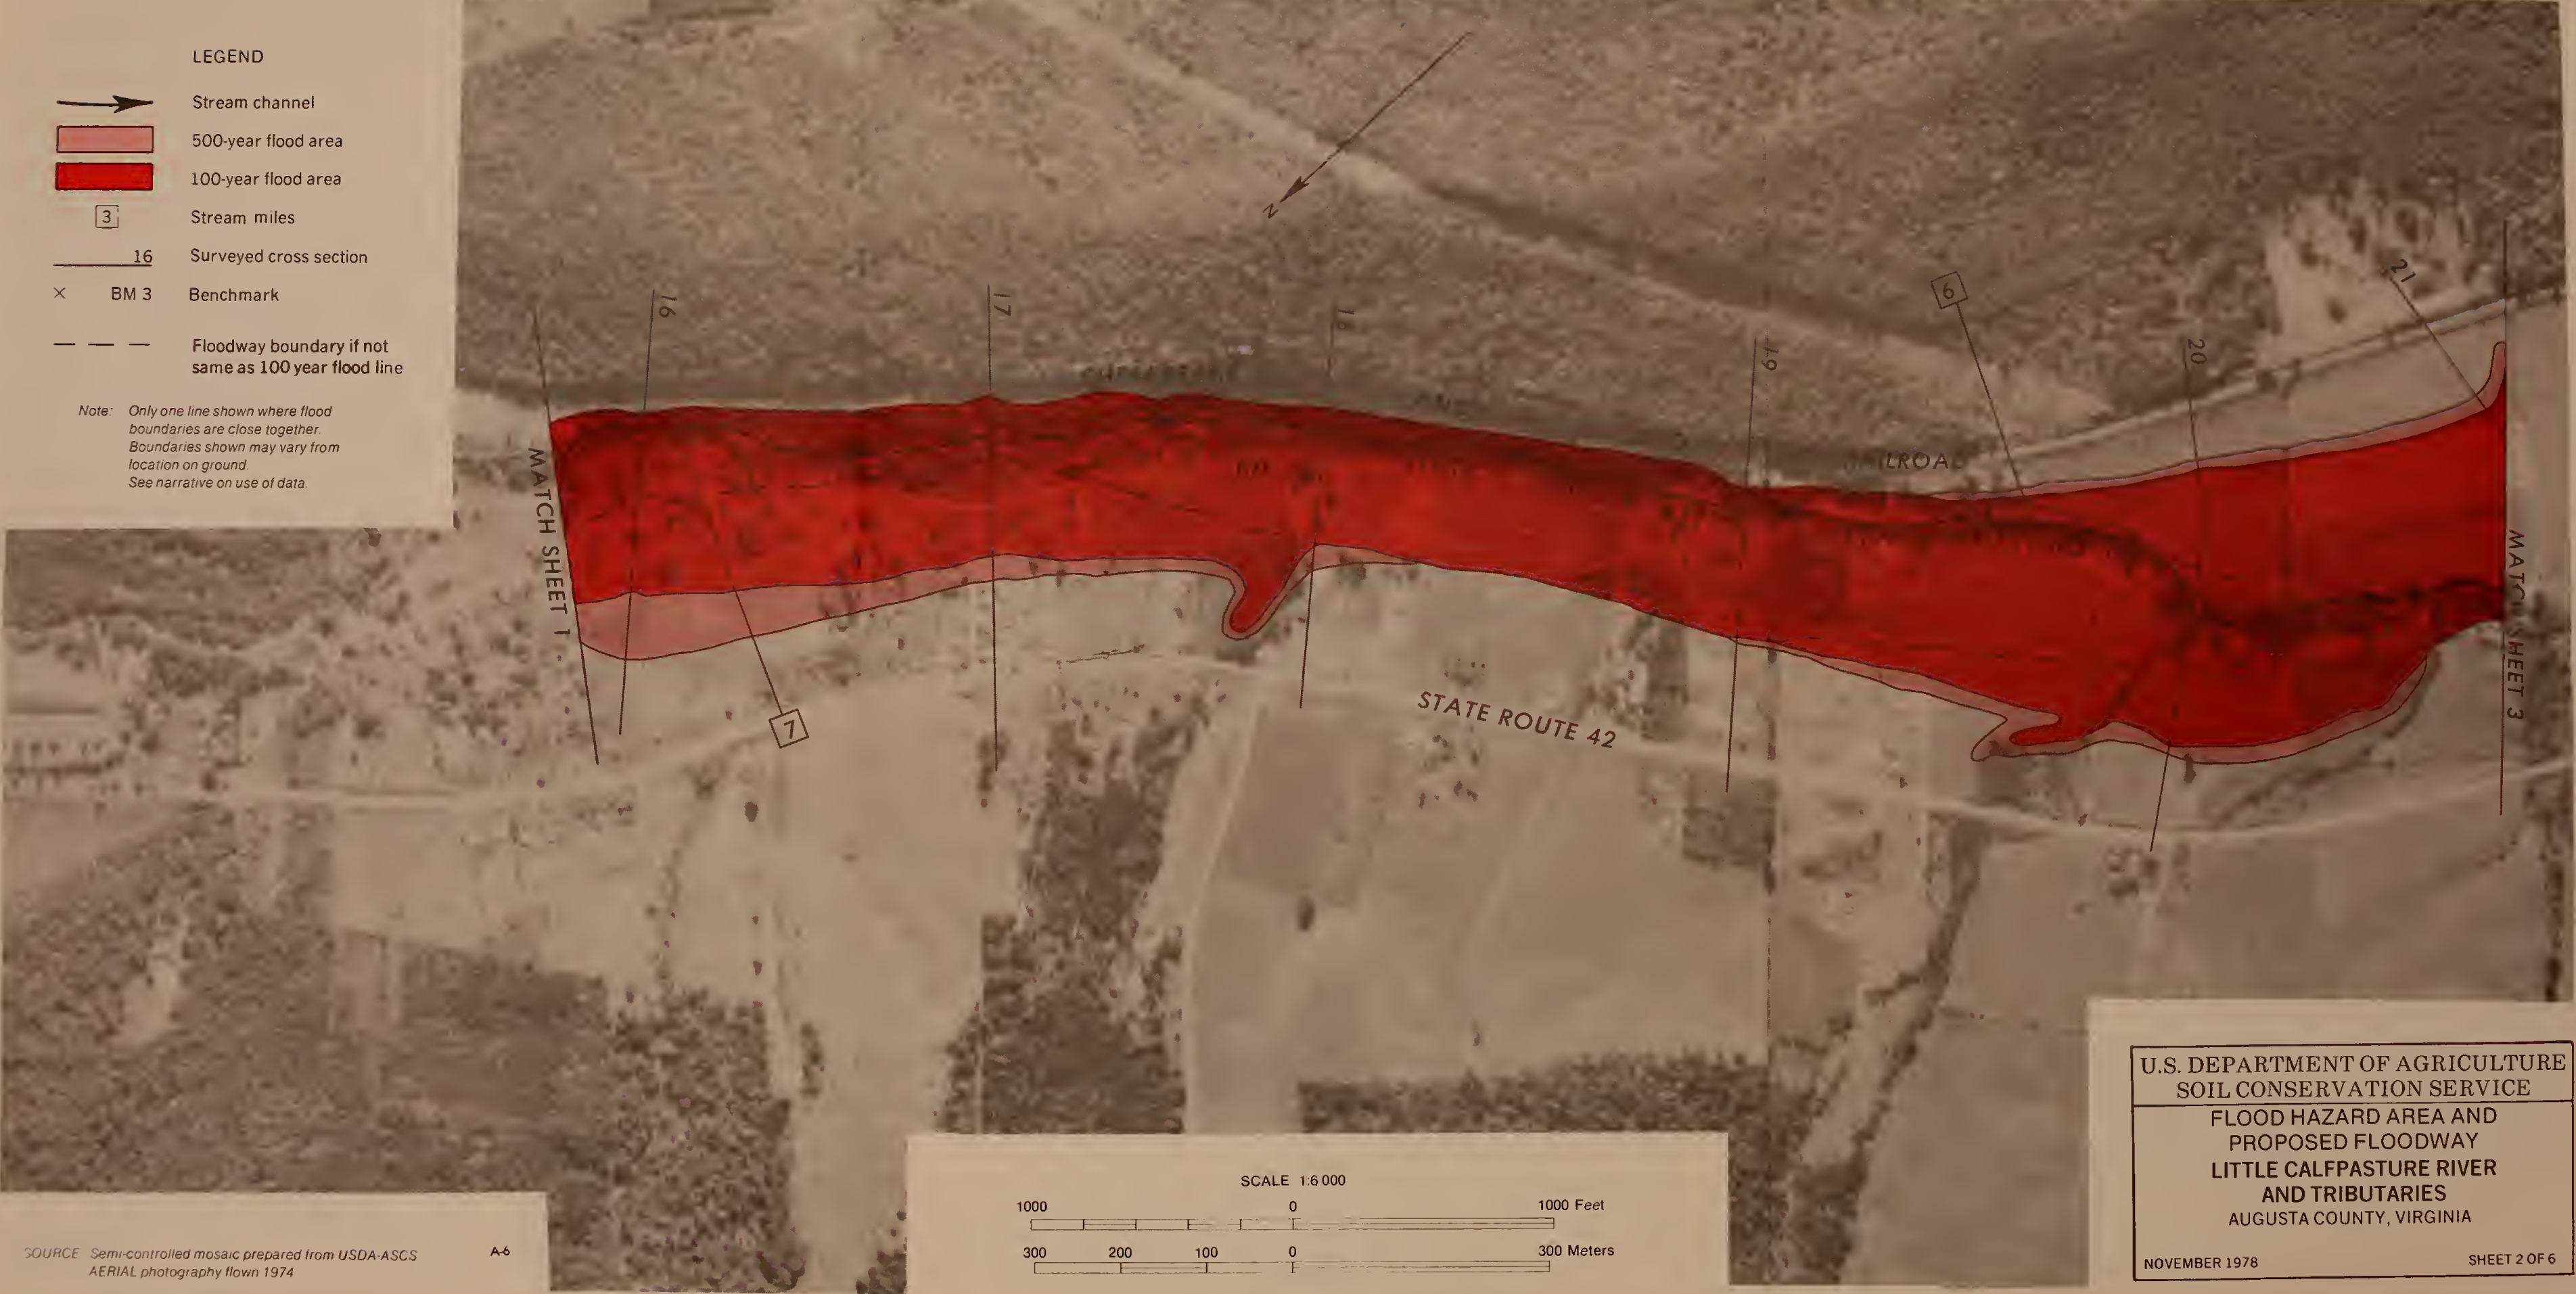
NOVEMBER 1978 SHEET 2 OF 6

SOURCE Semi-controlled mosaic prepared from USDA-ASCS AERIAL photography flown 1974

FLOOD HAZARD AREA AND  
PROPOSED FLOODWAY  
LITTLE CALPASTURE RIVER  
AND TRIBUTARIES  
AUGUSTA COUNTY, VIRGINIA

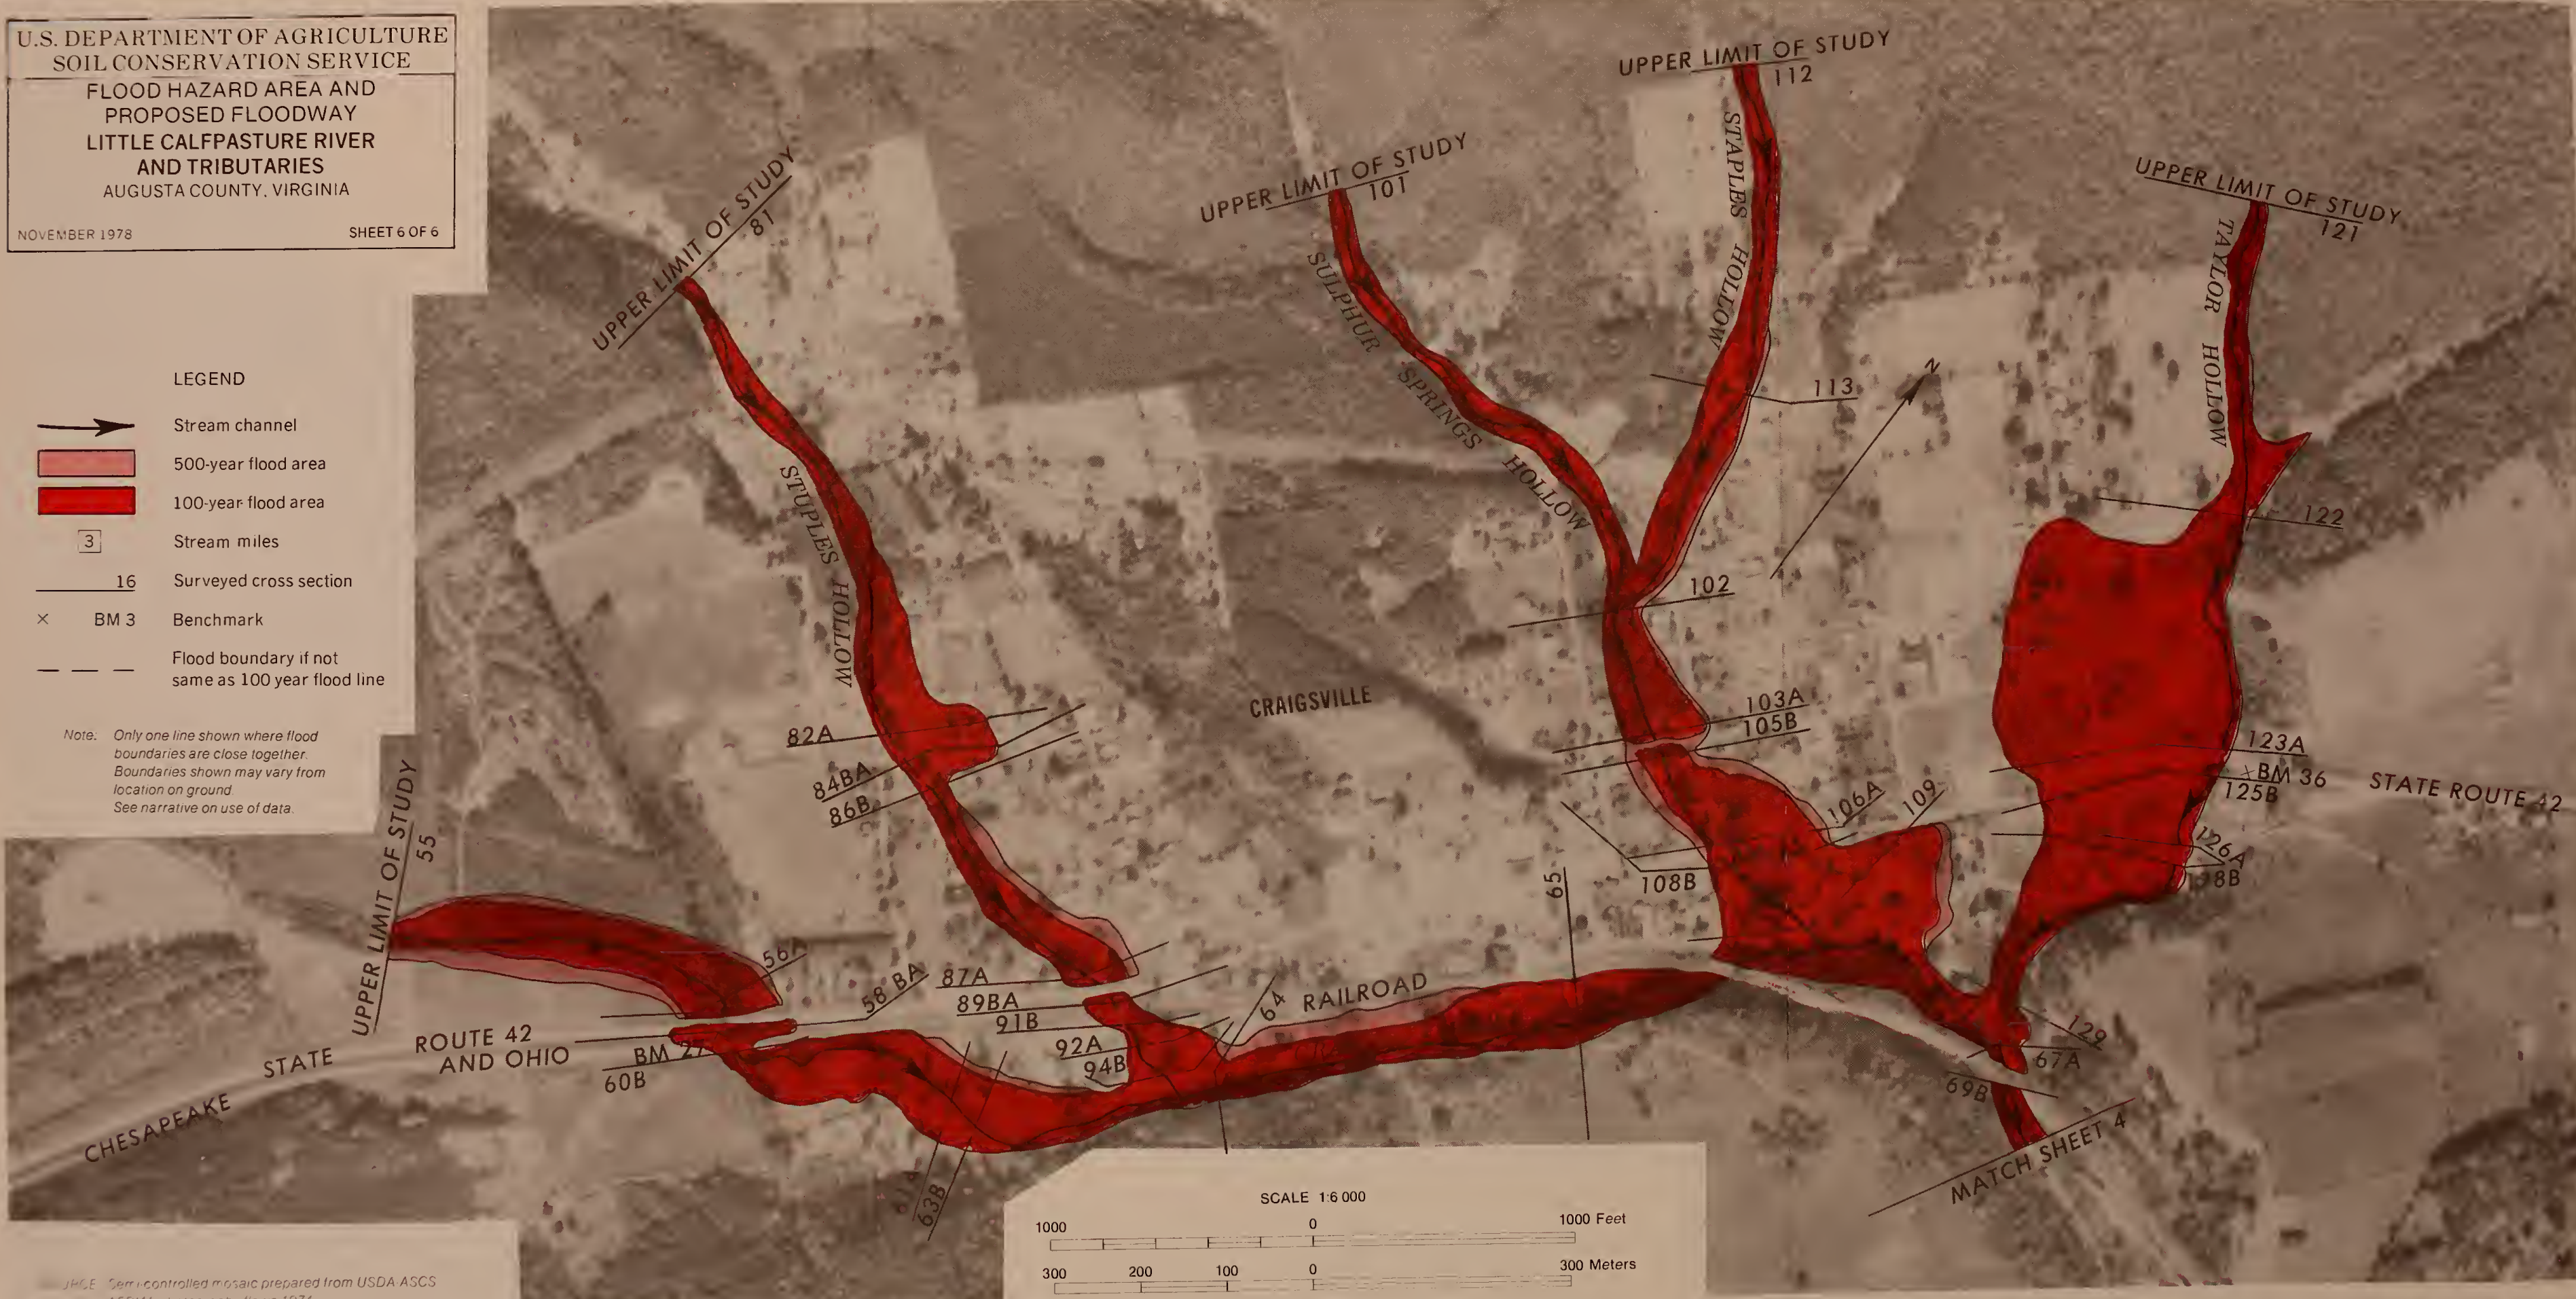
FLOOD PROFILES  
**LITTLE CALFPASTURE RIVER  
 AND TRIBUTARIES**  
 AUGUSTA COUNTY, VIRGINIA  
 U. S. DEPARTMENT OF AGRICULTURE  
 SOIL CONSERVATION SERVICE

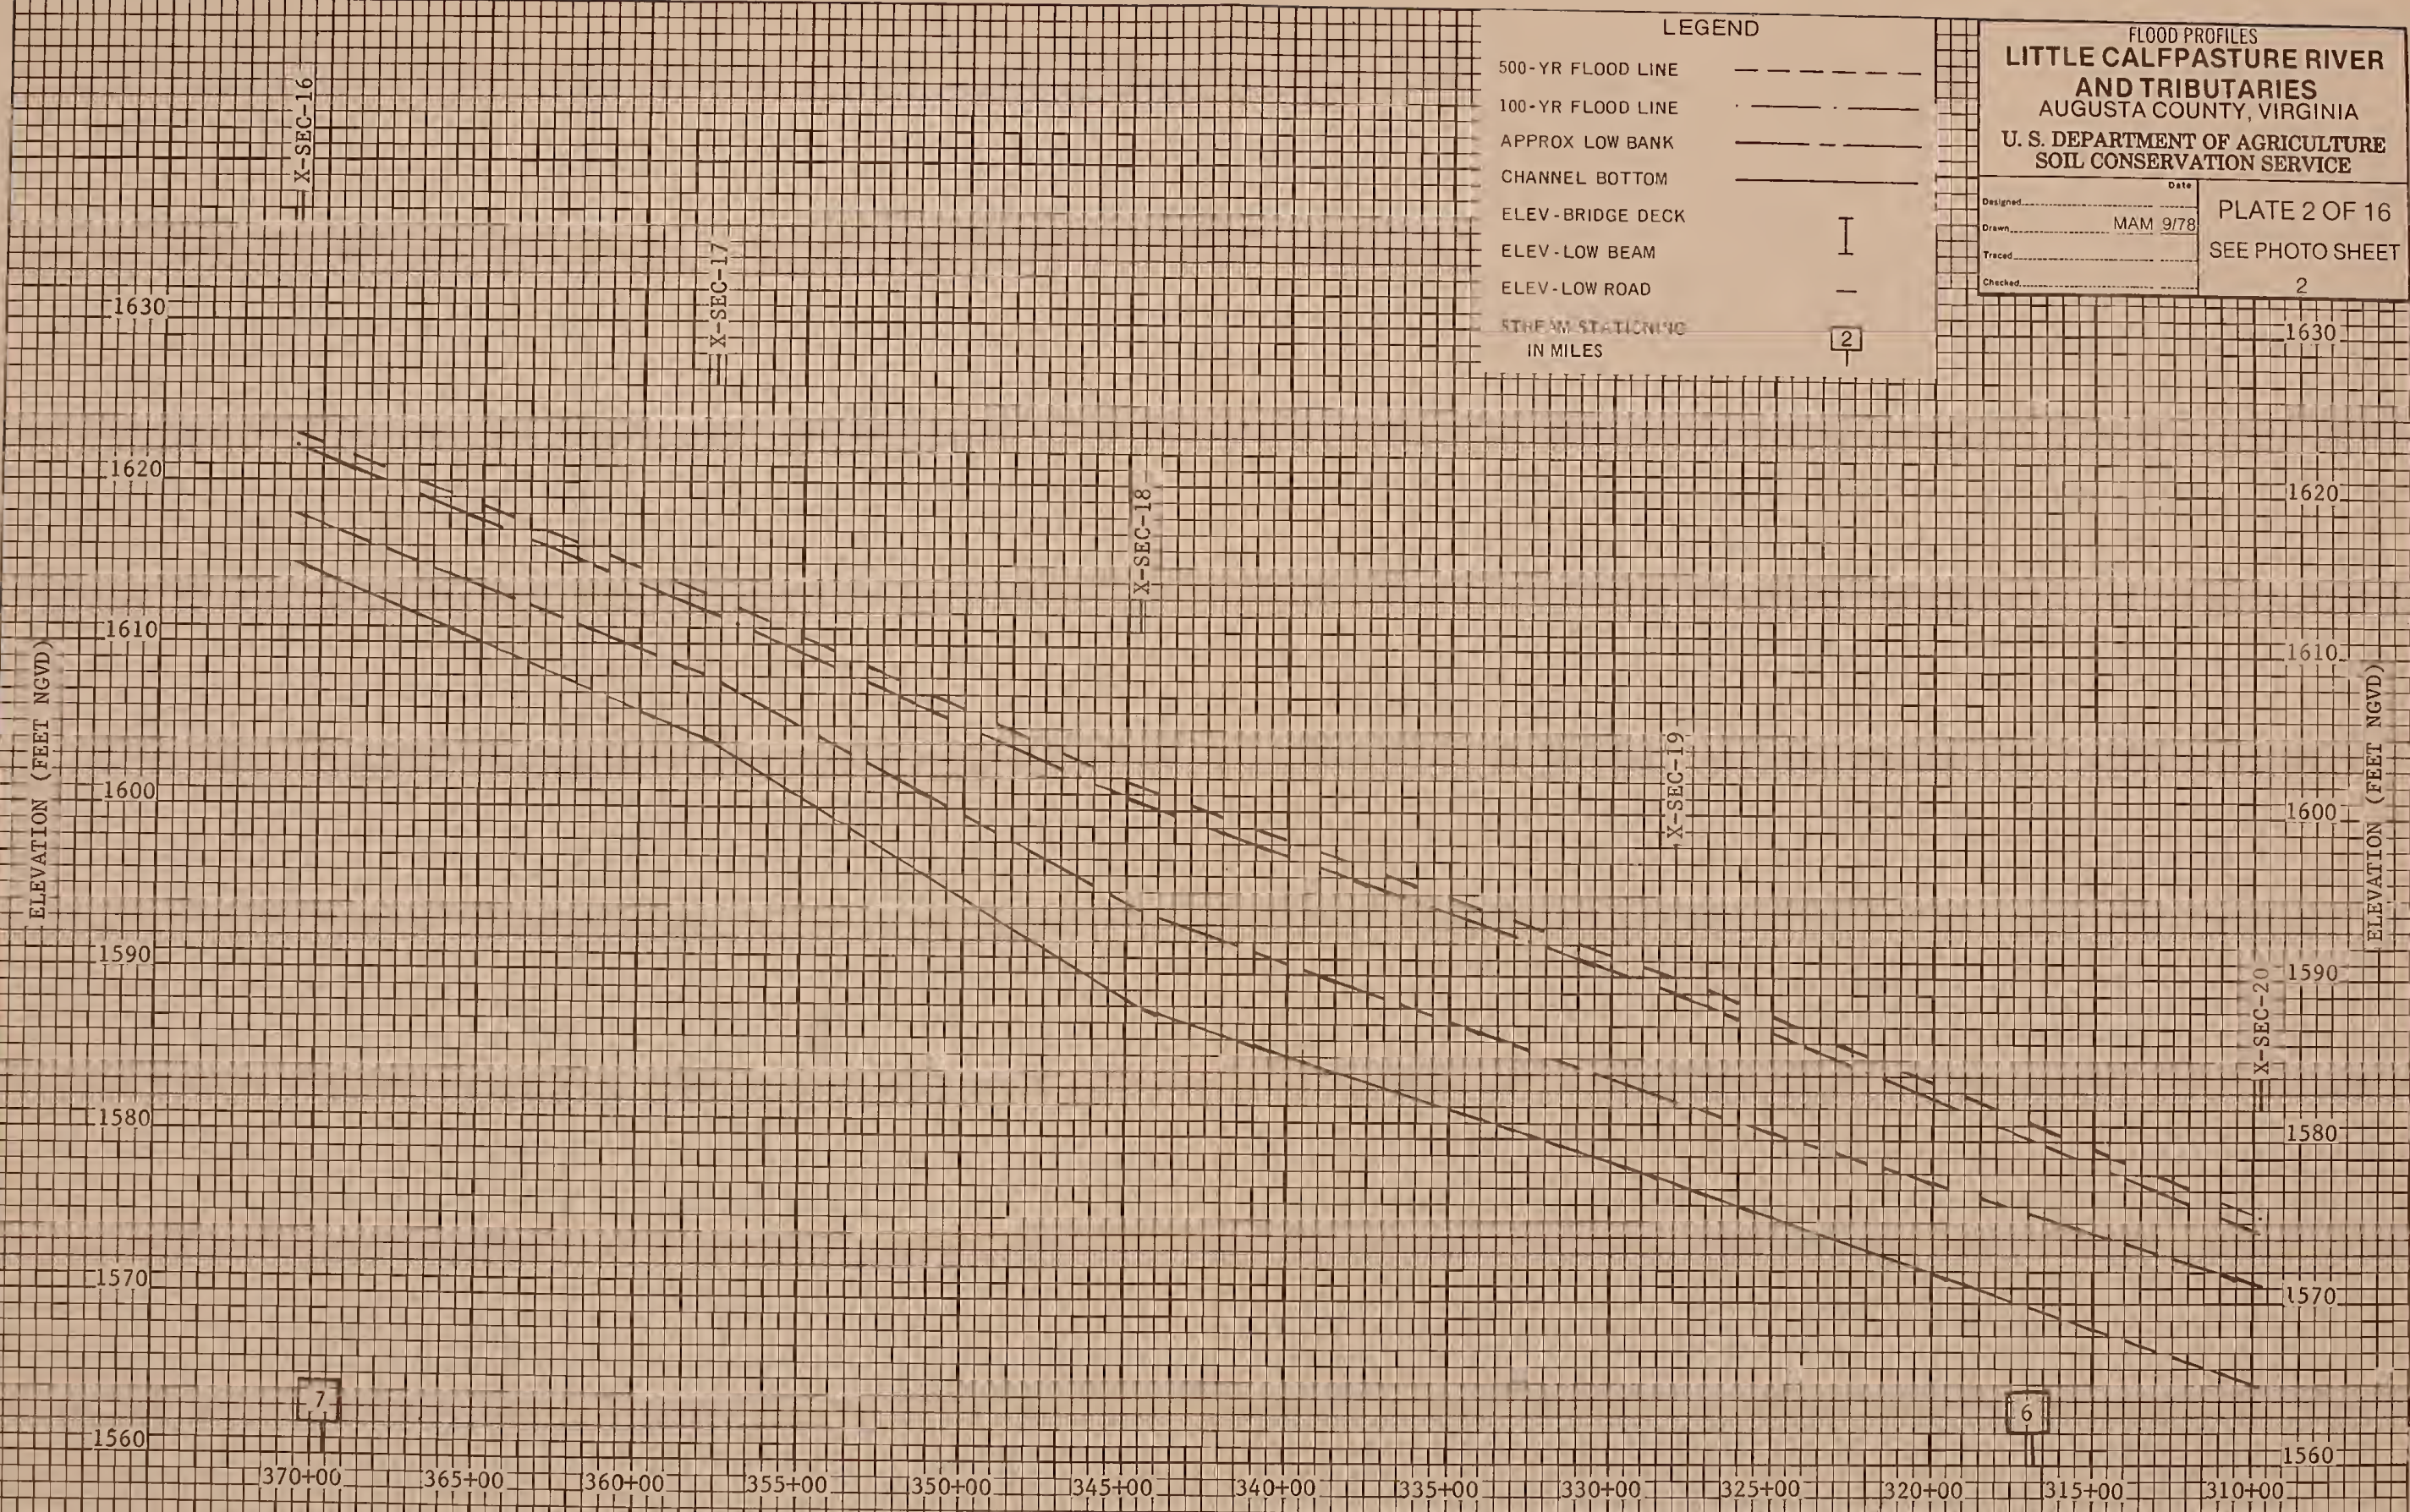
Designed..... Drawn..... MAM 9/78 Traced..... Checked.....	Date..... PLATE 3 OF 16 SEE PHOTO SHEET 2 & 3
---	--

CHANNEL STATIONS - LITTLE CALFPASTURE RIVER  
 FEET UPSTREAM FROM THE ROCKBRIDGE & AUGUSTA COUNTY LINE

FLOOD PROFILES  
**LITTLE CALFPASTURE RIVER  
 AND TRIBUTARIES**  
 AUGUSTA COUNTY, VIRGINIA  
 U. S. DEPARTMENT OF AGRICULTURE  
 SOIL CONSERVATION SERVICE

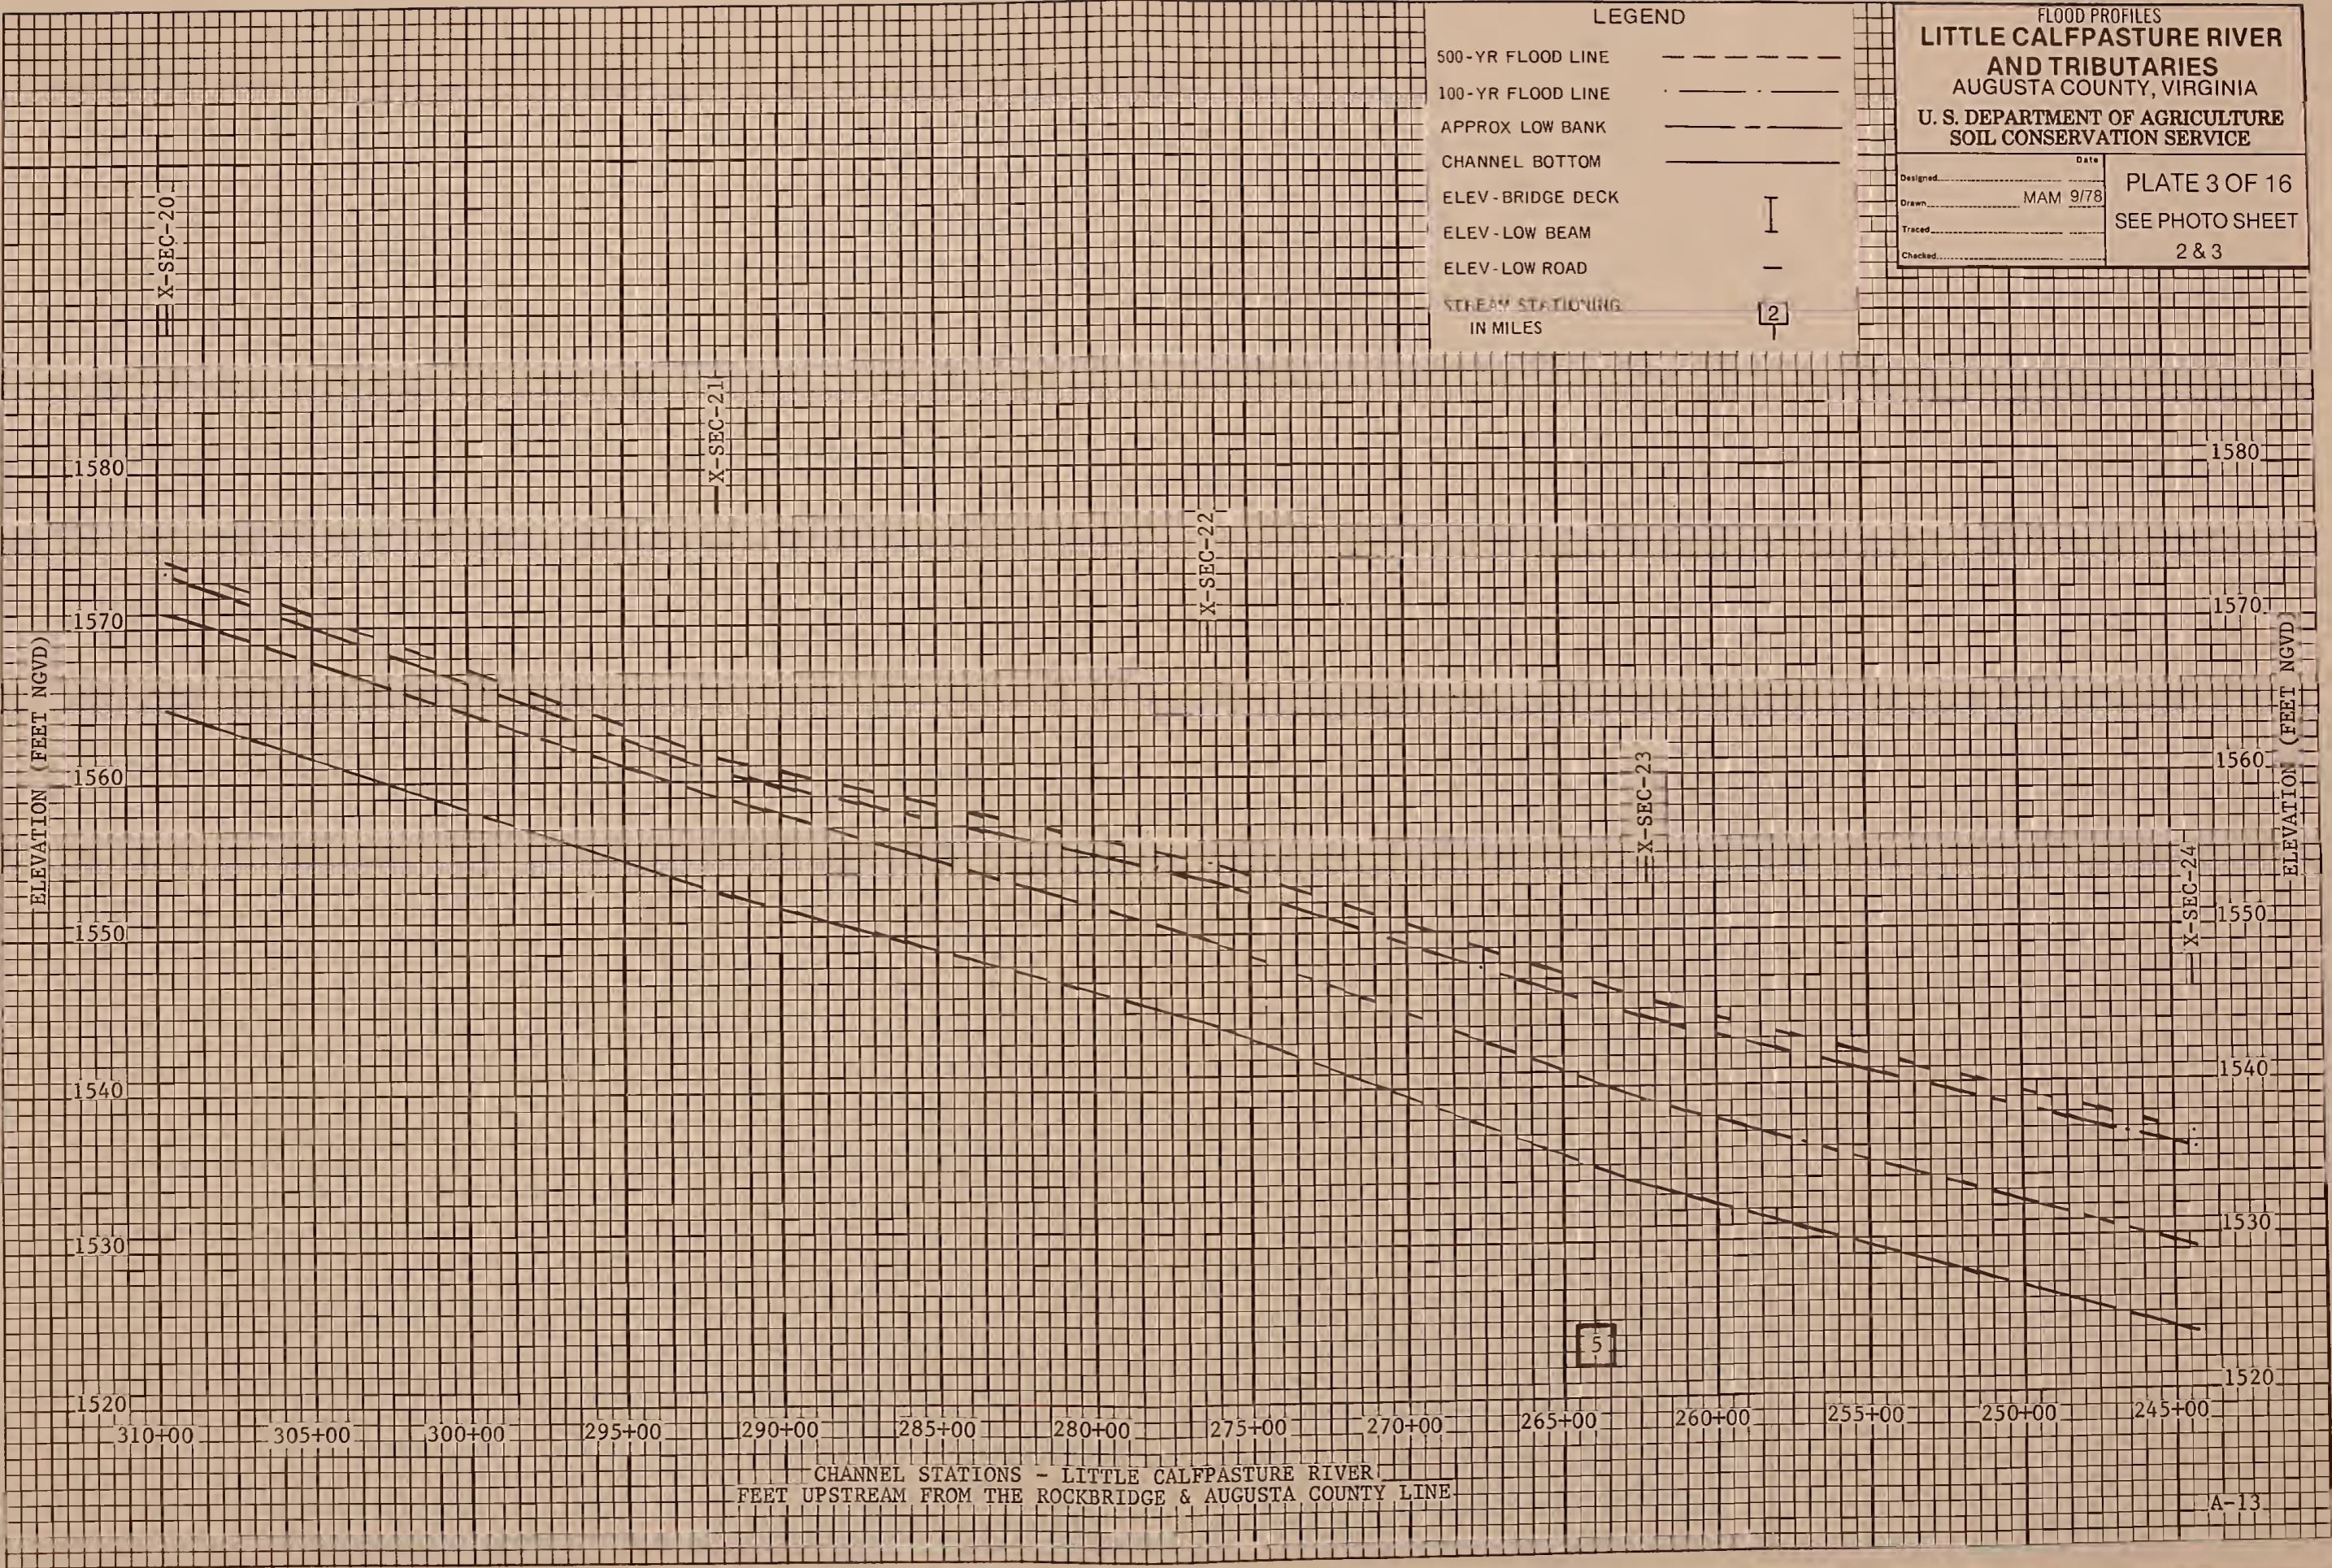
CHANNEL STATIONS - LITTLE CALFPASTURE RIVER  
 FEET UPSTREAM FROM THE ROCKBRIDGE & AUGUSTA COUNTY LINE

FLOOD PROFILES  
**LITTLE CALFPASTURE RIVER  
 AND TRIBUTARIES**  
 AUGUSTA COUNTY, VIRGINIA  
 U. S. DEPARTMENT OF AGRICULTURE  
 SOIL CONSERVATION SERVICE
