# FLOOD HAZARD STUDY

## LITTLE CALFPASTURE RIVER AND GRASSY RUN

AUGUSTA COUNTY, VIRGINIA

JUNE 1979

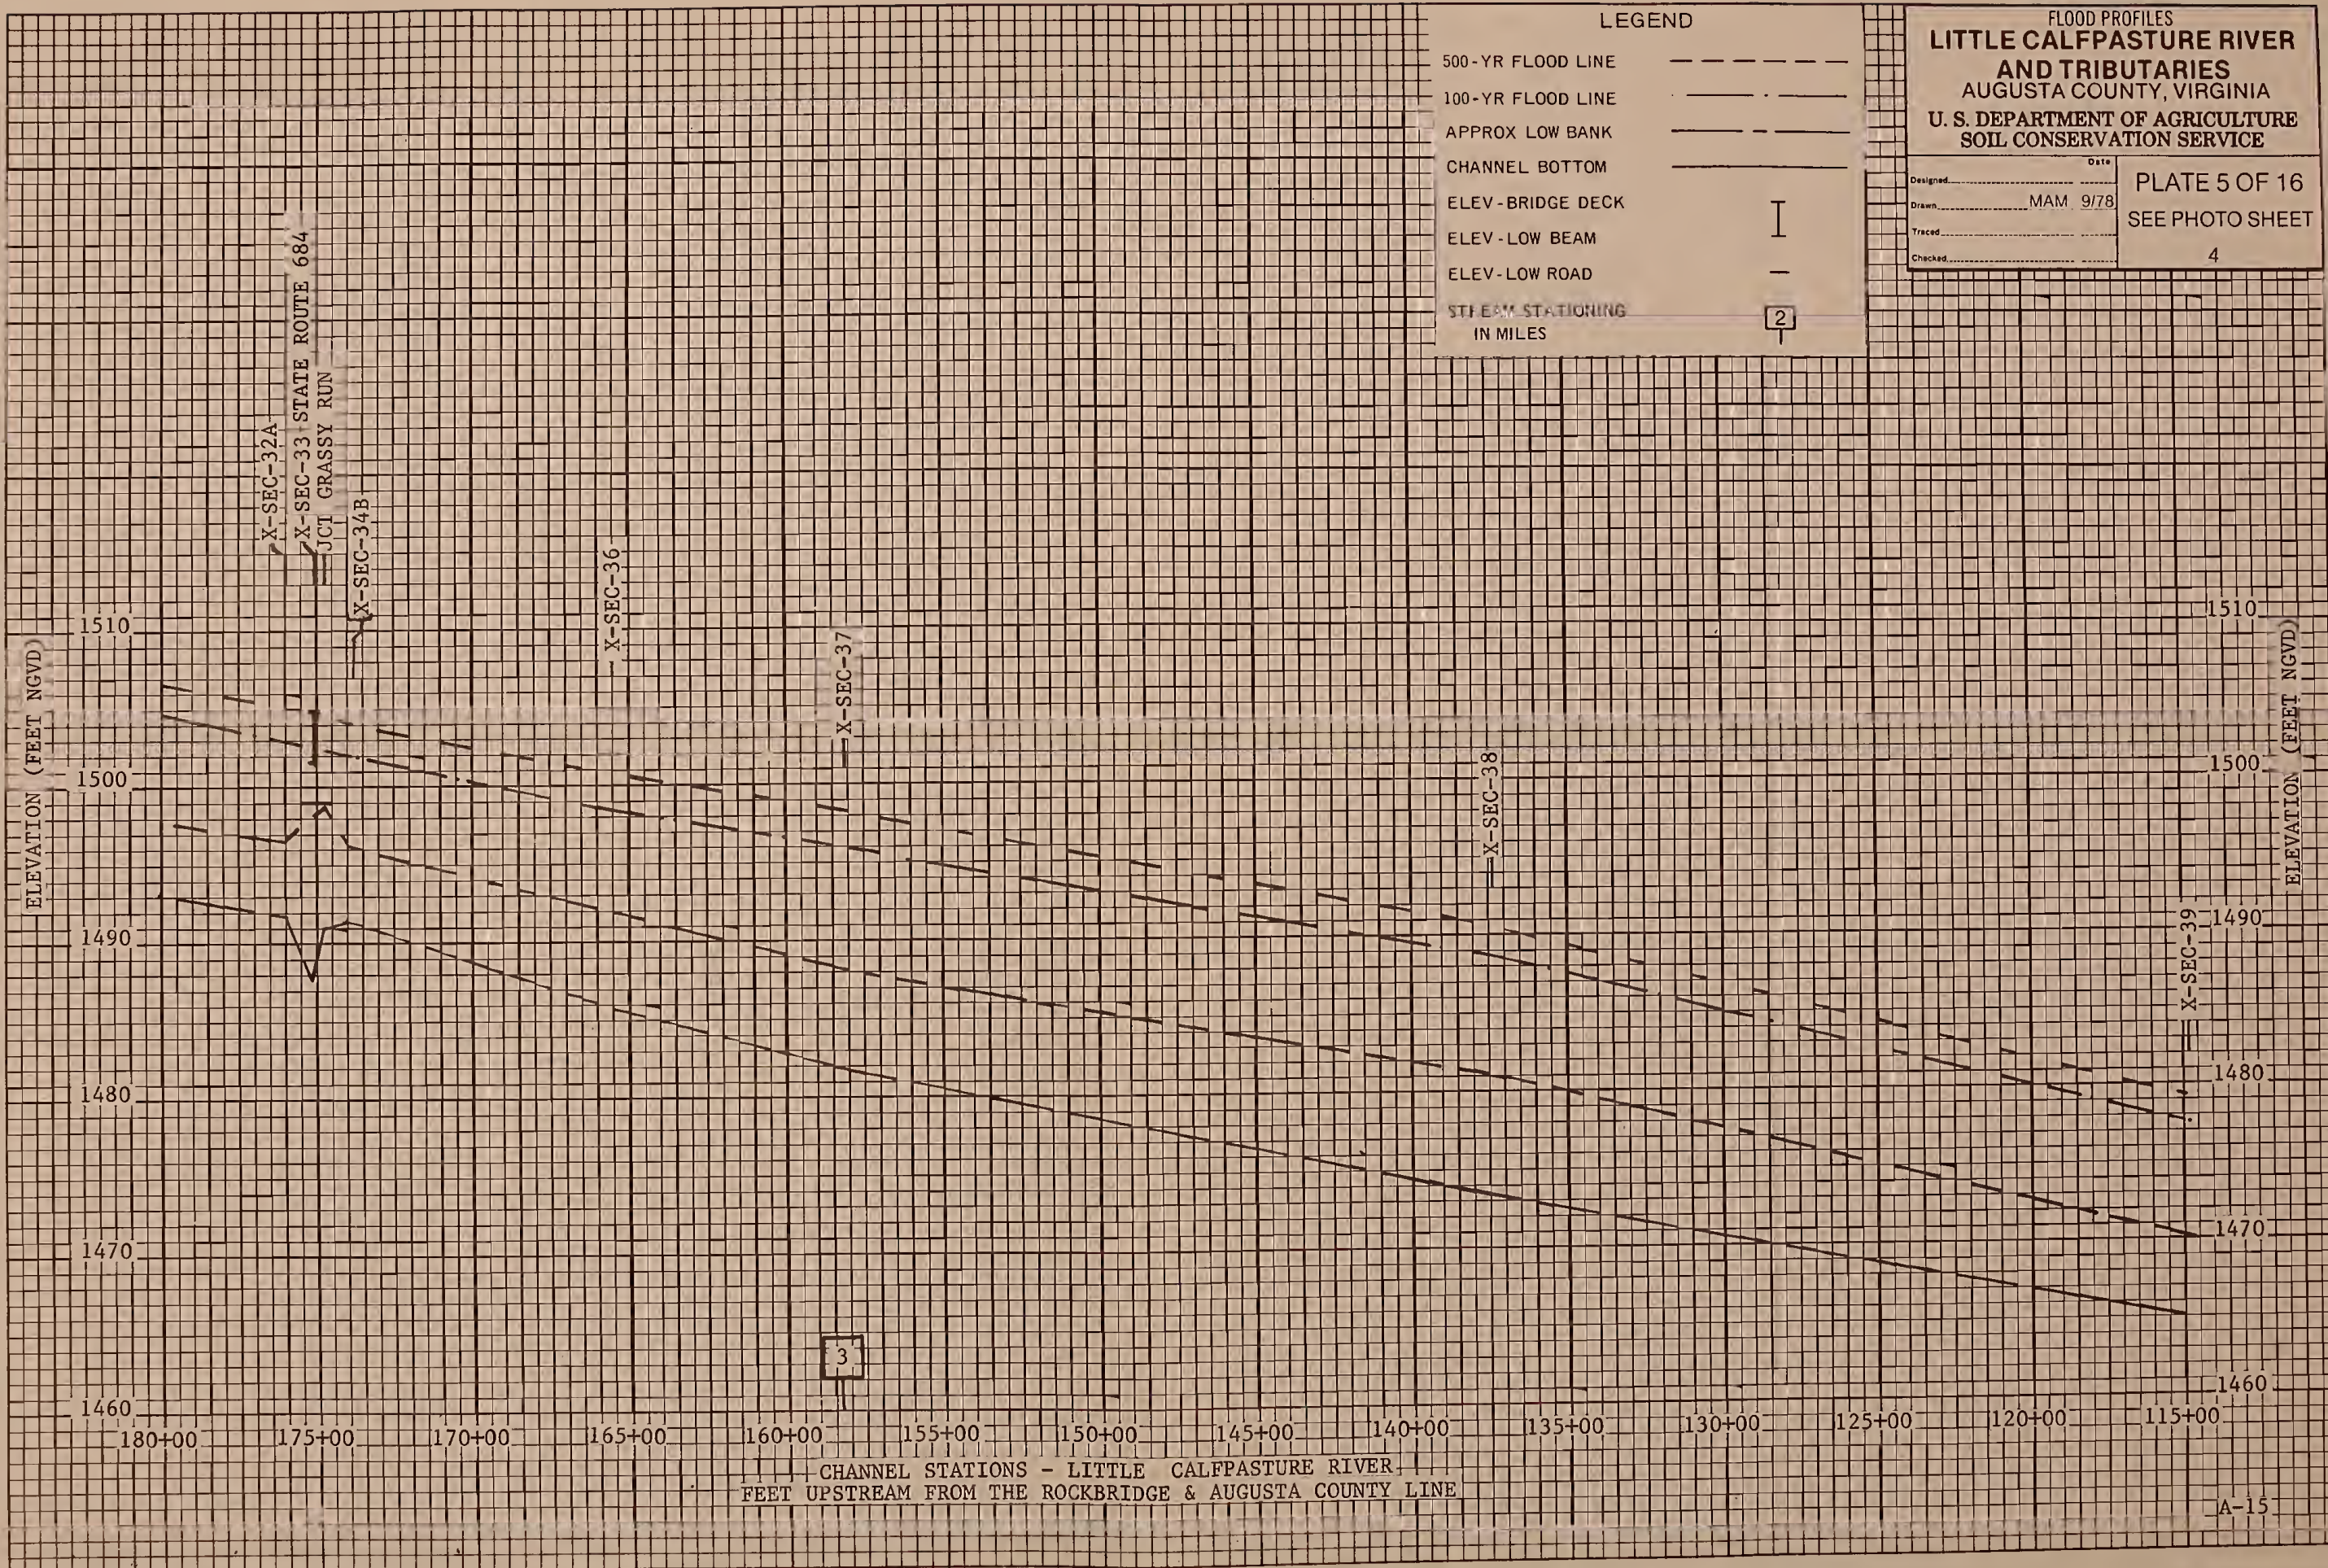
CHANNEL STATIONS - LITTLE CALFPASTURE RIVER  
 FEET UPSTREAM FROM THE ROCKBRIDGE & AUGUSTA COUNTY LINE

FLOOD PROFILES  
**LITTLE CALFPASTURE RIVER  
 AND TRIBUTARIES**  
 AUGUSTA COUNTY, VIRGINIA  
 U. S. DEPARTMENT OF AGRICULTURE  
 SOIL CONSERVATION SERVICE

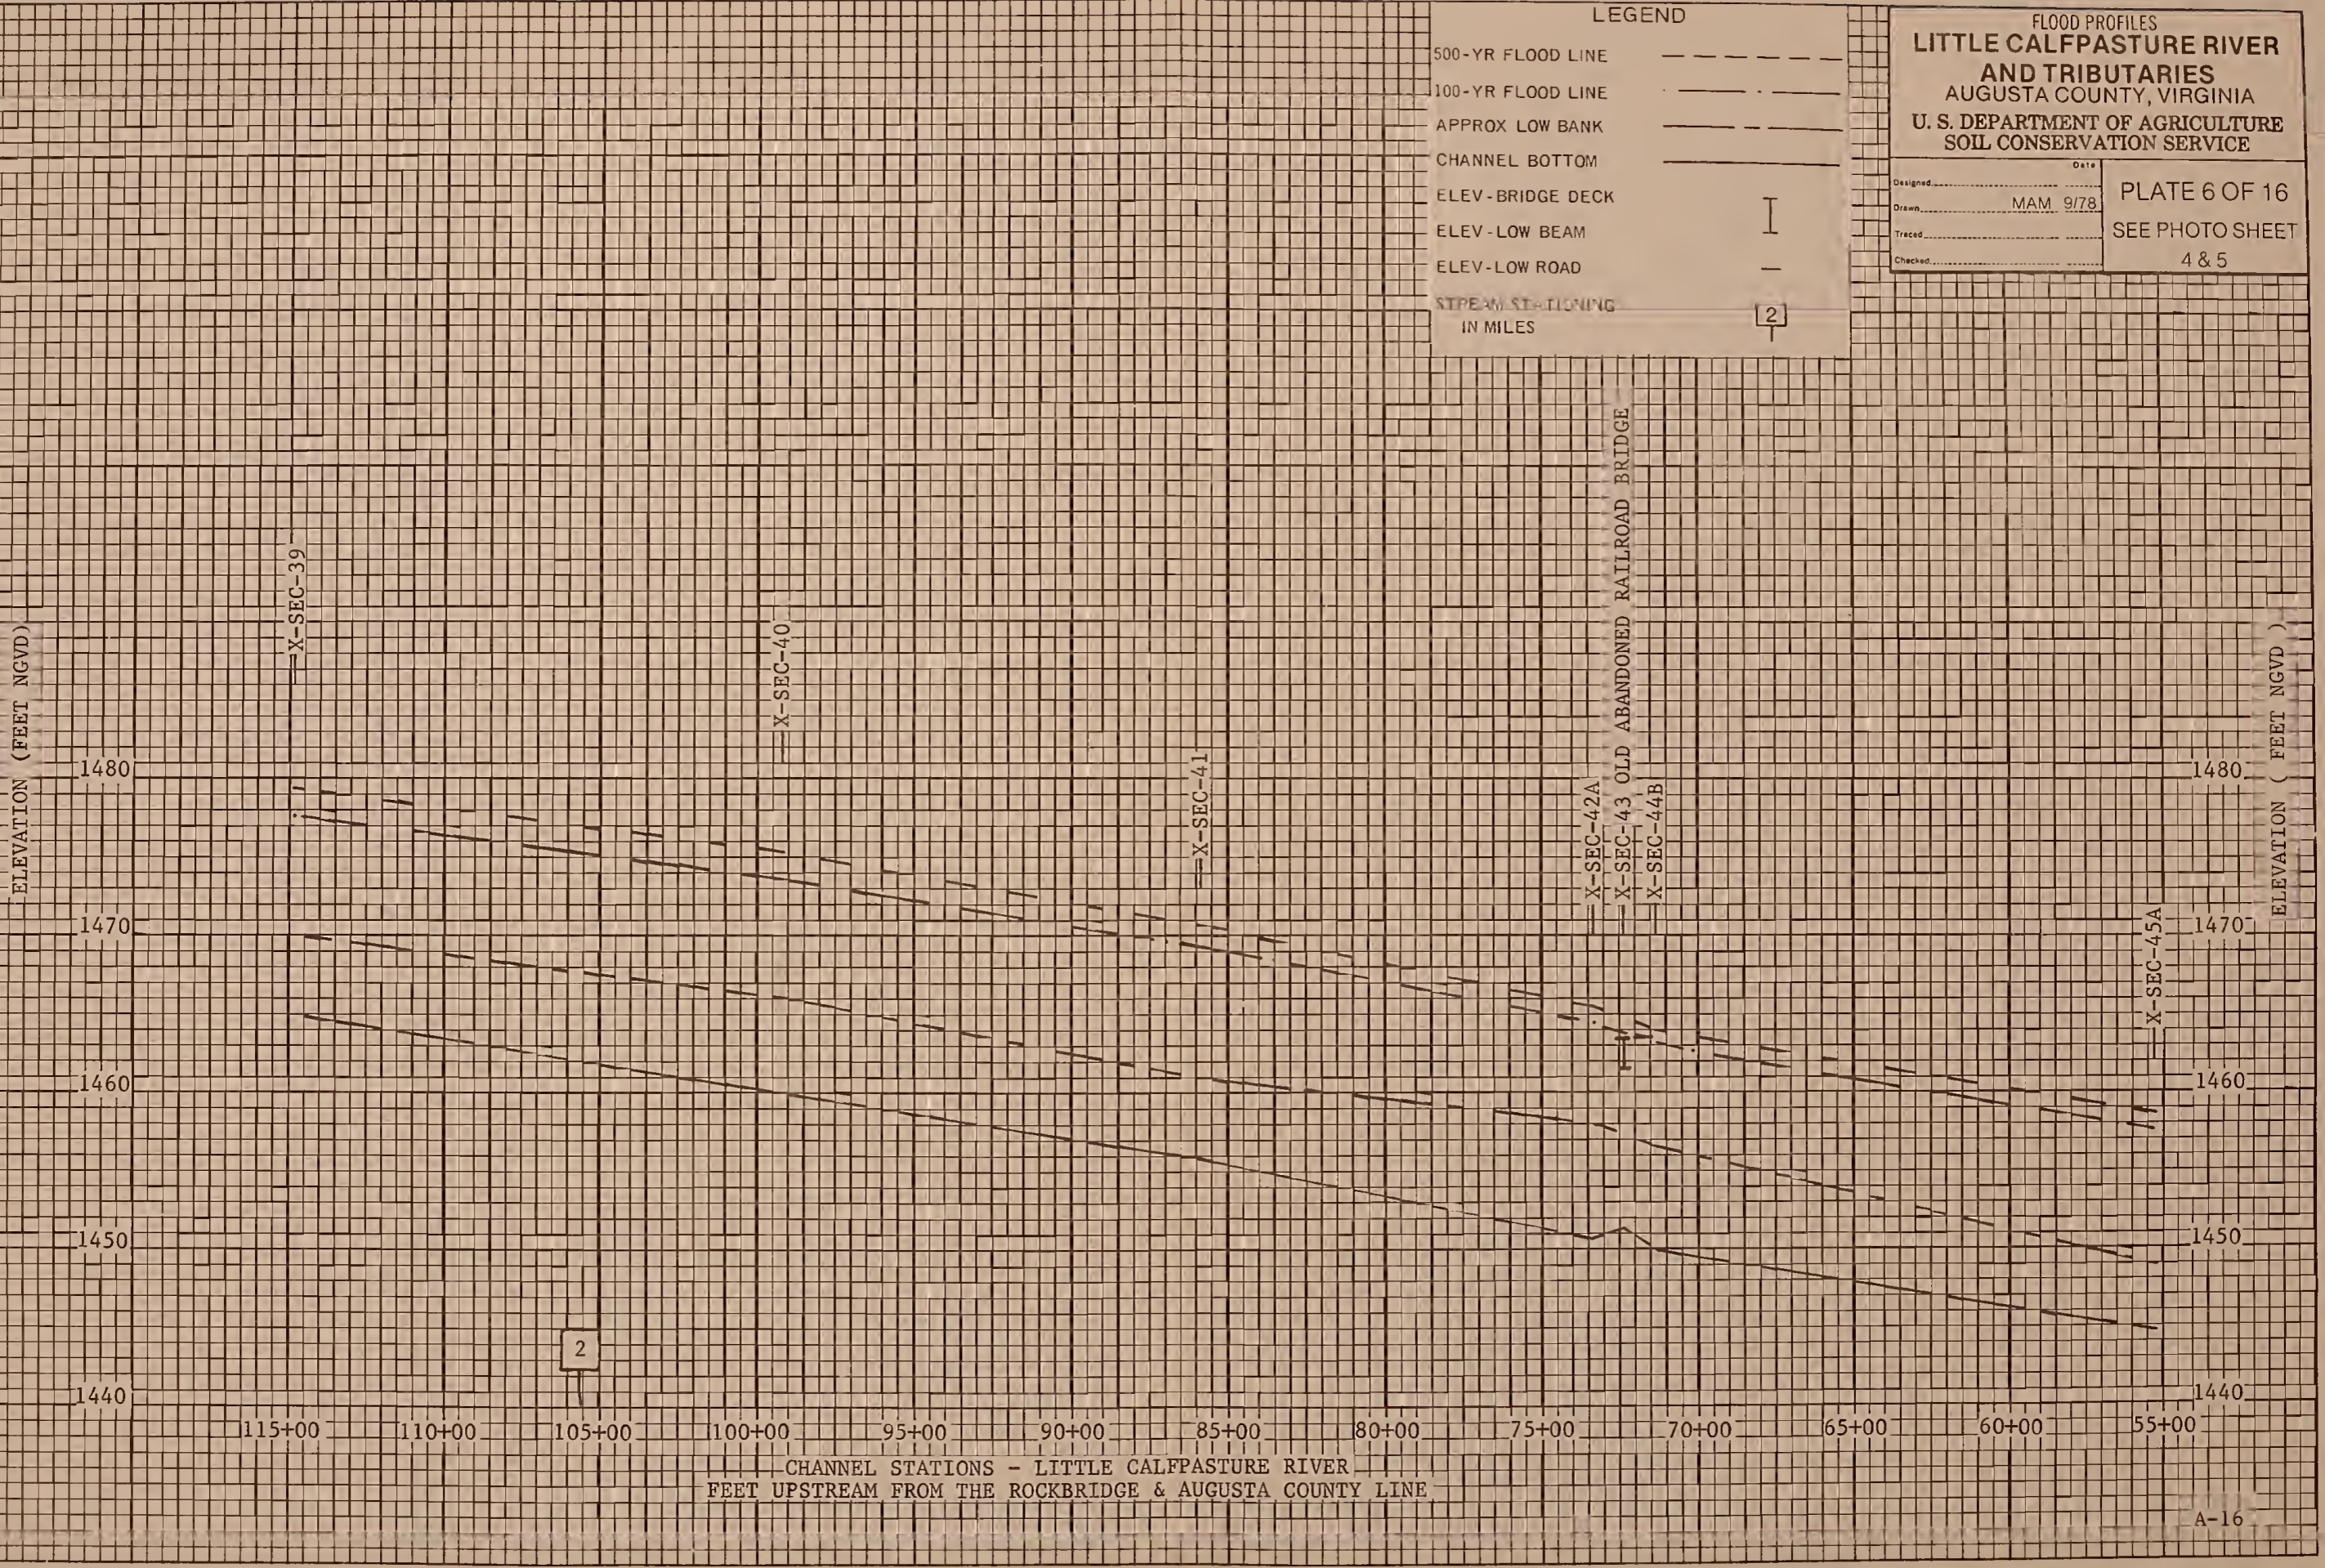
CHANNEL STATIONS - LITTLE CALFPASTURE RIVER  
 FEET UPSTREAM FROM THE ROCKBRIDGE & AUGUSTA COUNTY LINE

FLOOD PROFILES  
**LITTLE CALFPASTURE RIVER  
 AND TRIBUTARIES**  
 AUGUSTA COUNTY, VIRGINIA  
 U. S. DEPARTMENT OF AGRICULTURE  
 SOIL CONSERVATION SERVICE

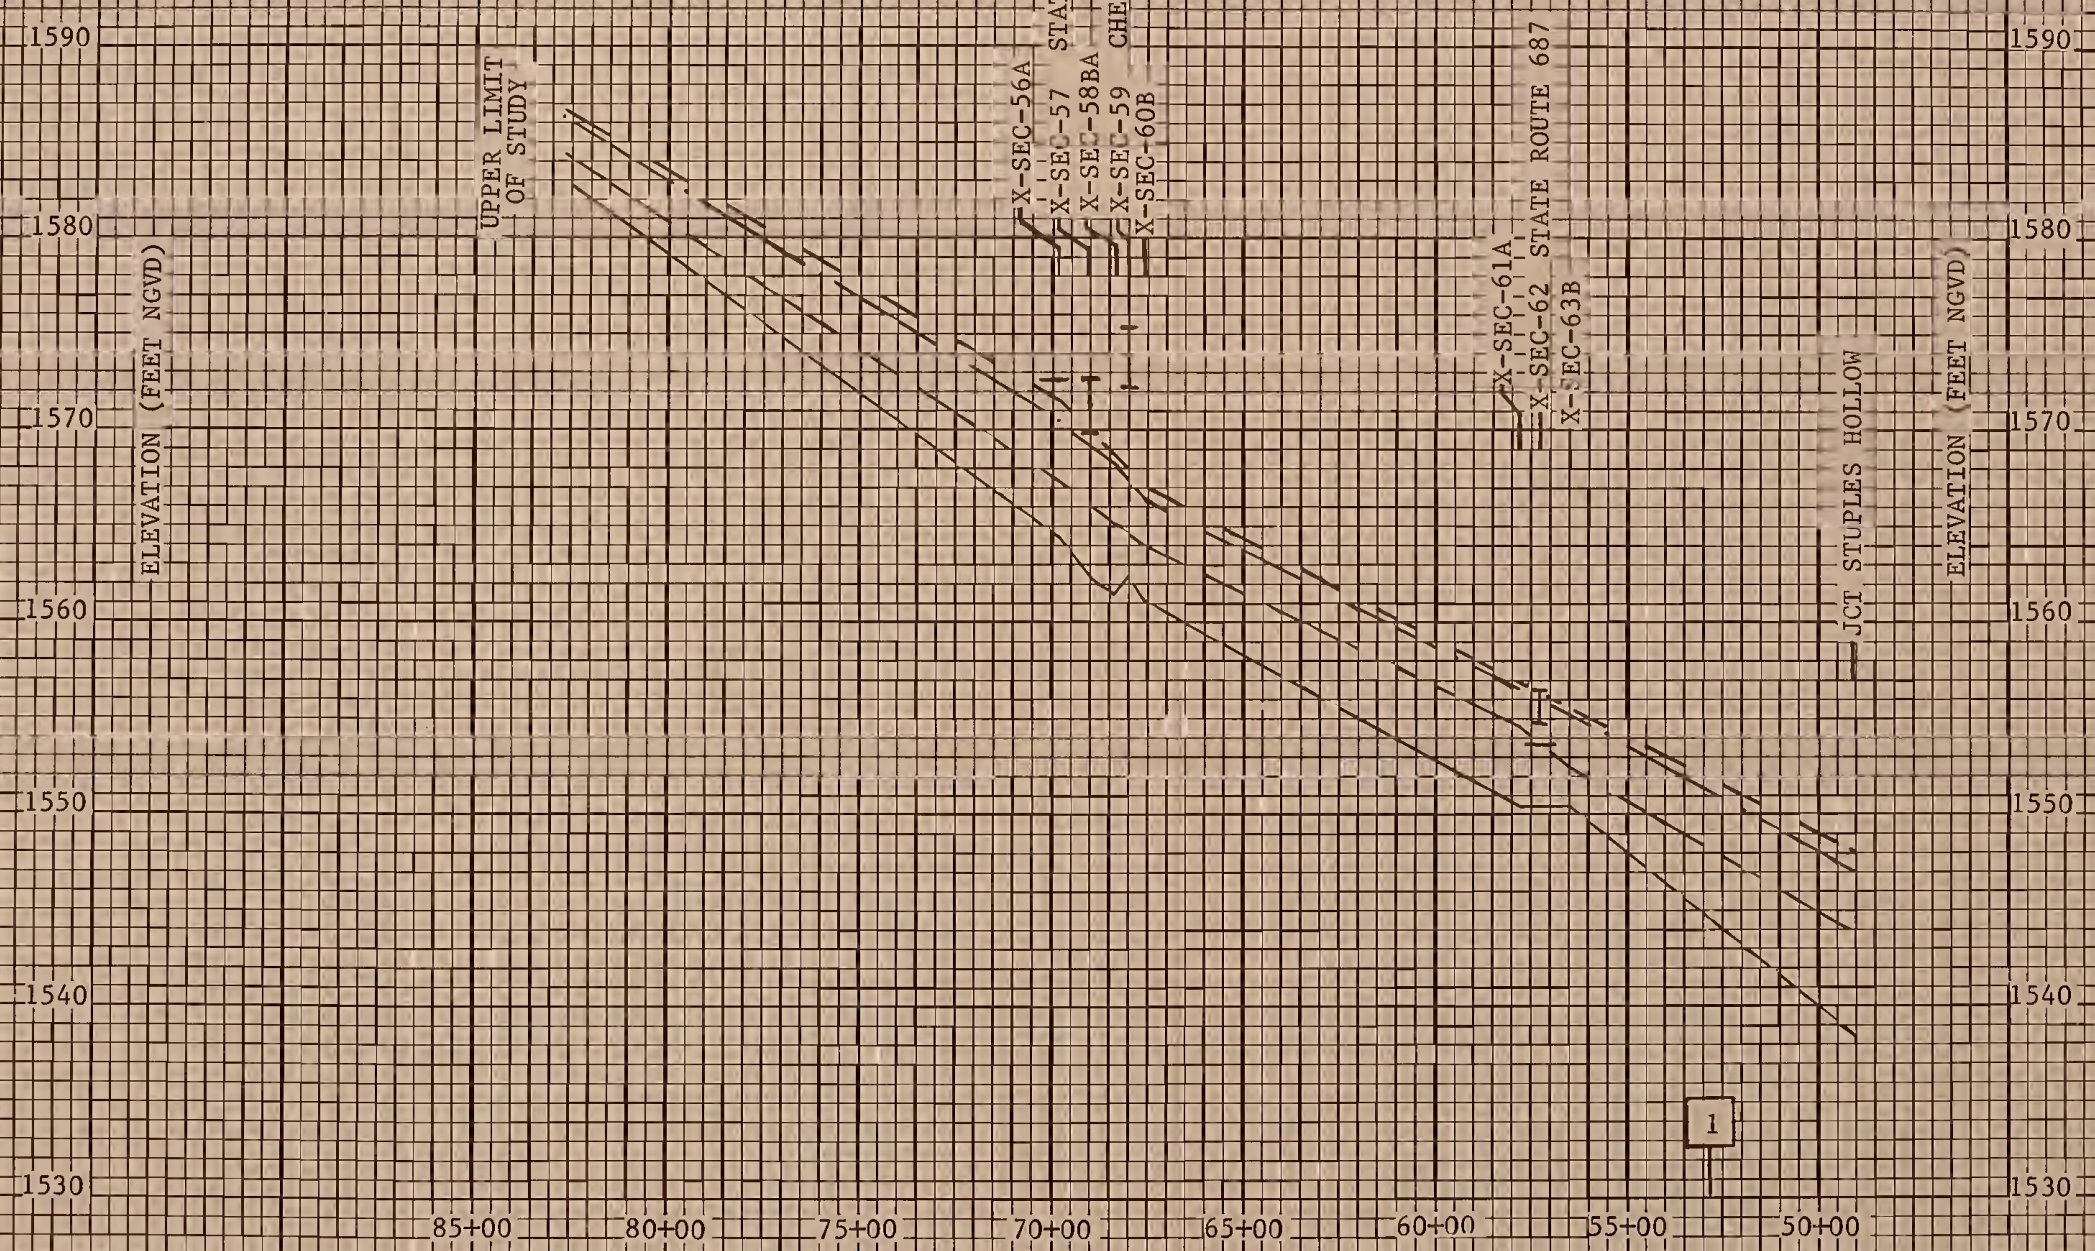
CHANNEL STATION - GRASSY RUN  
 FEET UPSTREAM WITH THE JUNCTION  
 LITTLE CALFPASTURE RIVER

FLOOD PROFILES  
 GRASSY RUN  
 TRIBUTARY OF  
 LITTLE CALFPASTURE RIVER  
 AUGUSTA COUNTY, VIRGINIA  
 U. S. DEPARTMENT OF AGRICULTURE  
 SOIL CONSERVATION SERVICE

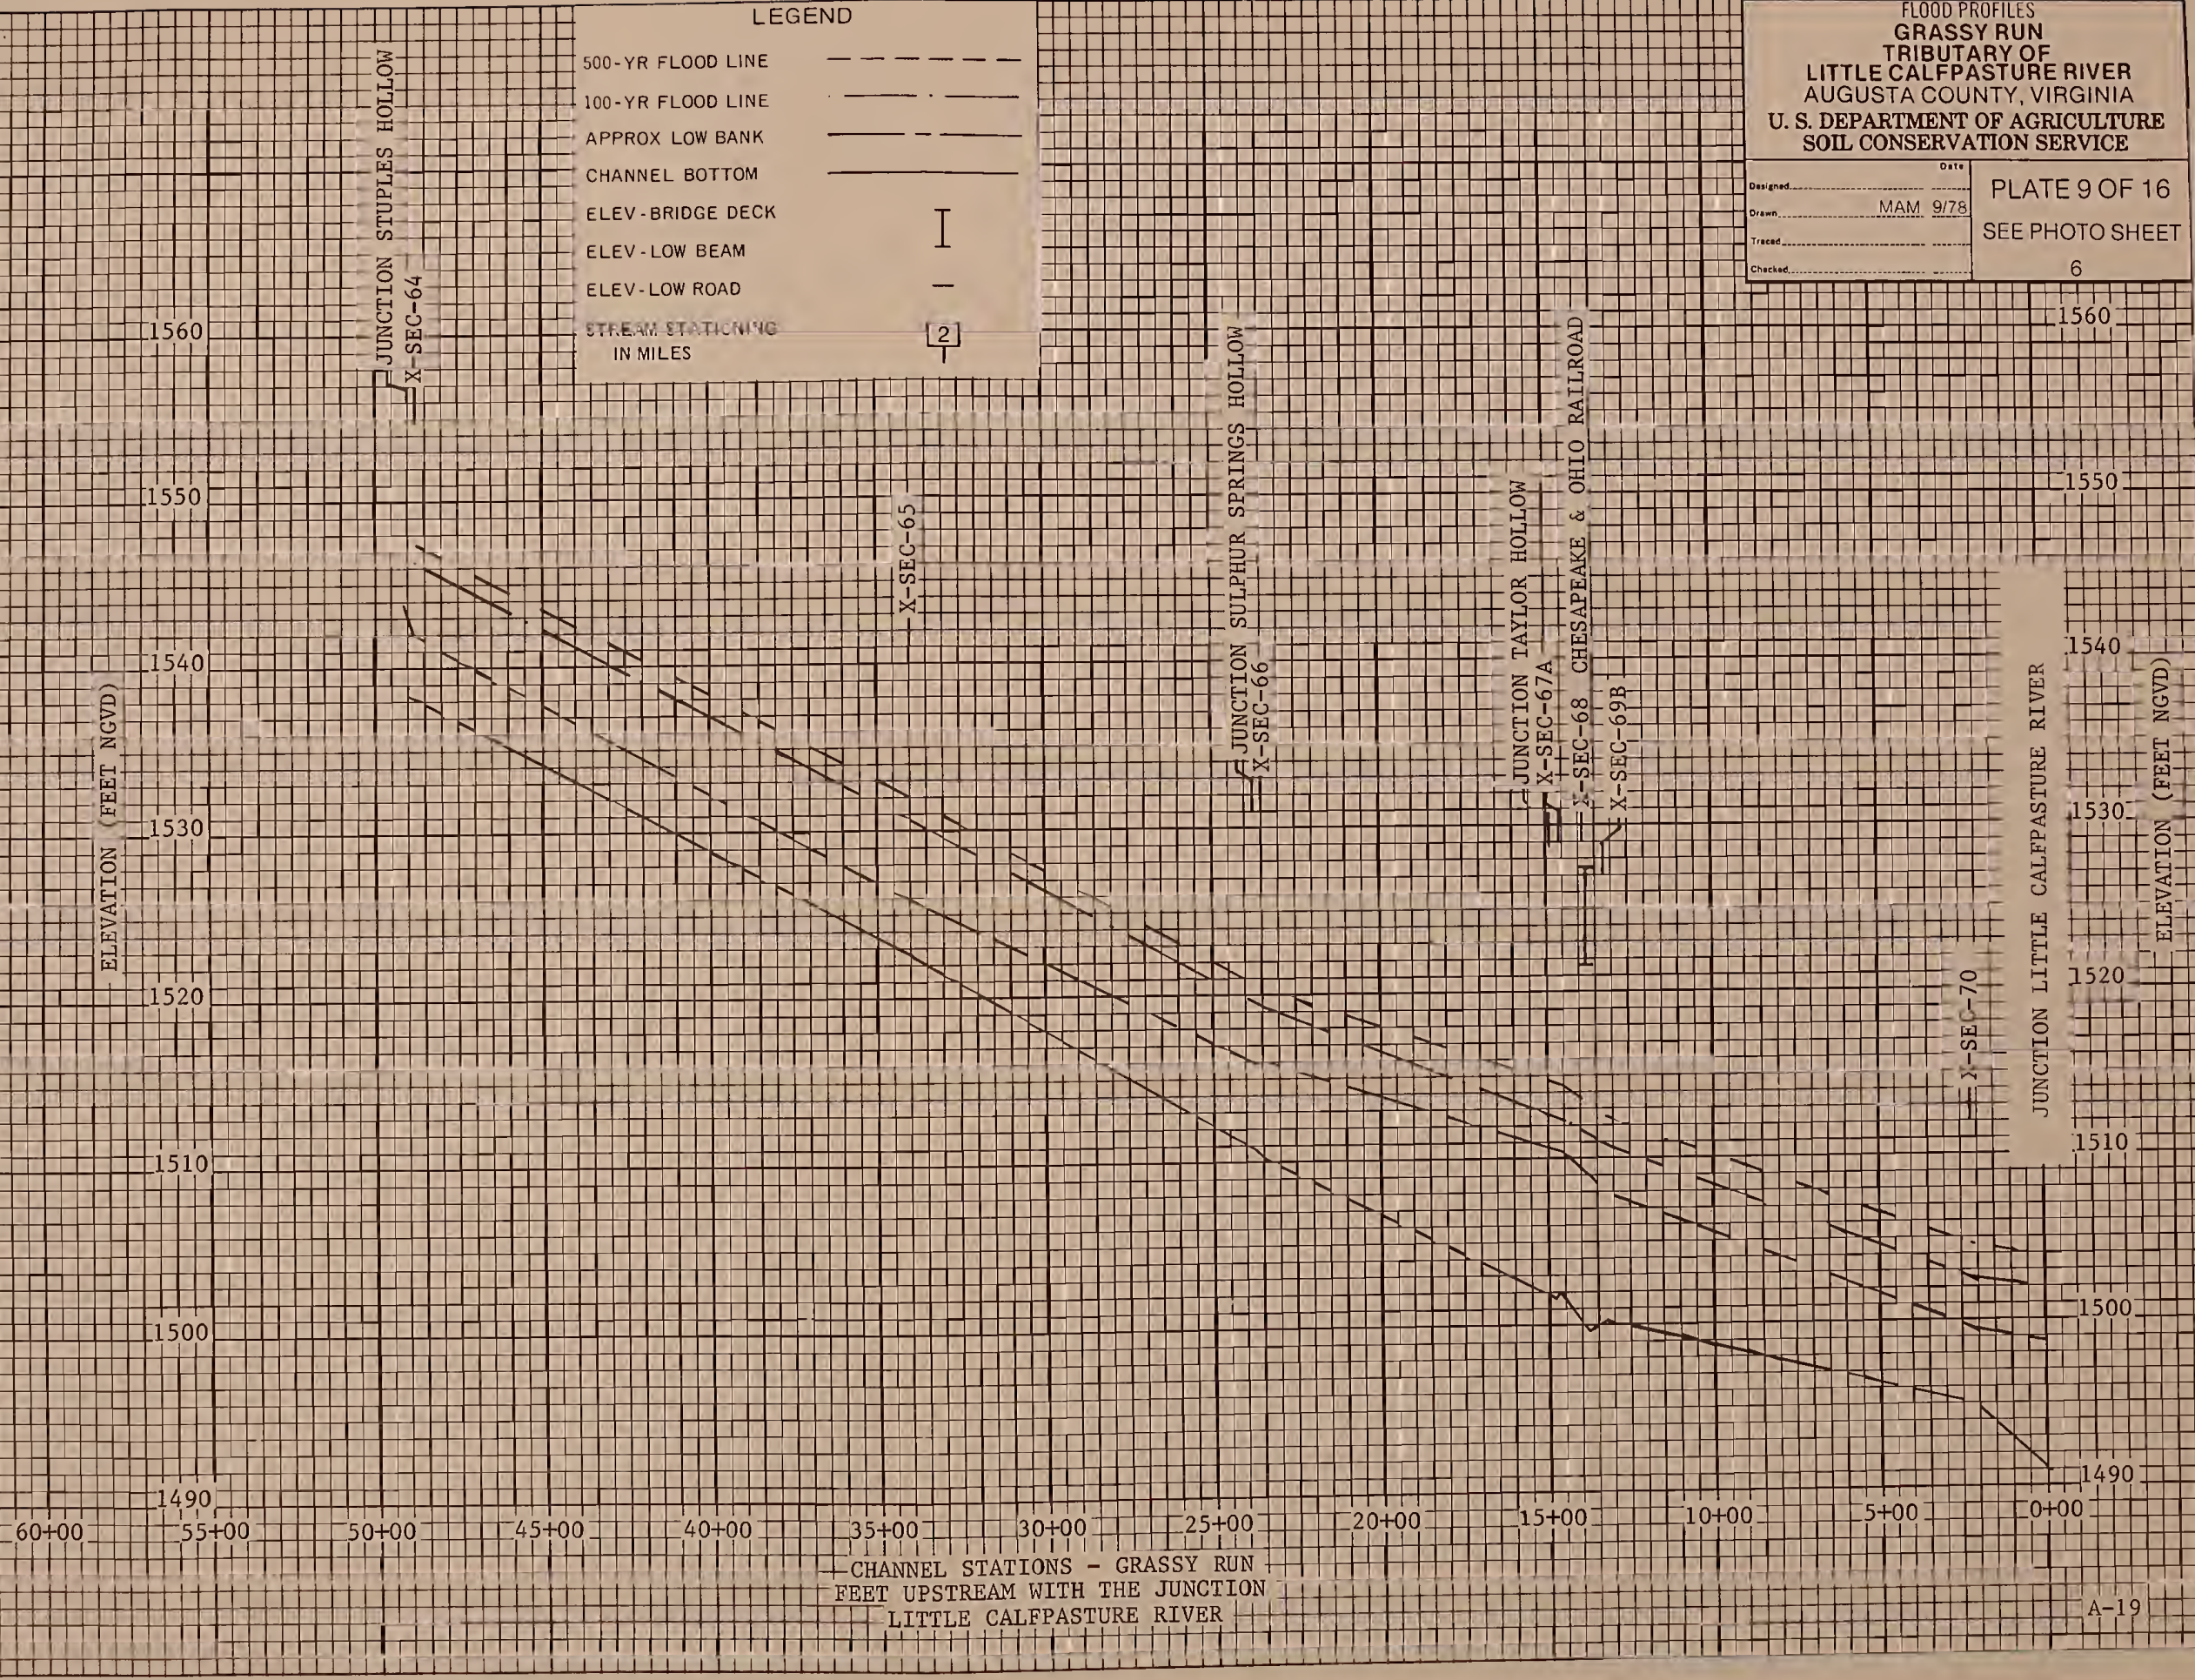
PLATE 10 OF 16  
 SEE PHOTO SHEET  
 6

CHANNEL STATIONS - GRASSY RUN  
 FEET UPSTREAM WITH THE JUNCTION  
 LITTLE CALFPASTURE RIVER

FLOOD PROFILES  
 STUPLES HOLLOW  
 TRIBUTARY OF  
 LITTLE CALFPASTURE RIVER  
 AUGUSTA COUNTY, VIRGINIA  
 U. S. DEPARTMENT OF AGRICULTURE  
 SOIL CONSERVATION SERVICE

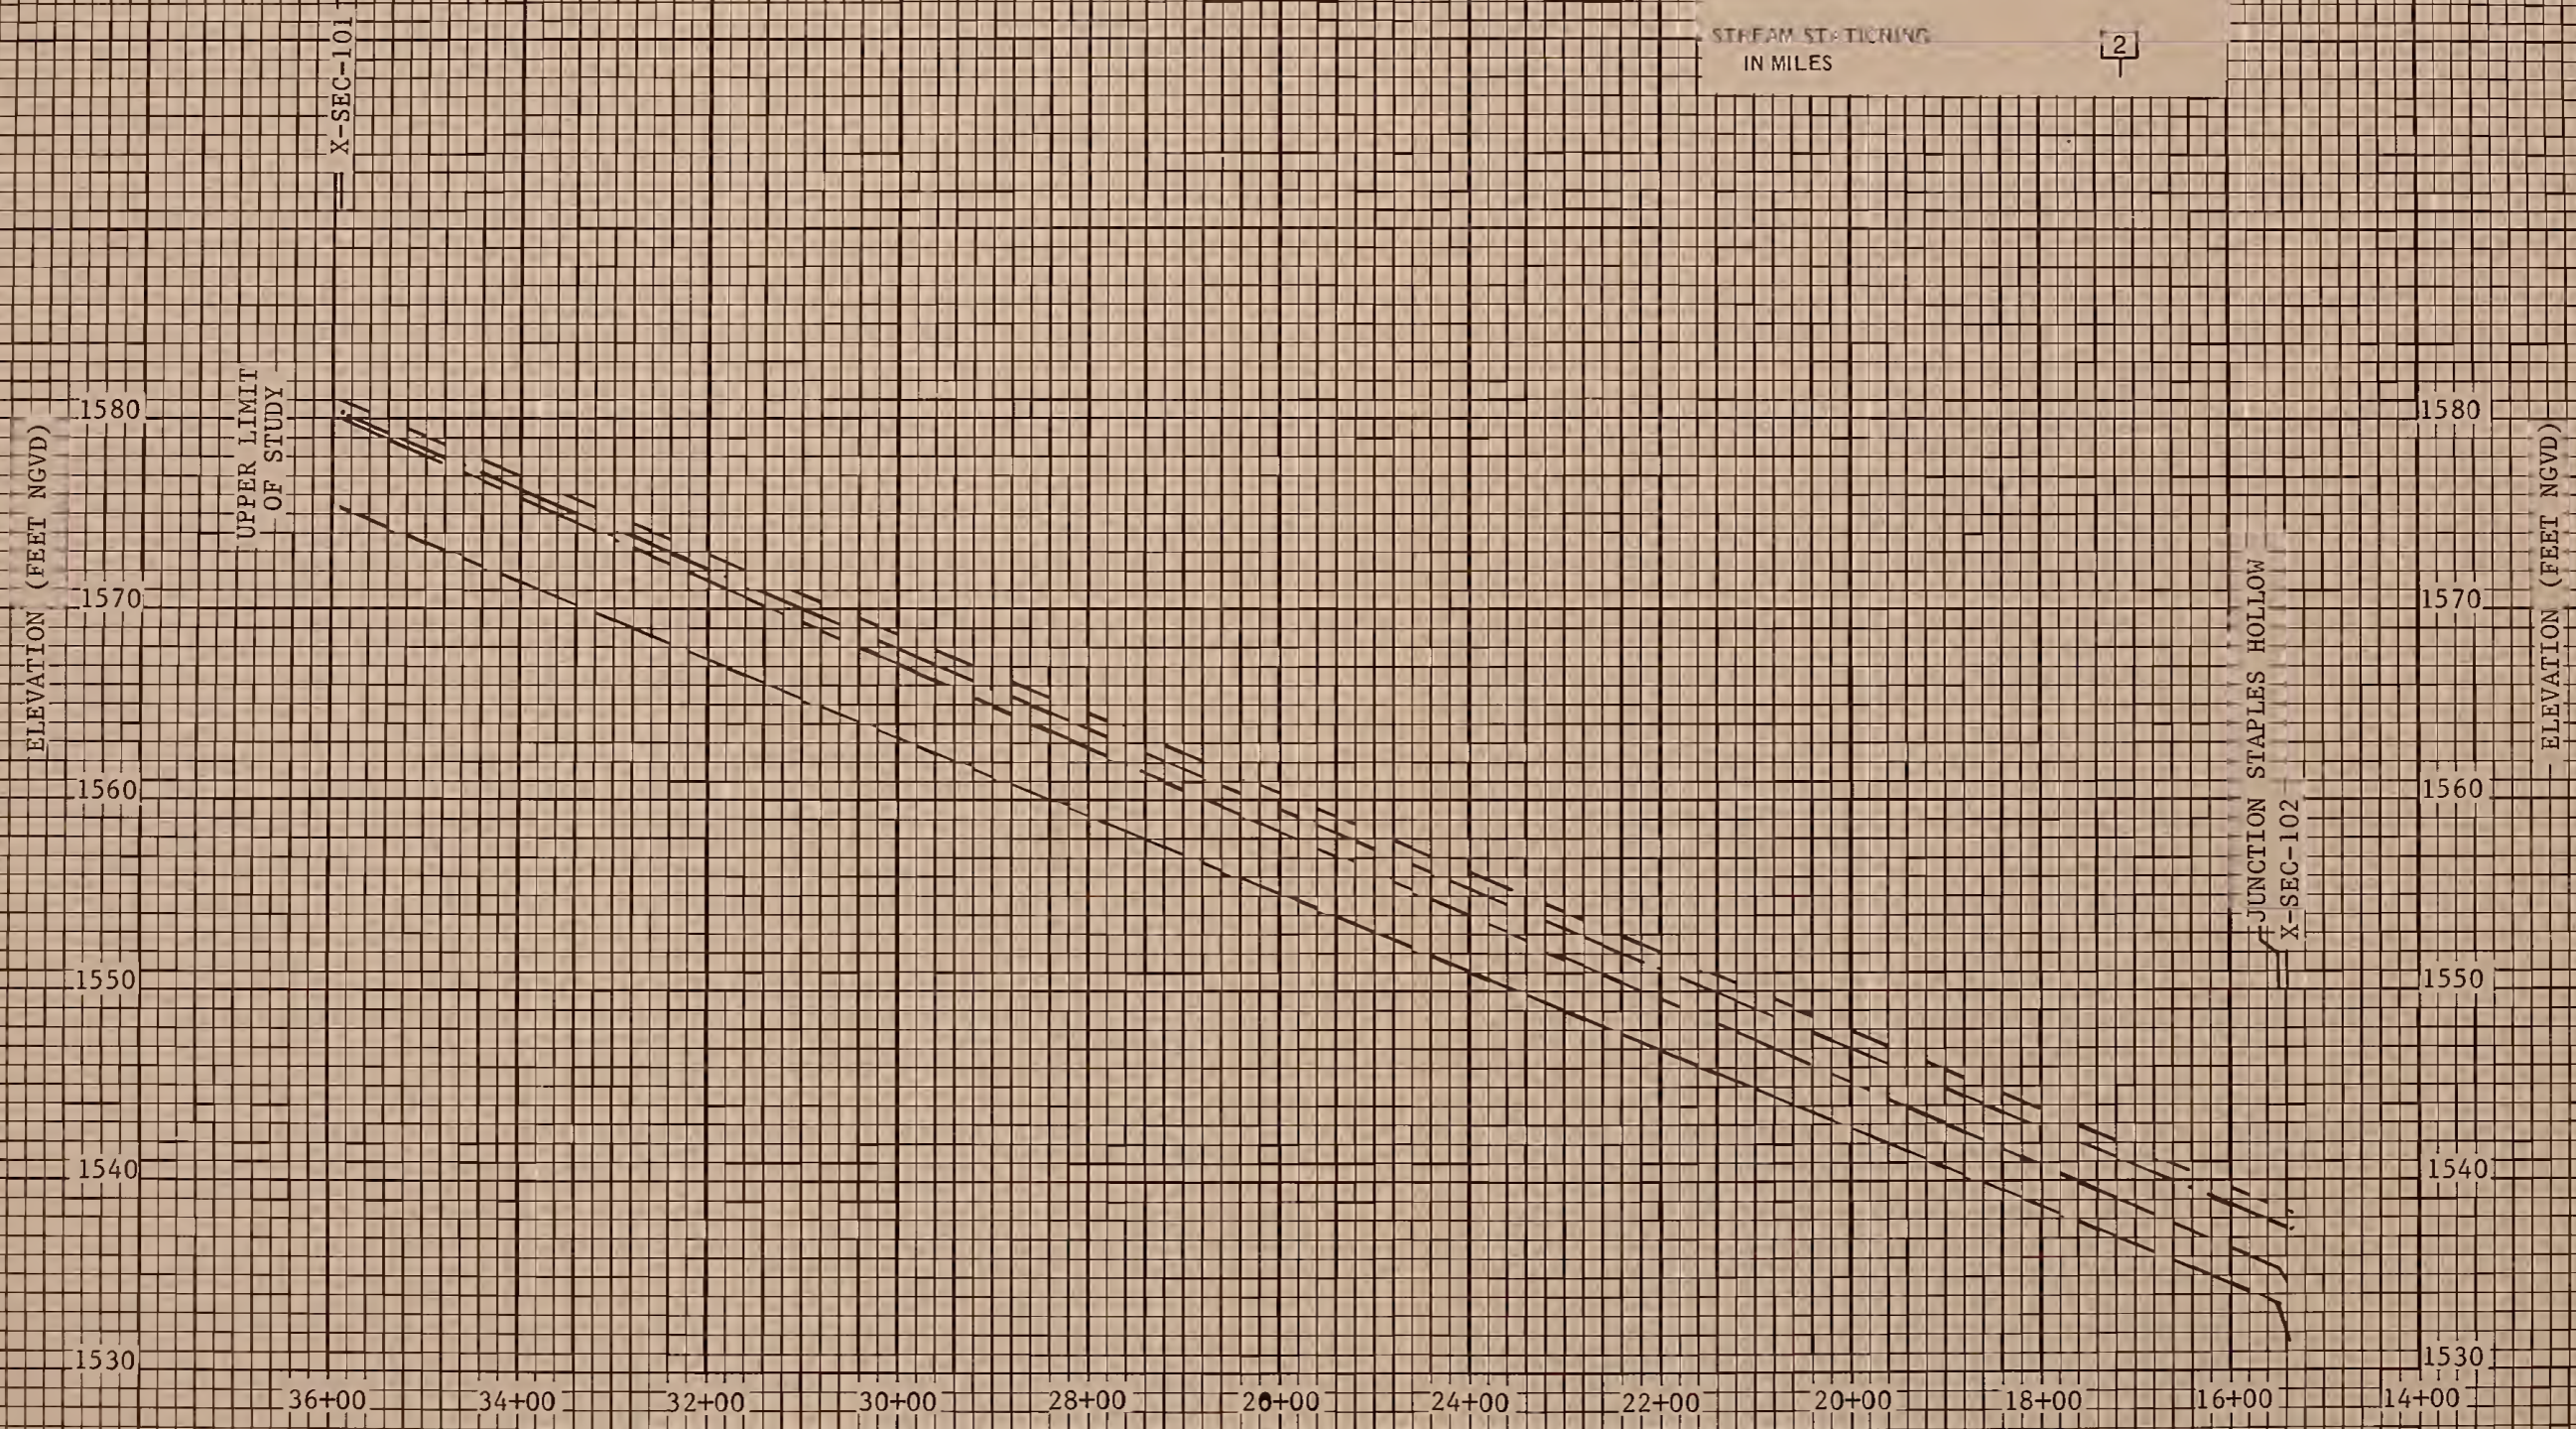
Designed.....	Date.....	PLATE 13 OF 16 SEE PHOTO SHEET 6
Drawn..... MAM 9/78		
Traced.....		
Checked.....

FLOOD PROFILES  
**SULPHUR SPRINGS HOLLOW**  
 TRIBUTARY OF  
**LITTLE CALFPASTURE RIVER**  
 AUGUSTA COUNTY, VIRGINIA  
 U. S. DEPARTMENT OF AGRICULTURE  
 SOIL CONSERVATION SERVICE

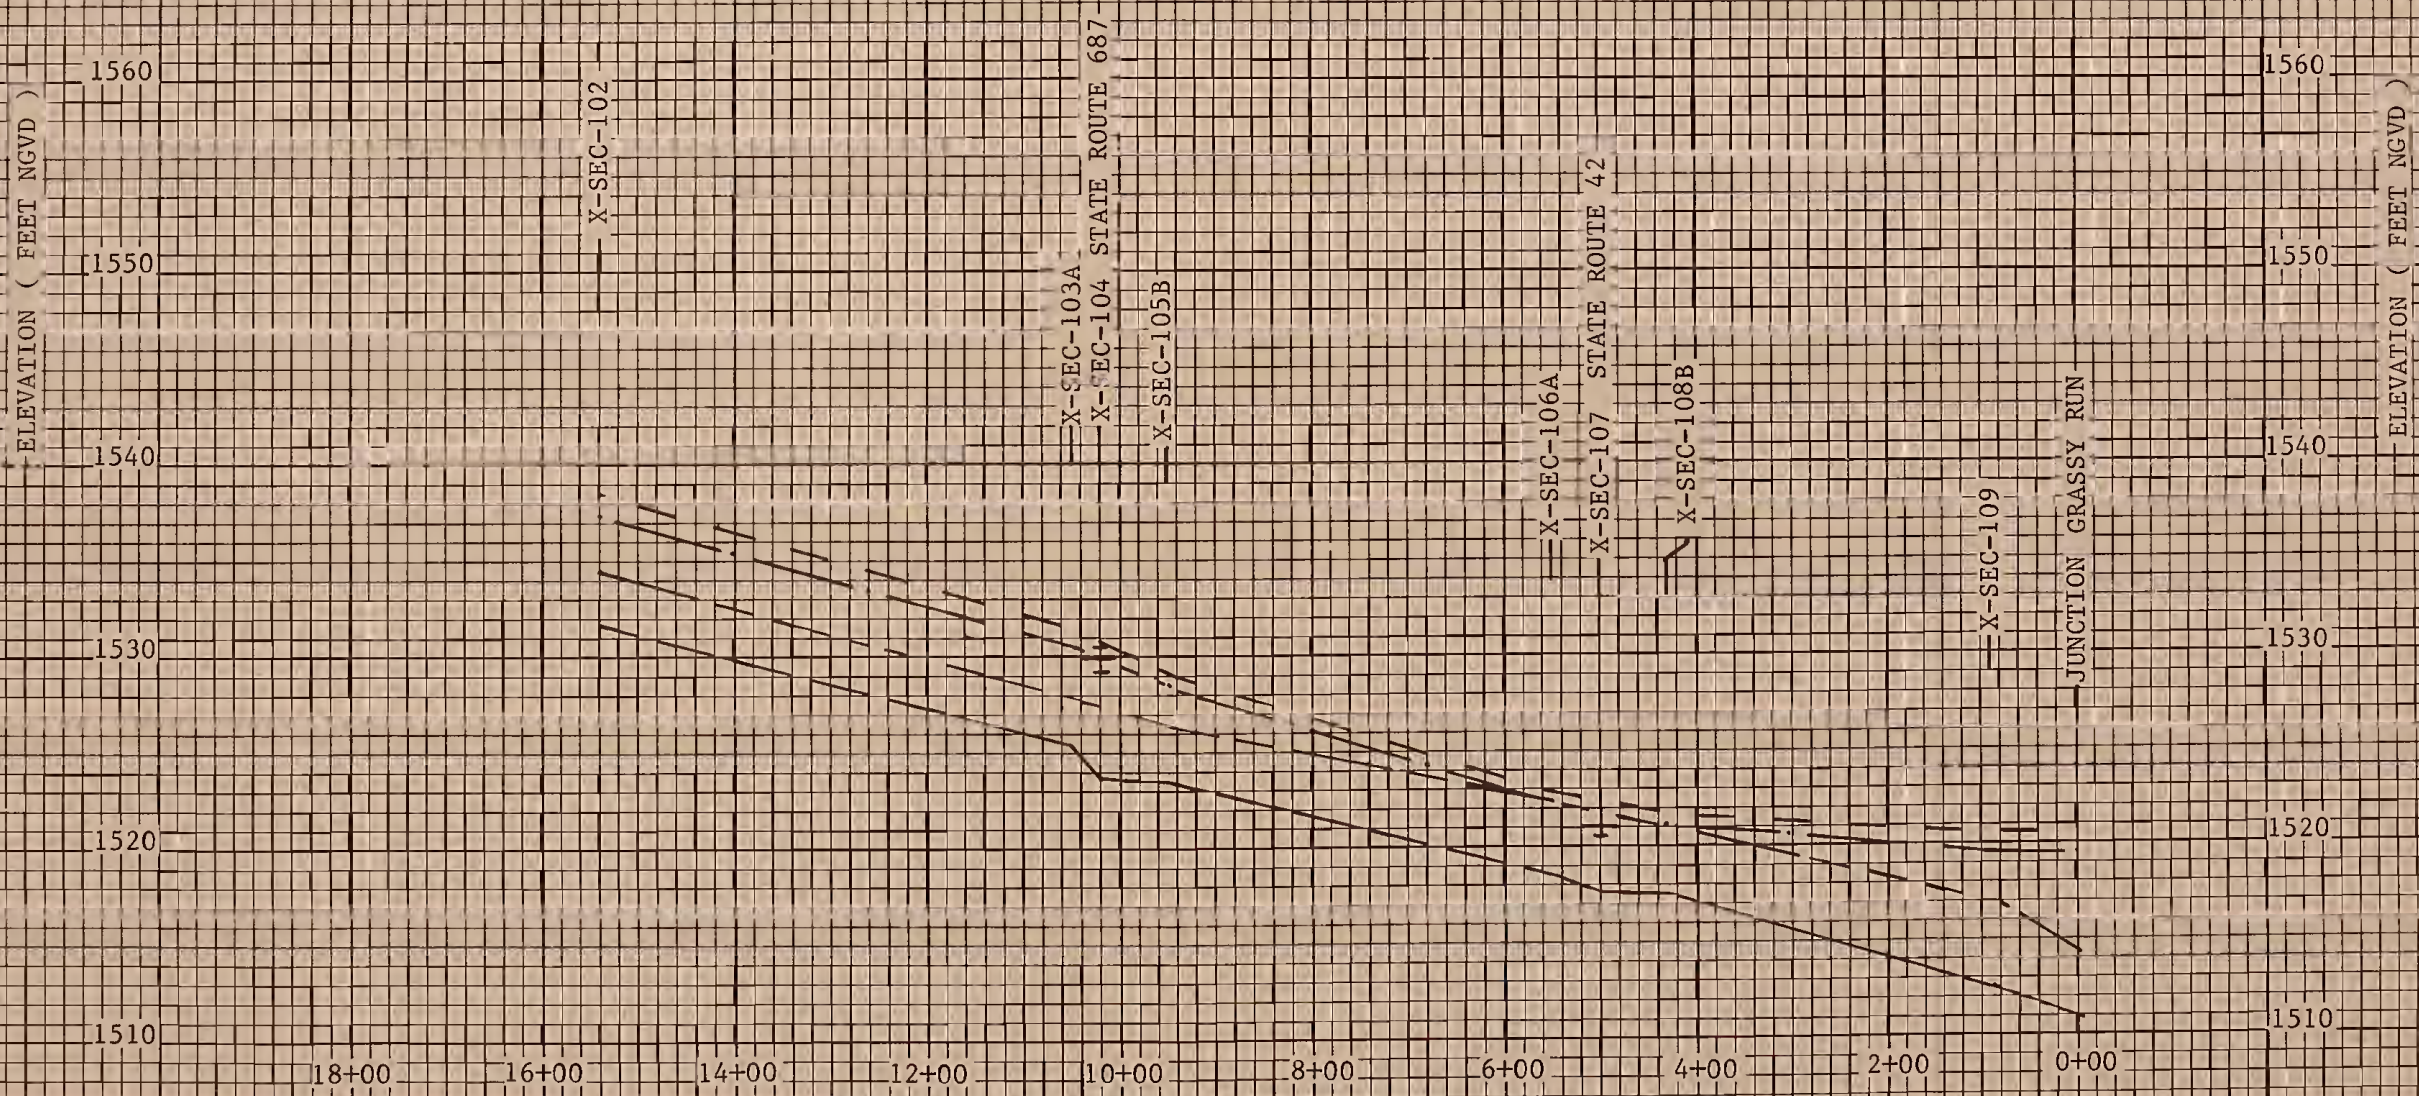
CHANNEL STATIONS - SULPHUR SPRINGS HOLLOW  
 FEET UPSTREAM FROM THE JUNCTION WITH GRASSY RUN

FLOOD PROFILES  
**STAPLES HOLLOW**  
 TRIBUTARY OF  
**LITTLE CALFPASTURE RIVER**  
 AUGUSTA COUNTY, VIRGINIA  
 U. S. DEPARTMENT OF AGRICULTURE  
 SOIL CONSERVATION SERVICE
