# FLOOD HAZARD STUDY

## LITTLE CALFPASTURE RIVER AND GRASSY RUN

AUGUSTA COUNTY, VIRGINIA

JUNE 1979

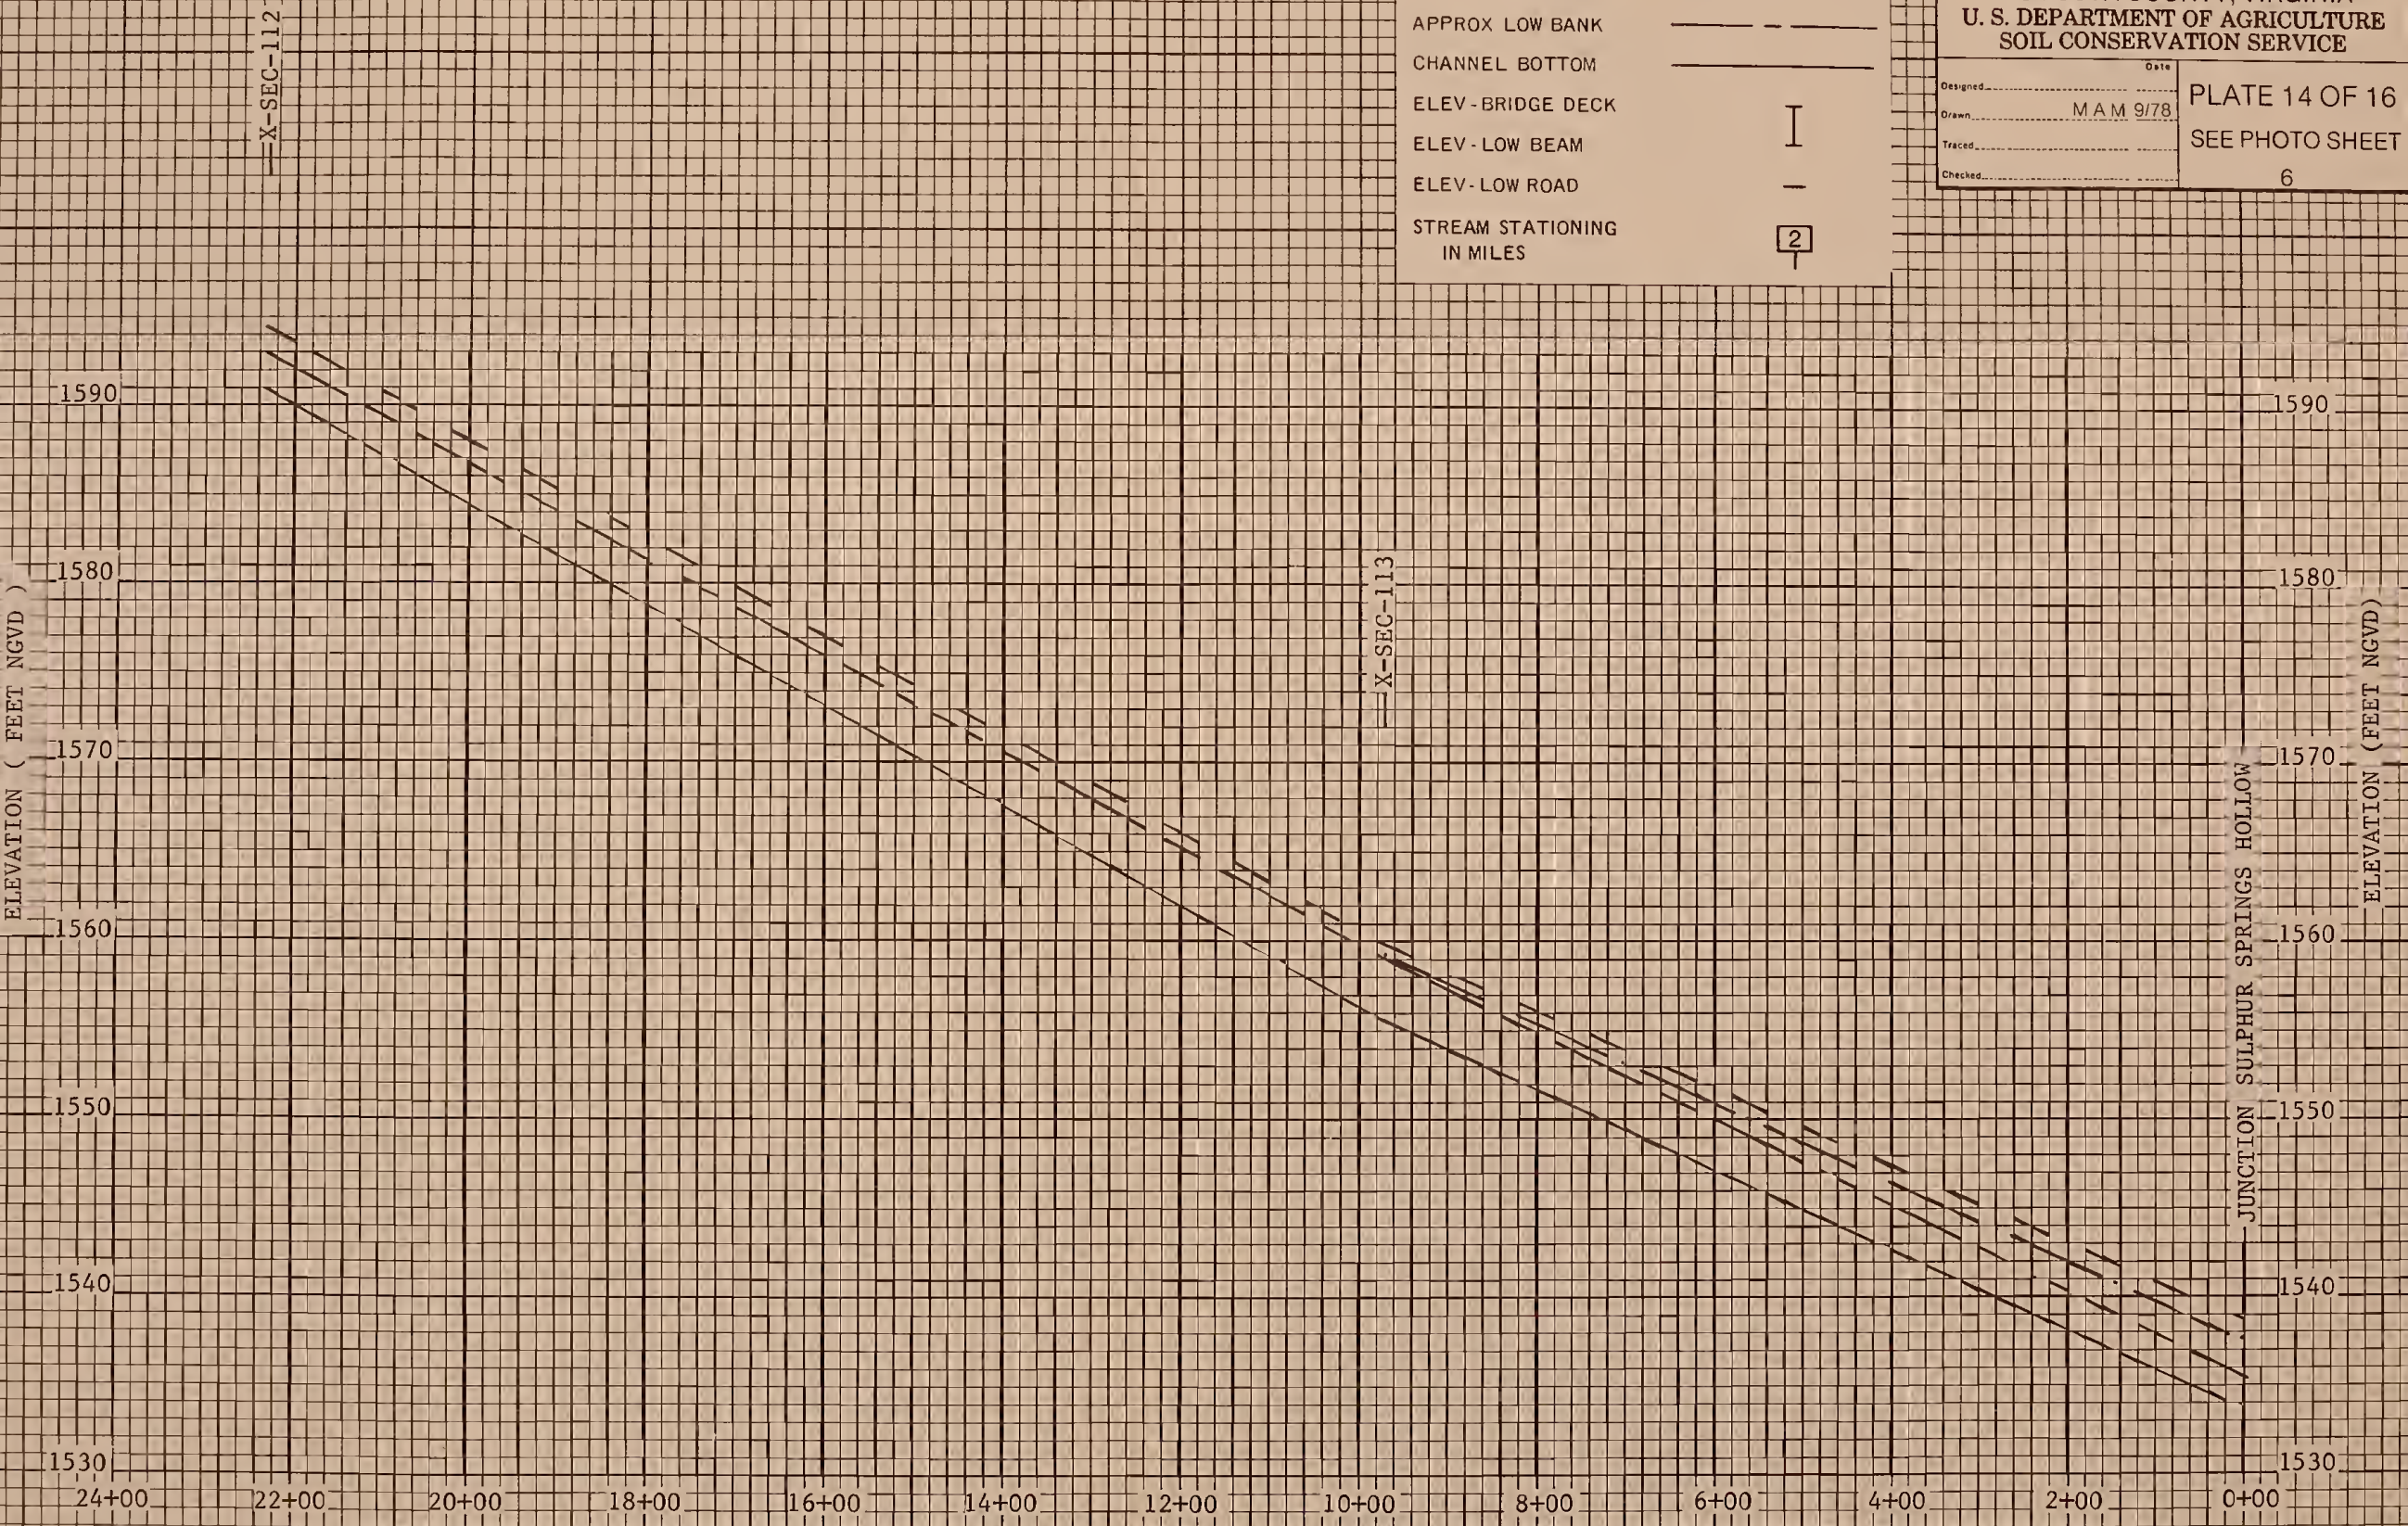
Designed.....	Date
Drawn..... MAM 9/78	PLATE 15 OF 16
Traced.....	SEE PHOTO SHEET
Checked.....	6

CHANNEL STATIONS - STAPLES HOLLOW  
 FEET ABOVE MOUTH WITH THE JUNCTION  
 SULPHUR SPRINGS HOLLOW

FLOOD PROFILES  
TAYLOR HOLLOW  
TRIBUTARY OF  
LITTLE CALFPASTURE RIVER  
AUGUSTA COUNTY, VIRGINIA  
U. S. DEPARTMENT OF AGRICULTURE  
SOIL CONSERVATION SERVICE

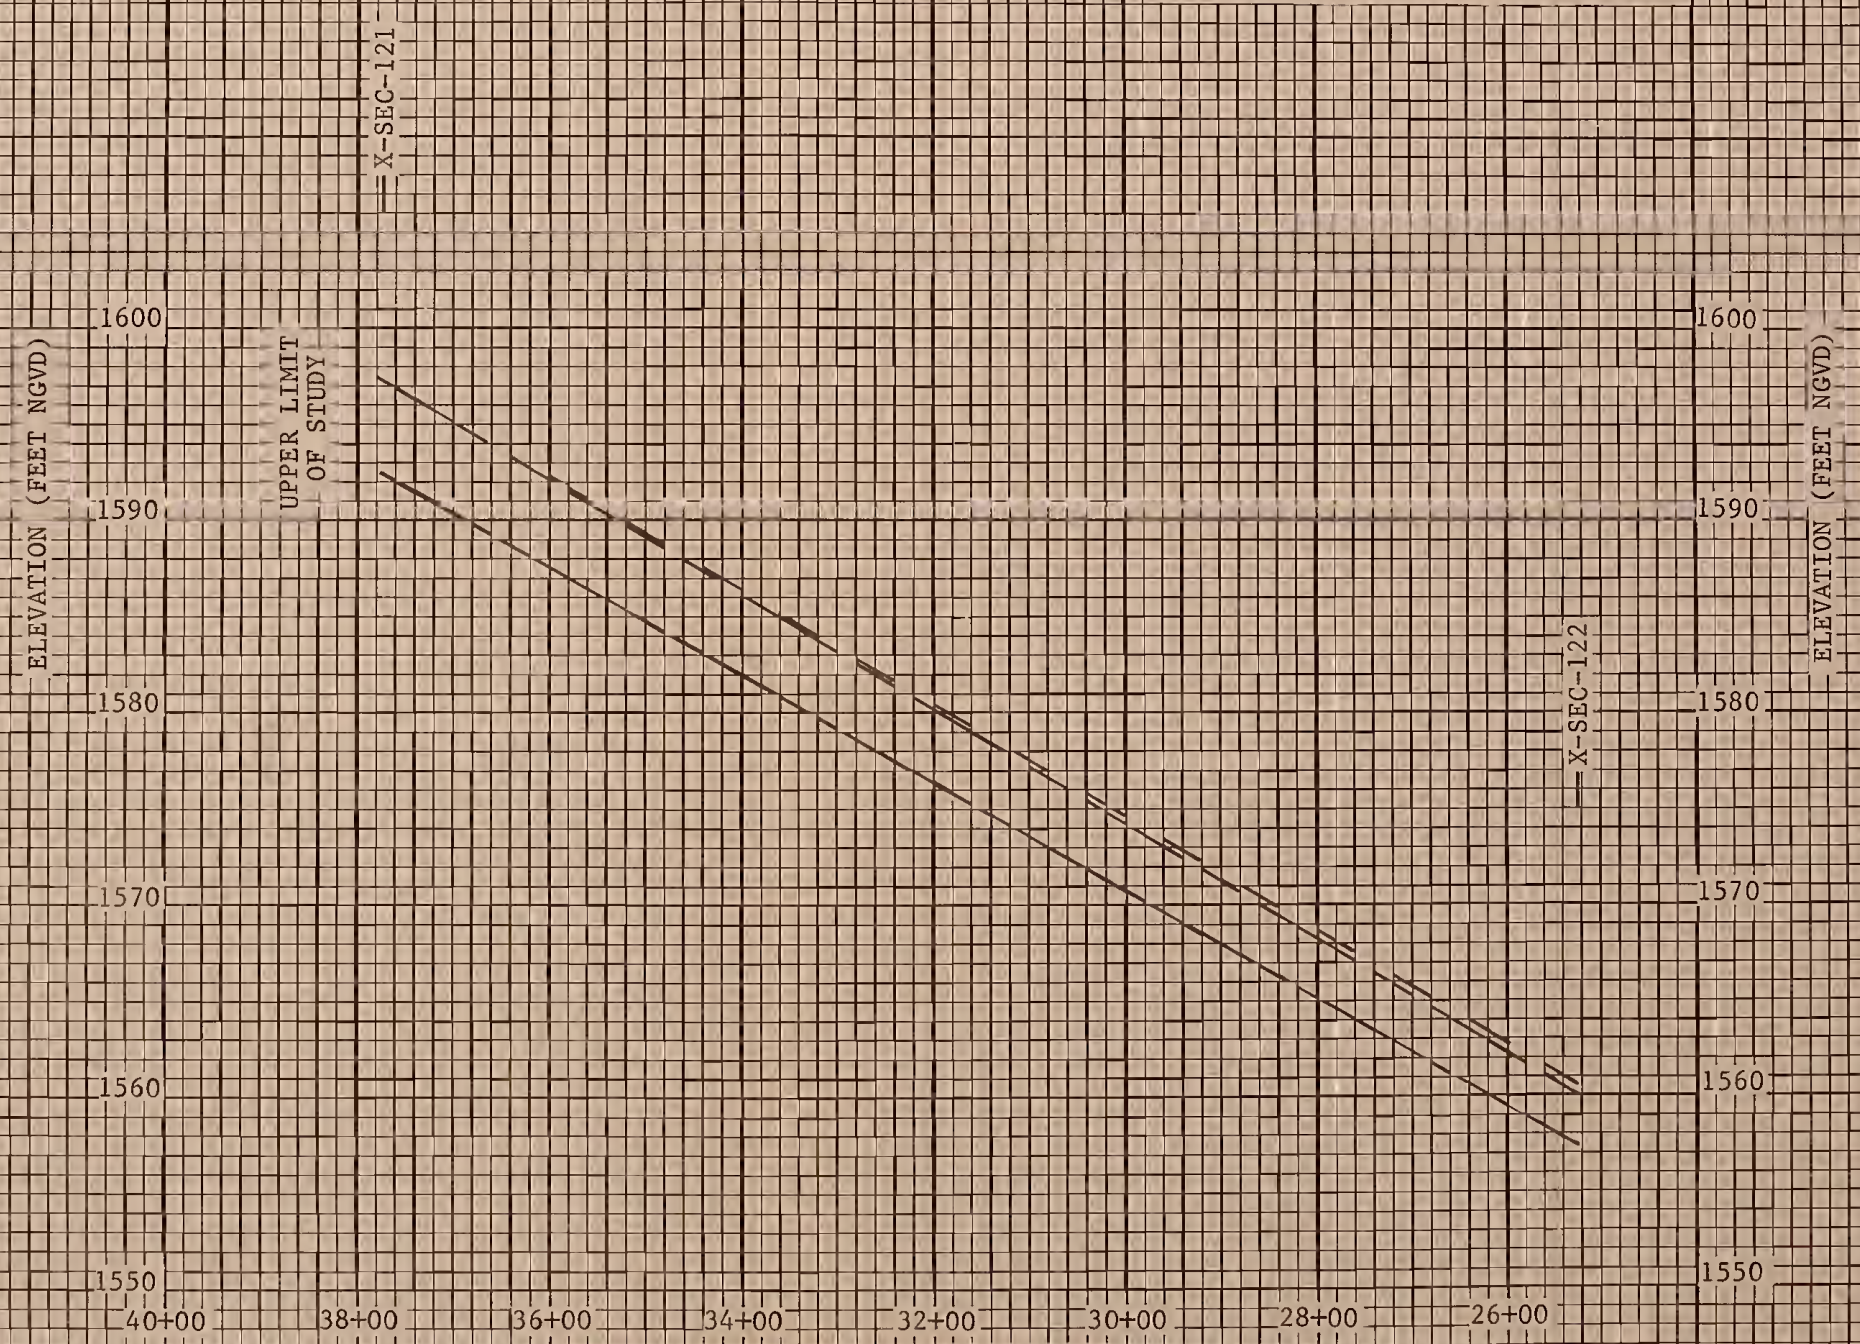
CHANNEL STATIONS - TAYLOR HOLLOW  
FEET UPSTREAM FROM THE JUNCTION  
WITH GRASSY RUN

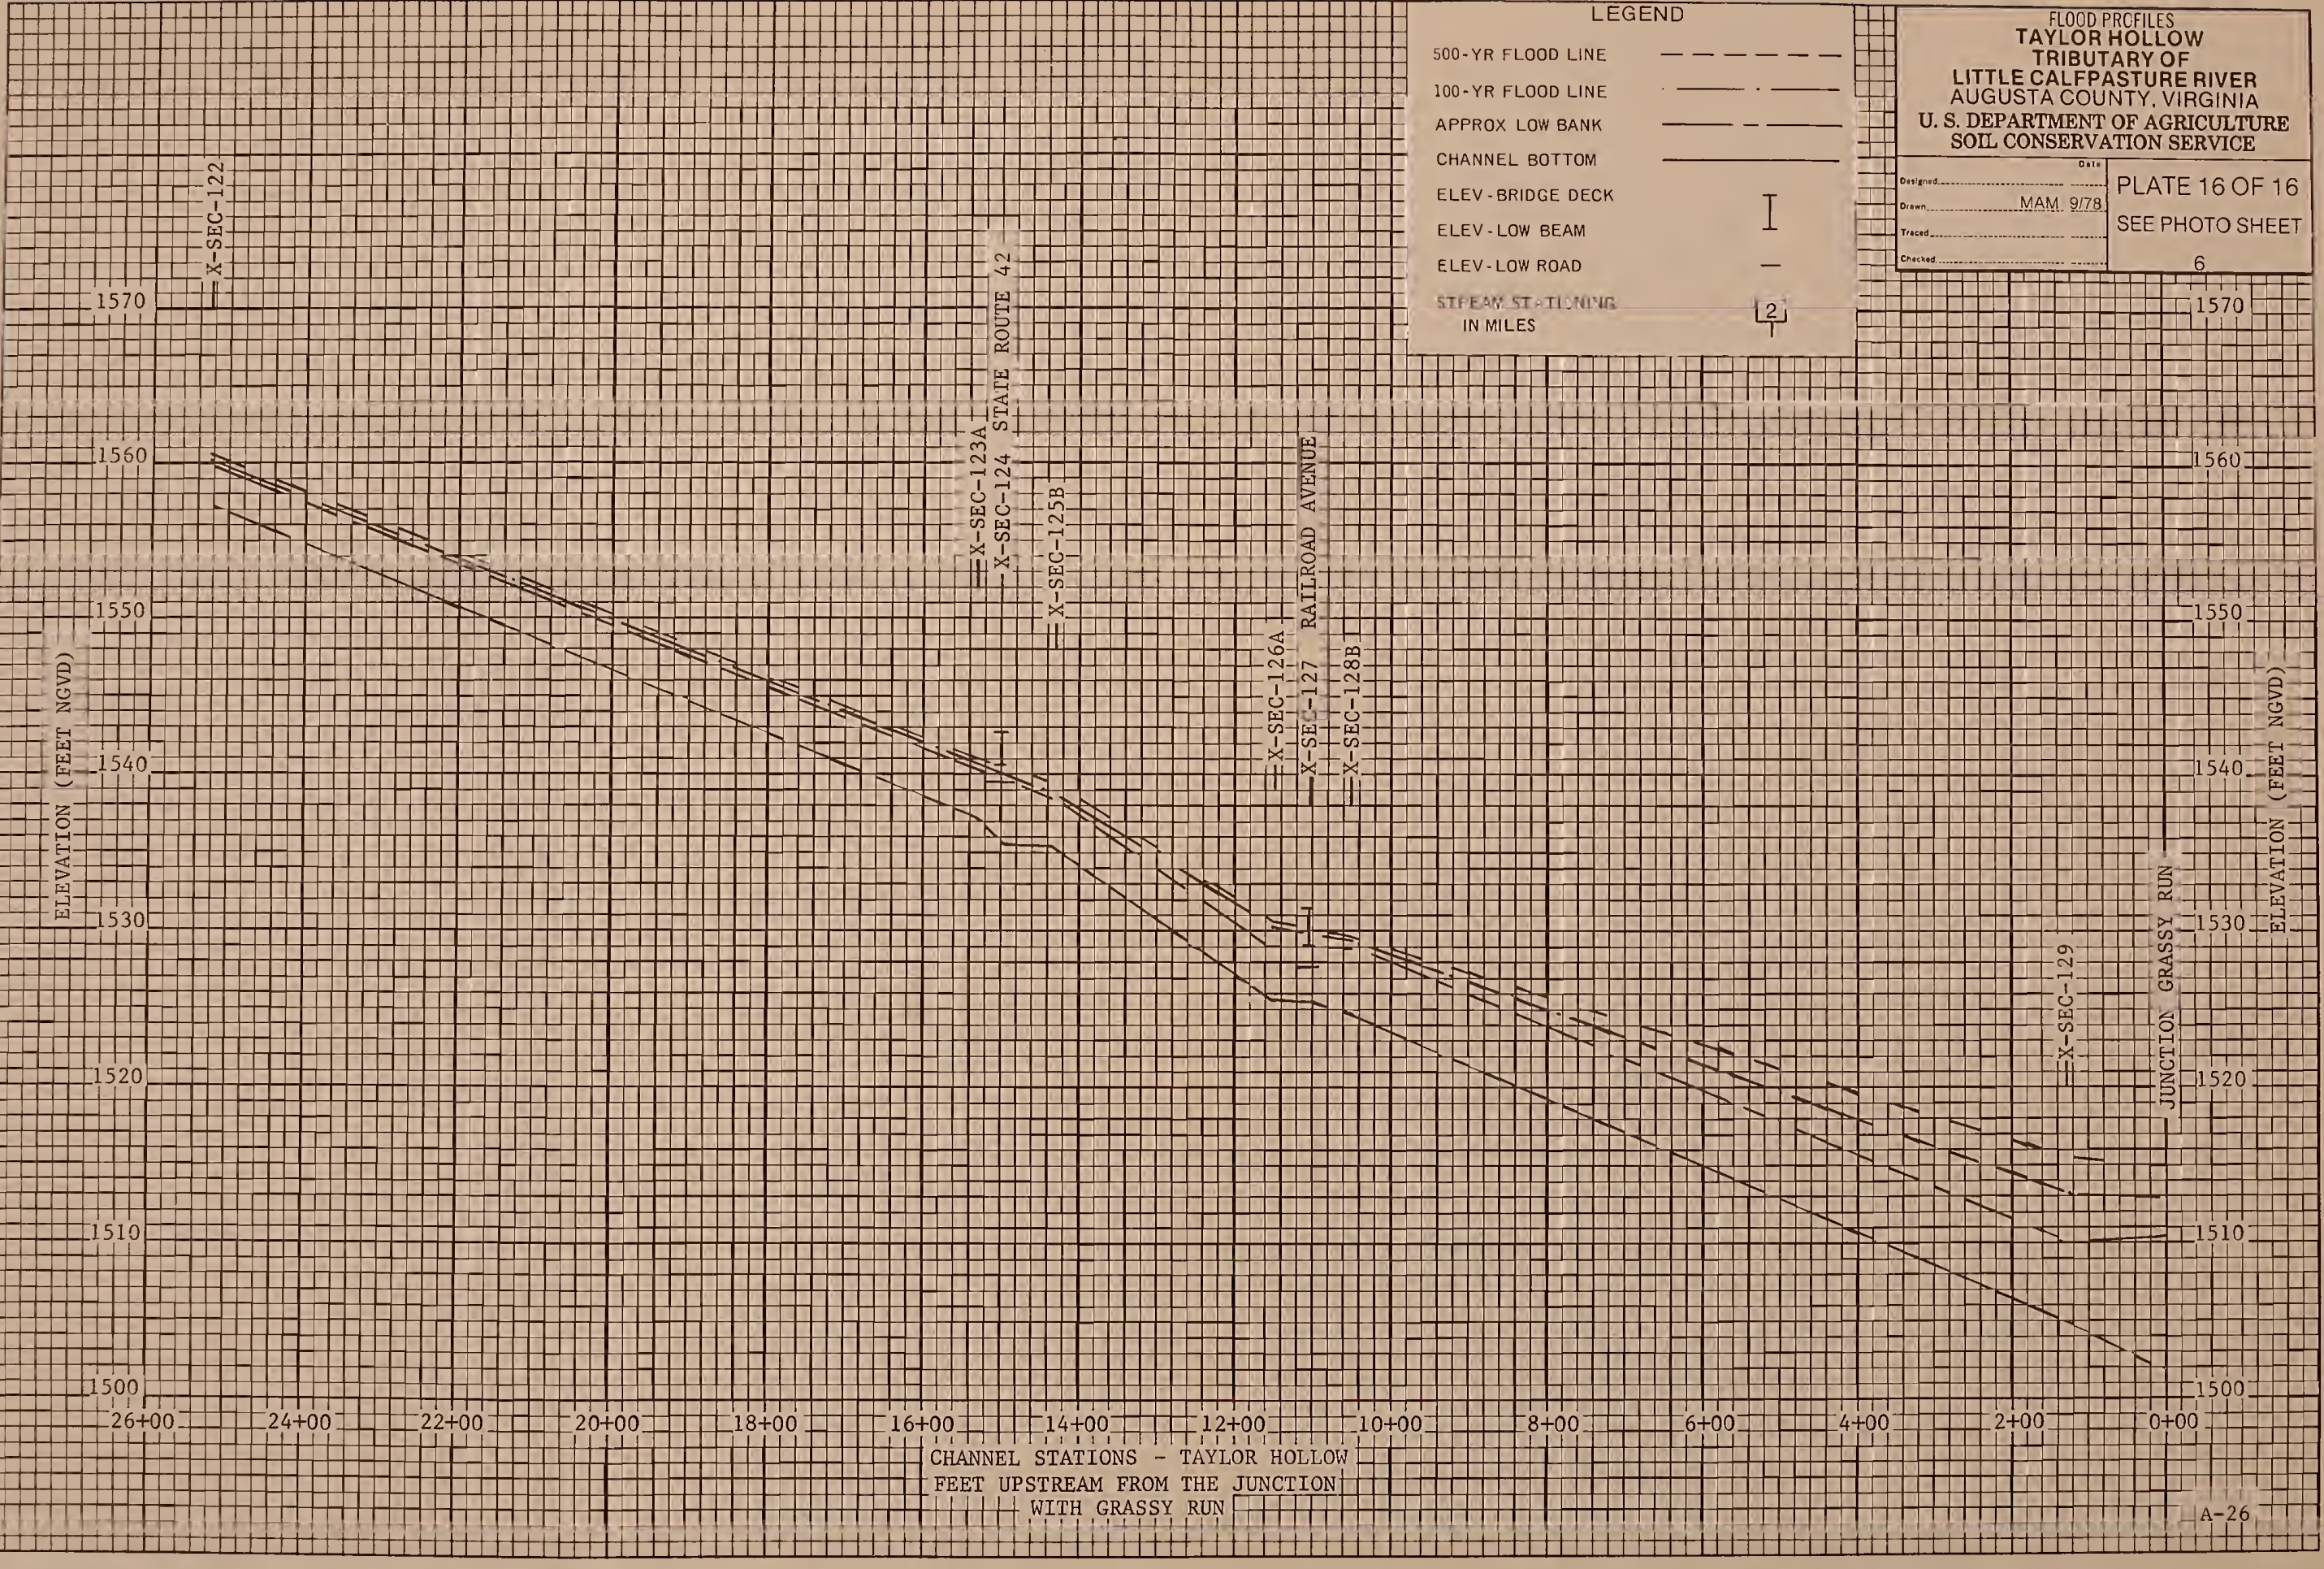
TYPICAL CROSS SECTIONS  
 FLOOD HAZARD ANALYSES  
**LITTLE CALPASTURE RIVER**  
 AUGUSTA COUNTY, VIRGINIA

Typical cross sections following the profile plates illustrate the procedure for transposing flood elevations to ground or to flood hazard area photomaps.

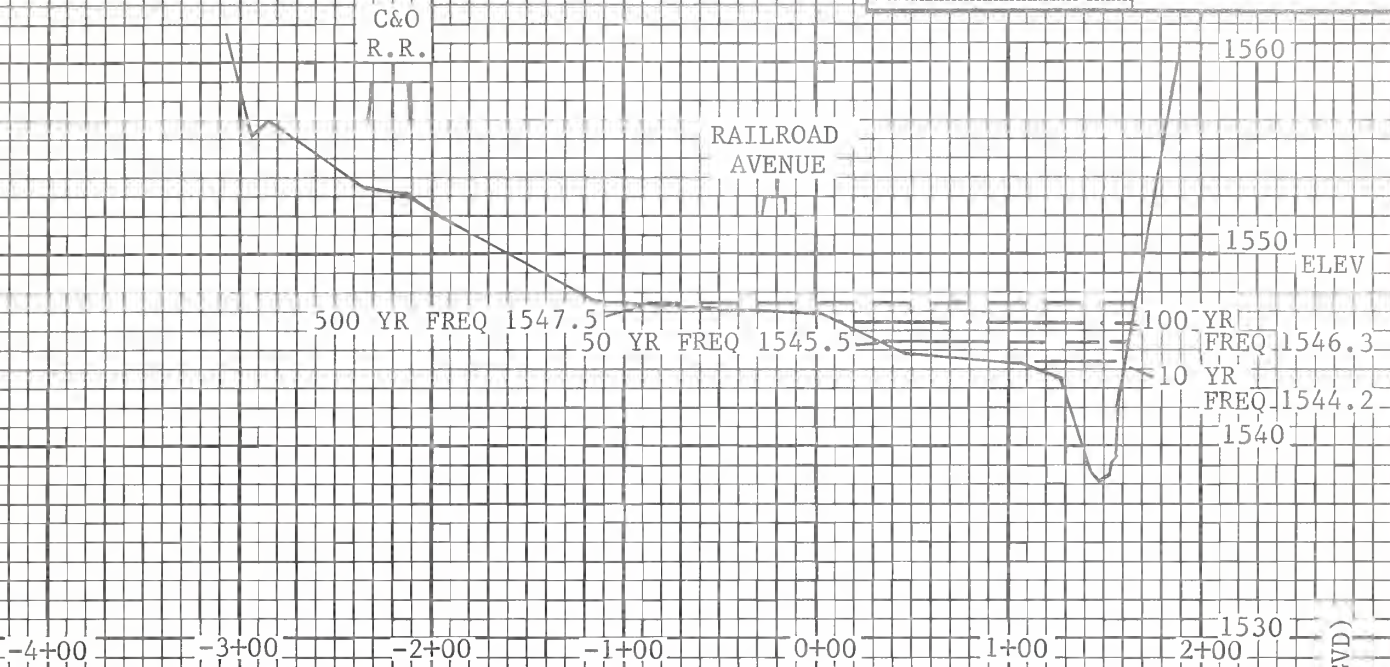
GRASSY RUN CROSS SECTION 64  
 TRIBUTARY OF LITTLE CALPASTURE RIVER
