FUNCTIONAL ANALYSIS REPORT NO. F/A-66

TARGET NO: 90.17 - 137 *Chemical*  
NAME OF TARGET: SHOWA FERTILIZER CO.  
LOCATION: KAWASAKI, HONSHU, JAPAN COORDINATES: 35° 30' N -139° 43' E  
PHOTOGRAPHY: Date 13 DEC 44 Mission 3PR/4M37A Prints 5R, 37, 38

SHOWA FERTILIZER CO., LTD.  
90.17-137  
LAT. 35° 30' N - LONG. 139° 43' E  
KAWASAKI, JAPAN

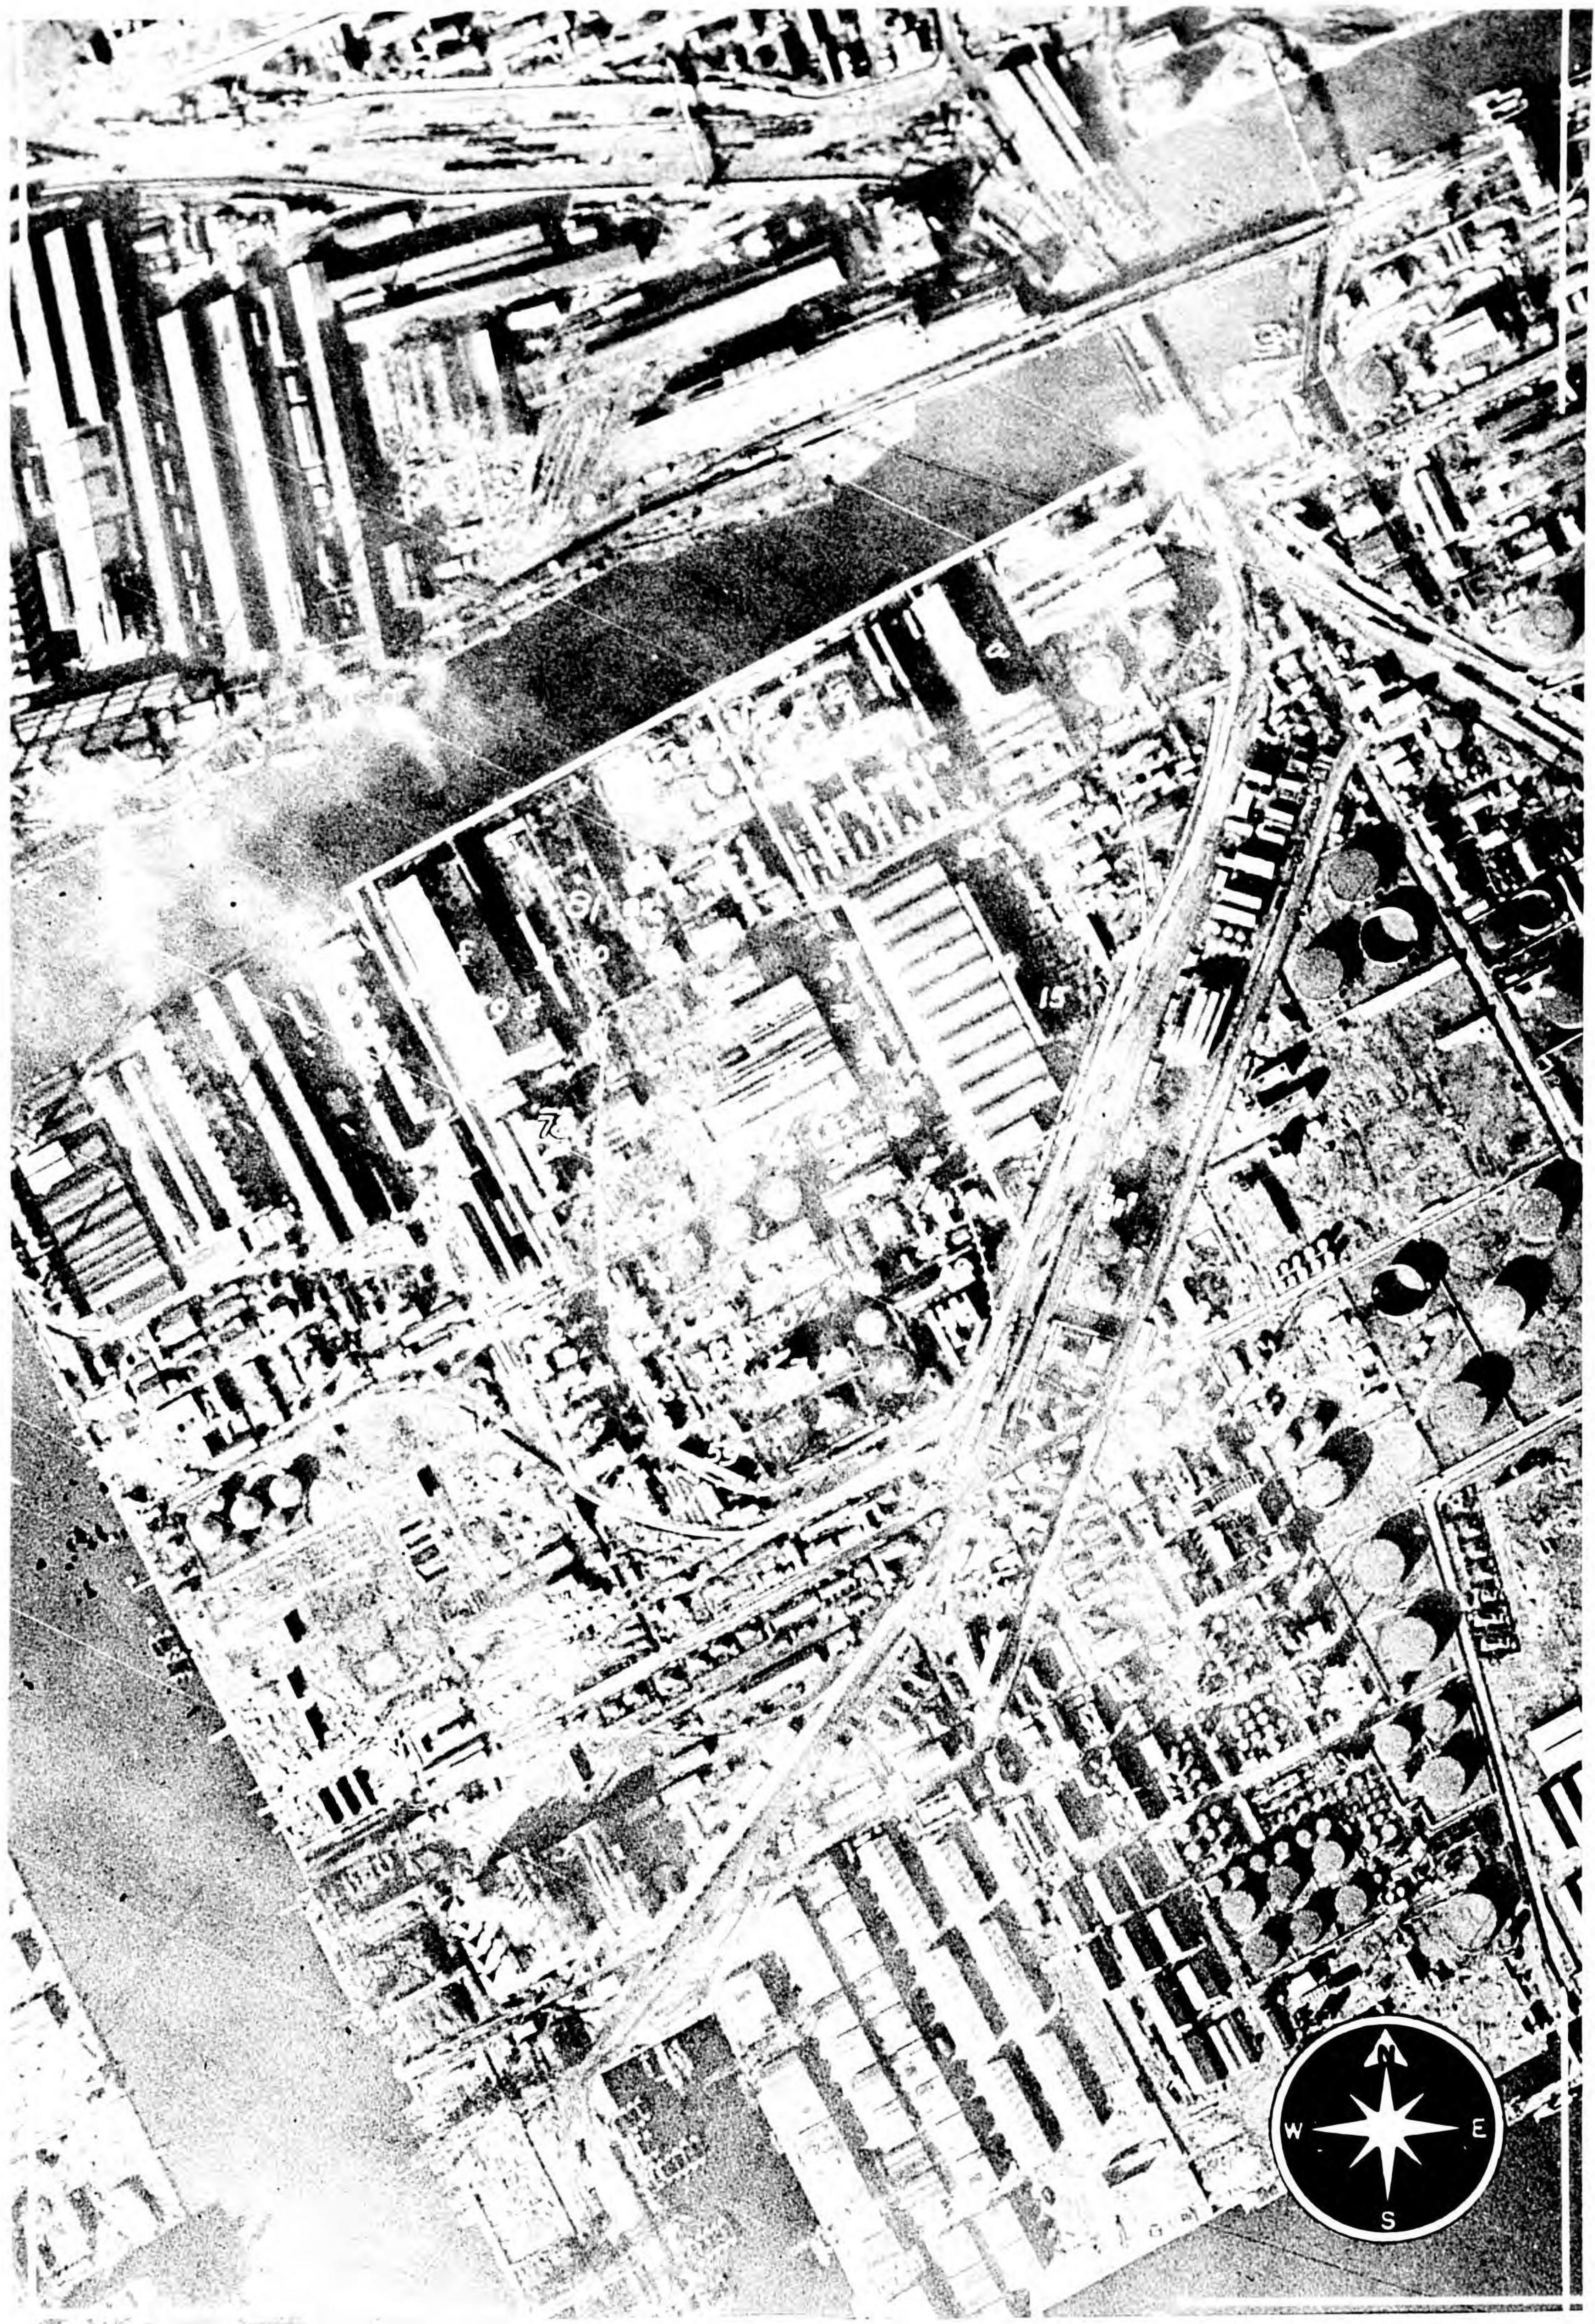
- 9 (a) Ammonium sulphate storage  
 (b) Ammonium sulphate drying  
 (c) Ammonium sulphate preparation  
 (d) Fan room
- 10 The whole complex is a plant for manufacturing sulphuric acid by the lead chamber process. The following portions are identified.
- (a) Pump room  
 (b)(c)(d) Sulphuric acid towers  
 (e) Pyrites storage  
 (j) Pyrites burning  
 (g)(r)(s) Lead chambers  
 (t) Lead work shop
- 11 Sulphuric acid tank  
 12 Oxygen gas holder - gas probably used in #10 (j)  
 13 Electrolysis of water for production of hydrogen  
 14 D.C. rectifiers  
 15 Transformer yard

- 16,17,18,19 Tanks, some at least, for sulphuric acid.  
 20 Pile of material which is being cut into for further tank sites. This may be sulphur or pyrites for adjacent sulphuric acid plant.

- 21 thru 25 Sulphuric acid plant, believed to be a Contact Process Plant
- 28 Compressor house and ammonia synthesis  
 36 Gas holder - gas not identified  
 37 Gas conversion and CO<sub>2</sub> absorption  
 40 Steam plant - a conveyor leads past building #13 to the railway tracks where coal is probably taken directly from railway siding.

- 41 Gas plants - probably water gas  
 44,45,46 Gas holder for water gas  
 47 Fuel piles, probably coke, with handling equipment, conveyors, cranes etc.

- 49 Steam plant and water gas plant  
 50 12 sulphur removal towers and overhead crane. The tops of 2 are removed at the time of photography.
- 51 Gas conversion and CO<sub>2</sub> absorption  
 52,53,54 Gas holders for purified hydrogen  
 79 (a)(b)(c) Connected with ammonium sulphate manufacture and drying.

(f) Ammonium sulphate (and possibly other ammonium salt) storage  
 (e)(g) Connected with conveyors for loading
- 80, 81 Larger stock yards with overhead cranes.

- 1 (a) Ammonia synthesis
- (b) Compressors and possibly synthesis as well
- (c) Air liquefaction and nitrogen separation plant
- 2 Nitrogen Gas Holder
- 3 Hydrogen Gas Holder
- 4 Possibly bottling liquid ammonia and ammonia liquor for external distribution.
- 5 Boiler House
- 6 Offices
- 7 Storage
- 8 Preparation of distilled water for #13 - a chimney shown on ground photos to have been associated with this building has been removed.
