WORK PLAN

FOR WATERSHED PROTECTION AND FLOOD PREVENTION,

RED DEER CREEK WATERSHED

GRAY, ROBERTS, AND HEMPHILL COUNTIES, TEXAS

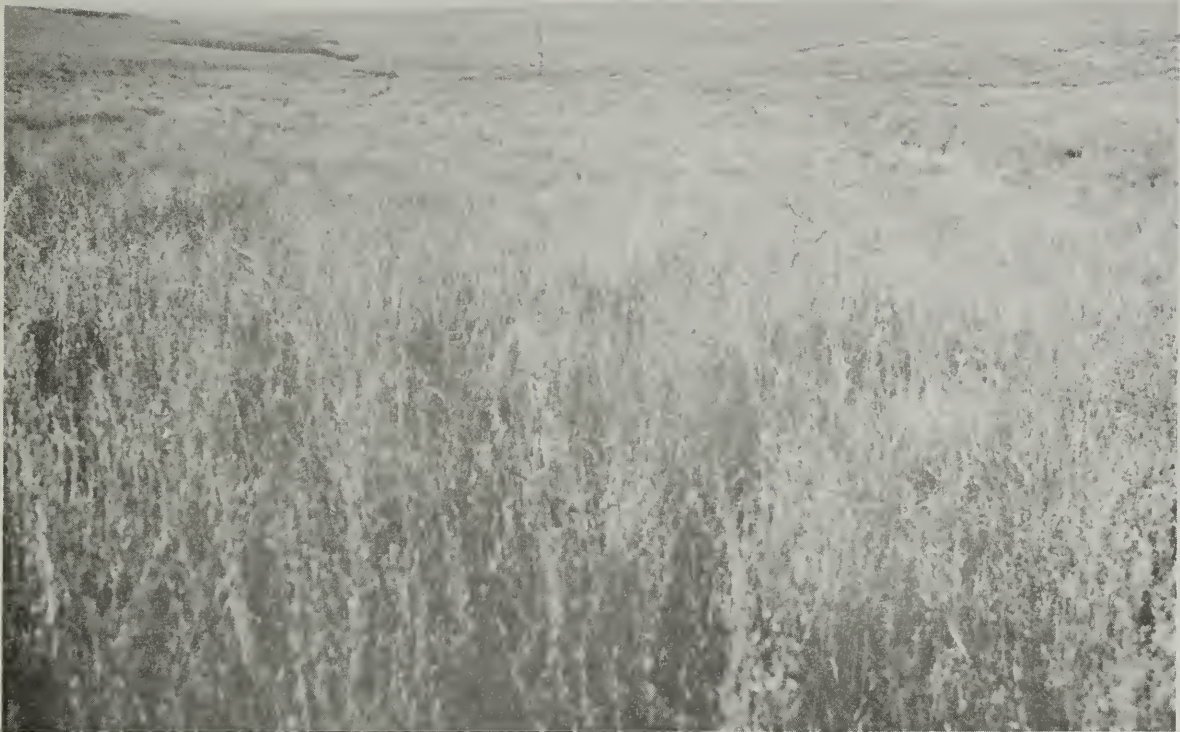
Rangeland Infested with Moisture Depleting Sand Sage

Brush management and proper grazing use are necessary to restore the original soil-protecting and productive native plant community to the rangeland.

Plants are predominantly sand bluestem, fall witchgrass, and western ragweed. Photograph is of same area as that shown in photograph on page 17.

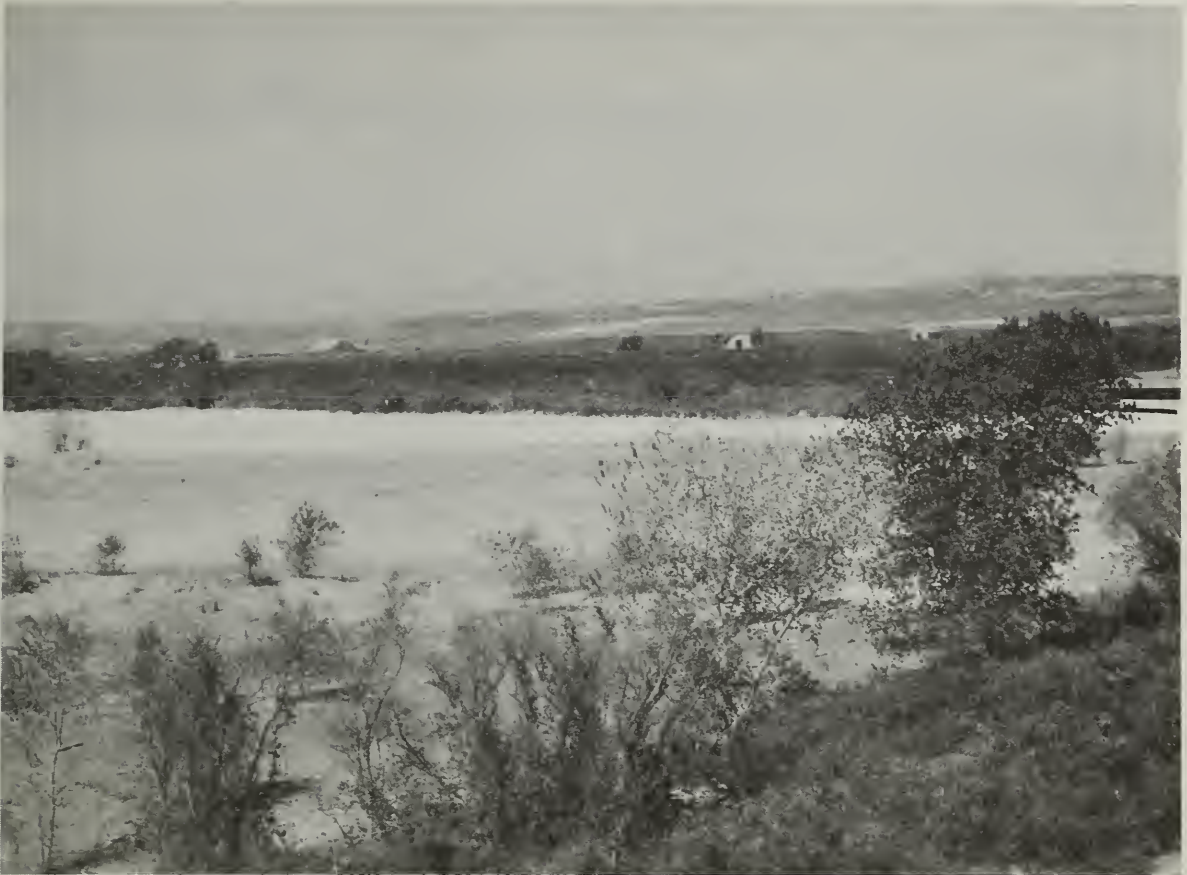
Deposition of infertile sediment on the flood plain is one of the major problems in the watershed.

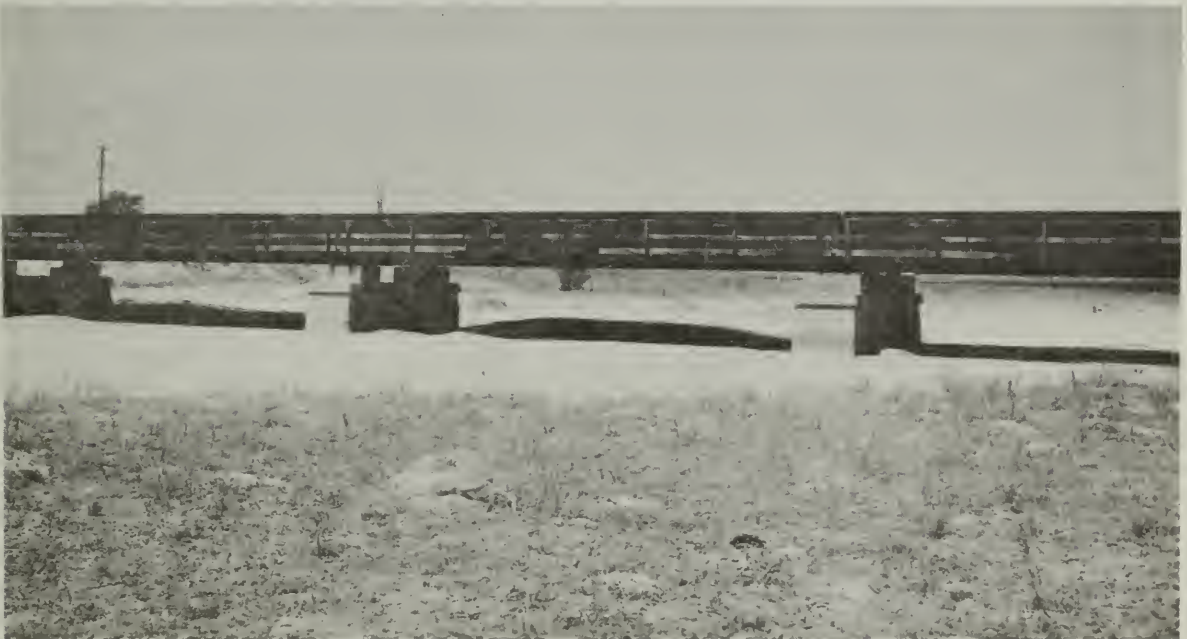
Sand accumulations in channels and deposition on the flood plain is encroaching on the effective capacity of this railroad bridge crossing Red Deer Creek. Other bridges, culverts, and the roadbed of the railroad, and the highways and county roads in the Red Deer Creek valley are similarly affected.

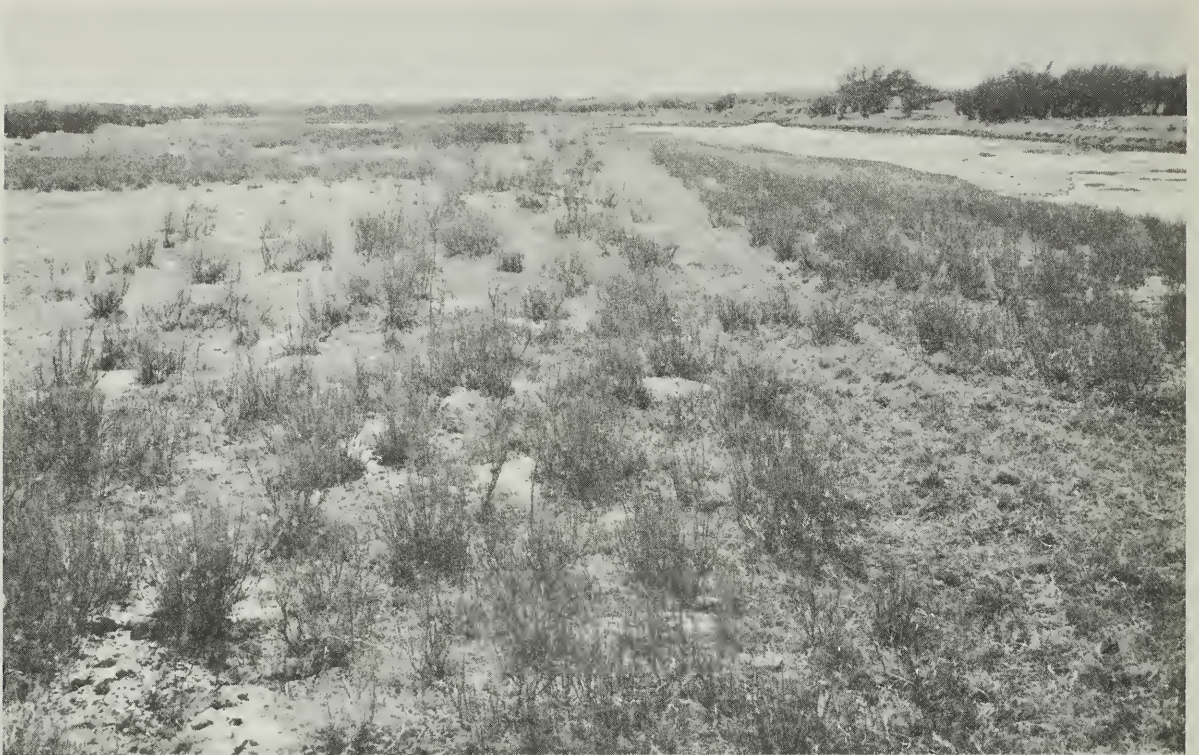
It takes from 3 to 5 years for the vegetation to recover after a major flood. This meadow is sub-irrigated.

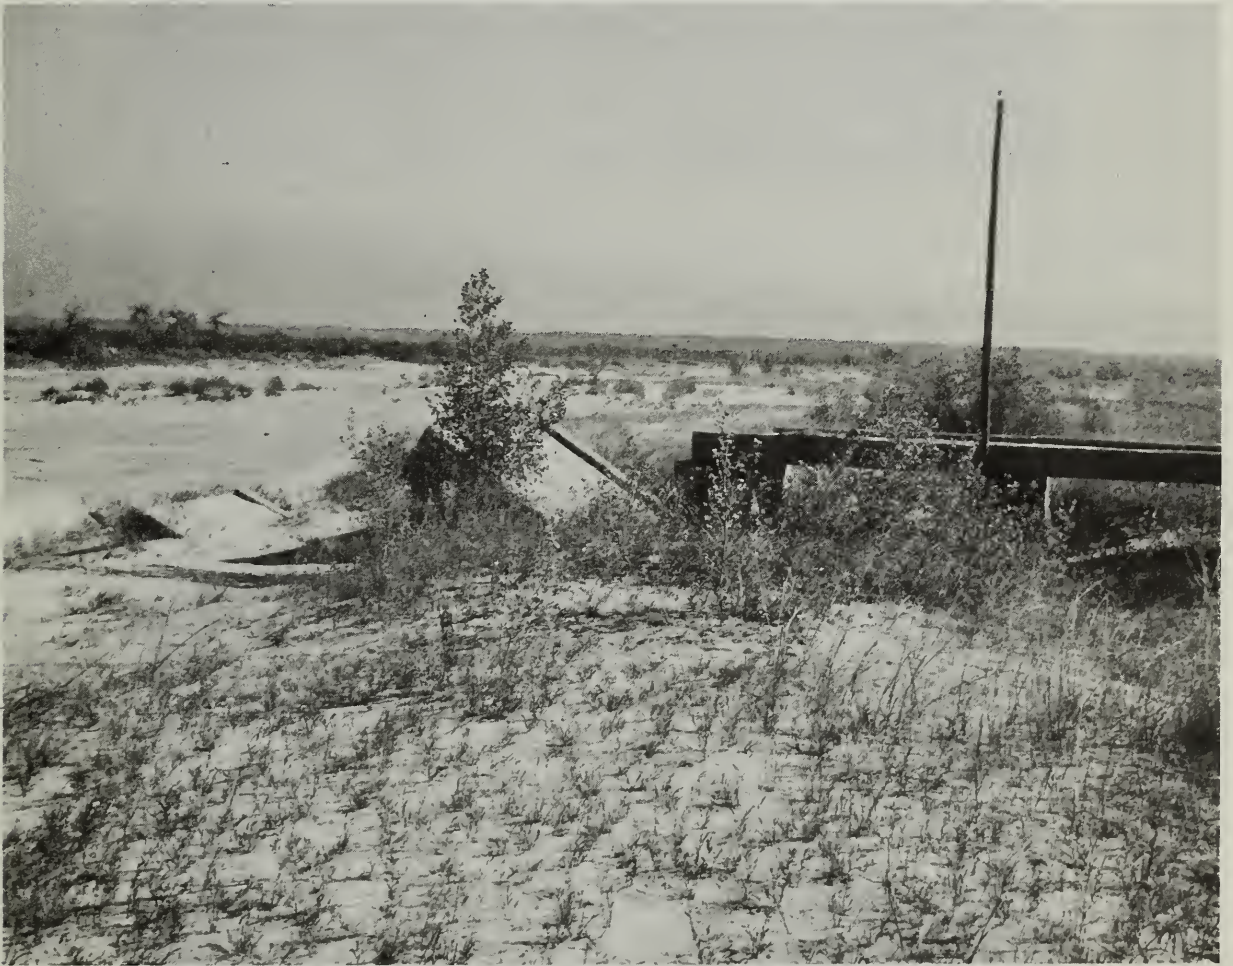
A large flood destroyed this county road bridge near Canadian and left a deep layer of sand on large areas of the flood plain.

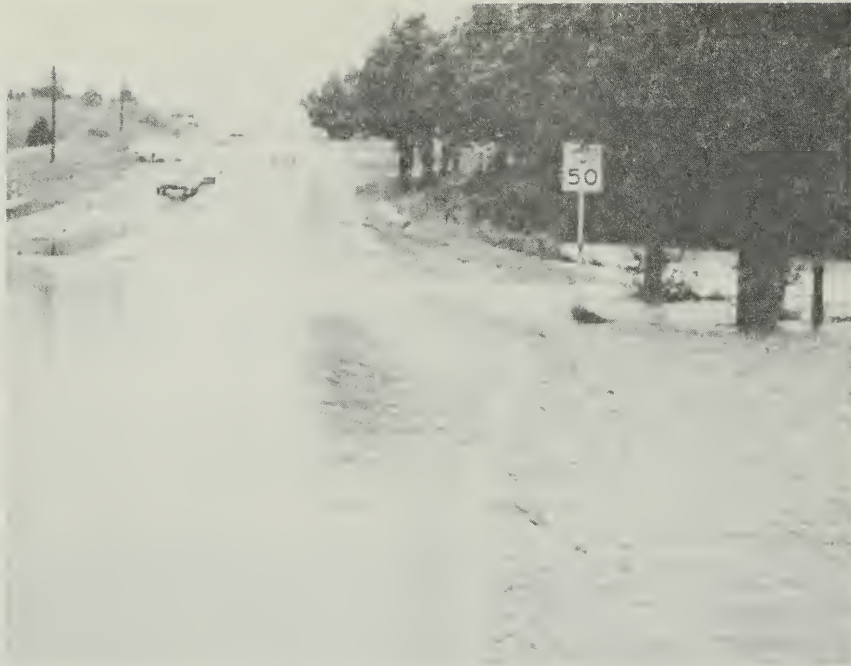
Traffic was stopped for several hours by flooding of U. S. Highway 60 in Miami.

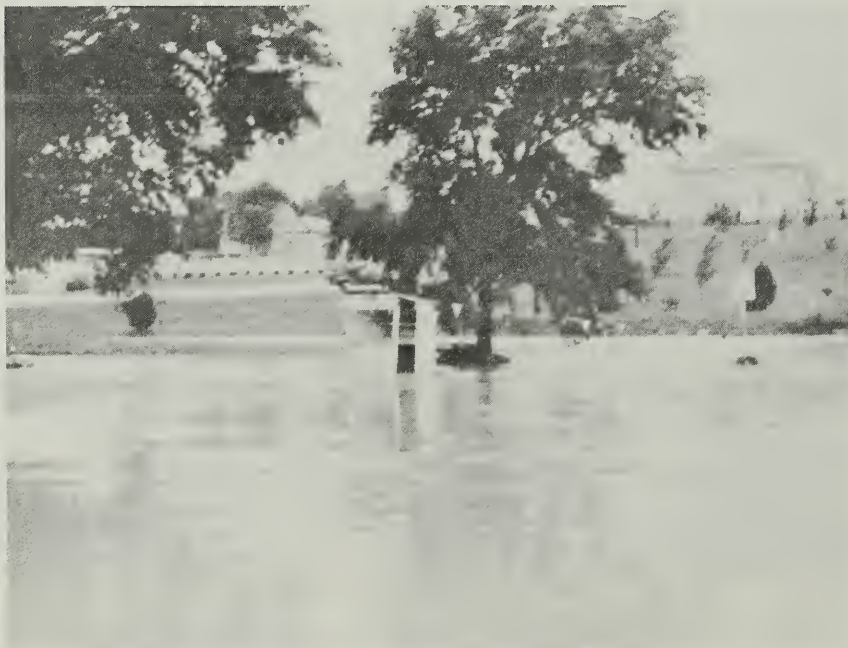
Floodwater Inundating City Park at Miami
The urban areas of Miami and Canadian
are damaged annually by floodwater.

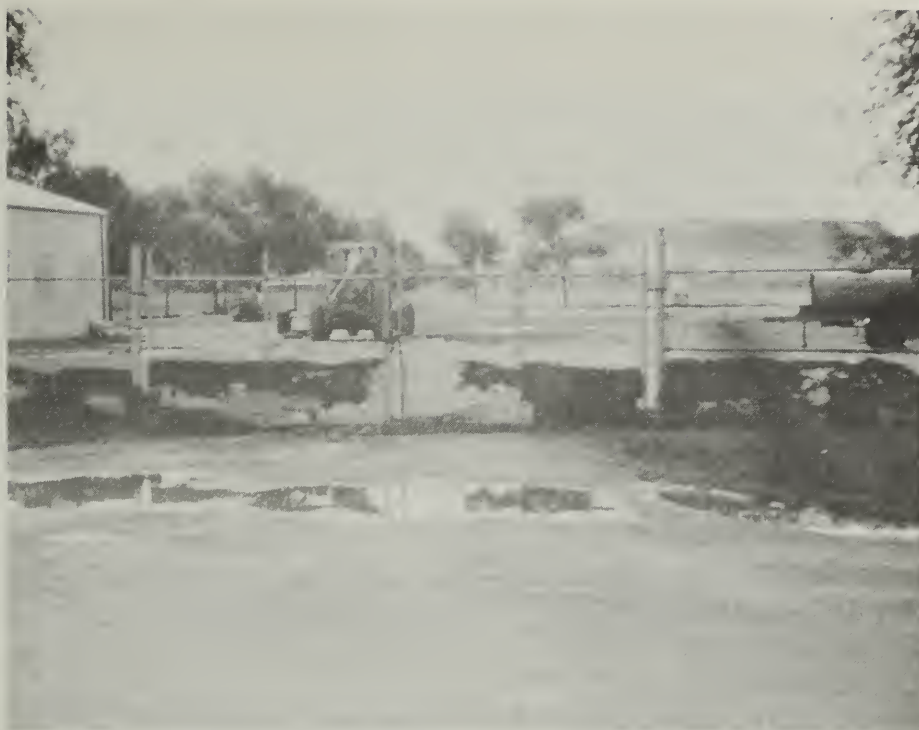
The flood of September 1969 inundated the maintenance yard of the Texas Highway Department at Miami.

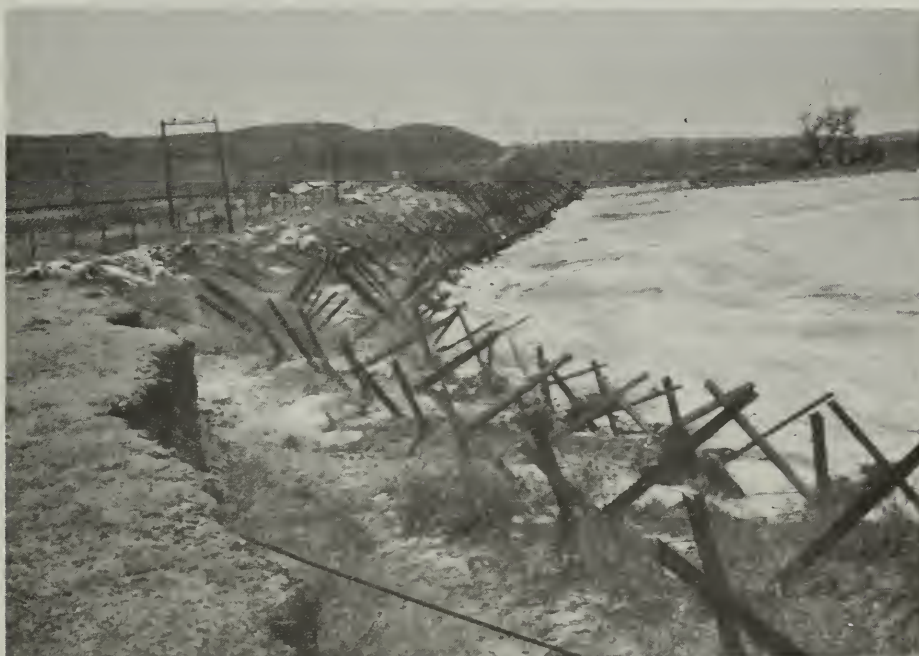
Many miles of steel jetties, riprap, and other similar protective measures have been installed by the Santa Fe Railway Co. in an attempt to protect its roadbed and track from erosion damage.

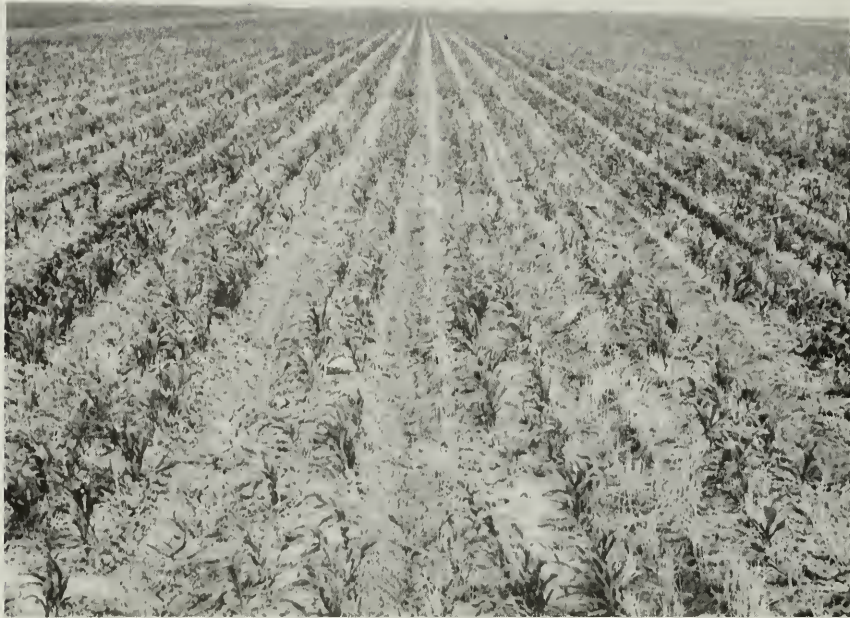
Minimum tillage, which reduces wind and water erosion, is being practiced on this field.

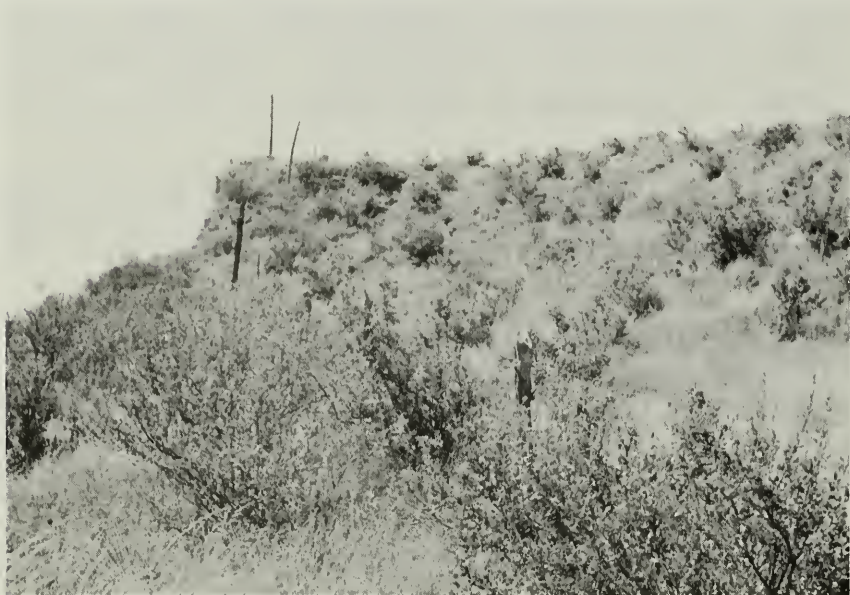
Brush left along rough escarpments provides food and cover for wildlife.

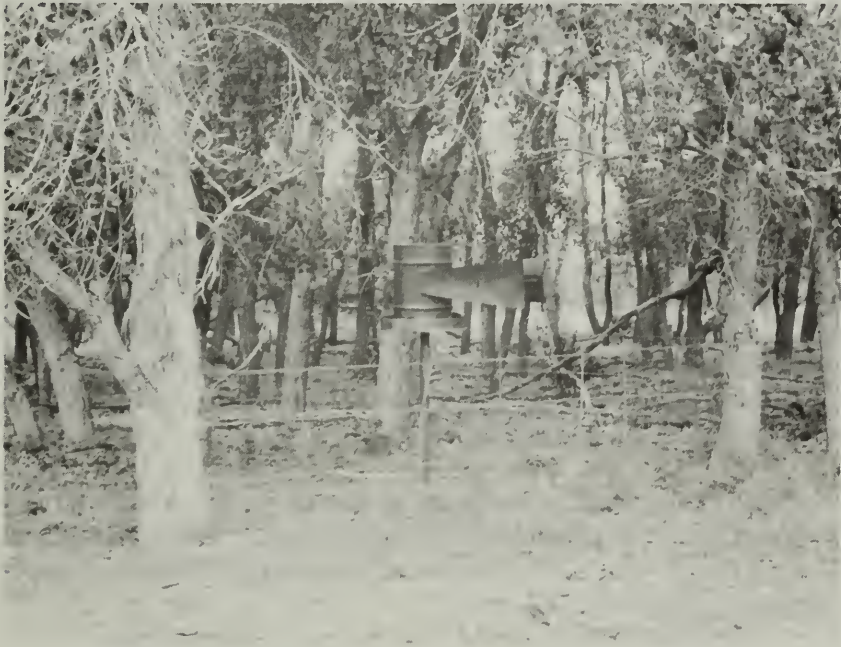
Upland wildlife habitat management will be applied to an estimated 84,000 acres of rangeland during the installation period. Note the wildlife feeder which provides supplemental feed for wildlife. The feeder is protected by a fence.

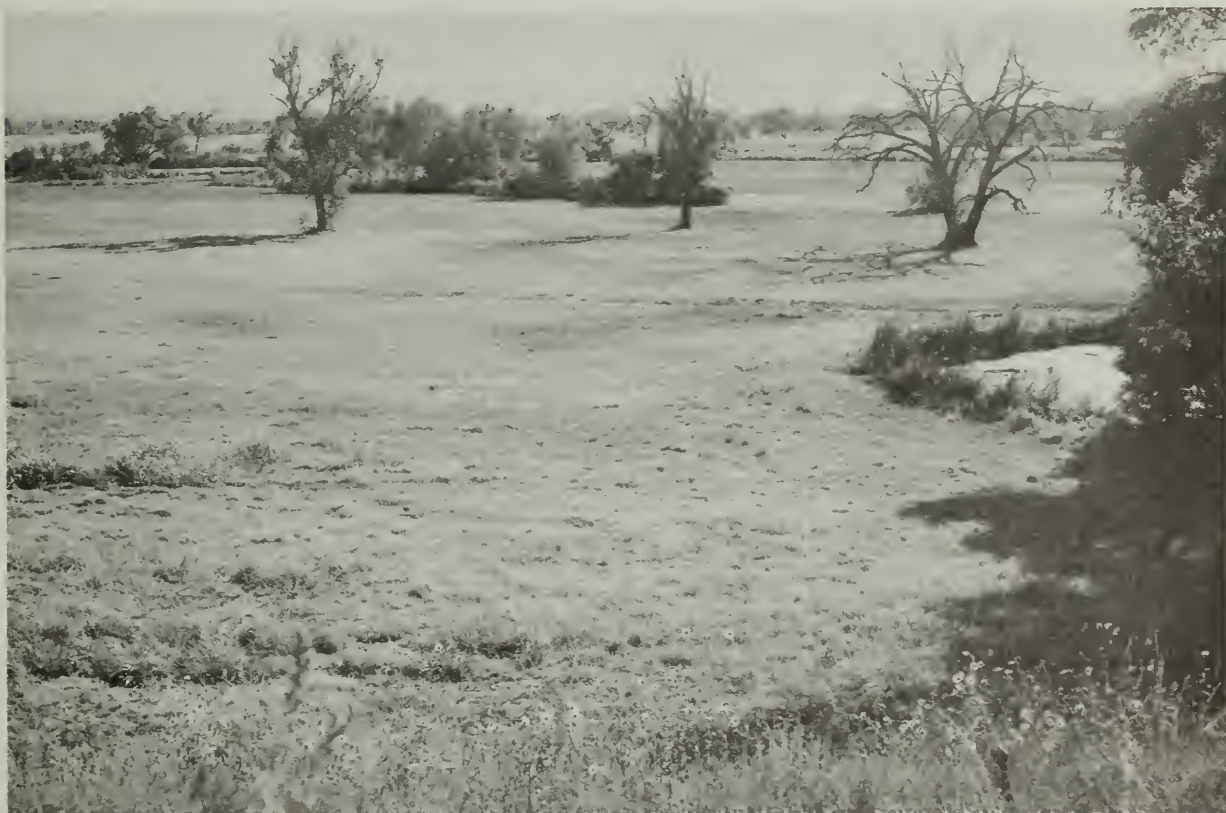
Farm and ranch operators will be able to manage over 4,000 acres of subirrigated flood plain soils for native hay meadow. This picture is of a recently mowed meadow on a protected flood plain in a nearby watershed.

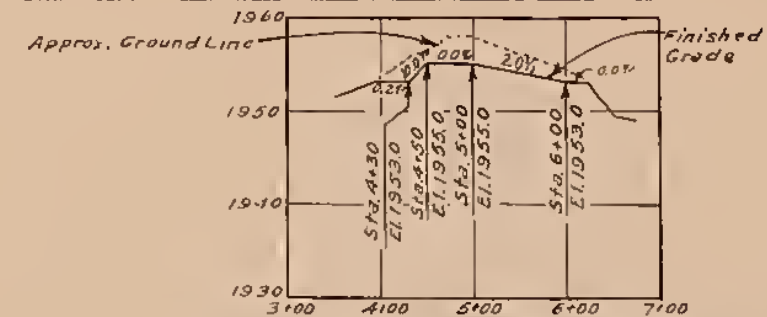
Figure 2
TYPICAL
FLOODWATER RETARDING STRUCTURE
GENERAL PLAN AND PROFILE
U. S. DEPARTMENT OF AGRICULTURE
SOIL CONSERVATION SERVICE

Stream Channel within embankment area shall be shaped and cleared of objectionable material (see sheet 12 and Construction Specification 4).

Dozer pits excavated during Soil and Foundation Investigation and not required by normal operations, shall be filled, levelled and graded by the contractor (See Construction Specification 5).

PROFILE ON C OF EMERGENCY SPILLWAY

PLAN OF EMBANKMENT AND SPILLWAYS

D	30°30'
D	30°07'
R	150.48'
L	80.00'
P.C.	Sta. 3+50.0
P.T.	Sta. 4+30.0

PROFILE ON C OF DAM

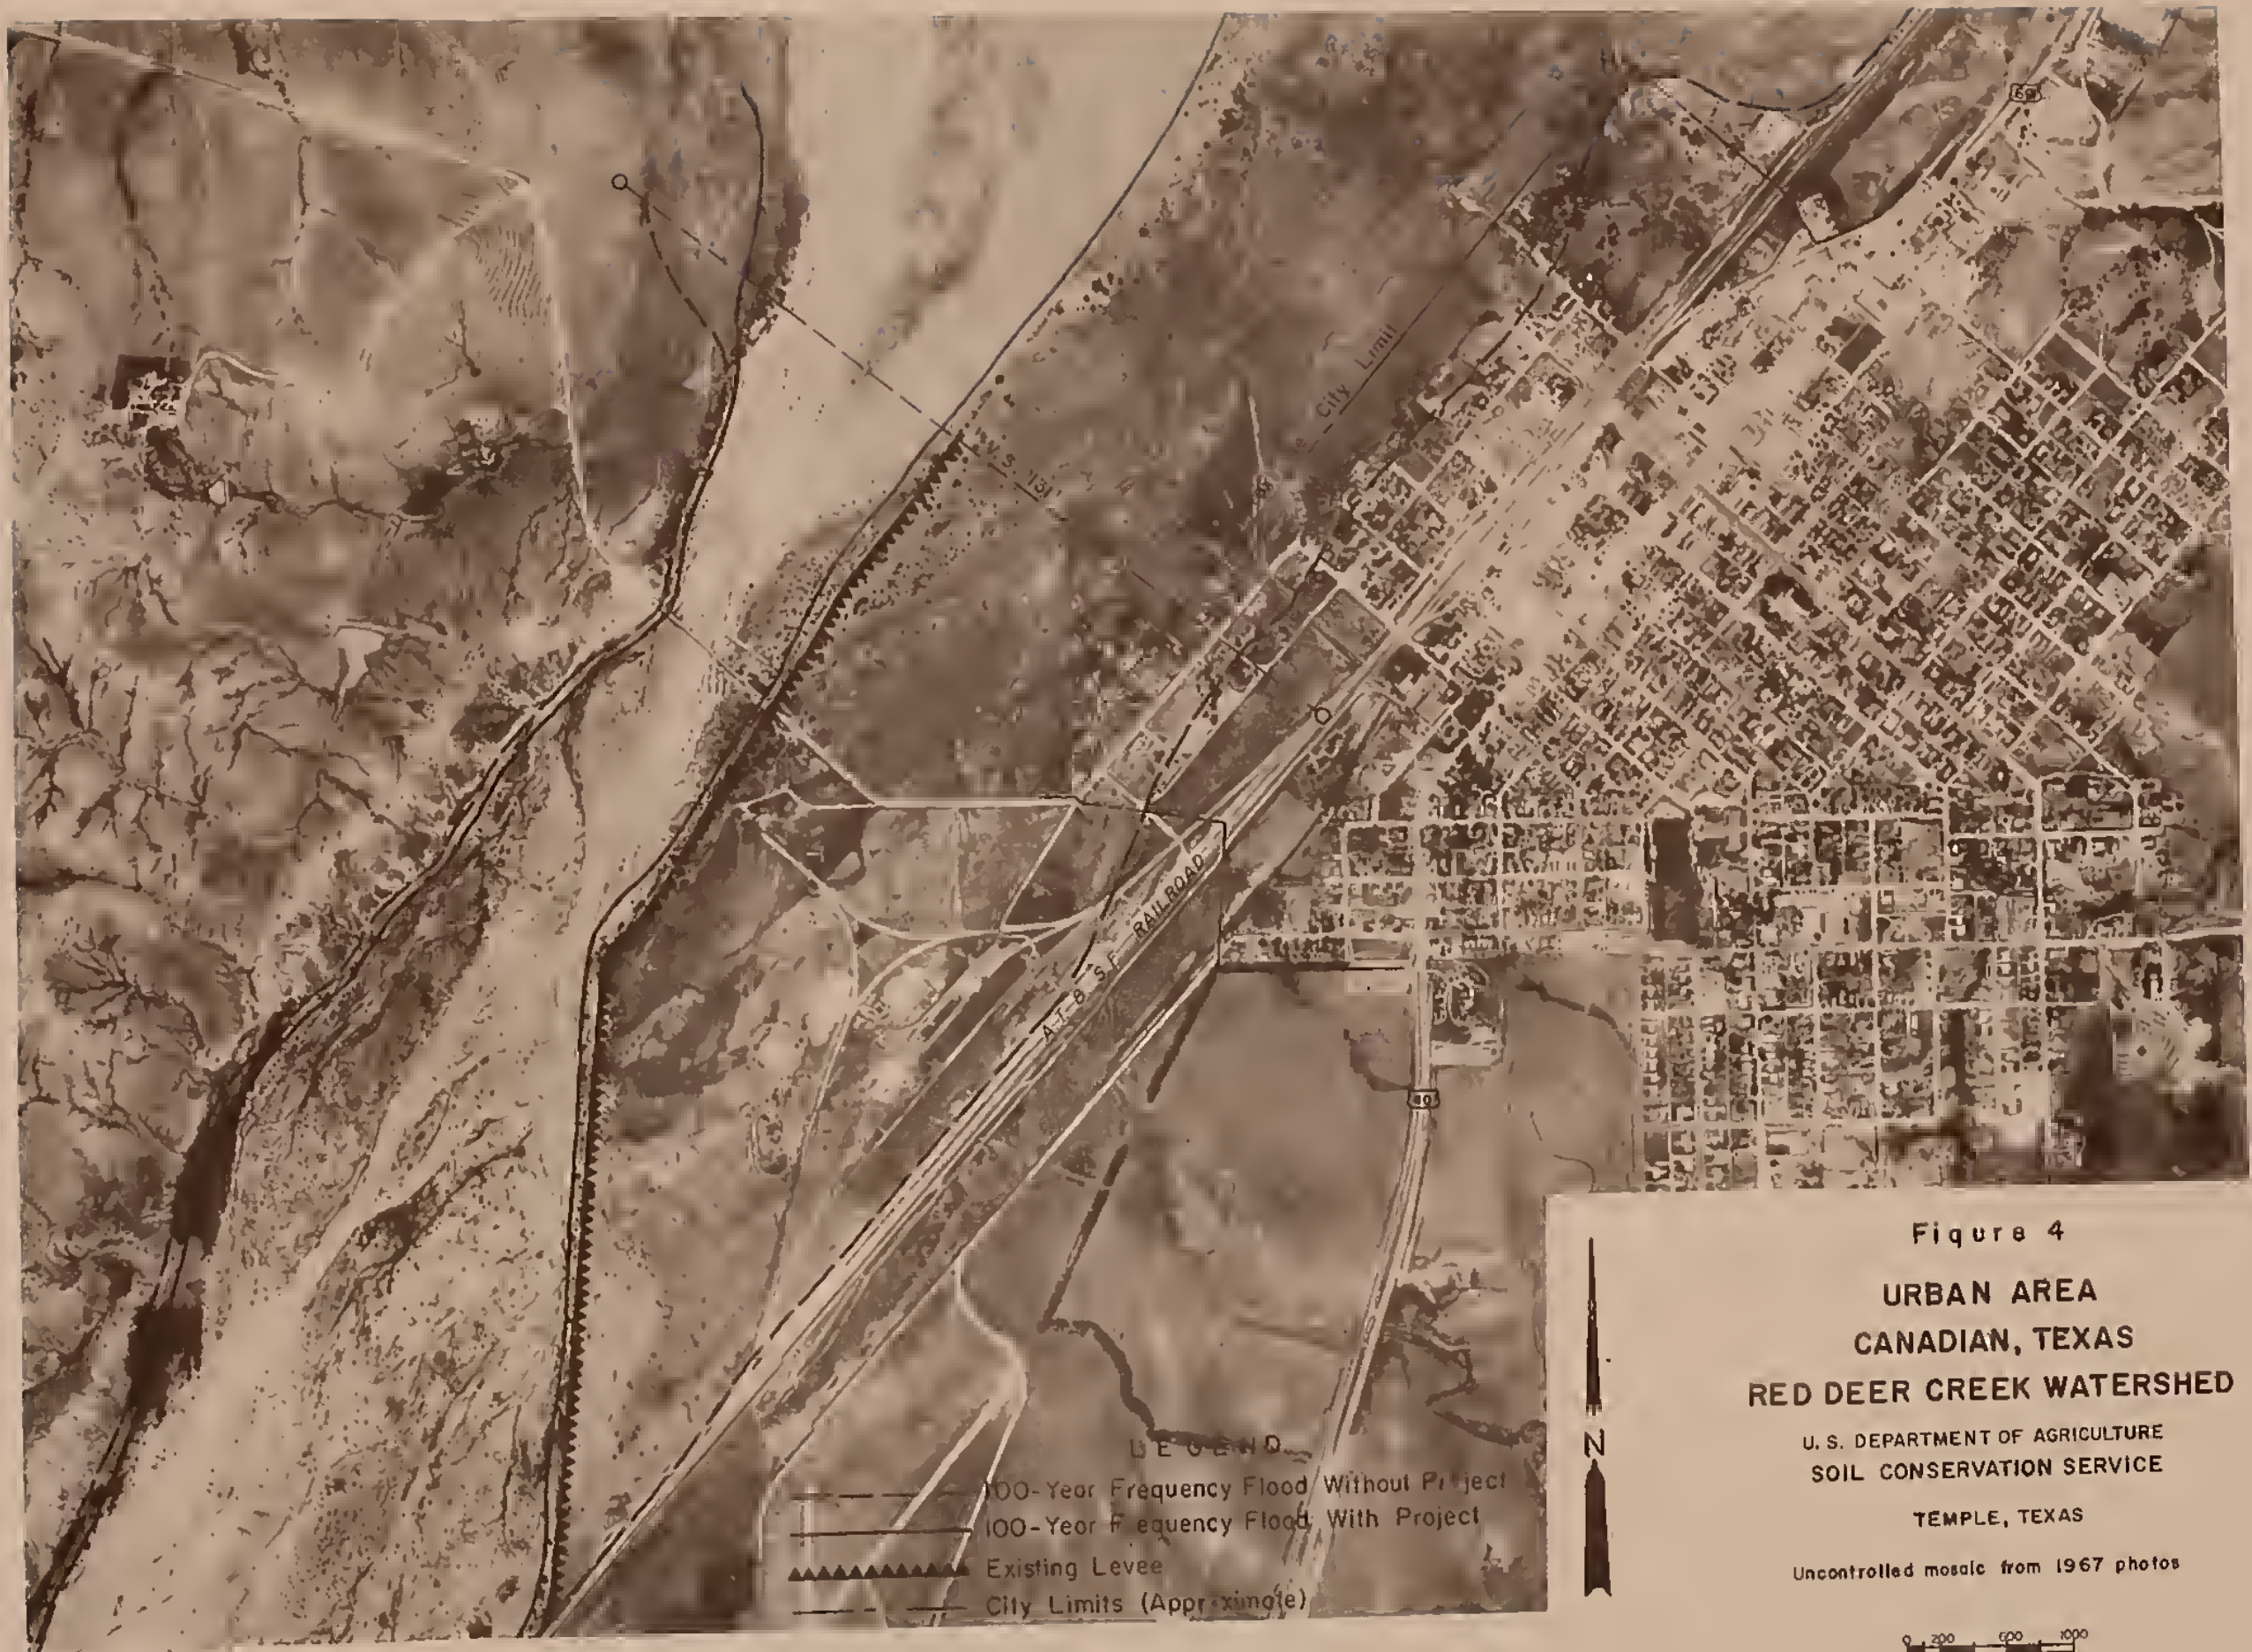
Figure 4
 URBAN AREA
 CANADIAN, TEXAS
 RED DEER CREEK WATERSHED

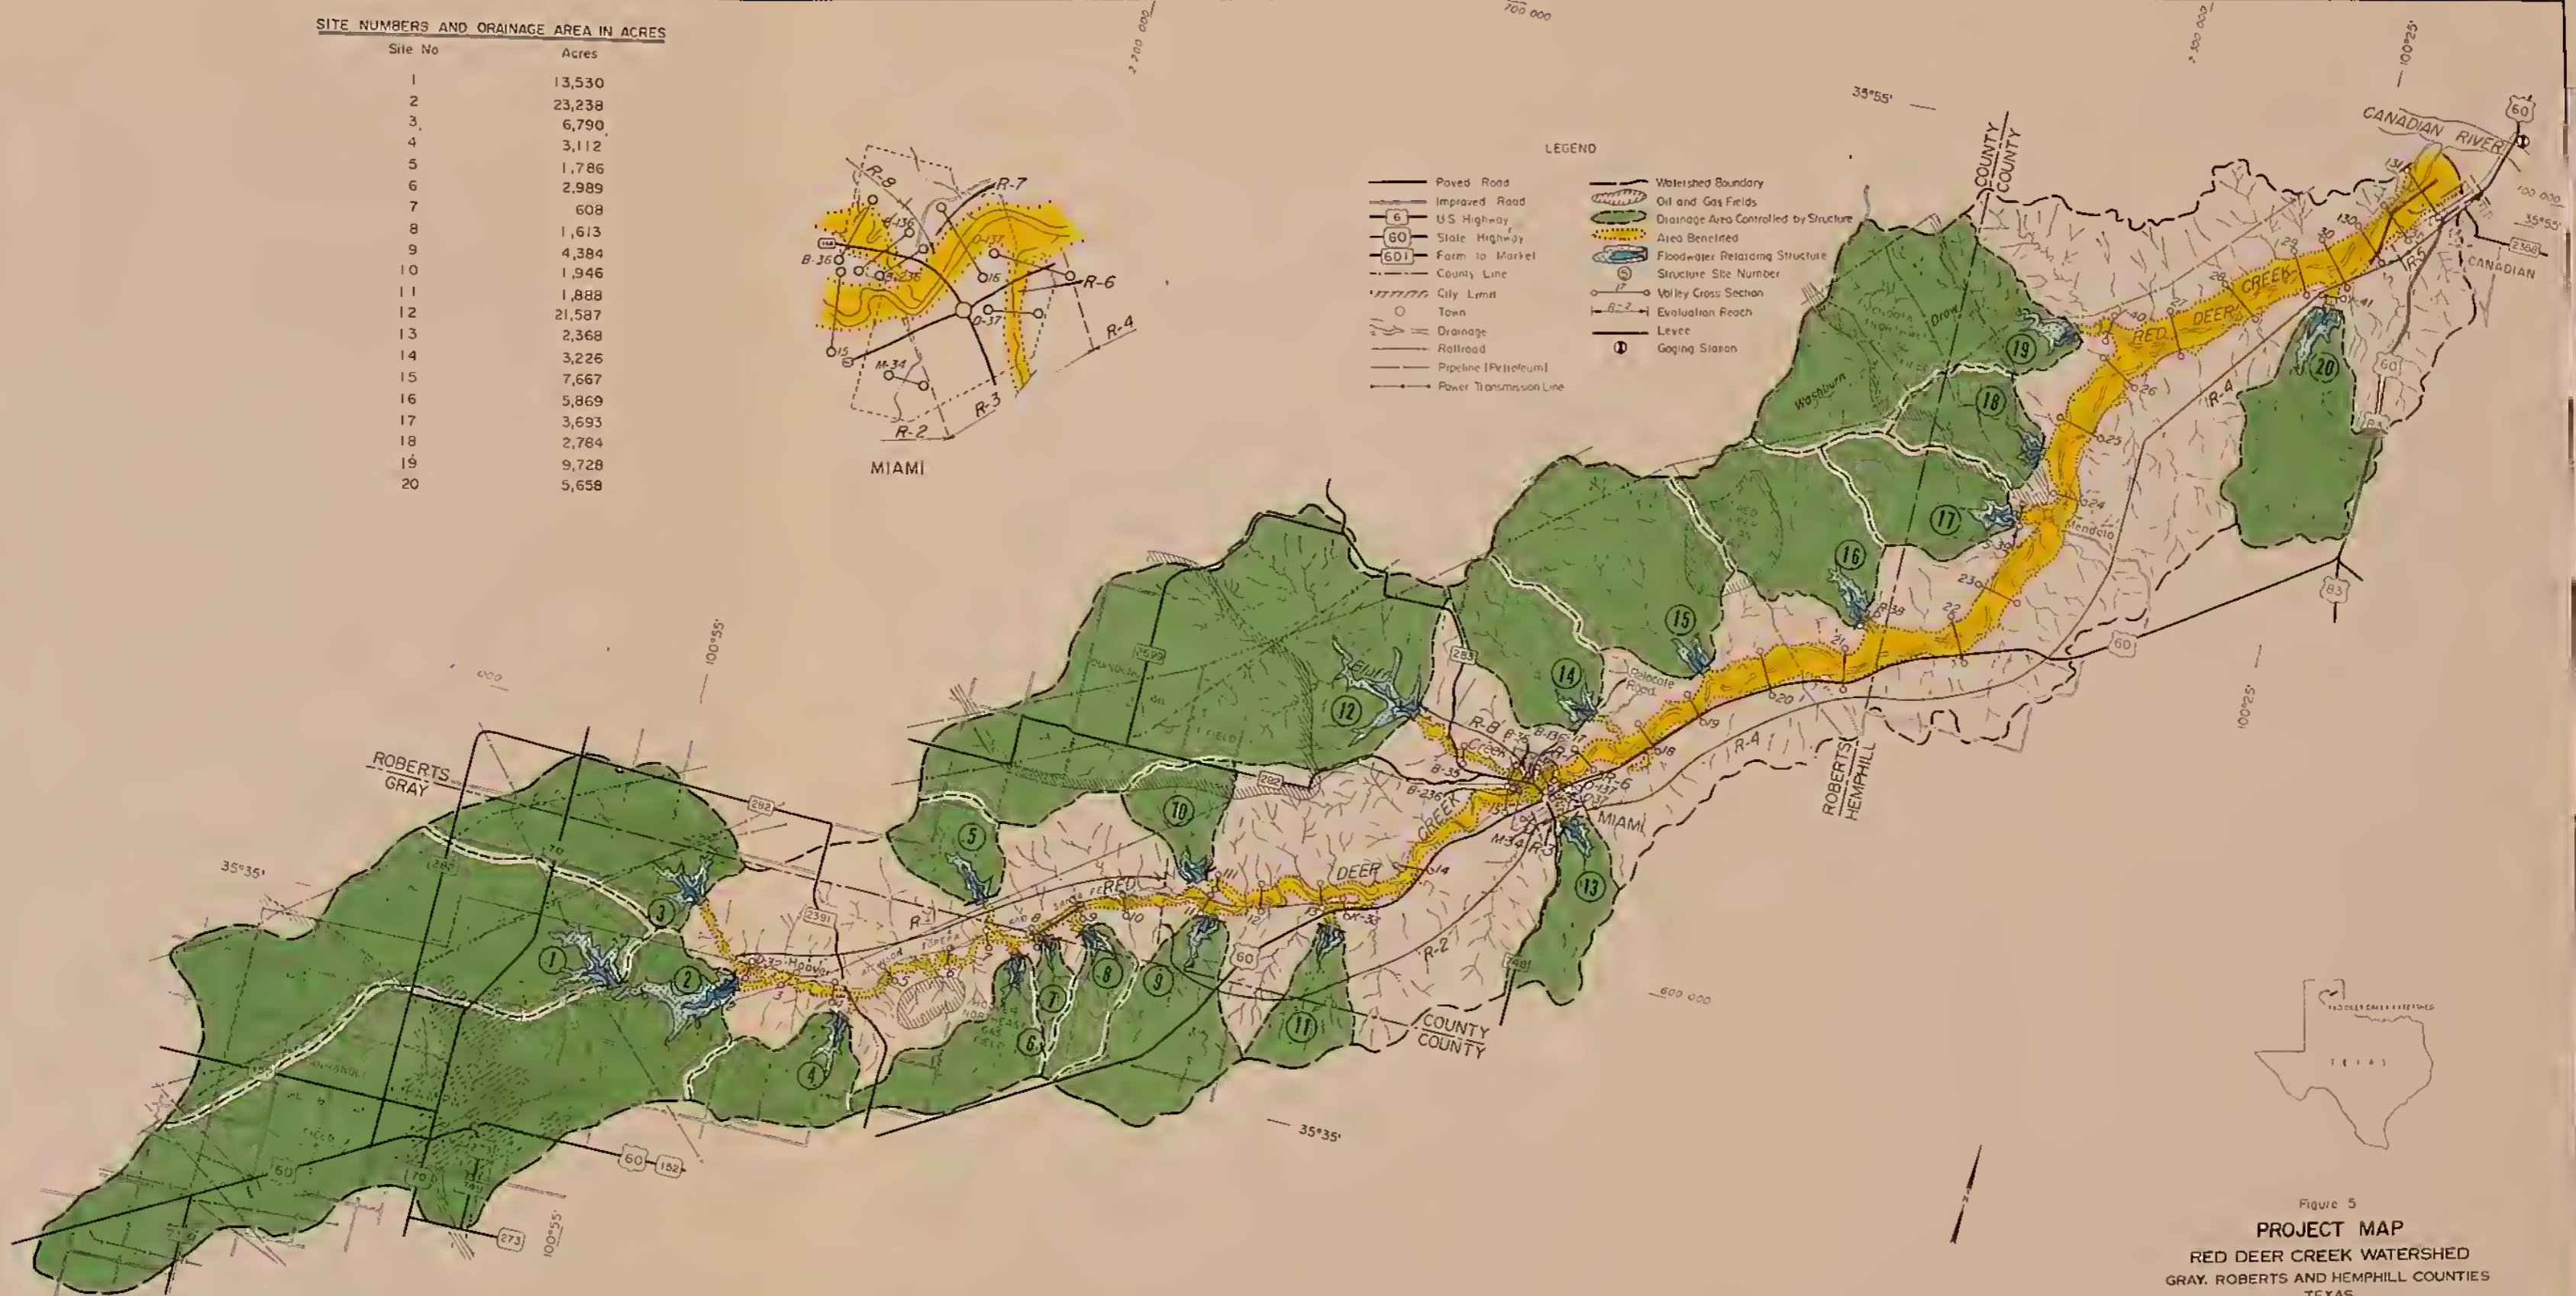
Site No	Acres
1	13,530
2	23,238
3	6,790
4	3,112
5	1,786
6	2,989
7	608
8	1,613
9	4,384
10	1,946
11	1,888
12	21,587
13	2,368
14	3,226
15	7,667
16	5,869
17	3,693
18	2,784
19	9,728
20	5,658

Figure 5
PROJECT MAP
 RED DEER CREEK WATERSHED
 GRAY, ROBERTS AND HEMPHILL COUNTIES
 TEXAS
 U.S. DEPARTMENT OF AGRICULTURE
 SOIL CONSERVATION SERVICE
 TEMPLE, TEXAS
