**REPORT OF  
SEDIMENTATION SURVEY  
LAKE WEATHERFORD  
Parker County, Texas**

APRIL 1973

UNITED STATES  
DEPARTMENT OF AGRICULTURE  
SOIL CONSERVATION SERVICE  
TEMPLE, TEXAS

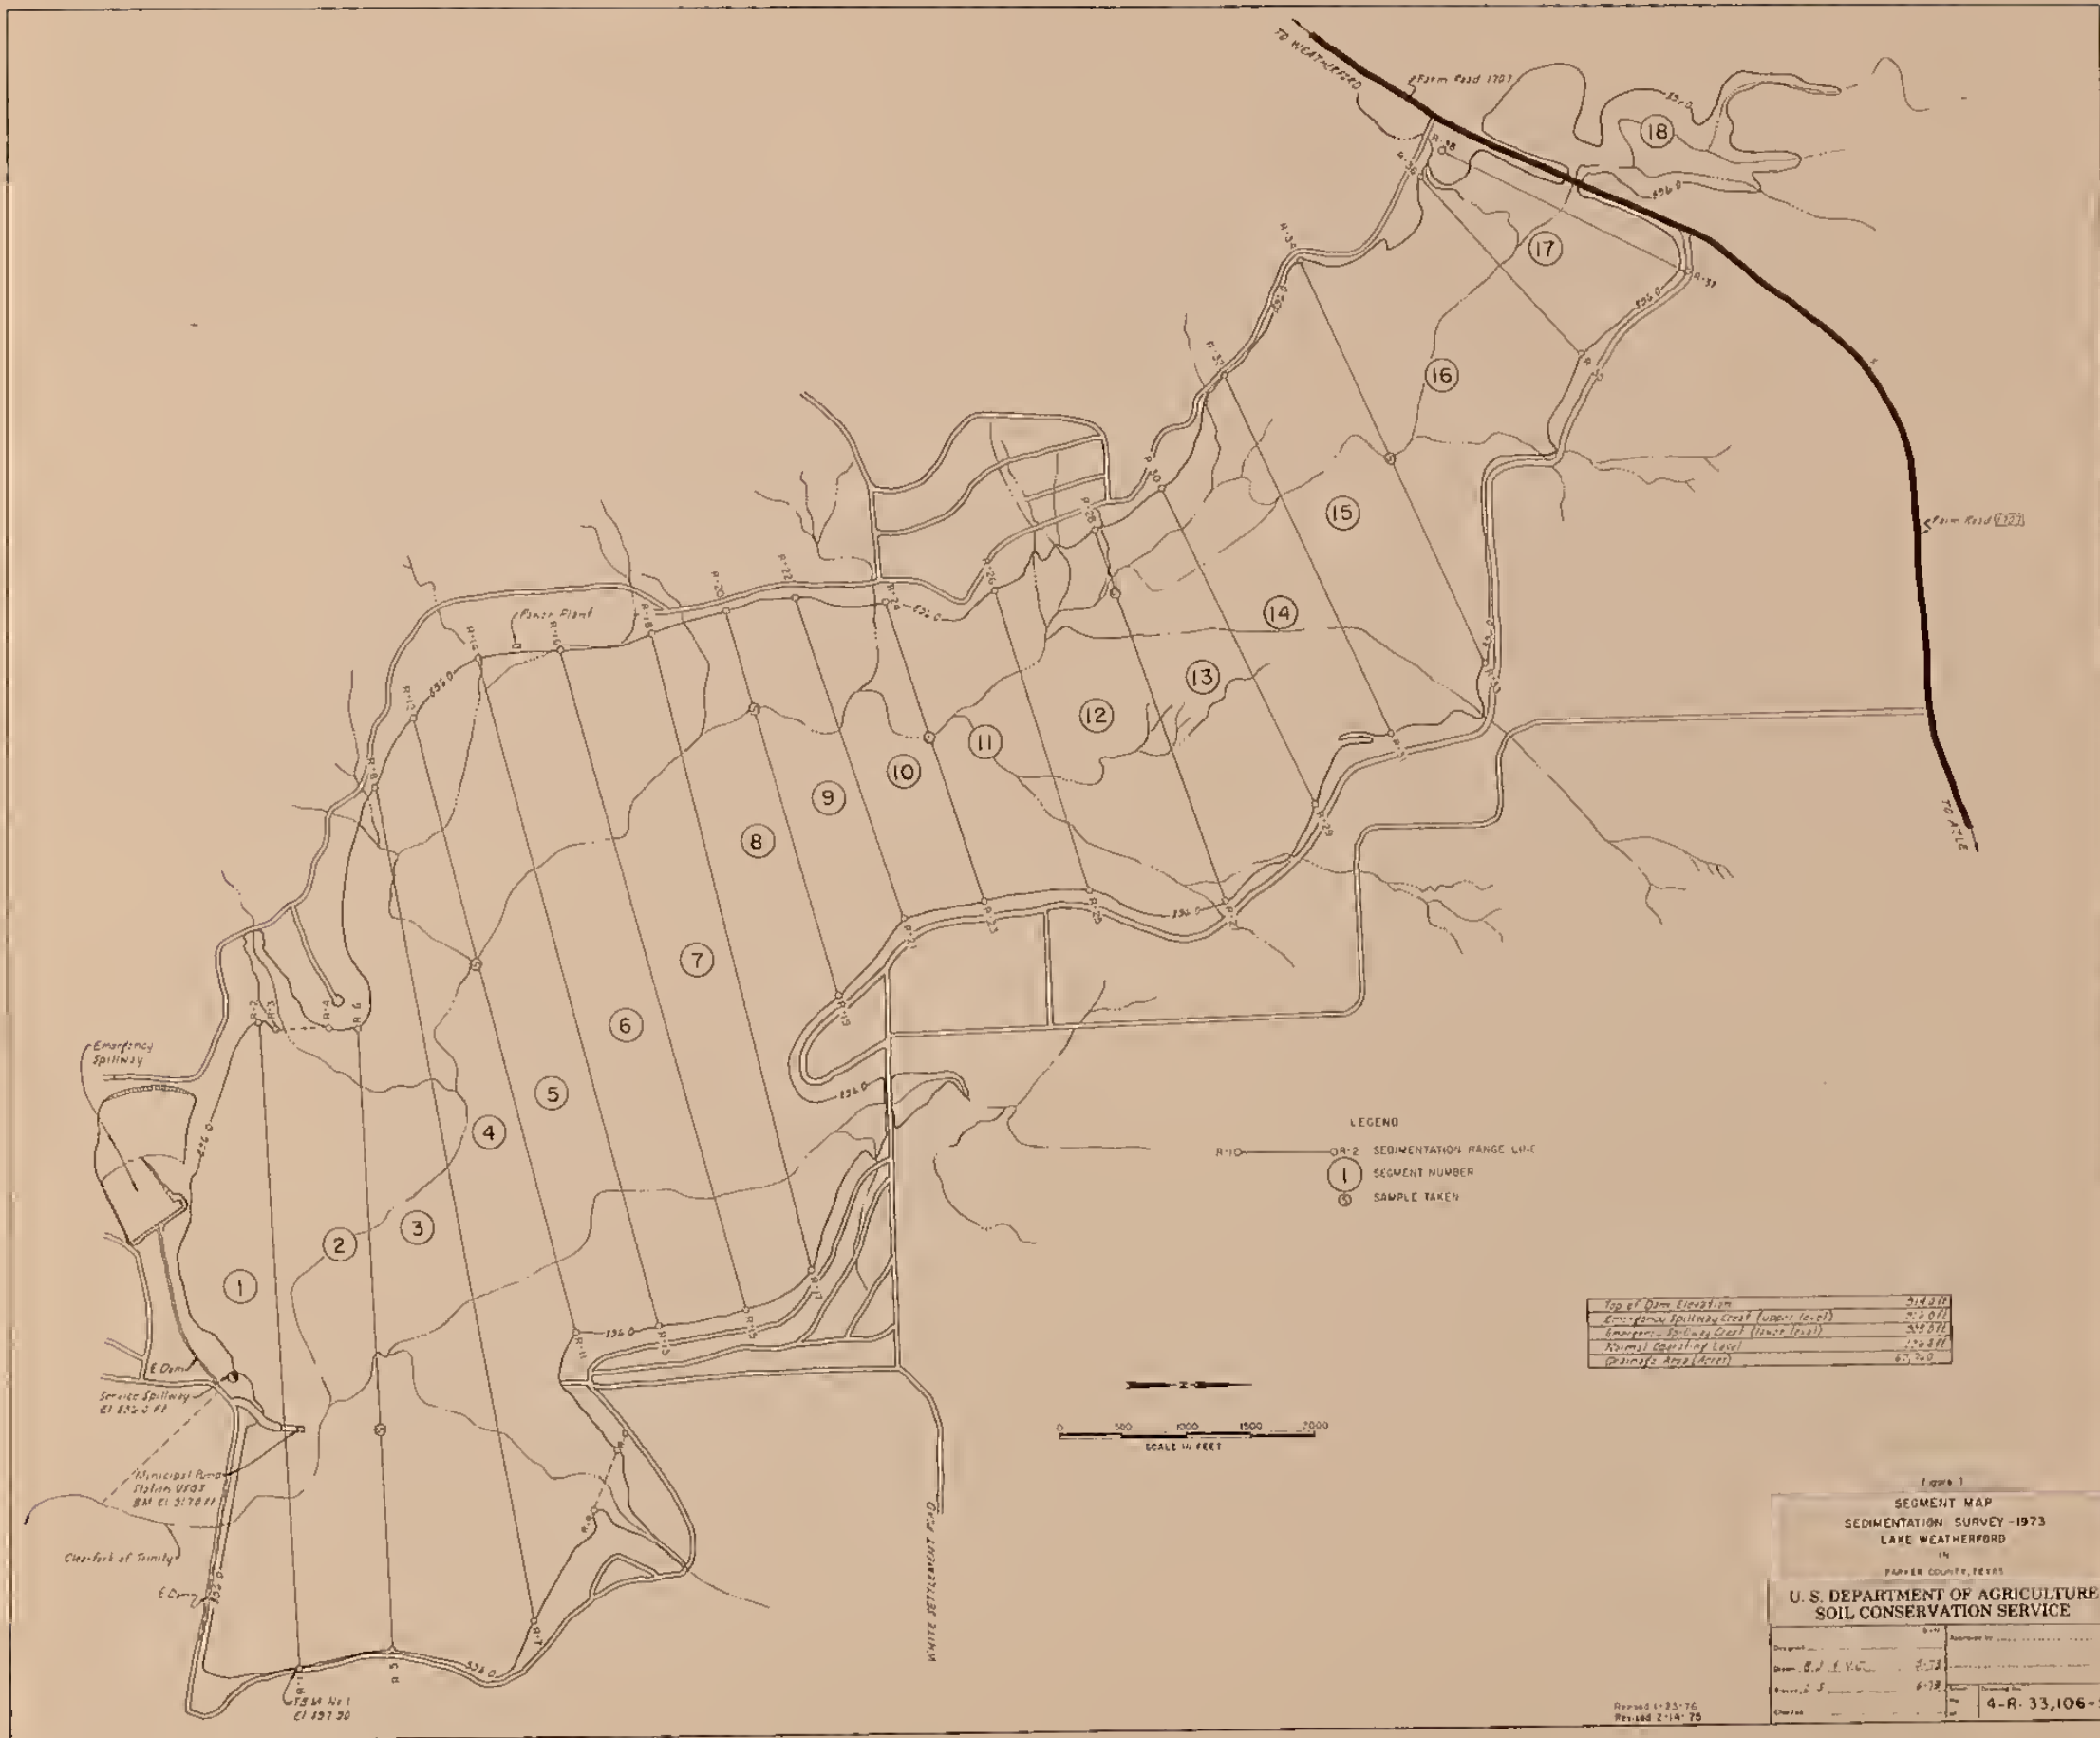
Figure 1

5. Sediment samples were obtained using a nine-foot piston-type sampler which employs a clear plexi-glass tube insert, which allows visual examination of all samples. See figure 1 for sampling locations.

SEGMENT MAP  
 SEDIMENTATION SURVEY - 1973  
 LAKE WEATHERFORD  
 IN  
 PARKER COUNTY, TEXAS

Distribution of Sediment - Sediment deposition in the reservoir is fairly uniform over two-thirds of the reservoir area. In the upper one-third of the reservoir area, segments 14 through 18, capacity loss ranges from 10.37 to 31.47 percent. Capacity loss in the lower two-thirds of the reservoir area ranges from 1.42 percent in segment 1 to 8.54 percent in segment 13, an average of 5.44 percent. Overall capacity loss for the entire reservoir is 6.44 percent, or an average annual capacity loss of 0.40 percent for the 16.08-year life of the reservoir.
