A FLOOD PLAIN MANAGEMENT STUDY

For the Town of
Thetford, Vermont

FLOOD PLAIN MANAGEMENT STUDY
TOWN OF THETFORD
ORANGE COUNTY, VERMONT

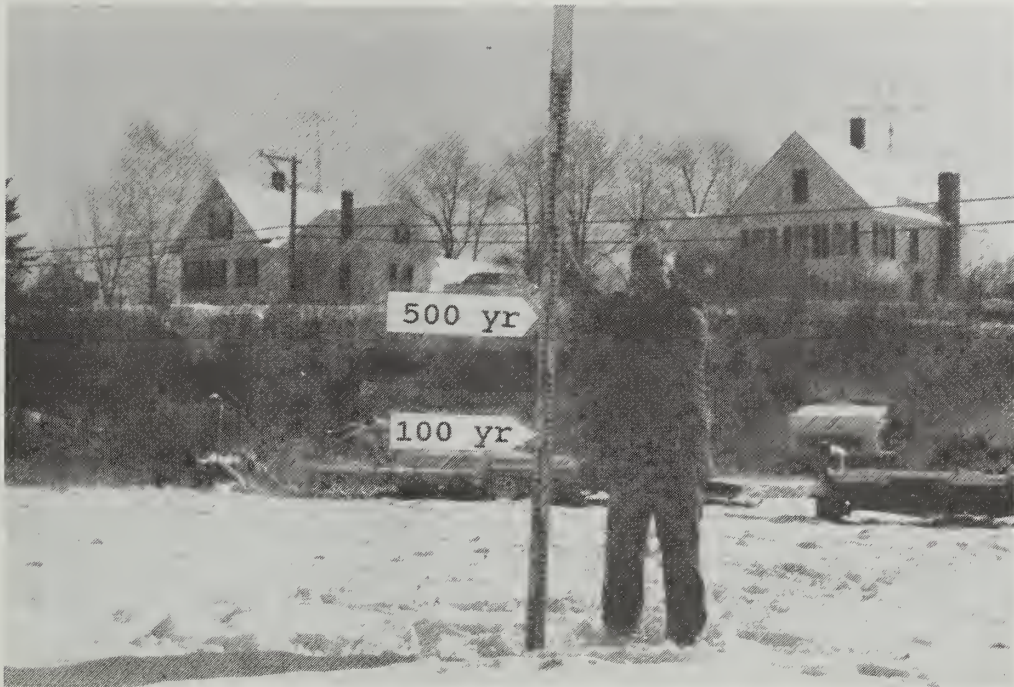
Figure 1. In Post Mills at cross section OM 28, in lower field upstream of Rt. 244 bridge, Rt. 244 in background on top of bank

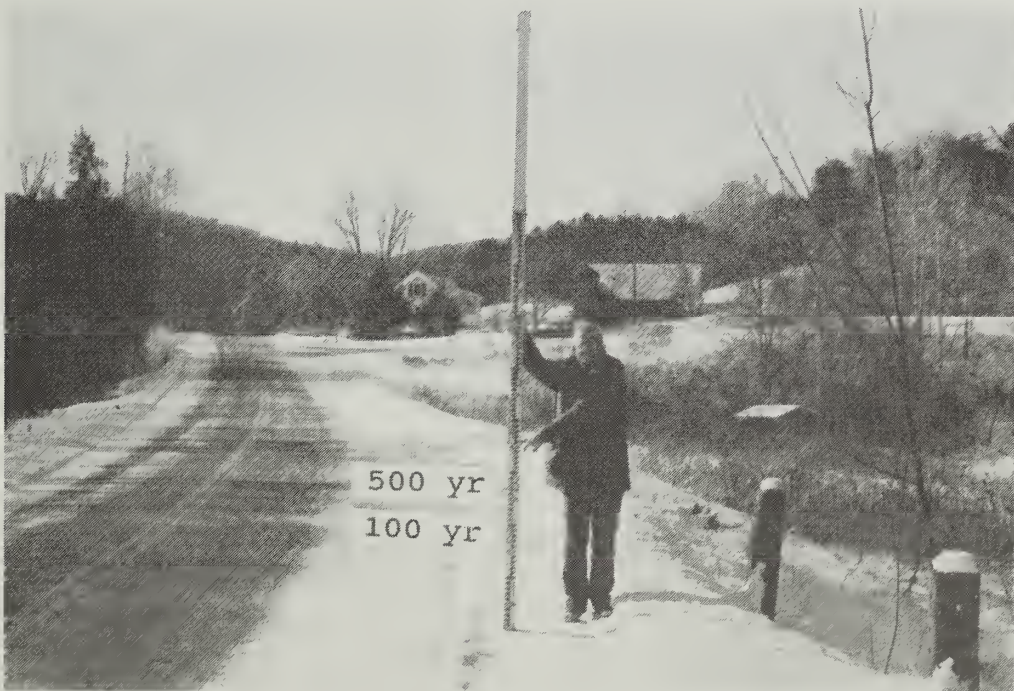
Figure 2. On Rt. 132 at Abbott Brook crossing

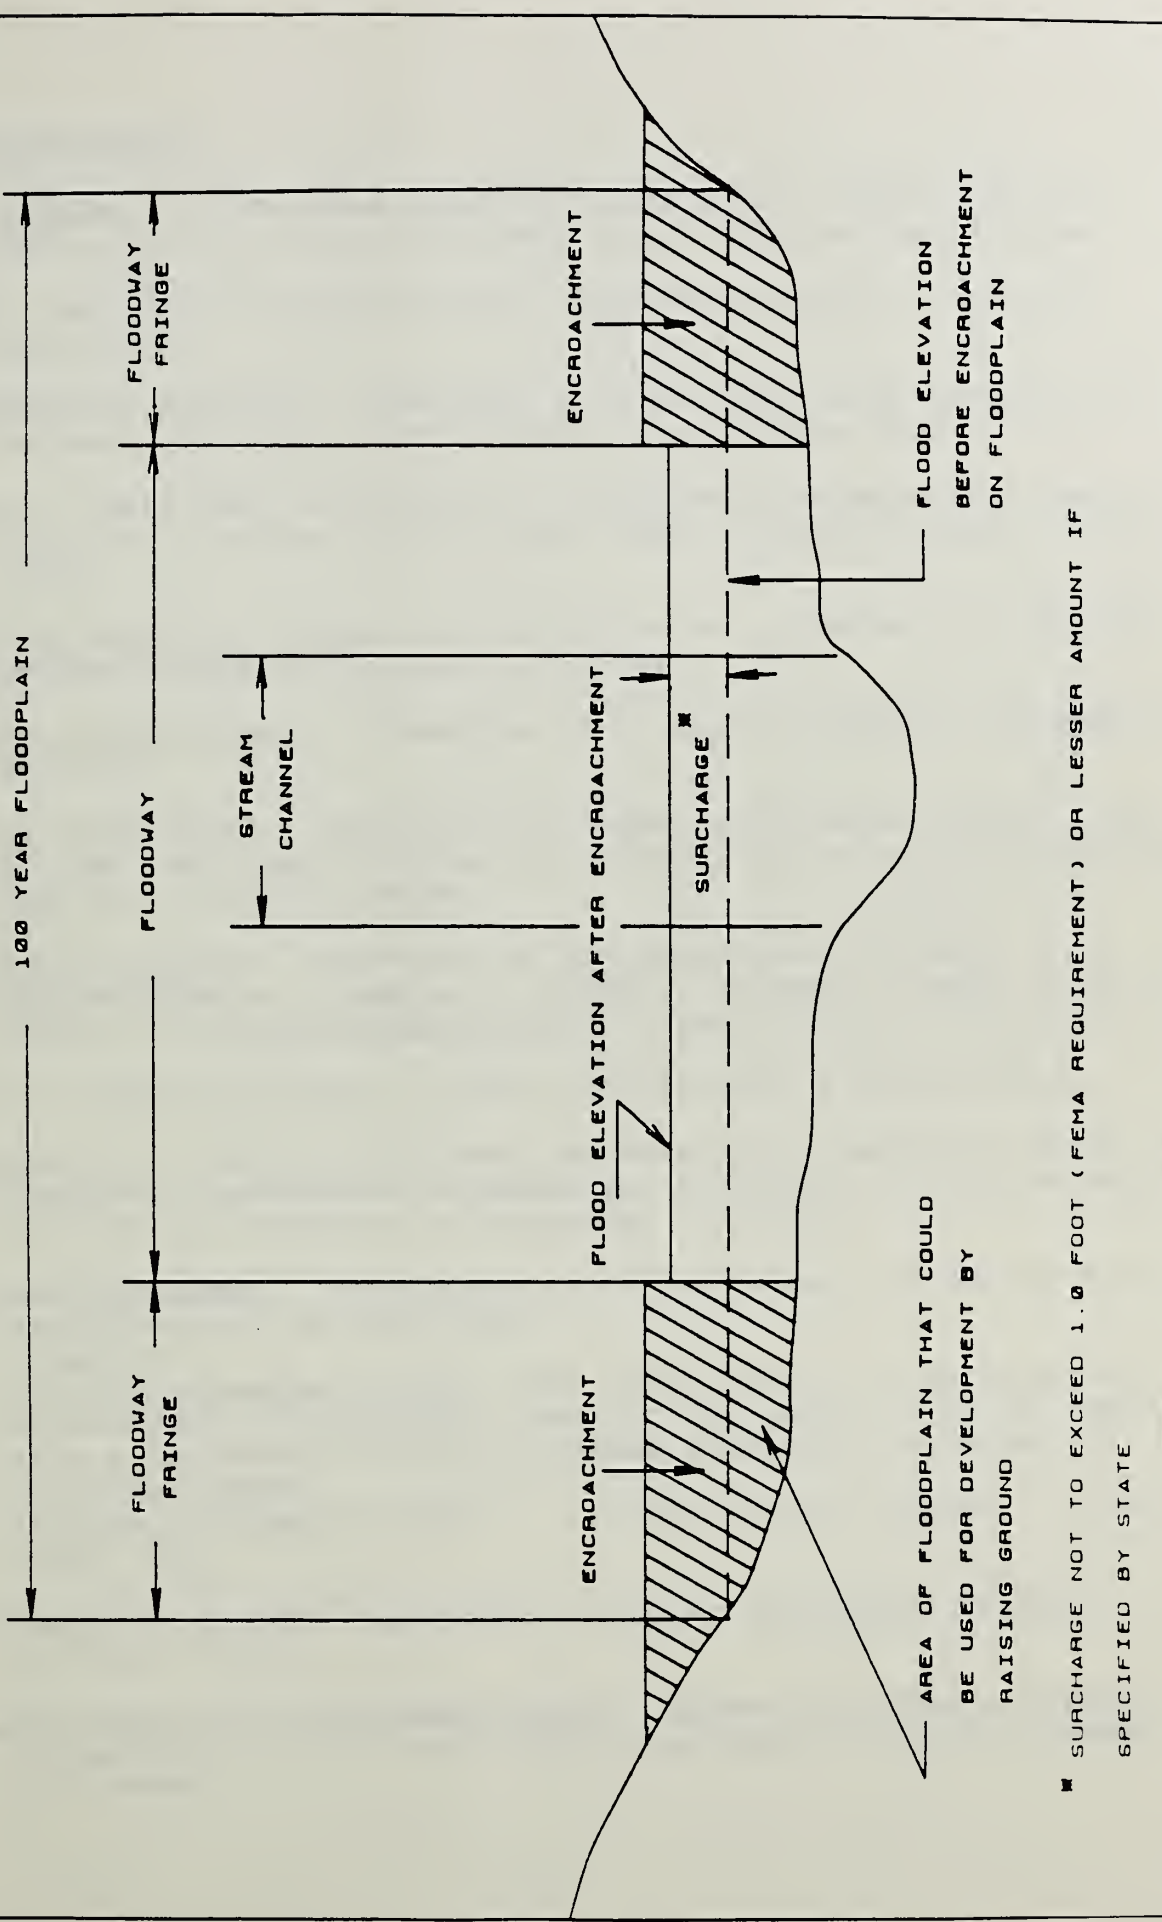
FLOODWAY SCHEMATIC

* SURCHARGE NOT TO EXCEED 1.0 FOOT (FEMA REQUIREMENT) OR LESSER AMOUNT IF SPECIFIED BY STATE

Any development activity that raises the elevation of the flood plain will restrict flow and increase flood heights. Communities have found benefits from allowing carefully controlled development to occur in the flood plain fringe provided resulting increases in flood hazard can be tolerated. The National Flood Insurance Administration uses the concept of floodway as an aid in evaluating such situations. This concept partitions the 100-year flood area into a floodway and a floodway fringe. The floodway fringe is the portion of the flood plain that can be completely obstructed without increasing the water-surface elevation of the 100-year flood more than one foot at any point. The floodway is the remaining portion of the channel and the flood plain (See Figure 3).

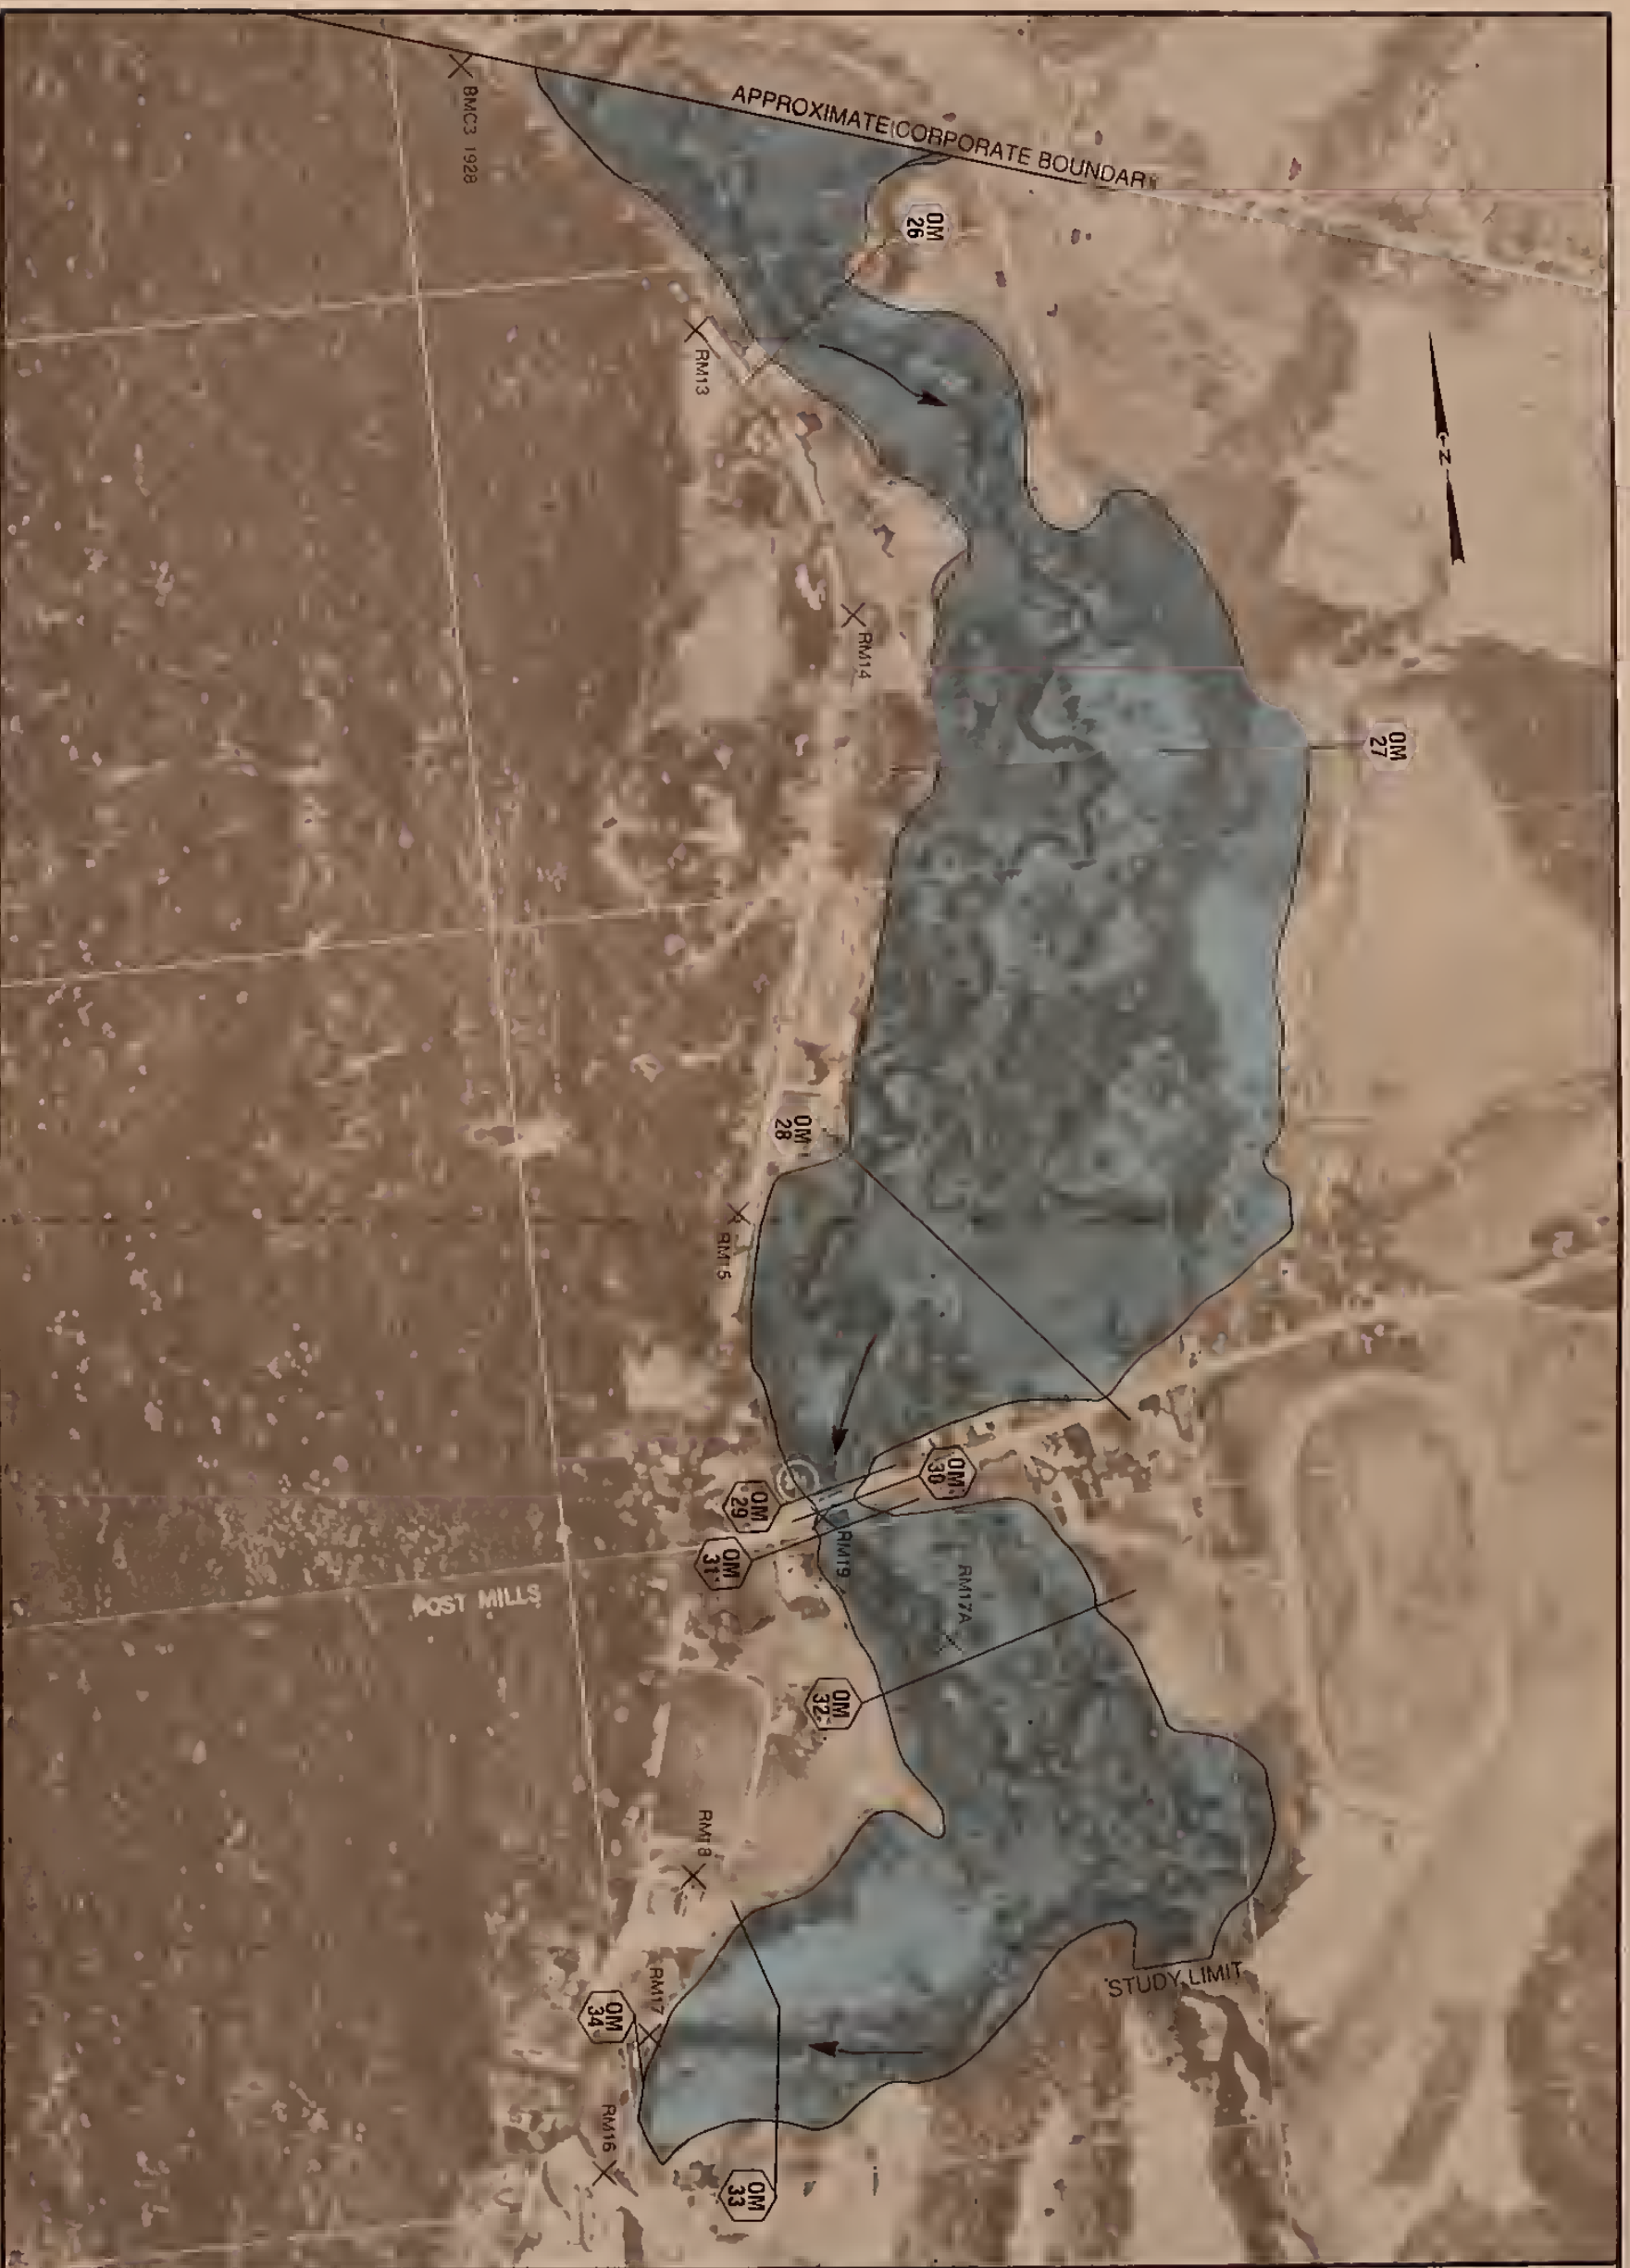
FLOOD HAZARD AREA
OMPOMPAOOSUC RIVER

100 YEAR FLOOD AREA		STREAM CHANNEL	0 500 1000 FEET
	500 YEAR FLOOD AREA		RM17 BENCH MARK	SCALE 0 100 200 300 METERS
	SURVEYED CROSS SECTION	Note: Flood Boundaries shown may vary from actual ground location. See narrative for use of data.

The photomaps entitled "Flood Hazard Areas" (sheets 1 through 5 in Appendix A) show the 100-year and 500-year flood areas. These areas are depicted based on present land use and management conditions. The flood boundaries show the approximate location on the ground for general reference purposes. The 500-year flood boundary is to be interpreted as being close to the 100-year flood boundary where it is not separately mapped. The reason for this is that the valley side slopes along many reaches of stream are steep and the map scale small. This yields a 500-year boundary which is nearly contiguous with the 100-year boundary. Along such reaches it is therefore not mapped.

Flood boundaries were taken from the profiles and may not be mapped as accurately as the profiles themselves. For this reason it is recommended that you locate the property of interest on the profiles and establish the flood boundary (for desired frequency) on the property by field survey. Appendix A provides a tabulation of elevation reference marks that can be used in connection with this activity.

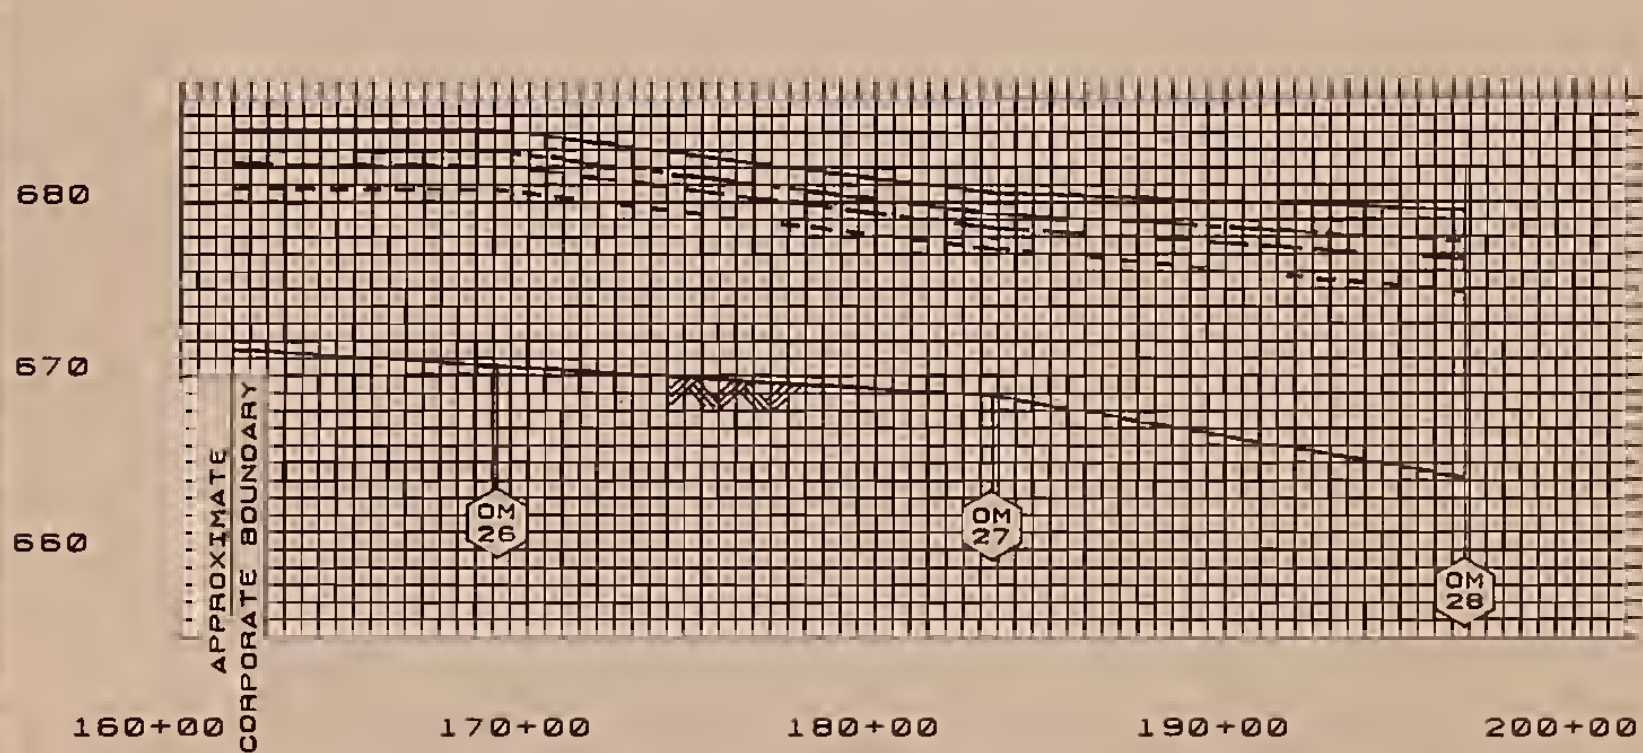
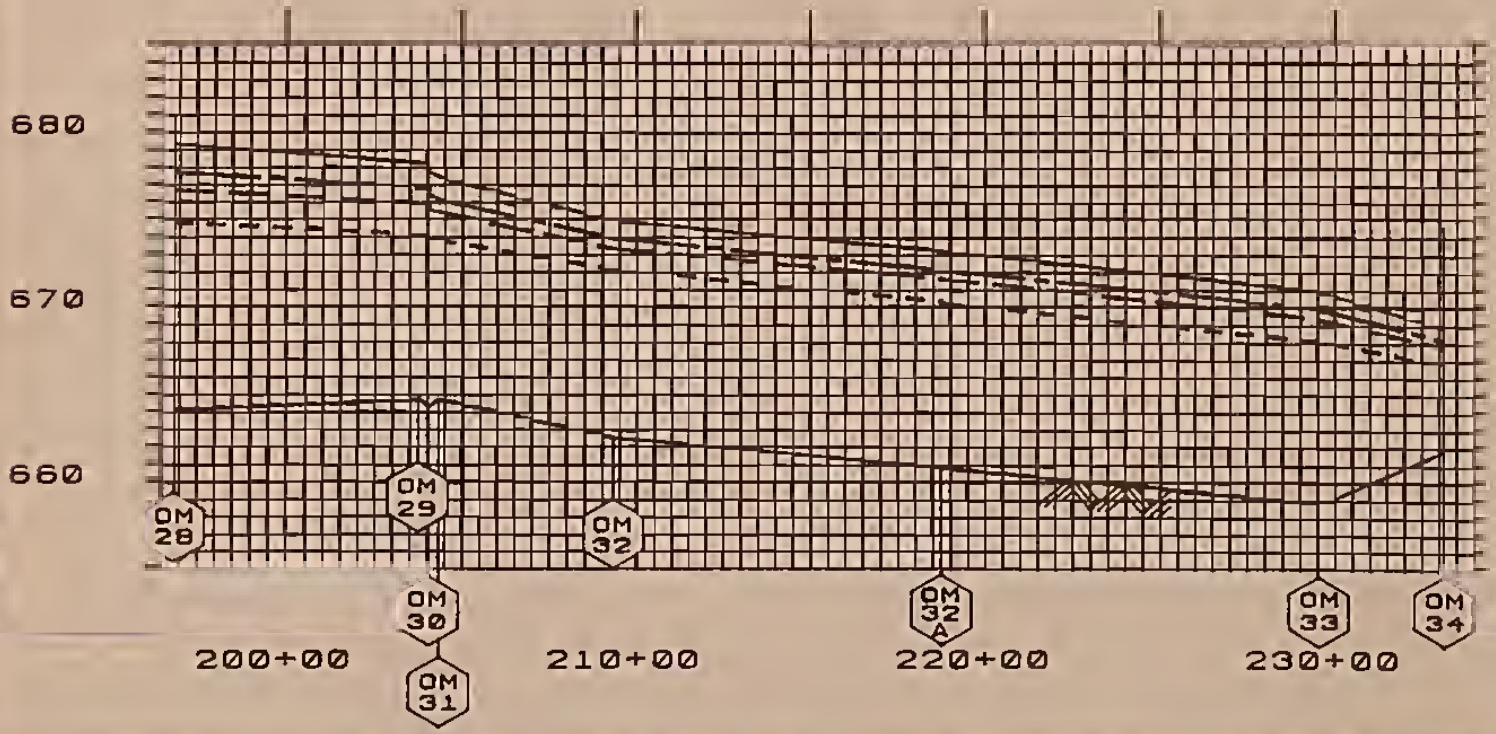
FLOOD PROFILES

All elevations in feet (NGVD)

OMPOMPANOOSUC RIVER

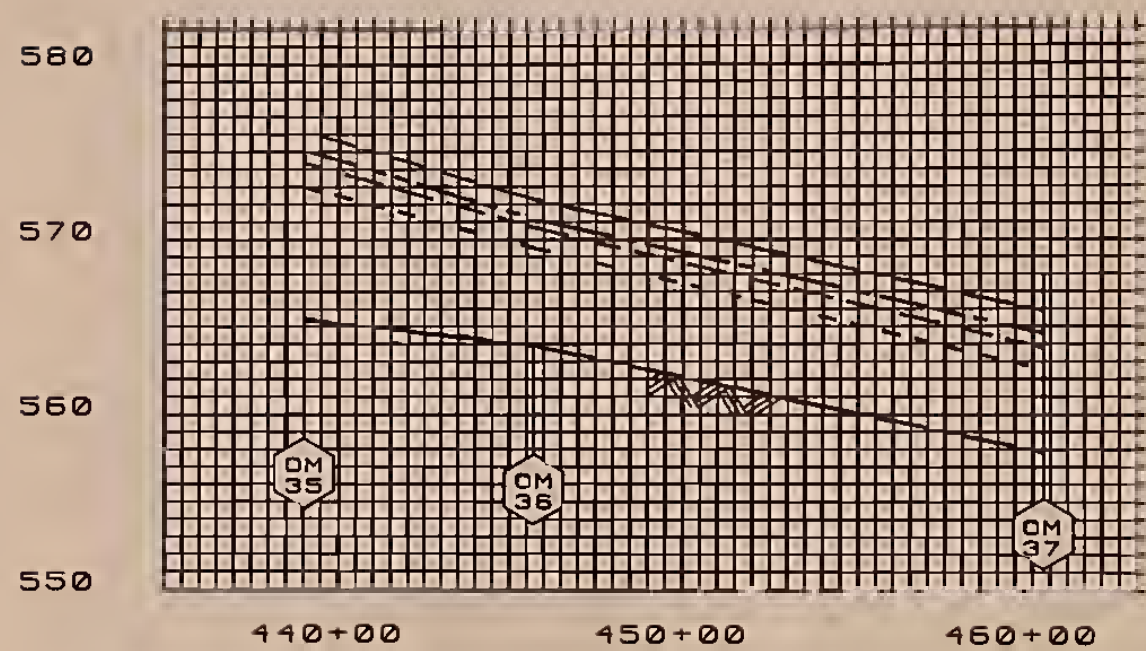
OMPOMPANOOSUC RIVER

- 500 YEAR STORM
- - - - - 100 YEAR STORM
- . - . - 50 YEAR STORM
- - - - - 10 YEAR STORM
- STREAM BED
- CROSS SECTION LOCATION
- bridge deck
- low chord
- RIVER CROSSING

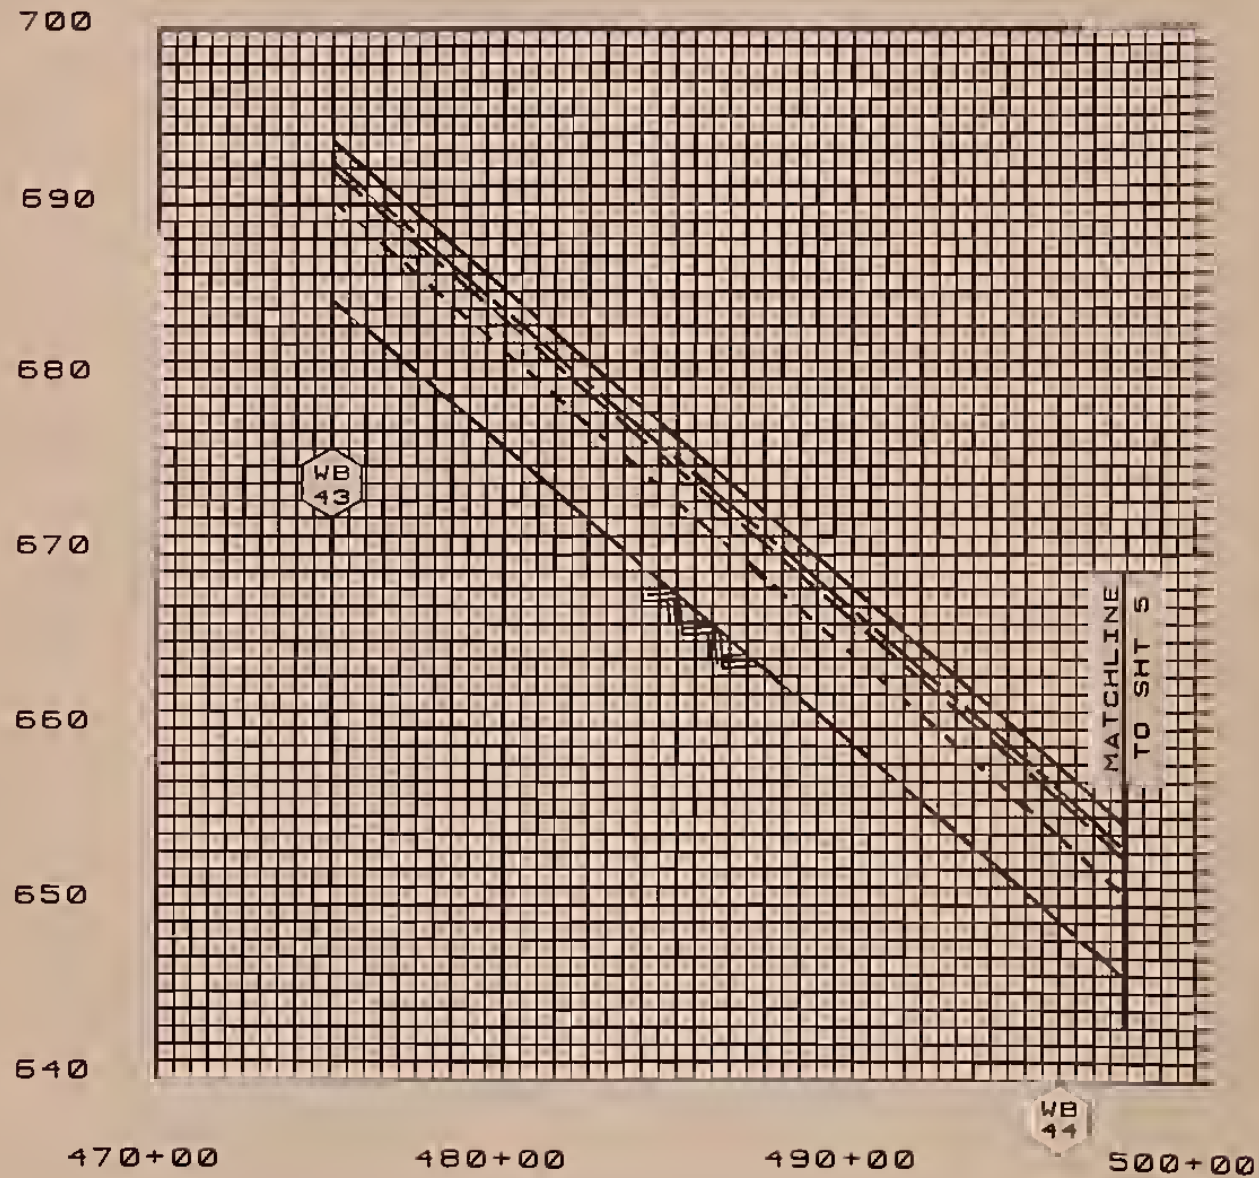
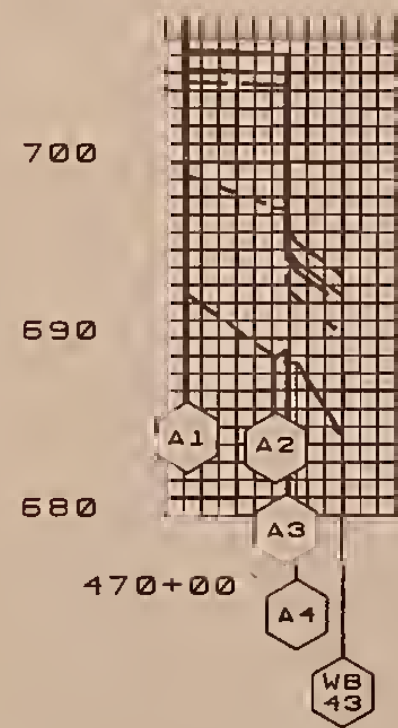
FLOOD PROFILES

WEST BRANCH OMPOMPANOOSUC RIVER

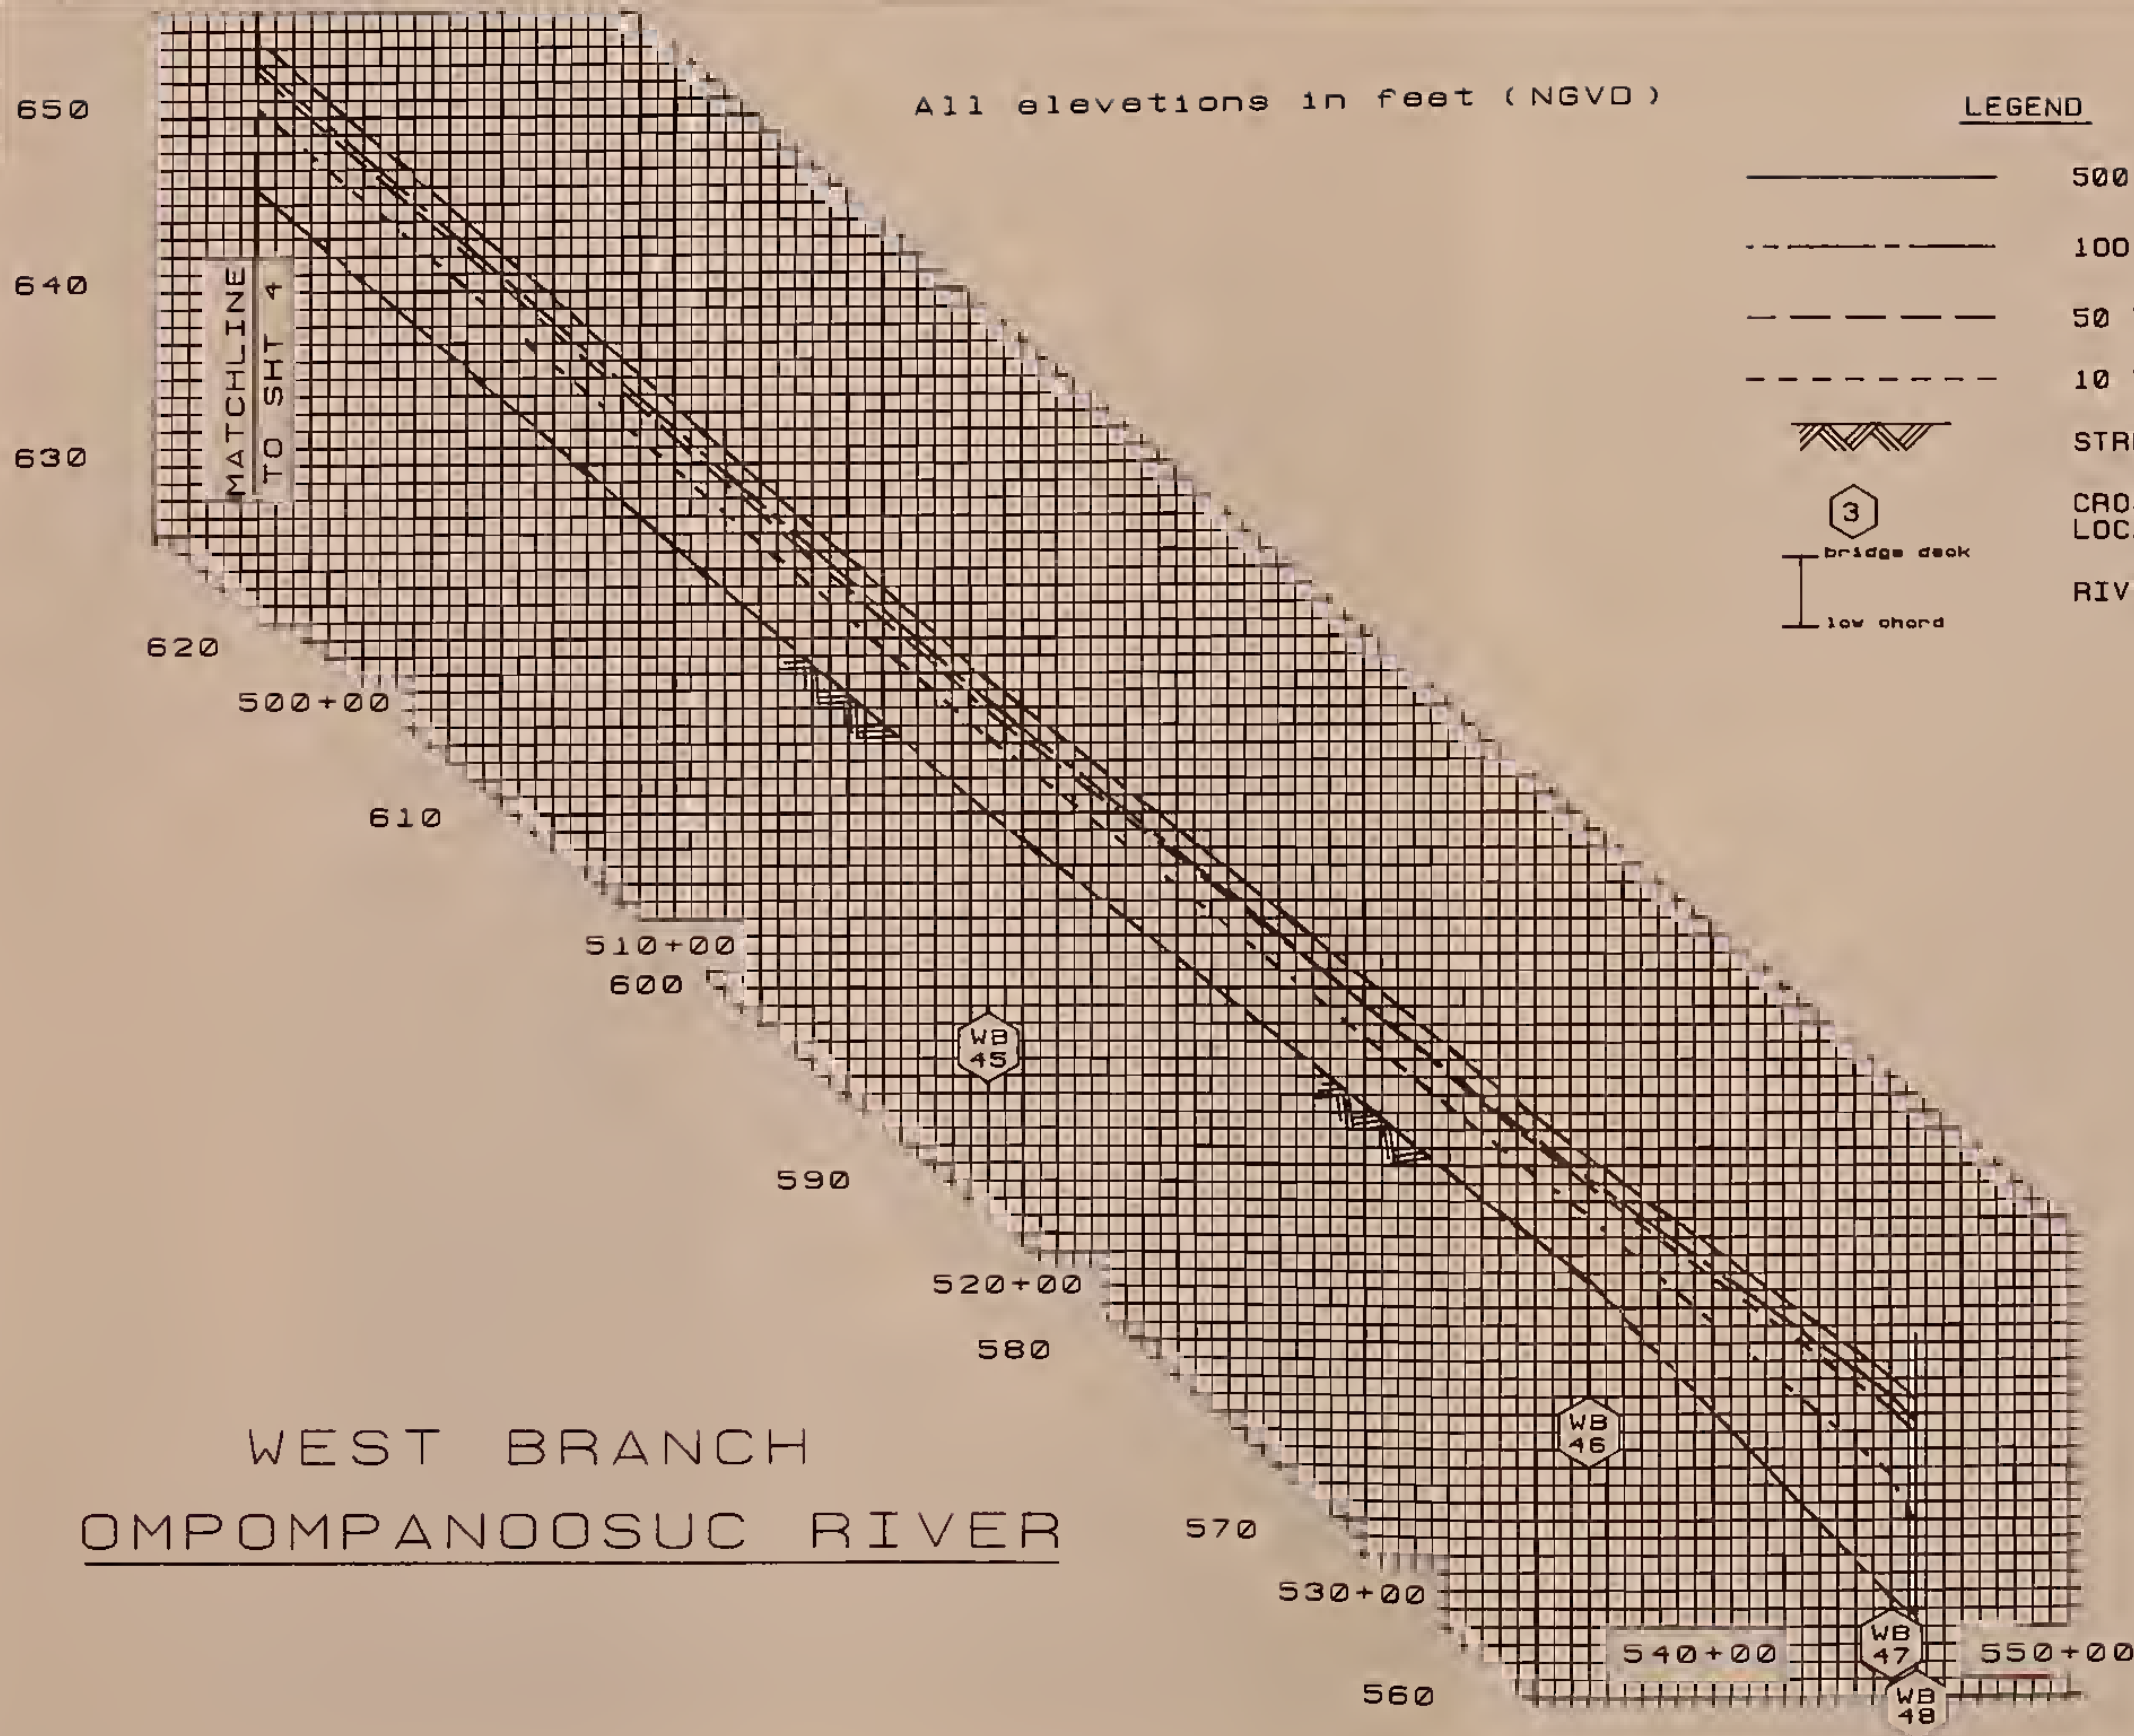
FLOOD PROFILES

WEST BRANCH OMPOMPANOOSUC RIVER

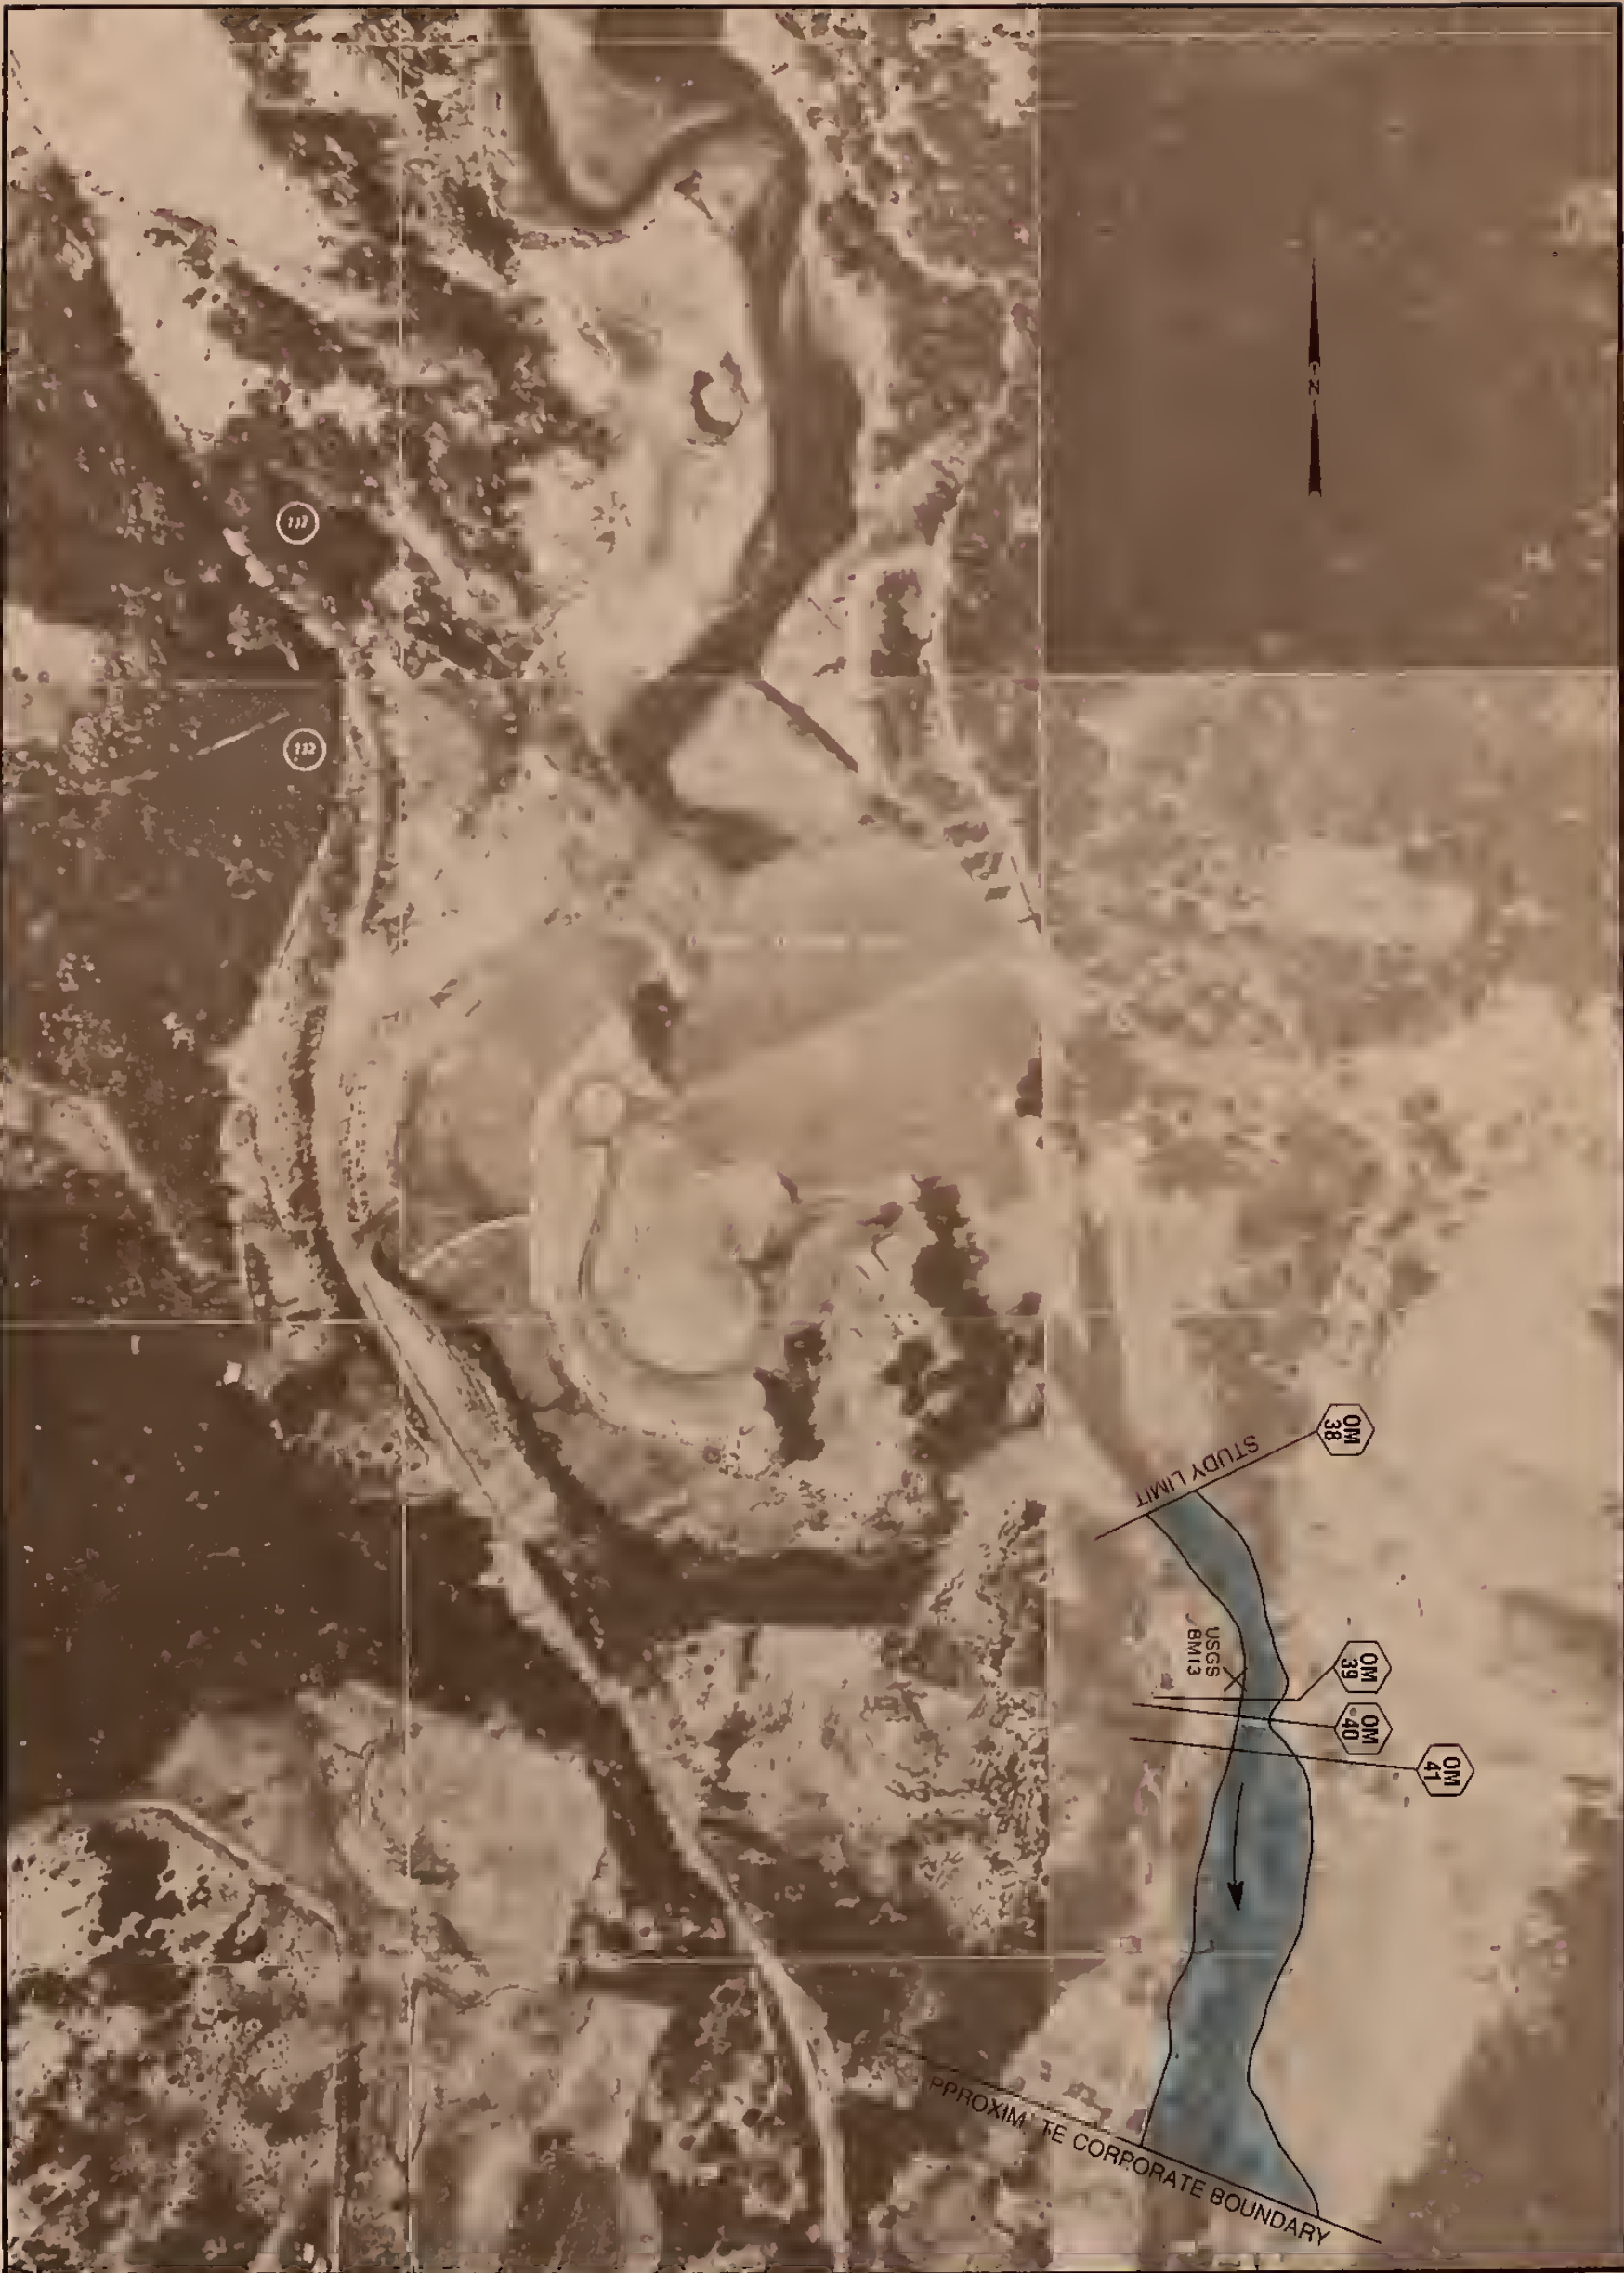
FLOOD HAZARD AREA
OMPOMPANOOSUC RIVER

- 100 YEAR FLOOD AREA
- 500 YEAR FLOOD AREA
- UV
3 SURVEYED CROSS SECTION
- STREAM CHANNEL
- X BM13 BENCH MARK

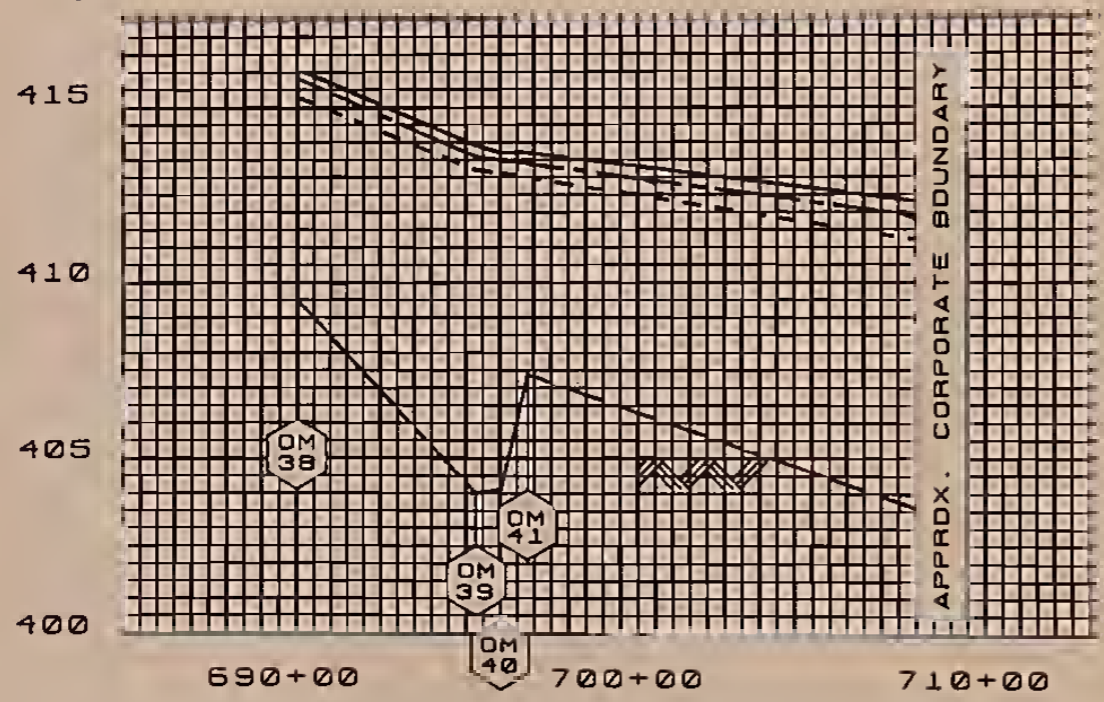
- 500 YEAR STORM
- 100 YEAR STORM
- . - . - . 50 YEAR STORM
- 10 YEAR STORM
- STREAM BED
- CROSS SECTION LOCATION
- RIVER CROSSING
