ANTHROPOLOGICAL SERIES.

RUINS OF XKICHMOOK,
YUCATAN

EDWARD H. THOMPSON,
Field Assistant.

CHICAGO, U. S. A.
July, 1898.

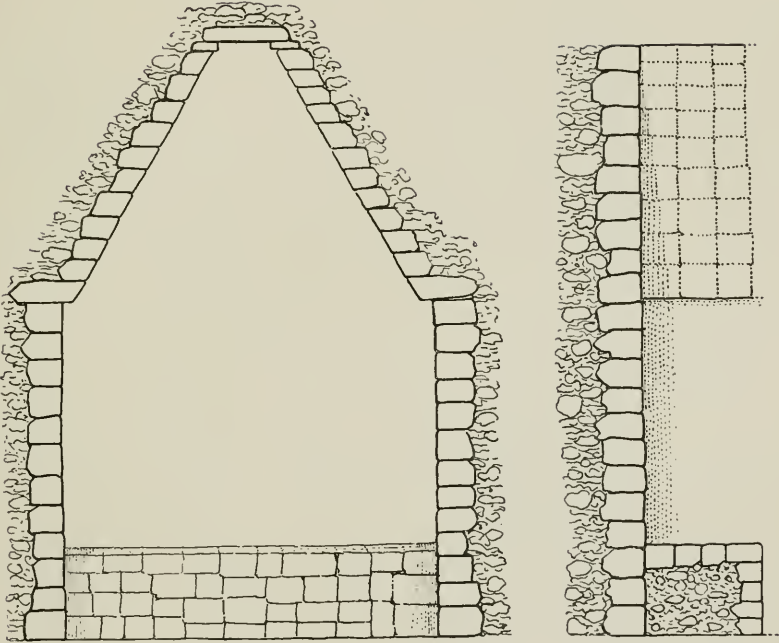
FIG. 23. SECTION OF CHAMBER, WITH FRONT VIEW OF STONE PLATFORM.

FIG. 24. SECTION OF END OF CHAMBER, WITH SECTION OF STONE PLATFORM.

Five of the Palace chambers have platforms at one or both ends of the rooms, raised about 18 inches above the floor and about 2 feet wide. (See Figs. 23 and 24.) Their shape and size would indicate that they had served for seats, beds or tables.

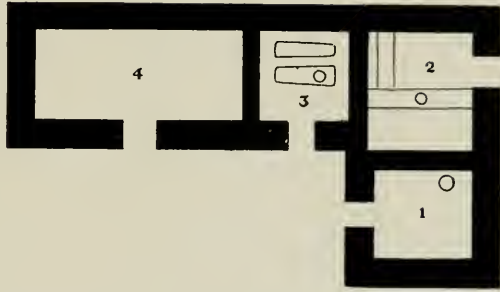
FIG. 25. PLAN OF EDIFICE No. 8.

EXCAVATIONS (EDIFICE NO. 8).—Edifice No. 8 (Fig. 25) appeared at first glance to be simply an ordinary mound, so utterly was it ruined.

The roof-stones found here and there told the story of its original character, and excavation was continued until the bed-rock itself stopped the work. At the distance of a foot beneath the surface of the floor we found traces of an older floor. Buried a foot deep in the material of the floor was a rude grave and a shallow earthen dish inverted over a heap of human bones. Near by were fragments of clay figurines and potsherds. Beneath these objects was a third floor, and a few inches deeper still another. This is the first time I have found so many floors. A foot deeper we struck a filling of great stones that continued down to the bed-rock and yielded nothing of note.

Fifteen inches beneath the floor of Chamber No. 2 we found a curious wall-like ridge of mortar, and resting upon it an earthen vessel. The ridge of mortar was built upon a level floor, under which were found various portions of a human skeleton. Beneath these vestiges of the ancient people was a third floor, and further excavations revealed a second ridge of mortar in the northwest corner of the room; this was 3 feet long by 1 foot wide and $1\frac{1}{2}$ feet high. Beneath this ridge were found human bones which fell into dust at the touch, and many potsherds. This mound rested upon a fourth floor, and 2 feet beneath this was the undisturbed hardpan. One foot beneath the floor of Chamber No. 3 we came upon a second floor, and 1 foot beneath the surface of this, resting upon a leveled surface, were two burial places, coffin-shaped, like those found in Chamber No. 5, Edifice No. 3. Grave 1 was 6 feet long, 1 foot 7 inches wide at the head, tapering gradually to 1 foot 3 inches wide at the foot and 1 foot 3 inches deep. The bones in this grave were so broken and mixed (evidently by small rodents) that no idea could be obtained of the original position of the body. At about one-third of the length of the grave from the wider end was found a shallow earthen vessel overturned, and beneath it were the crumbling remains of a skull.

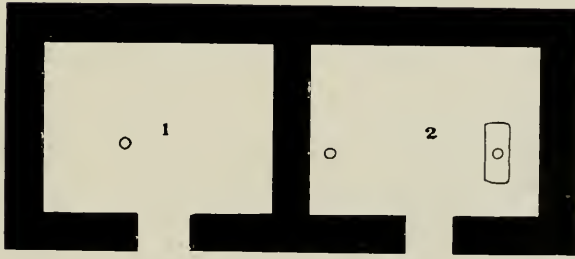
FIG. 26. PLAN OF EDIFICE No. 9.

EXCAVATIONS (EDIFICE NO. 9).—This edifice (Fig. 26) also appeared at first to be a large, shapeless mound, but excavation revealed a structure of two chambers, and in Chamber No. 1, at a depth of 9 inches beneath the floor, one small earthen jar and the fragments of several other vessels were found. Excavation in Chamber No. 2, at a depth of 2 feet 8 inches beneath the floor and 2 feet from the west

wall, brought to view a burial place 3 feet long by 1 foot 3 inches wide, and 1 foot 3 inches deep. The human bones encountered therein were very much decayed, and the fragments of a skull were covered by an inverted shallow vessel. Besides this were found some beads, among them one of jade, and various potsherds. In the material of the foundation, upon the east side of the room, we found a small earthen jar upright and intact which must have been placed in position by careful hands many centuries ago. Scattered about were many potsherds and ashes, but no traces of human bones.

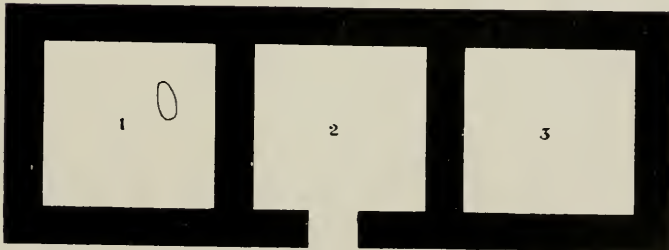
FIG. 27. PLAN OF EDIFICE No. 10.

EXCAVATIONS (EDIFICE NO. 10).—Edifice No: 10 (Fig. 27) was a mere mound, concealing within its mass, however, a ruined three-chambered structure. Excavation in Chamber No. 1 yielded many potsherds, and in the southeast corner was a rudely formed cavity holding a heap of badly decayed bones and human teeth. Chamber No. 2 contained an accumulation of potsherds, while Chamber No. 3 held potsherds and two cylindrical rubbing stones, the surfaces of the latter being highly polished by attrition.

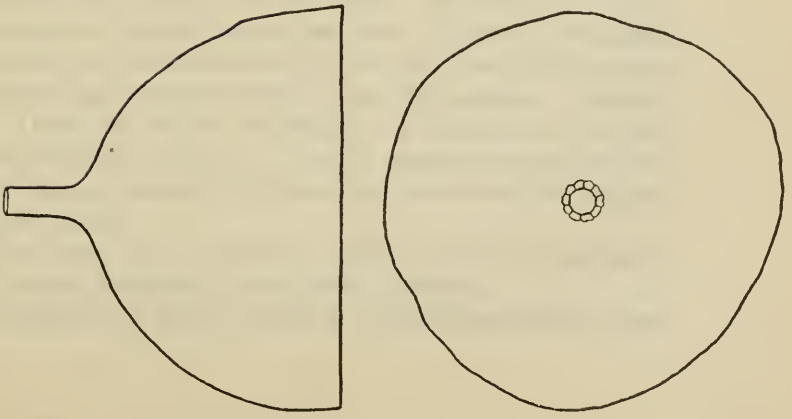
FIG. 30. CHULTUNE NO. 2.

Reservoir No. 16 is a low chamber with a curiously long slender orifice that barely permitted the passage of my body; it had painted upon its walls a phallic emblem and the figure of a turtle. A plan and profile of this cistern appears in Fig. 28, and similar examples are illustrated in Figs. 29 and 30.

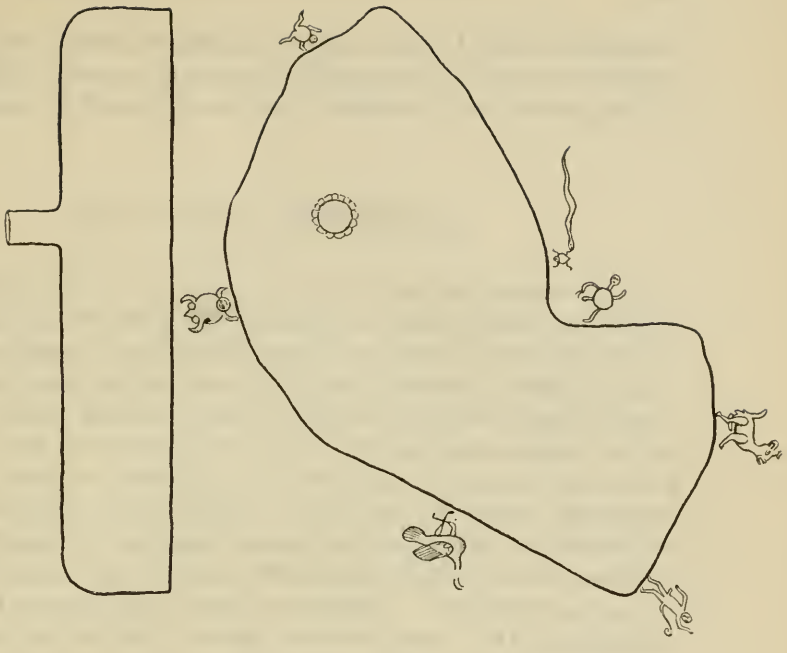
FIG. 31. SECTION OF RESERVOIR, 3 LEAGUES NORTHEAST OF XKICHMOOK.

Three leagues northeast of Xkichmook lies the Indian ranche of Nucuchtuk, built on the site of a small group of ruins. Within the group I encountered and excavated a most singular chultune. It was extremely shallow and, unlike the previously described examples, was quite close to the surface and very wide. Its walls have a most curious assortment of figures worked in stucco. Close by the orifice upon either side were two nondescript figures, and distributed around the walls were an ape, a wild turkey, a deer-like animal, a serpent and a frog. These are shown imperfectly in connection with the section of the reservoir in Fig. 31. I have personally explored the depths of more than a hundred chultunes, but this exceeds in interest any other I have found.

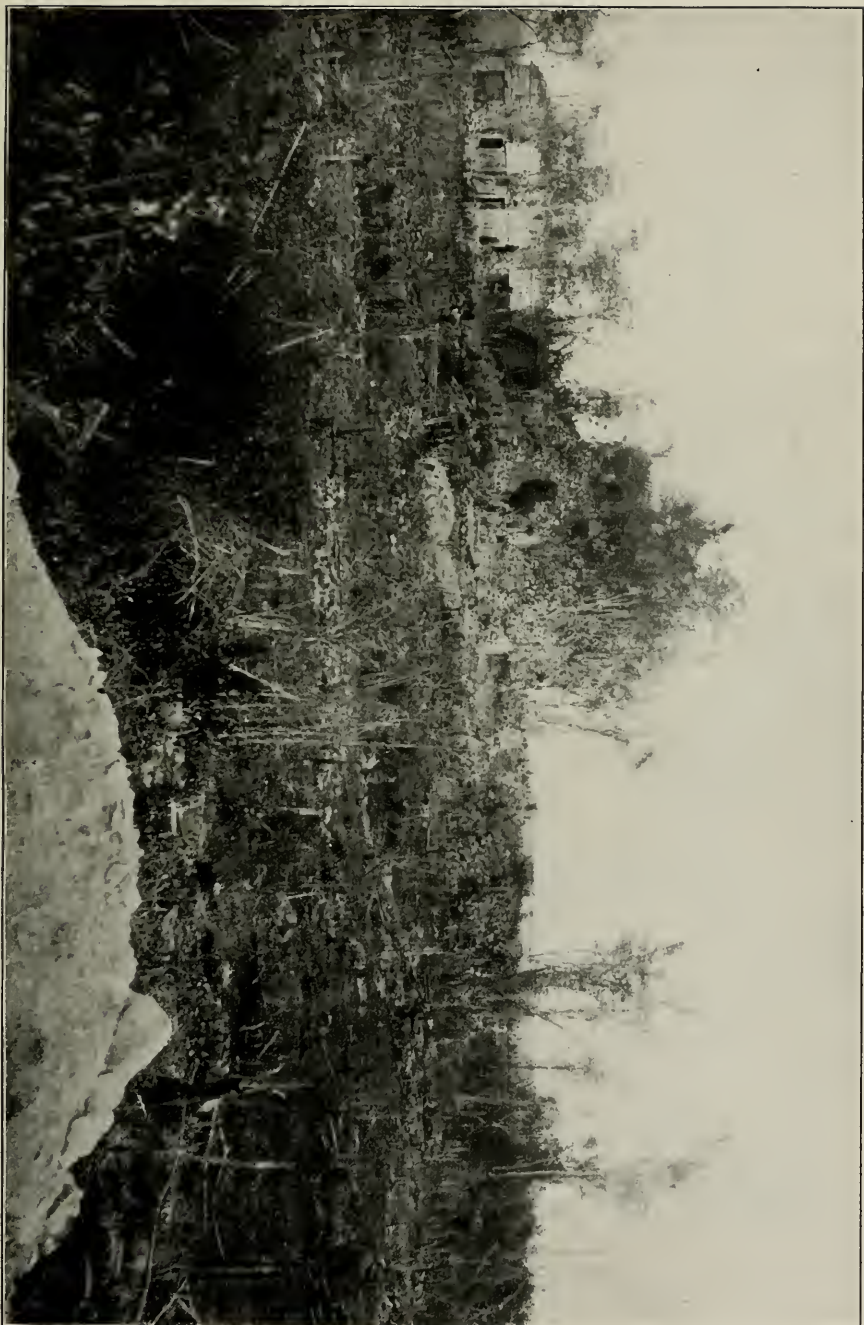
VIEW OF THE PALACE FROM THE SOUTHEAST.

Edifice No. 1, or the Palace, as the natives term it, is a most imposing structure. It is 64 feet high and, raised by terraced substructures, it towers 80 feet above the surrounding level, while its massive northern walls loom up like the face of some grim fortress; and, in truth, who can tell how many fierce frays have in the ancient time taken place in the shadow of these walls! This is the principal edifice of the group and is a composite structure, forming, with its two wings, three sides of an inclosure too irregular to be called a hollow square, with the open portion facing the south. The central portion (seen from the southeast in Pl. XII, from the northeast in Pl. XIII, and from the northwest in Pl. XIV), is a massive pile, fully 60 feet high, faced with worked stone and terminating in a much smaller upper structure of two rooms, probably a shrine or *Ku*. A wide staircase, its foundation a solid mass of rubble faced with carved stone ornaments, occupies fully one-third of the whole southern front, and extends upward to the narrow terrace in front of the shrine.

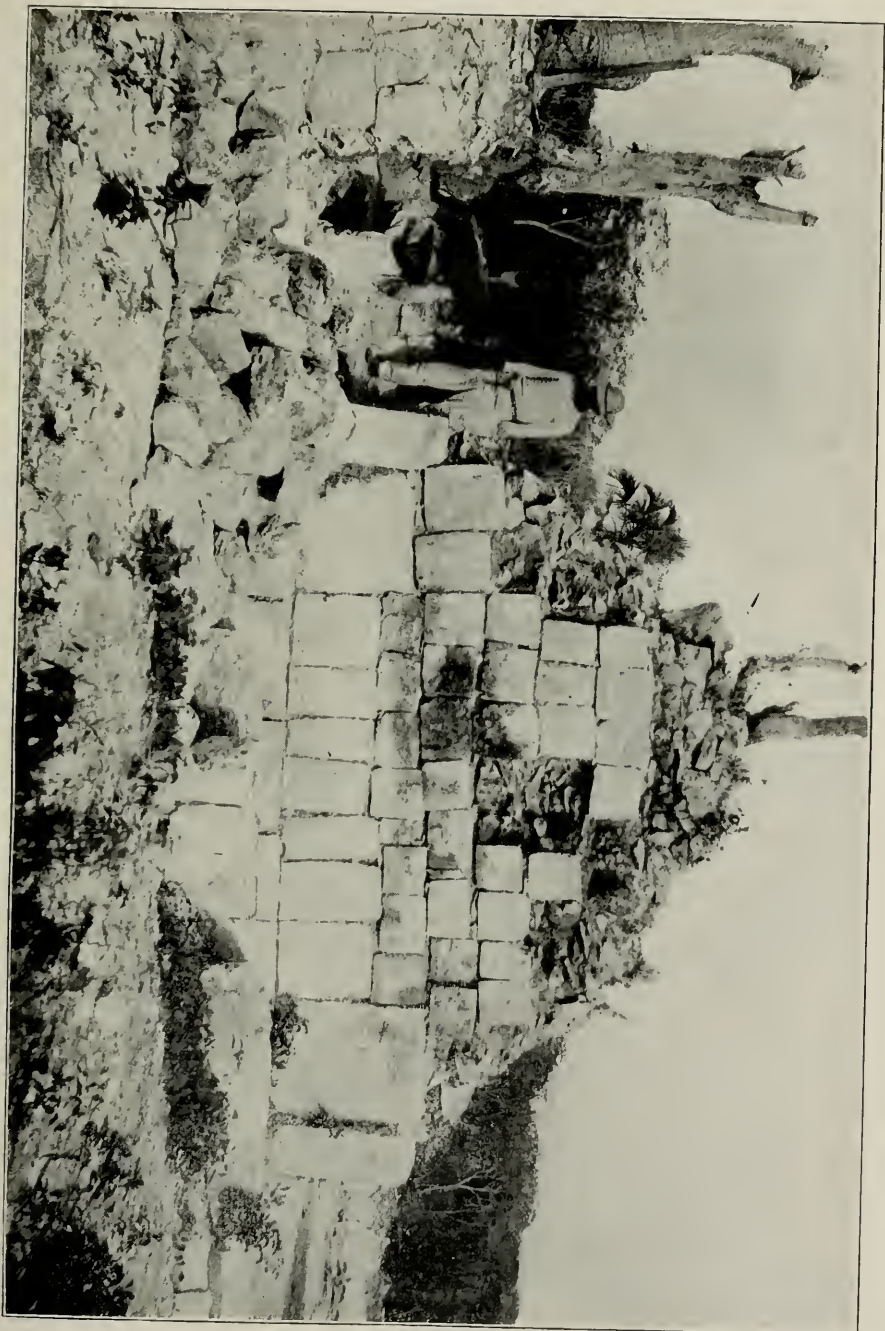
EDIFICE NO. 2, SHOWING MASONRY.

EXCAVATIONS.—Superficial excavation revealed the outlines of the edifice as shown upon the map, and the character of the masonry is well brought out in Pl. XV. Excavations beneath the floor surface of Chamber No. 1, at a depth of 1 foot and 8 inches, brought to light a rude sepulchre which was hardly more than a simple cavity in the stone filling. This cavity contained the much decayed fragments of a human skeleton. They had, apparently, been gathered up from some previous resting place and thrown into this cavity in a promiscuous heap. No signs of an earthen vessel or even of an ornament were found in the grave. Continuing the excavation into the material of the substructure, we found at a depth of 2 feet the remains of a second floor of an older structure. Apparently, this latter had been built partly above and upon the site of a still older edifice. This I have often found to be the case among these ruins. In the debris material I found many fragments of objects in terra cotta. Similar excavations in the floor material of Chamber No. 2 revealed, at a distance of 3 feet from the northern wall, a well-made grave 3 feet long by 1 foot 4 inches wide and 2 feet deep, which contained many human bones and teeth, all much decayed. In the material just above the grave I found many terra cotta fragments of vessels and figures. These votive offerings were evidently broken and thrown upon the half-covered grave. As in the excavations of Chamber No. 1, we found here signs of a previous floor. Continuing to the depth of 3 feet more we came to the bedrock and consequently to the limit of our excavation at that point. All the way from the surface down we found potsherds in great variety.

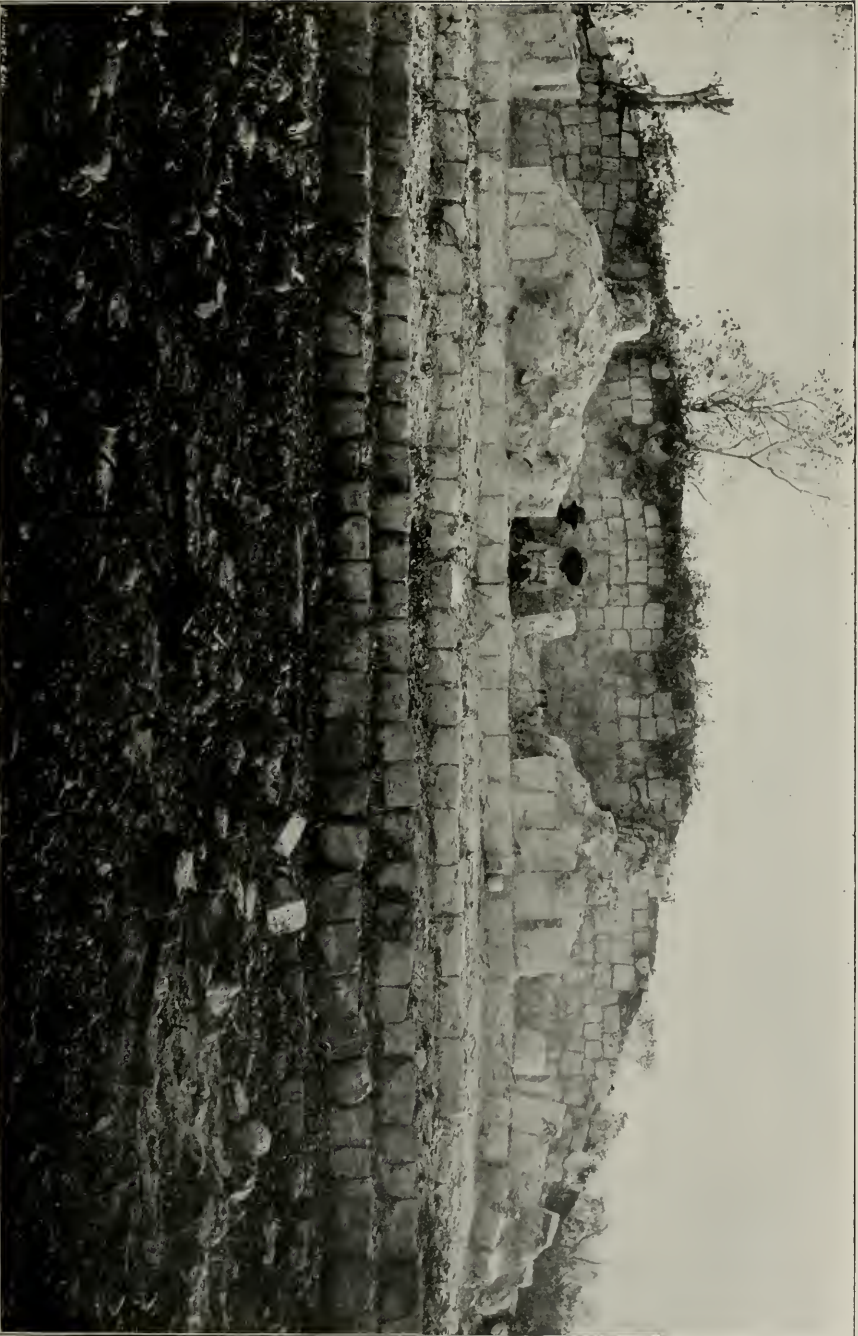
EDIFICE NO. 3, AS EXPOSED BY EXCAVATION, SHOWING STAIRWAY AND HALLS.

Southeast of Edifice No. 2 is Edifice No. 3, a low structure of five rooms. It occupies a terrace 6 feet high, and is approached both on the north and south by flights of stairs extending the entire length of the structure. This building, with its series of steps faced with upright stones as they appeared after excavation was complete, is well shown in Pl. XVI.

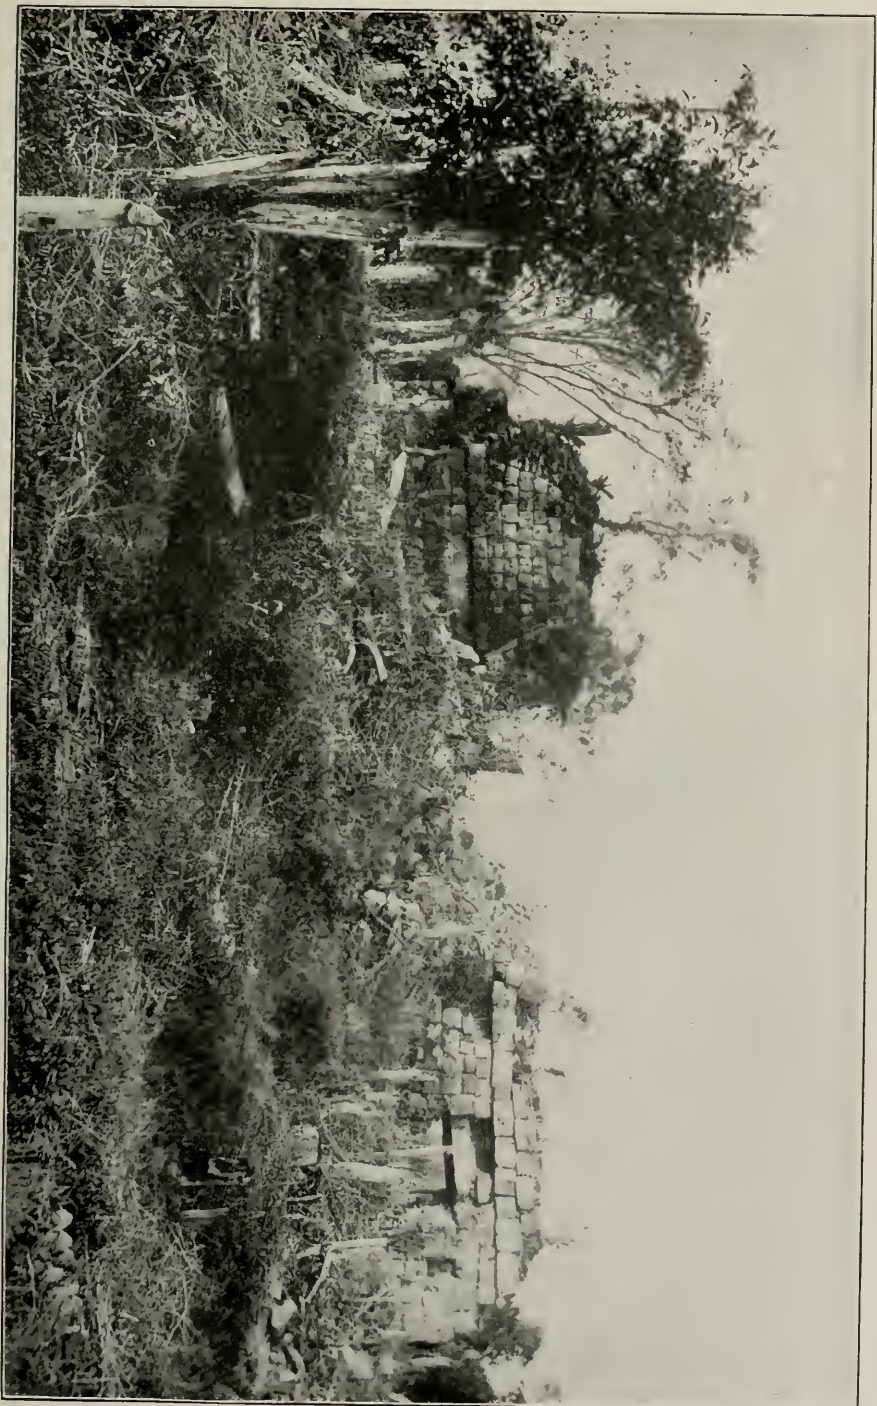
EDIFICE NO. 4, AS IT APPEARED AFTER REMOVAL OF THE FOREST GROWTH.

Edifice No. 4 is on the east side of the structure above described, and is separated from it by a narrow space only 5 feet wide. The chambers of this structure, nine in number, one being still intact, surround a solid, rectangular core of stone and rubble. This ruin, as it appeared when the forest trees and undergrowth were removed, is seen in Pl. XVII.

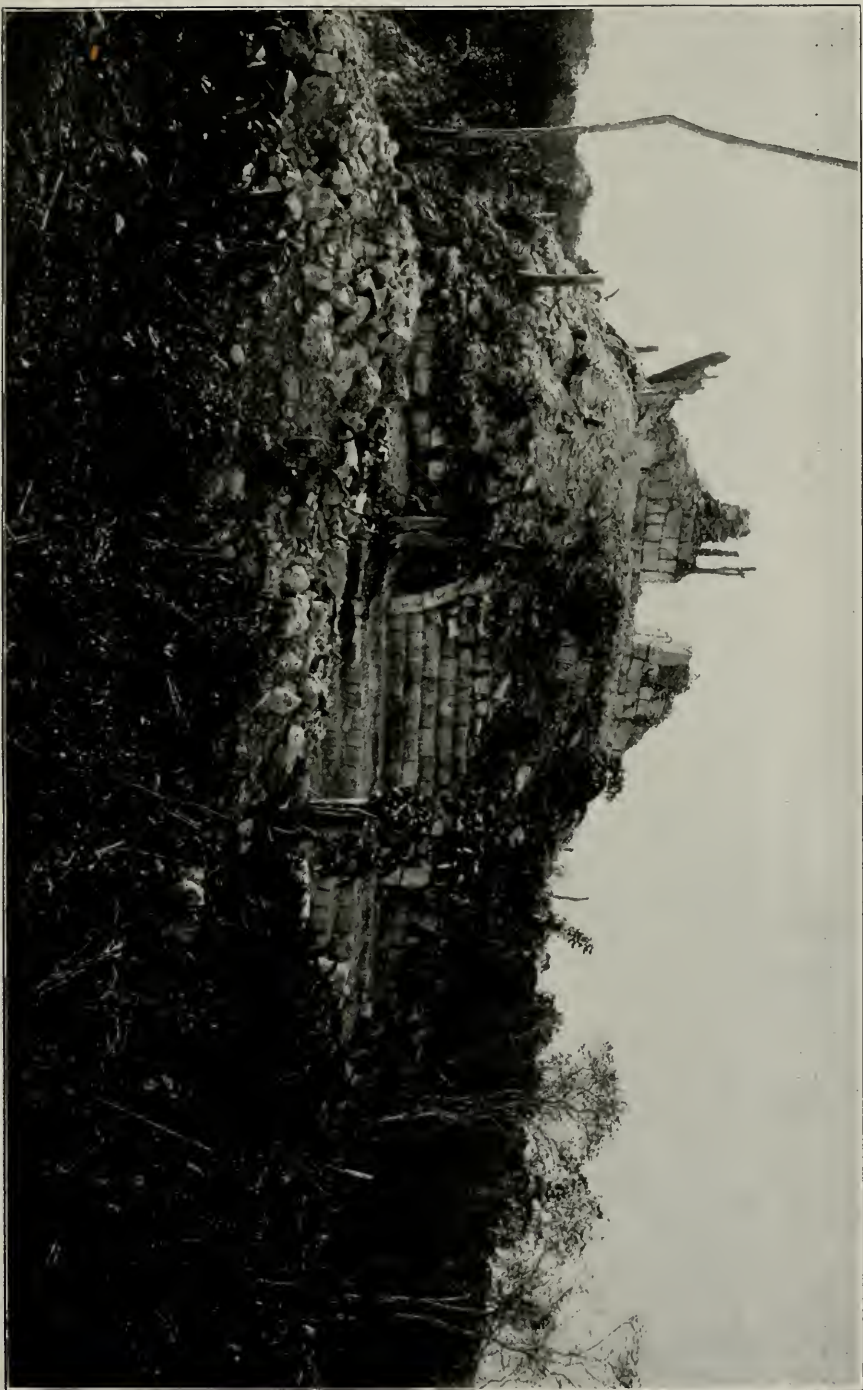
EDIFICE NO. 7, AFTER EXCAVATION, SHOWING STAIRWAY AND REMNANT OF FACADE.

When first examined all that could be noted of this ruin was a platform having upon its eastern edge a high, featureless mound. Excavation gradually developed the outline of a walled structure, one-storied and single-chambered, raised on a terrace 30 feet high and facing an enclosed courtyard. It communicated by stone stairways of various dimensions with the terrace facing it. (See Pl. XX.)

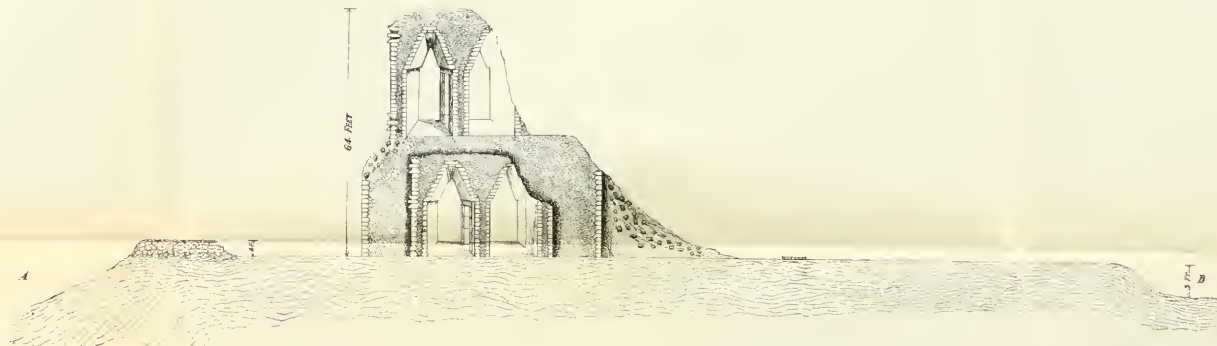
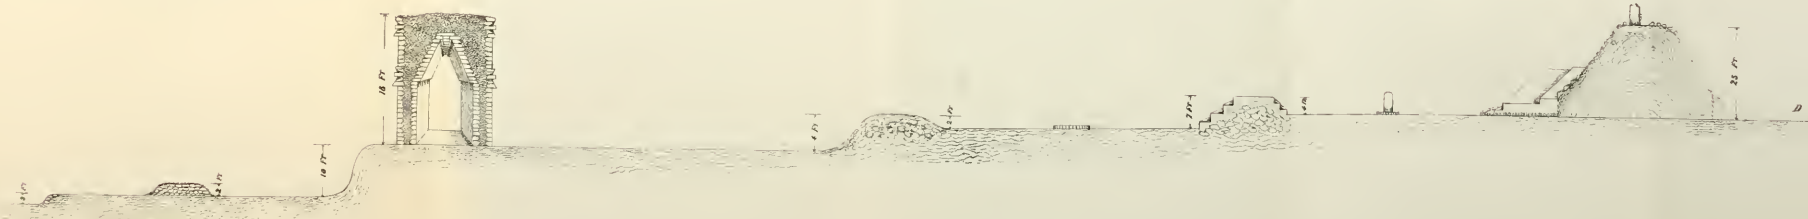
FIVE TRANSVERSE SECTIONS SHOWING ELEVATIONS OF GROUND PLAN (PL. XXV).
