Deep Water Capping

1. AGENCY USE ONLY (LEAVE BLANK)		2. REPORT DATE October 1995		3. REPORT TYPE AND DATES COVERED Final report	
4. TITLE AND SUBTITLE Deep Water Capping				5. FUNDING NUMBERS

9. SPONSORING/MONITORING AGENCY NAME(S) AND ADDRESS(ES) US Army Corps of Engineers-New England Division 424 Trapelo Road Waltham, MA 02254-9149				10. SPONSORING/ MONITORING AGENCY REPORT NUMBER DAMOS Contribution Number 98

DEEP WATER CAPPING

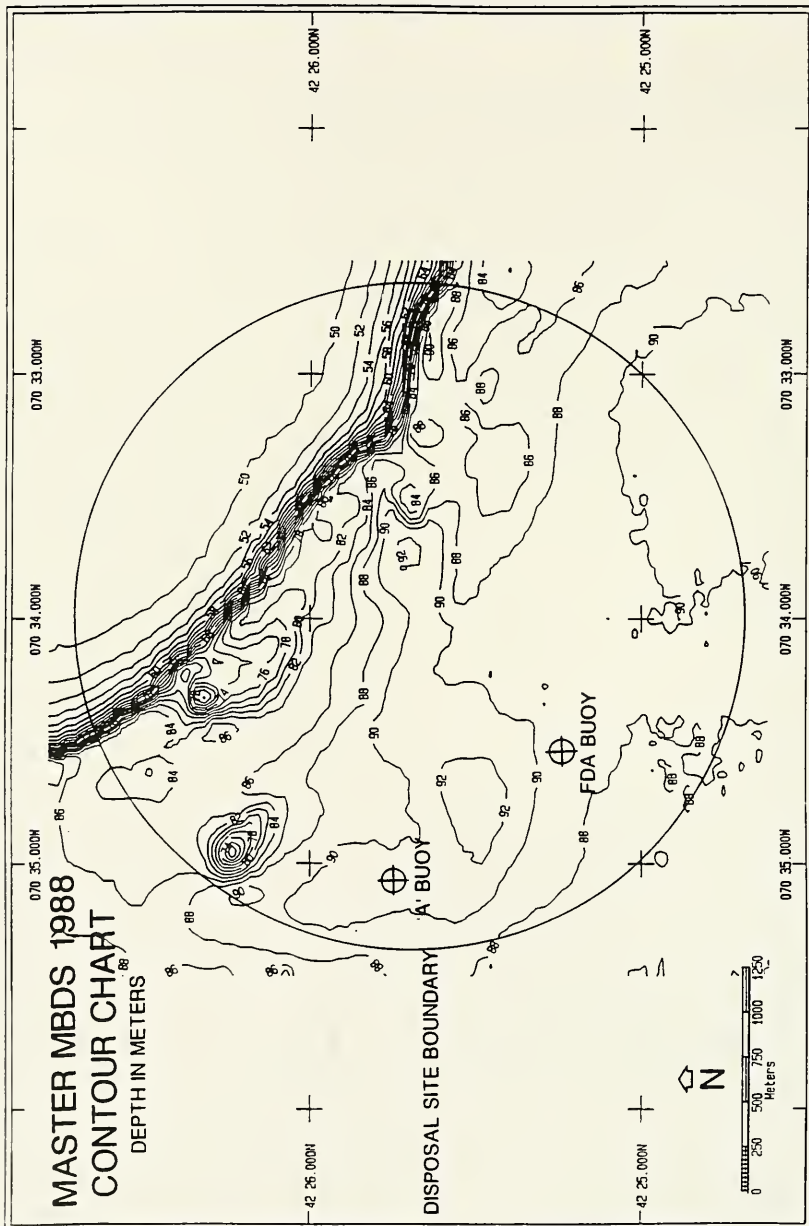
Figure 1-2. Bathymetric contour chart (depth in meters) of MBDS, November 1988

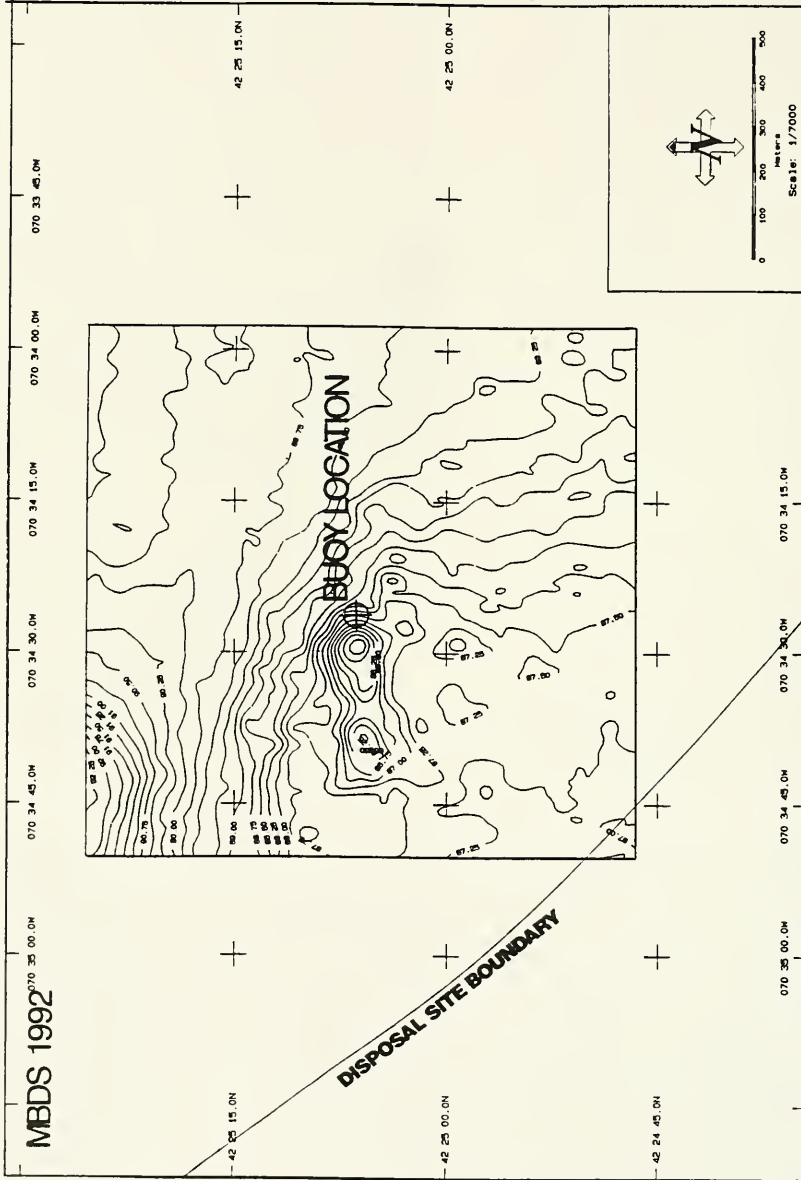
Figure 1-3. Bathymetric contour chart (depth in meters) of active disposal point at MBDS, 31 March 1992

The results from monitoring recent disposal operations at MBDS show that a distinct mound was formed at this site during these disposal operations. From 1987 to 1992, approximately 836,148 m³ of material dredged from the Boston area was deposited at the "MDA" (formerly the "FDA") buoy (SAIC 1990b, Germano et al. 1993). A bathymetric survey conducted in 1992 detected a mound over a 400 by 200 m area (Figure 1-3). From 1987 to 1990, a maximum of 0.8 m of material had accumulated to the east of the buoy location

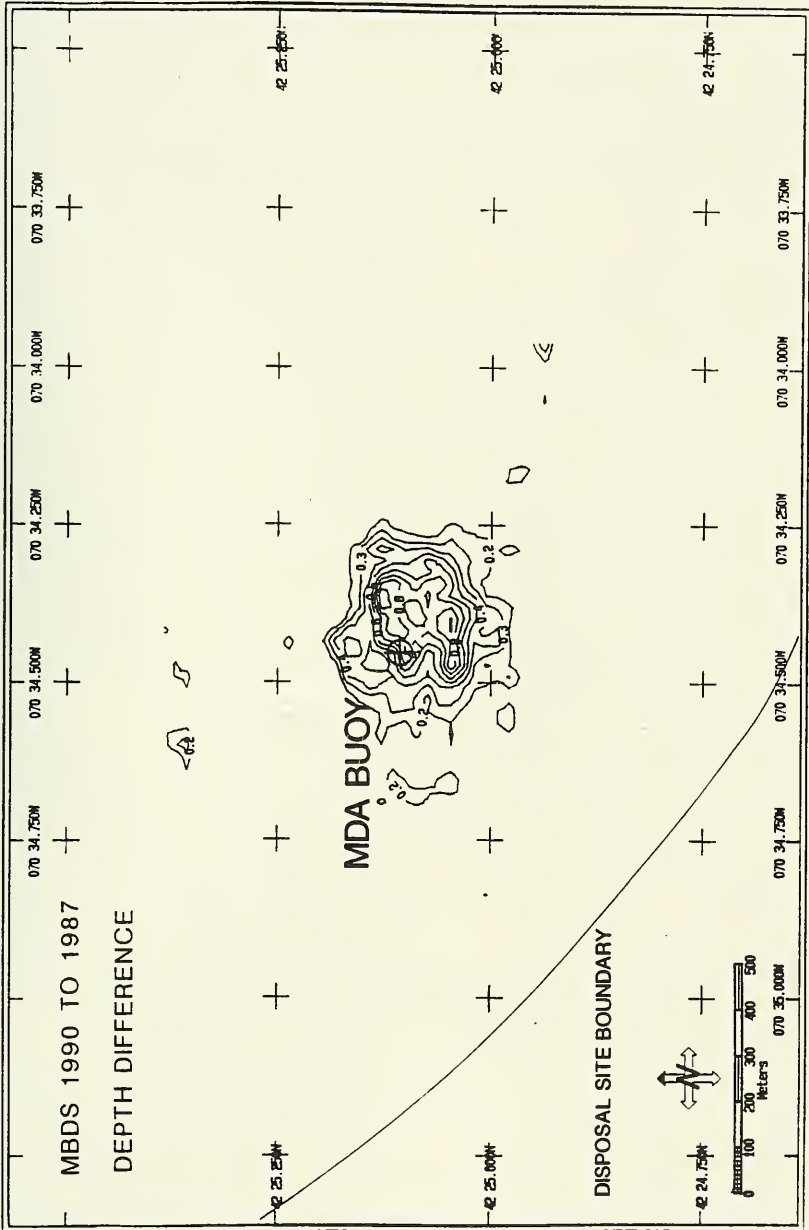
Figure 1-4. Depth difference contour chart (in meters) based on the comparison of 1990 and 1987 MBDS bathymetry

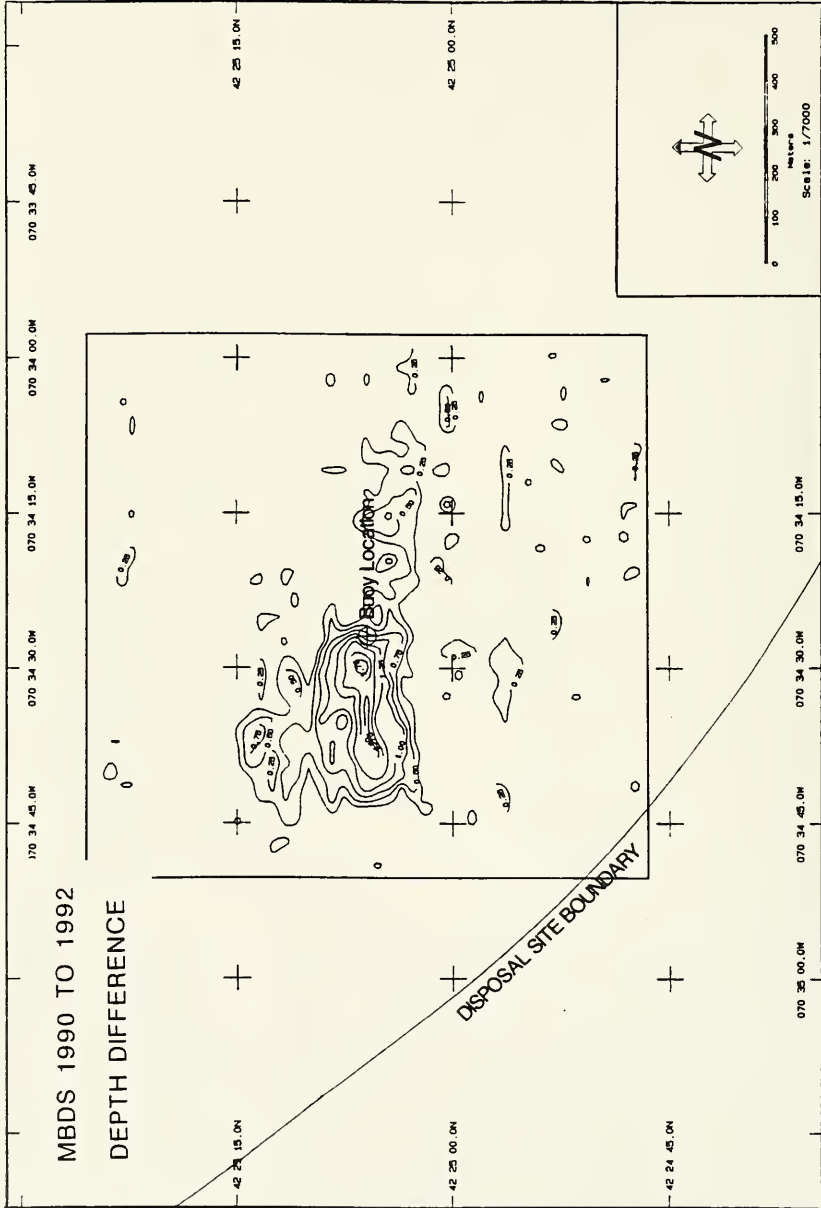
Figure 1-5. Depth difference contour chart (in meters) based on the comparison of 1990 and 1992 MBDS bathymetry

(Figure 1-4). From 1990 to 1992, up to 2.0 m of dredged material had accumulated west of the buoy location (Figure 1-5). The successful formation of a mound from these disposal activities suggests that the Boston Harbor material will also form a distinct dredged material mound at this site provided that tight control is exercised over disposal operations. Routine monitoring techniques (bathymetry and REMOTS[®] sediment- profile photography) can determine the areal extent of a discrete, stable deposit quite accurately, thereby allowing NED managers to direct subsequent disposal operations to form a cap over the initial mound.

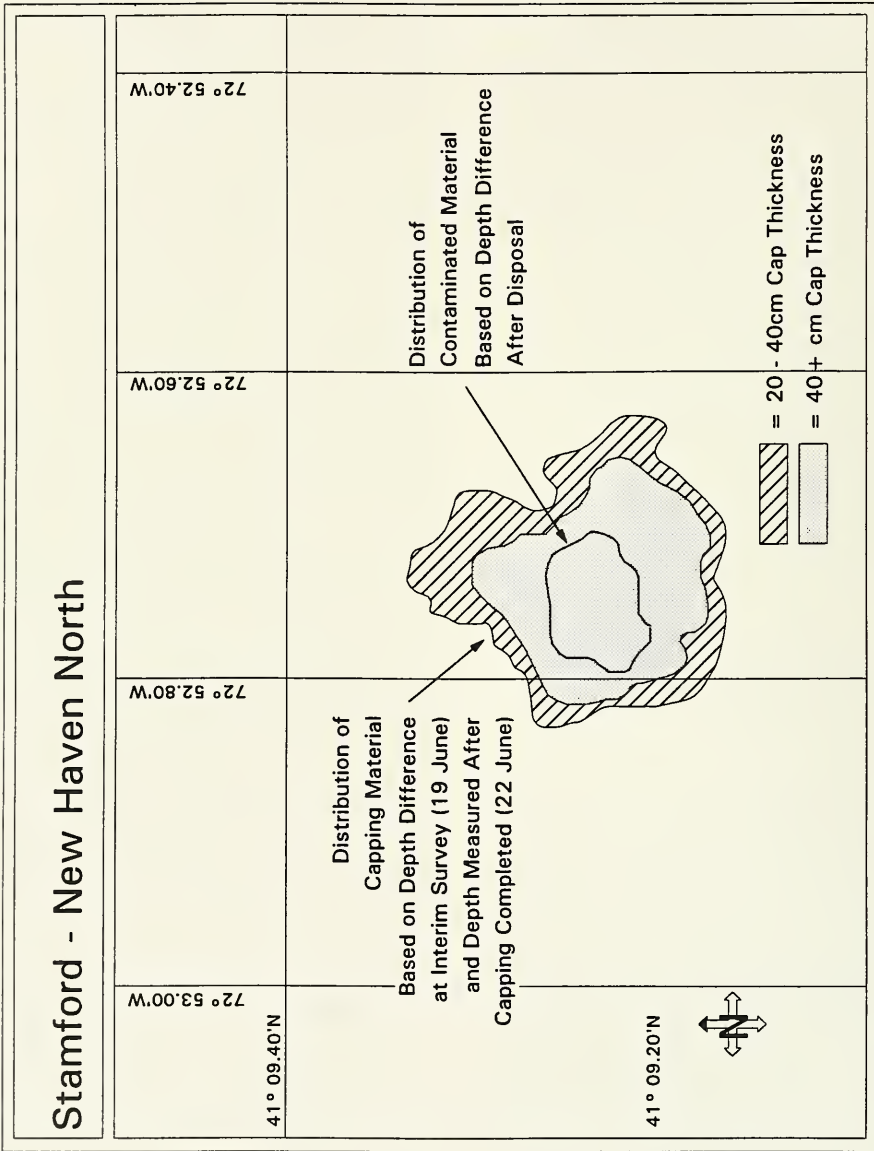
Figure 2-1. Distribution of dredged material at STNH-N (adapted from Fredette et al. 1992)

material completely covered the peak and flanks of the mound, extending its areal extent as well as its height (Figure 2-1). Cap coverage at STNH-S extended over most of the contaminated material (Figure 2-2). At CS-1 and CS-2, a LORAN-C fix was used as a location point for the disposal of cap material, and it was assumed that random error in placement would result in the correct distribution of the cap over the contaminated dredged material. At CS-2, the cap disposal points were concentrated to the west of the mound (Figure 2-3). Because a buoy existed as a stationary reference point, the cap material disposal points were close enough to the mound to cover it adequately. At CS-1 there was no buoy, and the barge operators relied only on LORAN-C coordinates to locate the cap material disposal location. As a result, the cap material at CS-1 was spread southwest of the disposal point by barges passing the release point as they steamed in from the northeast (Figure 2-4; SAIC 1987). These examples illustrate the importance of placement control for the contaminated dredged material and the cleaner cap material. Operational control over dredged material placement must be consistently applied to projects at all water depths to cap contaminated dredged material successfully.

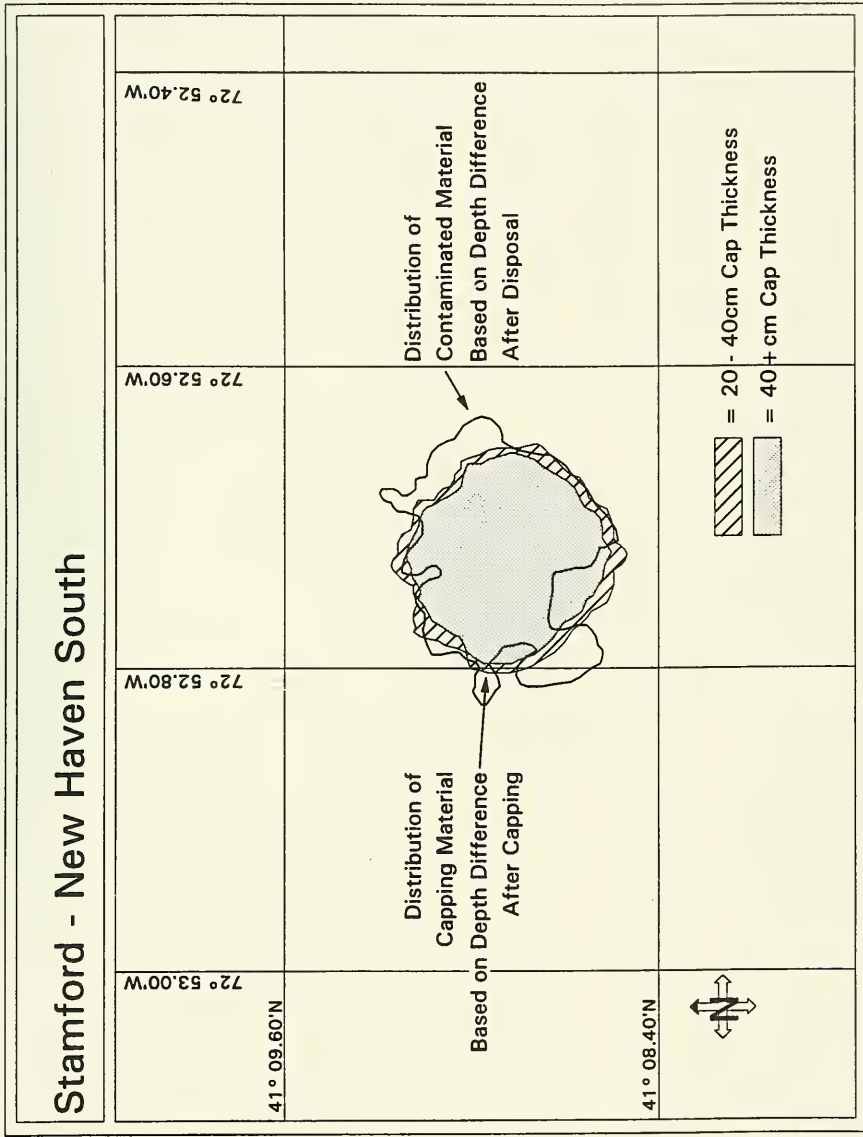
Figure 2-2. Distribution of dredged material at STNH-S (adapted from Fredette et al. 1992)

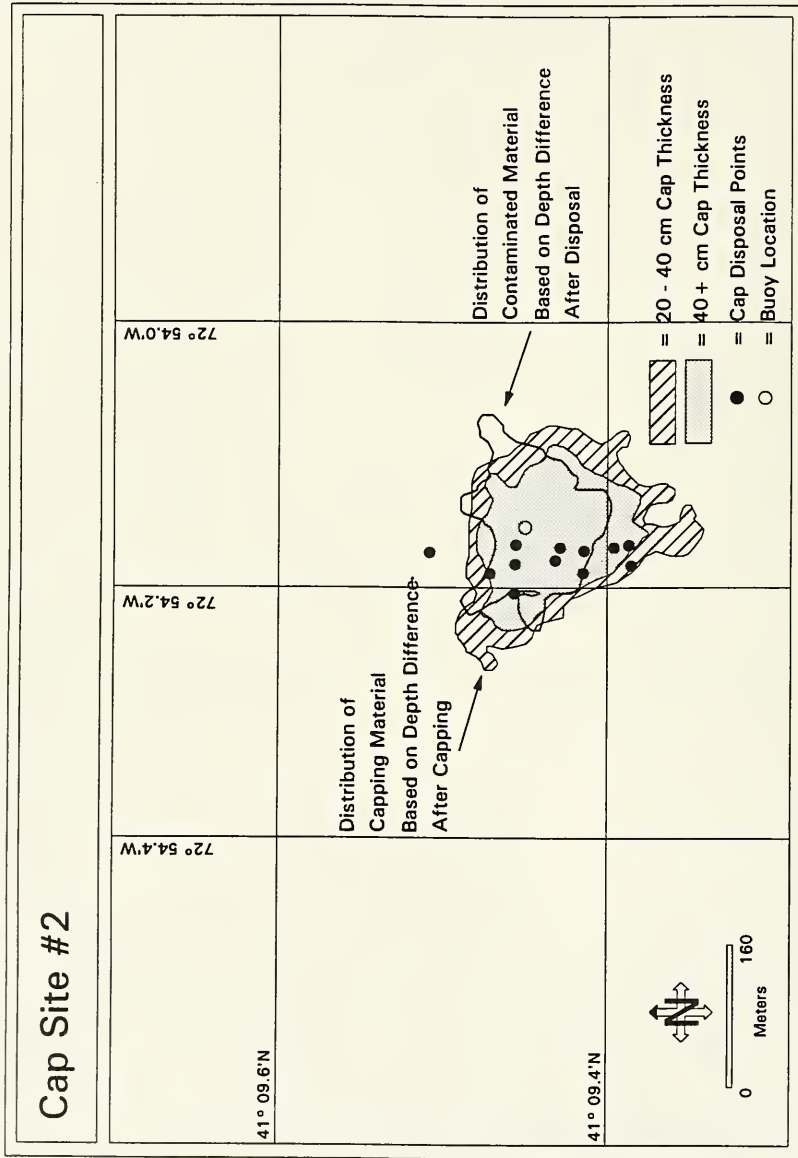
Figure 2-3. Disposal points for cap material at CS-2 with distribution of dredged material (adapted from Fredette et al. 1992)

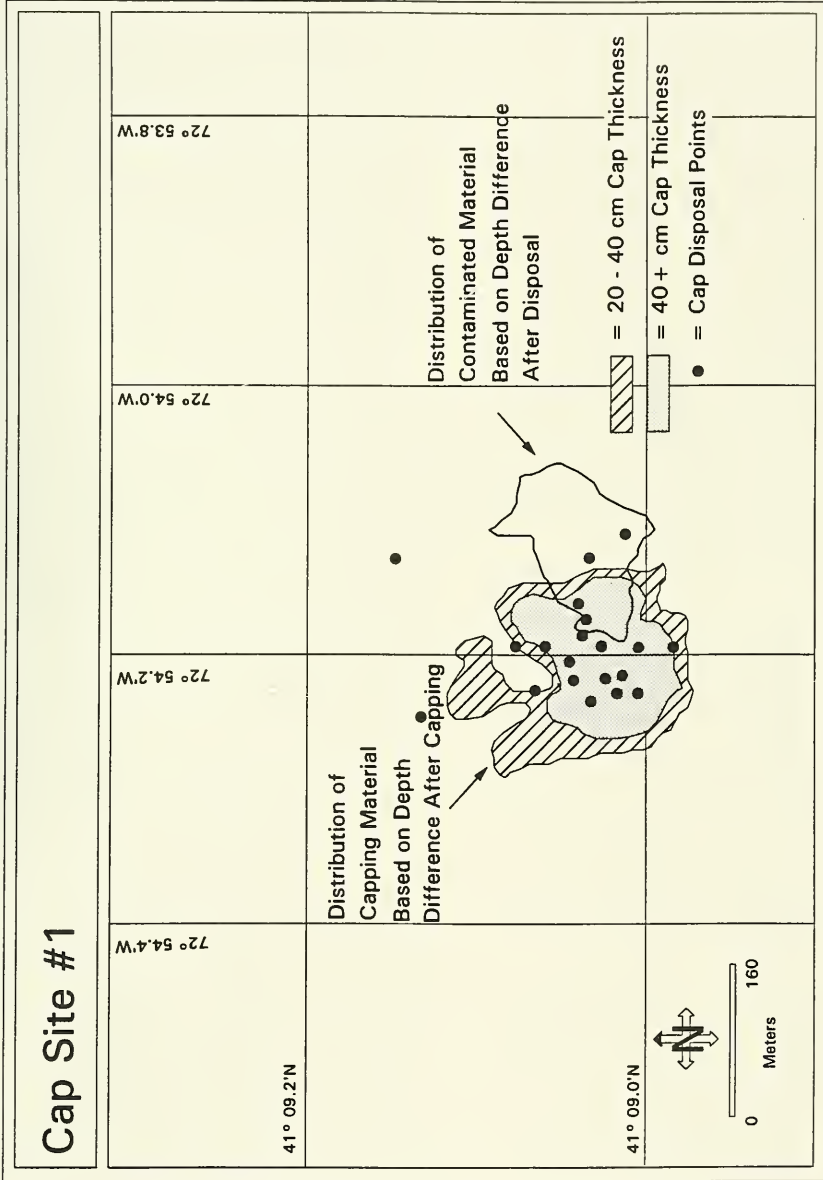
Figure 2-4. Disposal points for cap material at CS-1 with distribution of dredged material

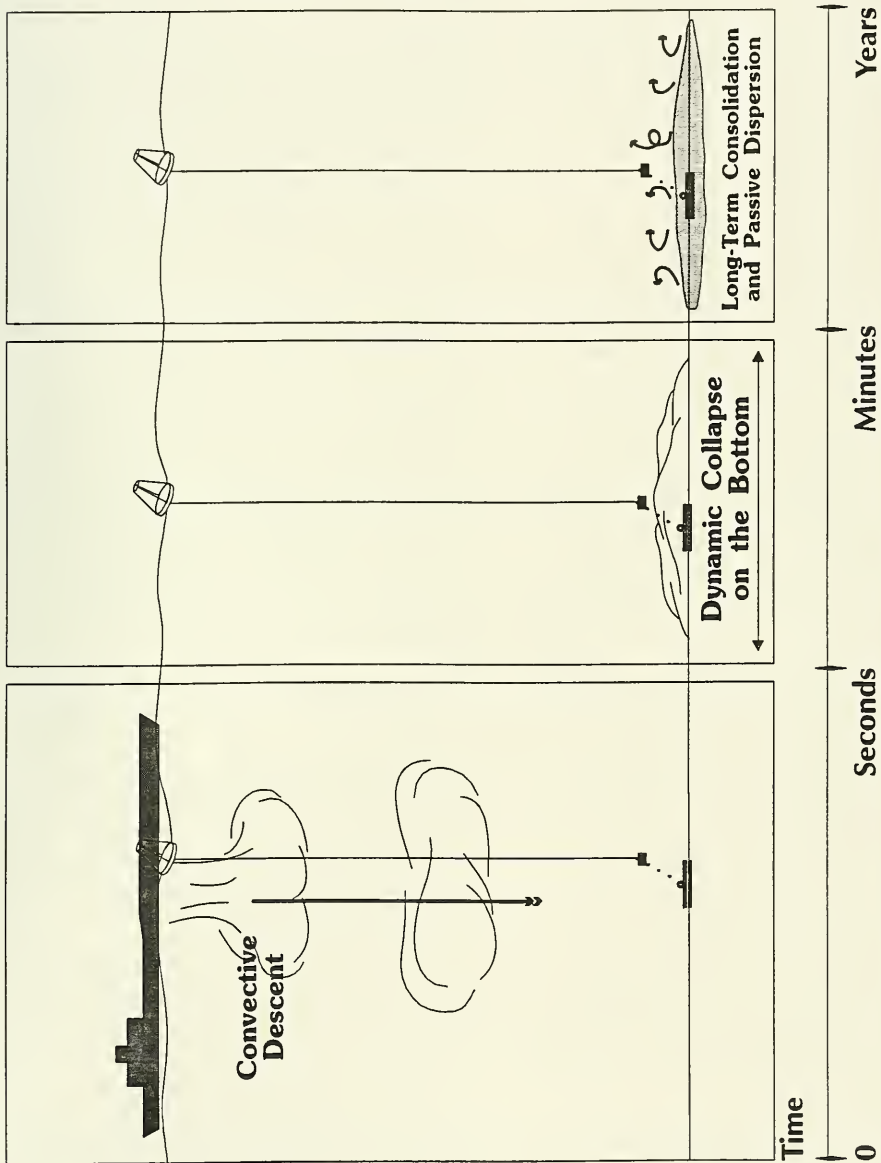
Figure 3-1. Schematic diagram of the phases encountered during a disposal event

Dredged materials go through three phases of descent independent of the water depth at the disposal site: convective descent, dynamic collapse, and passive dispersion (SAIC 1987; Figure 3-1). During convective descent, the material is transported to the bottom under the

influence of gravity. Sediments dredged with a clamshell dredge retain most of their consolidated nature during descent. At dynamic collapse, which occurs when the dredged material reaches the bottom (or a level of neutral buoyancy), the vertical momentum is transferred to horizontal spreading. The loss of momentum from the disposal operation initiates the passive dispersion phase where ambient currents and turbulence determine the transport and spread of material.

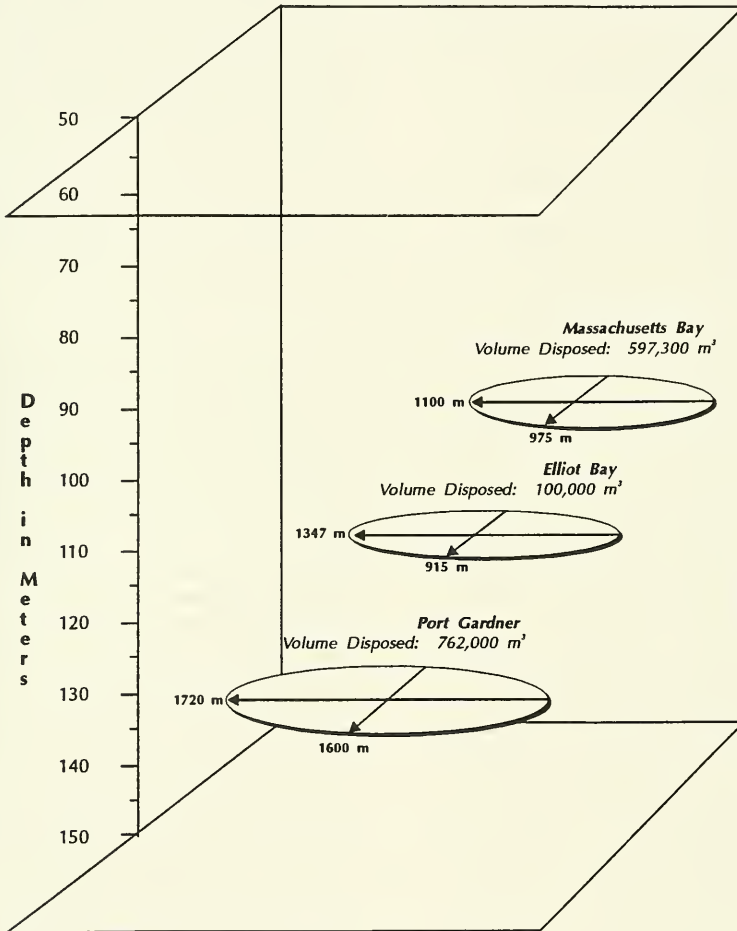
Figure 3-2. Area of dredged material mounds formed at Massachusetts Bay, Elliott Bay, and Port Gardner Disposal Sites

Distinct dredged material mounds have been mapped at five dredged material disposal sites where the water depth is greater than 25 m: Massachusetts Bay Disposal Site (MBDS; 90 m), Elliott Bay (108 m), in Seattle, WA, Port Gardner (132 m), in Everett, WA, Portland Disposal Site (60 m), and Rockland Disposal Site (65-80 m). MBDS, Elliott Bay, and Port Gardner have been proposed as possible locations for the capping of contaminated dredged material. The observation of well-defined dredged material mounds at these locations supports the feasibility of capping at sites ranging as deep as 130 m (Figure 3-2).

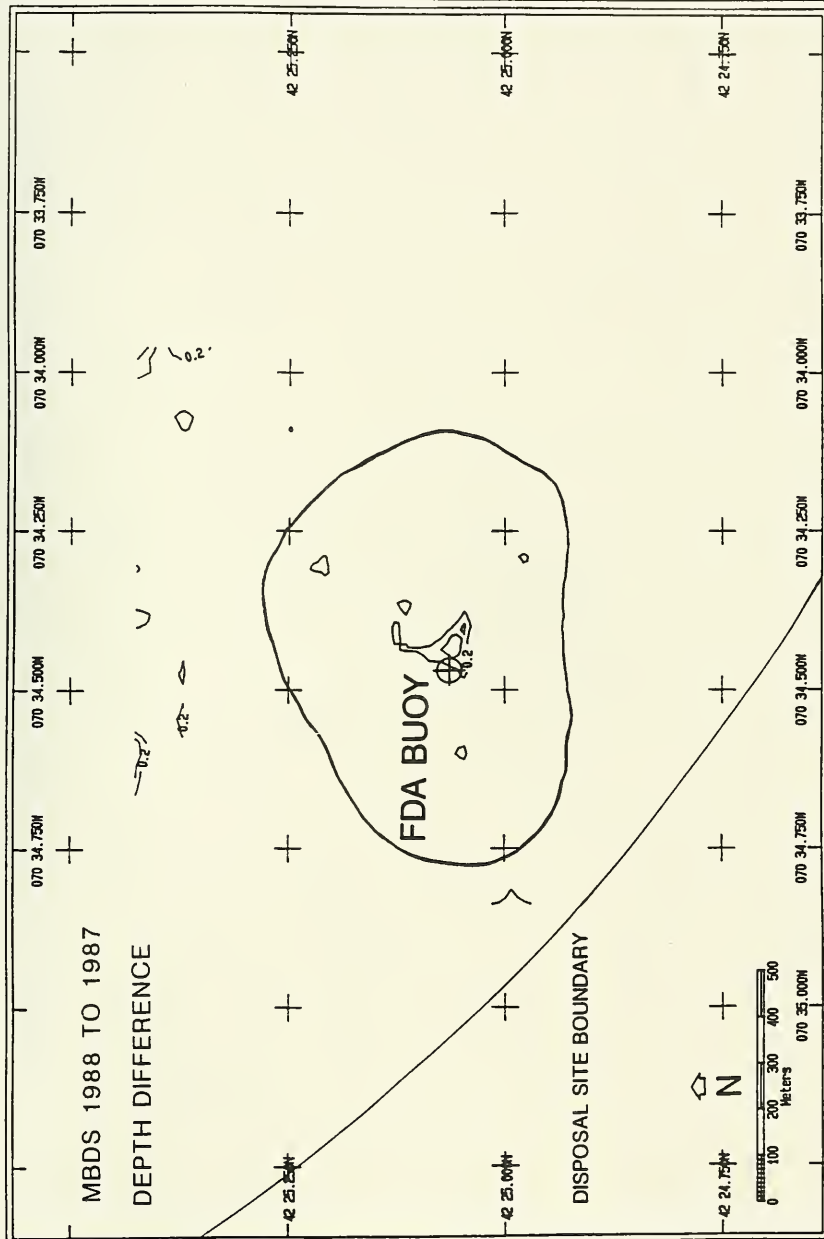
Figure 3-3. Depth difference (in meters) contour chart based on a comparison of 1988 and 1987 MBDS bathymetry. The area outlined indicated the extent of dredged material detected by REMOTS®.

Sequential surveys conducted from 1985 to 1992 have documented the development of a distinct disposal mound at MBDS. The volumes of dredged material released at MBDS annually since 1985 are listed in Table 3-1. Prior to 1985, disposal operations at MBDS were conducted using a conventionally moored buoy with a wide scope or only LORAN-C navigation. Acoustic bathymetric surveys at that time were unable to detect any dredged material mound (Bajek et al. 1987). In November 1985, a taut-wired buoy was deployed at a previously unused location in MBDS. An acoustic bathymetric survey conducted at the same area in 1987 still did not indicate any topographic features related to disposal. The REMOTS[®] sediment-profiling system, however, showed a large pancake-like deposit of dredged material (SAIC 1988). In 1988, a comparison of the 1988 and the 1987 bathymetric surveys was able to discern a layer of dredged material 0.3 m thick and 150 m in diameter (Figure 3-3). The REMOTS[®] survey detected flank deposits less than 20 cm thick at the edges and up to 900 m in diameter. A comparison of the 1990 bathymetry and the 1988 data indicated an additional thickness of 0.8 m and a diameter of

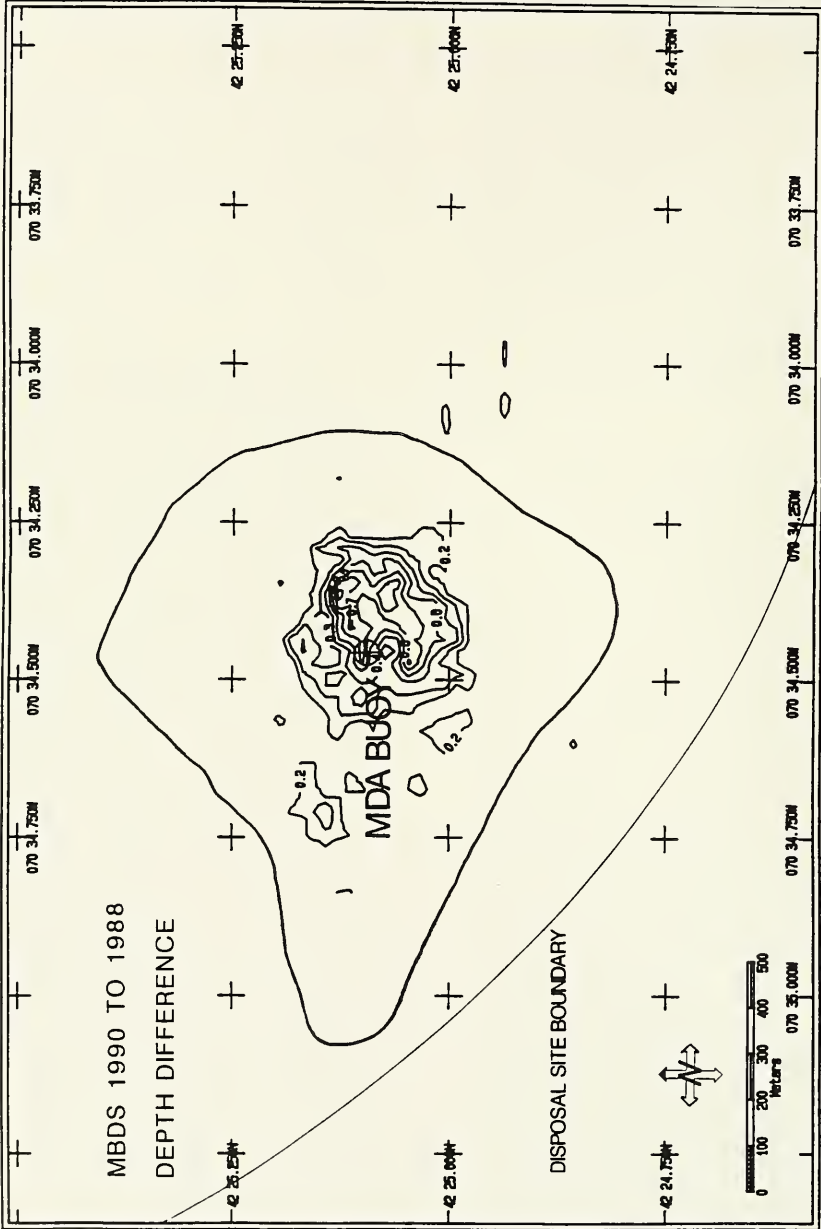
Figure 3-4. Depth difference (in meters) contour chart based on a comparison of 1990 and 1988 MBDS bathymetry. The area outlined indicates the extent of dredged material detected by REMOTS®.

420 m (Figure 3-4). The REMOTS[®] survey in 1990 recorded fresh dredged material up to 800 m west of the buoy location (Germano et al. 1993). The barge release locations from 1987 to 1990 indicated that most disposal points were 400 m from the buoy (Figure 3-5). From 1990 to 1992 the dredged material thickness increased by 2 m west of the buoy and covered an area 200 by 400 m (Figure 1-5). The barge release locations from 1990 to 1992 indicated that disposal locations again were within 400 m of the buoy location (Figure 3-6).

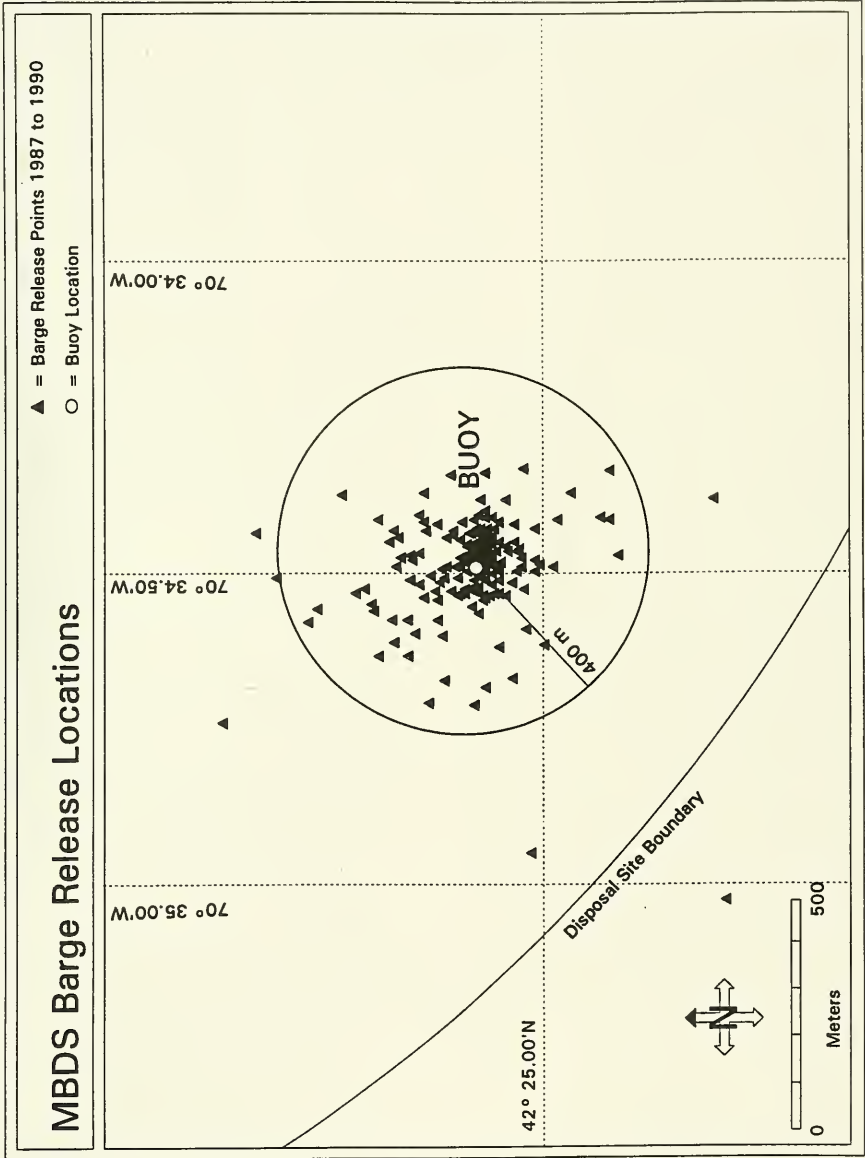
Figure 3-5. A plot of the barge release points indicating that the majority of barges released dredged sediment within 400 m of the buoy location from 1987 to 1990

larger area of dredged material detected by the REMOTS® survey could be due to the release of dredged material at a distance from the disposal point or to the spread of dredged material in deeper water depths. The cohesive nature of the dredged material found away from the disposal location and the reported location of barge release points indicate that the large area of dredged material may be due to releasing material away from the buoy. A plot of the barge release locations, which were LORAN-C positions reported in the barge logs rather than actual positions printed out on the tug, showed dredged material released at a distance from the disposal point up to 400 m from the buoy (Figure 3-5).

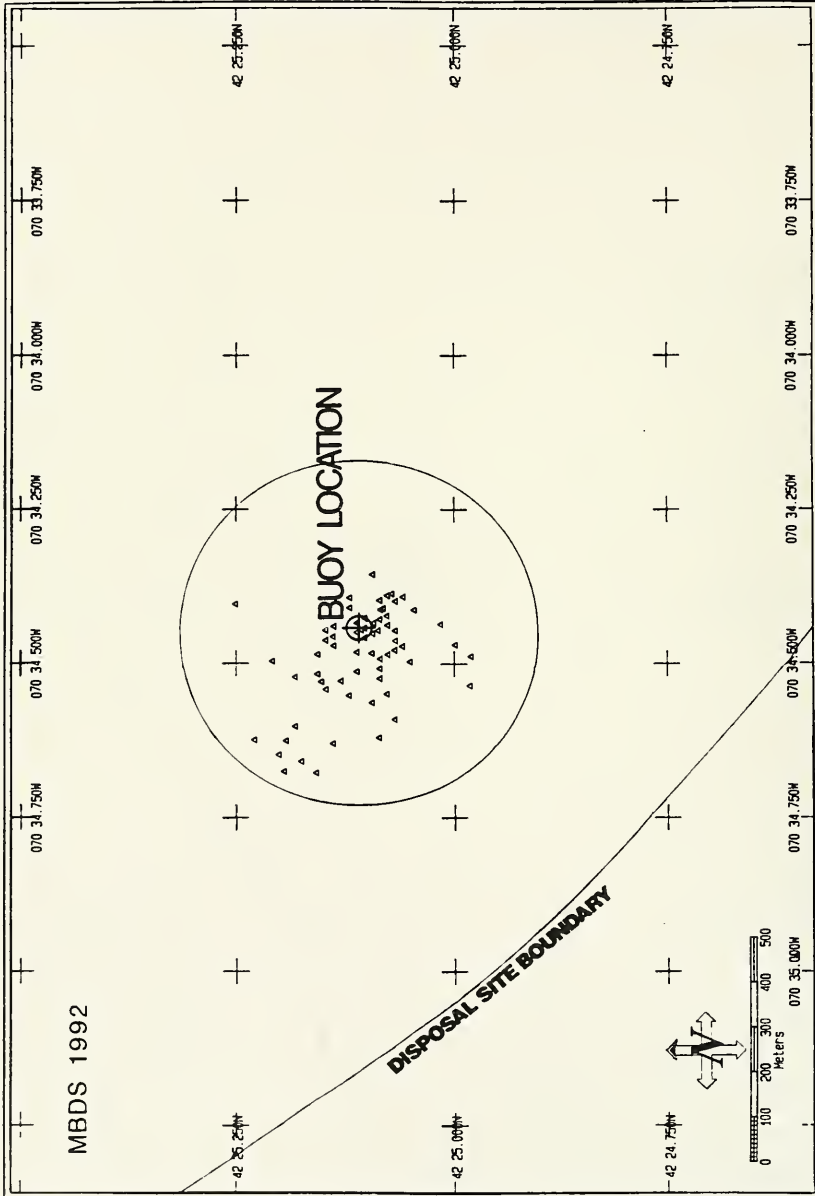
Figure 3-6. Barge release locations, September 1990 to March 1992

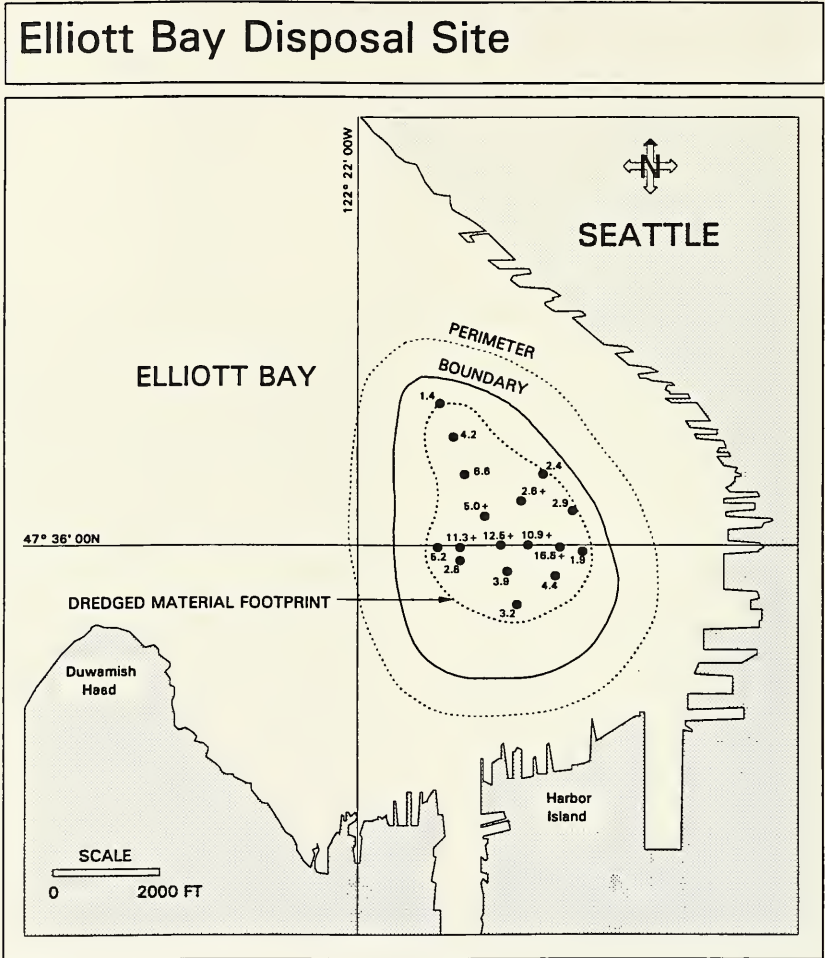
Figure 3-7. The distribution of dredged material (cm) at the Elliott Bay disposal site as detected by REMOTS®. The solid line is the site boundary; the dashed line is the site perimeter. The "+" indicates dredged material greater than penetration.

disposal site boundary with no evidence of dredged material in any of the perimeter stations (Figure 3-7). At Port Gardner, approximately 762,000 m³ of dredged material were released in the winter of 1989/1990. As at Elliott Bay, barges were allowed to open their doors in a 183 m radius target zone at the center of the site. The REMOTS® survey at Port Gardner showed dredged material at all stations within the boundary and eight stations outside the boundary (Figure 3-8). Prior to disposal, Port Gardner was modeled using the DIFID (Disposal From Instantaneous Dump) model from the US Army Engineer Waterways Experiment Station (WES) to predict the distribution of dredged material. The model correctly predicted areas of thick deposits but did not predict areas of thin cover to the west (Figure 3-9). The thin cover is > 3 cm thick at the perimeter stations.

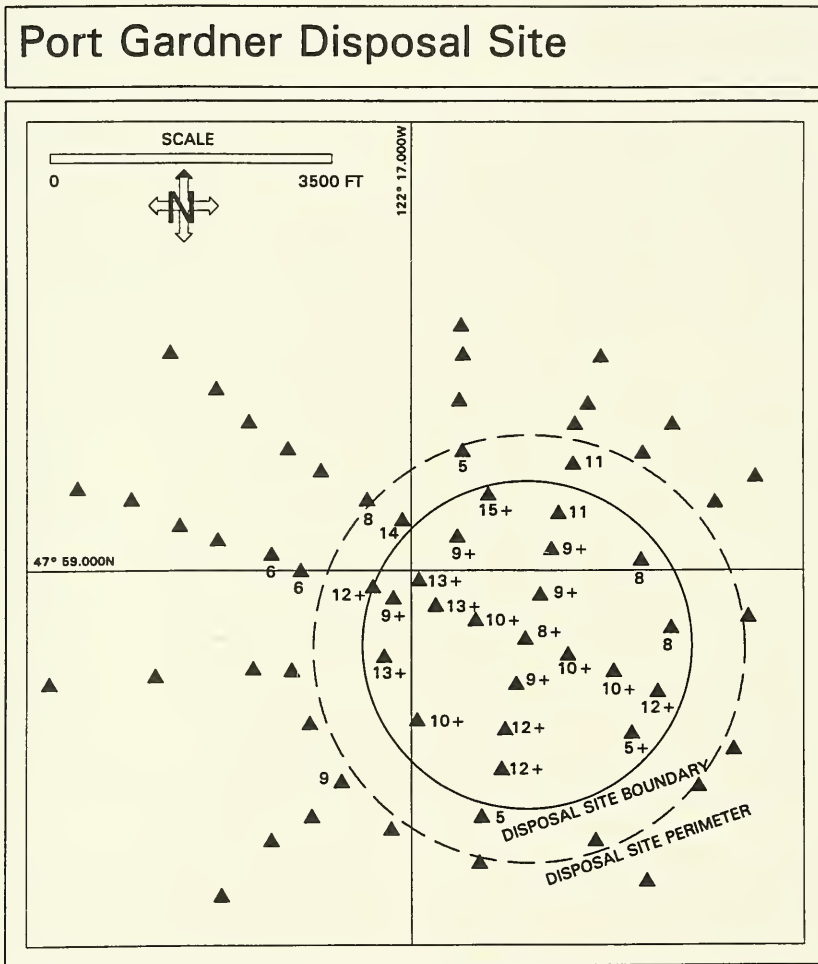
Figure 3-8. The distribution of dredged material (cm) at Port Gardner disposal site as detected by REMOTS® survey. The solid line is the site boundary; the dashed line is the site perimeter. The "+" indicates dredged material greater than penetration.

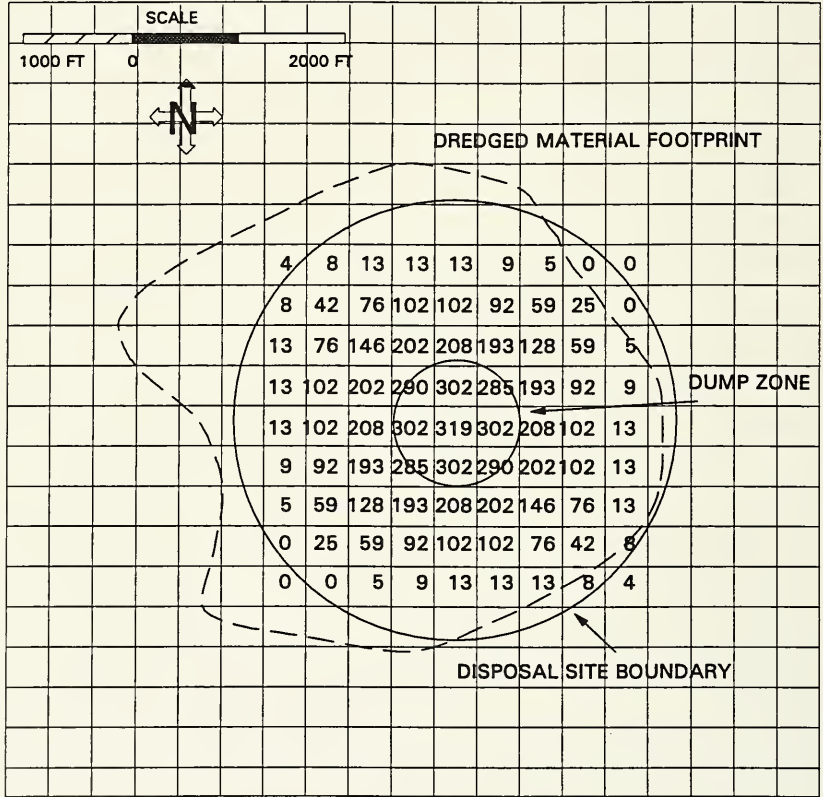
Port Gardner PSDDA Disposal Site

Figure 3-9. DIFID model prediction of dredged material distribution (cm) at Port Gardner

The height and lateral extent of a mound that would be formed by dredged material disposal was modeled for MBDS and for the Port Gardner Disposal Site. For the approximately 836,148 m³ of silty dredged material deposited at MBDS from 1987 to 1992, the DAMOS capping model predicted a mound height of 4.22 m and a radius of 600 m. At Port Gardner, the model incorporated a 10 cm·s⁻¹ NW/SE bottom current and predicted a dredged material footprint of 2000 m radius and 3.19 m mound height for the 762,000 m³ of dredged material released within a 183 m radius target zone.
