Nestucca

Watershed Analysis

October 1994

USDA Forest Service
Siuslaw National Forest

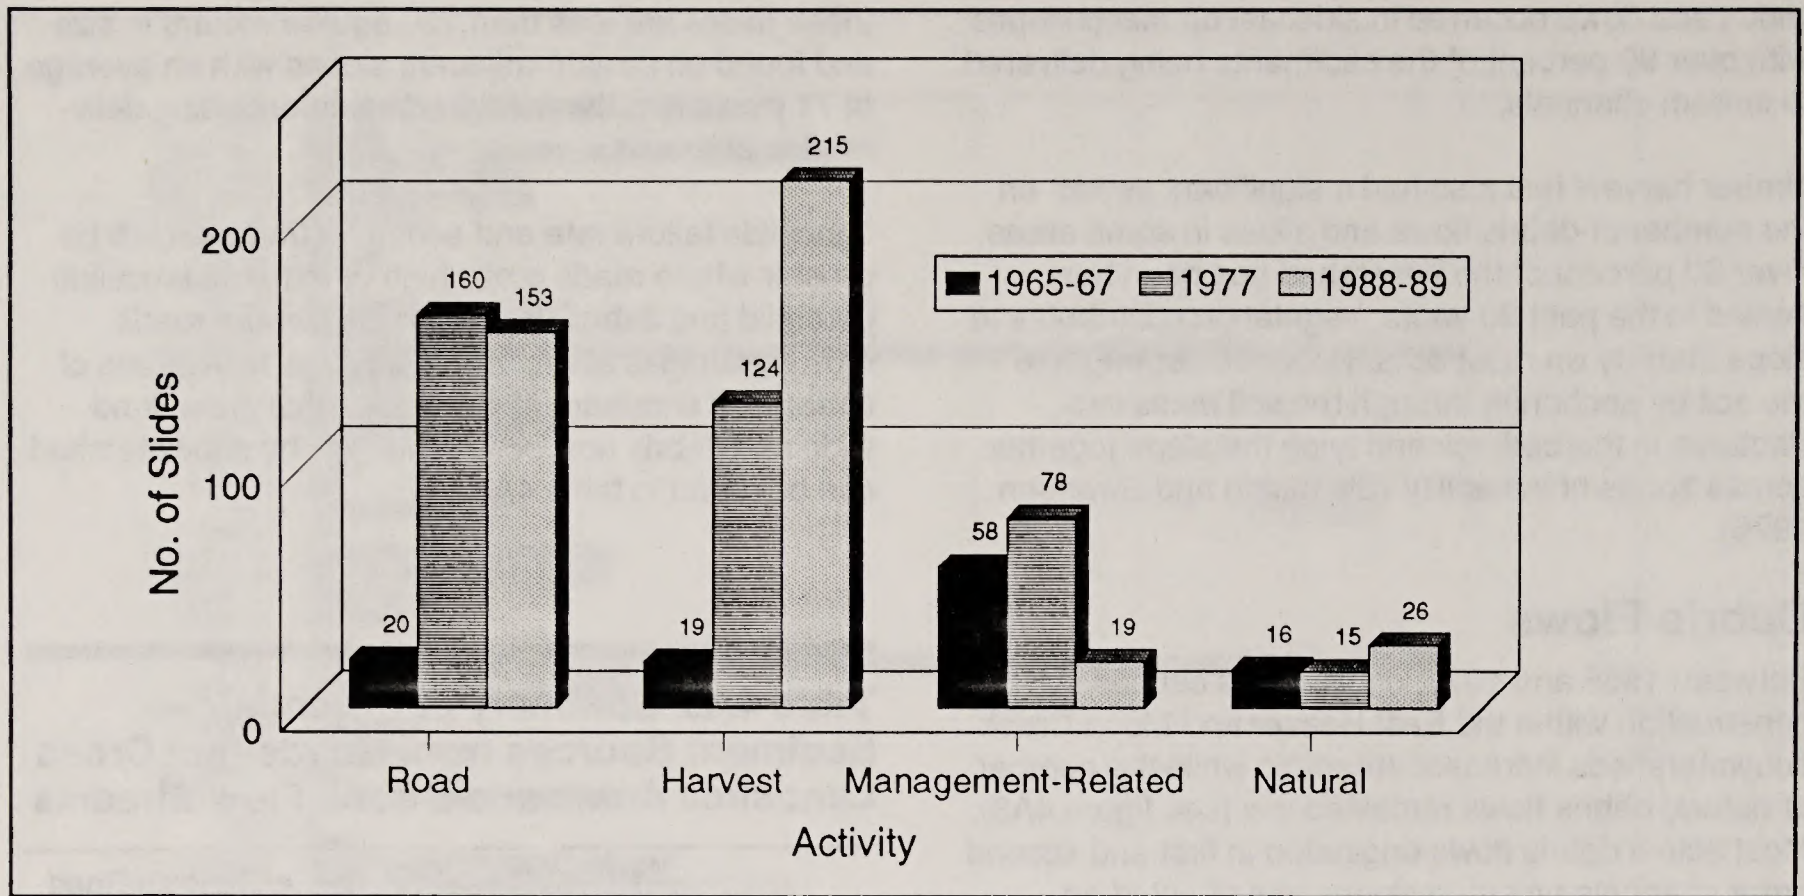
Figure 4A3 East Beaver and Moon Creek Active Debris Slide by Activity and Photo Year
 Management-related debris slides are associated with road and harvest activities, however, a probable cause was not evident on aerial photos.

Between 1965 and 1977, debris flows caused by road construction within the East Beaver and Moon Creek subwatersheds increased threefold while the number of natural debris flows remained low (see figure 4A3). Most active debris flows originated in first and second order channels on steep slopes and affected an average of 230 feet of channel; over 90 percent of sediments were delivered to the stream. Increased precipitation and runoff during the 1972 flood event, poor road location and construction, and road surface runoff increased failure rates.

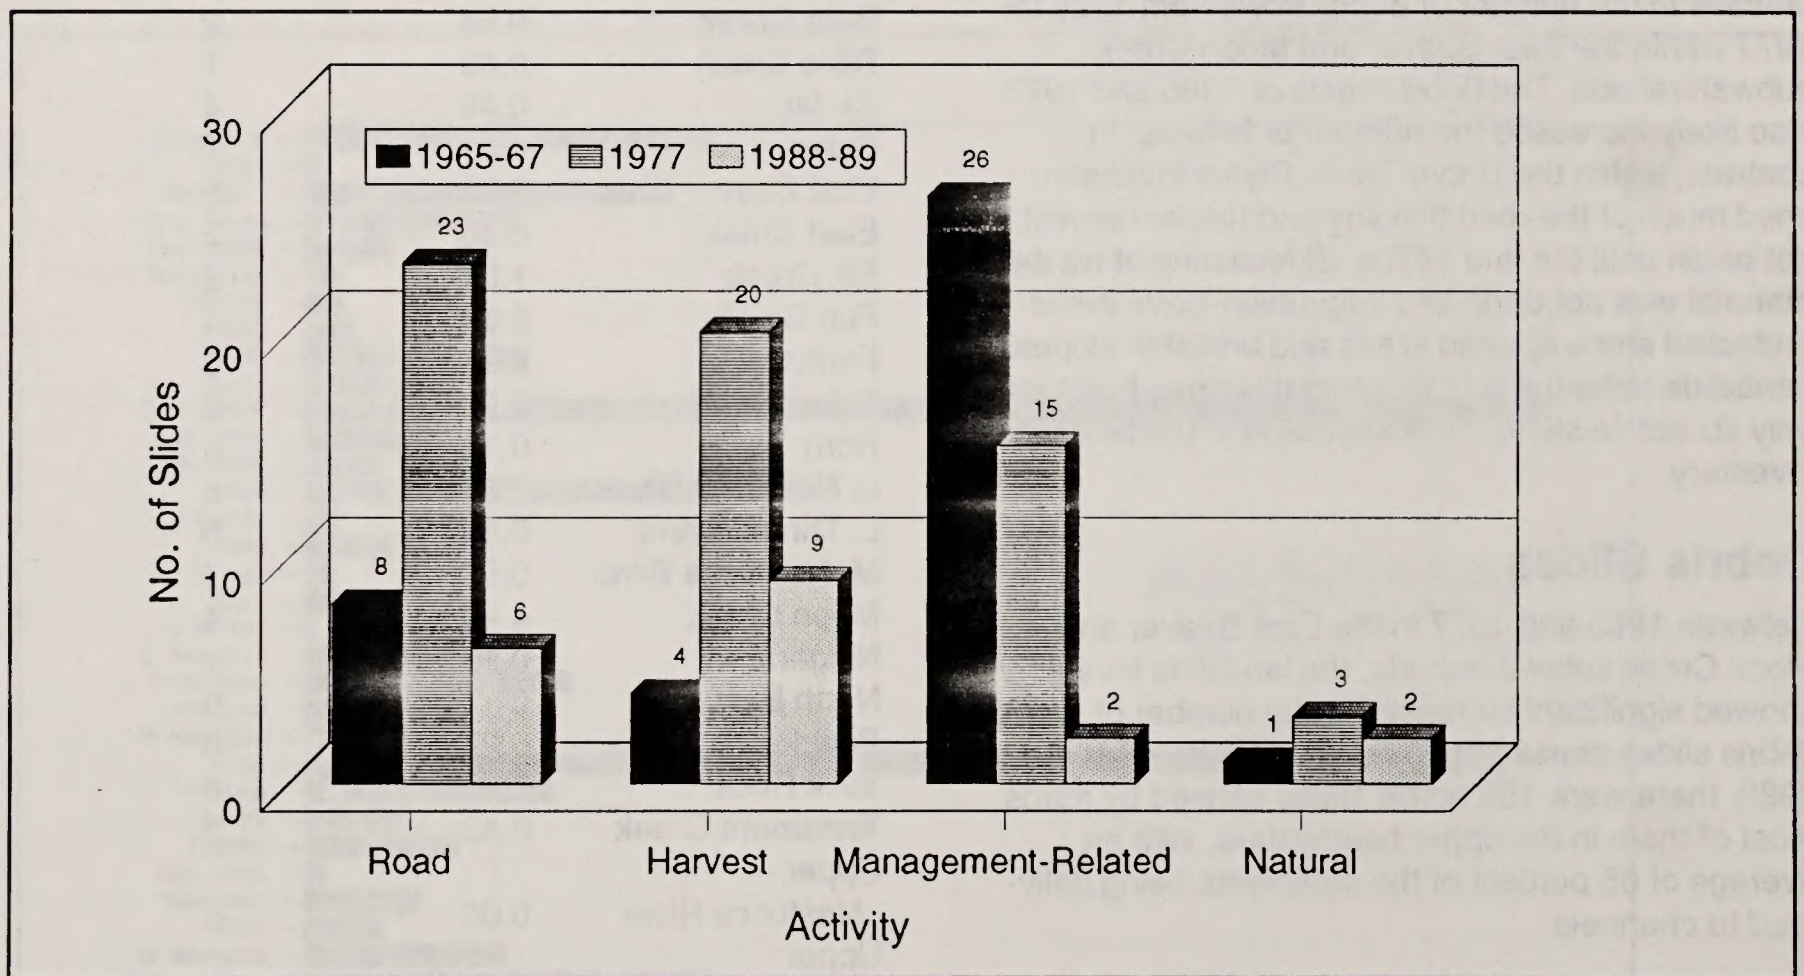
Figure 4A4 East Beaver and Moon Creek Active Debris Slide by Activity and Photo Year
 Debris flows caused by management activities increased after 1972 storm event. Management-related debris slides are associated with road and harvest activities, however, a probable cause was not evident on aerial photos.

Between 1965 and 1977 in the East Beaver and Moon Creek subwatersheds, the landslide inventory showed significant increases in the number of active debris slides caused by roads (see figure 4A4). As of 1989, there were 153 active slides caused by roads, most of them in the upper headwaters, with an average of 65 percent of the sediments being delivered to channels.
