# FLOOD HAZARD STUDY,

## DUGAN RUN,

Champaign County, Ohio

June 1967

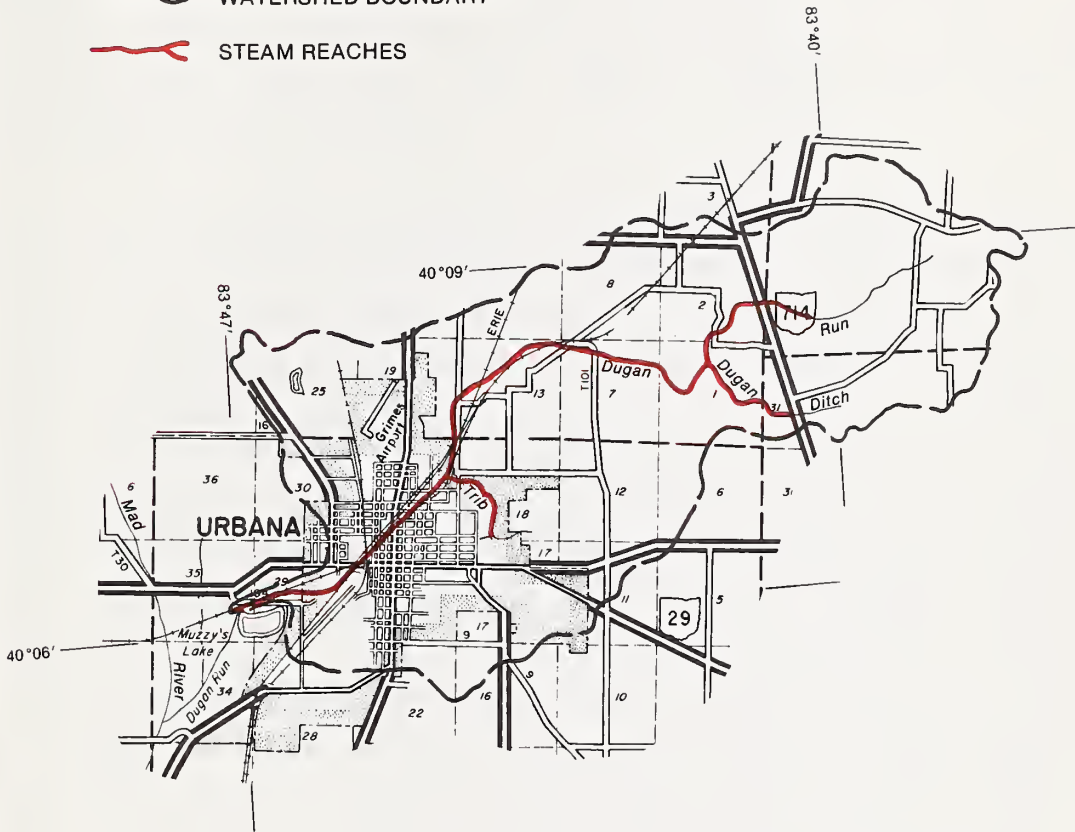
**FLOOD HAZARD STUDY AREA  
VICINITY MAP**

**DUGAN RUN**

CHAMPAIGN COUNTY, OHIO

The Dugan Run Watershed comprises 20.7 square miles and is located in central Champaign County. Champaign County lies in west-central Ohio approximately 40 miles west of Columbus. The stream flows to the southwest through the City of Urbana where it joins the Mad River, a tributary of the Great Miami River. The watershed is located in the designated U.S. Water Resources Council Region 05 (Ohio River), subregion 08, and is within USGS Hydrologic Unit 05080001 (See Figure 1).

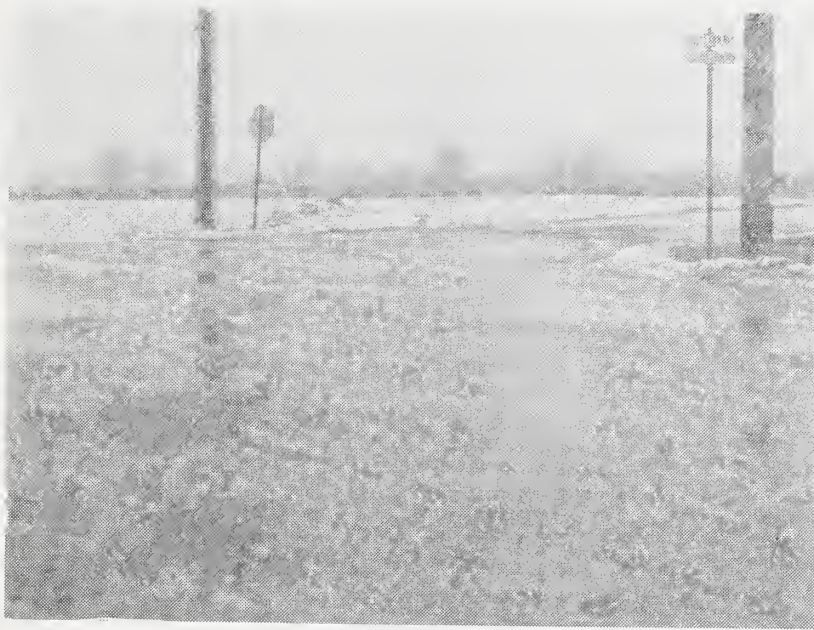
**Figure 2: Past Flooding**

**Flooding at Intersection of East Lawn Avenue and  
Children's Home Road                      February 3, 1982**

Potential flood areas exist along all the streams as outlined in this report, however, the primary flood damage area in the watershed is through the city of Urbana. Flooding of streets, intersections, and basements occurs annually.

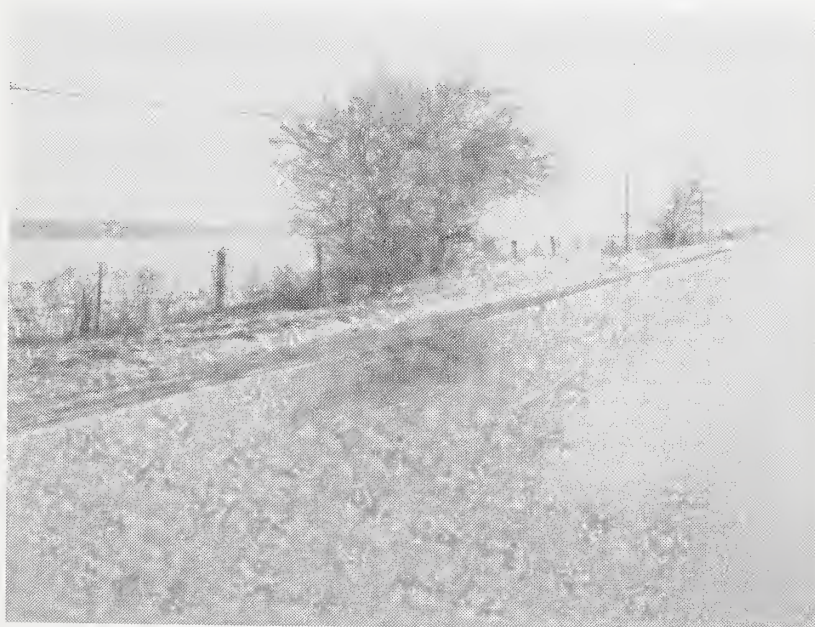
**Flooding Along State Route 714                      February 3, 1982**

Storm runoff from the hilly upland areas east of State Route 714 concentrates in a natural storage basin between State Route 714 and Dugan Road to the west. This area is characterized by level, very poorly drained soils on an old glacial lakebed (reference 3). Floodwaters spread out over this cropland area dissipating the magnitude of peak discharges downstream. Proceeding downstream in the watershed through Urbana to the mouth of Dugan Run peak discharges again increase in magnitude.

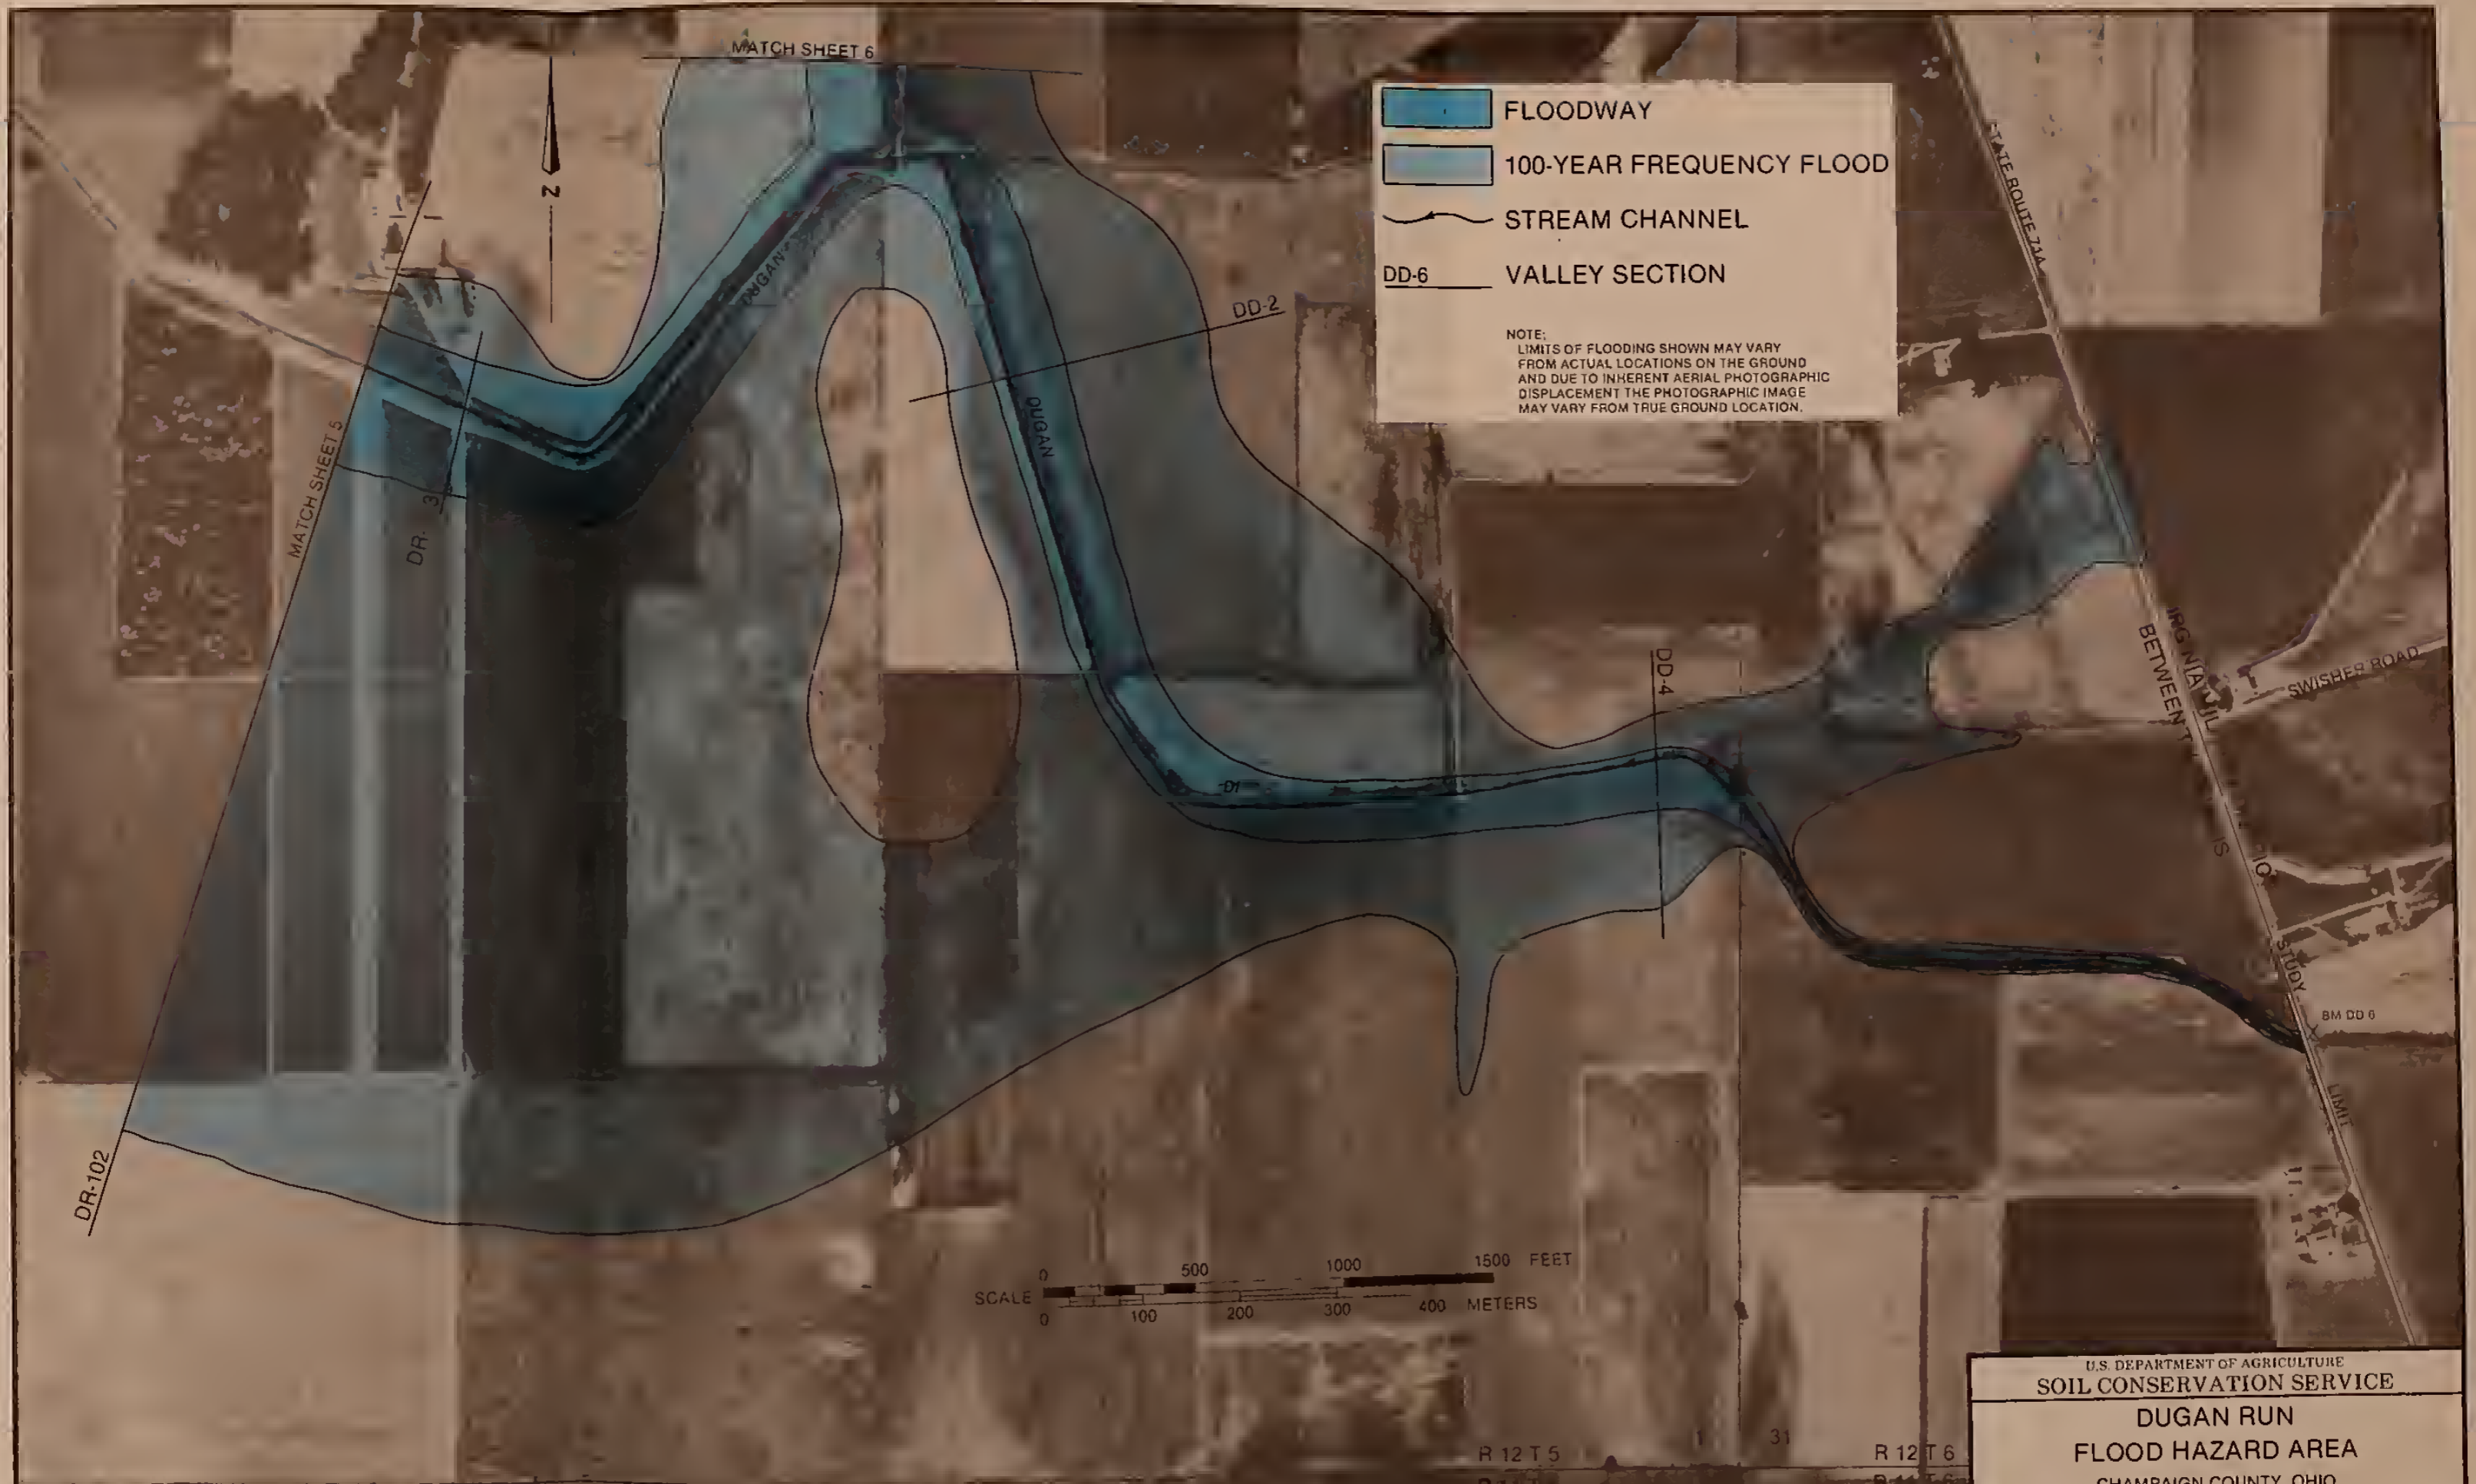
MARCH 1982 SHEET 7 of 7

**DUGAN RUN  
 FLOOD HAZARD AREA**

The photomosaics (Appendix A) are photographs put together to form the desired photographic coverage of the stream reach being studied. These maps include the location of cross sections, known landmarks, benchmarks, and the area bound by the theoretical floodway and the 100-year flood. The determination of the flood boundary lines in Appendix A is based upon existing topographic data. For specific site evaluations, it is recommended that field elevations be compared directly to flood profile elevations in Appendix B.

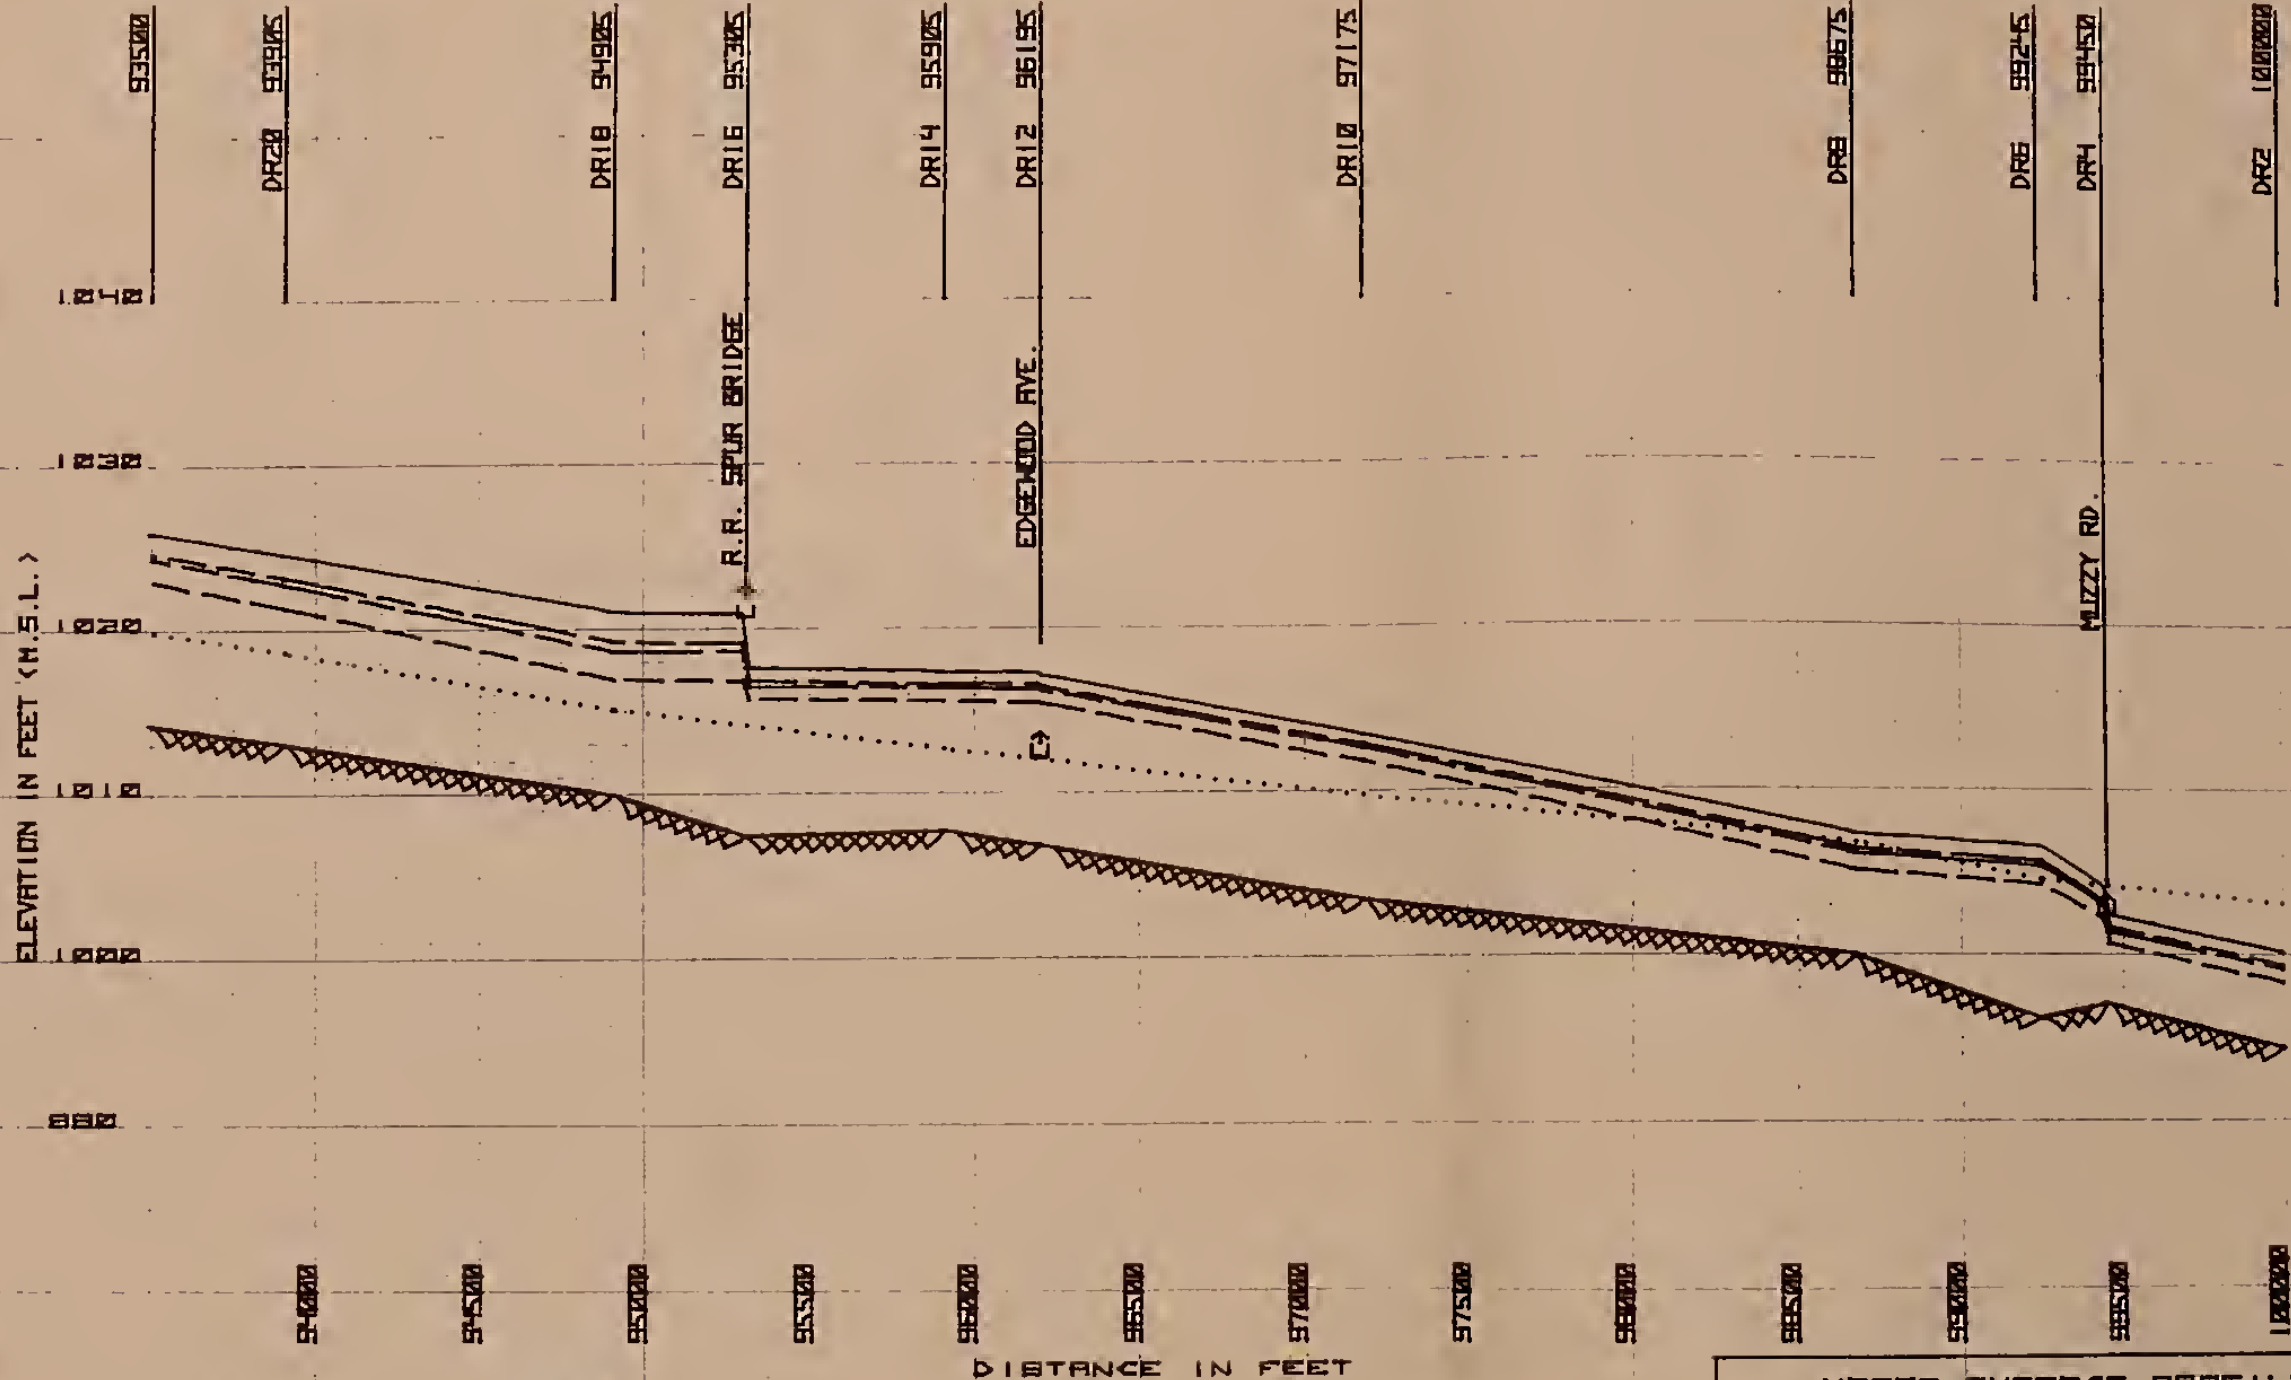
**DUGAN RUN**  
 SOIL CONSERVATION SERVICE  
 SHEET 1

WATER SURFACE PROFILES  
 DUGAN RUN F.H.B.  
 CHAMPAIGN CO., OHIO

The plotted water surface profiles in Appendix B show the location of cross sections and roads crossing the streams and the elevation of the water surface for the 10, 50, 100, and 500-year floods. The water surface elevation at a particular location can be found by: (1) locating the point in question on the photomosaics (Appendix A); (2) measuring the distance along the stream to the nearest cross section; (3) locating the selected cross section along the profile in Appendix B; and (4) measuring the same distance horizontally to the desired point. The water surface elevation can then be read from the vertical scale.

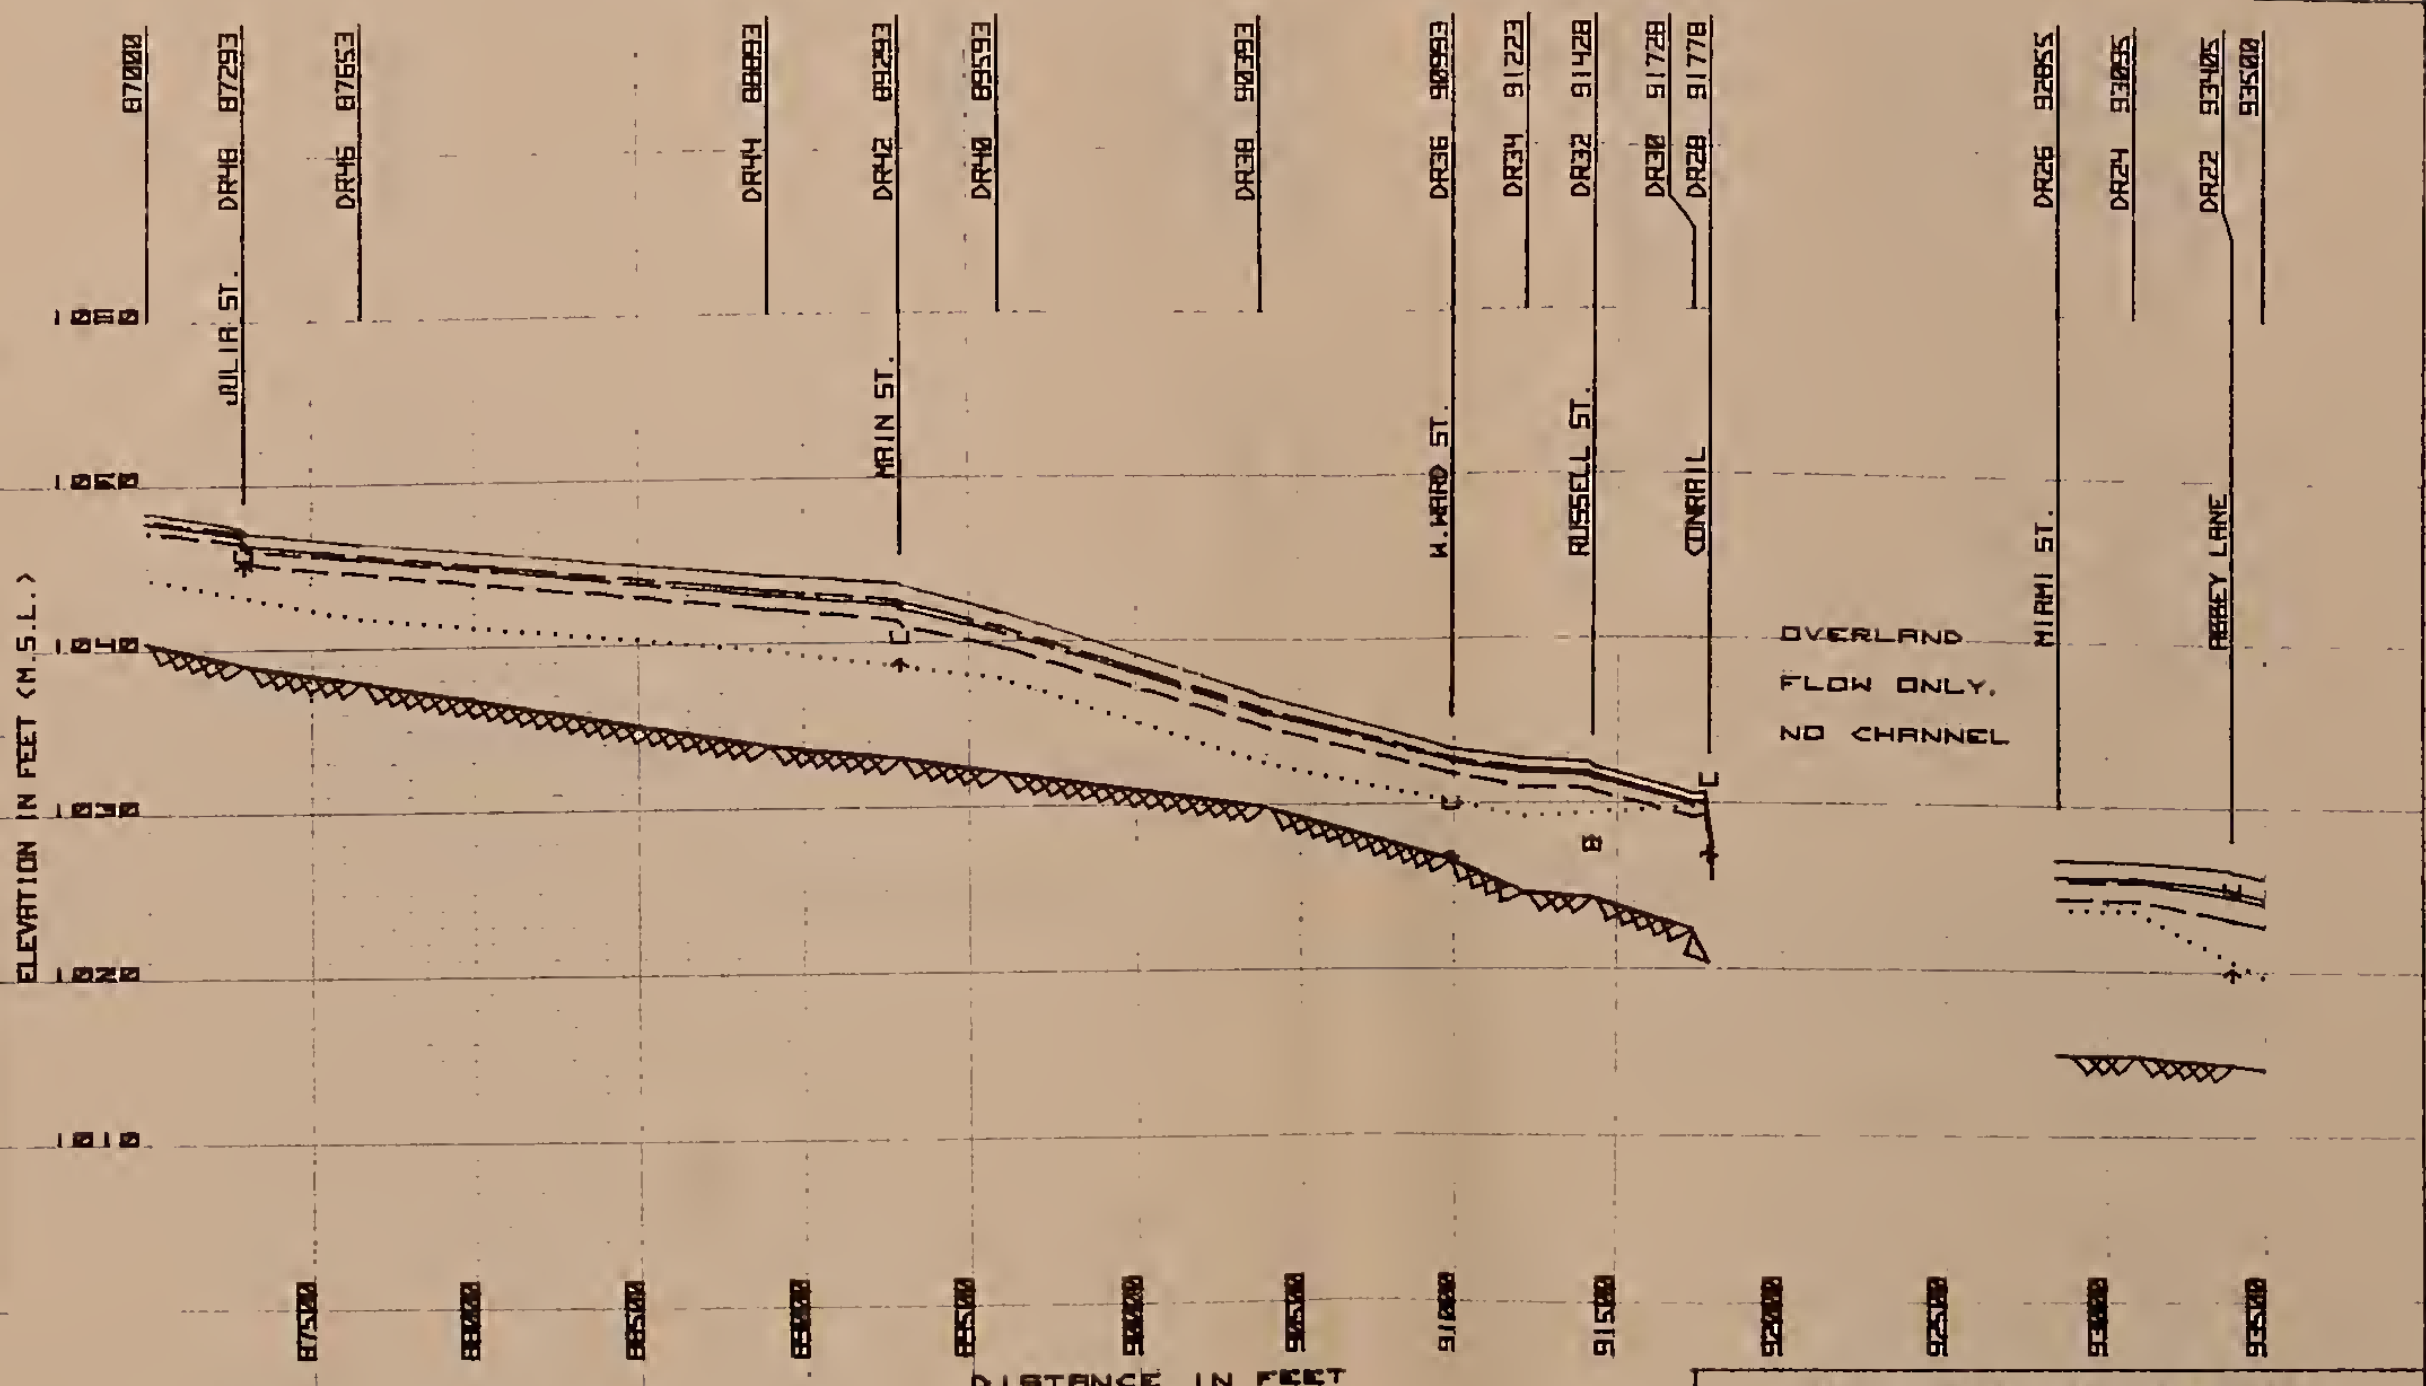
DUGAN RUN  
 SOIL CONSERVATION SERVICE  
 SHEET 2

WATER SURFACE PROFILES  
 DUGAN RUN F.T.D.  
 CHAMPAIGN CO., OHIO

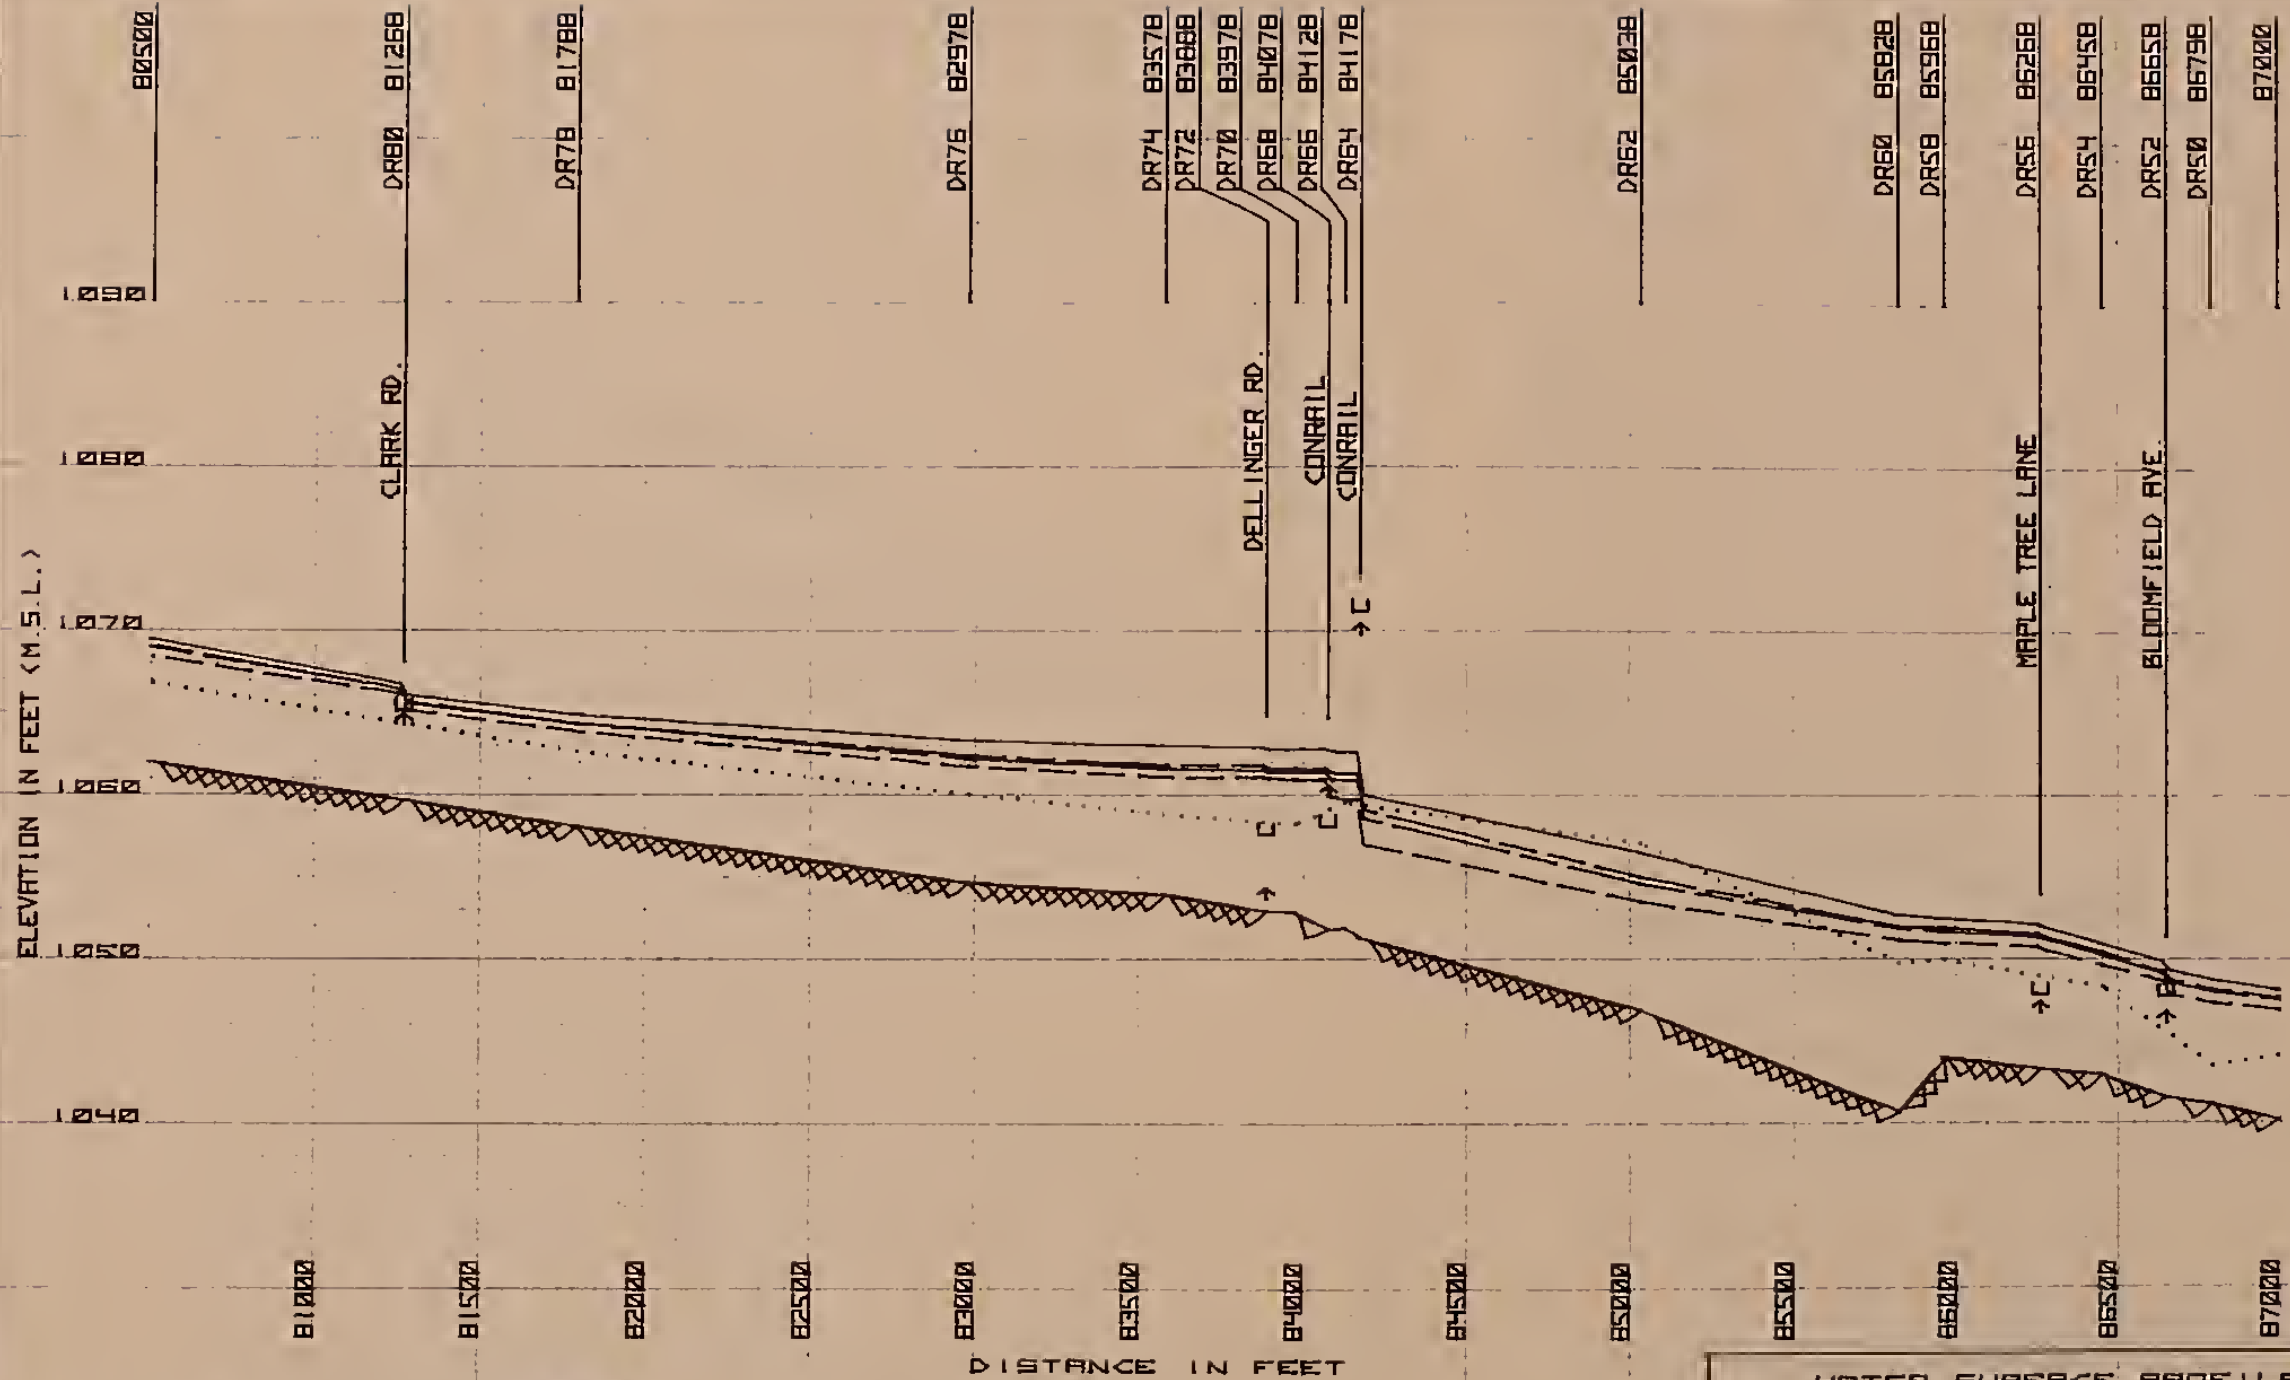
DUGAN RUN  
SOIL CONSERVATION SERVICE  
SHEET 3

WATER SURFACE PROFILES  
DUGAN RUN F.H.B.  
CHAMPAIGN CO., OHIO

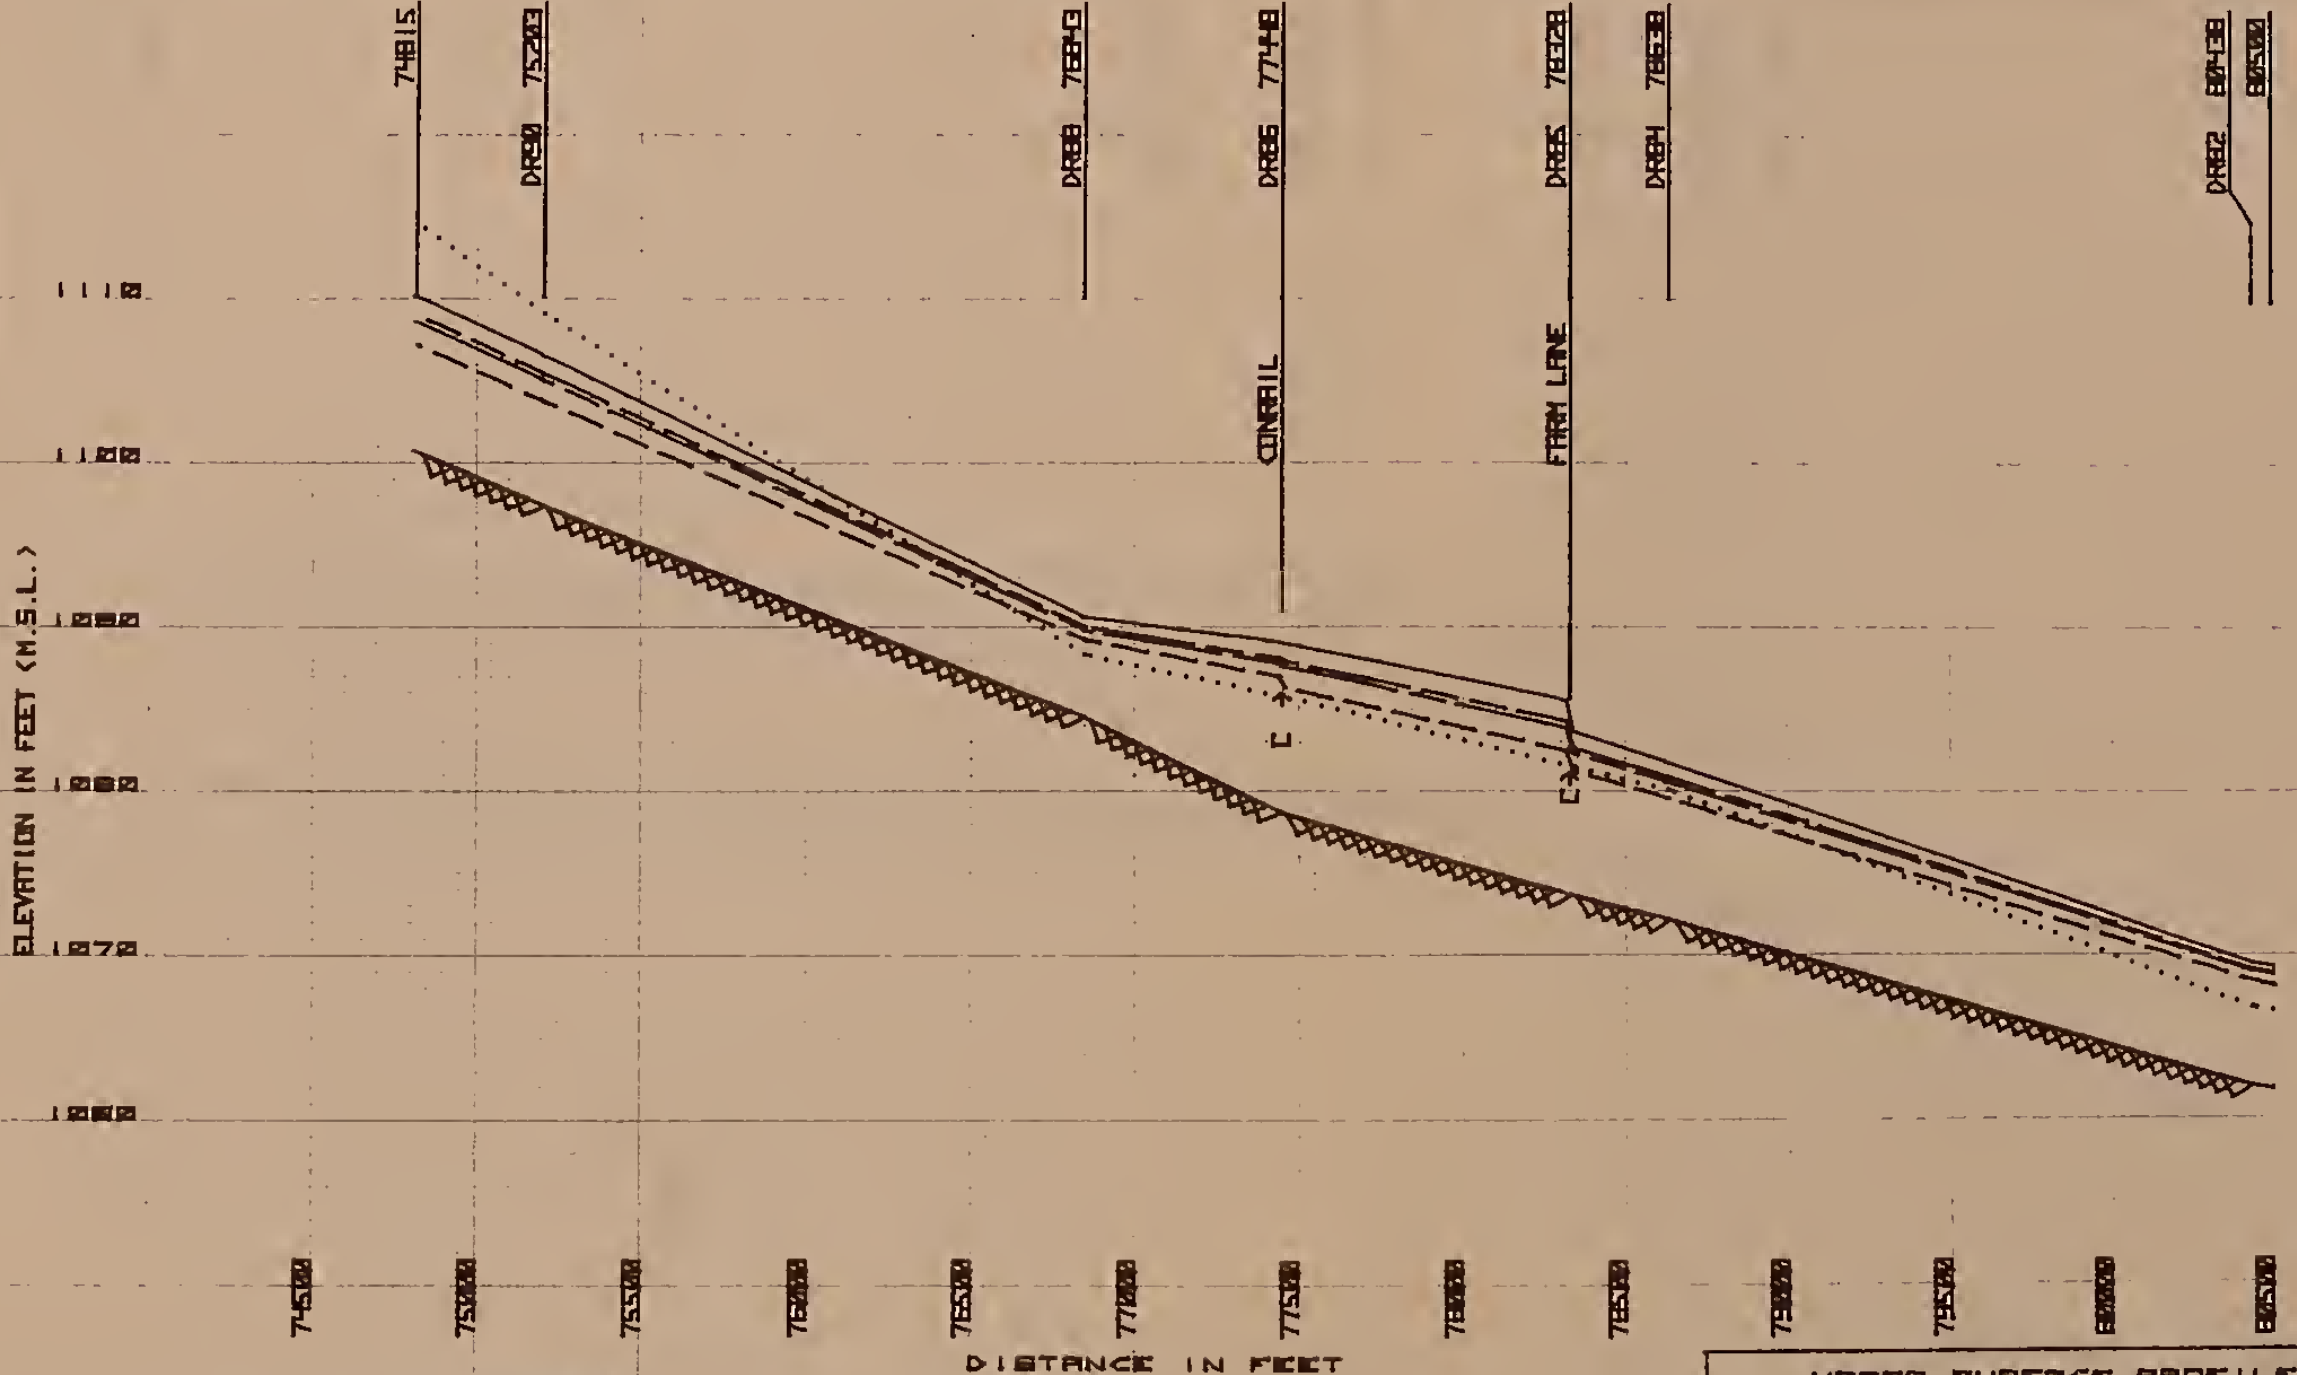
**DUGAN RUN**  
 SOIL CONSERVATION SERVICE  
 SHEET 4

WATER SURFACE PROFILED  
 DUGAN RUN F.H.B.  
 CHAMPAIGN CO., OHIO

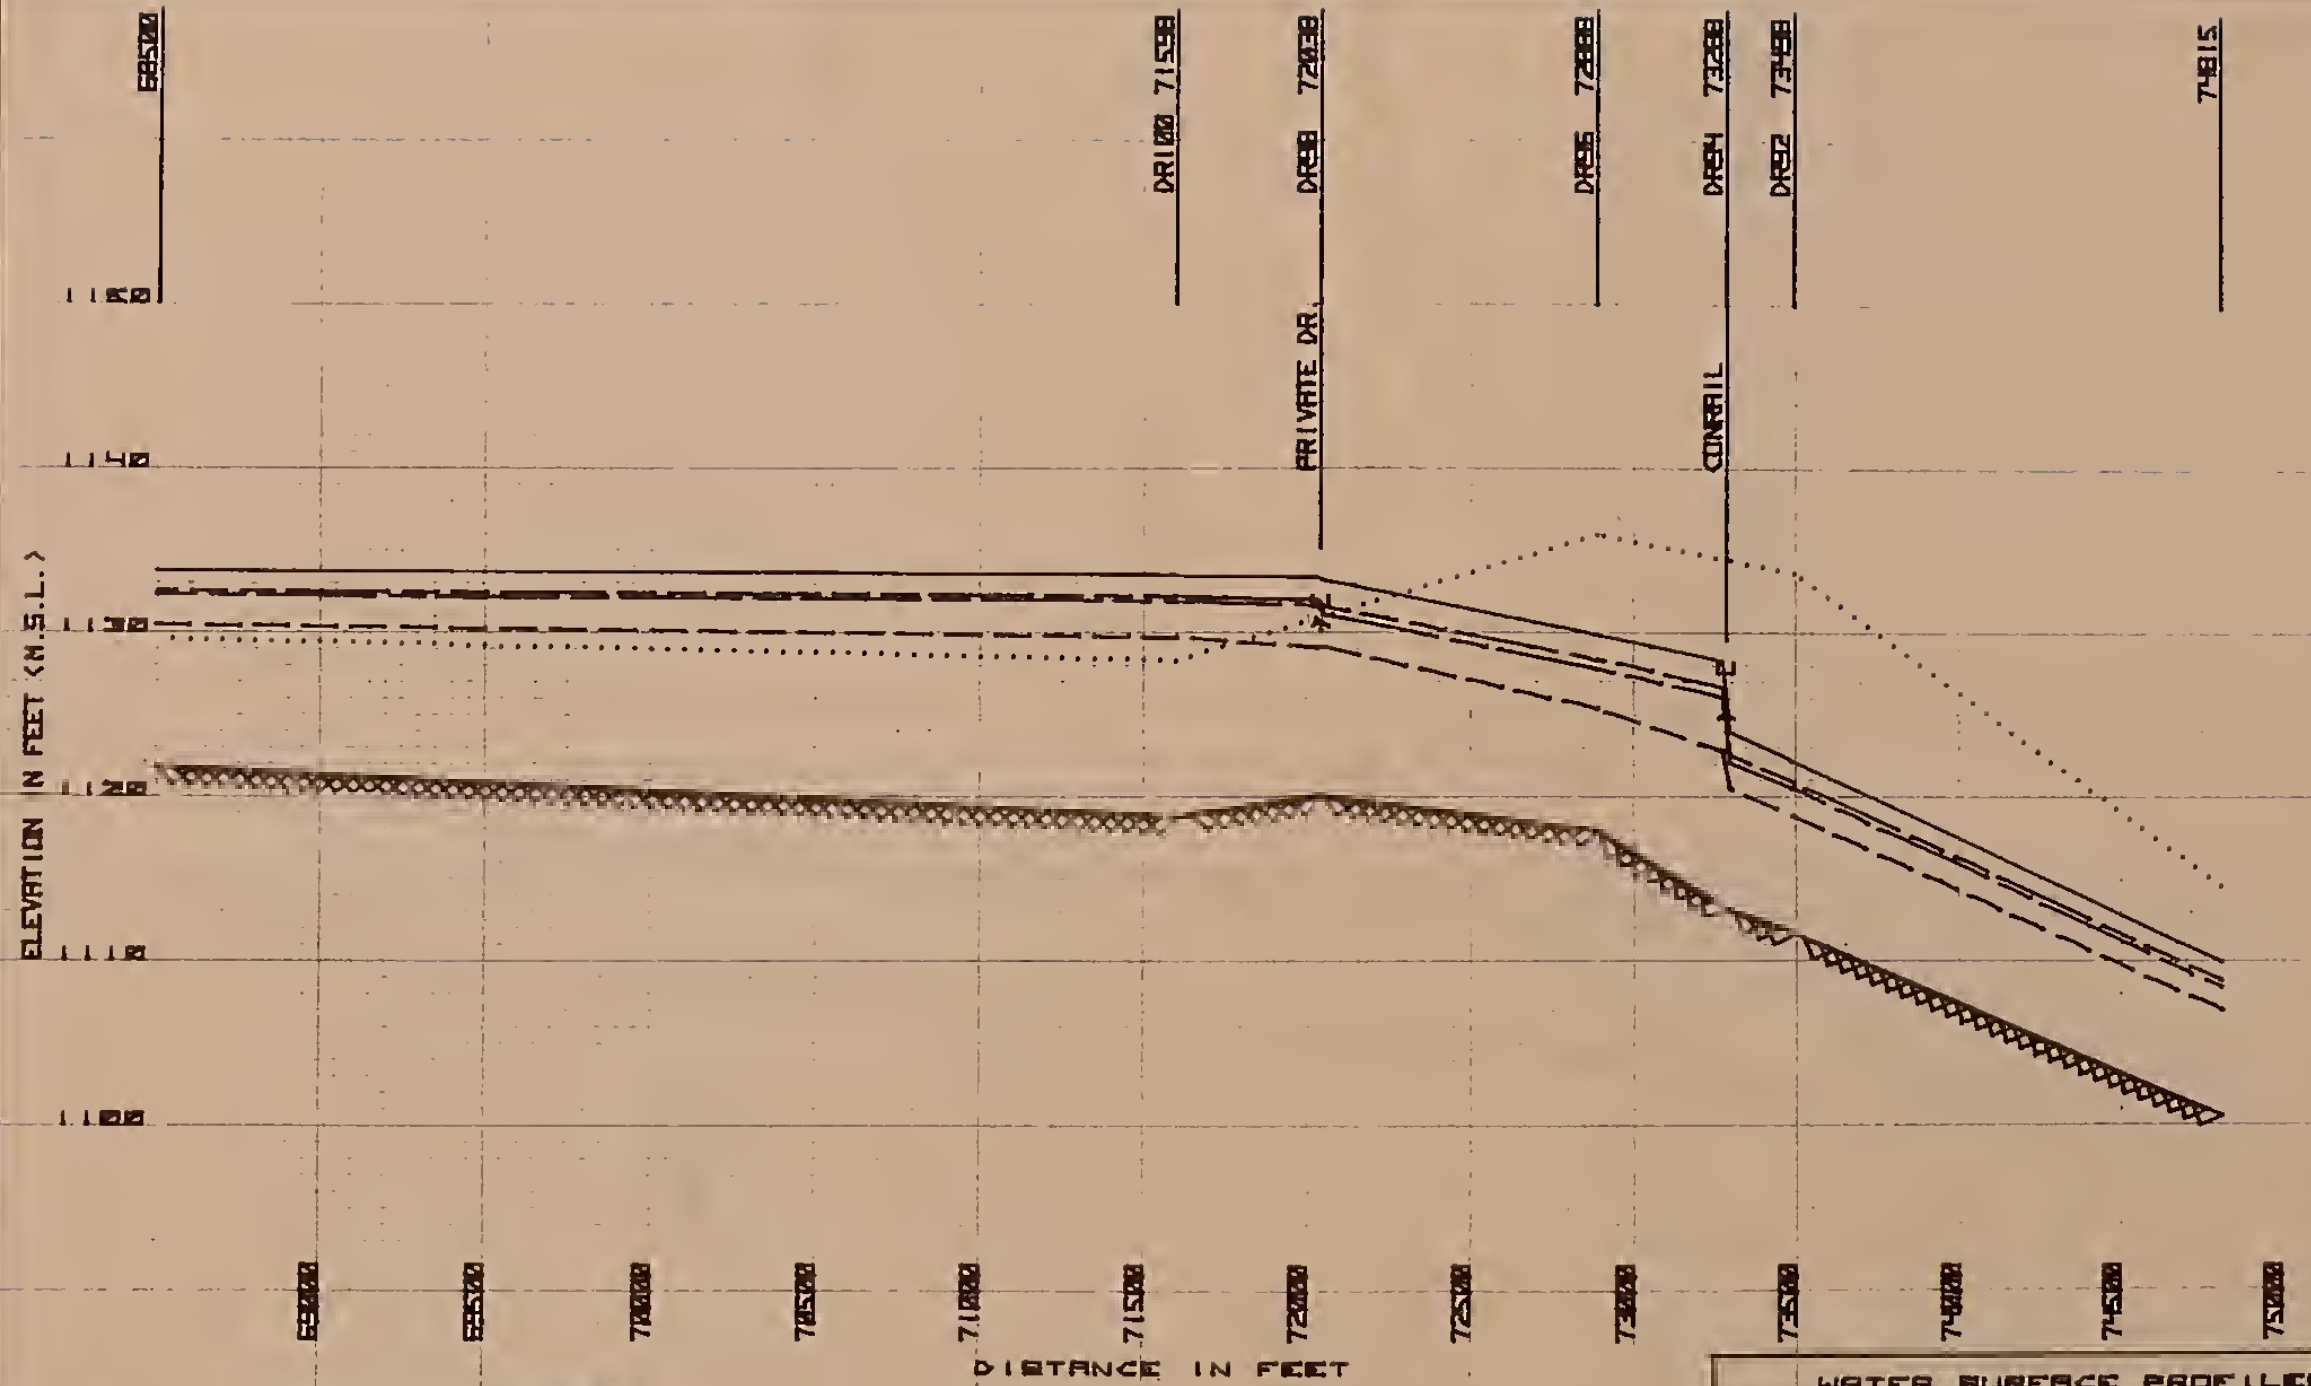
**DUGAN RUN**  
 SOIL CONSERVATION SERVICE  
 SHEET 5

WATER SURFACE PROFILES  
 DUGAN RUN F.H.B.  
 CHAMPAIGN CO., OHIO
