# FLOOD HAZARD STUDY,

## DUGAN RUN,

Champaign County, Ohio

June 1967

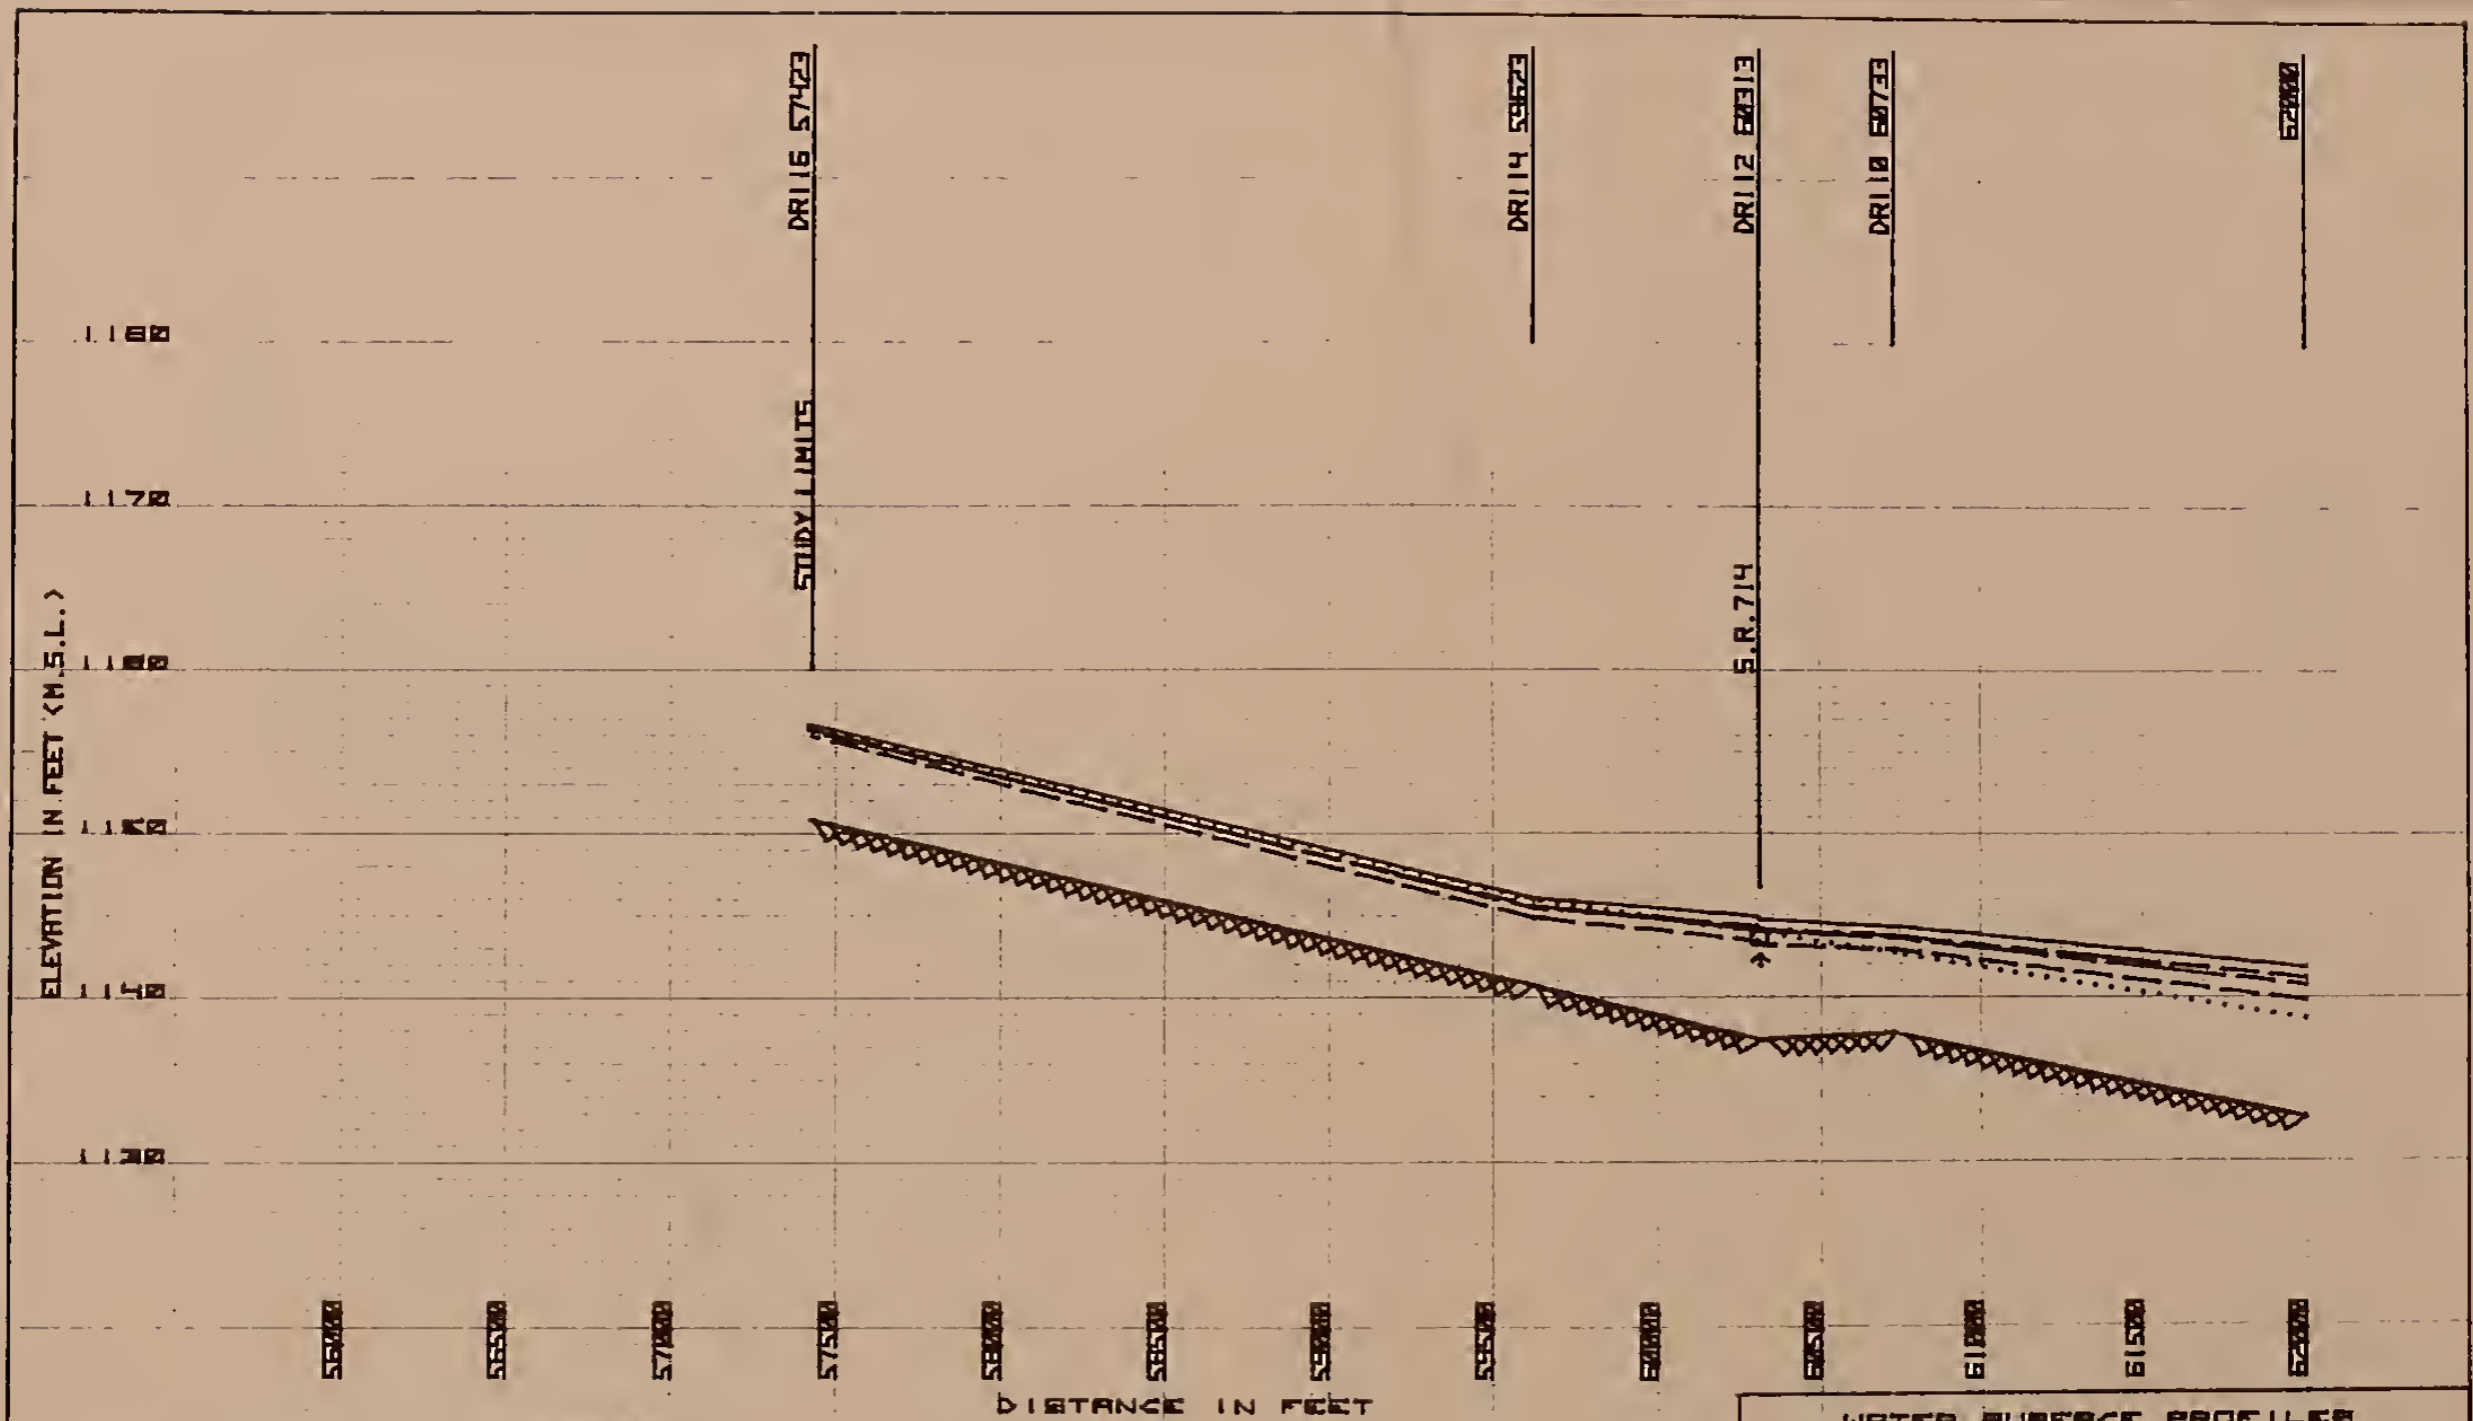
**DUGAN RUN**  
 SOIL CONSERVATION SERVICE  
 SHEET 7

WATER SURFACE PROFILES  
 DUGAN RUN F.H.S.  
 CHAMPAIGN CO., OHIO

The plotted water surface profiles in Appendix B show the location of cross sections and roads crossing the streams and the elevation of the water surface for the 10, 50, 100, and 500-year floods. The water surface elevation at a particular location can be found by: (1) locating the point in question on the photomosaics (Appendix A); (2) measuring the distance along the stream to the nearest cross section; (3) locating the selected cross section along the profile in Appendix B; and (4) measuring the same distance horizontally to the desired point. The water surface elevation can then be read from the vertical scale.

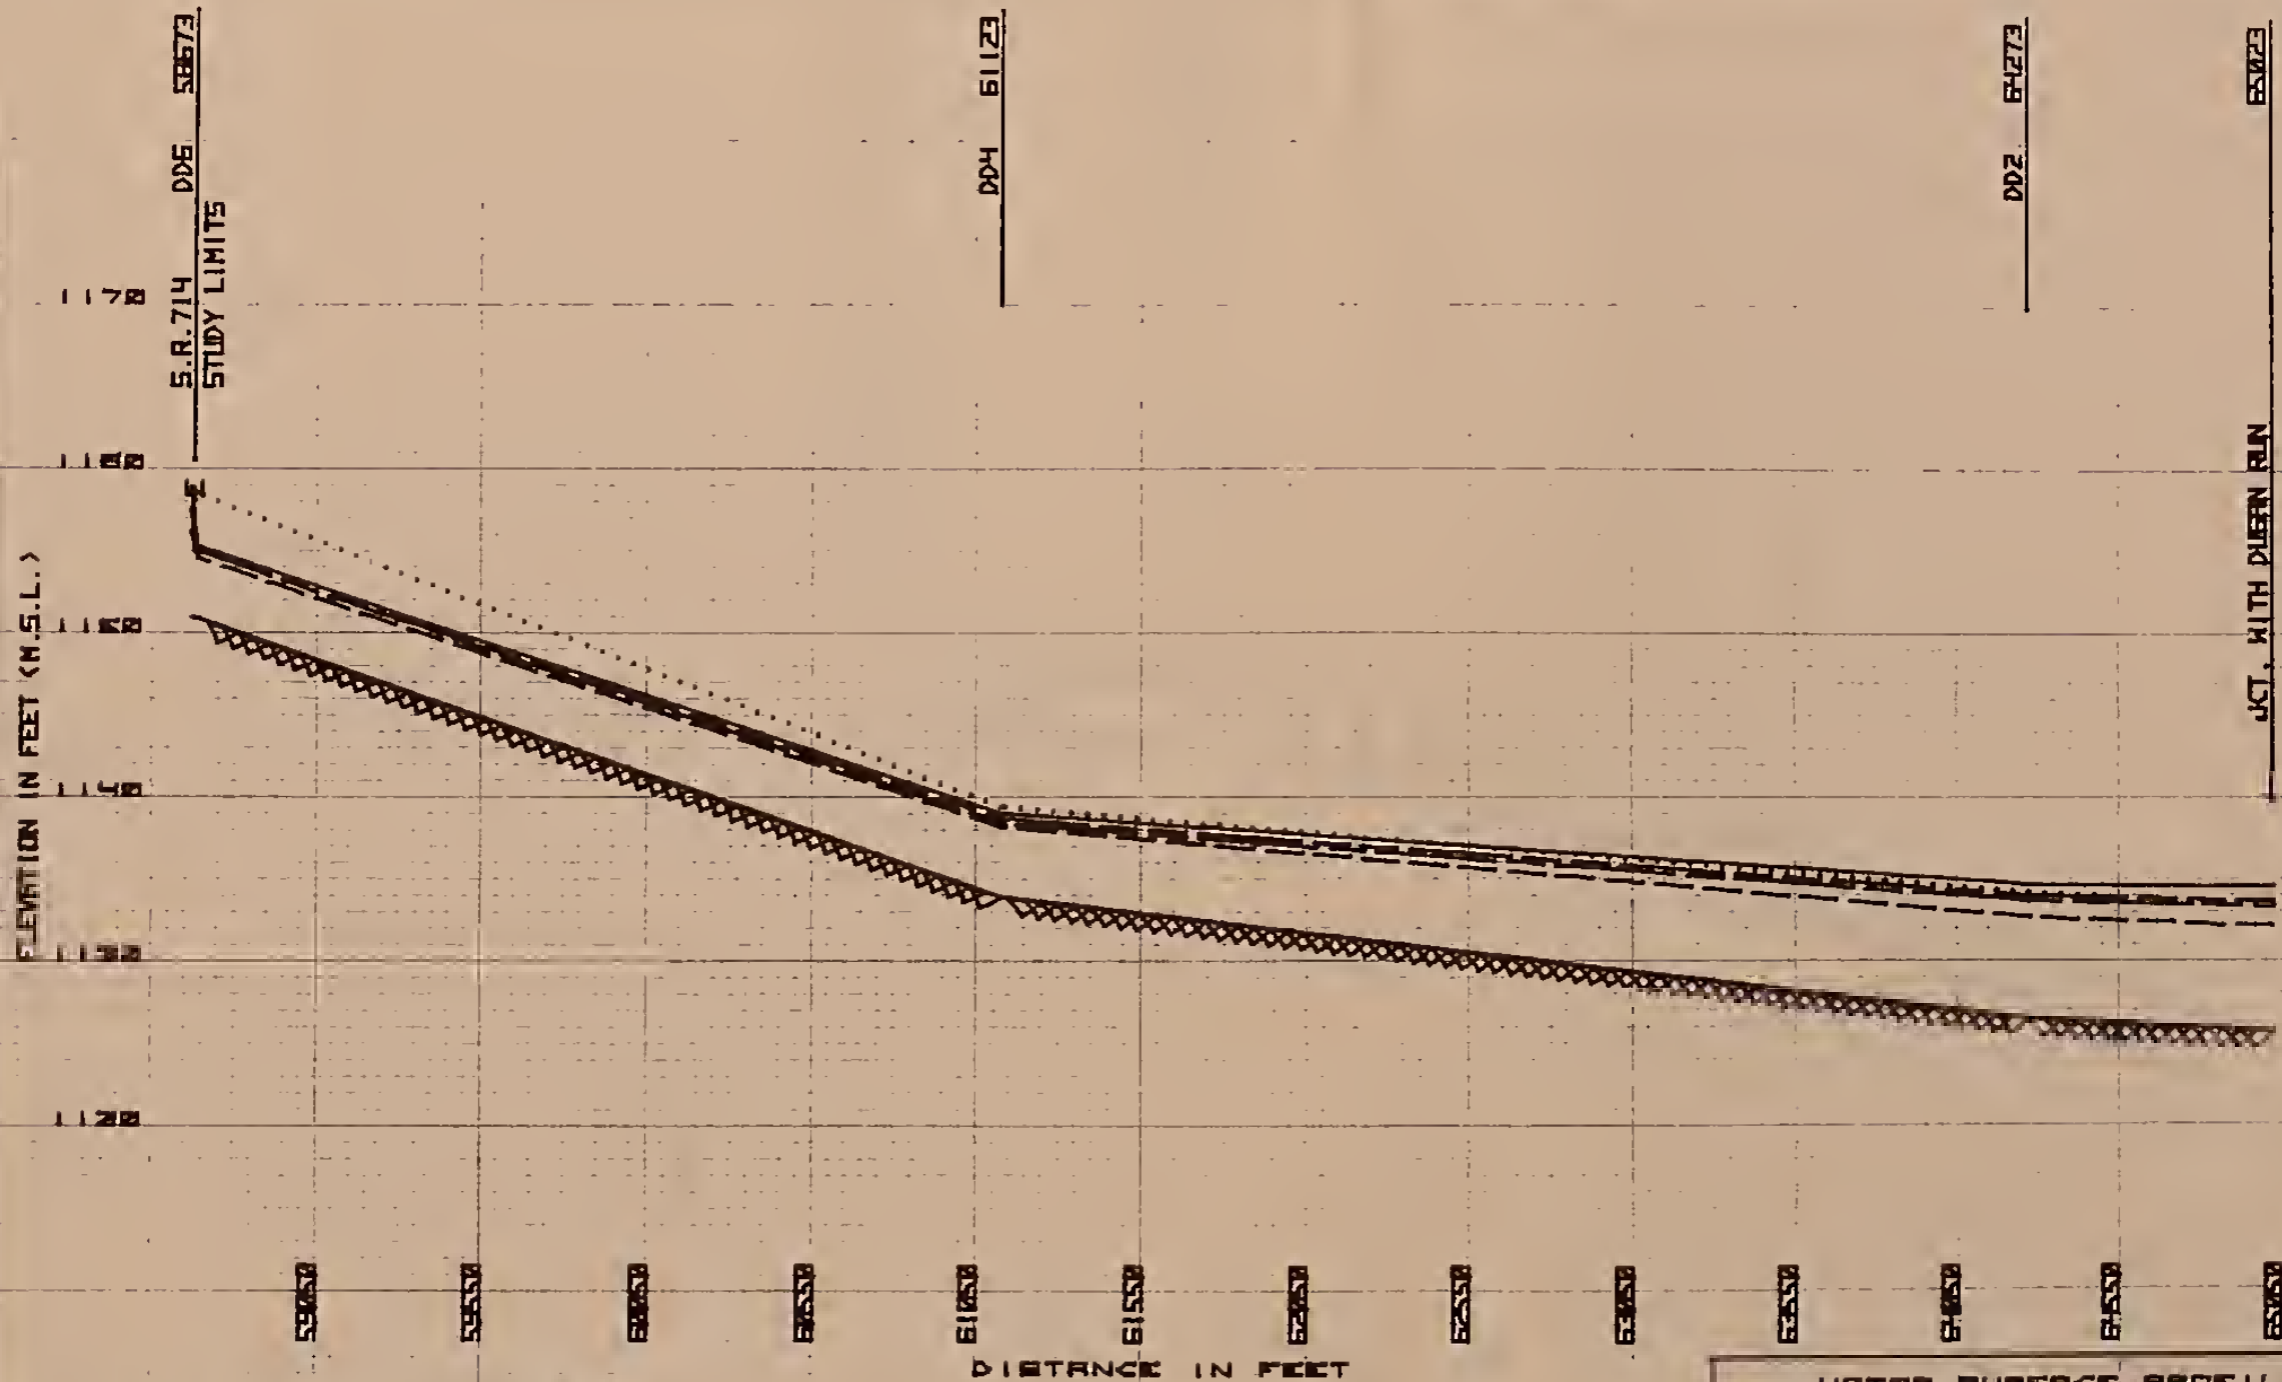
SOIL CONSERVATION SERVICE  
 SHEET 1

WATER SURFACE PROFILES  
 DUGAN RUN F.H.S.  
 CHAMPAIGN CO., OHIO

**DUGAN DITCH**

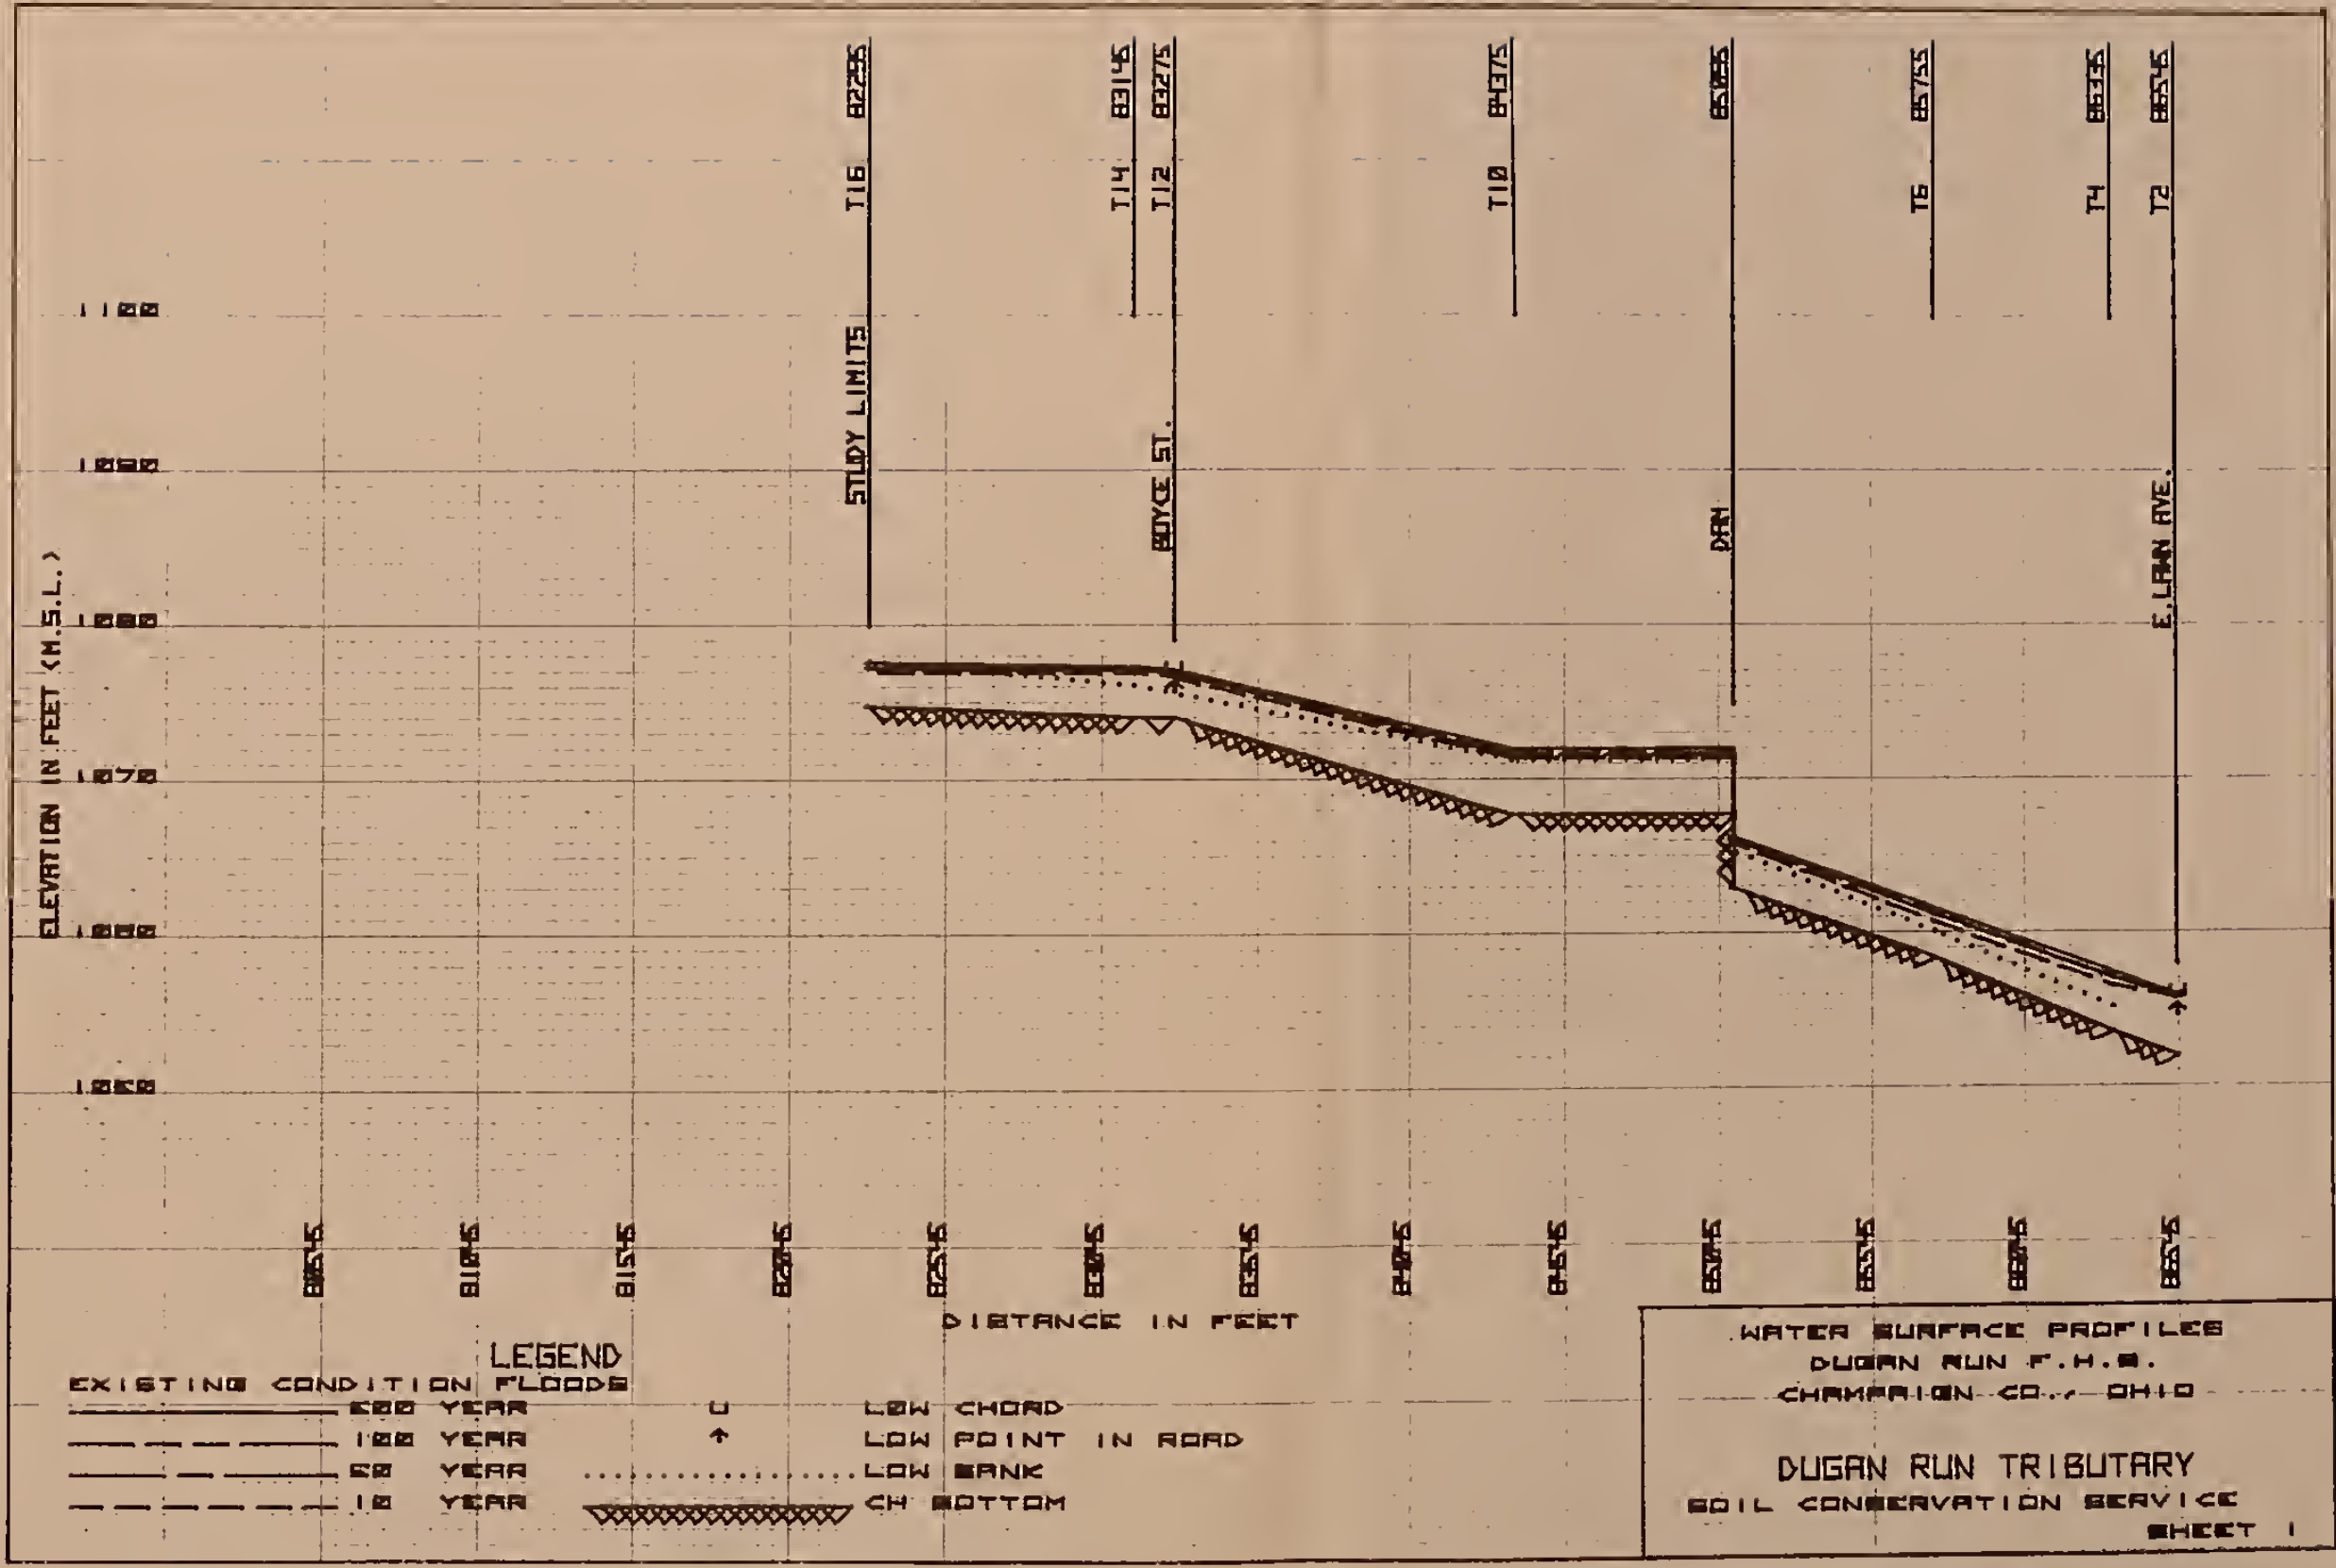
DUGAN RUN TRIBUTARY  
 SOIL CONSERVATION SERVICE  
 SHEET 1

WATER SURFACE PROFILES  
 DUGAN RUN F.H.S.  
 CHAMPAIGN CO., OHIO
