Improving Southwestern Riparian Areas Through Watershed Management

Rocky Mountain
Forest and Range
Experiment Station

Leonard F. DeBano and Larry J. Schmidt

General Technical
Report RM-182

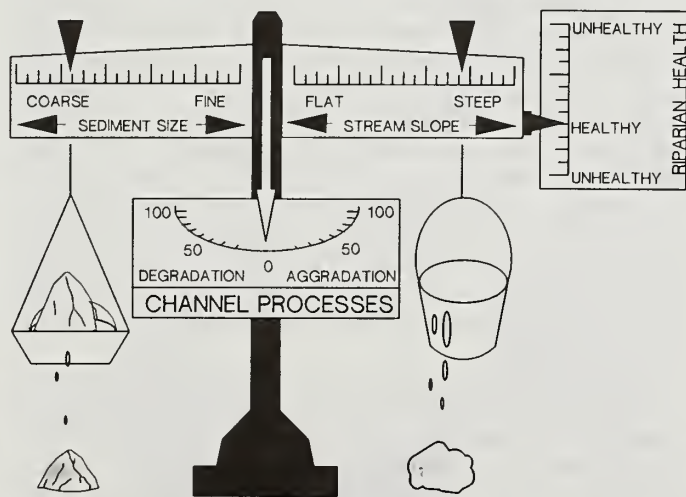
Figure 1.—Healthy riparian areas depend upon a dynamic equilibrium between channel aggradation and degradation processes. The equilibrium illustrated oscillates both in time and space throughout the channel network. The channel network adjusts in form and slope to handle increased storm flows with limited perturbation of channel and associated riparian plant community.

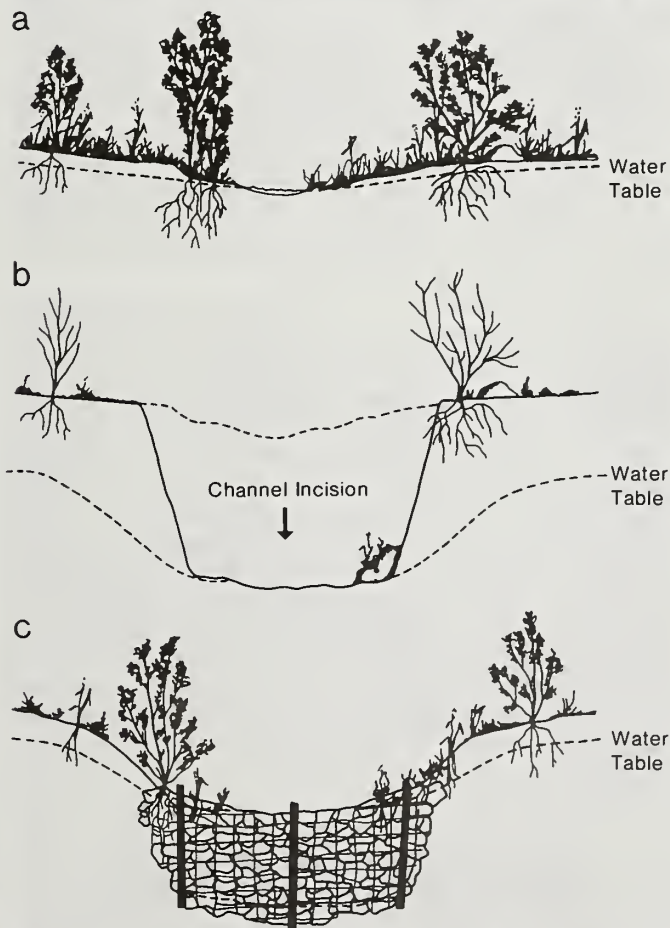
Figure 3.—Water table and riparian vegetation relationships: (a) before channel incision, (b) after channel incision, and (c) following rehabilitation with a channel structure.

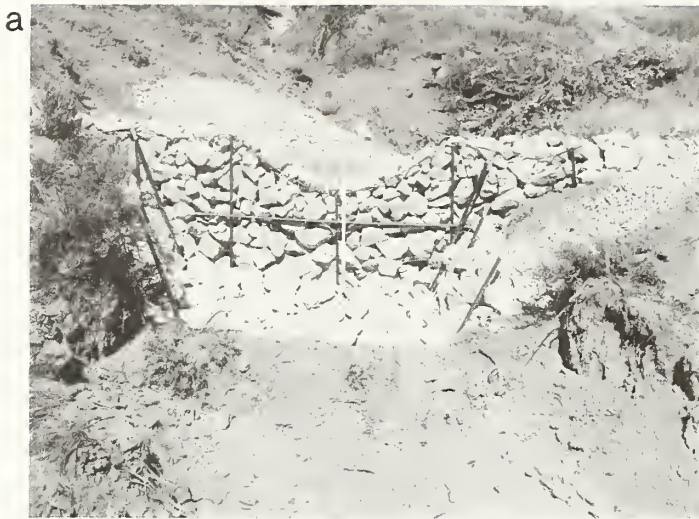
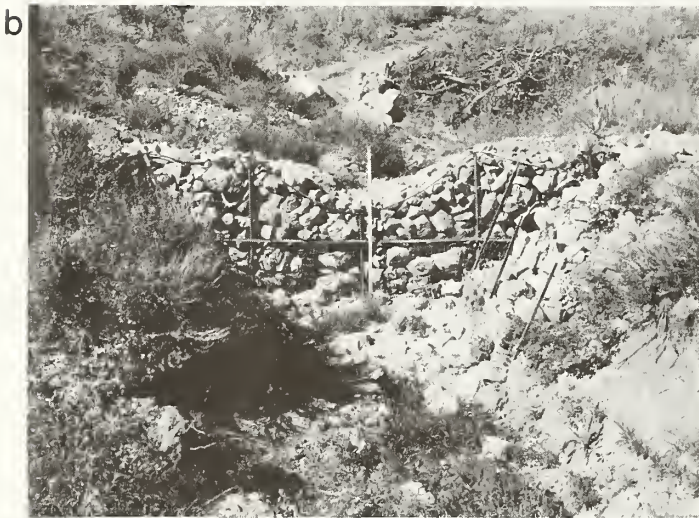
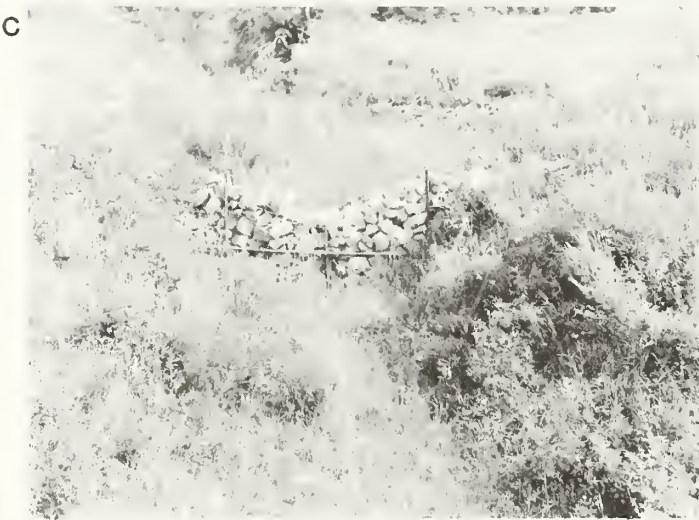
Figure 4.—An upstream view of a rock check dam constructed in an upper watershed channel on Alkali Creek in western Colorado: (a) immediately after construction in 1963, (b) in 1964, and (c) 12 years later in 1975. Notice the establishment of grass on channel banks and bottoms but the absence of riparian plants.

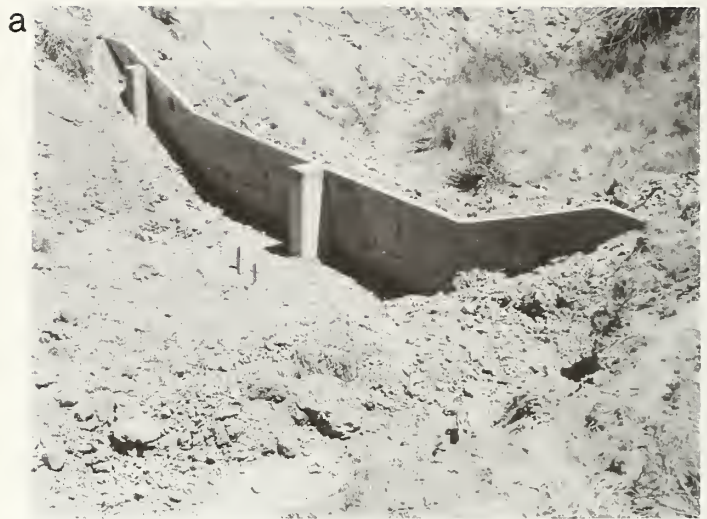
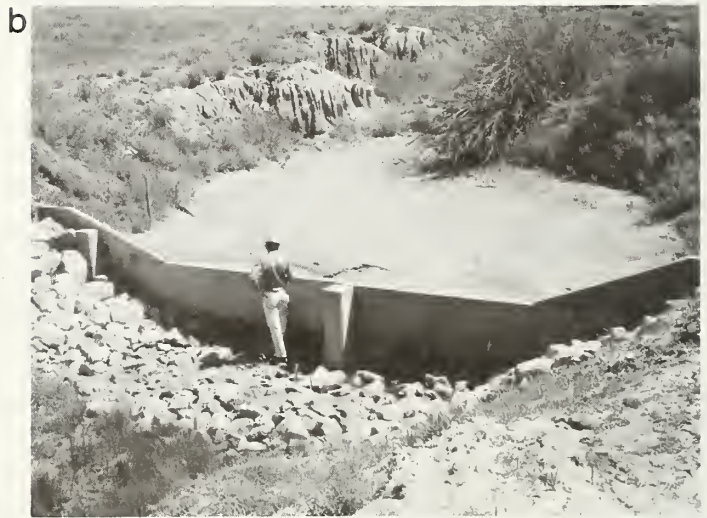
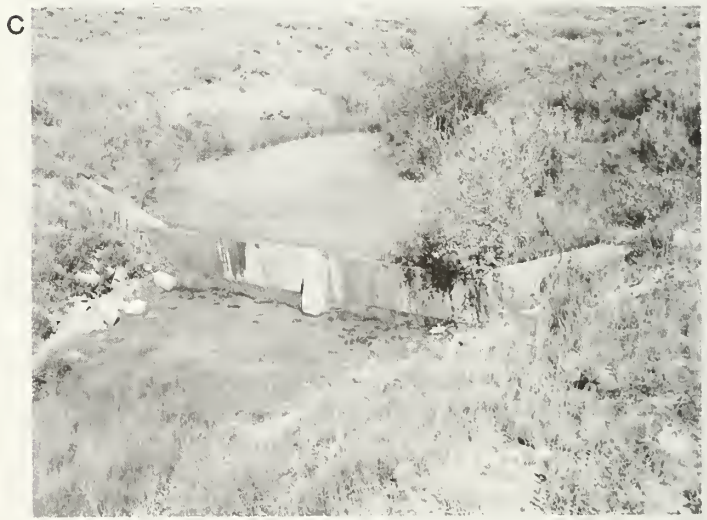
Figure 5.—The appearance of the site occupied by a larger gully control structure at the mouth of Alkali Creek in western Colorado: (a) immediately after treatment in 1963, (b) in 1964, and (c) 12 years later in 1975.

Prolonged streamflow at Alkali Creek allowed sedges and willows to become established, which enlarged into a dense riparian ecosystem by 1981 (fig. 5c). After the channel bottoms had become stabilized, riparian vegetation spread to the toe and lower segments of the gully sideslopes. Sediment deposits above the check dams prevented undercutting and loss of bank toes, and pro-

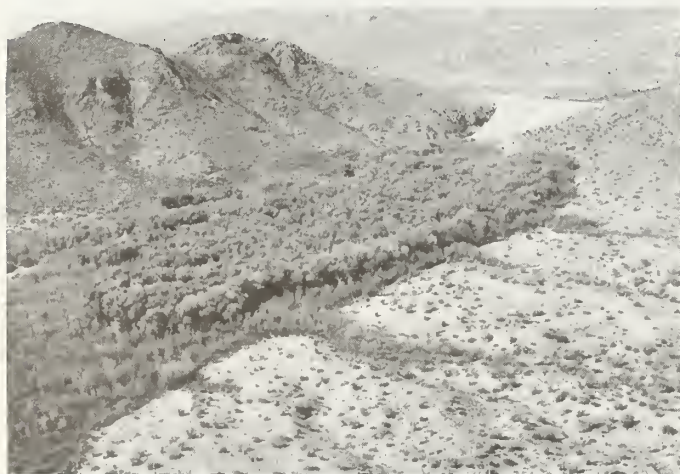
Figure 10.—A 79-acre riparian plant community above Whitlow Dam.

Case study.—A recent study of a flood control dam and reservoir in central Arizona illustrates how a large channel structure can alter streamflow and sediment regimes and enhance the establishment of a riparian ecosystem (Szaro and DeBano 1985). Whitlow Dam was built in 1960 as a flood control structure for temporarily delaying streamflow in Queen Creek by storing about 36,000 acre-feet of floodwater. The structure also stored sediment. By 1975, about 304 million cubic feet of sediment had been stored in the reservoir above the dam. Prior to construction, stream reaches above Whitlow Dam supported mainly Sonoran riparian scrubland (fig. 9a). There were no trees in the streambed, and adjoining banks supported mainly common mesquite, velvet mesquite, and ironwood. Only 7 years after completion, Gooding willow and saltcedar had occupied about 44 acres (fig. 9b). From 1967 to 1980, vegetation increased in both density and size to the 72-acre riparian community present today (figs. 9c and 10).

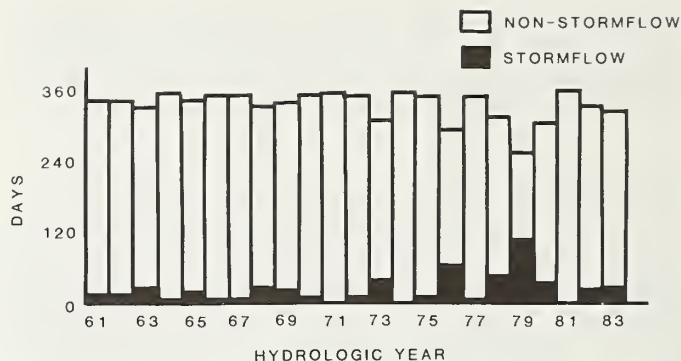
Figure 11.—The number of days per year of storm and nonstorm flow through Whitlow Dam, 1961-1983 (Szaró and DeBano 1985).

improved moisture relations and site fertility. Temporary impoundment of water in the reservoir charges both trapped sediment and surrounding reservoir banks with water, which provides nonstorm streamflow for a large part of the year. A hydrologic analysis of the inflow records for the dam over time since its construction in 1960 showed that, had the dam not been present, the channel reach would have only been wetted during stormflows an average of 24 days per year between 1960 and 1983 (fig. 11). In contrast, outflow records indicated that after construction, streamflow occurred about 340 days annually (fig. 11).

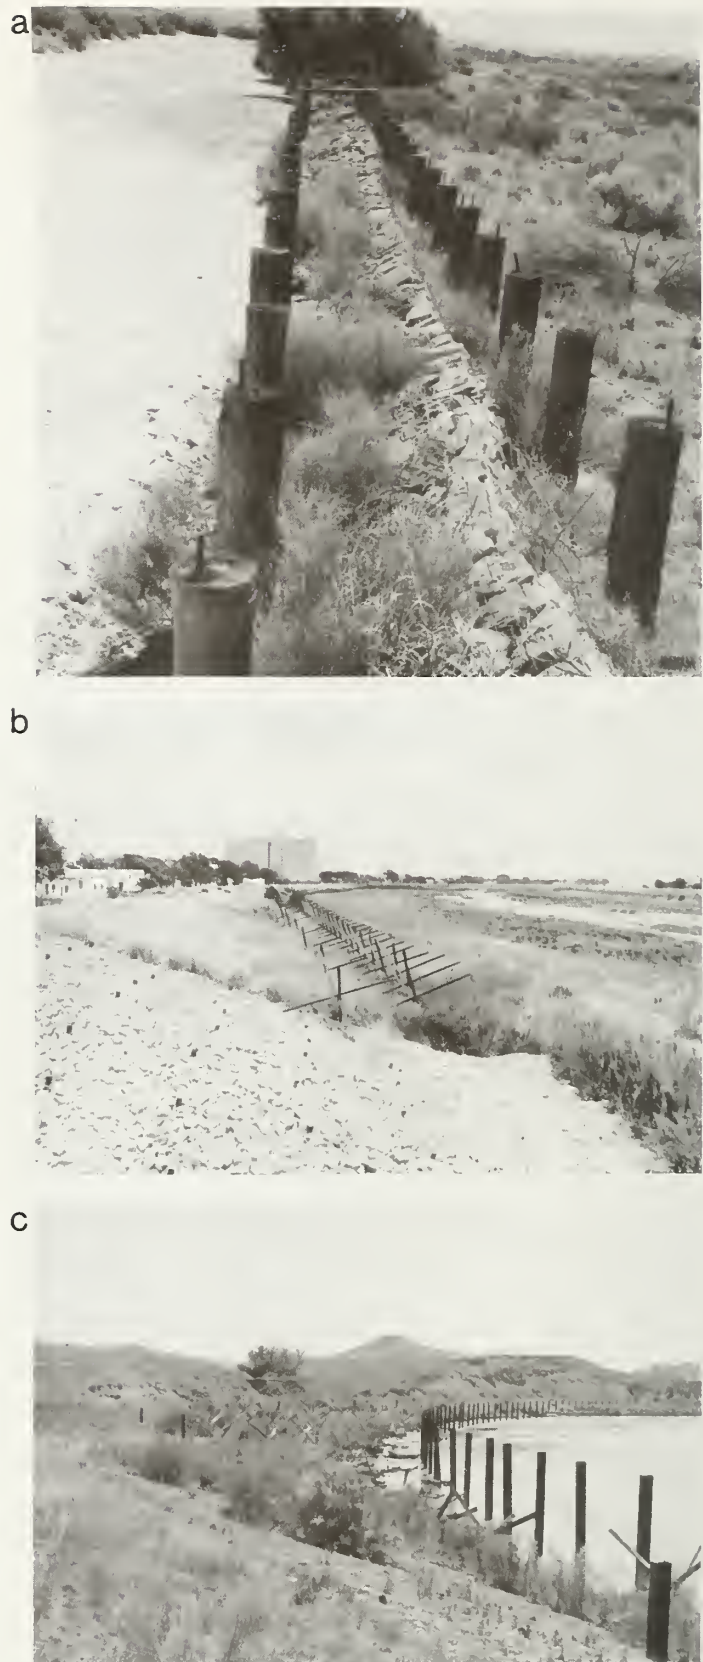
Figure 12. — Commonly used bank armoring and protection devices: (a) revetment posts and gabion near Moab, Utah; (b) jacks and bank armor at Dodge City, Kansas; and (c) jack field behind revetment posts on the Powder River, Wyoming.

Flow deflectors are frequently used for protecting banks and areas adjacent to the channel from the stream's impact. These deflectors can be used to save endangered riparian plant communities. However, careful engineering design is essential so deflected flows do not create new critical locations along the banks (DeBano and Heede 1987). Poor design may protect one side of the stream but cause destruction on opposite stream-banks. Long-term stability of deflection structures depends on the angle between deflector and water flow lines.
