Report 119

AIRCRAFT ACTION REPORT

(a) Unit Reporting MAG-61 (b) Based on or at Emirau Island (c) Report No. 119
 (d) Take off: Date 5 June, 1945 Time (LZT) 0815-0915L (Zone); Lat 01°36' S. Long 150° E.
Coordinated medium altitude bombing attack against
 (e) Mission Tobera #21, Yunakansu #9A and Rabeul #36, N. B. (f) Time of Return 1115-1212Z (Zone)

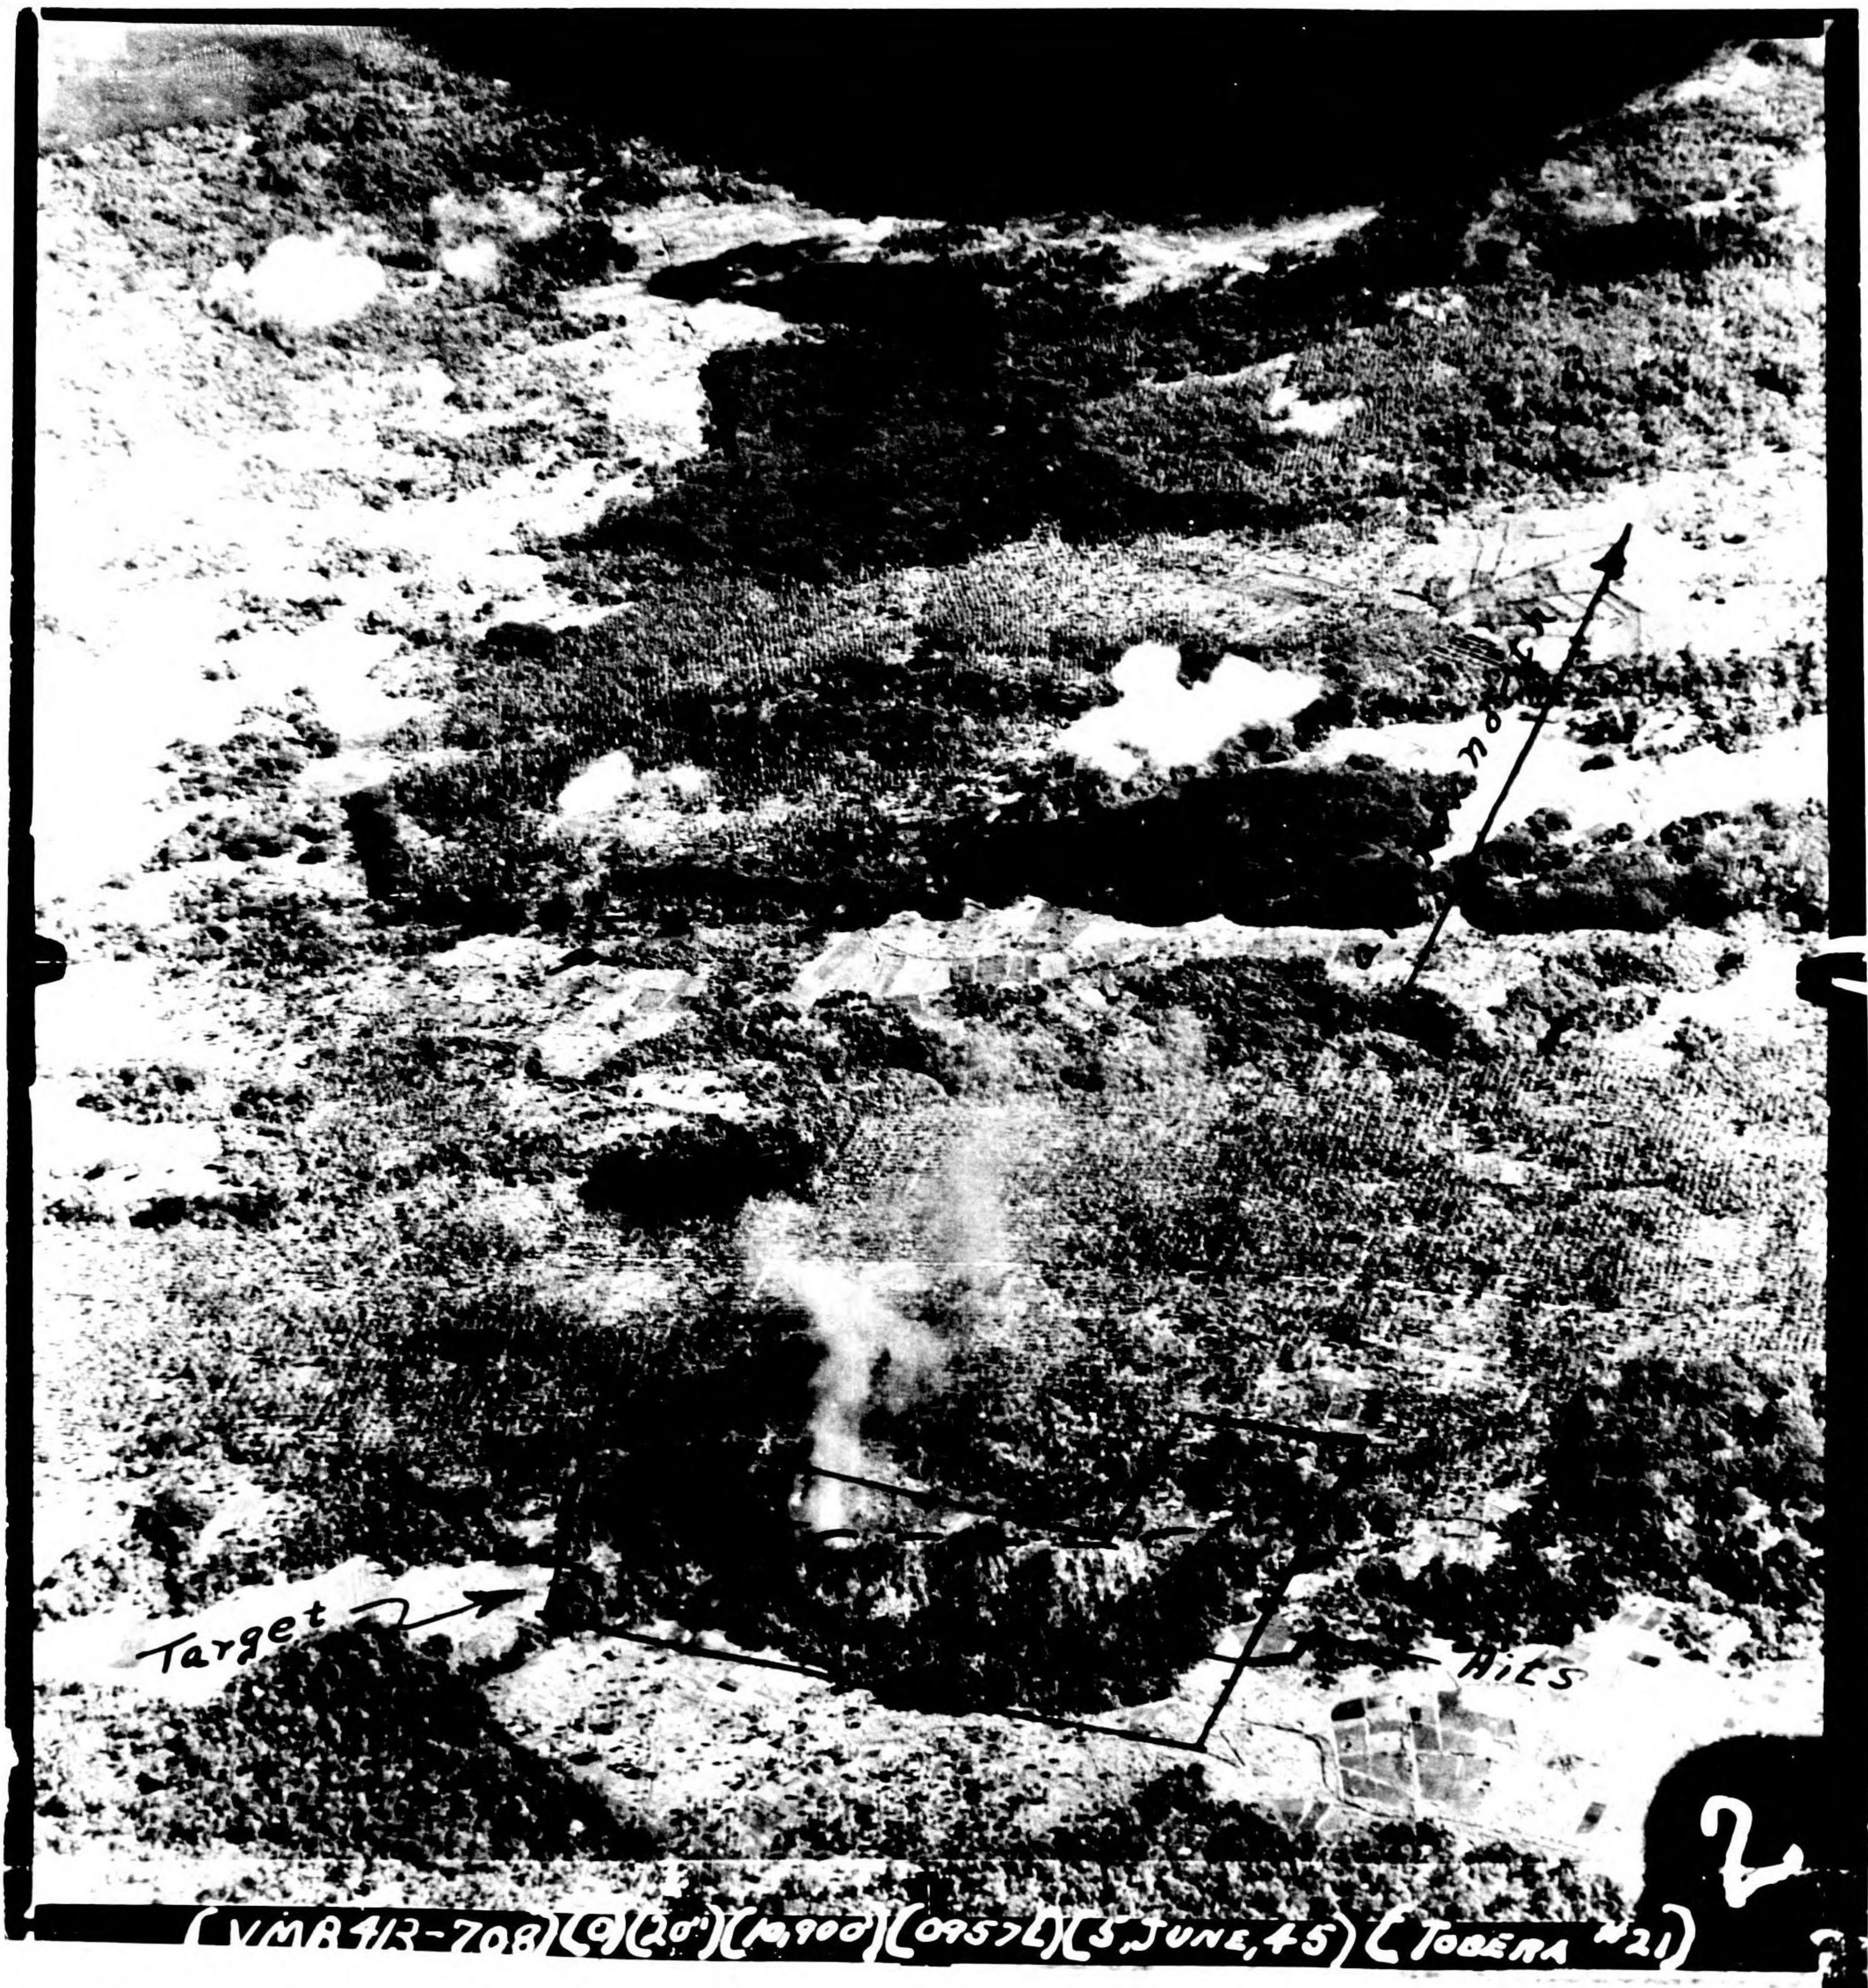
(YMB 433 Y/WI X 0 Y 20 Y 1000 X 0940 Y 5 JUNE 55 (VUN 9 KAMAU, NB)

During the run flames were observed from one of the hits and a large column of oily black smoke reached for the sky. After-strike photographs showed one building 120' x 60', one building 120' x 30', one building 95' x 30' and one building plus eight others of the smaller type (all revetted) destroyed.

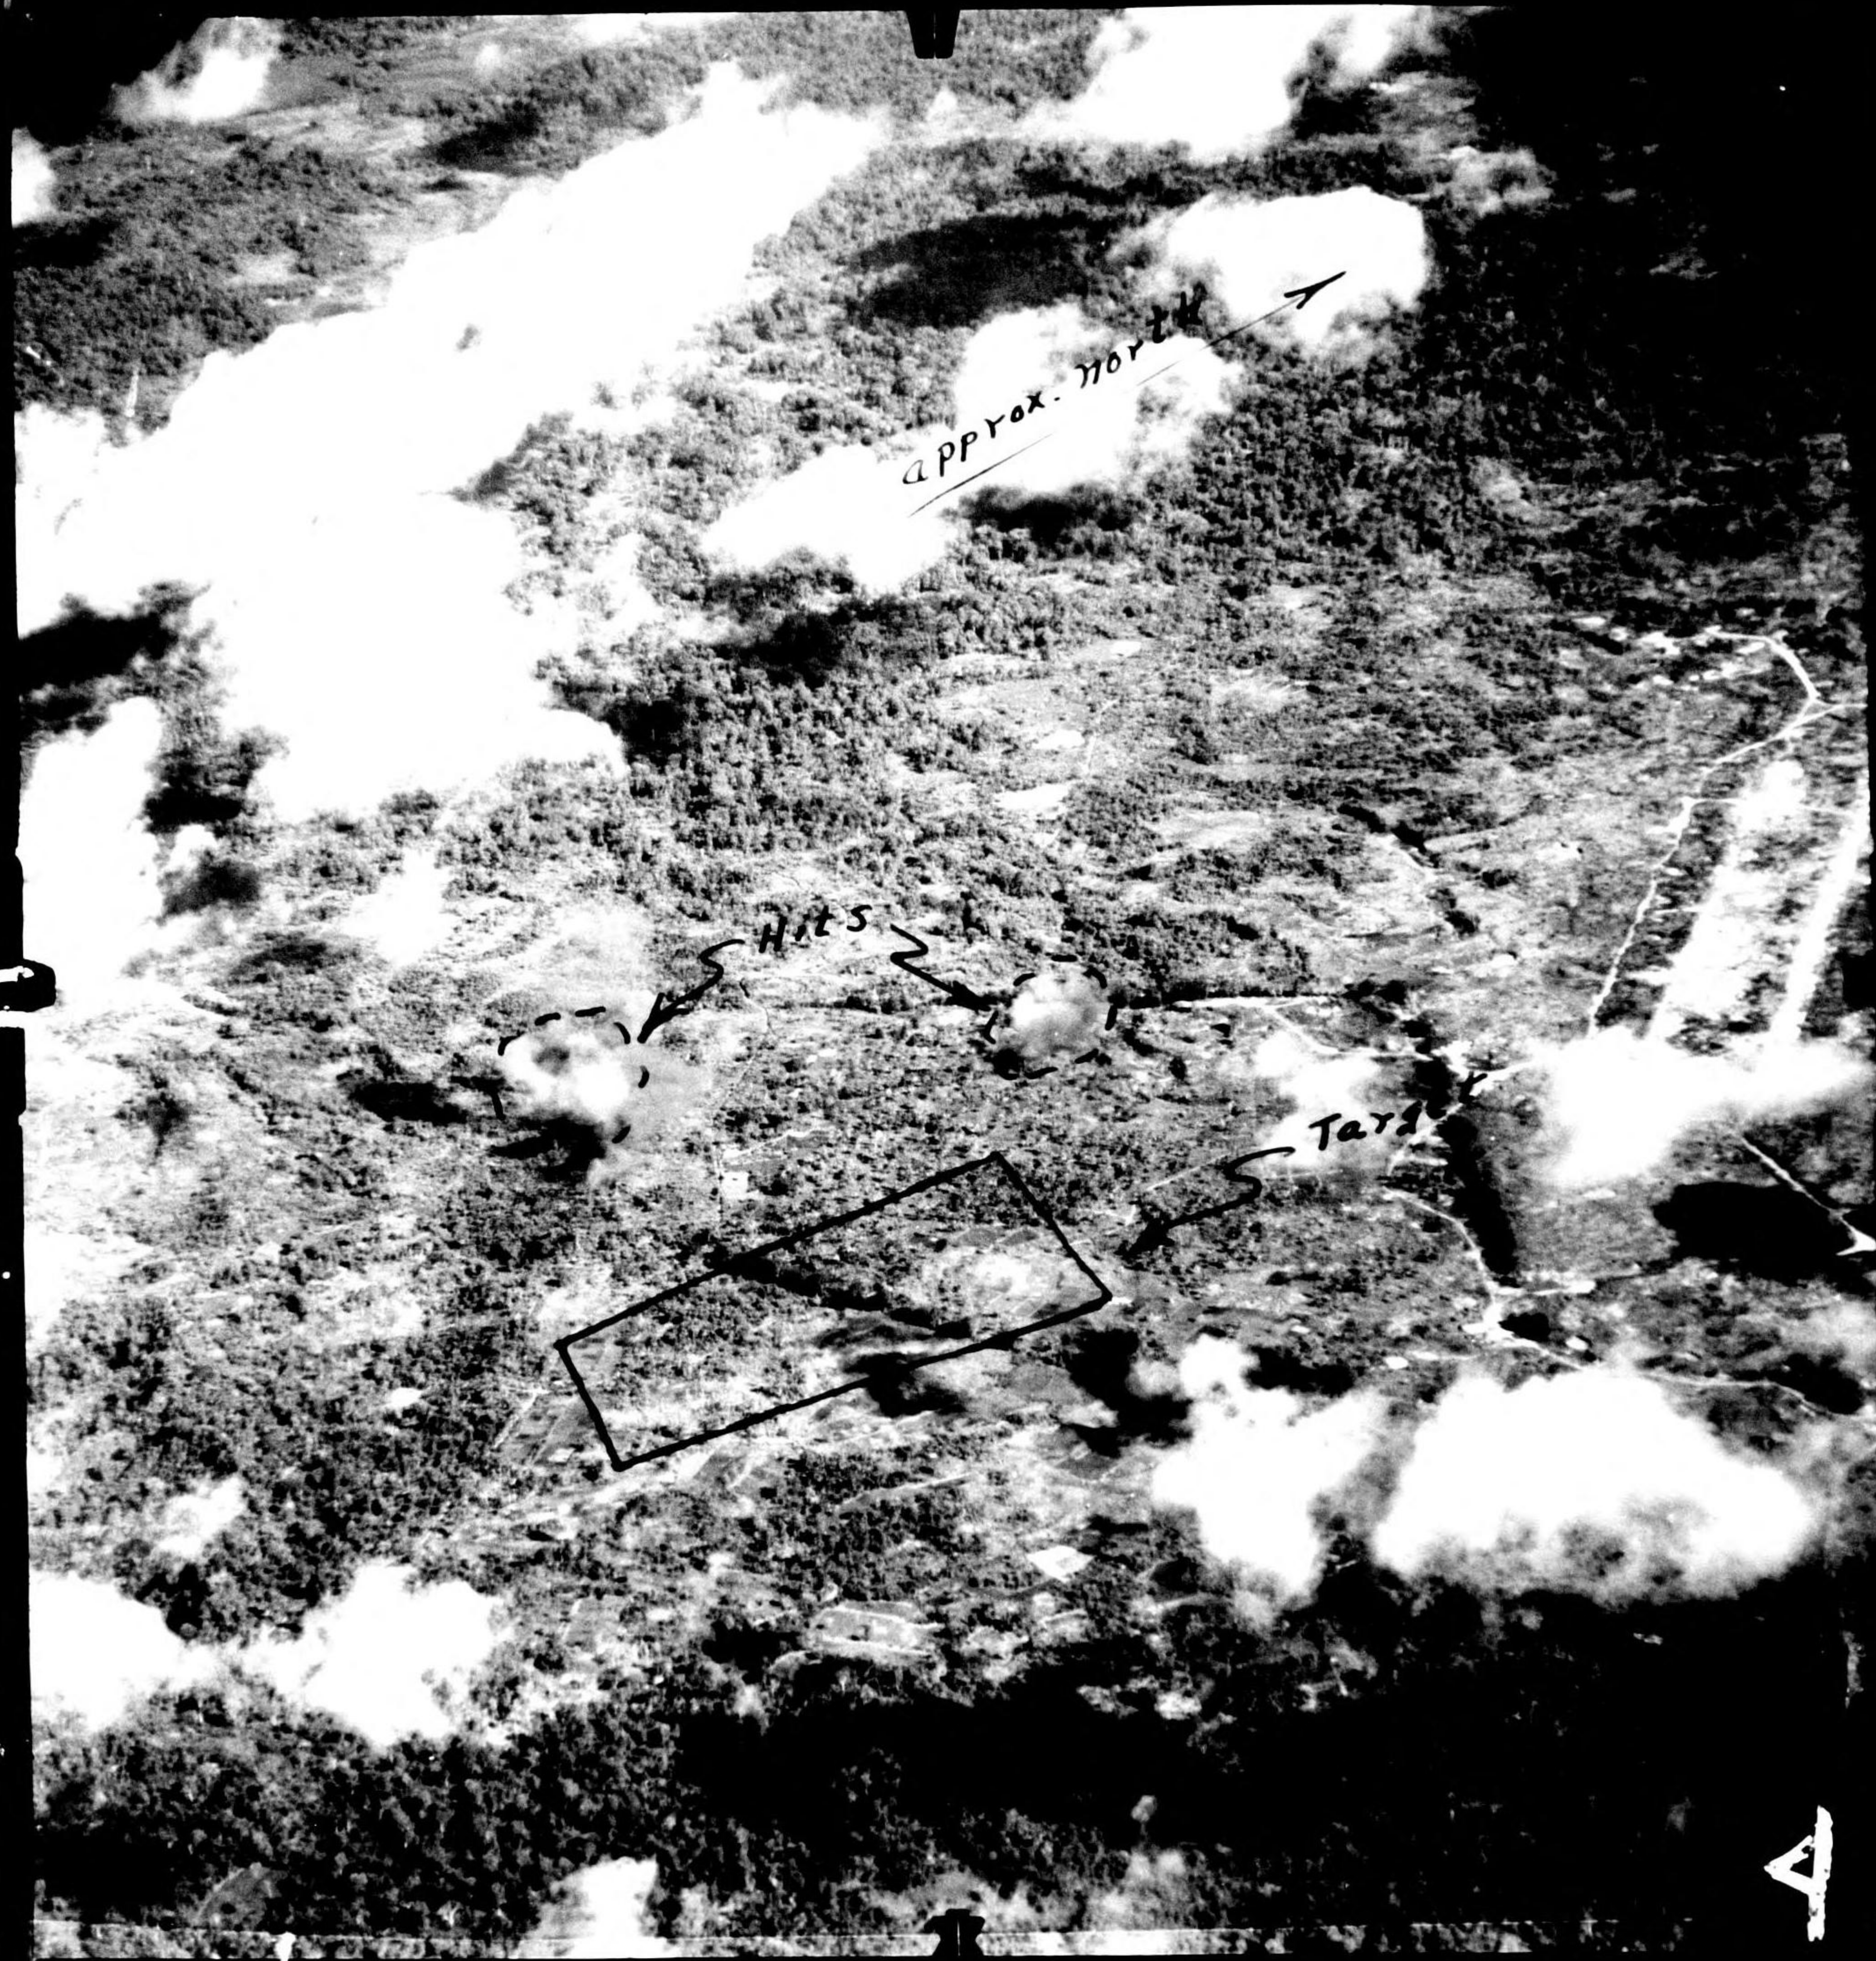
2.-12 x 1000⁺ GPs landed 1000' southwest of the target in wooded area.

6 x 1000⁺ GPs landed 2000' west of the target in a garden area.

The first squadron off was VMB-433, led by Major Whitney with 6 PWs participating. Eighteen bombs were released over Vanakanau #9A, a supply dump area and possible plane hide. After strike photos indicated that 12 bombs landed 1000' southwest of the target in a wooded area and 6 landed 2000' west of target in a garden area. Immediately following VMB-433's take-off Major Mendenhall led 6 Mitchells of VMB-413 in a similar raid on the storage area at Tobera #21. 36 x 500# GPs were dropped, 30 of which were strung from southwest to northeast through the middle of the target while 6 strayed southwest of the target. Later pictures showed large areas of vegetation cleared but no wreckage. VMB-443, led by Major Anderson, struck at Rabaul #36, a shore target at the head of Simpson Harbor, containing revetted stores. Of the 18 x 1000# GPs dropped 16 were shown, in after strike photographs, to have strung across the northern half of the target while 2 fell just east of the target astride of Malaguna Ave. Flames and smoke from a fuel dump were seen for 25 minutes after the strike.
