National Register of Historic Places
Inventory—Nomination Form

historic AS SOMBRERU PILLBOX III
Japanese World War II fortification

and or common West Matapang pillbox

NATIONAL REGISTER OF HISTORIC PLACES
REGISTRATION FORM

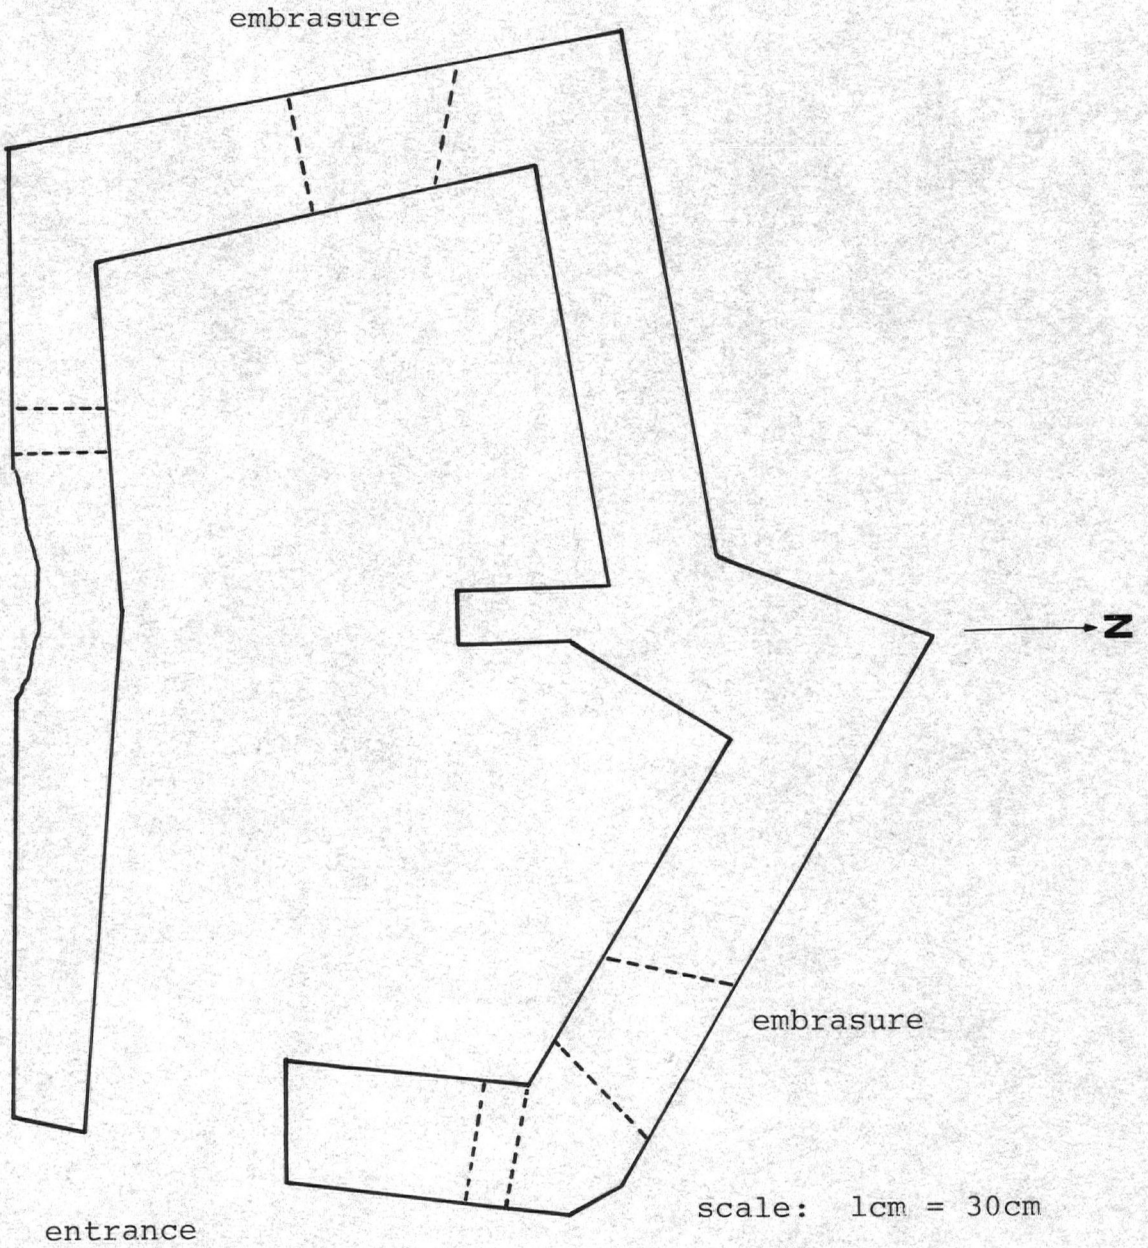
Plan view

entrance

West Matapang Pillbox, Tumon Bay
Guam

While the overall dimensions are 4.0m by 2.70m, the pillbox has a complex configuration. It has six exterior walls. Sand is banked against the exterior of the south or inland wall which is .25m .30m thick. A small air vent is located in the south wall. The west wall, about .45m thick, has a gun port with view of the center portion of Tumon Bay. The entrance and an air vent are located in the east wall.

An interior wall divides the space into two rooms. The interior height from the present sand floor to the ceiling is 1.35m. Horizontal impressions of the boards used to build the form into which the concrete was poured are apparent on the exterior and interior walls.

The roof slab of the structure is about .25m thick. To this, a conglomerate of concrete, coral, and glass fragments measuring about .25m to .20m thick has been added to the exterior surface of the roof. This conglomerate is heaped higher at the center than at the edges of the roof. Over the entrance of the structure, the roof has been reinforced with a cement strip, .20m wide, .05m to .20m high, and 1.50m long. Impressions of tabi prints and a possible Japanese character are apparent in the cement of the roof. The exterior height of the structure is 1.45m above ground surface.
