# FLOOD HAZARD ANALYSES UPPER SUDBURY RIVER MASSACHUSETTS

**FLOOD HAZARD ANALYSES**  
**UPPER SUDBURY RIVER**

within the towns of  
**ASHLAND, HOPKINTON,**  
**SOUTHBOROUGH and WESTBOROUGH,**  
**MASSACHUSETTS**

**JUNE 1973**

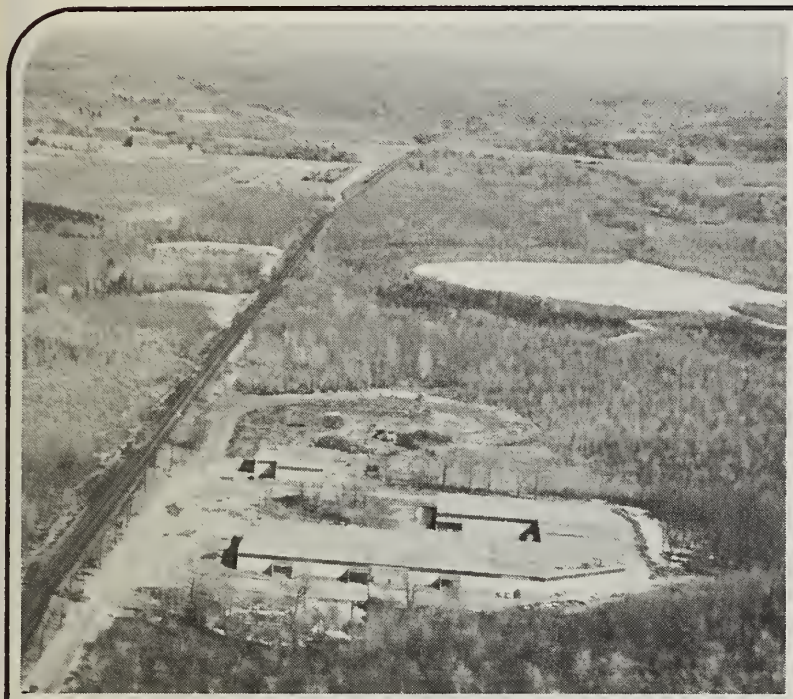
Upper Left (Westborough) -- Cedar Swamp divided by the railroad, with Rutters Brook in the foreground and Cedar Swamp Pond in the background. (W.R.C. Photo)

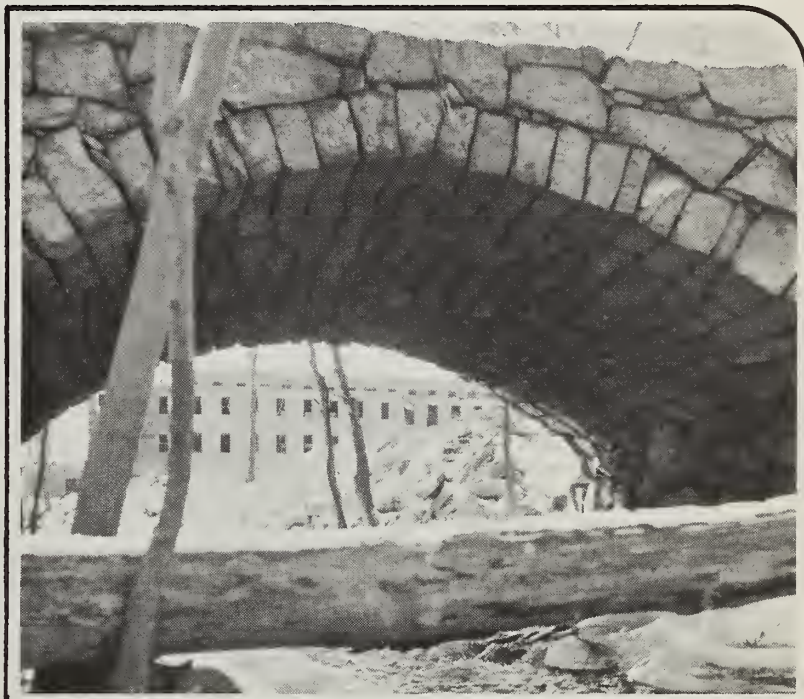
Upper Right (Southborough) -- Abandoned bridge and mill building on the Sudbury River at Cordaville. (SCS Photo)

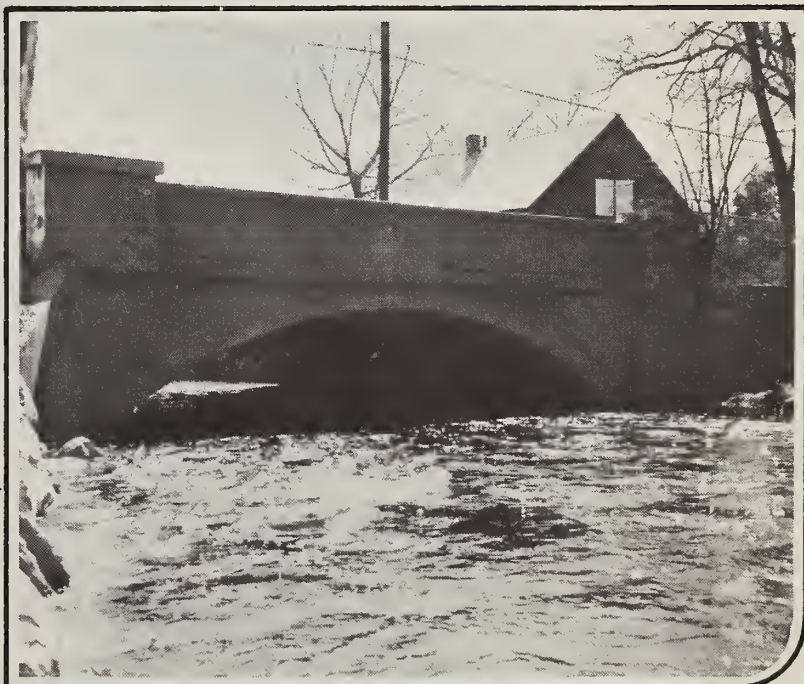
Lower Right (Ashland) -- Concord Street Bridge and the Sudbury River during a spring freshet. (SCS Photo)

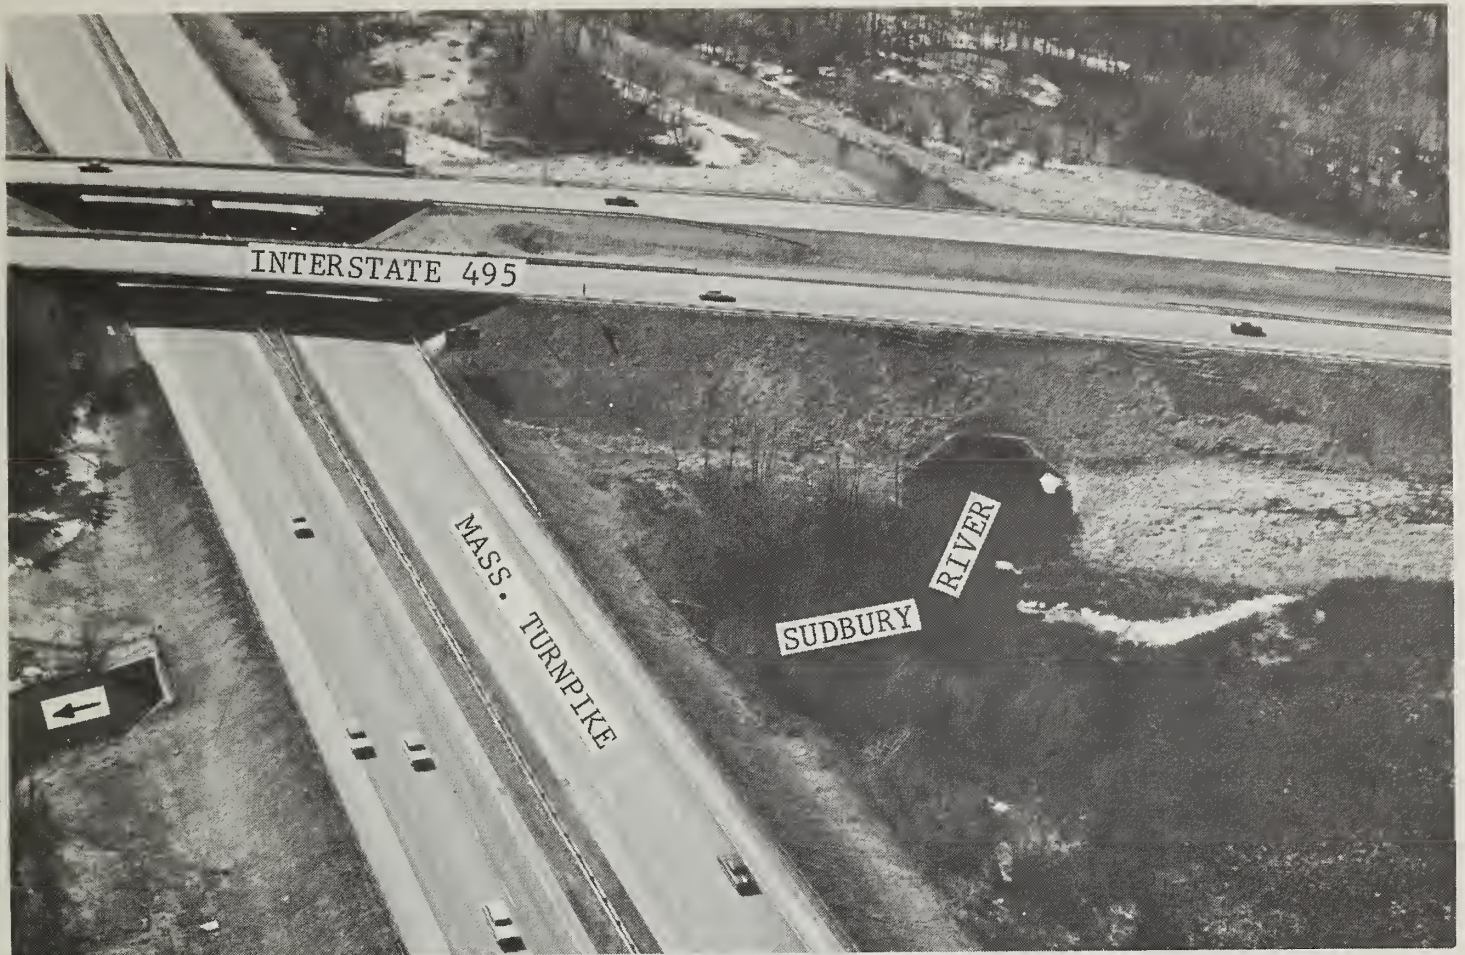
Westborough -- Hopkinton -- Major Interstate highway construction through Cedar Swamp with crossings over the Sudbury River. (W.R.C. photo)

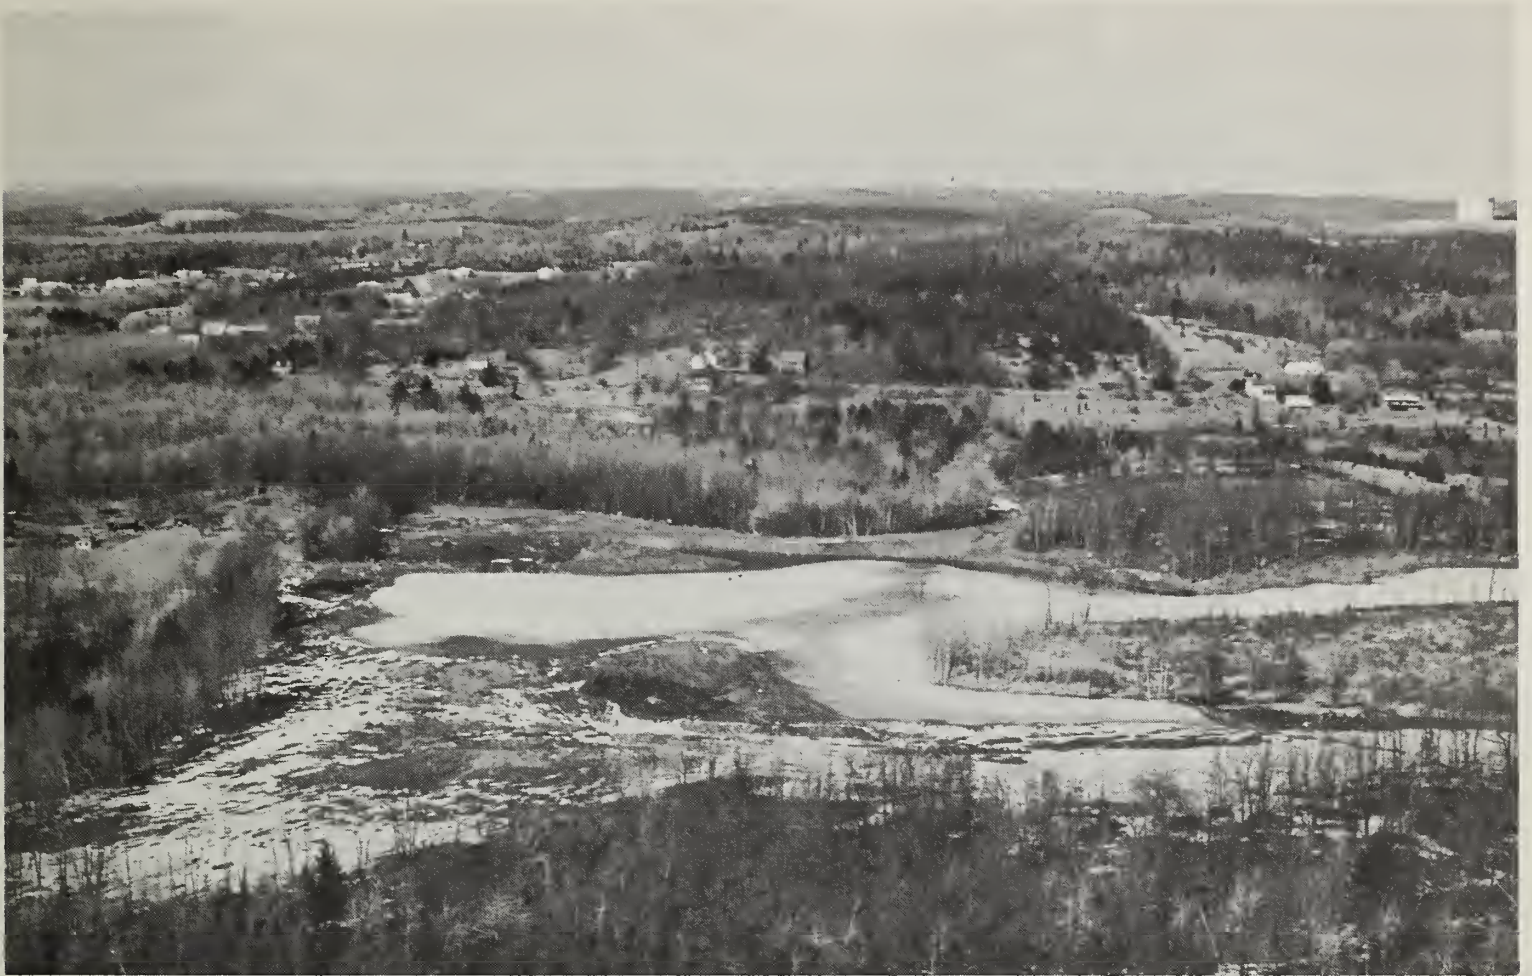
Westborough -- An aerial view of Cedar Swamp, north of the railroad, showing the "Equal Pondage Area" constructed to offset flood storage lost from industrial development. (W.R.C. photo)

In the last few years, development pressure has accelerated. The Penn Central Company obtained a permit in 1969 to level and fill the cross-hatched area on Plate 5-1, adjacent to Culvert No. 4, north of the railroad. A New England regional distribution center for Chrysler Corporation was constructed to unload, store and reload new vehicles from railroad cars onto trucks. In order to provide the required alternate storage of displaced floodwaters, Penn Central also constructed an "Equal Pondage Area" 2,000 feet northwest of Cedar Swamp Pond. This equal storage area was excavated in a gravel till upland area so as to provide at least 67 acre-feet of accessible flood storage between the normal water level and elevation 280. This replaced the amount of storage lost, between these elevations, by the fill placed in the low areas in the construction of the auto-unloading facility.

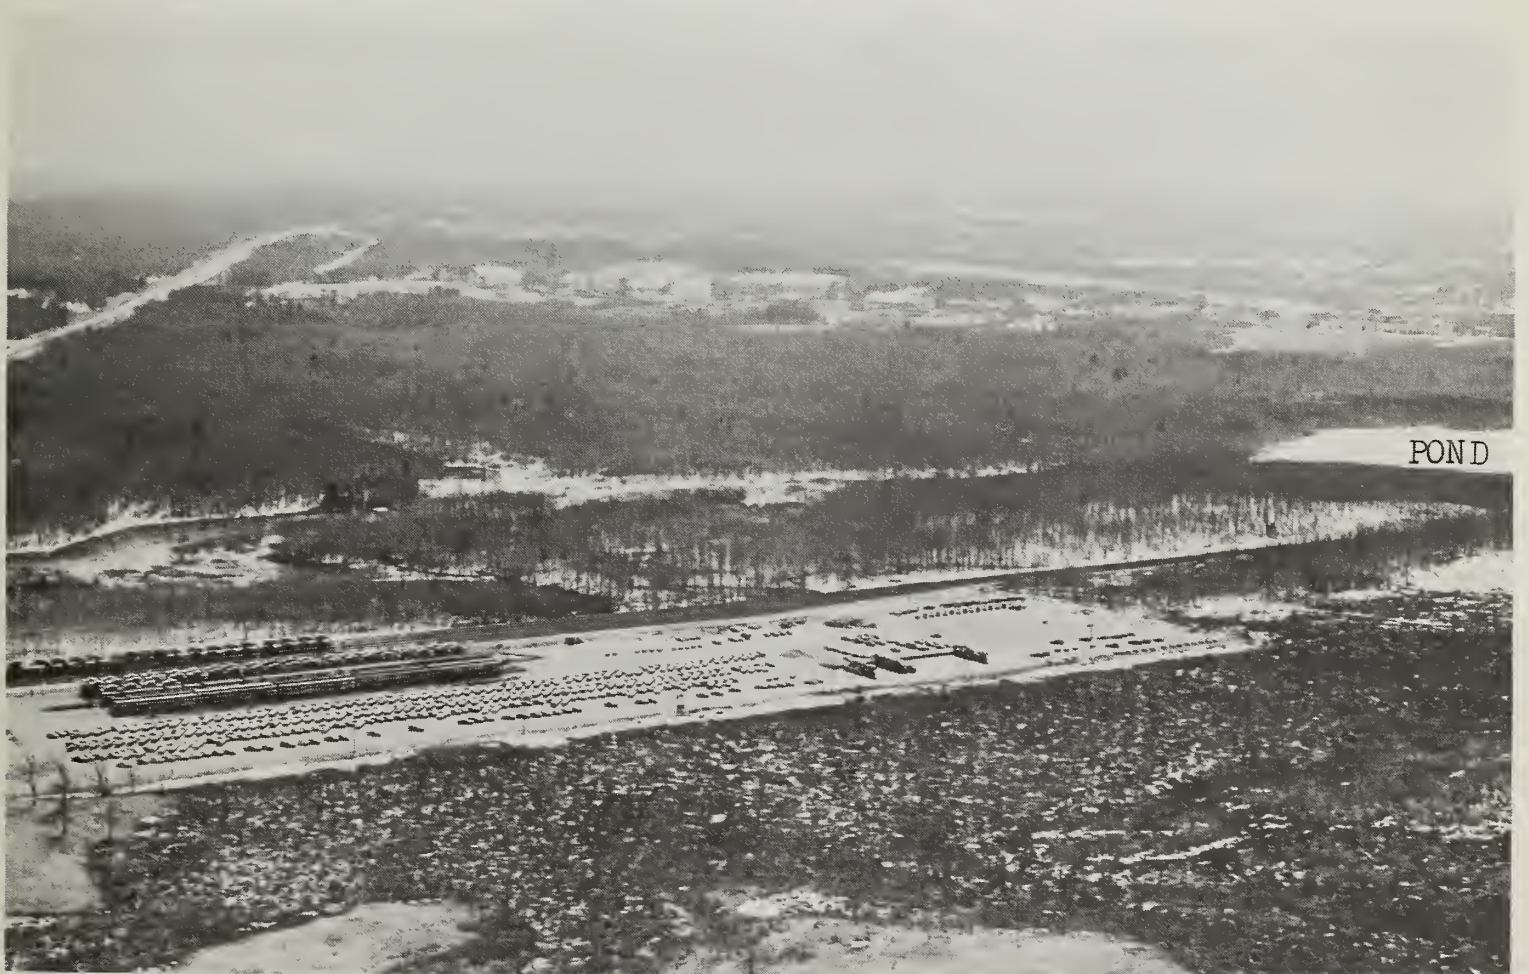
Westborough -- An aerial view of Cedar Swamp showing Cedar Swamp Pond and the Sudbury River in the background and the Chrysler auto unloading facilities in the foreground. (W.R.C. photo)

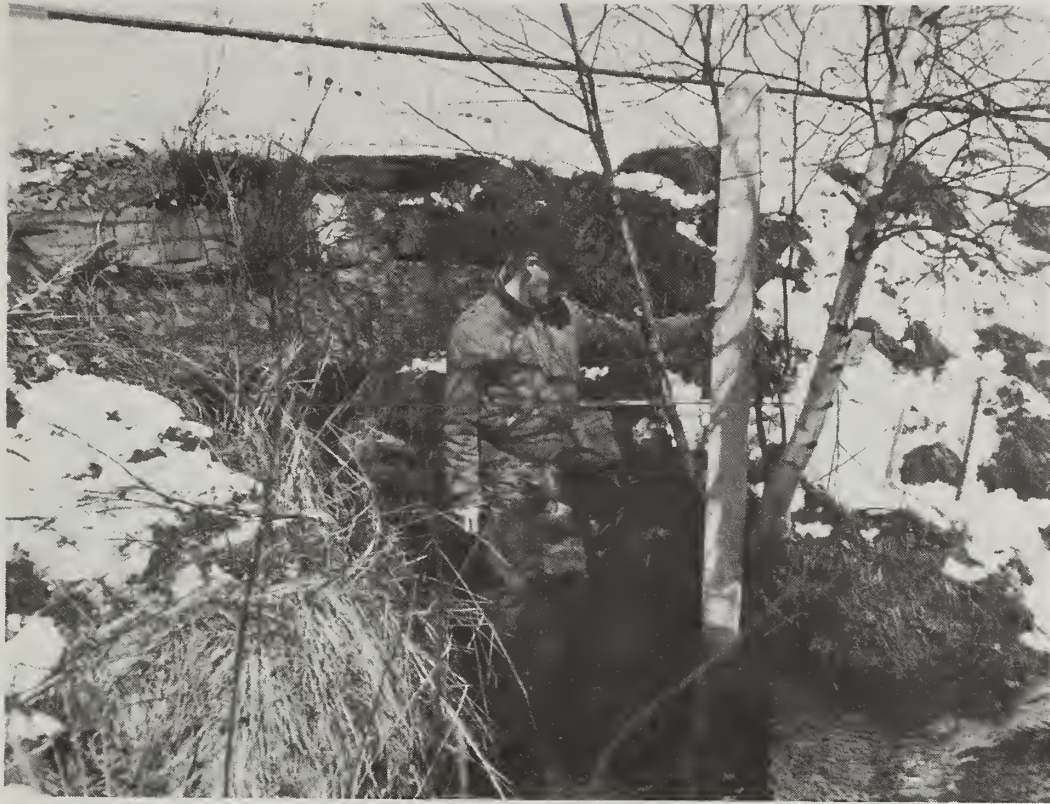
Westborough -- Staff gages were installed at key locations in Cedar Swamp to record fluctuations in water levels. This is location 7 shown on Plate 4. (SCS photo)

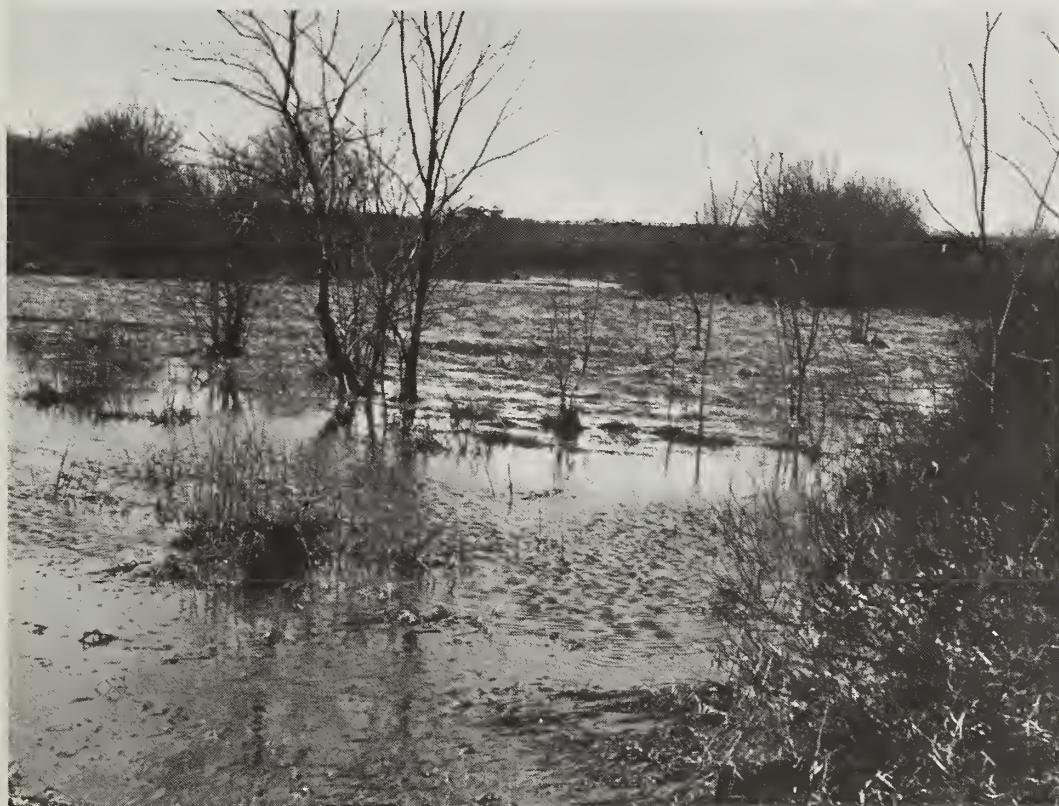
Westborough -- Hopkinton -- Cedar Swamp consists of a number of interacting flood storage areas. This is the Sudbury River fresh water marsh between the Mass. Turnpike and Fruit Street. (W.R.C. photo)

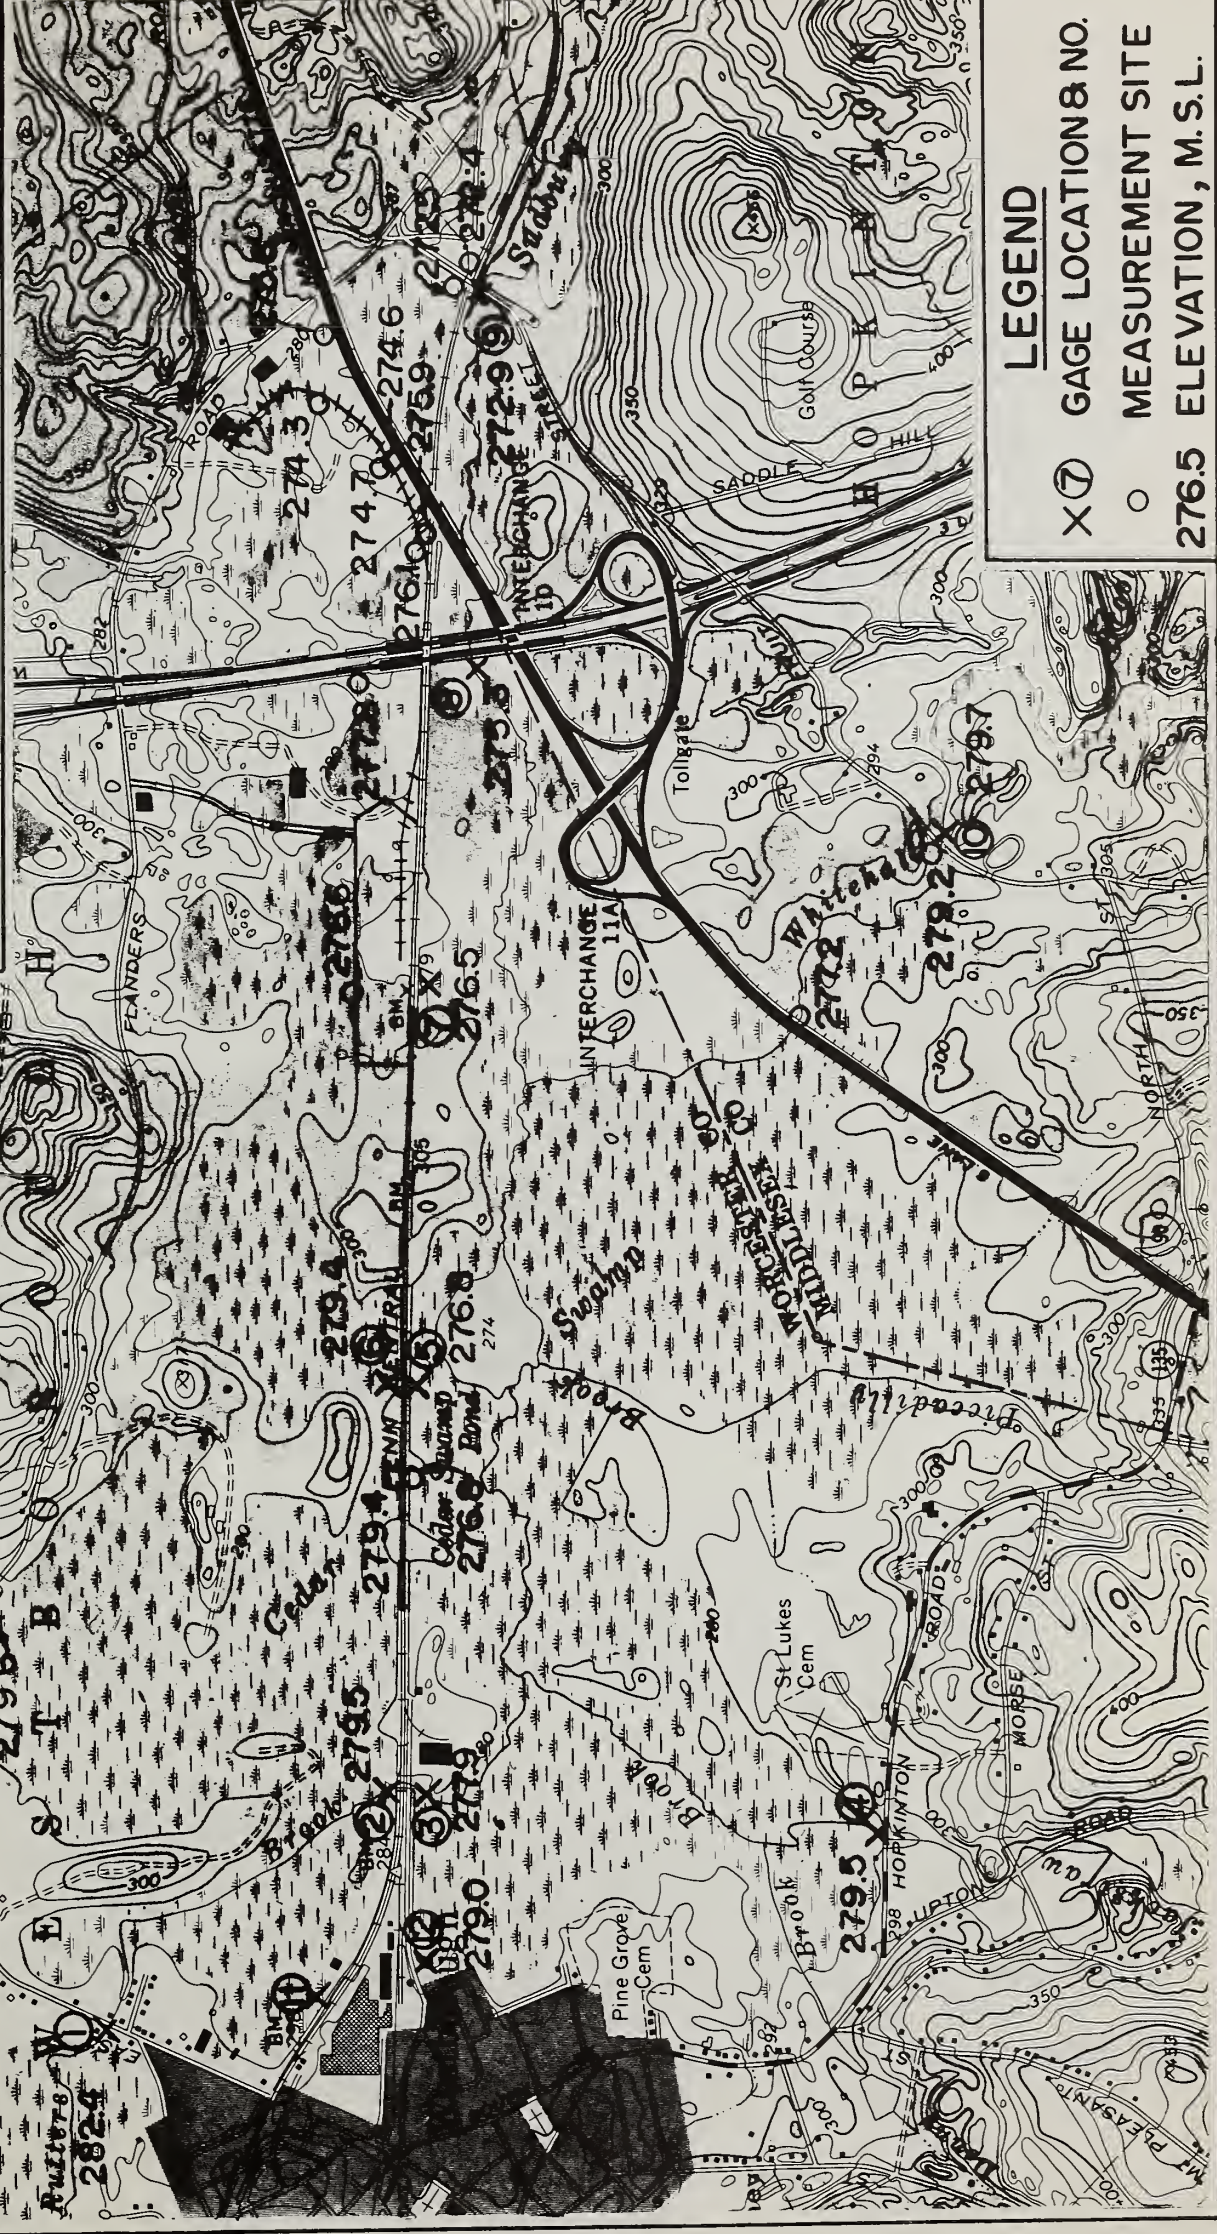
PLATE 4  
UPPER SUDBURY RIVER, MASSACHUSETTS  
CEDAR SWAMP  
WATER LEVEL READINGS  
MARCH 18 - 24, 1972  
UNITED STATES DEPARTMENT OF AGRICULTURE  
SOIL CONSERVATION SERVICE

Note: These gage readings were the highest recorded during this period but do not necessarily represent instantaneous peak water levels.

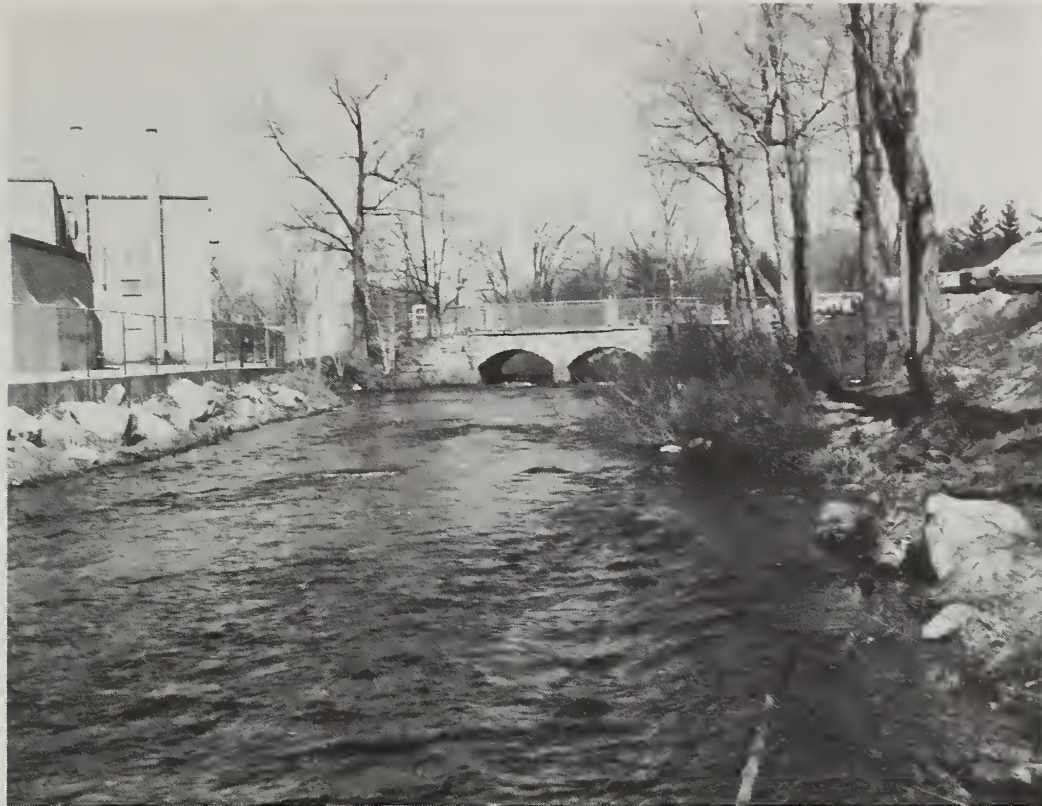
Ashland -- This twin stone arch bridge, near the General Electric Telechron Plant, is one of four restrictive stream crossings on the Sudbury River. (SCS photo)

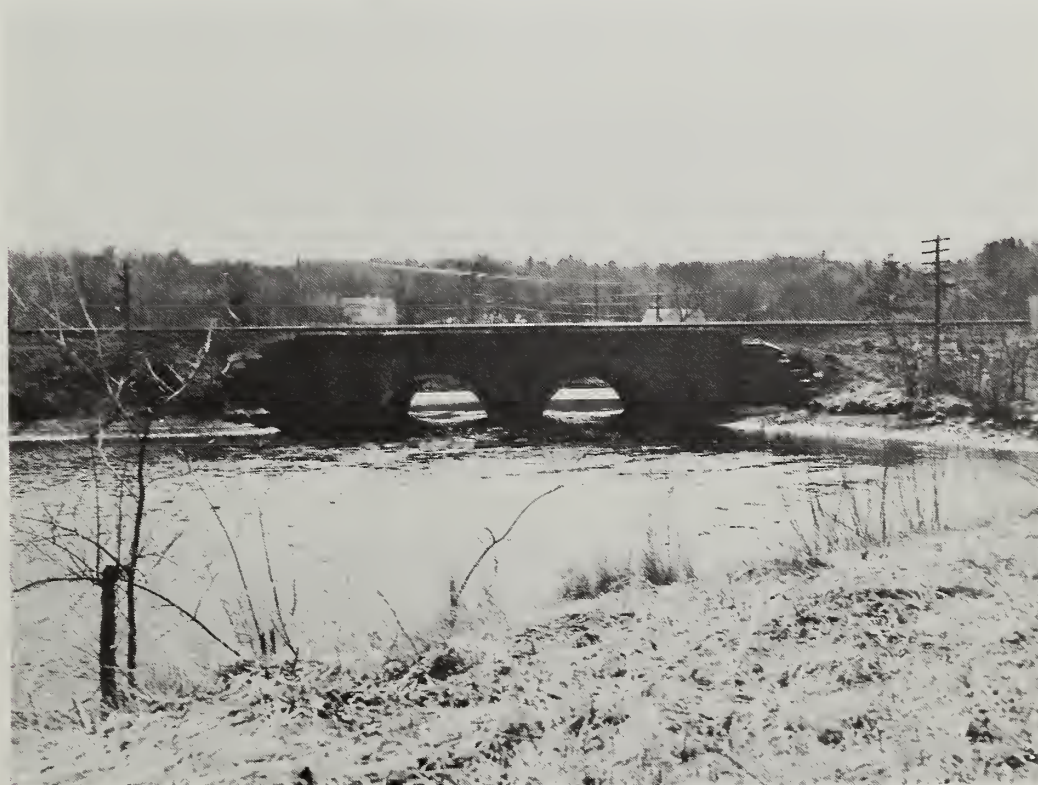
Ashland -- This Penn Central Railroad twin arch bridge at the upper end of Reservoir No. 2 acts as a bottleneck to major peak flood flows. (SCS photo)

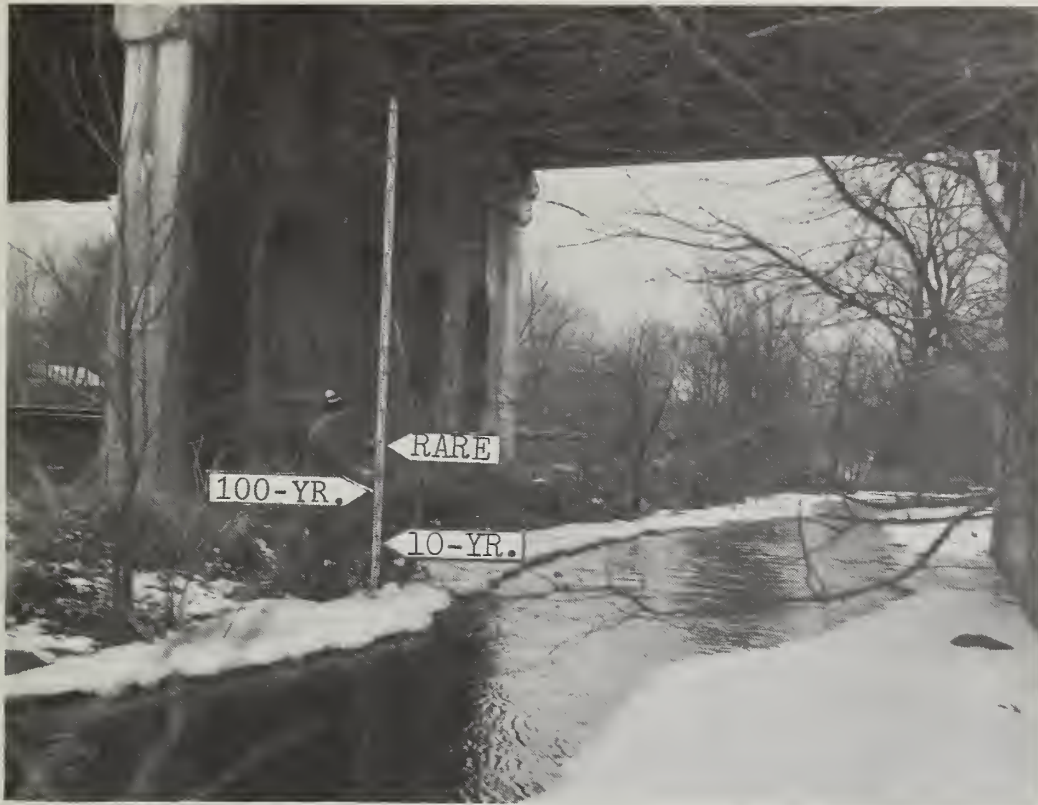
Bottom of rod  
at elevation 271.6

Flood stage on rod	
10-yr.	= 1.8'
100-yr.	= 3.4'
Rare	= 4.9'

Westborough -- Hopkinton -- Looking easterly at the Fruit Street overpass showing the Sudbury River and the Penn Central Railroad. (SCS photo)

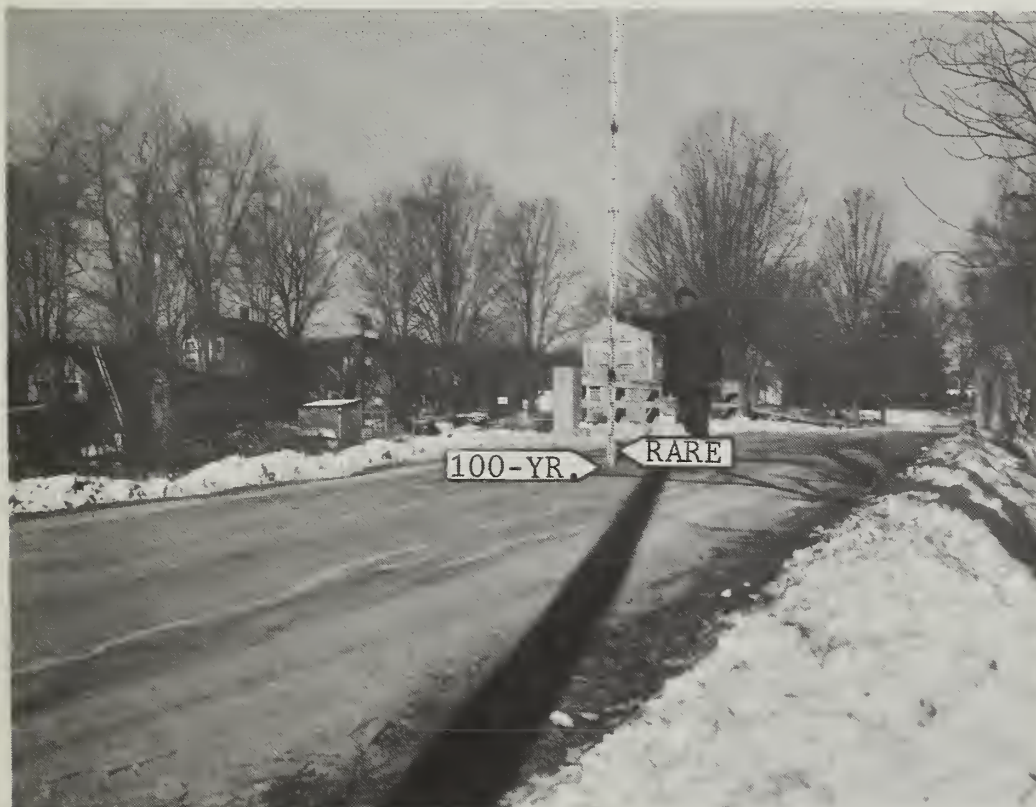
Bottom of rod  
at elevation 260.4

Flood stage on rod	
10-yr.	= - 1.9'
100-yr.	= 0.0'
Rare	= 0.5'

Southville -- Looking northwest at the Cedar Street Bridge over the Sudbury River with homes on Wood Street in the background. (SCS photo)

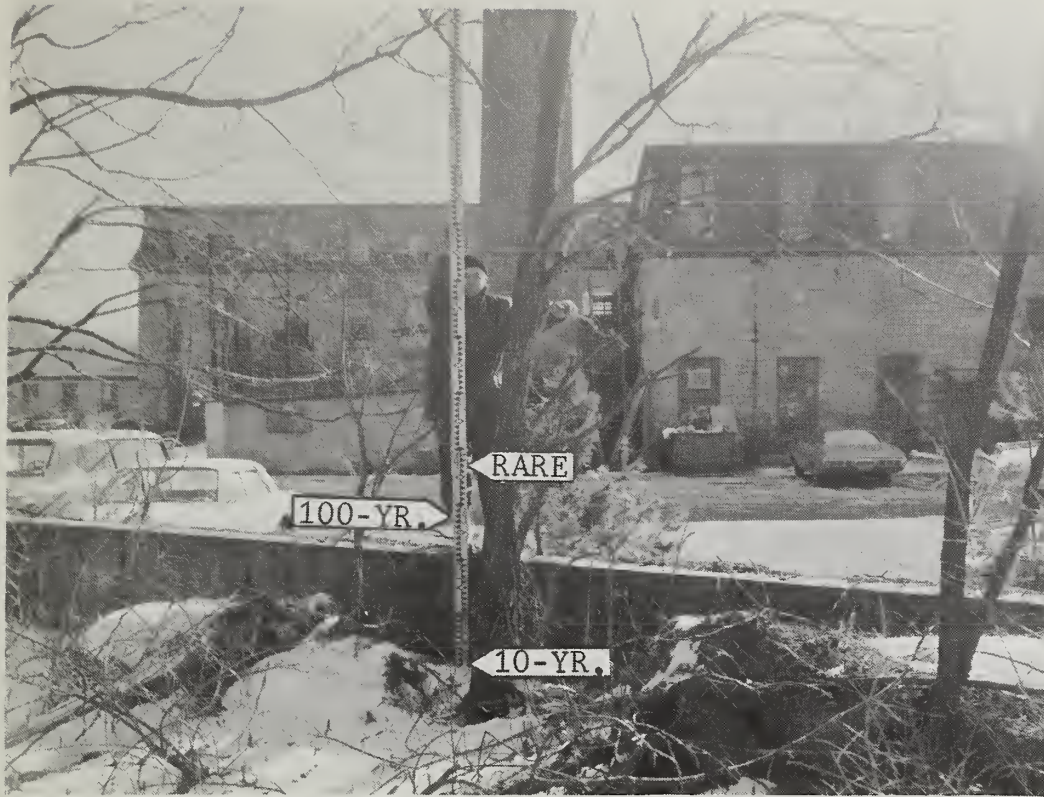
Bottom of rod  
 at elevation 185.7  
Flood stage on rod  
 10-yr. = 0.1'  
 100-yr. = 2.8'  
 Rare = 3.7'

Ashland -- Looking over the concrete retaining wall along the right bank of the Sudbury River at the former Lombard-Governor building downstream of Myrtle Street. (SCS photo)

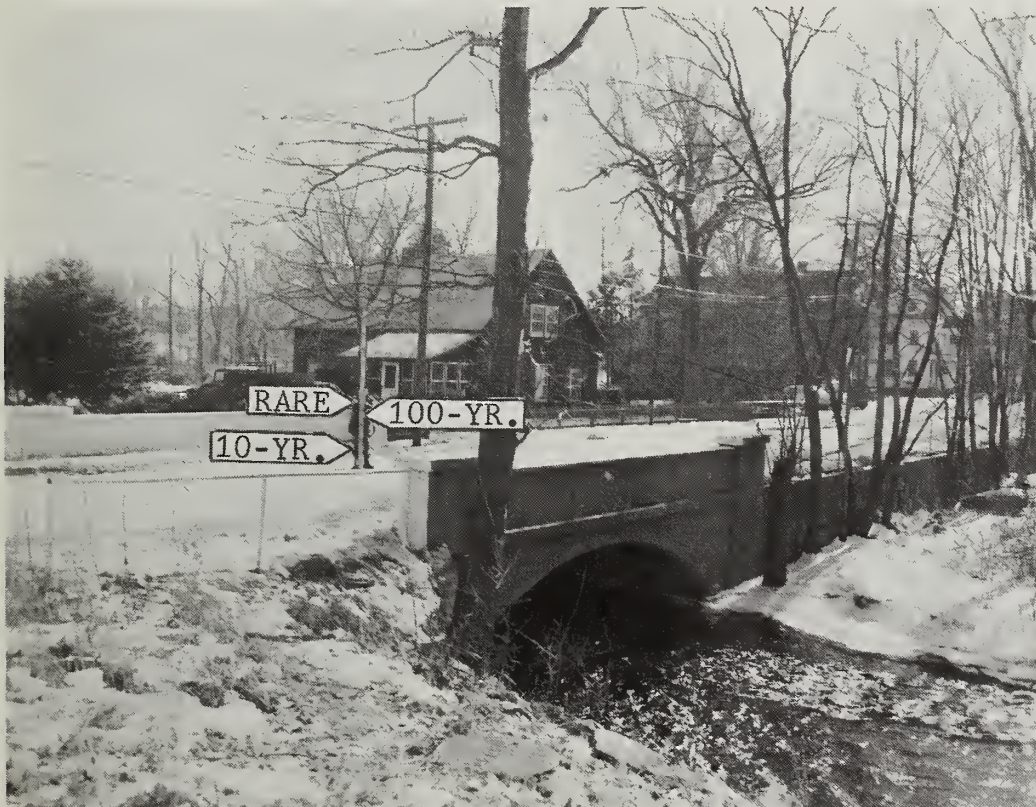
Bottom of rod  
 at elevation 183.2  
Flood stage on rod  
 10-yr. = 1.3'  
 100-yr. = 3.8'  
 Rare = 4.6'

Ashland -- Looking southeast at the Concord Street Bridge over the Sudbury River. (SCS photo)

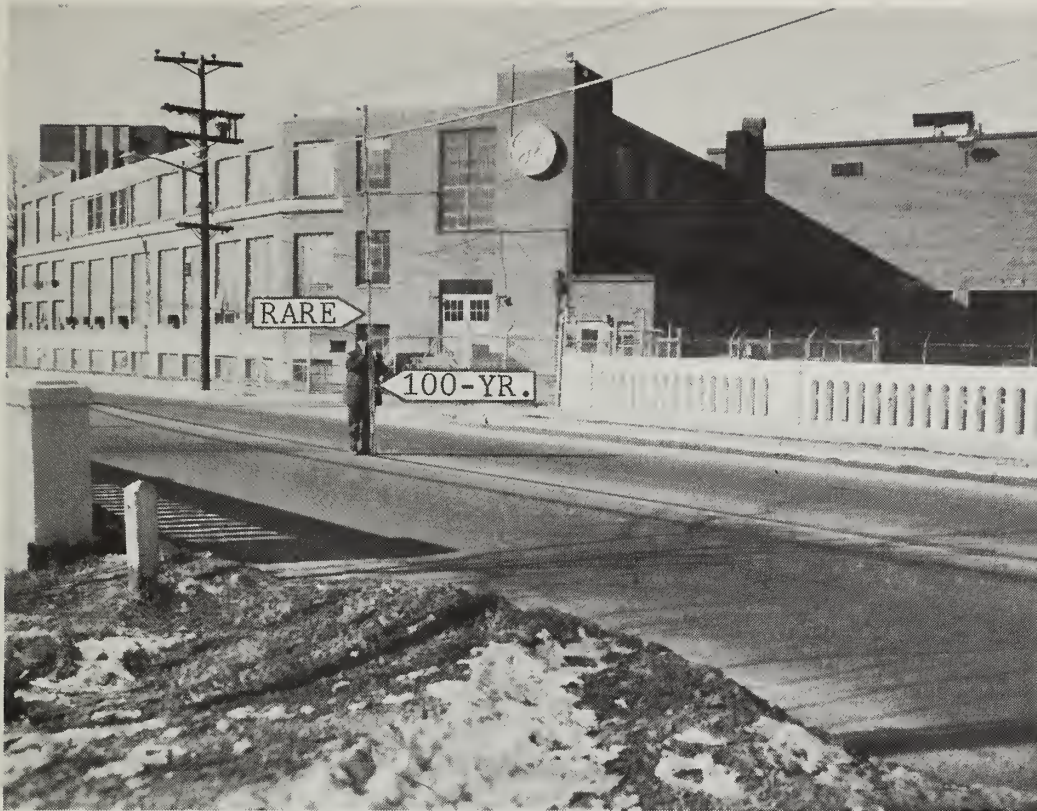
Bottom of rod	
at elevation 178.5	
<u>Flood stage on rod</u>	
10-yr.	= - 0.5'
100-yr.	= 3.3'
Rare	= 6.5'

Ashland -- Looking westward across the Union Street Bridge (SR-135, west crossing) over the Sudbury River with the General Electric Telechron plant in the background. (SCS photo)

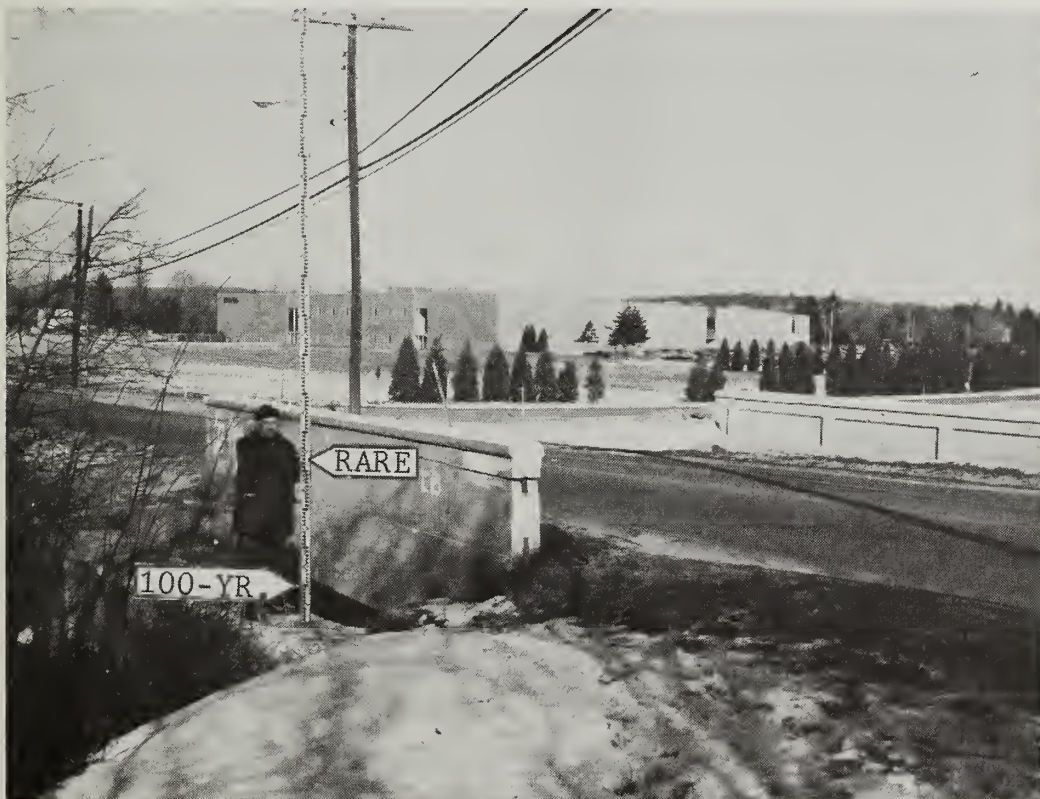
Bottom of rod	
at elevation 180.3	
<u>Flood stage on rod</u>	
10-yr.	= -2.2'
100-yr.	= 1.0'
Rare	= 4.3'

Ashland -- Looking northward at the Main Street Bridge and sewer crossing over Cold Spring Brook with the Fenwall Company in the background. (SCS photo)

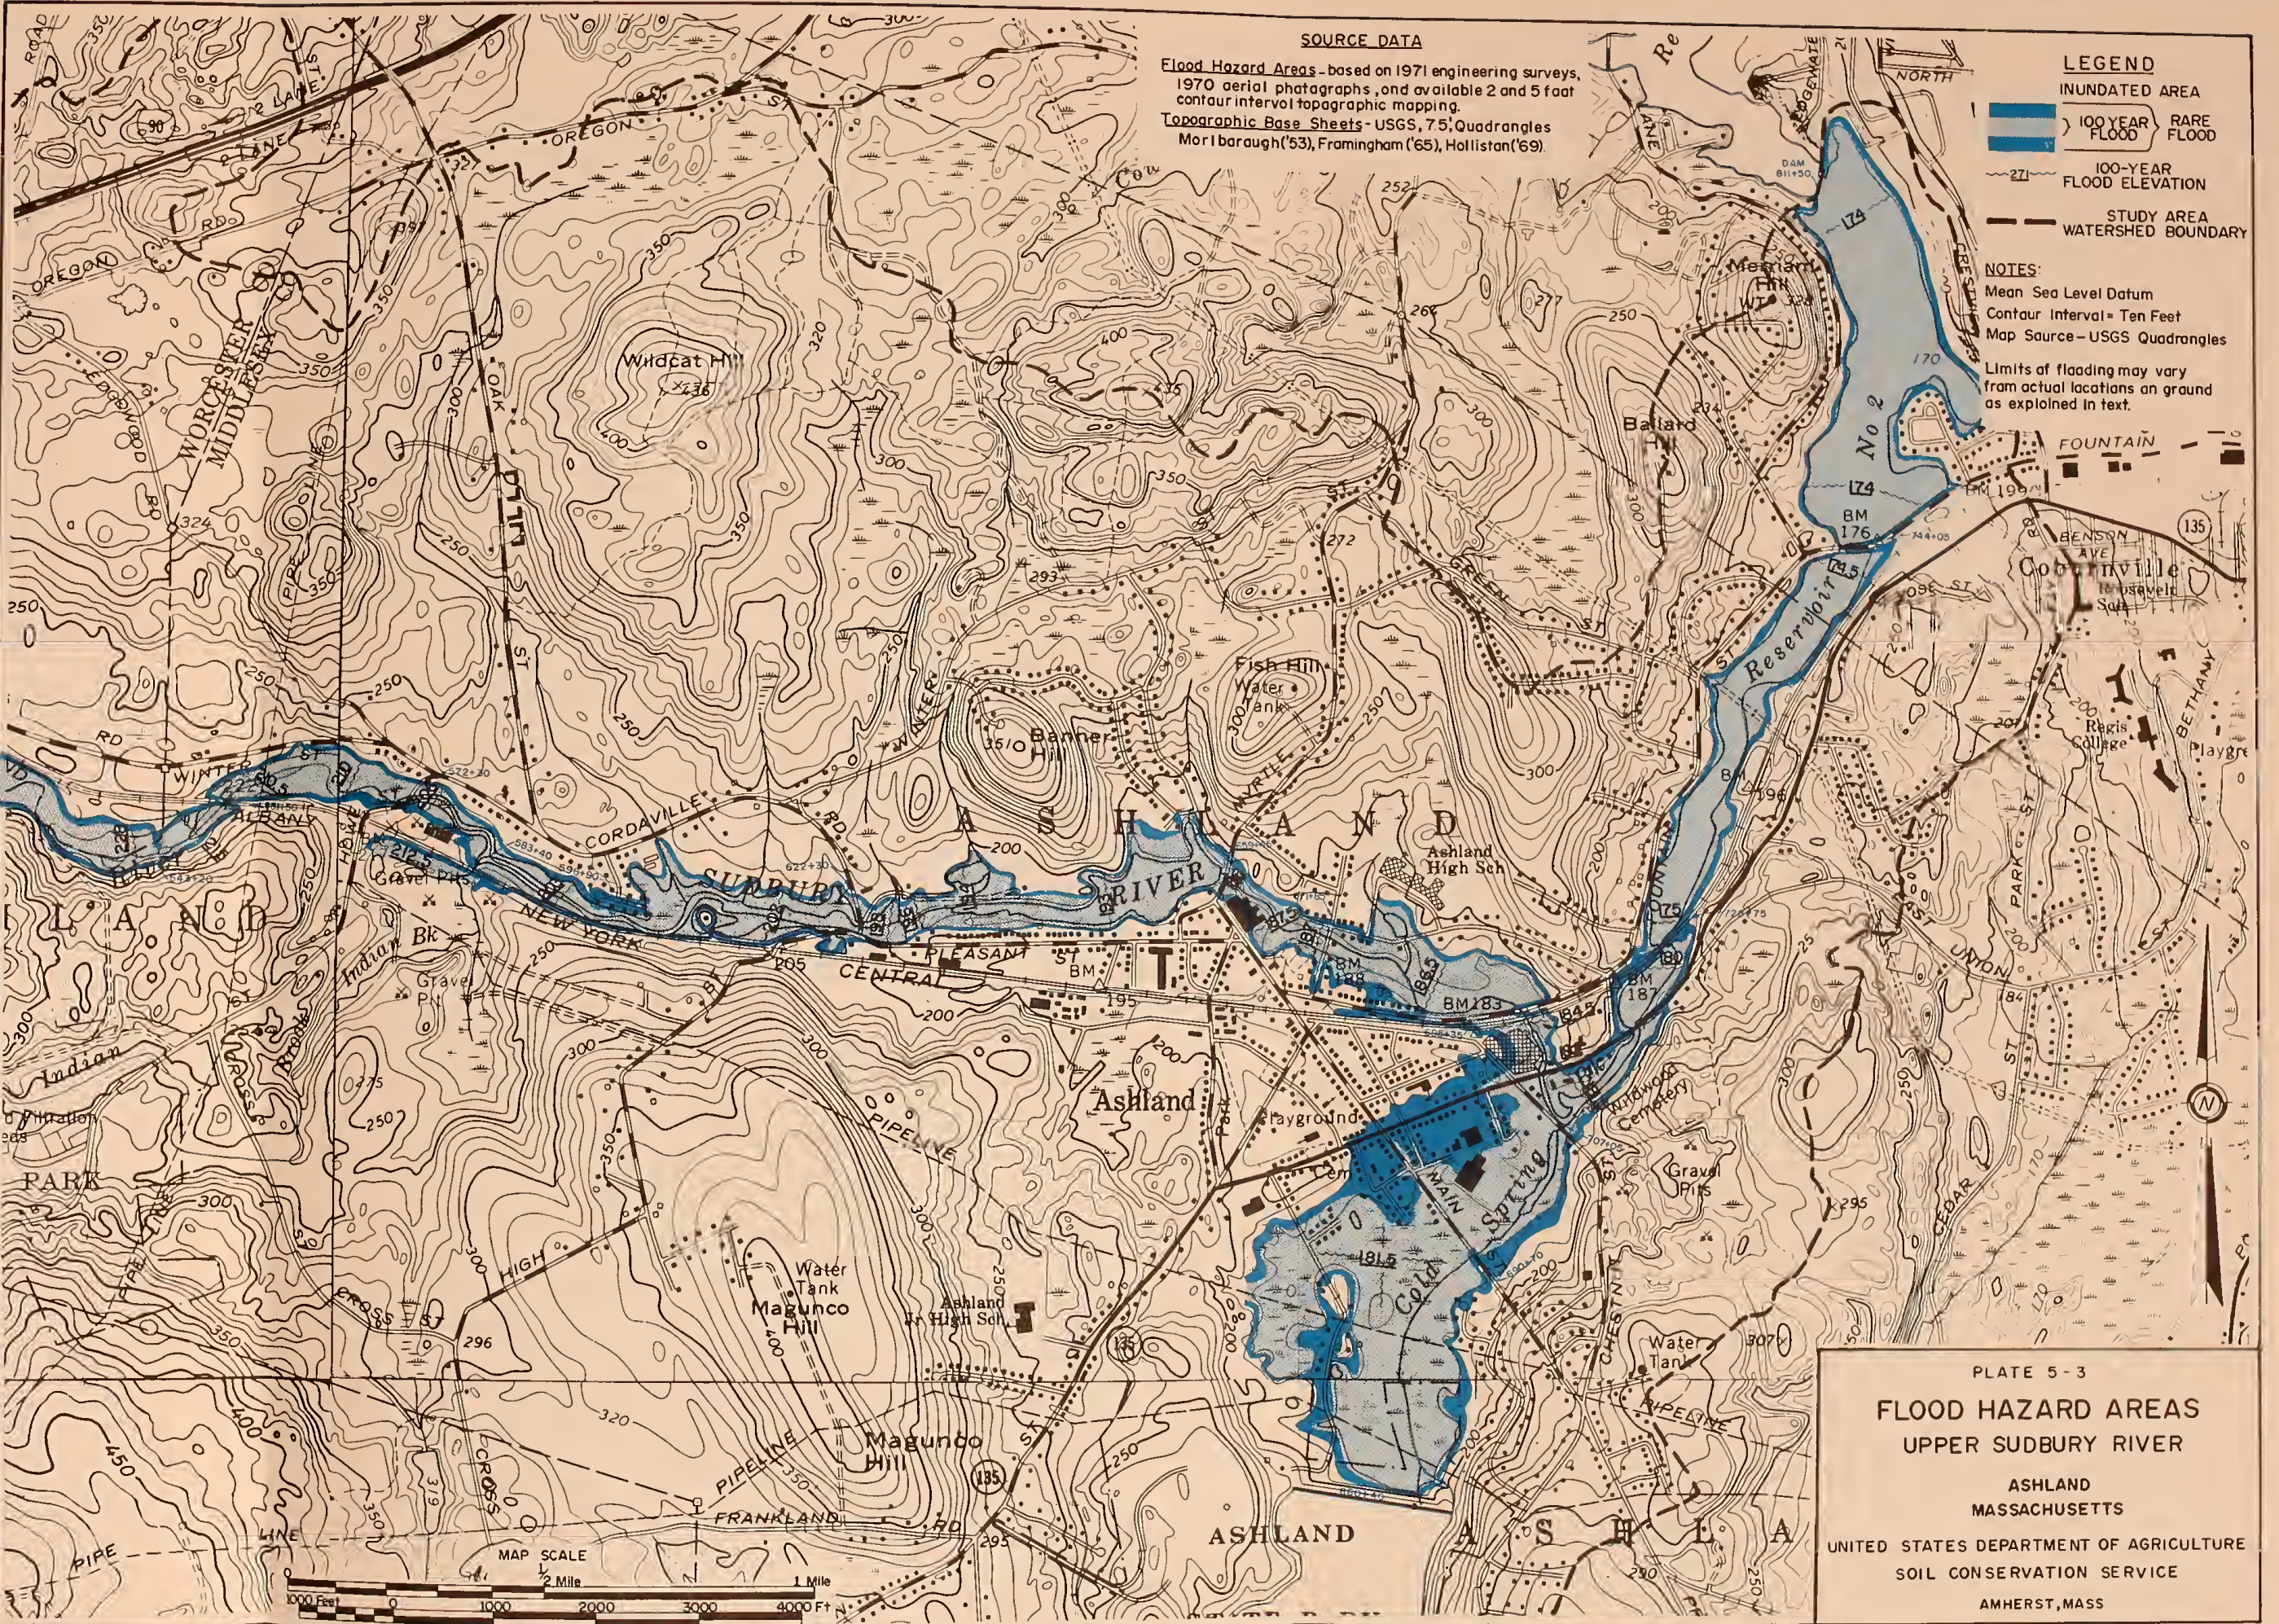
PLATE 5-3  
**FLOOD HAZARD AREAS**  
 UPPER SUDBURY RIVER  
 ASHLAND  
 MASSACHUSETTS  
 UNITED STATES DEPARTMENT OF AGRICULTURE  
 SOIL CONSERVATION SERVICE  
 AMHERST, MASS

The limits of the 100-year and Rare Floods were delineated on the base maps (Plates 5-1, 5-2, 5-3) to indicate the extent of area inundated. The base maps are reproductions of the composites of the latest 7½ minute U.S. Geological Survey quadrangle sheets, updated to show recent development in the flood plain. The flood lines shown on these sheets are based on several types of field information. Surveyed sections of roads, bridges, channel sections, valley sections, and damage areas provided the best information at most locations. Several topographic plans with two-and-five foot contour intervals were used for other locations. Where no field data were available, flood lines were based on stereoscopic study of aerial photographs. All questionable areas were field checked. Because of the inaccessibility of some portions of the flood plain and the difficult field survey conditions, the flood limits may vary on the ground from those shown on the map especially in swampy and wooded areas. Flood profile elevations should be used in all cases where there is a discrepancy with the flood lines shown on the Flood Hazard Area maps. Spot elevations for the 100-year flood were included on the Flood Hazard Area maps at convenient intervals to help correlate these maps with the flood profiles. The flood profiles and flood hazard maps were prepared at a scale of 1"=800' and reduced for this report.

**SOURCE DATA**  
 Flood Hazard Areas - based on 1971 engineering surveys, 1970 aerial photographs, and available 2 and 5 foot contour interval topographic mapping.  
 Topographic Base Sheets - USGS, 7.5' Quadrangles Morlbarough ('53), Framingham ('65), Holliston ('69).

The areas along the major streams that would be affected by the 100-year and Rare floods are shown on Plates 5-1, 5-2, and 5-3. Depths of flooding for the 10-year, 100-year and Rare flood can be estimated from the profiles shown on Plates 6-1, 6-2, and 7. Flood limits may vary on the ground from that shown in the swampy and wooded areas on the map. Therefore, flood profile elevations should be used in all cases where there is a discrepancy with the flood lines on the Flood Hazard Areas maps.
