THE **ARCHEOLOGY**
AND **STABILIZATION**
OF THE **DOMINGUEZ**
AND **ESCALANTE**
RUINS

The Dominguez Ruin:
A McElmo Phase Pueblo in Southwestern Colorado

Archeological Excavation at the Escalante Site,
Dolores, Colorado, 1975 and 1976

Stabilization of Escalante Ruin 5MT2149
and
Dominguez Ruin 5MT2148
Dolores, Colorado

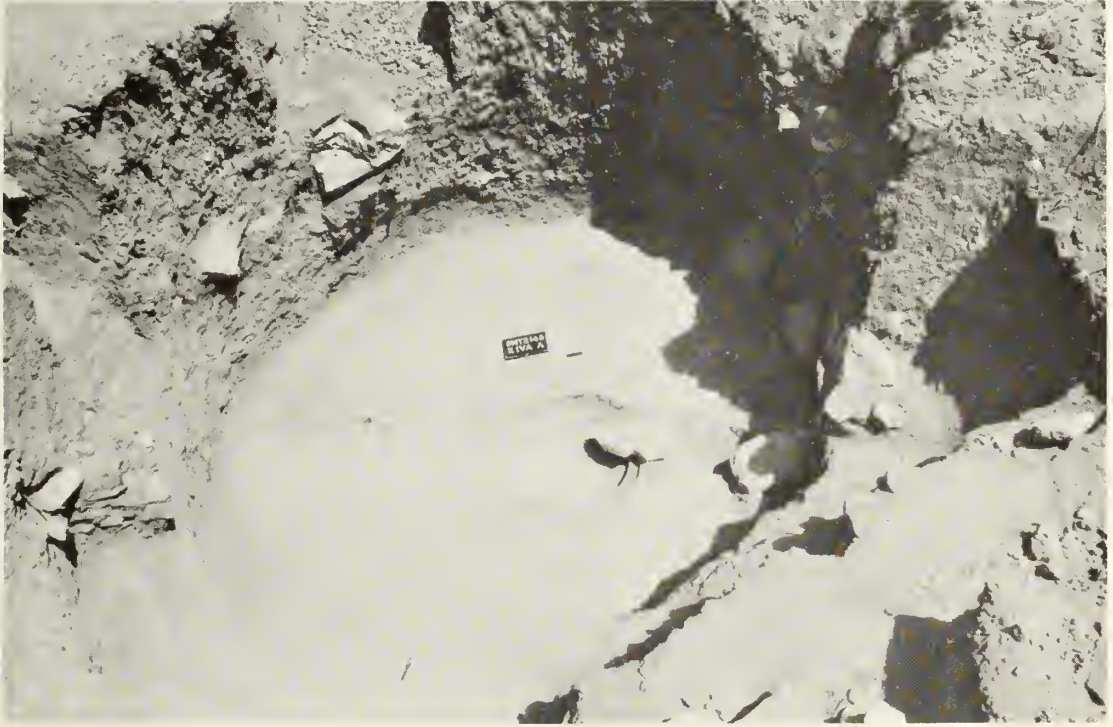
Figure 8. Kiva upon completion of excavations.

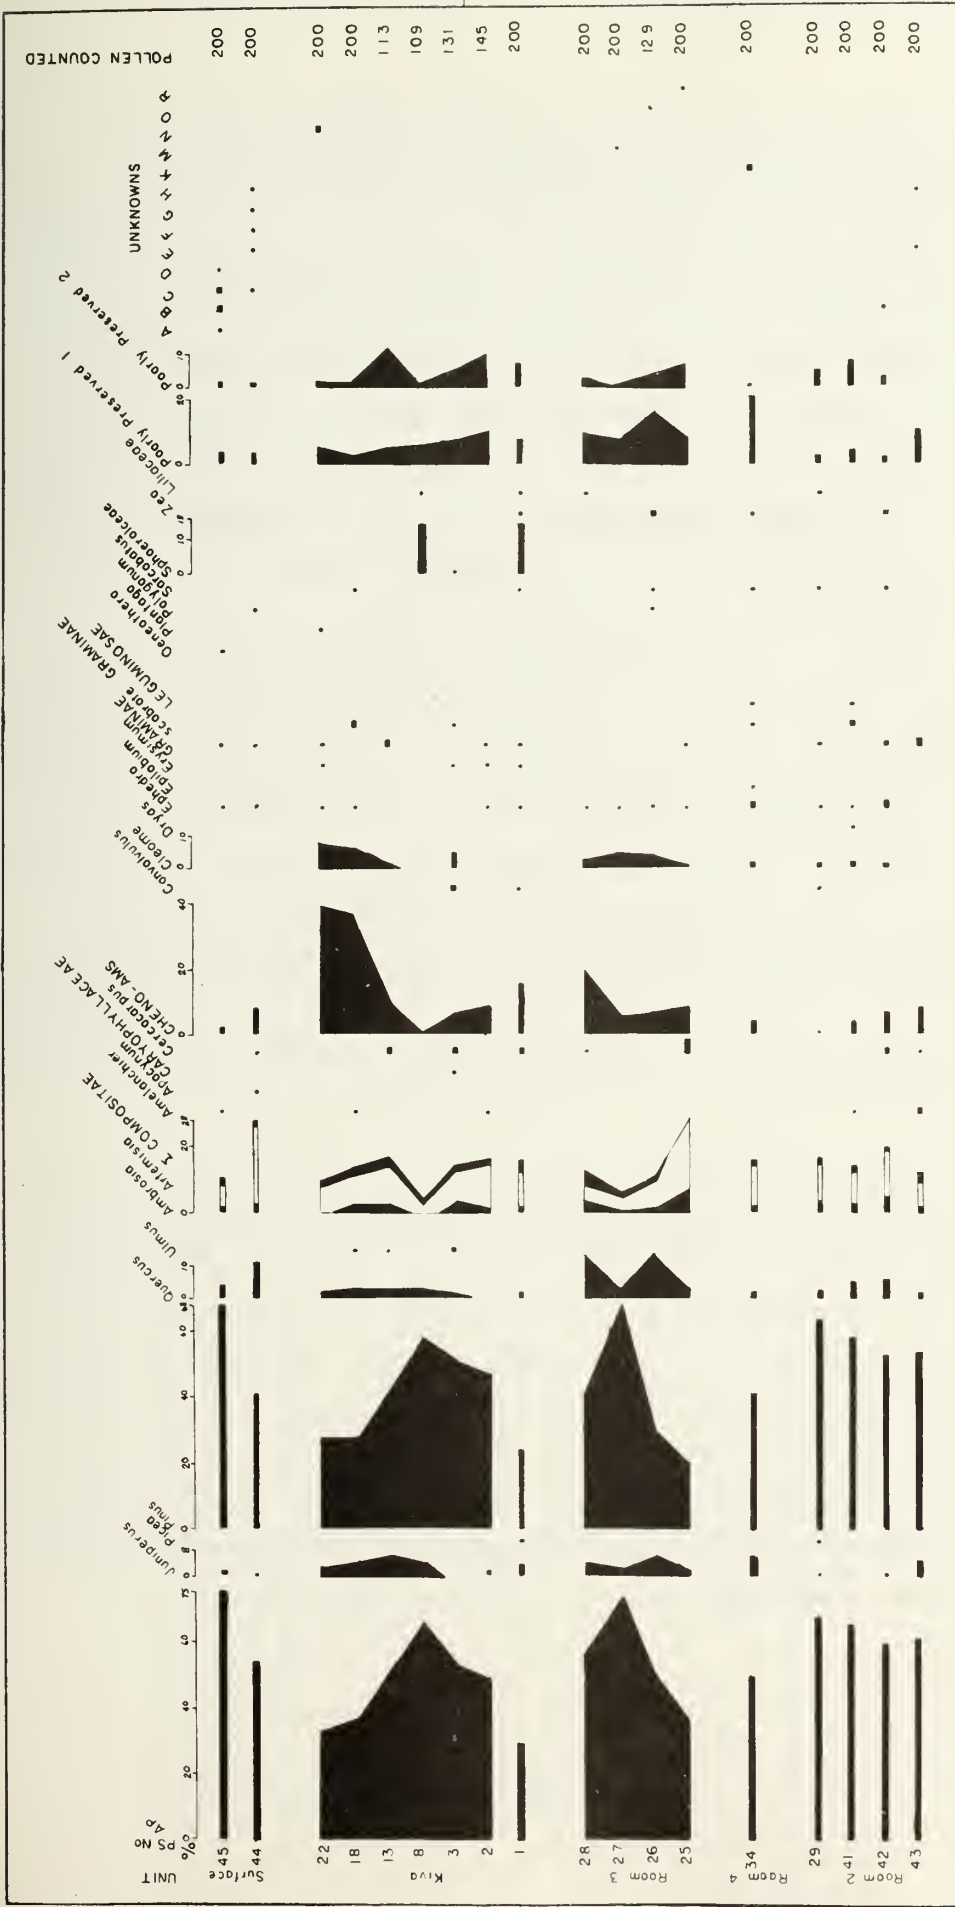
Fig. 1. Pollen diagram for Dominguez Ruin, 5MT2148.

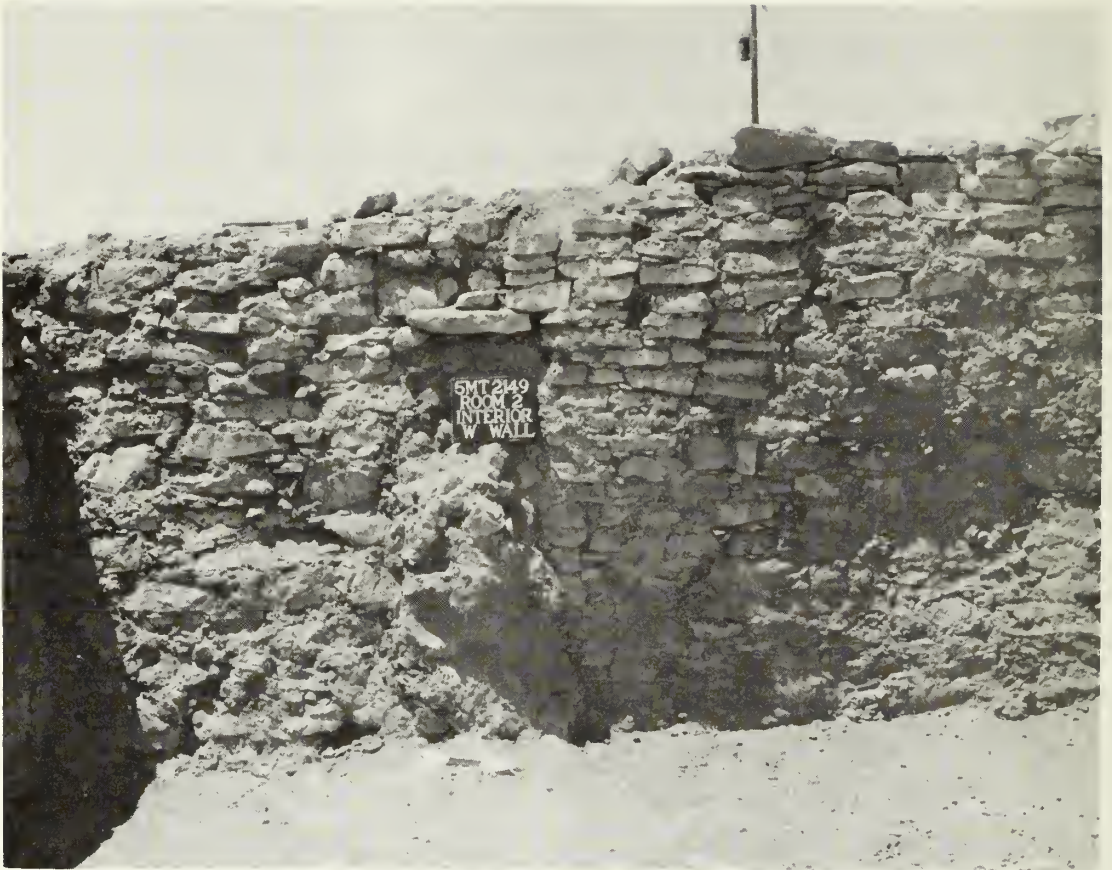
Figure 7: The west wall of Room 2 showing the Style 1 masonry.

The best example of Style 1 masonry is seen in Room 2. Roughly shaped sandstone blocks are set in uneven courses due to the range in sizes of blocks used, which varies from 4 by 23 cm to 12 by 37 cm. Rows of sandstone spalls are set in the mortar between the courses and continue in the fill between the stones within the wall. The chinking, achieving almost a decorative pattern, is fairly regular throughout the room, but is the most regular in the simple wall in the west wall of the room (Fig 7), which employs more uniformly sized building stones in the wall. The other walls of the room demonstrate the use of irregular sized blocks and an increasing use of larger blocks. In Room 8 adjoining and built onto Room 2, the blocks used are larger although there is a range in the size of the blocks, and the chinking though still present is less regular. The transition of the style

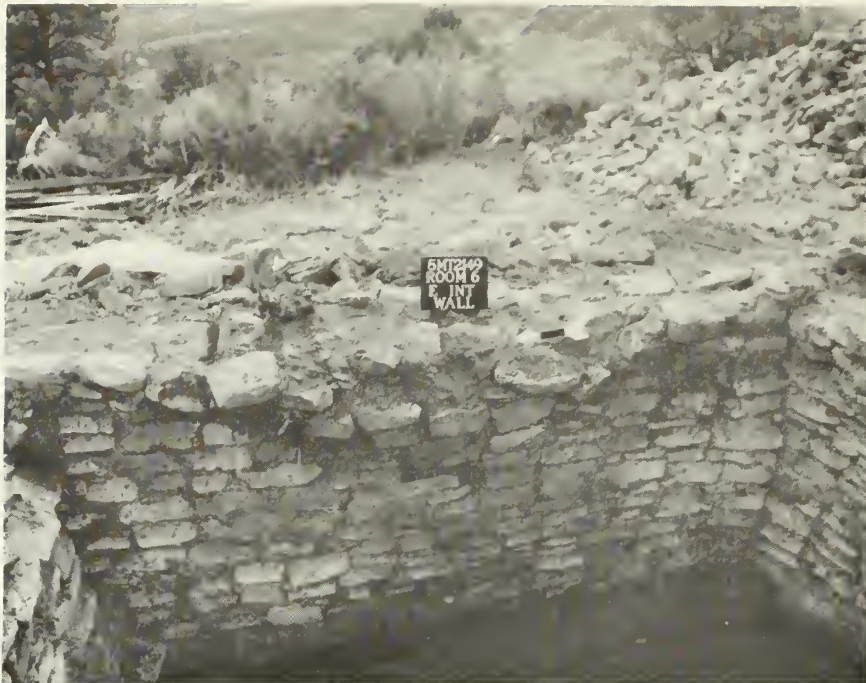
Figure 8: The east wall of Room 6 showing the Style 2 masonry.

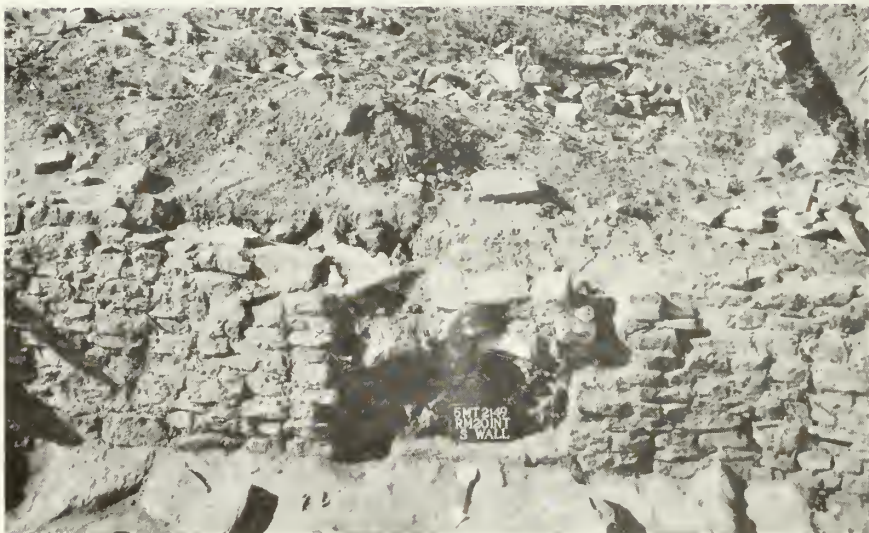
Figure 9: The south wall of Room 20 showing Style 3 masonry.

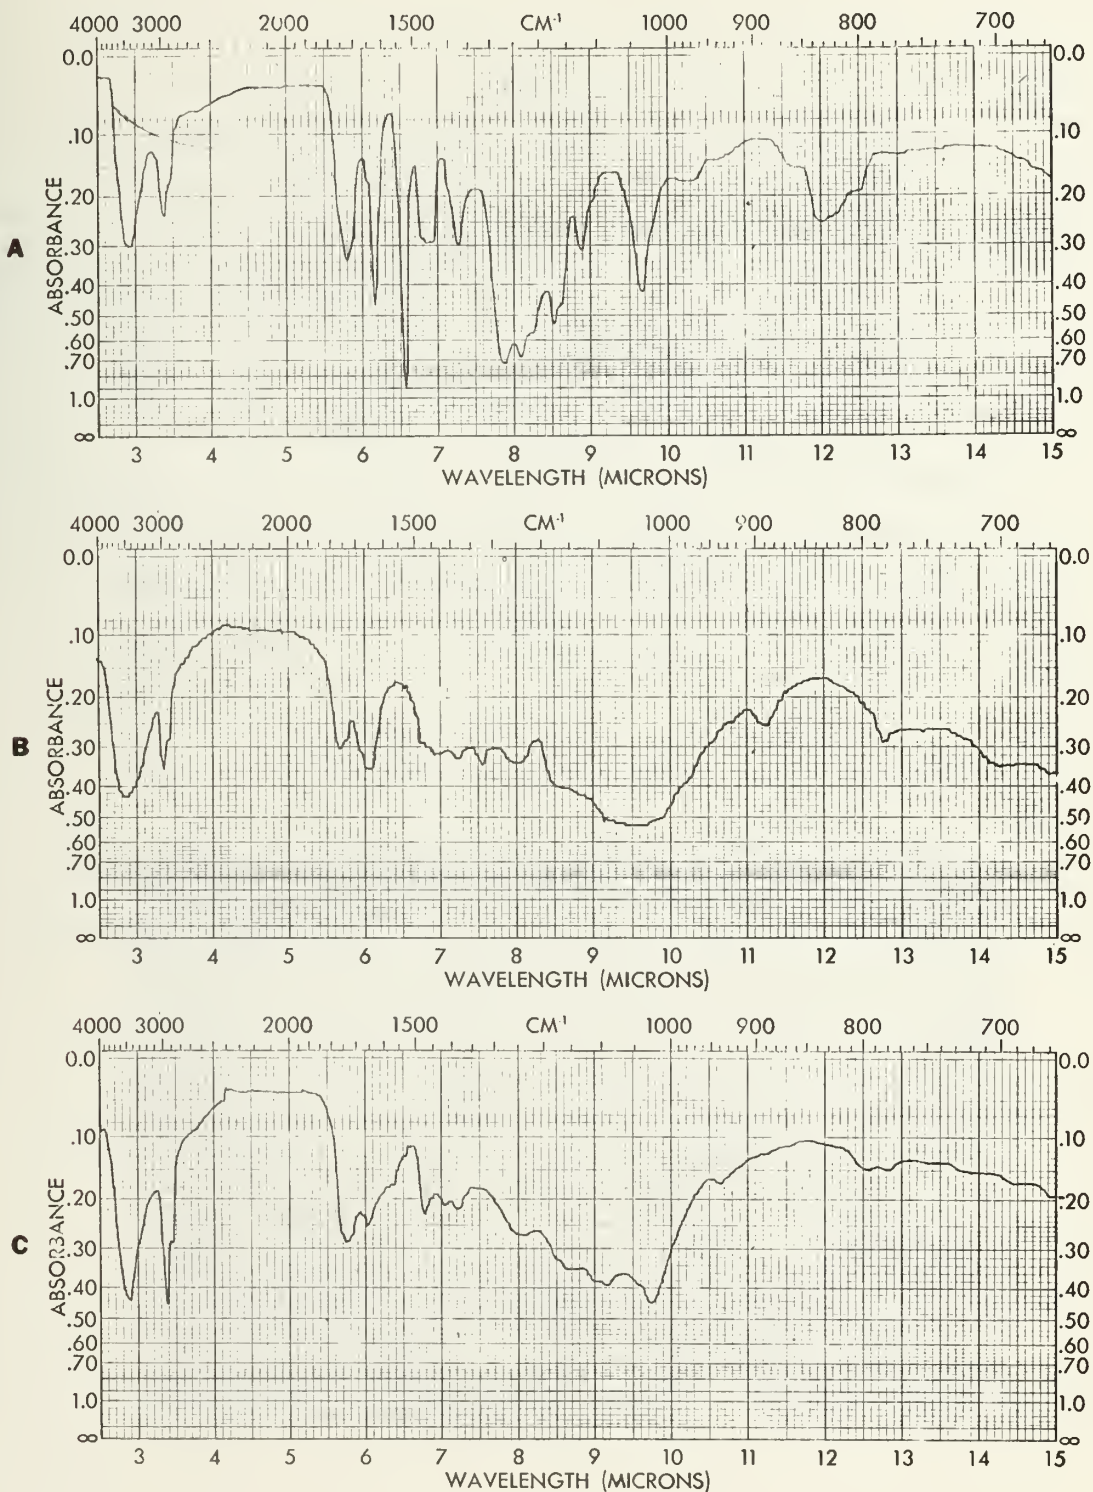
Figure 24: The infrared spectras. a, Pine pitch residue, 24 hours at 120^o C; b, Prickly pear sap, dried down; c, Adhesive residue from the jet and turquoise pendant.

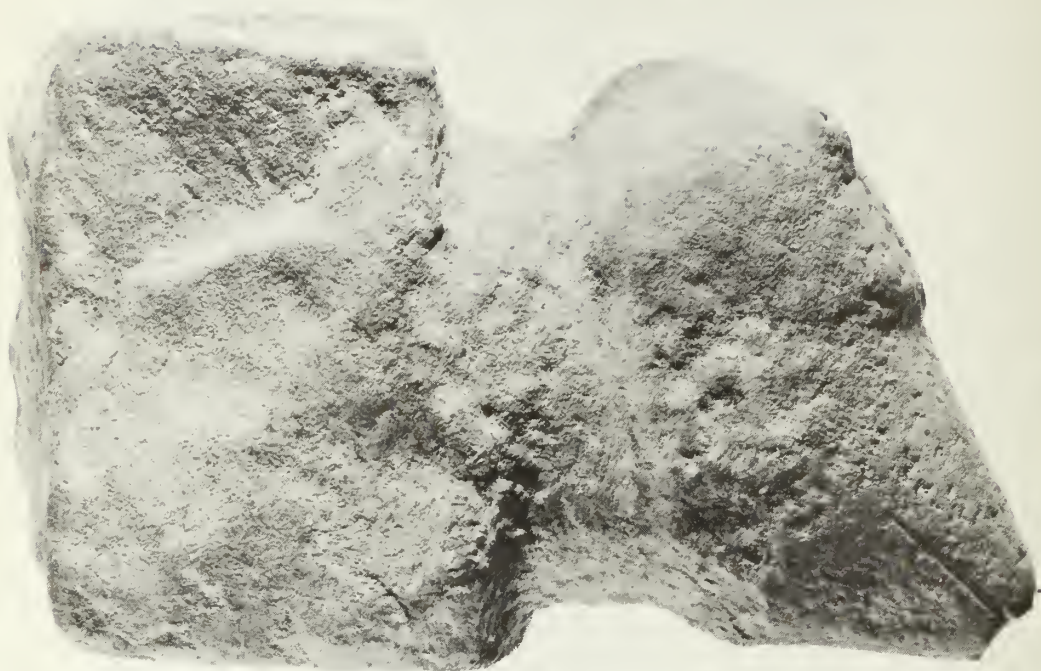
Figure 31: Building stone effigy designed to extend from a masonry wall.

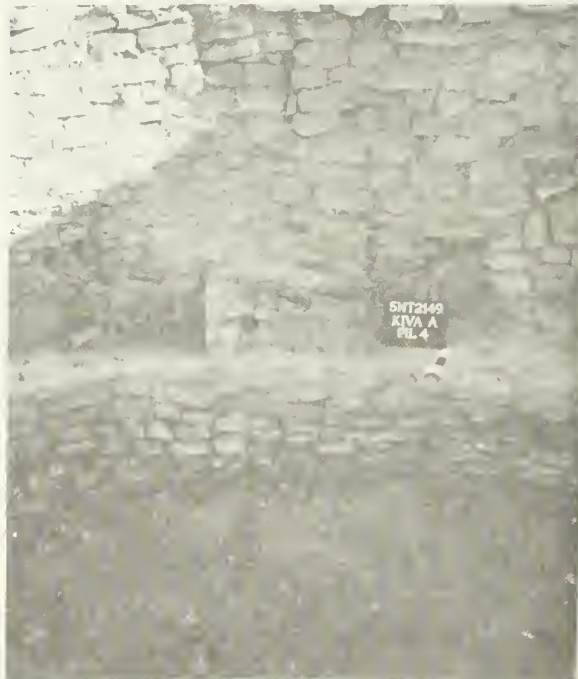
Figure 62: View in Kiva A of the remains of beams extending from the wall sockets and resting on Pilaster 4. The river cobble wall repair is seen in the wall.

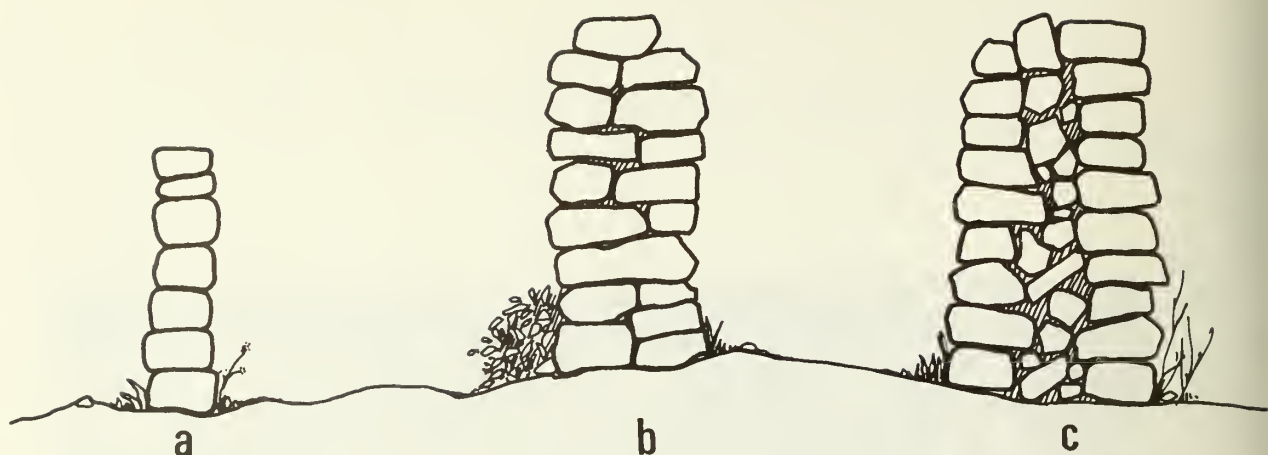
Figure 4. Wall Types. a, single wall; b, compound wall with no core; c, compound wall with rubble and mortar core.
